SITE ADDRESS	10 St. Sampson's Square, York			
CLIENT NAME	Morrison Utility Services			
YAT PROJECT #	5219	YAT REPORT #	2009/3	
MUSEUM ACCESSION #	n/a	GRID REFERENCE	SE 6034 5191	
PLANNING REFERENCE #	n/a	AAI OPS NOTICE #	09004	
ARCHIVE LOCATION	York Archaeological Trust			
DATE OF VISIT	10/03/09

On 10th March 2009 York Archaeological Trust undertook a watching brief outside 10 St Sampson's Square, York. The objective of the watching brief was to record any deposits, features or structures revealed during the excavation of a trench for a new water feed into the premises. Unfortunately the excavation failed to locate the feed point and after some delay a second hole was dug on 6th July 2009, immediately adjacent to the one dug in March which was located immediately outside the premises in the pavement at the south-west end of Three Cranes Lane. The site lies within the area of the Roman Legionary Fortress, the medieval walled city north-east of the River Ouse and the Central York Area of Archaeological Importance.

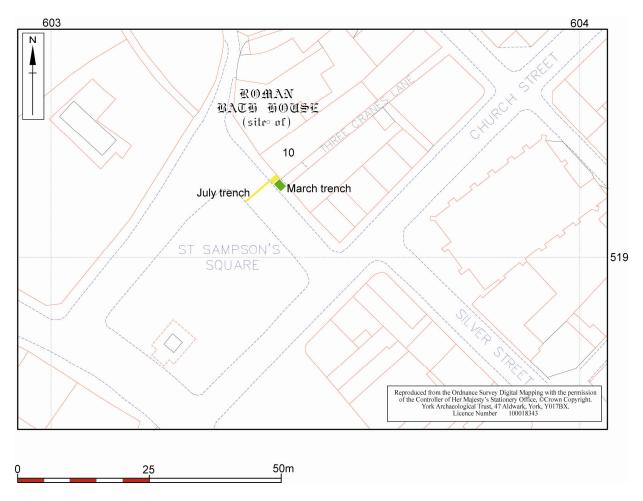
Figure 2 Location of trench

Recording took the form of written notes and measured sketches in a field notebook. The March trench was c.1.5 m long and 0.9 m wide although the width was narrowed at c.0.35 m below ground level (BGL) making the lower part of the trench approximately 0.6 m wide. The trench had a maximum depth of 1.2 m. The trench excavated in the pavement in July was $1.4 \text{m} \times 0.7 \text{m}$ and around 0.5 m deep. Additionally a trench, c.0.3 m wide and between 0.45 m and 1 m deep, was dug from the trench excavated in July across the road to connect the feed to the existing water main running along the south-west edge of the road.

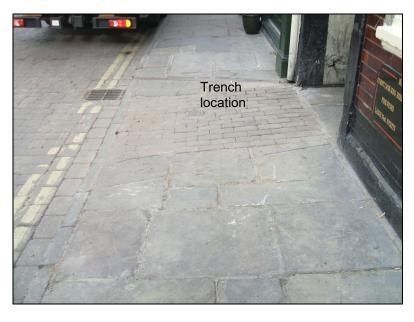
Plate 2 Location of March trench, looking north-west

In the March trench the earliest deposit recorded, between 0.7m BGL and at least the base of the trench, was a dark greyish-brown slightly clayey silt with moderate amounts of pale brown mortar (1005). This was probably cut by an unseen construction trench (1008) of uncertain dimensions. Within this putative cut was a foundation deposit of occasional cobbles set in a mid brown slightly sandy clay (1007). Sat on this were the remains of a limestone wall (1006) bonded with a soft pale brown mortar and surviving for just 0.3m above its foundations. It was a minimum of 0.7m wide and appeared to be aligned north-east / south-west. Sealing the wall was a dark brown clayey silt with moderate quantities of limestone fragments and pale brown mortar (1004). Above this was a mid brownish-grey slightly clayey silt containing a large number of relatively modern metal service pipes (1003). Overlying this was a dark brownish-grey slightly clayey silt with moderate brick / tile and occasional pale brown mortar (1002). It was sealed by a layer of coarse mid brown sand (1001) which formed the bedding for the modern ground surface of stone flags (1000).

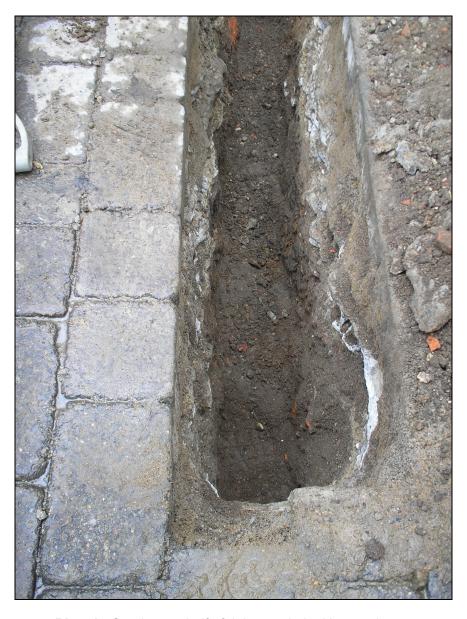
Plate 3 South-west half of July trench, looking north-east

The third section was at the south-west end of the trench across the road. Here the earliest deposit, recorded between 0.5 and at least 1m BGL, was a mid orange-brown very slightly clayey silt with

moderate brick / tile, lenses of dark greyish-brown silt, pea gravel and occasional patches of light to mid orange sand (1015). Overlying this was a 0.15m deep layer of very pale yellowish-brown crushed limestone (1016) and above this was a 0.1m deep layer of pale grey concrete (1017). This was overlain by a 0.15m deep deposit of mid brown sand (1018) which formed the bedding deposit for the modern road surface of concrete setts (1019).
