## YORK ARCHAEOLOGICAL TRUST REPORT

<b>SITE ADDRESS</b>	Utility trench, 1–41 Micklegate, York		
<b>CLIENT NAME</b>	Morgan Est Plc		
<b>YAT PROJECT #</b>	5268	<b>YAT REPORT #</b>	2009/63
<b>MUSEUM ACCESSION #</b>	n/a	<b>GRID REFERENCE</b>	SE 6007 5163
<b>PLANNING REFERENCE #</b>	n/a	<b>AAI OPS NOTICE #</b>	09022

Between 7<sup>th</sup> September and 29<sup>th</sup> September 2009 York Archaeological Trust undertook a watching brief on utility works between 1 and 41 Micklegate, York (Figure 1). The objective was to record any deposits, features or buried structures exposed during the replacement of a gas main along the southern side of Micklegate, although two trenches, 9 and 10, were actually within Bridge Street. Trenches were dug outside a number of properties to expose the feeder pipes, already renewed in plastic, and sections of the old iron main. The new plastic main would then be pushed through the inside of the old main thus avoiding the need for a continuous trench. A total of ten trenches (Figure 2) were observed although not all were recorded in detail. All the recorded or observed trenches lay within the road. Most trenches were roughly rectangular and measured c.1m x 1.

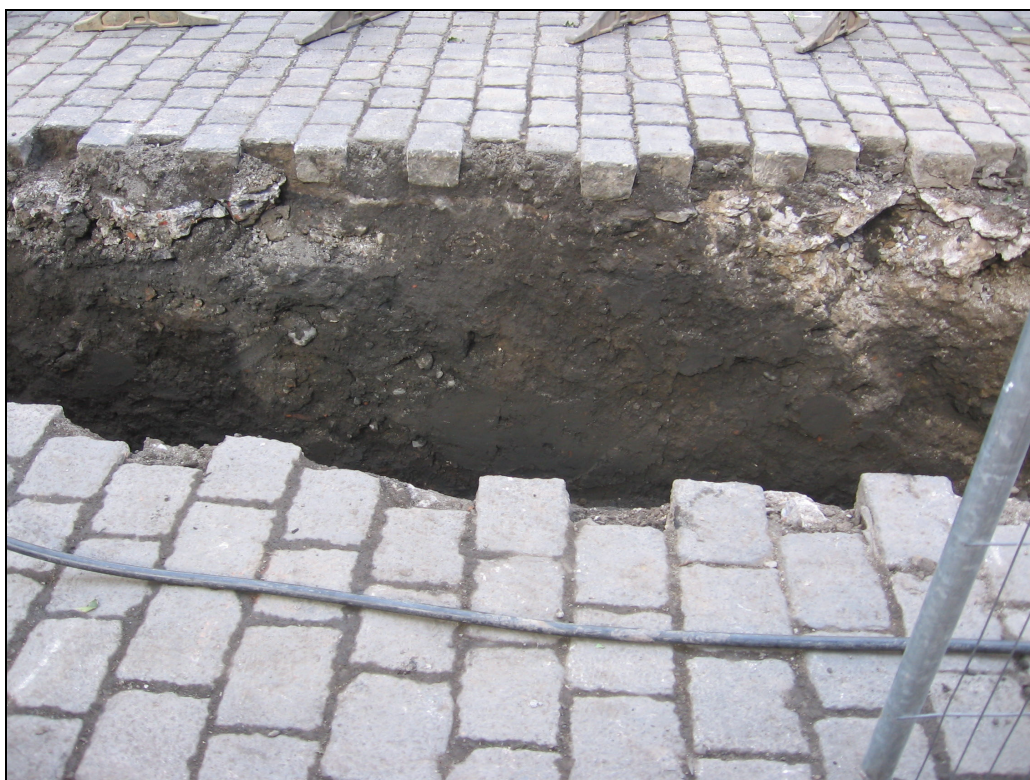
This section was located towards the west end of Trench 1. The lowest deposit noted, between 0.7m and at least c.1.2m below ground level (BGL), was a mid brown very slightly clayey silt with moderate cobbles and occasional brick / tile (1000). It was sealed by a 0.2m deep layer of mid brown silt with moderate patches of mid orange-brown silt and occasional flecks of pale brown mortar (1001). Overlying this was a 0.15m deep deposit of dark greyish-brown silt with occasional brick / tile and very occasional flecks of pale brown mortar (1002). Above it was a 0.1m deep layer of dark greyish-brown very slightly clayey silt with moderate pale brown mortar (1003). This was sealed by a 0.15m deep layer of pale grey concrete (1004) which formed the bedding for the modern road surface of stone setts (1005).

**Plate 1** Western end of Trench 1, looking north

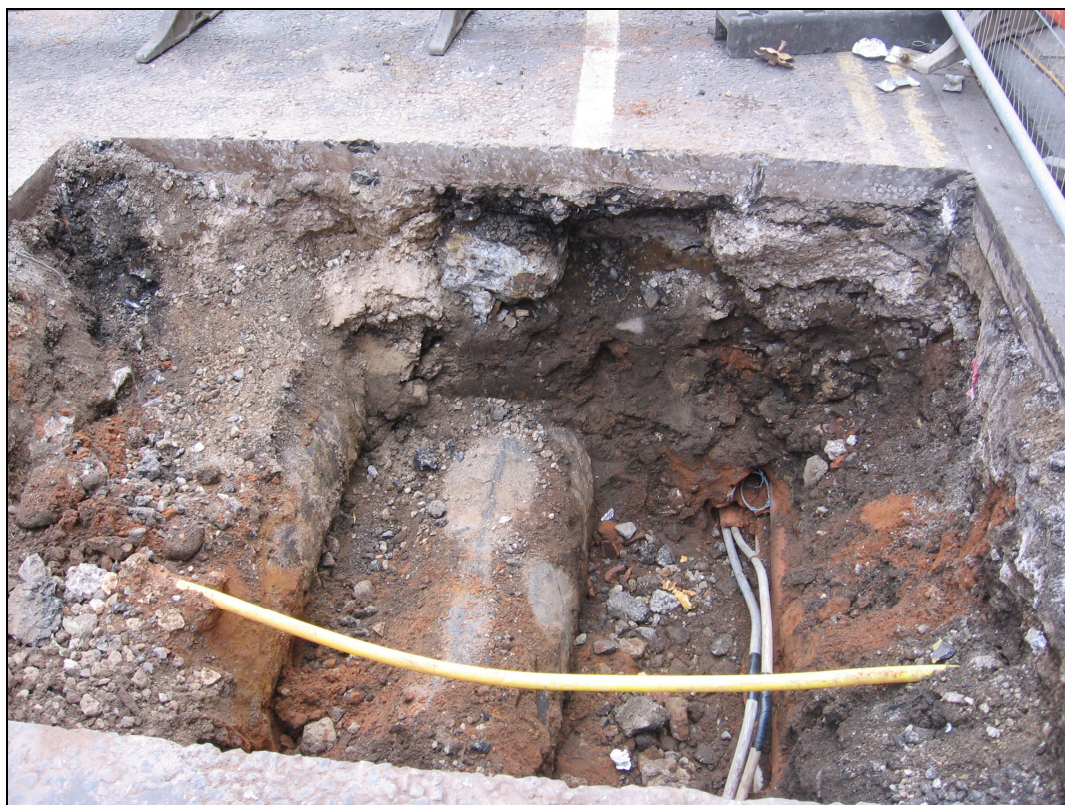
**Plate 2** Trench 6, looking east

The eastern side of Trench 6 was recorded for this section in which the lowest deposit seen, between 0.3m and at least 1m BGL, was a dark brown very slightly clayey silt with occasional limestone fragments and flecks of pale brown mortar (1028). Sealing this was a 0.2m deep layer of pale grey concrete (1029) which was the bedding for the modern road surface of black tarmac (1030).

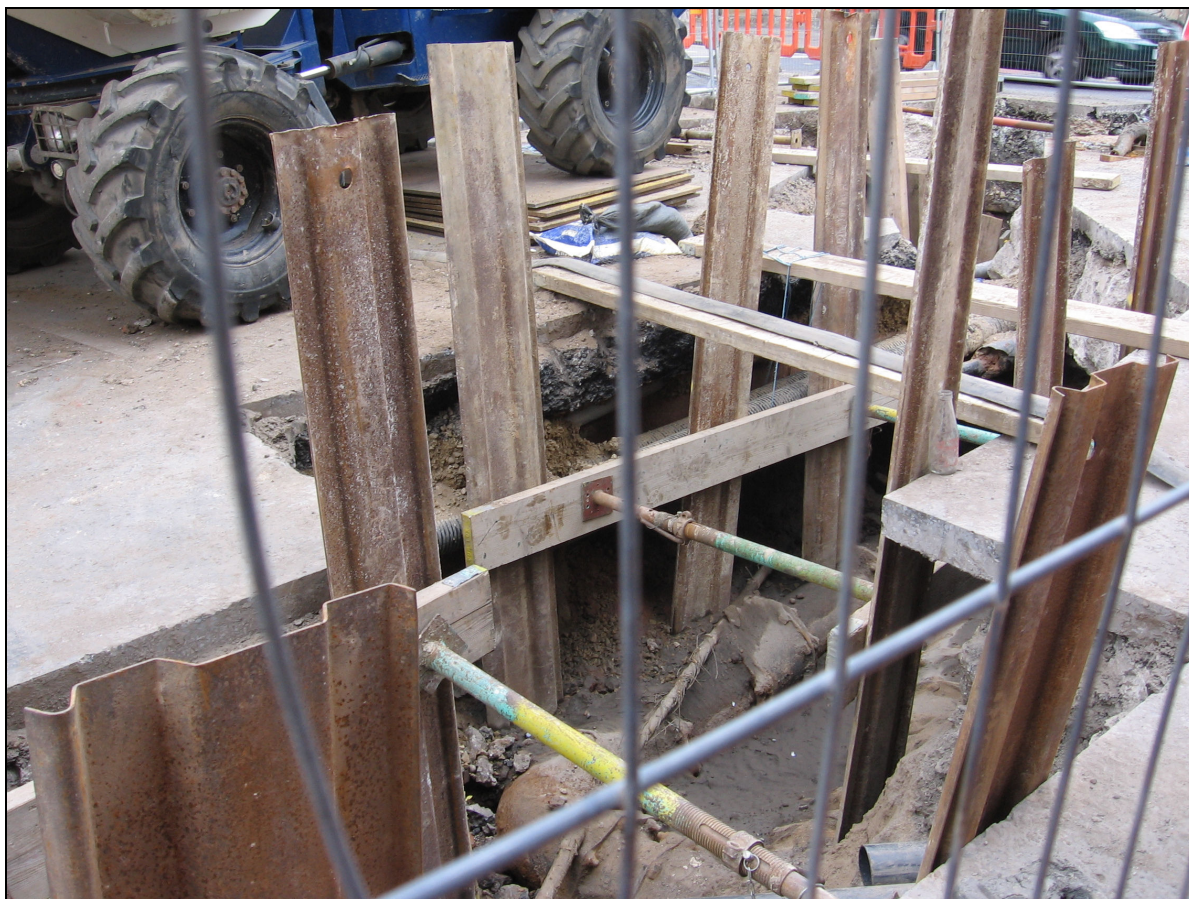
**Plate 3** Trench 8, looking north

This section was located at the northern end of Trench 8. The lowest deposit, noted between 0.3m and at least 0.8m BGL, was a very dark greyish-brown slightly clayey silt with occasional brick / tile and cobbles (1034). Overlying it was a 0.2m deep layer of pale grey concrete (1035) which formed the bedding for the current tarmac road surface (1036).

This section was recorded at the southern end of Trench 8. The earliest deposit seen, between 0.8 and at least 1.4m BGL, was a mid greyish-brown silt with moderate limestone fragments and occasional brick / tile (1037). Overlying it was a 0.5m deep layer of mid greyish-brown silt with frequent brick / tile and pale brown mortar (1038). Above this was a 0.2m deep layer of pale grey concrete (1039) forming the bedding for the road surface of black tarmac (1040).
