# YORK ARCHAEOLOGICAL TRUST REPORT

<b>SITE ADDRESS</b>	Utility trench, Ogleforth, York		
<b>CLIENT NAME</b>	Morrison Utility Services		
<b>YAT PROJECT #</b>	5273	<b>YAT REPORT #</b>	2009/61
<b>MUSEUM ACCESSION #</b>	n/a	<b>GRID REFERENCE</b>	SE 6050 5222
<b>PLANNING REFERENCE #</b>	n/a	<b>AAI OPS NOTICE #</b>	n/a

On 14<sup>th</sup> September 2009 York Archaeological Trust undertook a watching brief outside 4 Ogleforth, York (Figure 1). The objective was to record any deposits, features or buried structures exposed during the excavation of a trench to connect a new water supply to an adjacent development. A trench, measuring c.1.5m x 1m, was dug partly within the pavement and partly within the site boundary to expose the water pipes leading from the development. A second trench, c.0.8m x 0.5m, was then dug within the road to expose the main and a narrow trench, 1.4m x 0.3m, excavated to connect the two trenches, effectively making single trench roughly in the shape of a dumb-bell. One specimen section was recorded from the road area and another from the pavement / site area (Figure 2) and are described below. The excavation was generally by mini-digger with some hand digging close

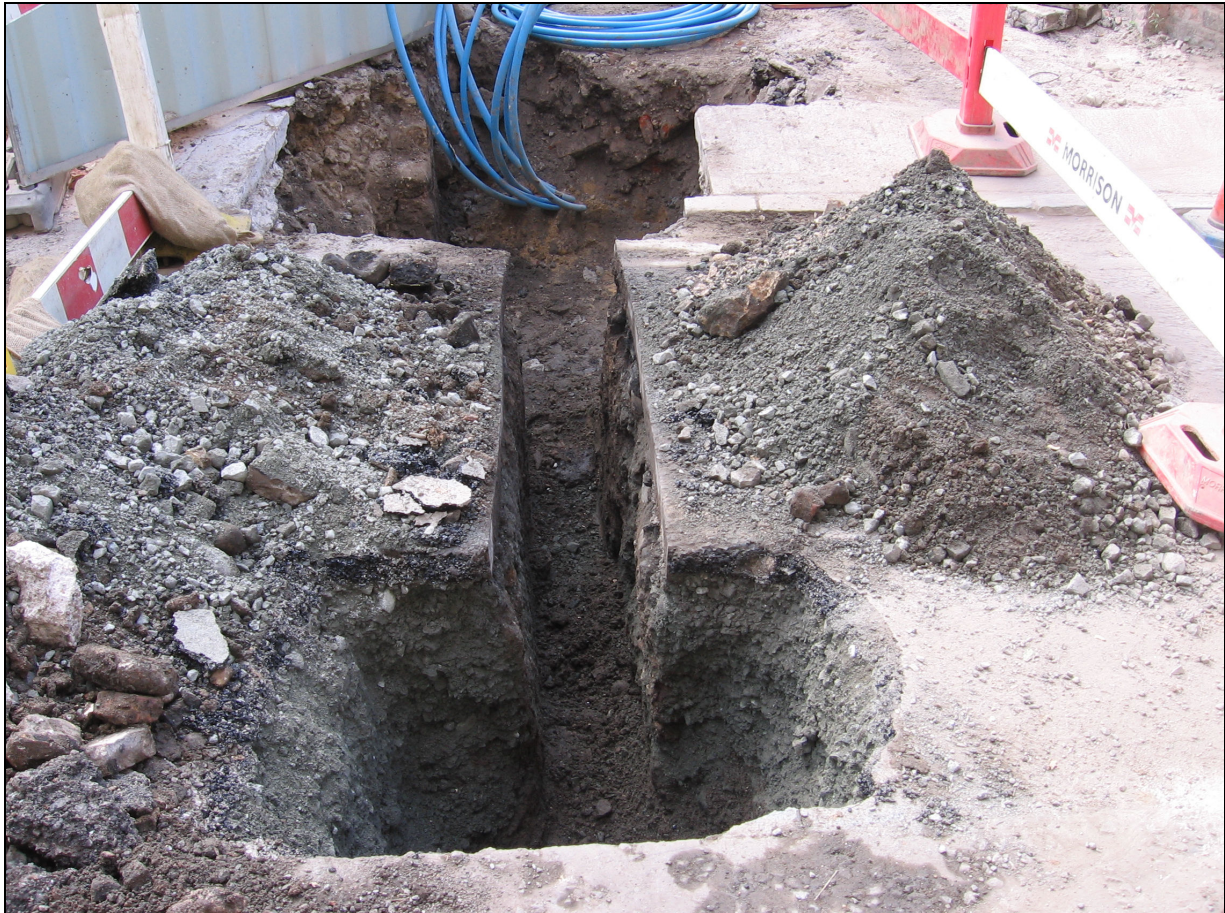
**Plate 1** General view of trench, looking south-west

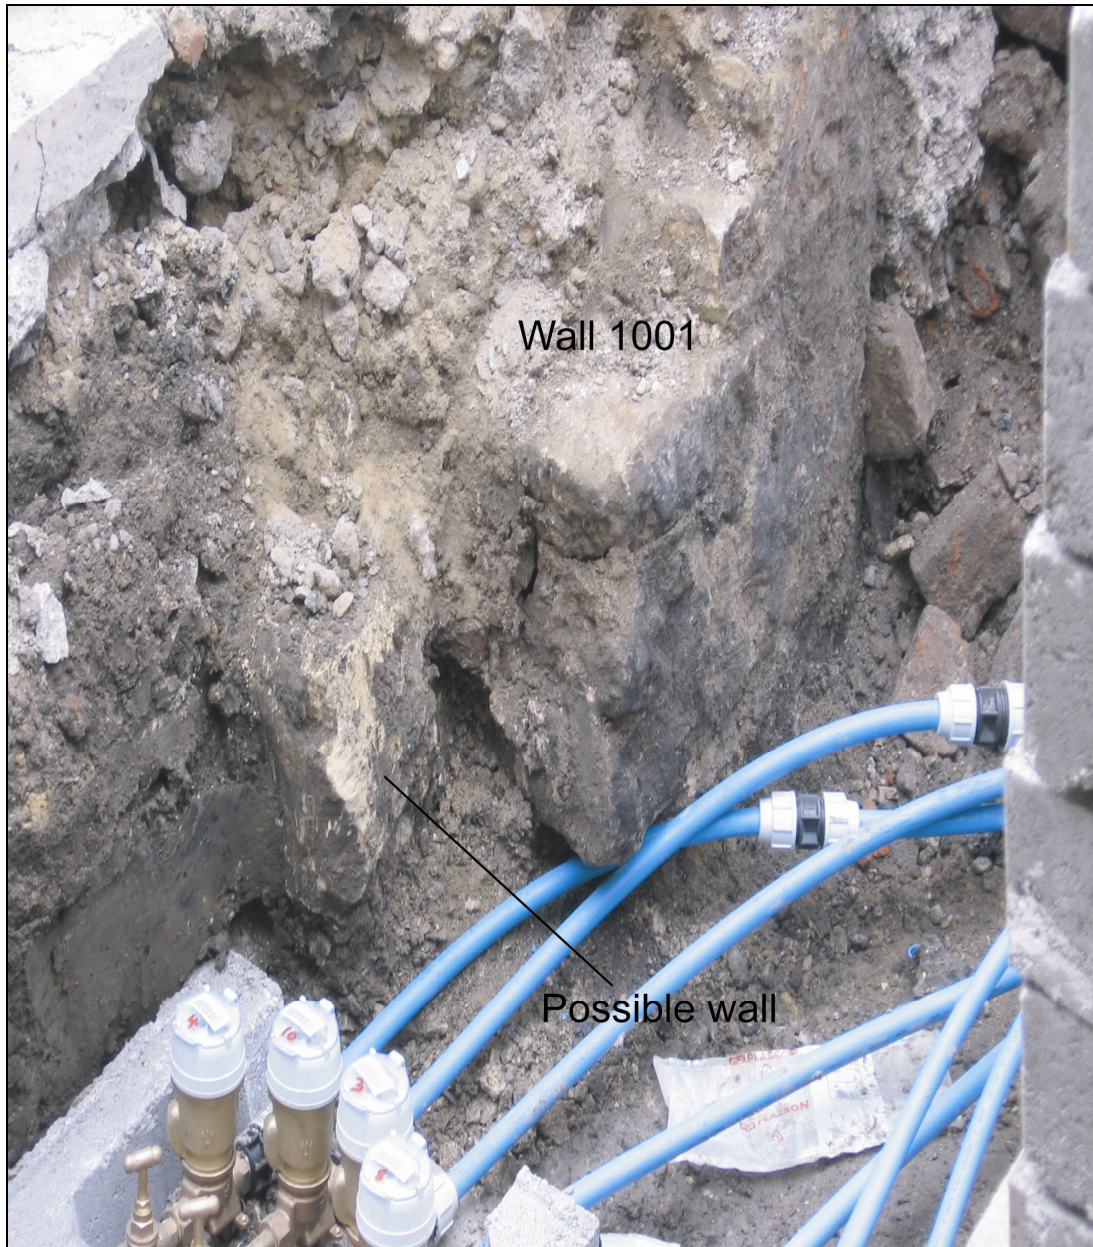
This section lay below the pavement extending into the development site. The earliest context noted, between 0.45m and at least 0.8m below ground level (BGL), was a short, c.0.5m length of stone wall (1000) aligned south-west / north-east and at least three courses survived bonded with a soft pale brown mortar. Although it could not be confirmed a separate block seen in the north-west facing section may indicate a north-west / south-east section of this wall lying almost exactly under the site side of the pavement facing onto Ogleforth. A deposit, again seen between 0.45m and at least 0.8m BGL, of dark greyish-brown very slightly clayey silt with occasional charcoal and pale brown mortar (1001) appeared to butt the wall. Both 1000 and 1001 were sealed by a 0.25m deep layer of dark brown silt with occasional brick / tile (1002). Above this was a 0.1m deep slab of

Most of the deposits seen were clearly modern and disturbed although it is possible that Context 1001 in Section 1 represents a relatively intact build-up deposit. The wall is of more interest since a previous evaluation of this area (YAT Report 2005/59) did reveal stone walls and various floor levels dating from the medieval and post-medieval periods. The date of the wall in this trench is uncertain but its depth and that it did not apparently contain any brick may argue for a medieval date. No floor levels were recorded associated with but may exist at a greater depth. Overall relatively little damage has been done to any archaeological remains.

**Plate 2** Detail view of wall 1001, looking south-east
