YORK ARCHAEOLOGICAL TRUST REPORT

SITE ADDRESS	Utility trench, Micklegate – George Hudson Street, York.		
CLIENT NAME	Morgan Est Plc		
YAT PROJECT #	5278	YAT REPORT #	2009/72
MUSEUM ACCESSION #	n/a	GRID REFERENCE	SE 6001 5170
PLANNING REFERENCE #	n/a	AAI OPS NOTICE #	09023

Between 14th September and 15th October 2009 York Archaeological Trust undertook a watching brief on utility works between the junction of George Street / Micklegate and the junction of Tanner Row and George Street, York (Figure 1). The objective was to record any deposits, features or buried structures exposed during the replacement of a gas main along the eastern side of George Hudson Street. A total of fourteen trenches (Figure 2) were observed although not all were recorded in detail. Most of the recorded or observed trenches lay within the road although three, Trenches 12 – 14, lay within the pavement on the west side of George Hudson Street. Most trenches were roughly rectangular and measured c.1m x 1.5m although there were some substantial variations in shape and size. After cutting out the tarmac initial excavation was by mini-digger although as the gas main, or any other known service, was approached ex

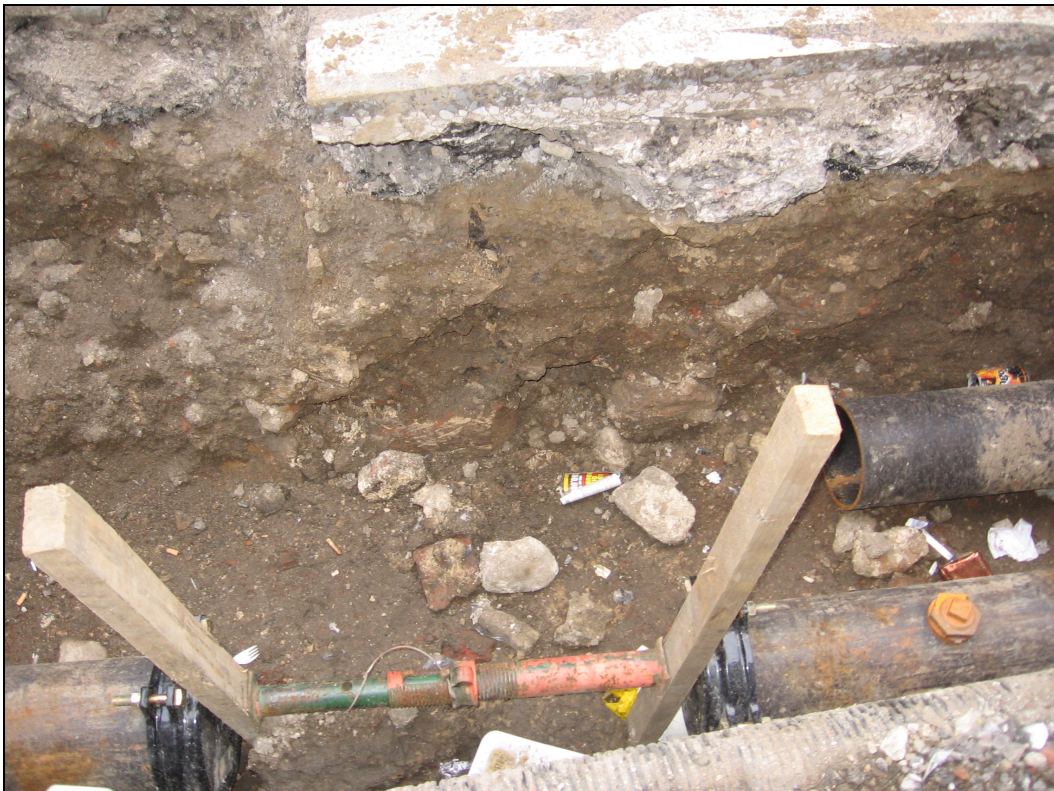
This was recorded within Trench 1. All of the deposits (1000 – 1002) seen in this trench were believed to be modern levelling deposits below the modern road surface (1003). The earliest of these deposits (1000) was, however, notable in that it contained moderate quantities of worked, squared limestone blocks.

Plate 1 Limestone blocks in base of Trench 1, looking west

Most of the trenches produced only modern deposits or possible disturbed build-up deposits of uncertain date. However, Trench 2 did contain a stub of limestone wall and Trench 1 squared blocks of limestone. It may well be the case that the blocks and the wall are derived from a medieval structure or structures demolished in order to widen the road, a practice well attested in York. Evidence for this has come from recent observations on the gas main replacement programme in North Street and Micklegate. It is therefore possible that significant archaeological remains survive in the vicinity away from areas of modern activity. Since the wall stub was left in-situ it can be concluded that the current works have done no significant damage to the archaeology of the area.

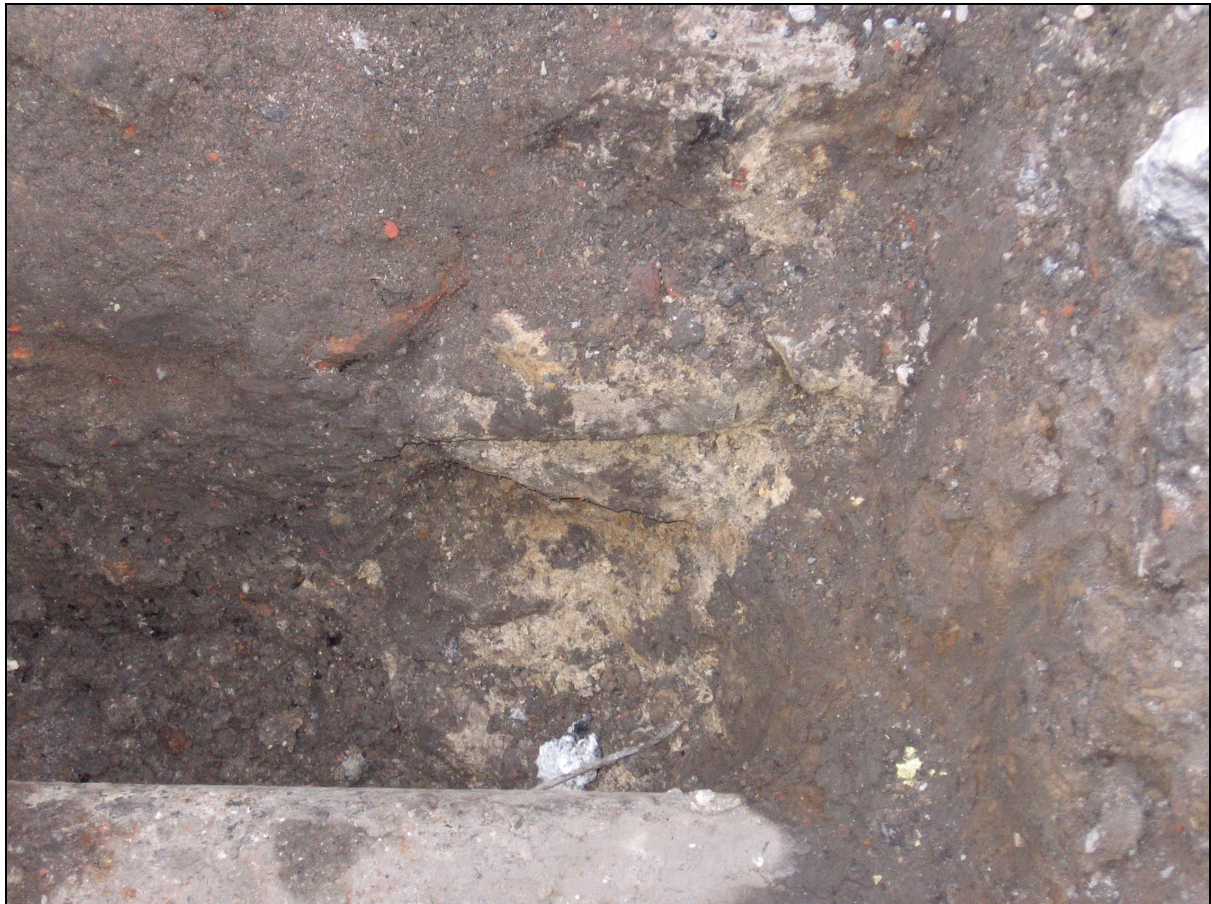
This section was recorded along the east side of Trench 2. In the south-east corner of the trench was a stub of limestone wall (1004). The width was uncertain but the wall was at least 0.5m long and 0.8m high, the top being c.0.4m below the modern ground level. It was aligned approximately north-south, bonded with a soft brown mortar and appeared to contain no brick. Seen butting this wall, between 0.8m and at least 1.2m below ground level (BGL), was a dark greyish-brown slightly clayey silt with moderate white / pale brown mortar and occasional charcoal flecks (1005). This was sealed by a 0.4m deep layer of mid brown very slightly clayey silt with moderate flecks of brick / tile and pale brown mortar (1006). Both may have been disturbed build-up deposits. Sealing Contexts 1004 and 1006 were modern levelling deposits (1007 and 1008) and above this the modern tarmac road surface (1009).

Plate 2 Limestone wall in Trench 2, looking east

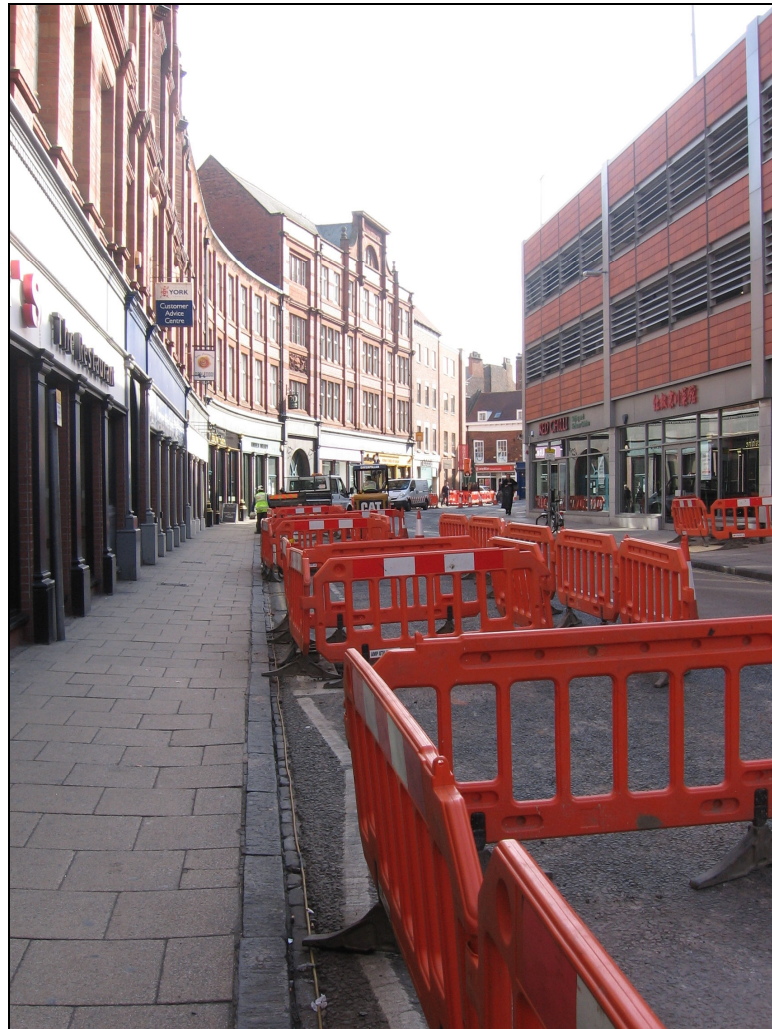
Plate 3 General view of works in progress, looking south
