SITE ADDRESS	Utility trench, Winterscale Street, York					
CLIENT NAME	Morgan-Est					
YAT PROJECT #	5289 YAT REPORT # 2009/75					
MUSEUM ACCESSION #	N/A	GRID REFERENCE	SE 6080 5094			
PLANNING REFERENCE #	N/A AAI OPS NOTICE # N/A

Introduction

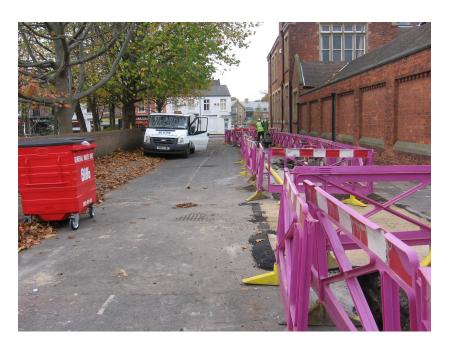
Plate 1 General view of trench along Winterscale Street, looking W

A broadly similar sequence of deposits was encountered along the length of the Winterscale Street trench with relatively minor variations being noted. The lowest deposits encountered in the trench were light brown clayey sands of clean appearance and containing no material indicative of human disturbance, context 1001. This material, which is interpreted as natural drift, was seen to extend to heights of between 0.55m - 0.36m BGL. The putative natural was generally sealed by mid - dark brown, clayey silts and sandy clay silts, context 1002, this varying slightly along the length of the trench and was generally around 0.15m deep. Occasional flecks of charcoal, fragments of brick, flecks of mortar and pieces of stone were evident within this material. 1002 is does not represent a former topsoil, though it could conceivably represent a disturbed sub-soil. In places along the trench the natural deposits were sealed by a darker and slightly more clayey deposit, context 1003, that in some areas contained substantial quantities of 19th century brick rubble together with lesser quantities of stone and mortar. This made ground may represent attempts at levelling prior to the laying of a street surface. Along much of the trench contexts 1002 and 1003 were sealed by a layer of orangish yellow, compact, gravelly sand, typically in the region of 0.04 - 0.10m thick and whose upper horizon was typically around 0.25 - 0.20m BGL. The purpose of 1003 was to act as a firm levelling off of the ground surface to facilitate the laying of a layer of cobbles, generally 1 – 2 cobbles deep, set within a matrix of firm, dark brown, clayey silt, context 1004. This cobble layer formed the street surface of Winterscale Street until is replacement with a surface of tarmac. The presence of 19th century brick below this metalling indicates a fairly late date, perhaps at the time of the laying out of Winterscale Street itself. The uppermost deposit within the trench was the extant road surface of tarmac, generally around 0.08m thick.

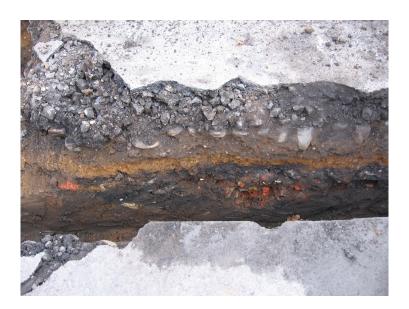
Plate 2 Trench section at east end of Winterscale Street, looking E

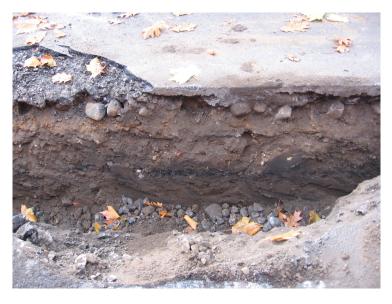
Plate 3 Trench section along central part of trench, looking S

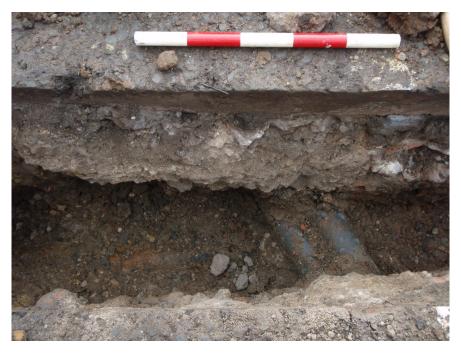
The Fishergate part of the trench, which extended into the central part of the road to connect with the gas main, was composed of a deposit sequence that bore distinct differences from that part within Winterscale Street. At the base of the trench the upper part of the old gas main was seen to

be an iron pipe, context 2001. Around and above this (extending to an upper height of some 0.47m BGL) was a very mixed deposit, context 2002. Seemingly comprised largely of re-deposited, brown, natural clays, this material contained quantities of stone, pebbles and brick fragments. The stratigraphic position of 2002, as well as its highly mixed characteristics, indicate this to be backfill of the trench excavated for the original gas main. Sealing this backfill was context 2003, a layer of concrete, generally around 0.35m – 0.38m deep. Context 1004 formed the bedding for the existing road surface of tarmac, context 2004, that was generally around 0.12m in thickness. The absence of a former street surface of cobbles in the Fishergate part of the trench, which stands in contrast to that in Winterscale Street, is owed to the depth of road foundation material in Fishergate, this of course being necessitated by the volume and weight of vehicles using the busy Fishergate route.

Plate 4 Trench section along part of trench into Fishergate, looking S

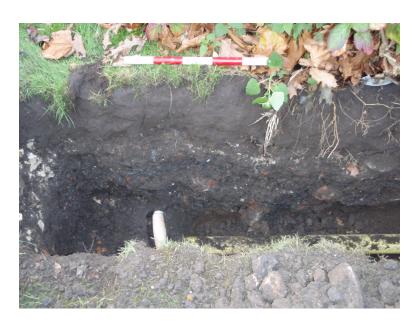
This stretch of trench extended from the boundary wall of the school on Winterscale Street and extended some 3.5m into the school grounds and had a depth of some 1.10m BGL. This area of the grounds is laid to grass. The lowest 0.80m of deposit visible in the section of the trench was essentially a rubbly topsoil, context 3001. Being composed predominantly of a dark greyish brown, sandy clay silt, this material contained significant quantities of brick rubble, stones, pebbles, mortar flecks and some clinker. A single sherd of 19th century pottery and a fragment of bottle glass were observed in the upper parts of this context. No significant layering within this material was evident. Sealing 3001 was context 3002, a dark greyish brown, sandy clay silt topsoil, generally around 0.30m deep, that supports the extant turf-line.

Plate 5 Southern end of the trench within the school grounds, looking W
