SITE ADDRESS	St. Dominic's Crag, Copley Gardens, Sprotbrough, South Yorkshire					
CLIENT NAME	JVN Architecture Limited					
PROJECT #	5321	REPORT #	2010/35			
MUSEUM ACCESSION #	N/A	GRID REFERENCE	SE 5403 0182			
PLANNING REFERENCE #	05/01750/FUL	AAI OPS NOTICE #	N/A

Archaeological observations and records were made during the mechanical removal of topsoil and the demolition of a twentieth-century house during ground-works at Copley Gardens, Sprotbrough. A crude modern road and yard surface were identified and associated with the house, and the underlying soil was thought constitute modern ground-raising. The remains of an eighteenth century ice house known to survive beneath the building were monitored during demolition.

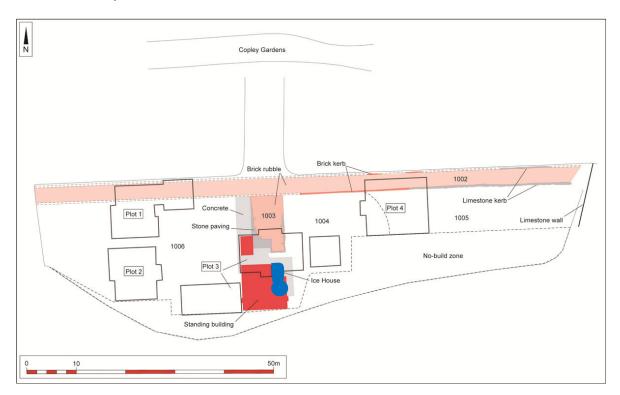
Figure 2 Location of features (adapted from developer's plan)

Soil stripping commenced in the eastern half of site, over the areas of plots 3 and 4 (Figure 2). Vegetation was removed with a mechanical excavator, which was then used to strip off up to 0.20m of the topsoil (context 1001) with a toothless ditching bucket under archaeological supervision by lan Milsted. This revealed the remains of a crude road, 1002, which consisted of a 3.6m wide surface made of packed crushed brick rubble with limestone fragments, bounded on either side by a kerb. The kerb was constructed in some places with a single row of bricks and in others by edge-set subrectangular limestone blocks (Figure 2, Plates 1 and 2). This road ran along the entire northern edge of the site (Figure 2) and is considered to be modern in date. The bricks used on the surface and the kerb were machine-made and measured 0.25 x 0.11 x 0.08m, indicating a date of no earlier than c.1850; the presence of more modern building materials in the surface suggests a much more recent date than this, and the current interpretation of 1002 is that it is contemporary with the dwelling house referred to above, thought to date from the 1940s (Mark Hardy, pers. comm.).

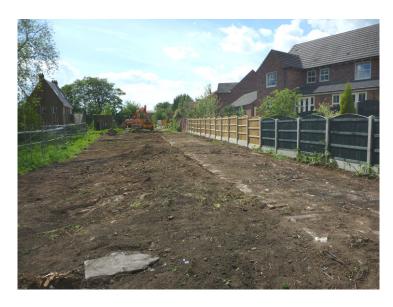
Plate 1 Looking west from eastern end of site with road 1002

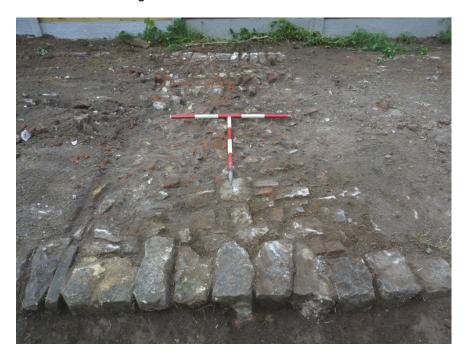
Plate 2 Detail of road 1002, looking north

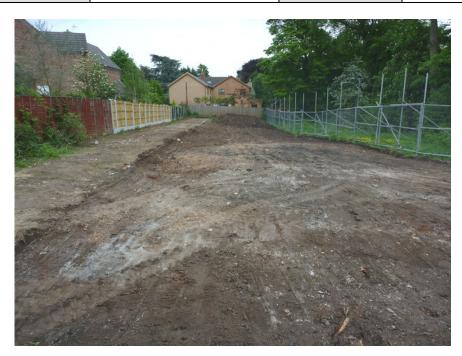
The area exposed south of road 1002 revealed two distinct deposits (Figure 2, Plate 3). 1004 was an area of compact mid-brown sandy-silt with a large amount of crushed limestone and brick fragments, together with plastic piping and other modern materials, and was interpreted as a levelling deposit of modern building waste. 1004 extended eastwards from the eastern edge of the house and yard for around 21m. Beneath this was 1005, a firm-friable, mid-brown sandy silt with patches of redeposited stiff orange-pink clay and occasional brick and limestone debris, which was interpreted as a ground make-up deposit. Both 1004 and 1005 contained lenses of ash, and there were several places where modern bonfires appeared to have been sited.

Plate 3 Looking east, showing 1002, with 1004 in foreground and 1005 beyond

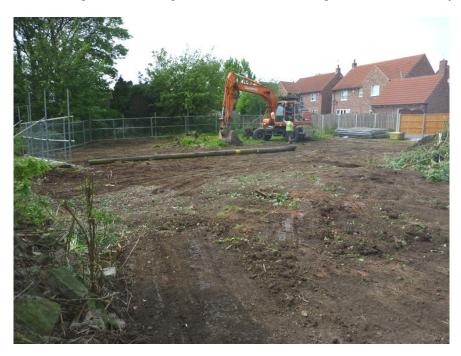
To the west of the house and yard surface 1003, up to 0.20m of topsoil was stripped, exposing 1006, an expanse of firm-friable, mid brown, sandy silt virtually identical to 1004, which had been disturbed by modern services and fence-lines (Figure 2, Plate 4). This area was observed by Andrew Lines, SYAS, while it was being stripped, and on the basis of observations already made, no further archaeological supervision was deemed necessary.

Plate 4 Looking west, showing 1006 in western part of site

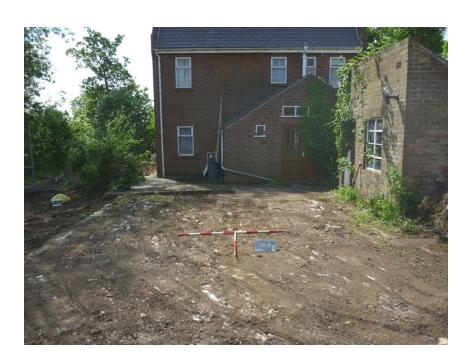
In the centre of the development area, immediately north of the dwelling house, was a yard, 1003 (Figure 2, Plate 5). This was constructed in a similar way to road 1002, and abutted it at its northern edge. Yard surface 1003 consisted of limestone block kerbs up to 0.90m x 0.50m in size, which bounded an area of mixed rough stone paving, concrete slabs and packed crushed brick and limestone rubble.

Plate 5 Looking south, showing yard 1003 and house to be demolished

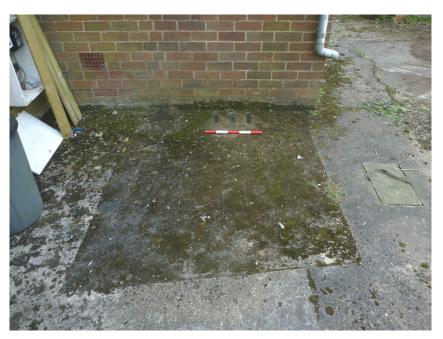
Plate 6 Concrete cap and sky-light over position of ice house entrance, looking west

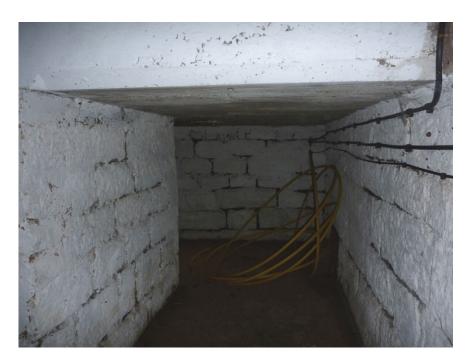
Plate 7 Interior view of ice house entrance prior to demolition of building above, looking north

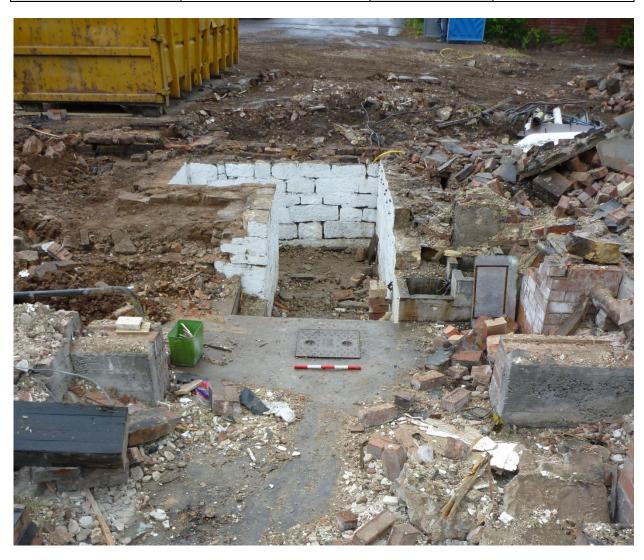
**Plate 8** View of ice house entrance walls with ice house chamber access manhole in the foreground, looking north

The demolition of the dwelling house was observed, as stipulated by the WSI, by Ben Reeves. The condition of the ice house remains were monitored (Plates 8 & 9) and care taken to prevent damage to its fabric. The exposed walling was covered with steel sheeting following demolition of the buildings, and the area placed off-limits for machinery until consolidation takes place.

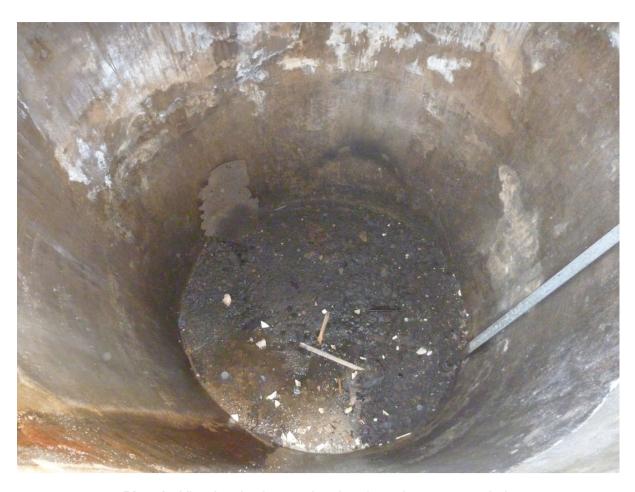
Plate 9 View into ice house chamber through access manhole
