SITE ADDRESS	Plant borders, Dean's Park, York				
CLIENT NAME	Dean and Chapter of York Minster				
YAT PROJECT #	5299	YAT REPORT #	2010/4		
MUSEUM ACCESSION #	n/a	GRID REFERENCE	SE 6027 5222		
PLANNING REFERENCE #	n/a	AAI OPS NOTICE #	n/a

On 1st -2nd February 2010 a watching brief was undertaken by YAT of the machine removal of soil from a flower-bed adjacent to a limestone wall which forms the western boundary of Dean's Park, York. The soil was removed using a mechanical mini-digger, and will be replaced with fresh imported soil prior to the planting a new rose bushes. The works followed on from the excavation of seven small test trenches excavated by YAT in November 2009.

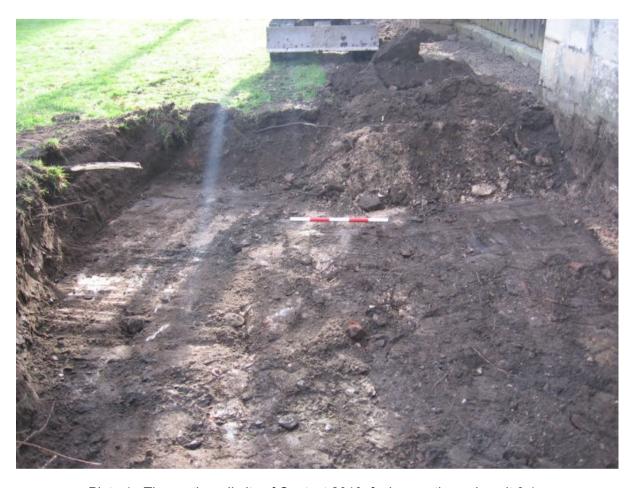
Plate 1 The northern limits of Context 8010, facing south, scale unit 0.1m

The earliest deposit reached was Context 8010, the upper surface of which was seen over the southernmost 2m of this trench at c.0.3m BGL. It is unclear if this deposit petered out on the northern side, or was sloping downwards beyond the depth-limits of the present excavations. A modern flower bed edging (Context 8012) of limestone blocks 0.25 x 0.15 x 0.10m in size, bedded on mortar, had been inserted around the original 1.35m wide flower bed. The uppermost deposit encountered was Context 8000 which was up to 0.46m thick.

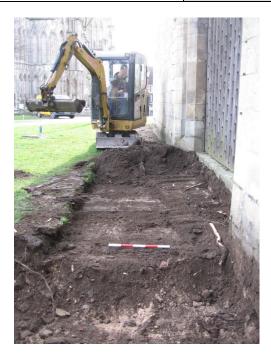
Plate 2 Context 8000 adjacent to the Purey Cust gateway, facing south, scale unit 0.1m

Context 8000 continued across this area to the maximum depth excavated, i.e. 0.15m. No features of archaeological interest were seen, due to the shallower excavation in this area.

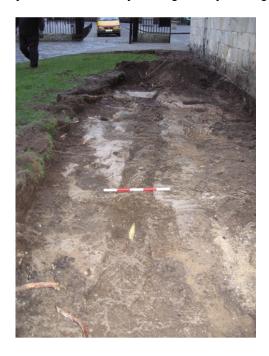
Plate 3 Context 8011 and services trench fill 8007-8, facing south, scale unit 0.1m

Sealing the southern portion of 8010 was a deposit of sandy mortar (Context 8011) up to 1m wide and up to 0.1m thick; this was clearly of modern date and this seems to have been used to cap the underlying rubble deposits. This deposit was visible over the eastern half of the trench.

Truncating 8010 and 8011 was a modern services pipe trench. The trench (Context 8009) was up to 0.3m wide and contained a yellow plastic pipe c.0.1m in diameter (Context 8007). The trench was infilled with mid brown slightly gravelly sand (Context 8008). The top of the pipe was c.0.4m BGL.

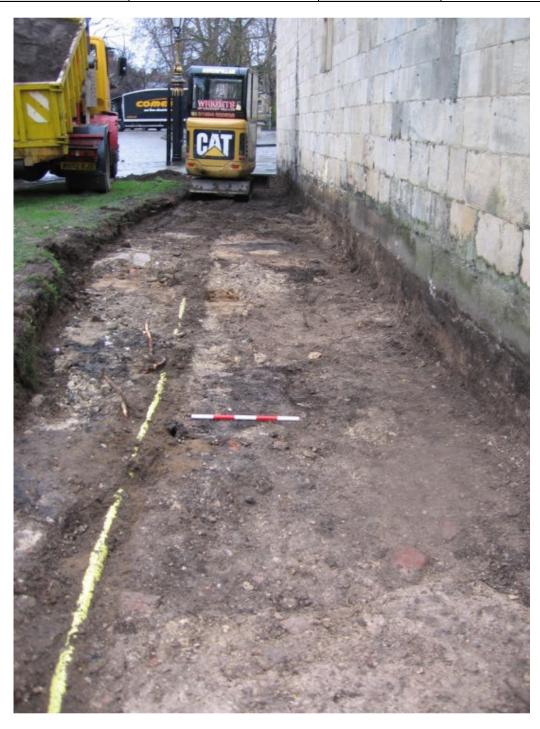
Plate 4 Context 8011 and services trench fill 8007-8, facing south, scale unit 0.1m

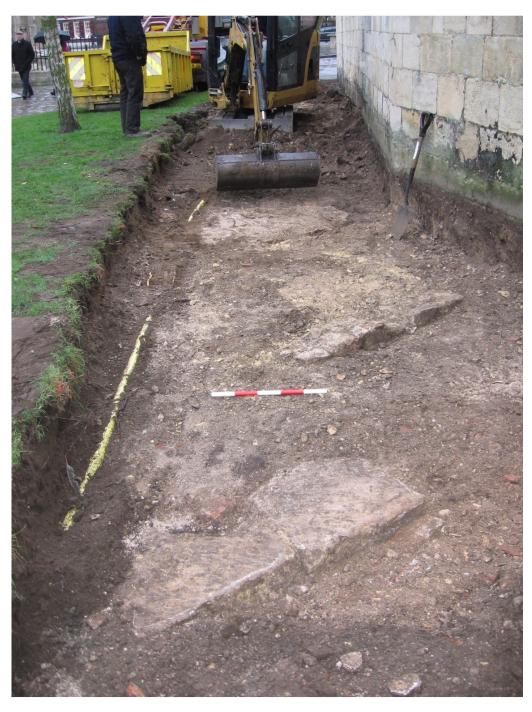
Plate 5 Contexts 8004 (foreground), 8005 (mid-ground), 8006 (adjacent to machine bucket), and services pipe 8007 (along the left hand side of the trench), scale unit 0.1m

The earliest deposits encountered were the remains of three walls (Figure 3) the upper surface of which were all at c.0.44m BGL, which was almost the maximum depth required for excavation of 0.46m; the decision was taken to excavate only to the top of these walls.

Within the excavation area there are the remains of three walls. Unfortunately no dating evidence was recovered with any of the walls, so it is unclear if they are of medieval or post-medieval date. The three walls appeared to be on marginally different alignments, though all were aligned broadly north-east to south-west. Without full excavation it is difficult to know if these structures represent internal or external building walls, or how they relate to one another chronologically.

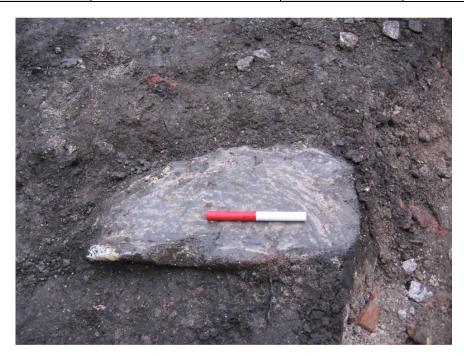
Plate 6 Context 8003, scale unit 0.1m

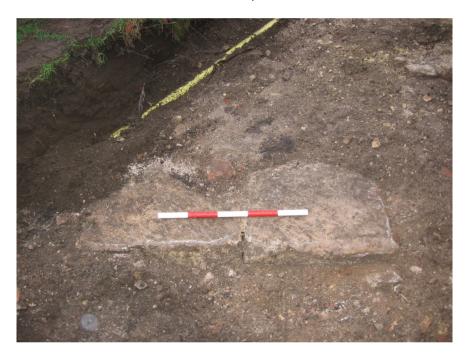
Plate 7 Context 8004, scale unit 0.1m

The northernmost wall, Context 8004, was aligned north-east to south-west and was 1.08m long and 0.42m wide. The wall comprised two blocks of limestone $0.50 \times 0.40m$ in area and $0.48 \times 0.42m$ in area respectively. The two blocks were bonded with a coarse yellow mortar. Both blocks were carefully dressed on the north-western facing elevation, but were of irregular shape on the south-eastern elevation, suggesting that the north-western side was the original exterior. It is unclear what form the south-eastern elevation took originally, as this face was sealed by demolition material

implying that it had been robbed away. There was some hint of wear on the north-western edge of the westernmost stone, perhaps hinting that this could have been a doorway or sill, however, this was far from clear. A small area was cleared adjacent to the western edge of the south-westernmost block which revealed that the block was 0.19m high with claw tooling and a small area of mortar present on the south-western face of the block; it was unclear if this mortar was bonding material or an adjacent (now missing) block of stone or a mortar surface which could imply that this was the original termination of the wall. It was also clear that this block represented an upper course of stonework and that there was a lower course of stonework beneath. The north-eastern end of the wall had been destroyed by a later intrusion (Context 8009).

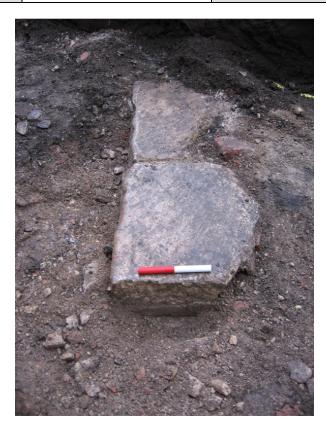
Plate 8 The south-western end of Context 8004, facing north-east, scale unit 0.1m

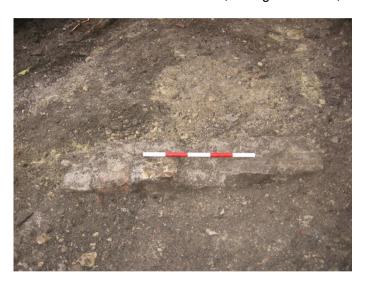
Plate 9 Context 8005, facing south, scale unit 0.1m

The second wall, Context 8005, was also aligned north-east to south-west and was c.0.8m south of wall 8004. This wall was 1.20m long and 0.24m wide and was made from roughly squared limestone blocks ranging from 0.25 x 0.1 x 0.8m to 0.16 x 0.17 x 0.10m in size, bonded with a coarse white lime mortar. Some of these blocks were discoloured pink/red due to burning. The pattern of the burning indicated that the stones had be re-used from elsewhere rather than being burnt in-situ. There was no discernable difference in the facing of the north-western and south-eastern facing sections. The south-western end of the wall had been destroyed by a later intrusion (8002), and it was unclear if the north-eastern end had been destroyed by robbing or not. A small area was cleared adjacent to the south-eastern elevation which showed that the wall continued for a depth of 0.23m and that there was a mortar surface adjacent to the wall at this point. It is unclear if this represents a mortar floor or a spread of demolition material. As this mortar surface was beneath the excavation-depth required it was not possible to investigate further.

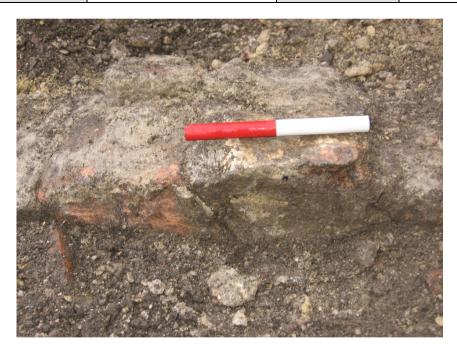
Plate 10 Detail of burning on the north-western elevation of Context 8005, scale unit 0.1m

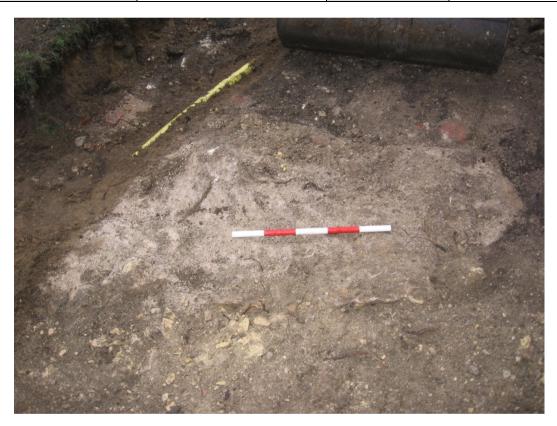
Plate 12 Context 8006, facing south, scale unit 0.1m

The third wall, Context 8006, was also aligned north-east to south-west and was 0.75m wide and 1.80m in length. The south-eastern end had been destroyed by a later wall foundation cut (Context 8002), and the north-eastern end continued beyond the limits of excavation. Context 8006 was a portion of wall core, with no clear facing stones visible, though there was a hint of these at a slightly lower depth on the north-western elevation. The wall core comprised limestone rubble up to 0.1 x 0.1 x 0.08m in size set in a hard white lime based mortar.
