LAND ADJACENT TO 12 DONCASTER GATE, ROTHERHAM

EVALUATION REPORT

Report Number 2010/46

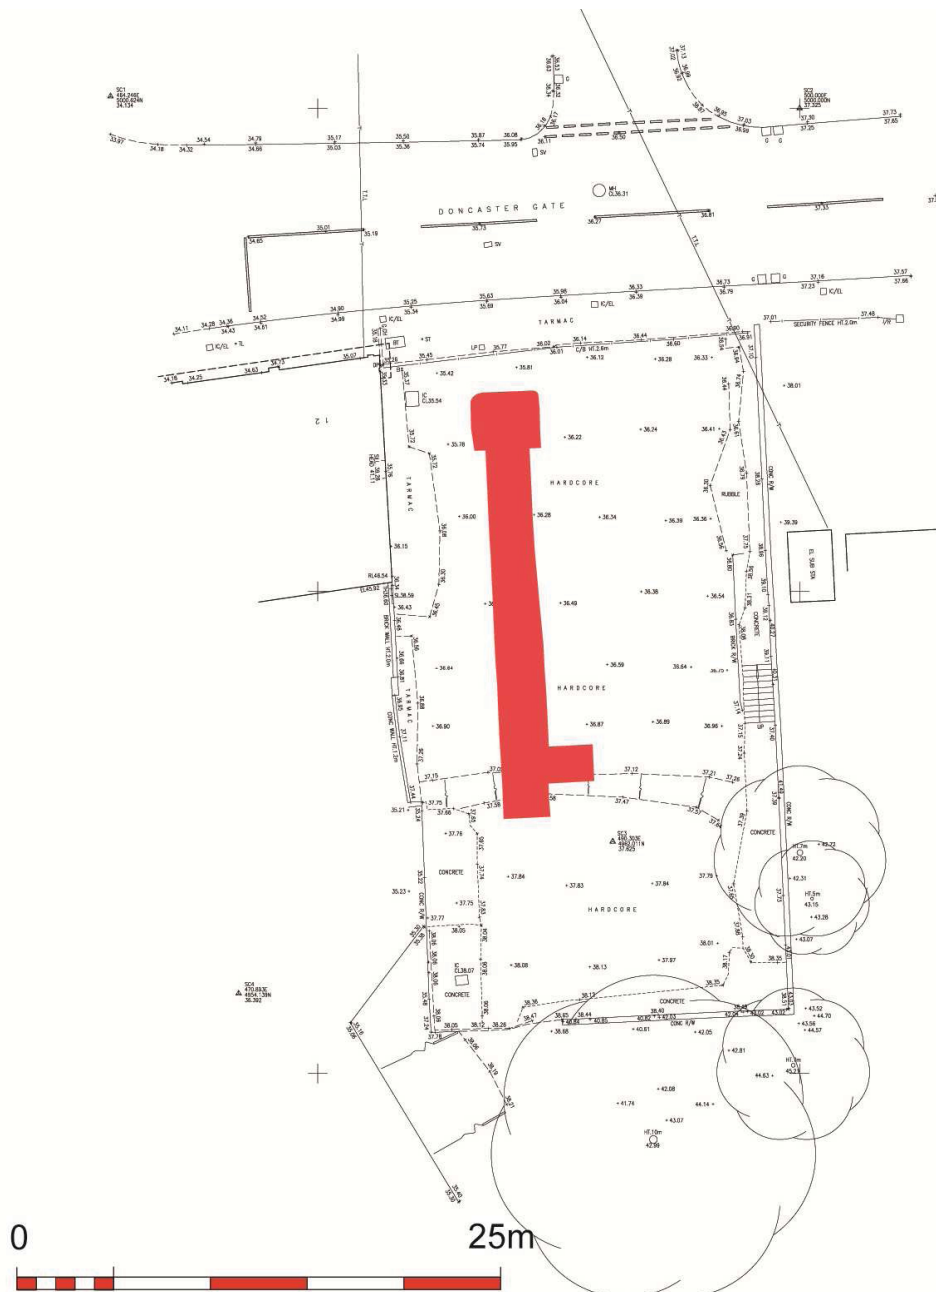
Figure 2: Location of the trench (based on the site plan in the WSI)

A single trench was excavated. This was intended to be 22 x 2m in size, but the presence of a large concrete slab at the rear of the site precluded the excavation of the southernmost 2m of the intended trench. In order to ensure that the correct area was excavated, the trench was extended in area by 2 x 2m on the eastern side (immediately to the north of the concrete slab).

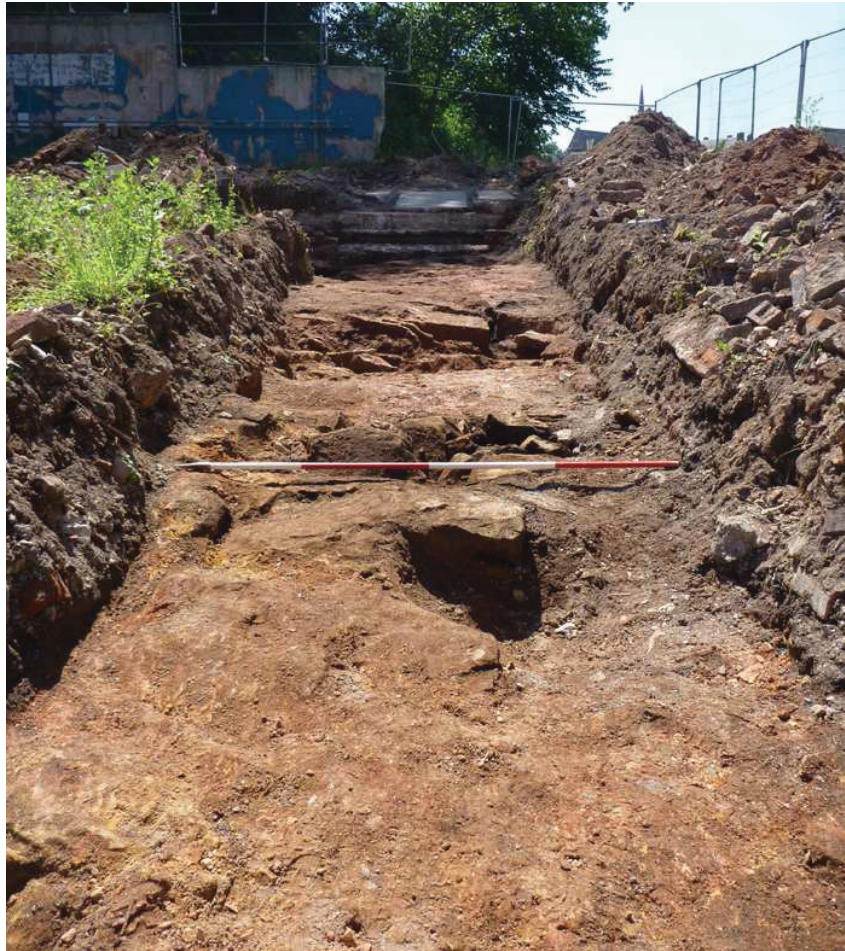
Plate 2: Context 1005, showing the natural slope of the bedrock and the two areas of machine damage to either side of the scale, facing south

The natural bedrock comprises red sandstone, the upper surface of which was degraded and cracked, with narrow fissures (Context 1005). The bedrock slopes downwards from south to north.

During machining, the bucket of the machine caught on two of the fissures, which caused the machine to remove large fragments of sandstone, thereby damaging the upper surface of the bedrock.

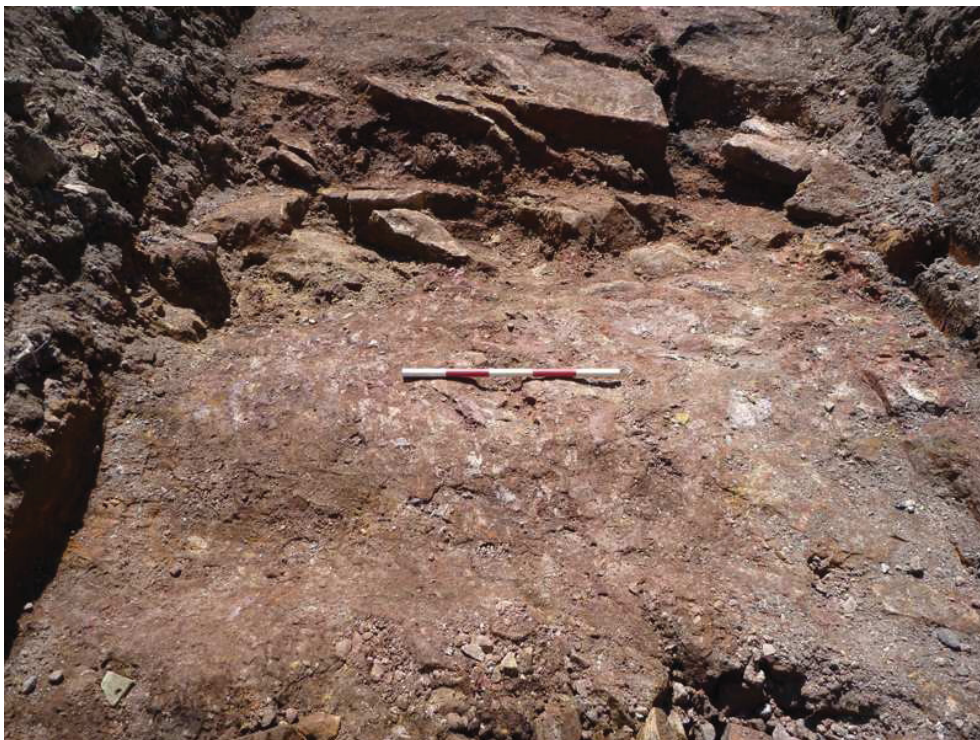
Plate 3: Context 1007, facing south

The sandstone was partially sealed by a thin layer of dark brown-red clay, 1.2m in width, which occurred approximately mid-way along the length of the trench (Context 1007). This was naturally occurring deposit, resulting from the weathering of the sandstone surface.

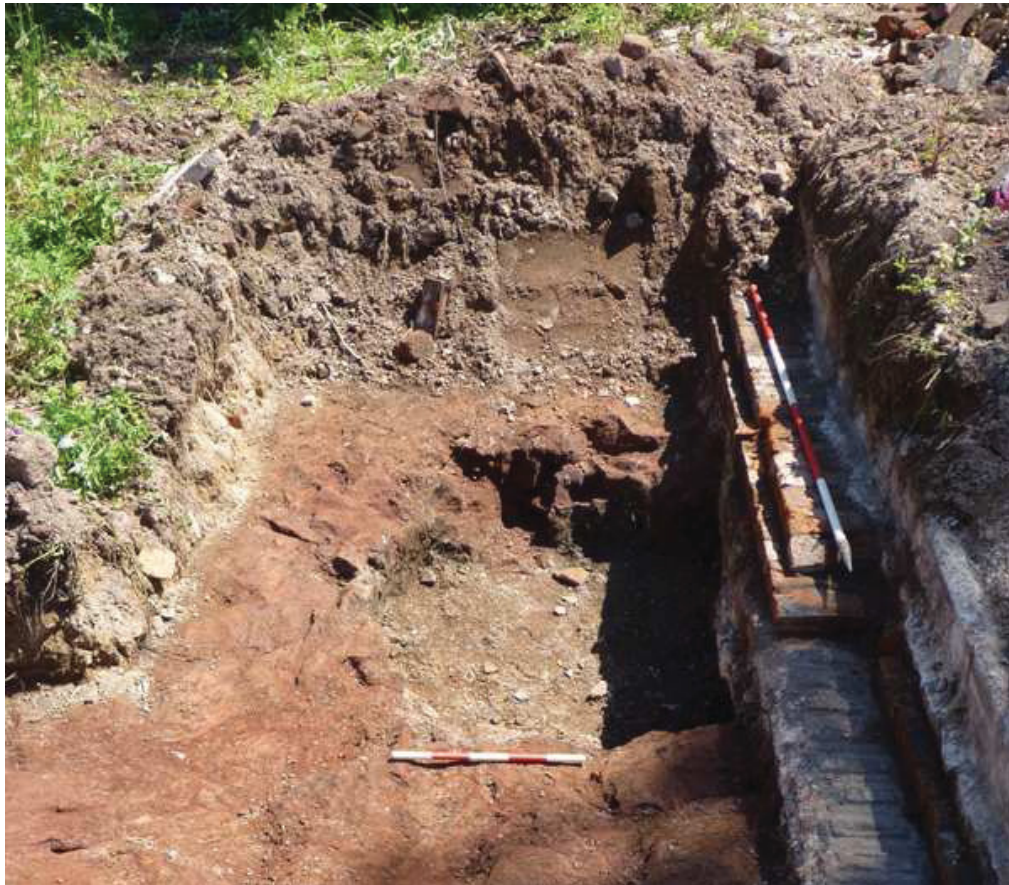
Plate 4: Context 1004, facing east

A roughly circular cut was present at the southernmost end of the site (Context 1004). The cut was approximately 1.5m in diameter, in excess of 0.8m in depth, and was cut directly into the underlying bedrock. The cut ran beneath a later concrete slab on the south side. The base of the cut was not sought during the excavation, in order to avoid undermining the concrete slab.

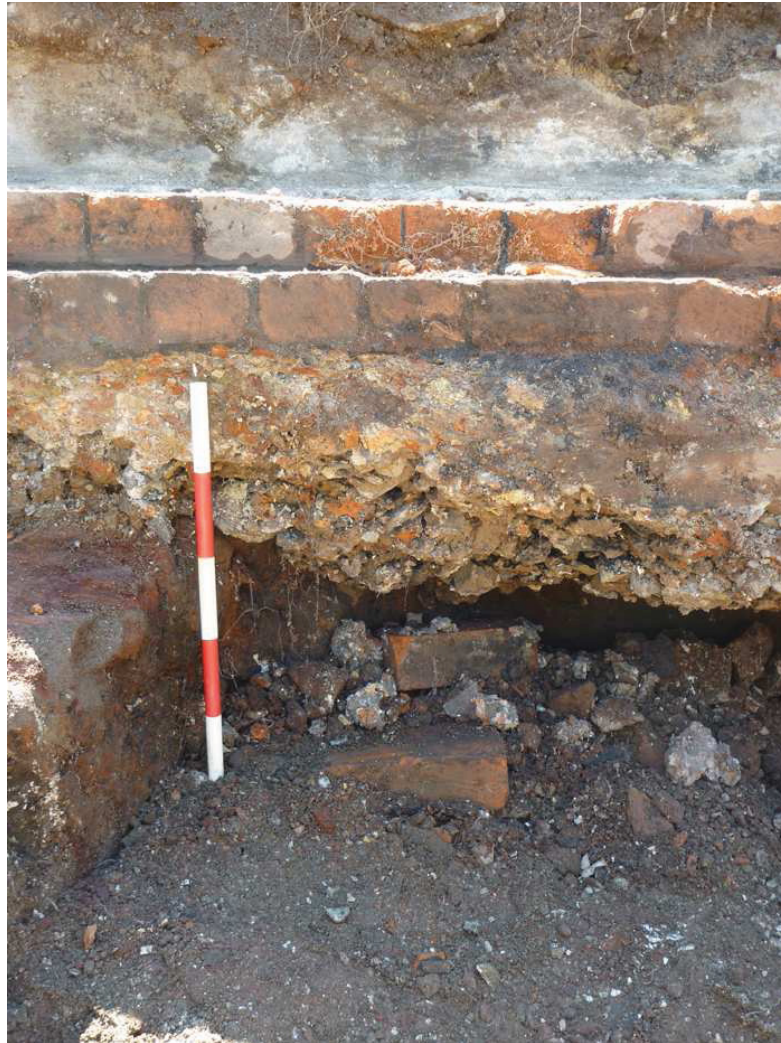
Plate 5: Context 1003 continuing beneath the concrete slab, facing south

The cut was infilled with loose brick rubble (Context 1003), which appeared to derive from machine-made bricks that are likely to have been early 20th-century in date. It is possible that the cut was associated with a cellar or the construction of the cinema; however, this is speculative and the cut's date and function are unclear.

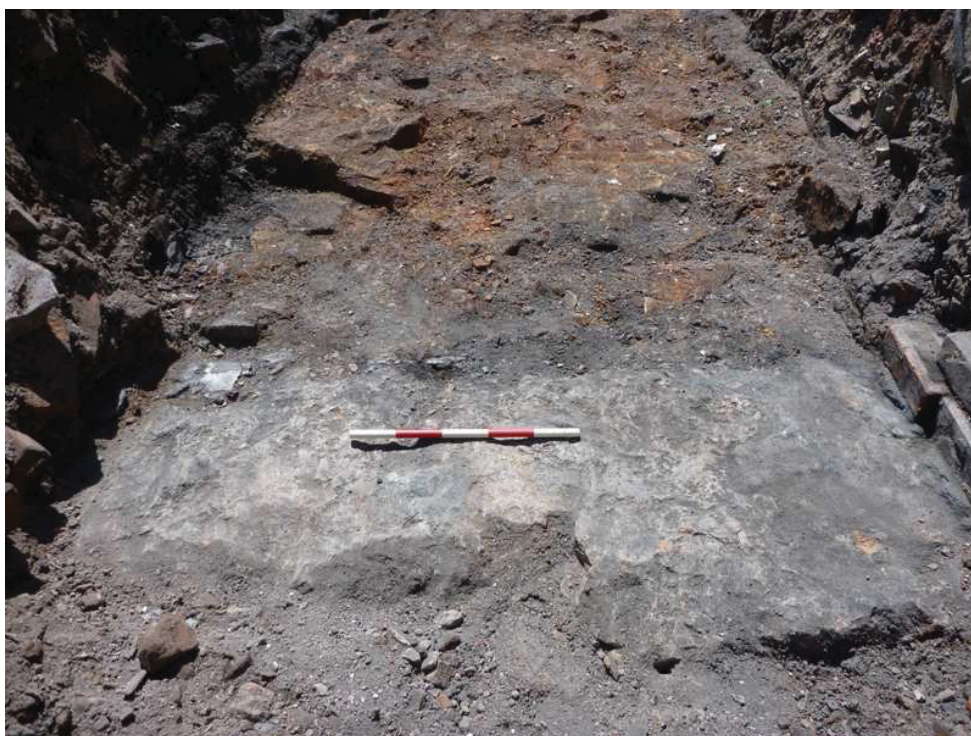
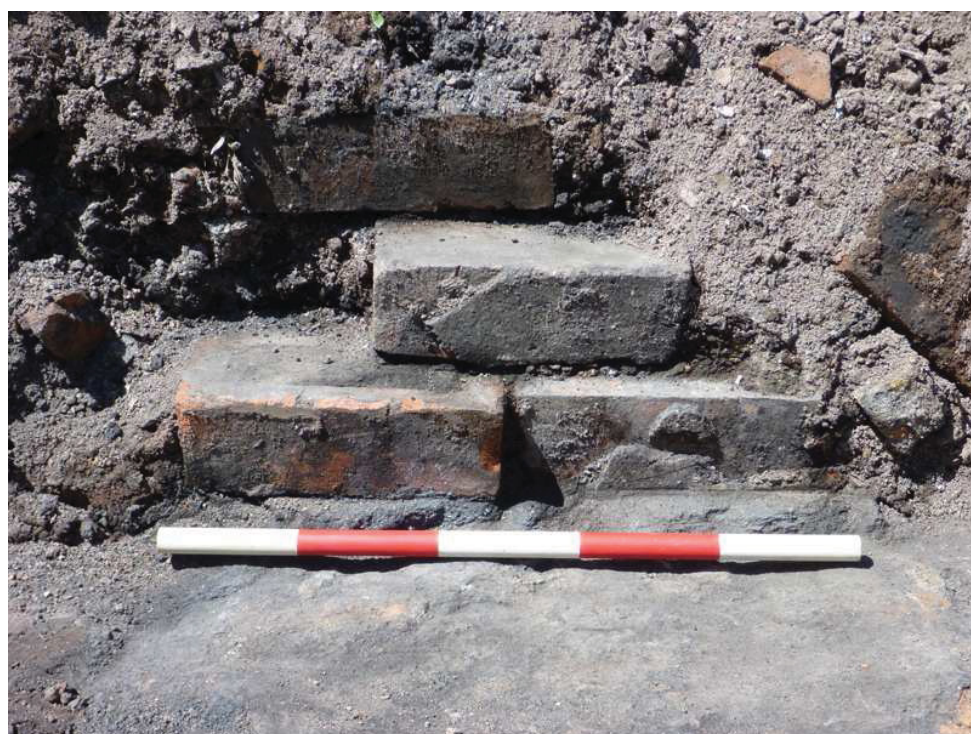
A cellar was constructed subsequently along the Doncaster Gate street frontage. The rear wall of the cellar was located approximately 5m south of, and parallel with, the street with the front wall being situated beyond the limit of excavation. The lower part of the rear cellar wall comprised a concrete wall approximately 0.7m in width (Context 1011), above which two courses of brick wall survived (Context 1010). The early 20th-century bricks in this wall measured 235 x 115 x 70mm and were bonded with black mortar. The depth of the cellar was in excess of 1.78m, extending to a depth of 34.23m aOD. The material that had been used to backfill the cellar was so loose that it collapsed repeatedly during machining, making it unsafe to excavate. The full depth of the cellar thus could not be determined.

Plate 6: Contexts 1010-11, facing north

Plate 7: Context 1010, facing west

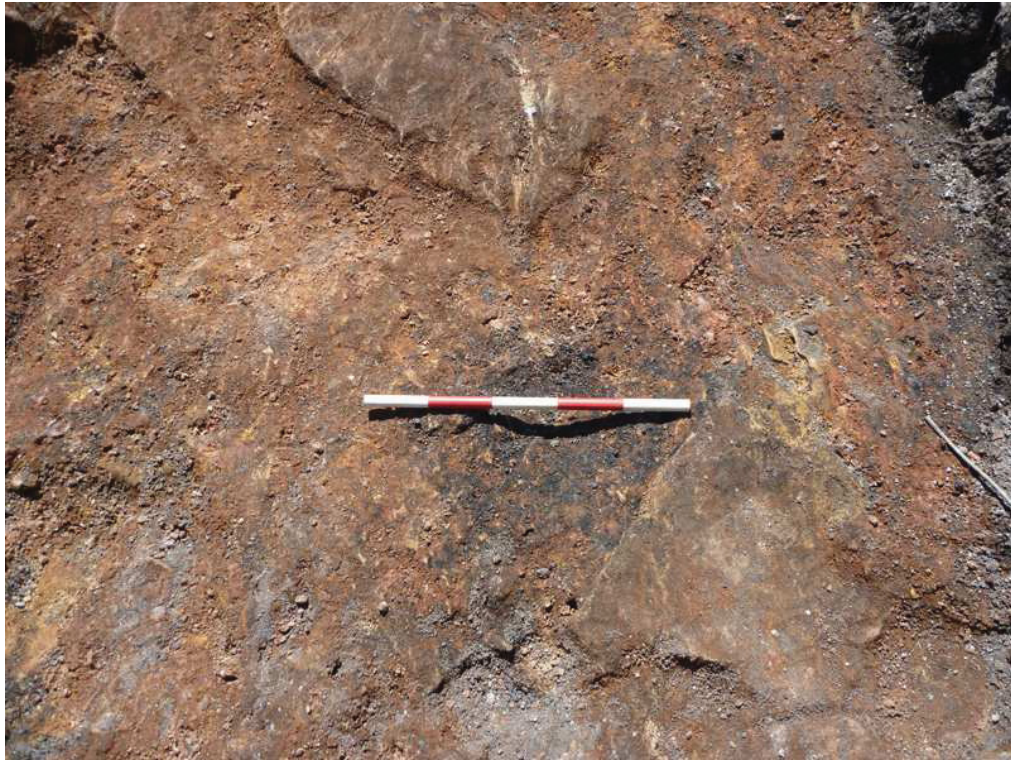
Plate 8: Context 1006, beneath scale, facing south

To the south of the cellar wall, two patches of levelling deposits were located directly above and embedded into the natural bedrock. The southernmost levelling deposit (Context 1006) was a pitch or tar-like material, while the northernmost levelling deposit (Context 1008) was a dark grey to black silty-sand. These thin levelling deposits may have been designed to seal the

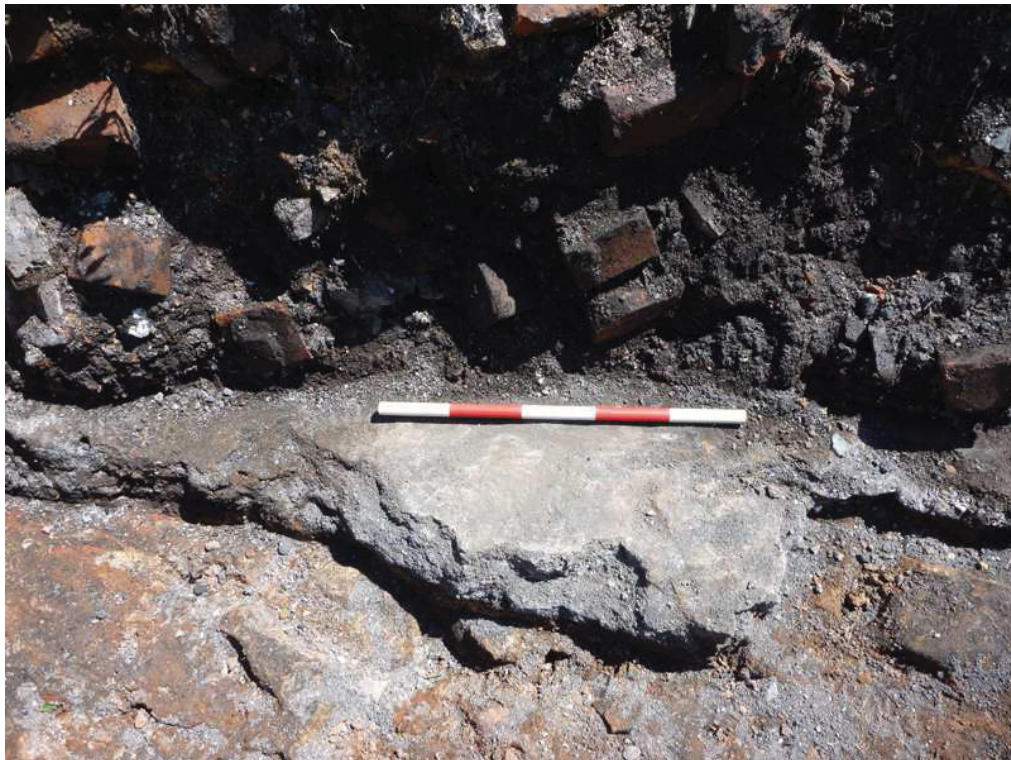
Plate 9: Context 1009, facing east

bedrock prior to the laying of the cinema floor. The remains of a concrete floor (Context 1009), 0.1m in depth was present towards the northern end of the site.

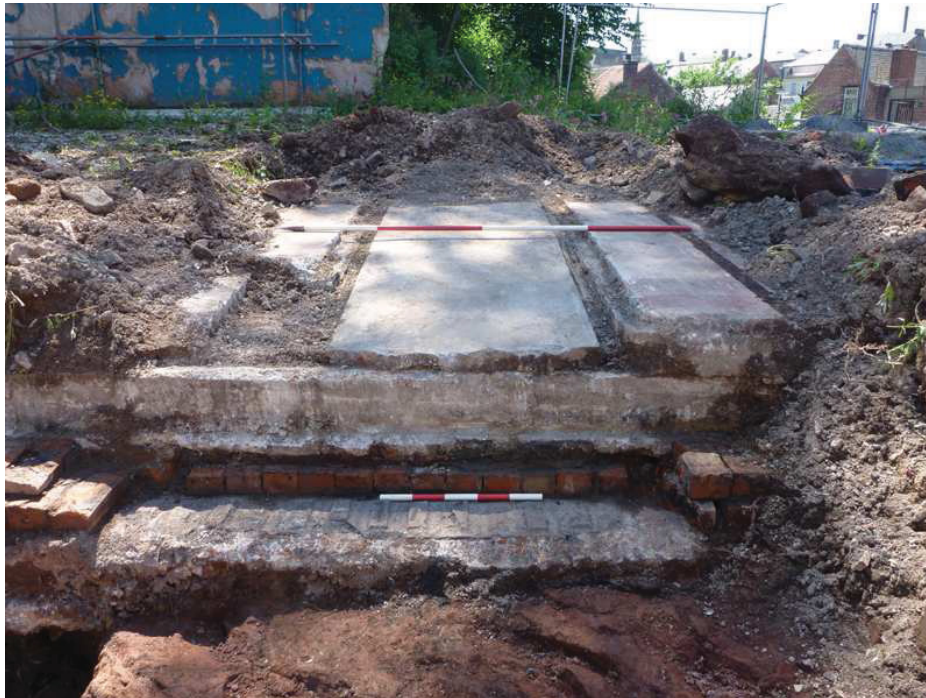
Plate 10: Context 1001-2, facing south

A large concrete slab (Context 1001) and a related wall (Context 1002) were present at the southern end of the site. The northern elevation of these contexts was parallel to, and approximately 23m south of, the street frontage.

The concrete slab extended beyond the limits of excavation on the south, west and east sides. The slab was 0.35m in depth with variable thickness along the upper surface. A central strip 0.86m in width sloped downwards to the north and was bordered to either side by shallow grooves 0.16m in width. The latter were aligned north-south and contained small wooden beams 0.1m in width. To either side of these beams, the upper surface of the concrete slab was flatter, although it continued to slope downwards slightly towards the north. A third shallow groove was present on the upper surface of the concrete slab near the westernmost limits of excavation. This groove was 0.16m in width and was infilled with gravel. Traces of dark red paint were present on the concrete surface.

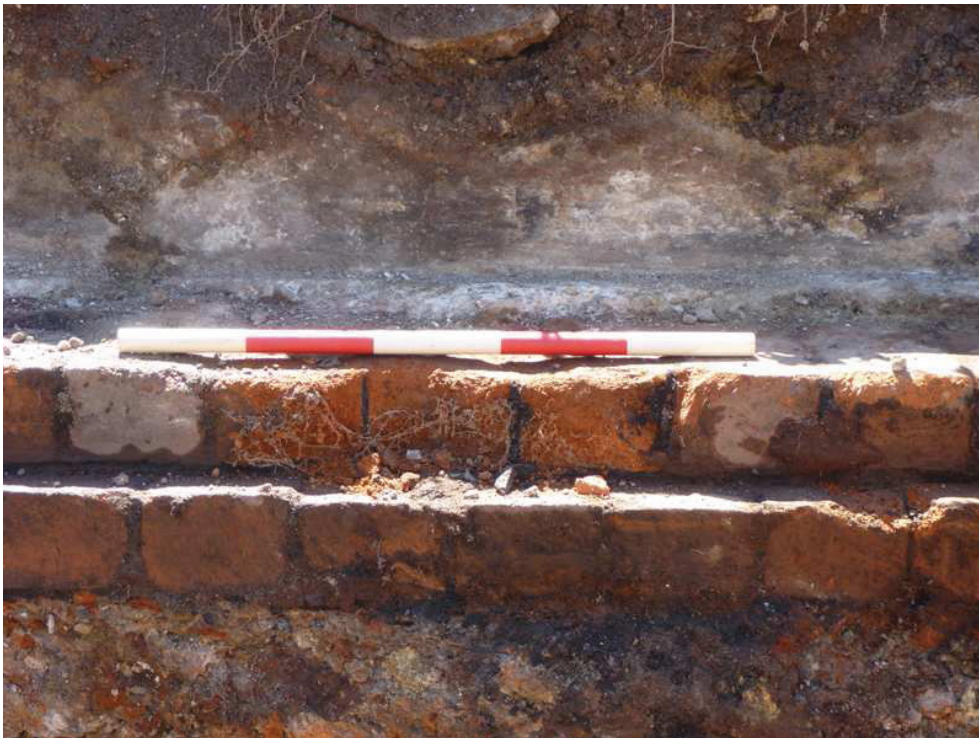
Plate 12: Detail of Context 1002, facing south

The northern edge of the concrete slab was faced by a brick wall with a concrete foundation. The concrete foundation was 0.35m in depth and the surviving brick wall had one footing course which was stepped out 0.06m from two courses of walling above. The wall was made of early 20th-century bricks laid in header-bond and was bonded with dark grey cement-based mortar. The bricks measured 235 x 110x 75mm and had a rectangular frog on one bed. The bricks were all laid with the frog facing downwards.

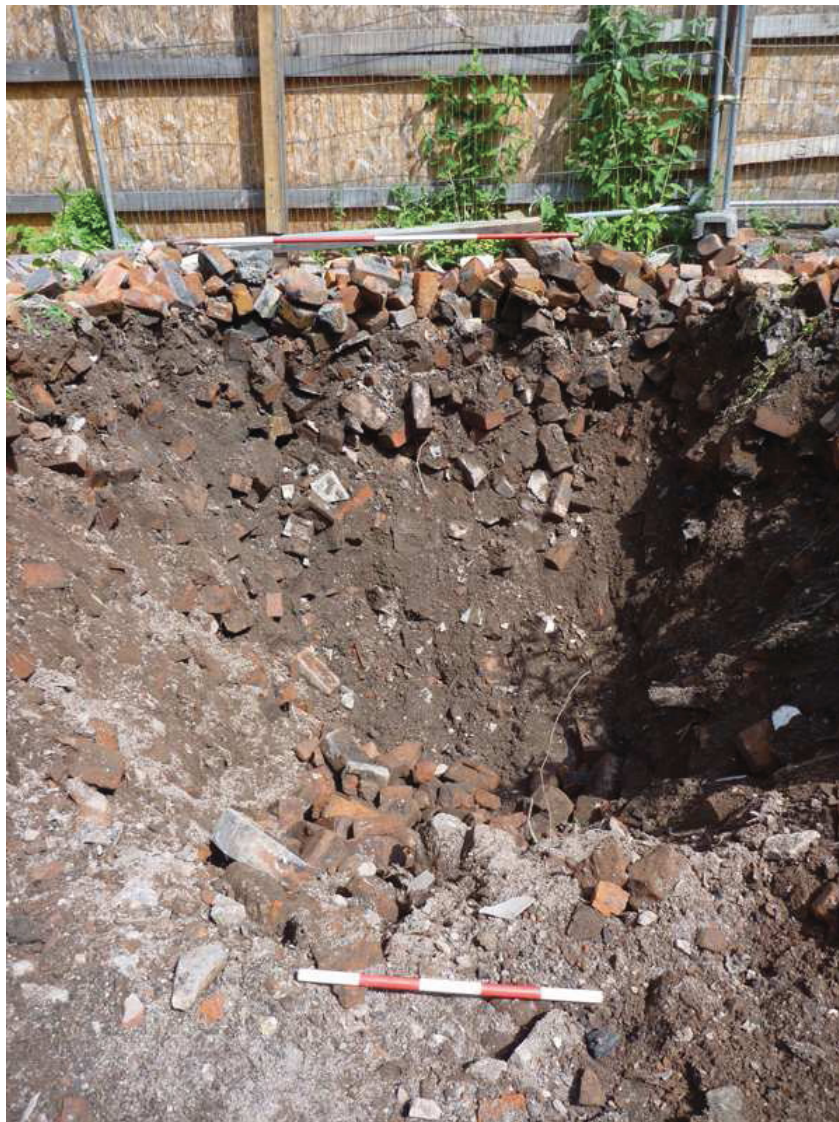
Plate 13: Context 1000 within the cellar fronting onto Doncaster Gate, facing north

An extensive dump of demolition rubble (Context 1000) covered the entire site and infilled the cellar on the street frontage. This deposit was typically 0.5-0.7m in depth, but was

considerably thicker within the infilled cellar and thinner above the concrete slab at the south end of the site. The demolition material consisted mainly of whole and broken bricks but also included mortar, plaster, concrete fragments, lead pipe fragments, iron pipe fragments, scrap metal, occasional plastic fragments, fragments of linoleum and fragments of wooden batons.

The bricks in the backfill were of early 20th-century date. Seven different designs were recorded on site (Plate 13), although none were retained. The early 20th-century date of the bricks suggests that all of the demolition rubble derived from the demolition of Cinema House, rather than from the demolition of any earlier Victorian buildings. This suggests that when the cinema was built, all the earlier buildings on the site had been demolished and the resultant material removed in order to provide a 'clean' site. The demolition of the cinema was undertaken so thoroughly that there was an almost total lack of surviving walls or floors relating to this structure.

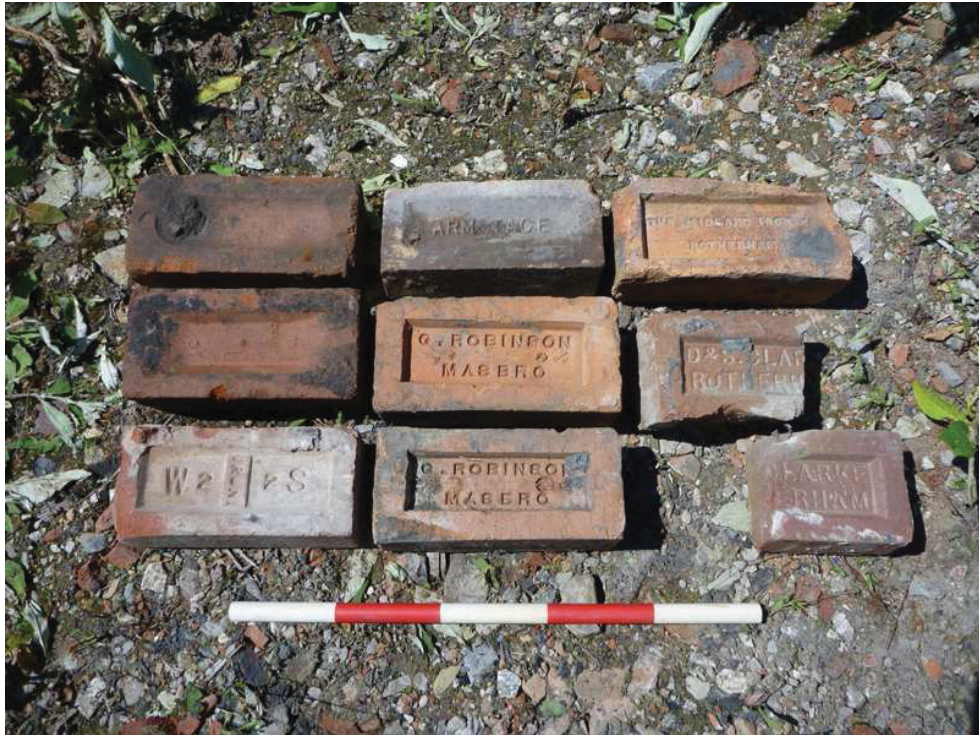
Plate 14: Bricks from Context 1000, scale 0.5m

Description of the bricks within Context 1000 (described in relation to the rows of bricks seen in Plate 14; top left to bottom right):

Brick 1: machine-made; 230 x 114 x 73mm, with an oval frog on one bed, 172 x 60 x 8mm in size. Two circular impressions 22mm in diameter, relating to manufacture, on the opposing bed.

Brick 2: machine-made; 224 x 109 x 75mm, with a frog 177 x 60 x 6 on one bed with the stamp 'ARMITAGE' in letters 12mm high. Rectangular frog on the opposing bed, 175 x 55 x 4mm in size with gently sloping ends and two circular impressions, relating to manufacture, 22mm in diameter and one 13mm in diameter.

Brick 3: machine-made; 236 x 110 x 81mm, with a frog 195 x 70 x 10mm on one bed. Two-line stamp, the upper line of which read 'THE MIDLAND IRON CO' and the lower line 'ROTHERHAM', all in letters 10mm high, with two circular impressions 16mm in diameter which related to manufacture.

Brick 4: machine-made; 227 x 110 x 73mm, with a rectangular frog 170 x 60 x 7mm on one bed, the frog having gently sloping shorter ends and two circular impressions, relating to manufacture, 7mm in diameter within the frog.

Brick 5: machine-made; 235 x 115 x 76mm, with a frog 177 x 60 x 6mm on one bed with a two-line stamp, the upper line of which read 'G. ROBINSON' and the lower line 'MASBRO', all in

letters 11mm high. Two circular impressions 15mm in diameter and two 7mm in diameter inside the frog and four 17mm in diameter outside the frog, all of which related to manufacture. A similar circular mark, 15mm in diameter, was present on the opposing bed of the brick. This was by far the commonest brick seen in the demolition rubble.

Brick 6: machine-made; no complete length seen but the remaining dimensions were 106 x 73mm, with a frog 60 x 10mm on one bed. Two-line stamp, the upper line of which read 'D&S CLARKE' and the lower line 'RUTHERHAM', all in letters 15mm high. It was not clear if the 'U' was a malformed 'O', in which case the stamp would have read 'Rotherham'.

Brick 7: machine-made; 220 x 101 x 74mm, with a frog 175 x 60 x 7mm on one bed with a central ridge bearing the stamp 'IRONI' and a stamp to either side: one saying 'W2' and the other '2S'. The 'W' and 'S' were 30mm high, the '2's were 13mm high and the 'IRONI' letters 12mm high. The opposing bed also had a frog, 170 x 50 x 3mm in size, with gently sloping ends and two circular impressions relating to manufacture 20mm in diameter.

Brick 8: same as Brick 5 but overfired.

Brick 9: same as Brick 6.
