**BRITANNIA MILL, MACKWORTH ROAD,
DERBY, DERBYSHIRE**

BUILDING AND EVALUATION REPORT

REPORT NUMBER 2010/54

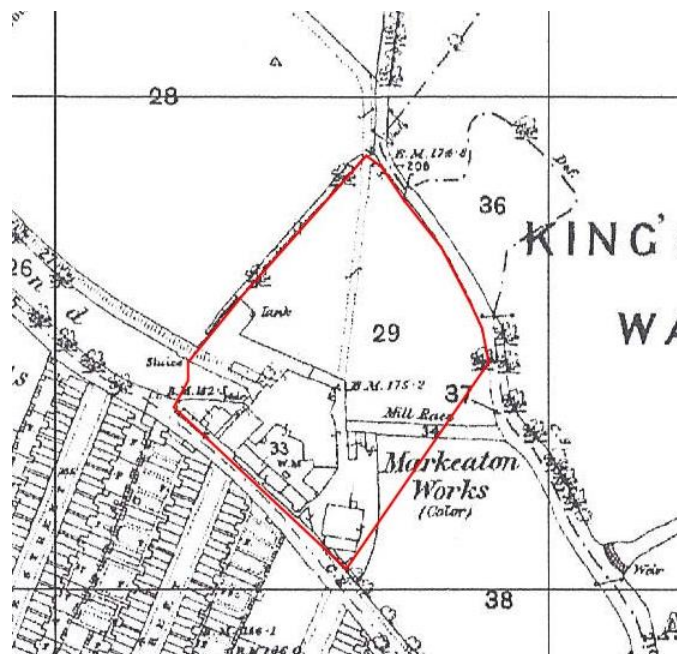
Figure 3 Ordnance Survey map of 1883

The site was marked as 'Markeaton Works' on the 1883 Ordnance Survey map (Figure 3). Extensive redevelopment had occurred within the site by that date. The mill's northernmost building had been extended both to the north-east and southwards into the yard and several new structures had been added around the site. These included extensions to the detached, square building at the site's south-east entrance; two narrow, rectangular buildings on the south bank of the mill race; a large, square building at the south-west of the mill; and two small rectangular structures at the north-west. The various functions of these buildings were not marked on the 1883 map.

A weighing machine was marked within the yard, while a small, circular tank stood within the rectangular plot at the north-west of the mill. A footpath crossed the leat at the north of the site, leading across the field to the mill's north-east corner. The Markeaton Brook's course in

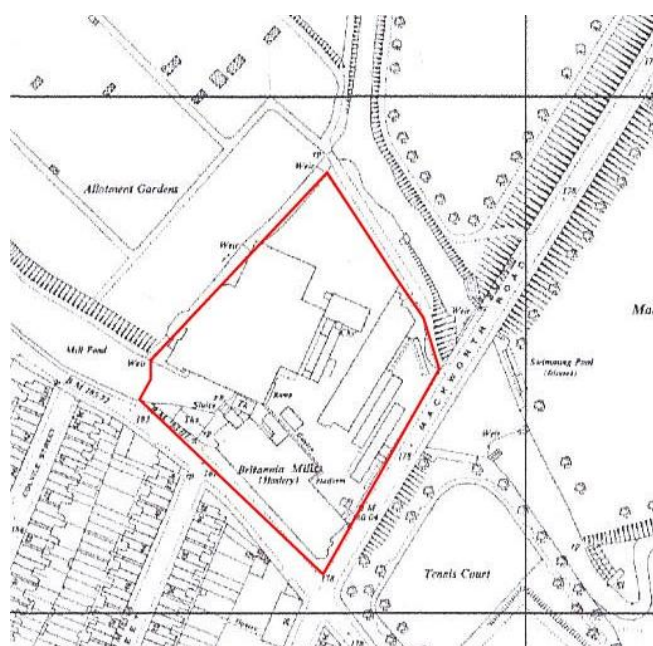
Figure 5 Ordnance Survey map of 1950

Extensive development had taken place to the north of the original Britannia Mill block by the time of the 1950 Ordnance Survey map (Figure 5). A large, irregularly-shaped building dominated the western part of the site, while three smaller, rectangular blocks had been constructed at the centre of the plot. Three further rectangular buildings had also been constructed at the east of the site. The eastern course of the leet was not marked on the 1950 map, suggesting that it had been infilled or covered by that date.

The new structures had been built in the formerly undeveloped land that had stood to the north of Markeaton Mill, with the exception of the south-east corner of the largest block, which had been constructed over the north-west corner of the former mill. The majority of the area occupied previously by the former mill's northernmost building was shown as an open area on the 1950 map. It is not clear if the new building had impacted on the probable site of the former waterwheel. Various features were marked throughout the site on the 1950 Ordnance Survey map, including a platform, gantry and ramp in the mill yard; tanks, a sluice and a footbridge at the east end of the mill dam; and a chimney at the centre of the site.

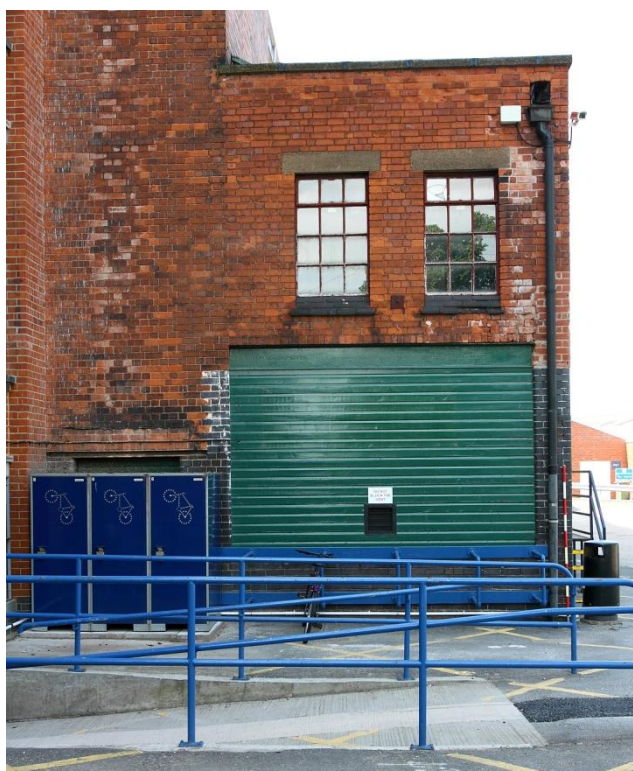
The brickwork of the SW side of this elevation is stitched in to that of the SE side of the lift shaft, which in this area houses a shuttered doorway, now blocked. A tall, wide opening with a steel lintel and shutters of steel opens on the lower part of this side of the structure. The base of this opening is some 750mm above exterior ground level and it would appear to have originally functioned as a loading bay. Brickwork below the ledge of the loading bay was all of grey blue engineering bricks. To the upper floor above this opening two windows, each with a concrete lintel and a sill formed of three courses of chamfered grey blue engineering bricks, are present. The windows (as elsewhere) are of wooden frames and each of twelve panes. A rainwater downpipe extends from a cast-iron hopper at parapet level at the NE end of this elevation.

Plate 1 *SE facing elevation*

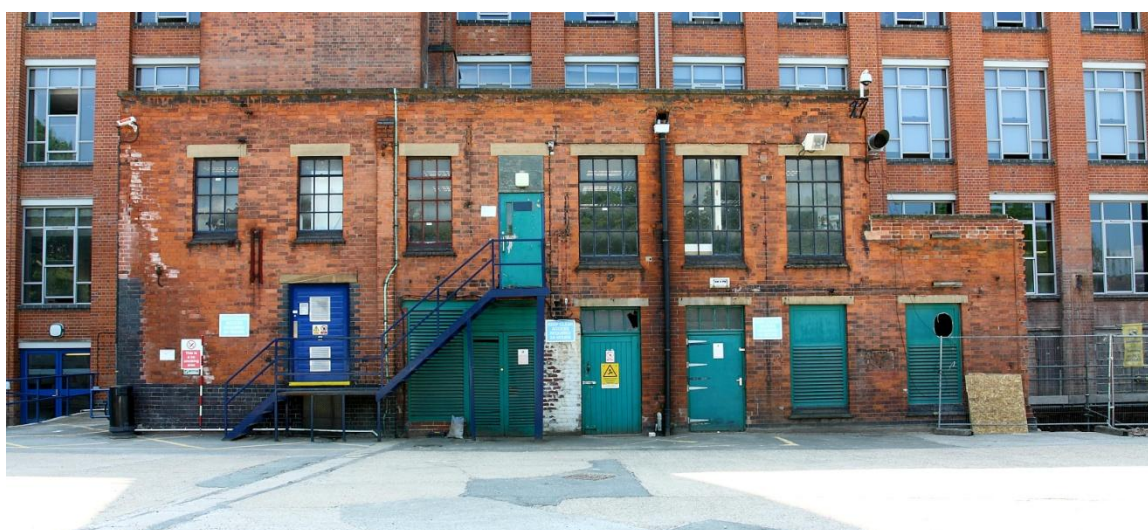
engineering bricks. This doorway, which is at the same level as the intermediate floor of the loading bay door to the SE facing elevation, provides access to what is now an open space with modern partitioning around the lift shaft. Immediately NW of this are a set of wooden slat double doors with a wooden slatted vent to their SE side. These doors, which are later 20th century replacements for an earlier door arrangement, provide access to what was formerly a boiler room. To the NW of the boiler room doors lies a further wooden door with four pane fanlight beneath a concrete lintel. This door gives access to a narrow space that until recently housed electrical switchgear, though originally formed part of the adjacent plant-room immediately to the NW. The plant-room doorway has a concrete lintel and four pane fanlight, though the door itself is a later 20th century replacement. Two former windows are present to the NW of the plant-room door. These have concrete lintels and grey blue brick sills but the windows themselves have been replaced with slatted wooden vents.

External access to the upper floor of the extension, until recently a refectory, is provided by a doorway with stone lintel and blocked fanlight at the head of the fire escape. To the NW of this doorway are three large windows of equal size. Each has a concrete lintel, a sill of grey blue bricks and a wooden frame of sixteen panes. Immediately SE of the doorway is smaller twelve pane window with similar lintel and sill, whilst adjacent to this are two further windows of similar pattern but of slightly smaller scale. The sills of the three windows to the SE of the doorway are set at a slightly higher level than those to the NW owing to their relating to a slightly higher floor level, this being necessitated by the intermediate floor level of the SE part of the extension. Towards the NW end of the elevation a rainwater downpipe extends from a hopper below an aperture in the parapet wall.

Plate 2 *NE facing elevation*

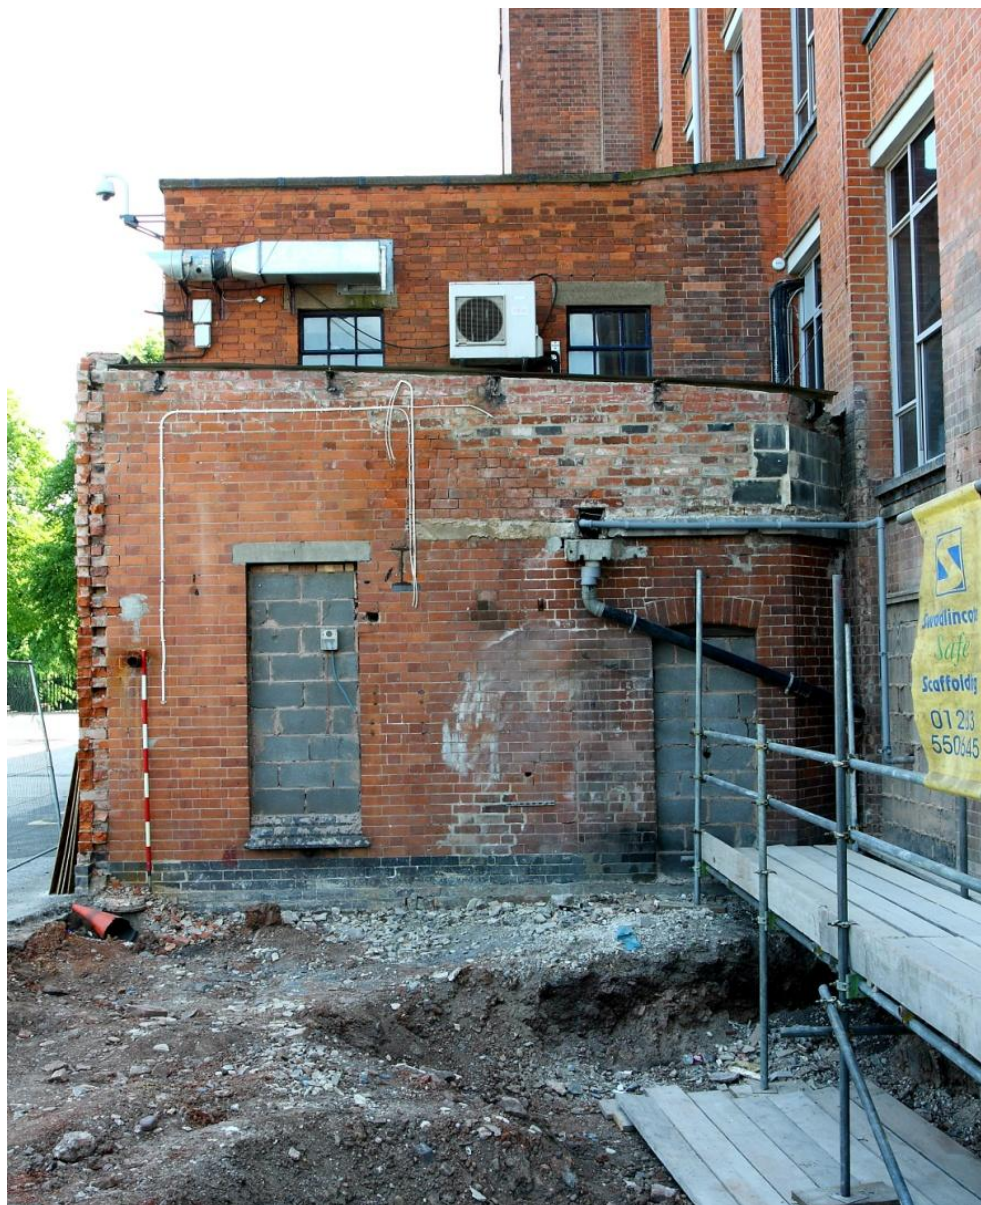
The upper part of this elevation is stepped back slightly from the lower part. The lower part of the NW facing elevation originally housed a window and a door, both of which have been sealed with concrete blocks. The former window has a concrete lintel and brick sill whilst the doorway has a segmental arch of brick. Scars to this lower part of the elevation relate to later works in the now demolished former garage area immediately to the NW.

The upper part of this elevation forms the exterior wall of the refectory. This is lit by two twelve pane windows with concrete lintels and brick sills. Extractor ducting and an air-conditioning system are affixed to the exterior of the upper part of this elevation.

Plate 3 NW facing elevation

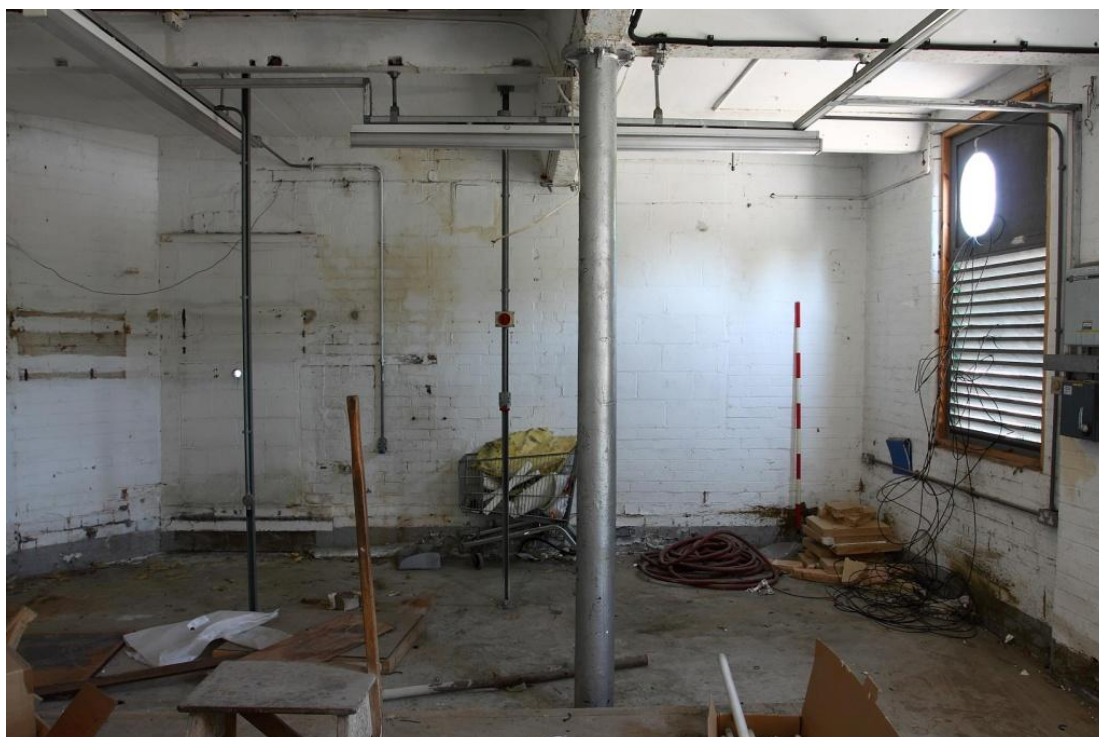
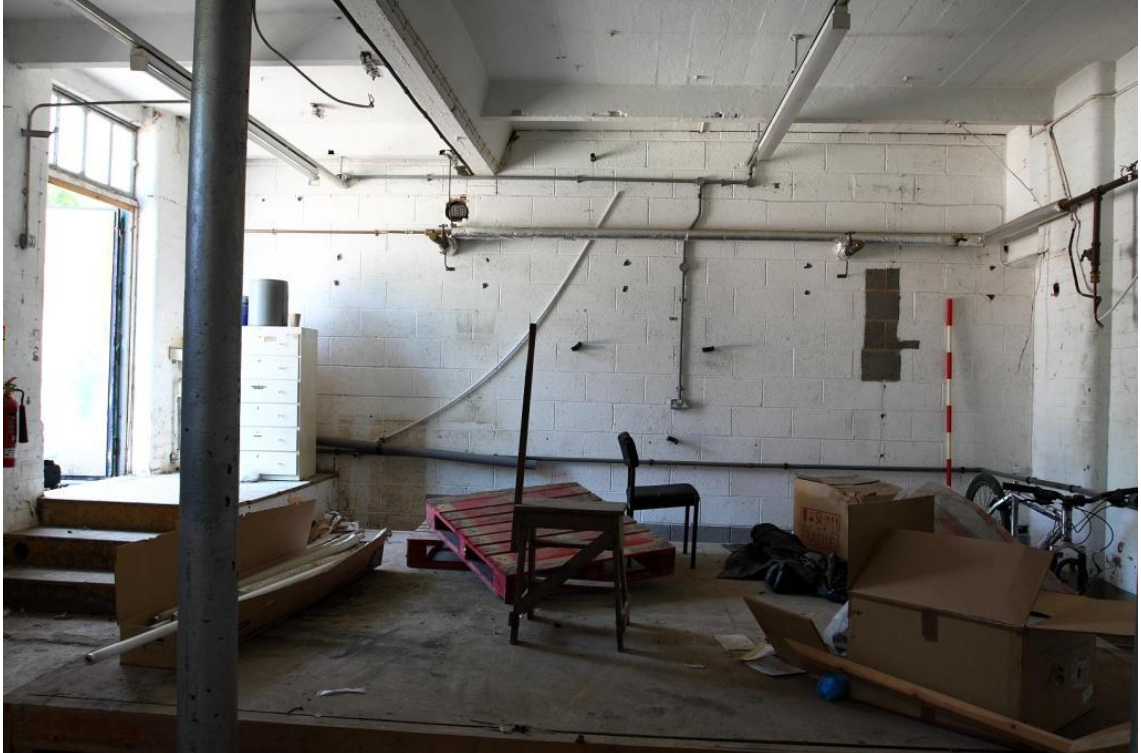
The NW-most ground floor room is accessed via a shallow flight of modern wooden steps from the threshold of the door of the NE facing elevation. These steps lead down to a concrete floor some 450mm below present exterior ground level. All walls are of white painted brick, excepting the blocking to the former window and doorway of the NW wall, a former doorway in the SW wall and the SE wall which are of concrete blockwork. It is clear that prior to the insertion of the SE wall this room also incorporated the narrow electrical switch room adjacent to the SE. The SW wall is formed of what was originally the exterior face of the mill, complete with pilaster's and the NW side of a blocked doorway in the southern corner. A single cast iron column supporting part of the ceiling is present in the NNW part of the room. All lighting in this space is artificial as the two windows to the NE elevation have been replaced by frames holding angled wooden slats. Information provided by staff at the University suggests that prior to its current storage use, this room was originally a plant room which housed various machinery connected with the running of the mill.

Plate 4 *Plant room, looking NW*

Plate 5 *Plant room, looking SE*

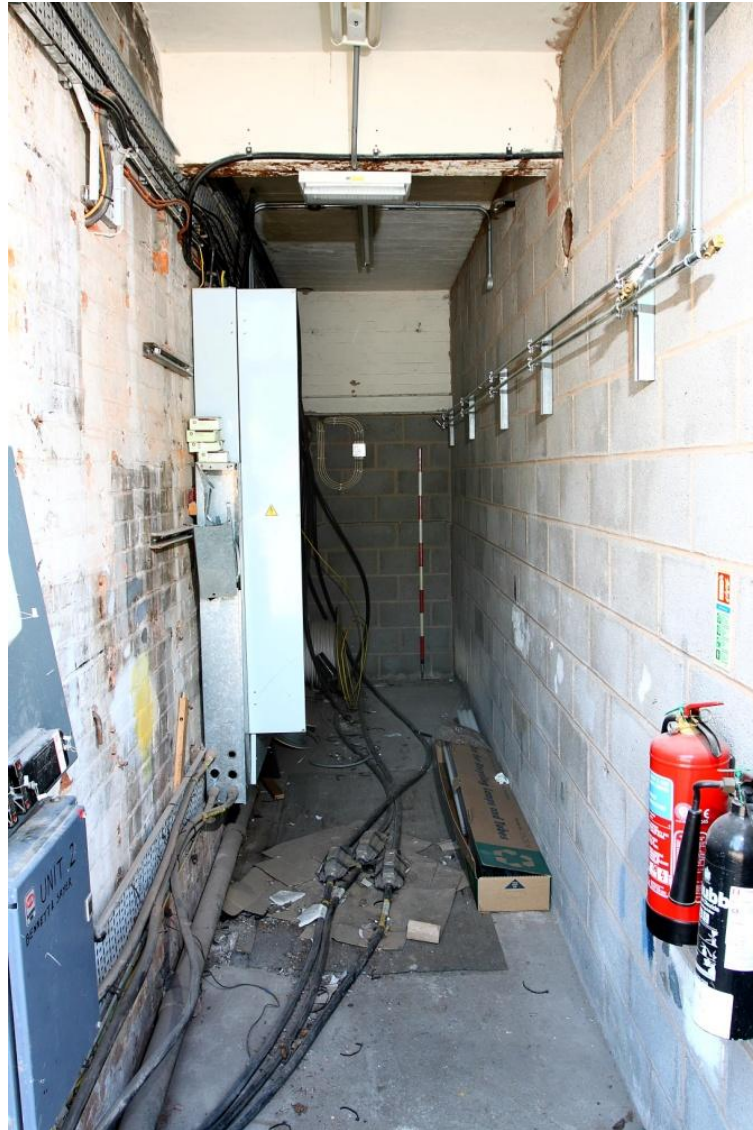
This narrow space, which is sandwiched between the plant room and boiler room, is accessed via two concrete steps which lead down to a concrete floor. The SE wall is an original brick wall whilst the NW is constructed of modern concrete blocks. As mentioned above, prior to the insertion of the NW wall this narrow spaced formed part of the plant room. The lower part of the SW wall is of concrete blocks and it is clear that the blocked doorway in the S corner of the plant room extended fully into this space also. This room is an entirely modern creation and was formed to house electrical switch gear, some of which still remains.

Plate 6 *Electrical switch room, looking SW*

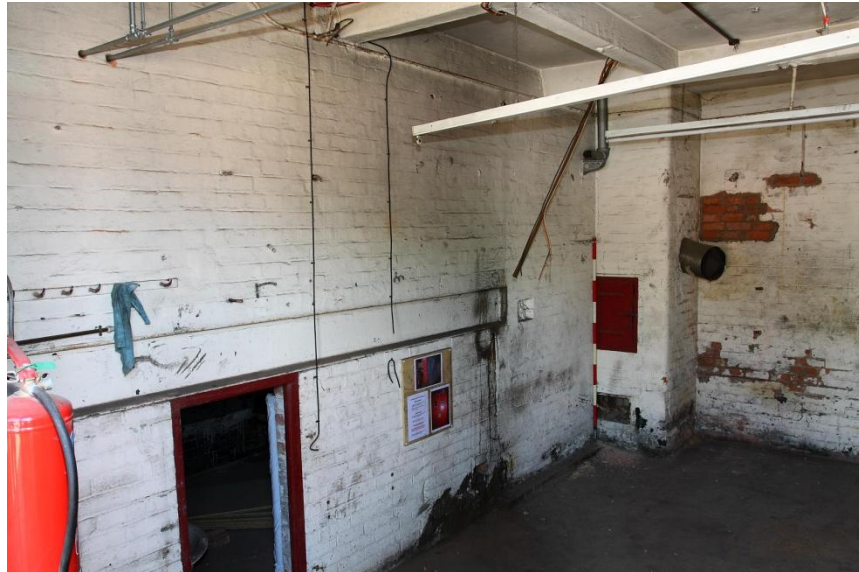
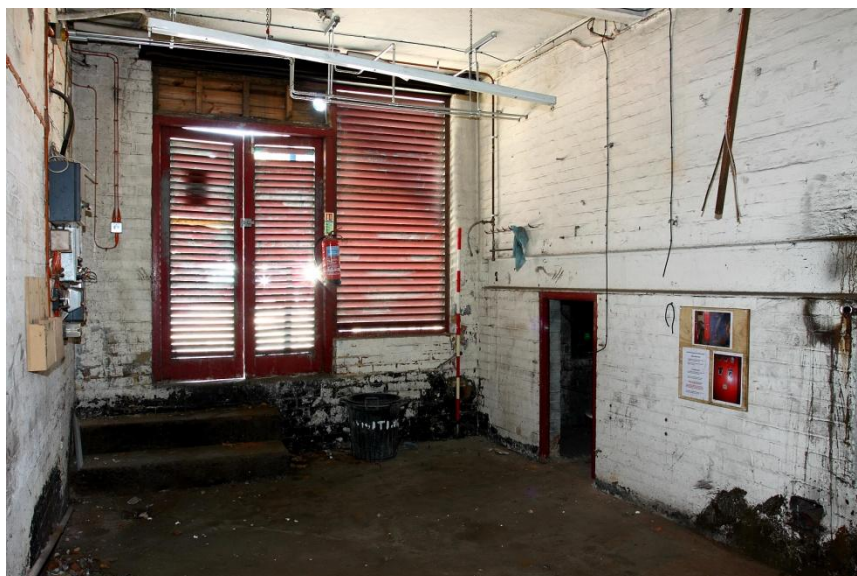
The two rooms that form the former boiler room lie at the SE end of the to be demolished building and are accessed via double doors and a flight of three concrete steps which lead down to the concrete floor of the larger room. In the S corner of this room a chimney stack, which extends to the full height of the mill against the NW side of the lift shaft, is present. Access to the second room, which lies immediately SE of the larger room but has a much lower ceiling, is via a low doorway. To the NE side of the small room a blocked up chute is present. Excepting modern materials in storage, both rooms are devoid of original fittings and equipment. However, the presence of the chimney and a chute (presumably for fuel) together with information supplied by university staff, suggest that these two rooms originally functioned as a boiler room and fuel store.

Plate 7 Boiler room, looking S

Plate 8 Boiler room, looking NE

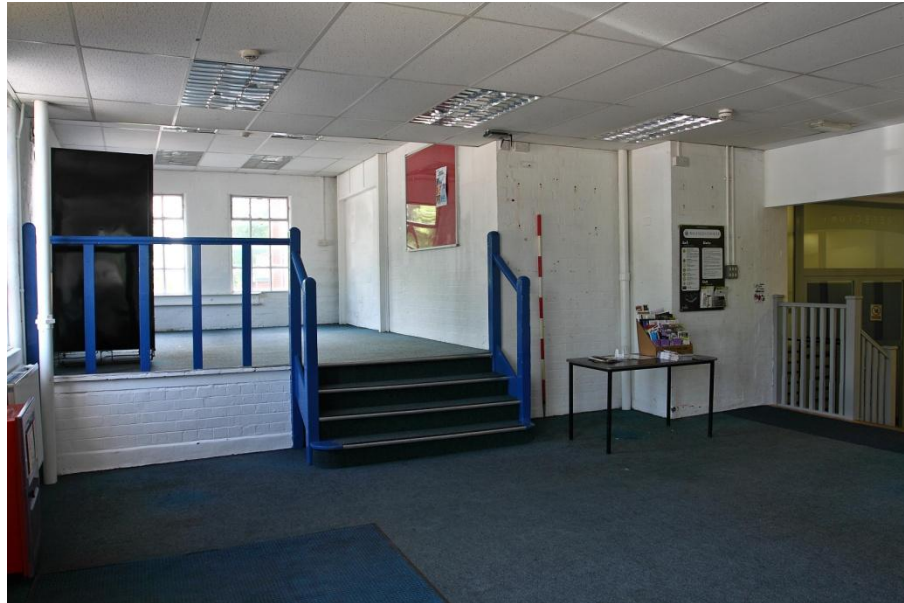
The upper floor forms a large single space accessible from within the main body of the mill building and from the top of the fire escape. The SE part of the room is narrower than that of the larger NW part owing to the presence of the lift shaft and is also set at a higher level, this latter being due to the intermediate floor level located immediately below. Faint scarring to the SW wall of the upper area suggests the likelihood that the lift shaft was once accessible from this area. There is no indication that the upper and lower areas were ever separated by solid walling. The presence of ten large windows to this area provides it with a very light and airy feel. Communication between the two parts of the room is via a broad flight of four steps. The ceiling in both areas is of modern suspended type. Modern renovation of this upper floor appears likely to have removed physical indicators of original usage, though this may have been as office space. At the present time this space is fitted out as a refectory with a food preparation and servery area at the NW end. The fittings within this servery suggest it was fitted out within the last decade or two.

Plate 10 Upper room, looking SE

Plate 11 Upper room, looking NW

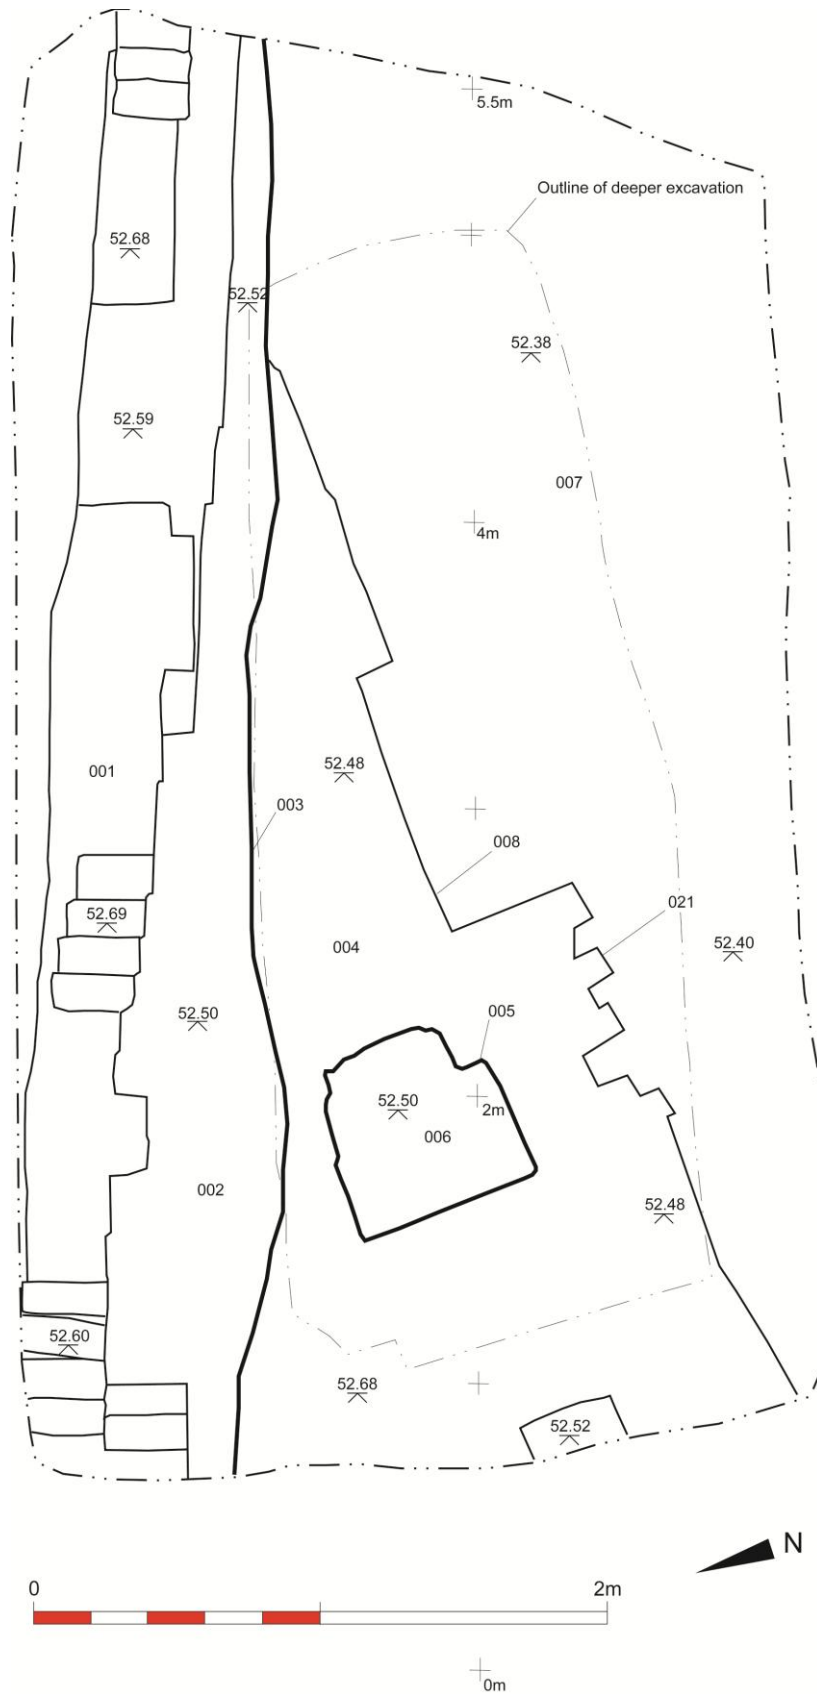
This later structural episode was comprised of the partially truncated remnants of a further brick surface, context 004. The red, plain bricks of this surface were bedded on a thin layer of sand and orientated at the same alignment as the earlier structures of 012, 013 and 011. Within the limits of the trench no walls were associated with this surface, which had an upper height of some 52.69m AOD.

Surface 004 was truncated by a number of features. One of these was construction cut 003 which sliced through the surface and held the concrete foundation 002 which supported brick walling 001. This walling was built of plain red bricks (size 230 x 110 x 80mm), bonded with a cement mortar, and survived up three courses high. Aligned in a SE to NW direction walling 001 formed a part of the walling of the recorded building and is said to have been demolished in recent months. A sub square cut through the floor, cut 005, housed a squared slab of stone, context 010, which measured some 560 x 510 x 130mm and was seated some 140mm below the upper level of the brick surface. It is assumed that this block of stone may have supported a vertical structural member such as a column although no traces of such survived, the cut simply being backfilled with a rubble fill, context 006. The remaining intrusion through the brick surface 004 was context 021 which contained the very mixed rubble deposit 007 in which large quantities of roof slate fragments were present. It is thought that 021 and 007 may relate to disturbance during the demolition of wall 001 and its related structure in recent months.

Figure 8 Plan of Trench 1 showing brick surface 004, cut by intrusion 005 and cut/foundation/wall 001, 002, 003

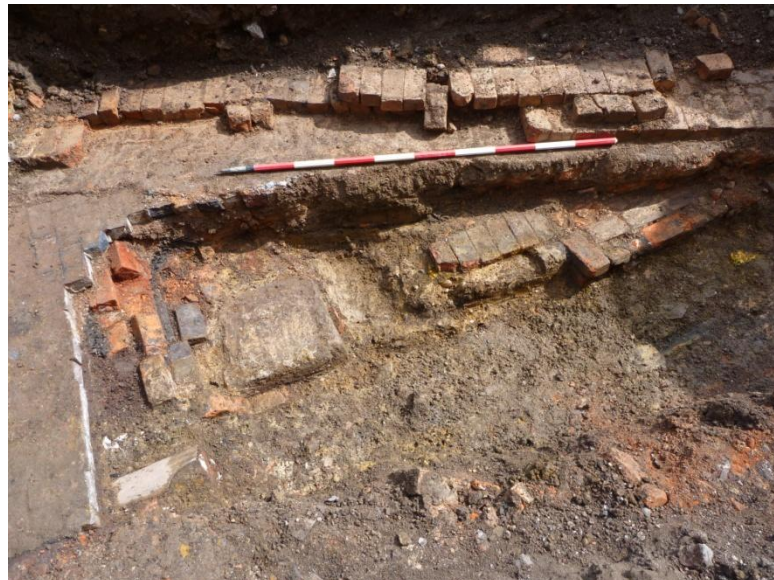
Plate 12 Trench 1 at completion of excavation, looking NNE

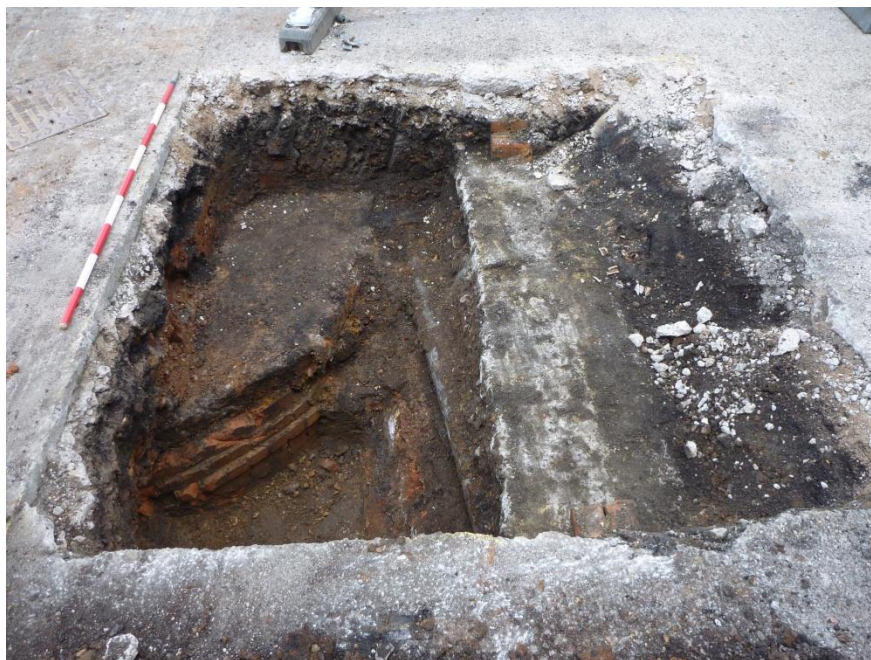
Plate 13 Trench 2 at completion of excavation, looking NNE

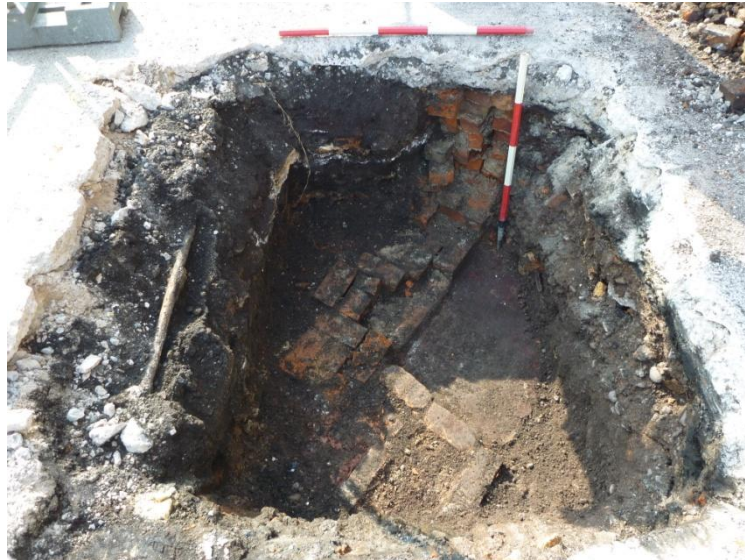
Plate 14 Trench 3, showing structural features, looking ESE
