| SITE ADDRESS | St Mary's Church Hall, Bishophill Junior, York | | | | | |
| YAT PROJECT# | 5336 | YAT REPORT # | 2010/8 | | | |

Between the 15th February and 7th May 2010, York Archaeological Trust undertook a watching brief at the former St Mary's Church Hall, Bishophill Junior, York (Figure 1). The objective was to record any deposits, features or buried structures exposed during the excavation of a number of foundation pits and a hole for a fireplace and chimney (Figure 2) associated with the conversion of the hall into a dwelling. Each of these was nominally 0.8m x 0.8m, the fireplace excavation was c.2m x 0.9m, and penetrated c.0.7m into the ground. This was encountered c.0.8m below the existing wooden floor of the hall which had been raised above the then existing ground surface at the time of the construction of the church hall sometime in the 19th century. This made the total depth of these pits around 1.5m deep which coupled with the fact they were inside the standing structure meant that all the digging, undertaken by Manor House Developments Ltd, was by hand. In addition to the foundation pits the excavation of a short length of new drain run to the north-east side of

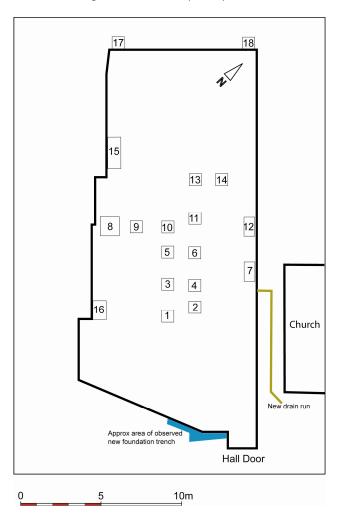
The observed stratigraphy was uniform across the area of observations and therefore a single stratigraphic sequence, and that within Foundation Pit 13, is described here. In Foundation Pit 13 the earliest deposit noted, between 1.3 and 1.5m below the wooden floor of the hall and between c.0.5 and 0.7m below the below floor ground level, was a loose, dark brown silt with occasional limestone, flecks of white mortar, animal bone, and disarticulated human bone (1000). This deposit was overlain by a 0.3m deep layer of very dark brown very slightly clayey silt with moderate pale grey mortar and occasional brick / tile (1001). Overlying 1001 was a 0.15m deep deposit which was a mixture of brick rubble, tile and pale grey plaster (1002). This varied in thickness from foundation pit to foundation pit being up to c.0.3m deep in some of the pits. Above this was the floor void (1003), c.0.8m deep, and over that the existing wooden floor (1004).

Figure 2 Hall outline with foundation pit locations and other observations

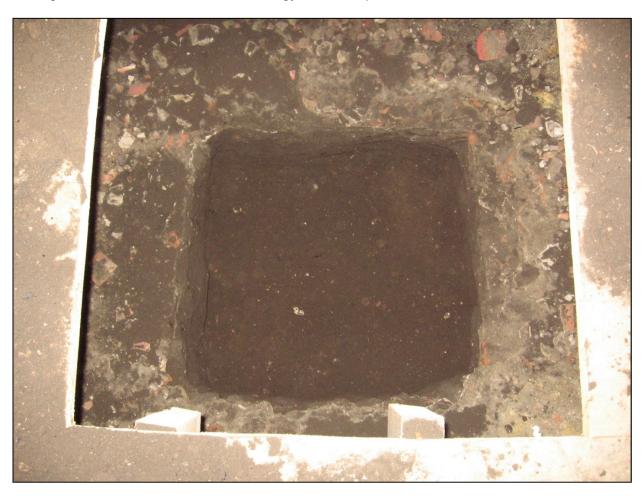
All of the deposits encountered in the new drain run and foundation trench were clearly modern and disturbed and were not recorded in detail. No datable finds were recovered from any of the foundation pits so dating of the contexts seen remains uncertain, although Context 1002 is likely to be directly associated with the construction of the hall and thus no earlier than the 19th century. Context 1001 is probably a disturbed version of Context 1000 which appears to be a medieval / post-medieval graveyard soil containing moderate quantities of disarticulated human bone. This bone was gathered together and reburied once all the foundation pits had been dug. Overall it appears that little significant disturbance to the archaeology has taken place.

Plate 1 Foundation Pit 13, looking north-west

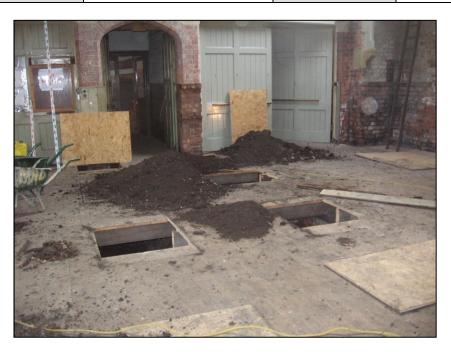
Plate 2 Foundation Pits 1-6 during excavation, looking south-east

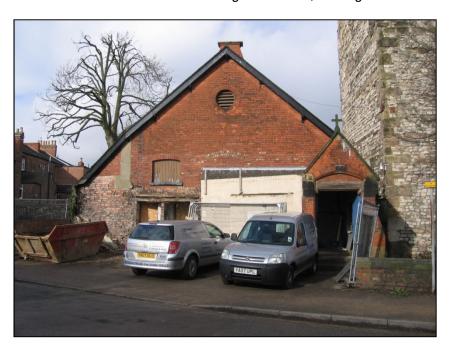
Plate 3 The south-east end of the church hall, looking north-west
