YORK ARCHAEOLOGICAL TRUST REPORT

SITE ADDRESS	St. Mary's Church, Bishophill Junior, York		
CLIENT NAME	St. Mary's Church PCC		
YAT PROJECT #	5339	YAT REPORT #	2010/47
MUSEUM ACCESSION #	n/a	GRID REFERENCE	SE 6000 5148
PLANNING REFERENCE #	n/a	AAI OPS NOTICE #	10004

INTRODUCTION

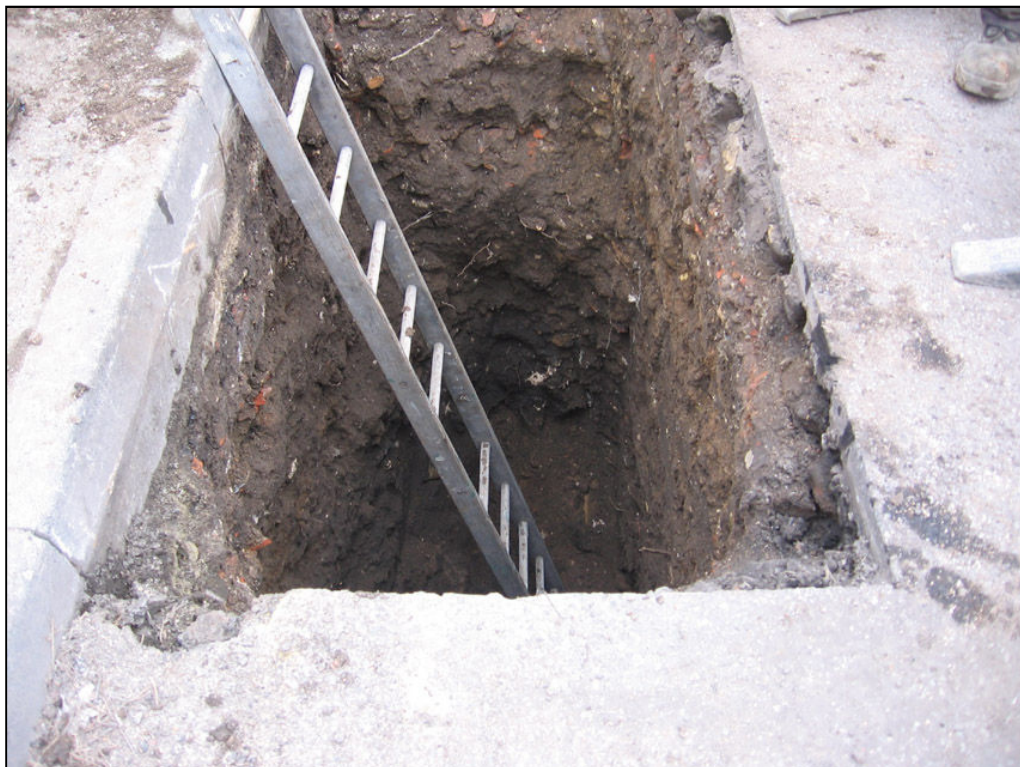
Initially, a trench c.2m x 1m was excavated in the roadway to locate the foul water sewer running along Bishophill Junior. On the Prospect Terrace side of the trench this sewer in the form of a brick culvert (1000) was located at a depth of c.3m below the road surface. It appeared to have been constructed by the tunnelling method but it was not possible to confirm this. The very limited exposure of this culvert meant that no details of it could be established. On the St Mary's Church side of the trench, the lowest context noted, between 2.6 and at least 3.2m below ground level (BGL), was a light brown slightly clayey silt containing frequent fragments of sandstone slates (1001). Overlying this there was a 0.4m deep layer of dark brownish-grey very slightly clayey silt containing moderate quantities of disarticulated human bone (1002). This layer also produced a green-glazed jug handle of the 13th century and a sherd of Roman grey ware; these were not retained. Between 0.8m and 2.2m BGL there was a deposit of dark brownish-grey very slightly clayey silt with occasional flecks of white mortar (1003) and at c.2.1m BGL, a human skull. Overlying Context 1003 was a 0.5m deep layer of mid greyish-brown silt with moderate patches of medium brown sand and occasional flecks of white mortar (1004). This was sealed by a firm, mid brown silt with frequent fragments of brick / tile and pale brown / white mortar and occasional limestone fragments (1005). Above this was a horizontal band of stone setts (1006), probably an earlier road surface. The uppermost context was the current road surface of tarmac (1007).

Plate 1 Foul water excavation in roadway, looking north-east

There are some significant findings from this watching brief, mainly associated with the trench dug in the roadway to locate the sewer. Context 1001, at the base of the trench, contained significant quantities of sandstone roofing tile. Due to its depth this may be Roman in date and derived from the collapse of the roofs of buildings, suggesting that the main Roman sequence will be below this deposit, that is at a depth greater than 3.2m BGL. This is of interest since in the vicinity of Trinity Lane Roman structures have been discovered a little over a metre down and may indicate the presence of another Roman terrace in addition to the one already documented in the Fetter Lane / Bishophill Senior area, but further work in this area would be needed to confirm or clarify this.

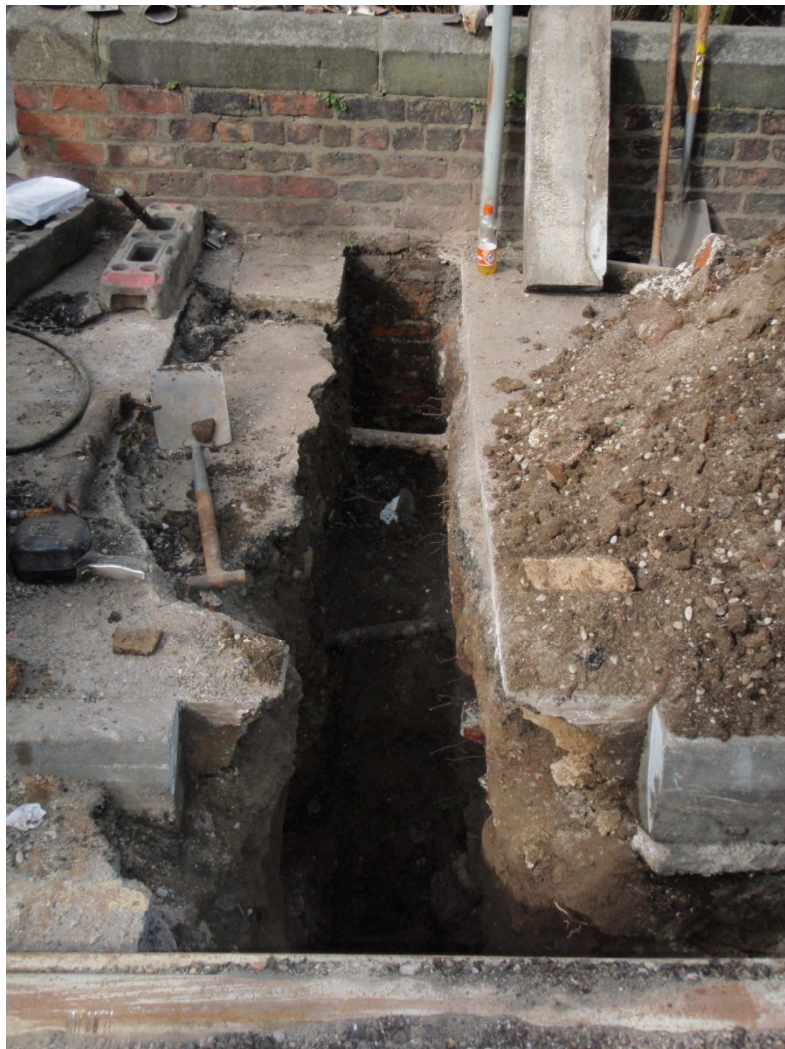
A trench c.0.4m wide was then dug from the road excavation to the current graveyard wall. In this trench the earliest deposit noted, between 0.6m and at least 1.6m BGL, was a dark brownish-grey very slightly clayey silt with occasional brick / tile and flecks of white mortar (1008). This deposit appeared to butt a brick wall (1009) running parallel to the graveyard wall but located 1.8m to the south-east, almost below the pavement kerb. It was 0.3m wide, up to 1.1m high and its top lay c.0.5m below the pavement surface. Overlying it was a 0.2m deep layer of dark brown silt with moderate flecks of pale brown mortar and very occasional brick / tile (1010) and this was sealed by a 0.2m deep deposit of mid brown silt with moderate pebbles and brick / tile and occasional pale brown mortar (1011). Above this was a levelling deposit of tarmac pieces and mid brown silt with occasional brick / tile (1012) and the current pavement surface of tarmac (1013).

Plate 2 Sewer trench dug through pavement towards churchyard wall

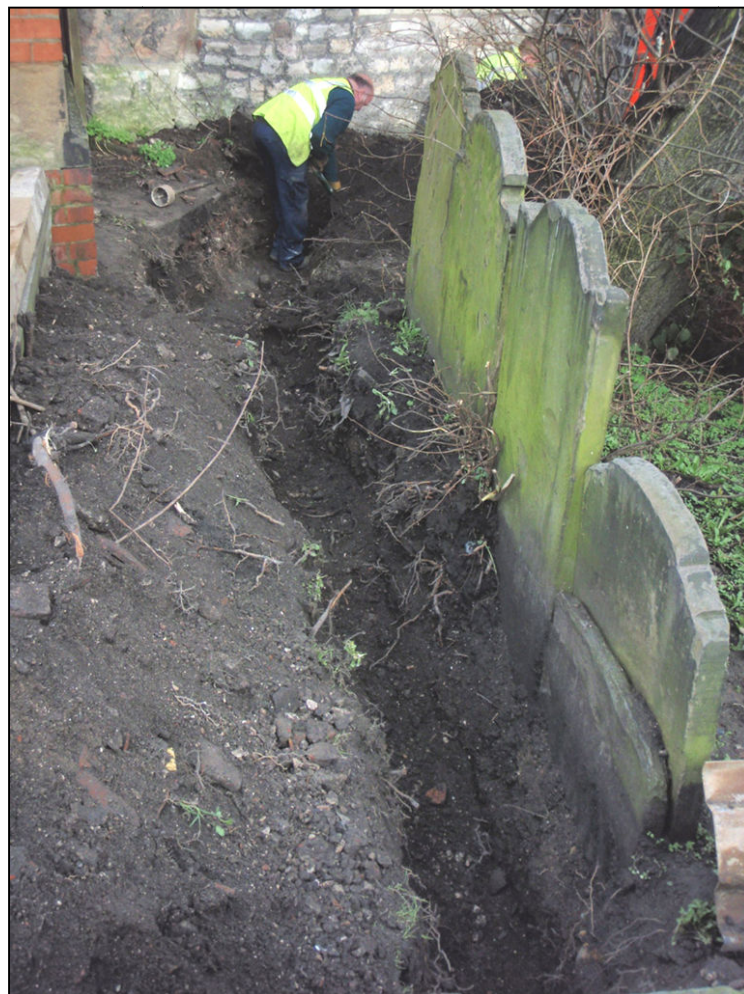
The next stage involved the digging of a trench, again c.0.4m wide, through the graveyard. This was initially aligned south-east / north-west and passed between part of the graveyard boundary wall and a row of four headstones dating from the 19th century before turning through 90 degrees to run south-west / north-east. It met the stonework of the church at the exterior of the intersection of the tower and the south-east aisle. Towards the graveyard wall this trench was up to 0.9m deep but it was only c.0.5m deep close to the church. No clear stratigraphy was observed along this section of trench the only deposit recorded being a friable, dark, slightly orange, greyish-brown sandy silty clay with moderate pebbles and occasional fragments of brick / tile (1014).

Plate 3 Part of the north-west / south-east sewer trench within the graveyard, looking north-west

During the excavation of the trench in the graveyard no articulated bones were noted but around 100 fragments of disarticulated bone were recovered. These were placed in a covered box and on completion of the trench digging a small rectangular pit was dug in the base of the trench and the

bones reinterred (See Fig X) in accordance with the wishes of the local priest and Annexe S8 of the Church of England / English Heritage 2005 publication "Guidance for best practice for treatment of human remains excavated from Christian burial grounds in England".

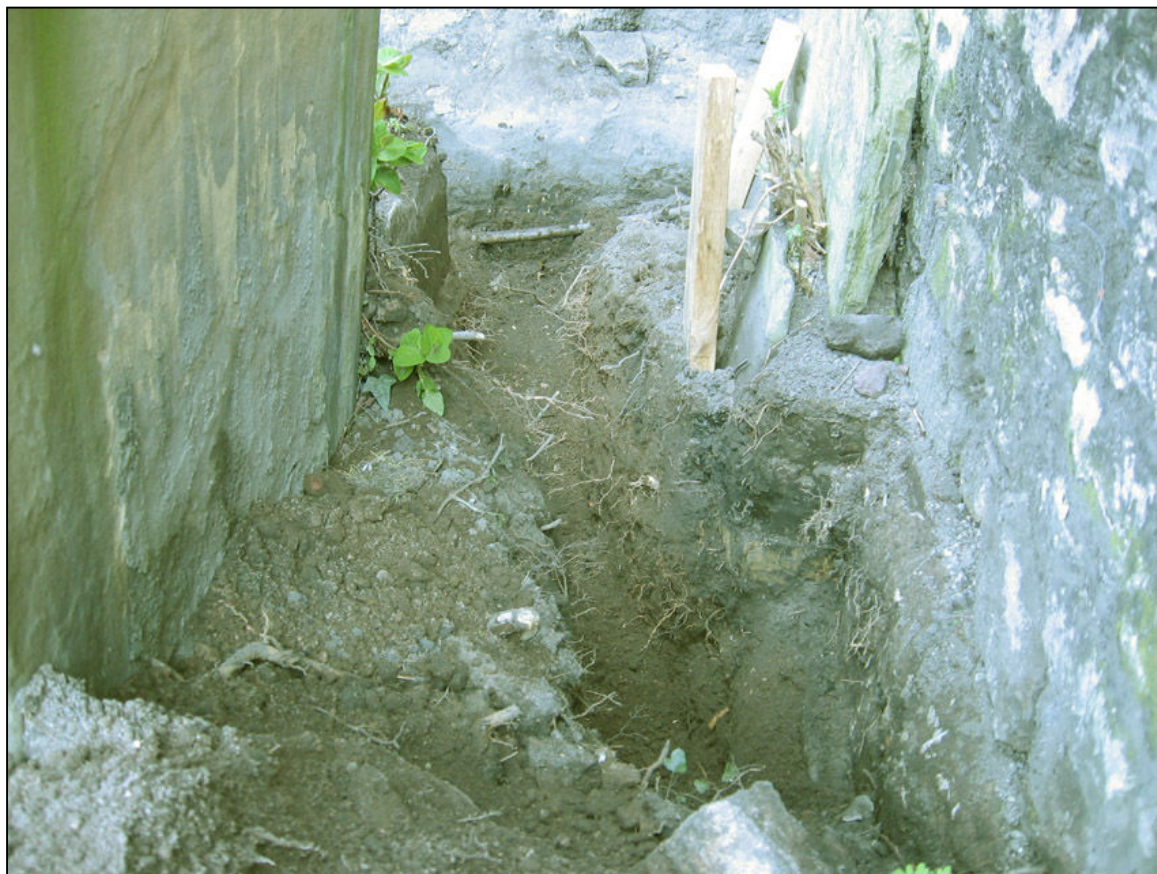
Plate 4 Fully excavated electric cable trench, looking north-west

The final work undertaken was the observation of a short stretch of trench dug almost adjacent to the exterior of the liturgical west wall of the south aisle. This trench was c.0.35m deep and was c.0.6m deep where it met the foul water trench and c.0.9m deep at its opposite end where the cable was to enter the church. At the north-west end of the trench the lowest deposit noted, between 0.2m and at least 0.6m BGL, was a dark brown very slightly clayey silt with moderate bricks and occasional tile (1015). Sealing this was an horizontal surface of Yorkstone slabs (1016) which were c.0.05m thick. This had been covered by the modern topsoil which was a very dark brownish-grey very slightly sandy silt (1016). In the central part of the trench the lowest deposit, between 0.2m and at least 0.7m BGL, was a mixture of dark brown very slightly clayey silt and light to mid brown silt with moderate bricks and very small flecks of white / pale brown mortar and occasional tile (1017). The overlying sequence was the same as at the north-western end of the trench. At the south-east

end of the trench the earliest deposit, seen between 0.5m and at least 0.9m, was a loose, mid brown silt (1018). Above this was a dark brown very slightly clayey silt with moderate patches of light brownish-yellow sticky clay (1019). The overlying sequence of contexts was the same as seen in the central and north-western parts of the trench.

Within the existing graveyard no intact burials were encountered although moderate amounts of human bone were recovered and reburied. Nothing of great archaeological significance was noted from the trenches within the graveyard, although the electric cable trench did produce evidence that the path from the south door did take a different route at some time in the past.
