SITE ADDRESS	Utility trench, Foss Islands Road and Lawrence Street, York					
CLIENT NAME	Morgan Sindall (Infrastructure) plc					
YAT PROJECT #	5366	YAT REPORT #	2010/79			
MUSEUM ACCESSION #	n/a	GRID REFERENCE	SE 6110 5140			
PLANNING REFERENCE #	n/a	AAI OPS NOTICE #	10009

INTRODUCTION

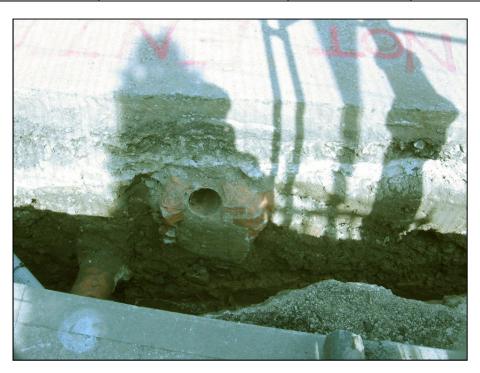
In Section 3 the earliest deposit seen, between 0.6 and at least 1m BGL, was a firm, mid brown clay with occasional cobbles (1010). Cut into this was a brick culvert (1011) thought to be aligned approximately north-west / south-east. It had walls one brick, c.0.1m, thick and was at least 0.6m tall although the very top of the roof arch had been partially truncated and the base of the culvert lay below the level of the base of the utility trench. Butting the south-west wall of the culvert was a deposit of dark greyish-brown silt with moderate pebbles and occasional pale brown mortar (1012). Butting the north-east wall of the culvert there was a layer of dark brown silt with moderate pebbles and occasional brick / tile (1013). Gradually the culvert filled up with a very dark brown slightly clayey silt (1014) and at some point the top of the culvert was broken through and a ceramic drain (1015) was inserted to replace the culvert. The overlying contexts were modern levelling deposits (1016) and 1017) and the road surface of tarmac (1018).

Plate 1 Culvert 1011, looking north-west

No other definite features were noted during this watching brief but definite or probable build-up deposits were recorded from all the described trenches. The only other context of note was the brick culvert, Context 1011, seen in Section 3. Generally the trenches excavated for this work followed quite closely the line of previous service trenches and overall little damage was done to any archaeological remains.

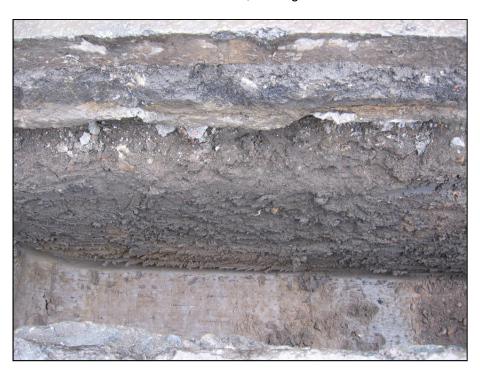
The lowest deposits observed in Section 9, between 1 and at least 1.4m BGL, were a light orange sand (1051) and a mid brown sand (1052), both believed to be natural in origin. These had been cut by a substantial linear feature (1055) which was around 8m wide and aligned approximately northwest / south-east. Only the upper c.0.4m of this feature, possibly a large ditch, but it was seen to have a sharp break of slope at the top leading to steeply sloping sides. The base was an uncertain depth below the base of the trench. It had at least two backfills the lower of which was a mid grev slightly clayey silt with moderate animal bone and charcoal (1053). The upper backfill was a mid brown very slightly clayey silt with moderate charcoal (1054). The feature had been sealed by a 0.5m deep layer of dark brownish-grey slightly clayey sandy silt with occasional brick / tile (1056). Overlying this was a 0.1m deep deposit of mid brown slightly sandy silt with moderate brick / tile and pebbles (1057). The remainder of the contexts seen at this point were modern and comprised levelling deposits (1058 and 1059) and the tarmac road surface (1060).

Plate 2 Backfilled linear feature 1055, looking east

Natural deposits were recorded in at least seven of the sections and was generally a firm mid brown clay although in Section 9 it proved to be sand. The Lawrence Street area is known for having sand rather than clay as the immediate underlying natural deposit. The only definite feature recorded was the large linear cut, Context 1055, in Section 9. Although not precisely datable it was possible to demonstrate that it cut directly into natural and was sealed by clean dark build-up deposits of probable medieval date. It is probable, therefore, that it is of Roman date but this is problematic since it is in the same location, and aligned similarly, as a possible Roman road heading for the Legionary Fortress. It is far too wide to be a roadside ditch and its function remains uncertain. Moderate to large quantities of animal bone from its lower backfill do, however, suggest that it was used for tipping waste bone.

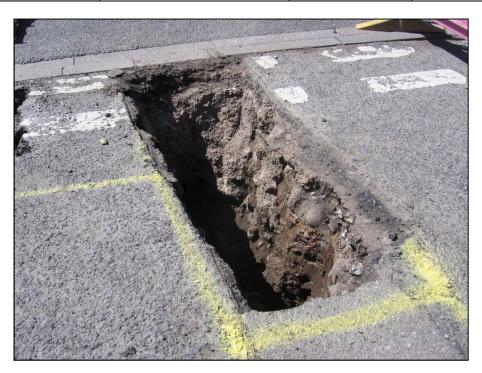
In Section 17 the earliest recorded deposit, at between 0.7 and at least 1.2m BGL, was a light greyish-brown silty sand (1099). It was sealed by a 0.2m deep layer of mid greyish-brown sandy silt with occasional limestone and animal bone (1100). Above this was a 0.3m deep deposit of mid brown sandy silt with moderate brick / tile (1101). The remaining contexts were probably or definitely quite modern and comprised a cobbled road surface (1102), a levelling deposit (1103) and the existing road surface of tarmac (1104).

Plate 3 View of Section 17, looking south
