# YORK ARCHAEOLOGICAL TRUST REPORT

<b>SITE ADDRESS</b>	Utility trench, Bootham Row, Bootham, York		
<b>CLIENT NAME</b>	CE Electric UK		
<b>YAT PROJECT #</b>	5380	<b>YAT REPORT #</b>	2010/55
<b>MUSEUM ACCESSION #</b>	n/a	<b>GRID REFERENCE</b>	SE 6006 5236
<b>PLANNING REFERENCE #</b>	n/a	<b>AAI OPS NOTICE #</b>	10021

Between 9<sup>th</sup> June and 21<sup>st</sup> June 2010, York Archaeological Trust undertook a watching brief along Bootham Row and a short part of Bootham, York (Figure 1). The objective was to record any deposits, features or buried structures of archaeological interest exposed during the excavation of a trench for the installation of a new electric cable. Most of the trench lay along the north-west side of Bootham Row and was generally c.0.35m wide and 0.7m deep although larger and deeper trenches were excavated to the immediate south-west of the Radio York studios and in the pavement on the south-west side of Bootham (Figure 2). It was not necessary to dig up Bootham itself since it was possible to use existing ducting. A number of specimen sections were recorded along different parts of the trench along Bootham Row and the trench in the Bootham pavement and are

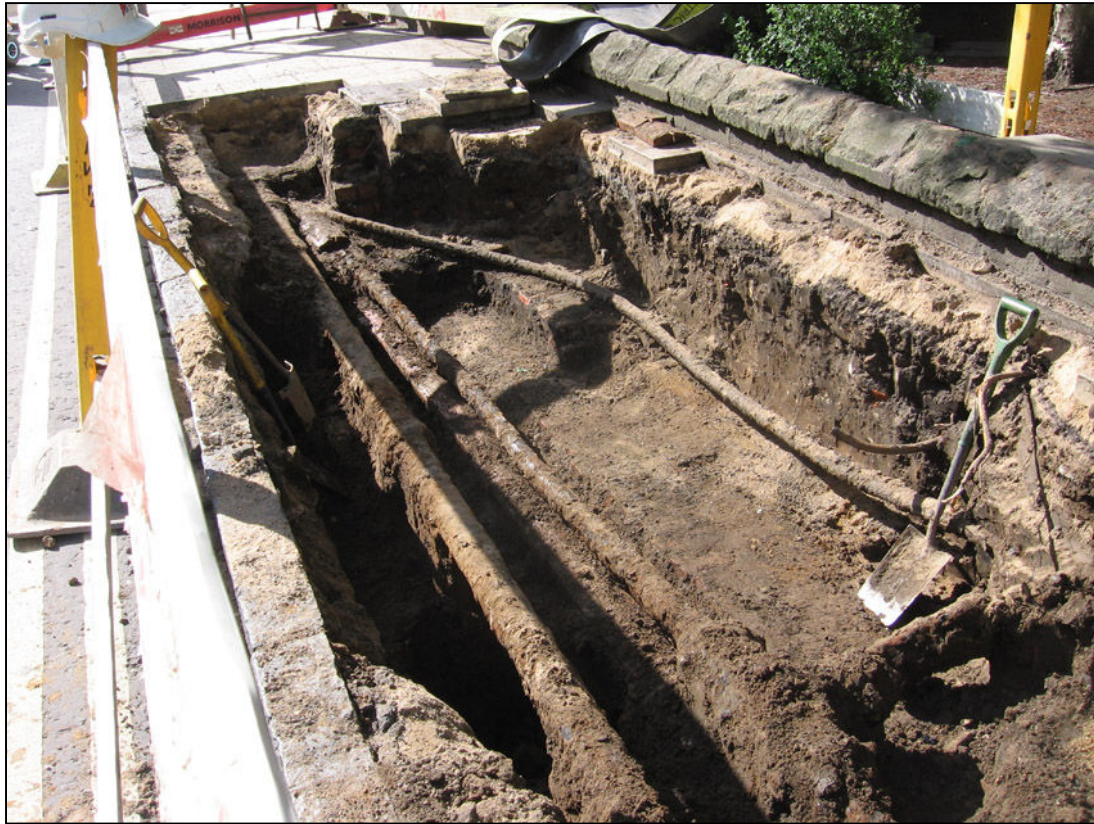
A section was recorded in the trench in the pavement to the south-west of Bootham. Here the earliest deposit noted, at between 0.5m and at least 0.8m below ground level (BGL), was a mid brown sandy silt with occasional patches of light brown sand and flecks of charcoal and pale brown mortar (1000). Many services were within this layer which was clearly modern. Overlying it was a 0.4m deep deposit of dark brown slightly clayey silt with moderate pale brown mortar and occasional charcoal and brick / tile (1001). Above this was a modern levelling deposit of mid orange-brown sand (1002) and the pavement surface of concrete flags (1003).

**Plate 1** Trench on south-west side of Bootham, looking south-east

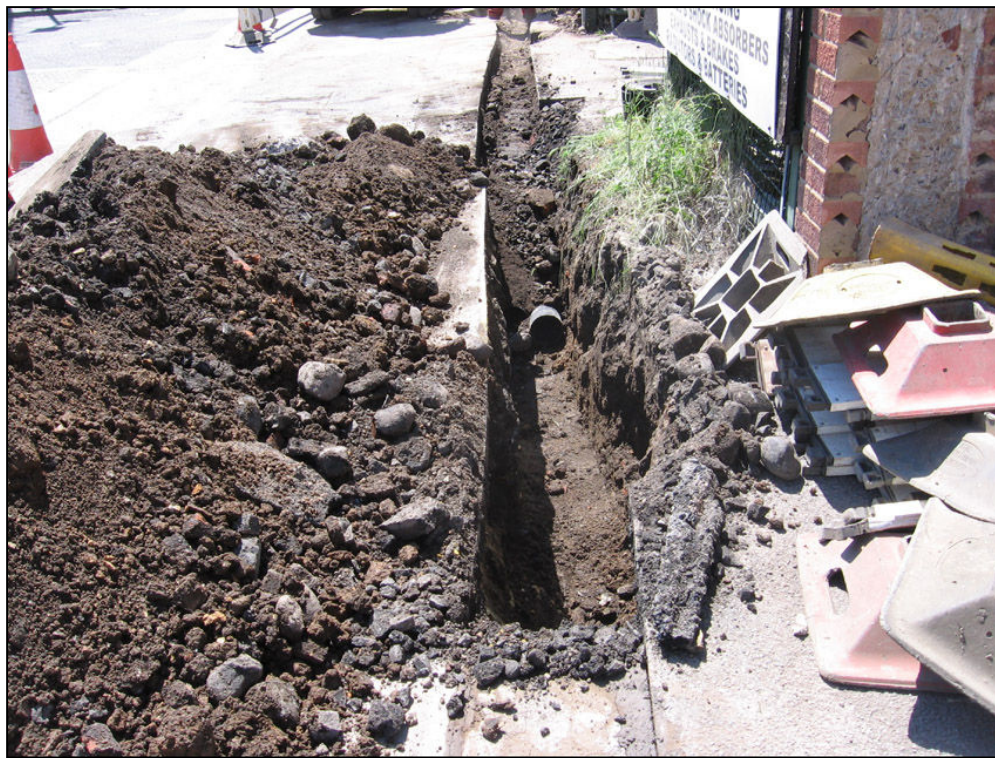
**Plate 2** The trench in the central part of Bootham Row, looking south-west

The next recorded section was located a short distance to the south-east, close to the centre of Bootham Row. The earliest deposit, seen between 0.6m and at least 0.8m BGL, was a mid brown silt with moderate flecks of pale brown mortar and occasional charcoal (1015). It was sealed by a 0.4m deep deposit of very dark grey very slightly clayey silt with occasional pale brown mortar (1016) and above this was a 0.1m deep layer of dark brown silt with occasional pale brown mortar and brick / tile fragments (1017). Overlying this was the crushed limestone make-up (1018) for the existing tarmac road surface (1019).

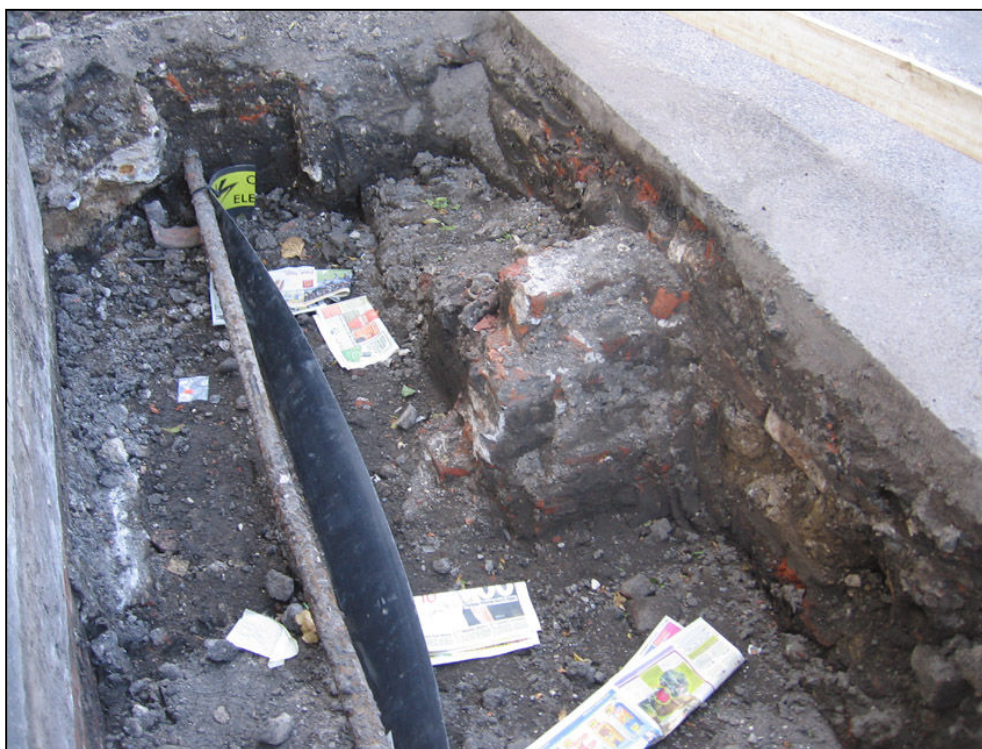
The last section was recorded within a stretch of trench to the south-east side of Bootham Row and butting the Radio York studios. The earliest context noted was a brick wall (1028) aligned approximately south-west / north-east. It was two bricks, 0.23m, wide and at least six courses, standing c.0.55m high, survived bonded with a hard white mortar. Butting its south-east face, and recorded between 0.45m and 0.8m BGL, was a 0.35m deep deposit of clean dark brown very slightly clayey silt (1029) and above this was a 0.2m deep layer of dark greyish-brown silt with occasional brick / tile and pale brown mortar (1030). Butting the north-west face of the wall was a 0.3m deep layer of mid greyish-brown very slightly clayey silt with occasional brick / tile and pebbles (1031). Overlying it was a 0.25m deep deposit of mid greyish-brown silt with moderate pale brown mortar and occasional brick / tile (1032). Sealing Contexts 1028, 1030 and 1032 was a levelling deposit of firm, dark brown silt with moderate brick / tile and occasional pale brown mortar (1033) forming the make-up for the current road surface of tarmac (1034).

**Plate 3** Trench adjacent to Radio York studios, looking south-east
