**CB369R**

**Report on an Archaeological Watching  
Brief at St Margaret's Church, Old Catton, Norfolk'**

**ENF135758**

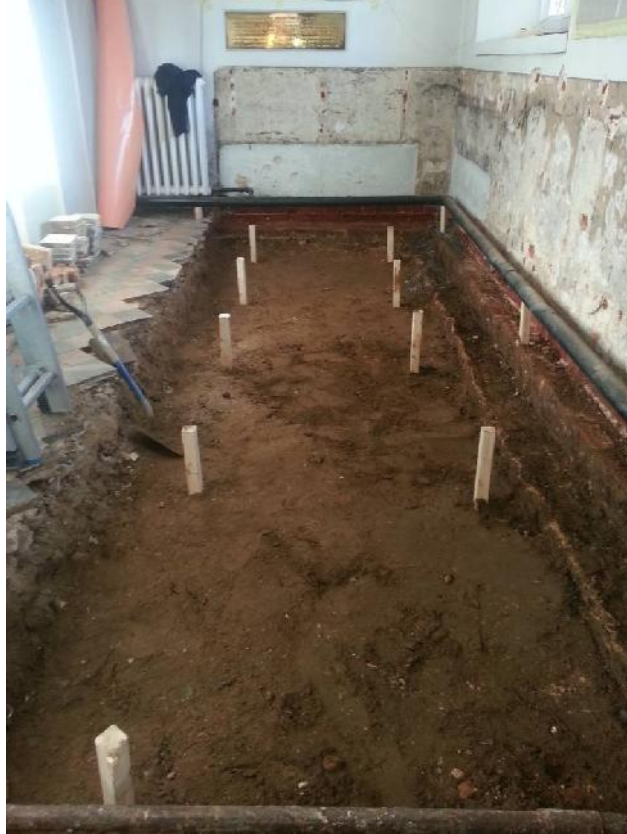
- 5.2 The internal floor in the south aisle covering an area approximately 6.1m by 1.8m was reduced by 0.25m in depth removing glazed terracotta floor tiles and 0.13m of mixed lime mortar and red brick/tile rubble that overlay dark brown silty sand deposit, the full extent of which was not reached (*Plate 1*). A replacement tiled floor over a lime concrete sub base was laid.

**Plate 1.** Floor reduction in the south aisle, looking east

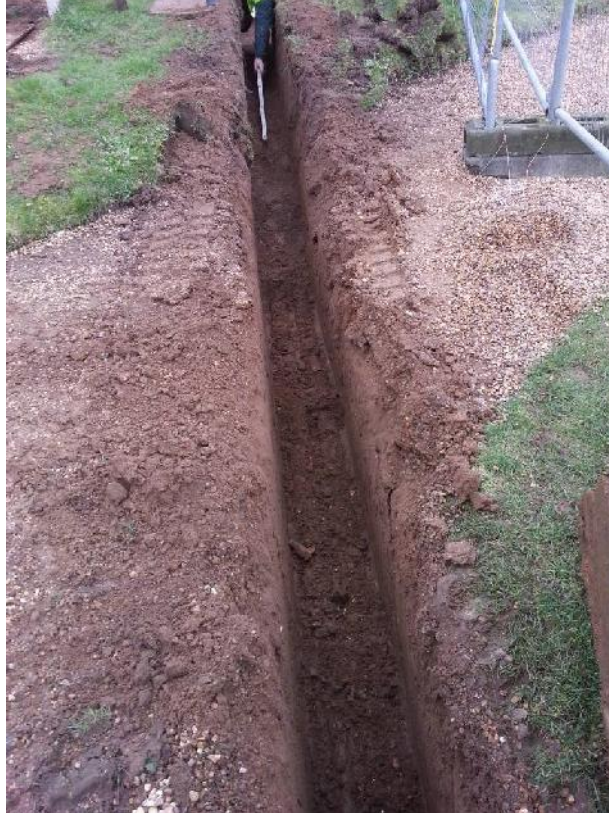
churchyard boundary wall adjacent to Church Street (*Fig. 2*). It was excavated to a maximum depth of 0.72m beneath present ground level removing 0.26m of dark greyish brown silty sand topsoil and dark brown silty sand subsoil, the full extent of which was not reached (*Plate 3*). A total of 64 fragments of human bone were recovered from topsoil and subsoil deposits and by consent of the Parochial Church Council were reburied in the backfill of the trench. No significant information was gained from the bone due to its fragmentary nature.

**Plate 3.** Sample view during excavation of the foul water trench, looking southeast
