**Report on an Archaeological Watching
Brief at 'St Mary's Church, Great Bircham, Norfolk'**

ENF133777

Reference No. CB323R
© Chris Birks March 2015

**St Mary's Church,
Great Bircham, Norfolk**

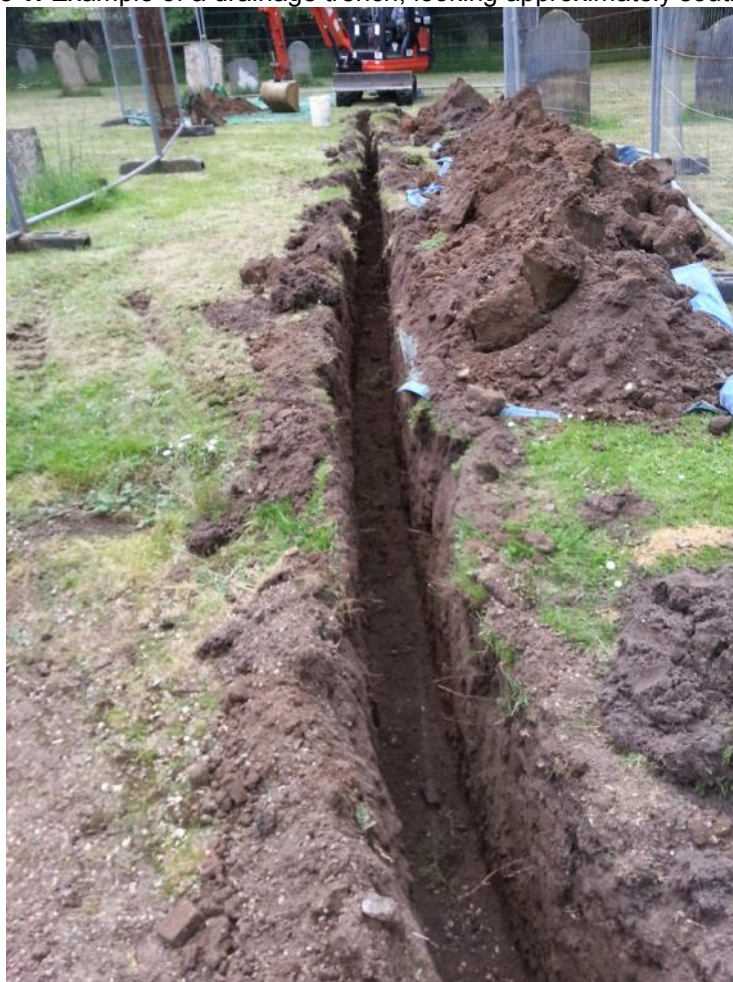
- 5.2 Site conditions were good and access was gained from Stanhoe Road to the north of the church. The weather remained dry and bright.
- 5.3 Trenches to the north of the church were excavated to a maximum depth of 0.7m beneath present ground level removing c. 0.3m of mid- to dark-grey brown sandy loam topsoil with occasional small-sized subangular flints and light- to mid-brown clayey loam subsoil with rare small-sized subangular flints, the full extent of which was not reached. A total of 28 fragments of disarticulated human bone were recovered from subsoil deposits.

- 5.4 Trenches to the south of the church were excavated to a maximum depth of 0.7m beneath present ground level removing c. 0.3m of mid- to dark-grey brown sandy loam topsoil with occasional small-sized subangular flints and light- to mid-brown clayey loam subsoil with rare small-sized subangular flints, the full extent of which was not reached (*Plate 1*). A total of 35 fragments of disarticulated human bone were recovered from subsoil deposits. No indications of foundations were observed.

Plate 1. Example of a drainage trench, looking approximately southwest

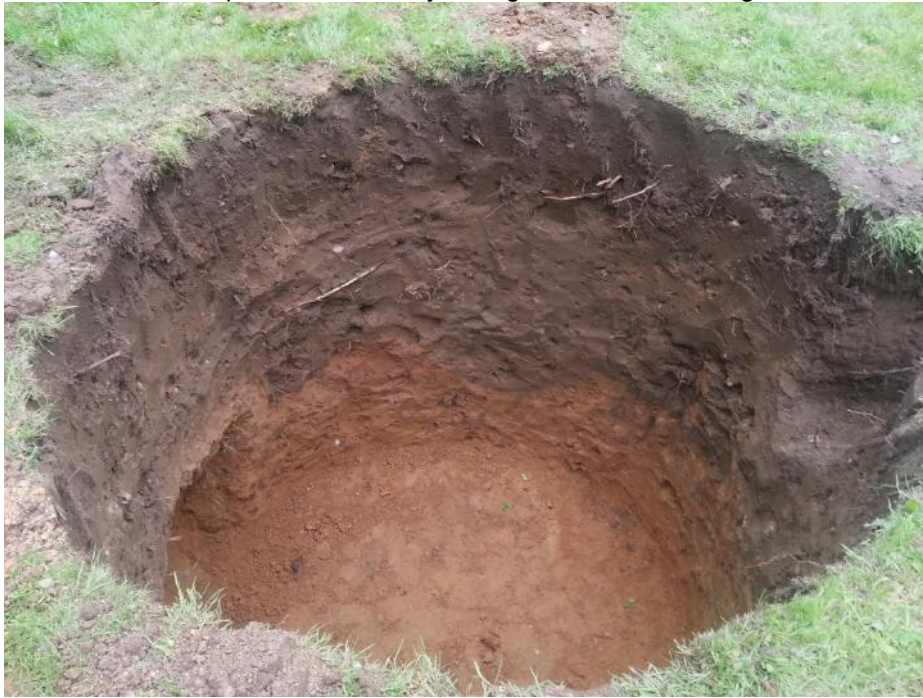
- 5.5 Excavations for 4 soakaways each measured c. 1.8m by 1.8m to a depth of c. 1.8m beneath present ground level (*Plate 2*). Initially, c. 0.3m of mid- to dark-grey brown sandy loam topsoil with occasional small-sized subangular flints was removed that overlay c. 0.6m of light- to mid-brown clayey loam subsoil with rare small-sized subangular flints. Subsoil overlay light-

brown/orange sandy clay undisturbed 'natural' deposits, the full extent of which was not reached. A total of 83 fragments of human bone were recovered from subsoil deposits.

Plate 2. Example of a soakaway during excavation, looking northwest
