## **Archaeology Report Number CB539R v.1.1**

### **Moat Farm Caravan and Camp Site, Low Road, Breckles, Stow Bedon Norfolk**

### **Programme of Archaeological Mitigatory Work – Earthwork Survey and Works Under Archaeological Supervision and Control**

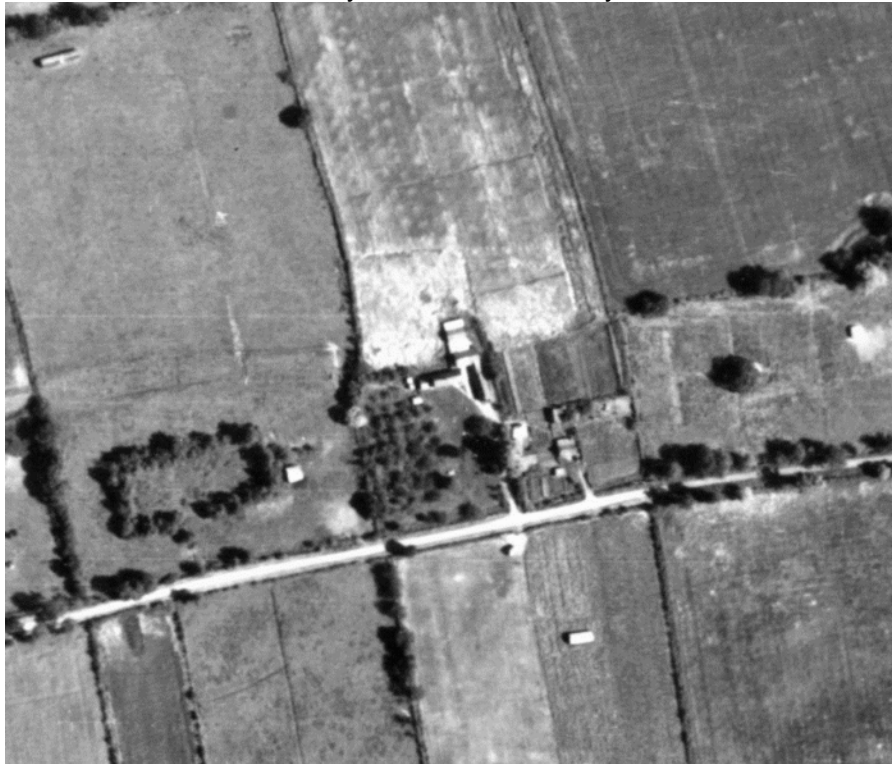
**Plate 1.** Extract from 1946 aerial photograph (RAF106G/UK/1634 5366-7 09\_JUL-1946) used courtesy of the Norfolk County Council

- 3.6 Aerial photographs taken in 1946 (RAF 106G/UK/1634 5366 09-JUL-1946 (TL9594A, *Plate 1*), RAF TL99/TL9535/B, RAF 3G/TUD/UK/101 6185-6 30-MAR-1946 and RAF106G/UK/1634 5366-7 09\_JUL-1946) and 1976 (OS 76-018-075 to 078 and OS/76018 076-7 19-APR-1976) show cropmarks of a rectangular moat to the west of and extending into the development site (NHER 9058), and investigations show that the moat appears to be a genuine medieval feature. The remaining ditches to the west still hold water and the internal area was wooded before it was cleared. The area is now managed to allow wildlife to flourish. The moat and the easterly extension

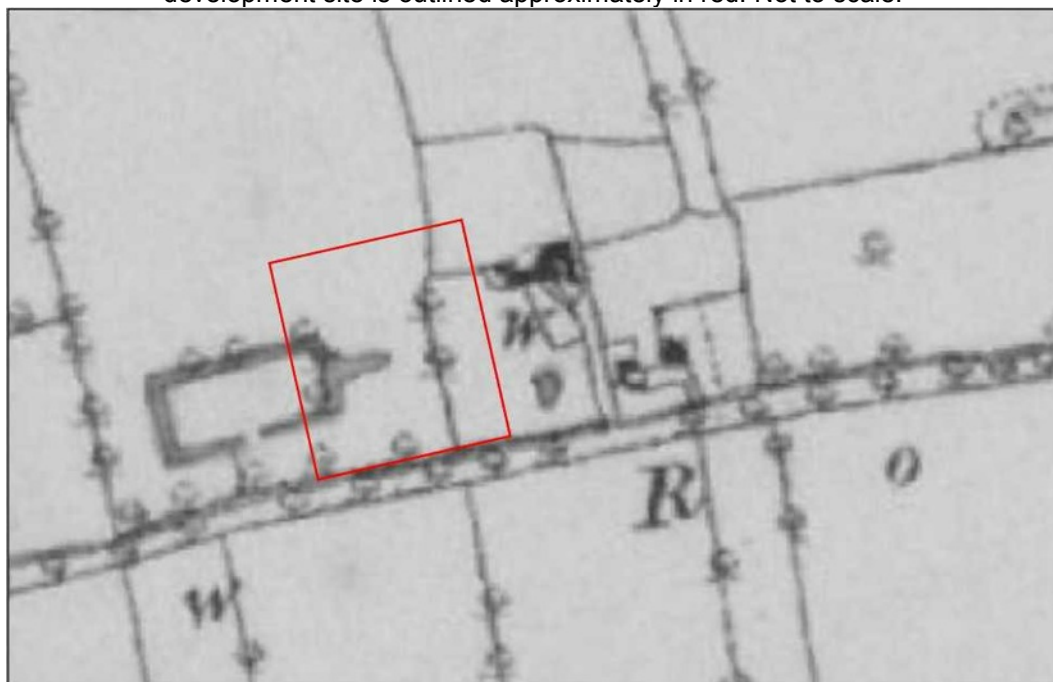
**Fig. 2.** Extract from 1889-95 Ordnance Survey 6-inch map, courtesy of Norfolk County Council. The development site is outlined approximately in red. Not to scale.

are shown on Ordnance Survey First edition 1884 and Ordnance Survey Second Edition 6 inch (1906-7) maps. An extract from a 1889-95 Ordnance Survey map is provided (Norfolk County Council 2011, *Fig. 2*). A cropmark transcription (9058 TL9594 17/01/95) shows the moated site and enclosure to the south and the line of the hollow way extending north from the moat then east towards the development site can be seen (*Fig. 3*).

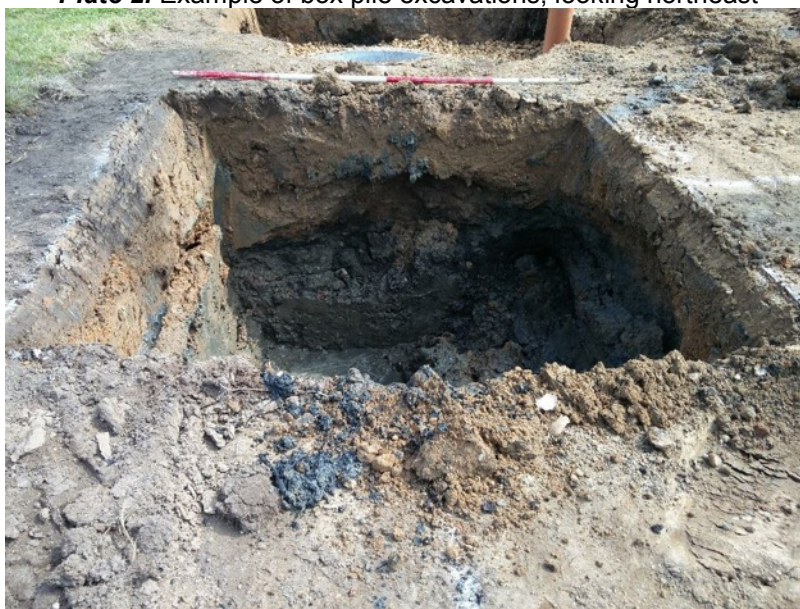
**Plate 2.** Example of box pile excavations, looking northeast

5.3.2 Excavations for 3 box piles measured 2m by 2m to a depth of c. 1.7m beneath present ground level (to c. 30.2m OD) removed 0.17m of topsoil (100) and 0.64m of subsoil (101) above clayey silt deposit (109) (Plate 2). They were required as historically, woodland to the east had been felled and buried at this location. Deposits were extremely wet and prone to collapse.

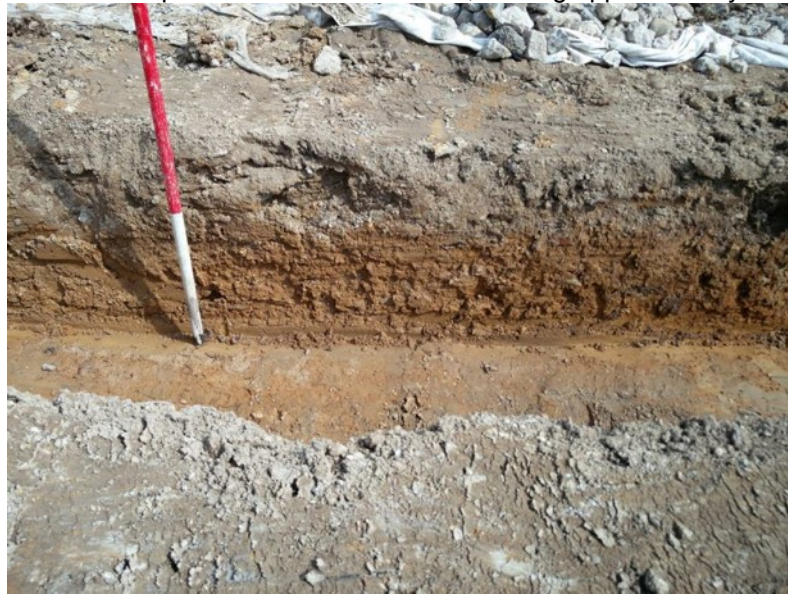
**Plate 3.** Example of foundation trenches, looking approximately north

5.3.3 Excavations for foundation trenches measured 0.6m wide to a depth of between c. 0.5m and c. 0.7m beneath present ground level removing c. 0.2m of topsoil (100) and c. 0.3m to 0.5m of subsoil (101) above undisturbed 'natural' deposits (102) (Plates 3 and 4).

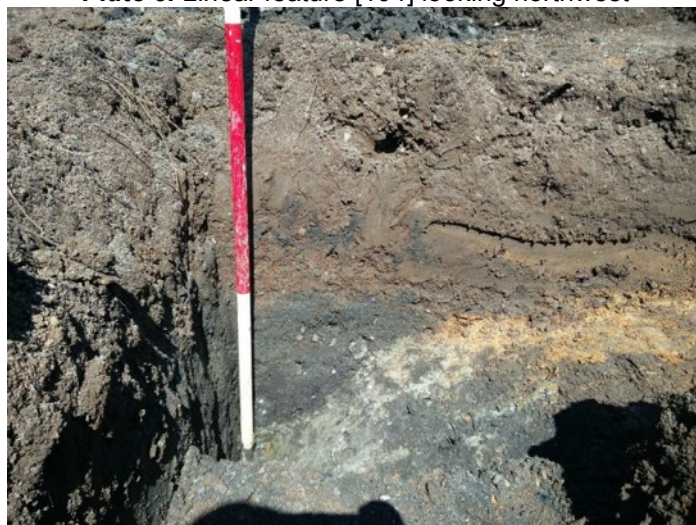
**Plate 5.** Linear feature [104] looking northwest

5.3.4 Feature [104] extended beyond the north, south and west edges of excavations at c. 0.5m beneath present ground level (c. 30.6m OD), overlain by subsoil (101) and contained fill (103) that produced no finds (*Plate 5*). Little of this feature was observed.

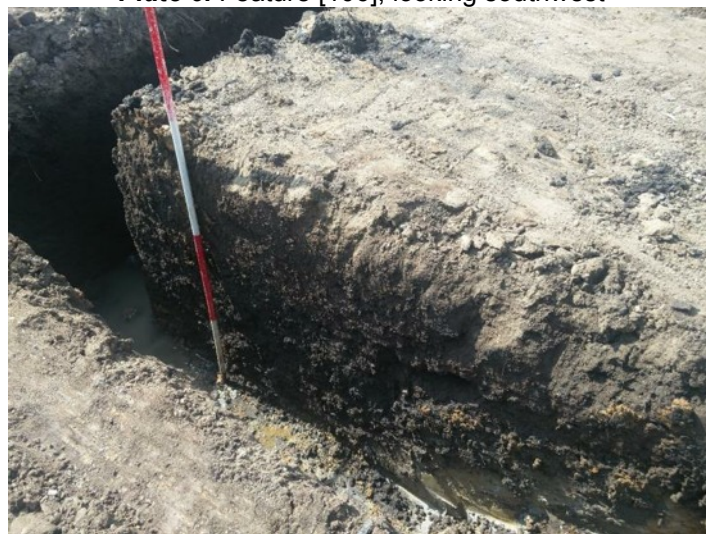
**Plate 6.** Feature [106], looking southwest

5.3.5 Linear feature [106] was recorded within the northeast corner of the house footprint at c. 0.55m beneath present ground level (c. 30.6m OD), sealed by subsoil (101) and contained fill (105) that produced a sherd of 19<sup>th</sup>/20<sup>th</sup> century blue and white transfer ware (*Plate 6*). Water ingress at a c. 0.5m beneath present ground level caused problems with the stability of the edges of excavation. Wooden shuttering was used to stabilise the trench edges but further investigation of feature [106] was unsafe.

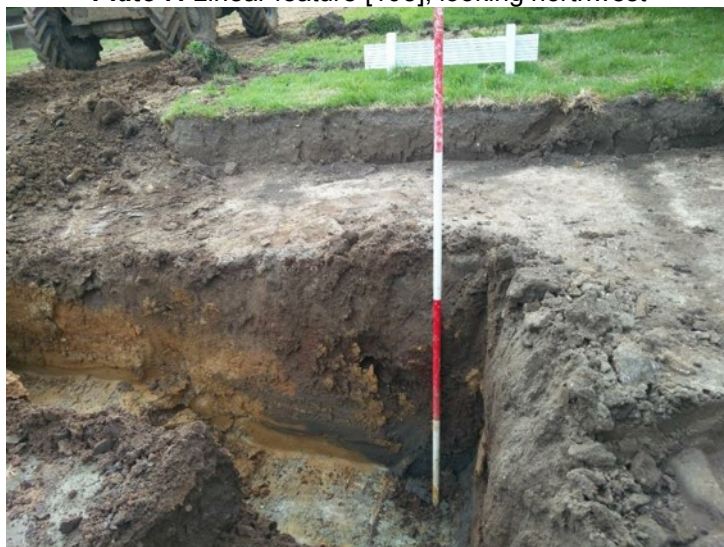
**Plate 7.** Linear feature [108], looking northwest

5.3.6 Linear feature [108] was partially revealed within the northwest foundation trenches at c. 0.5m beneath present ground level (c. 30.6m OD), sealed by subsoil (101) and contained fill (107) that produced no finds (*Plate 7*). Water ingress again caused the trench sides to collapse and it was unsafe to investigate further.

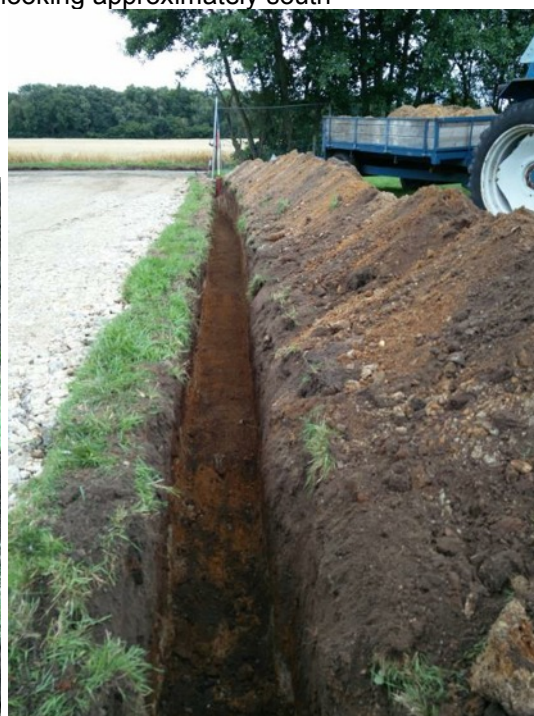
**Plate 9.** Example of mains service trench, looking approximately south

- 5.3.7 Excavations for surface water drainage trenches that extended to the existing pond, a foul water trench that extended to an area for a sewerage treatment plant (c. 2m by 2m) and mains service trenches measured 0.4m wide to a depth of c. 0.9m beneath present ground level removing c. 0.2m of topsoil (100) and c. 0.5m of subsoil (101) above undisturbed 'natural' deposits (102) (*Plates 8 and 9*). No archaeological remains were observed.

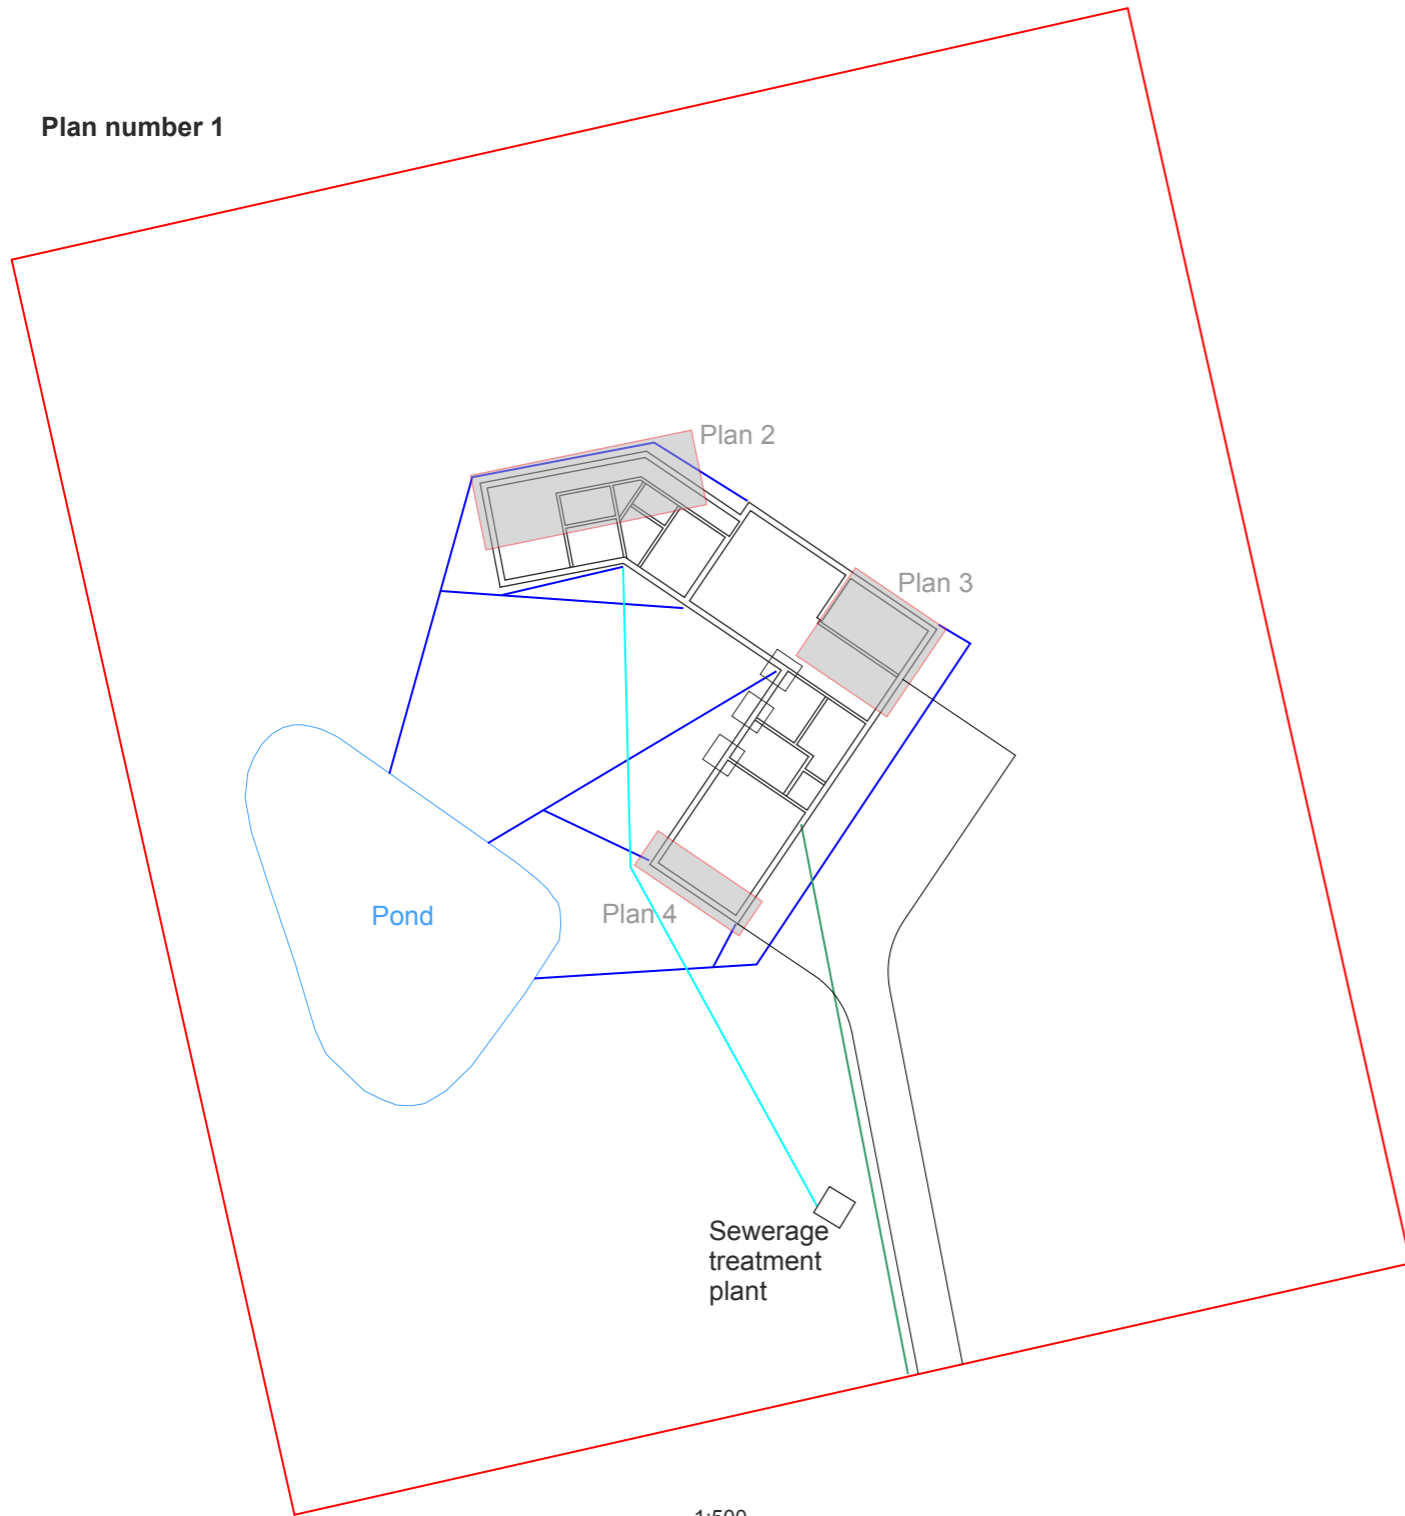
Figure 10. Plan drawings

5.3.1 An area including the footprint of the new house was initially stripped to a depth of c. 0.2m beneath present ground level removing topsoil (100).
