# Archaeology Report Number CB645R v.1.1

Morley Church of England Voluntary Aided Primary School, Deopham Road, Morley St Botolph, Norfolk

Works under Archaeological Supervision and Control 10, 11 and 14 September and 23 and 27 October 2020

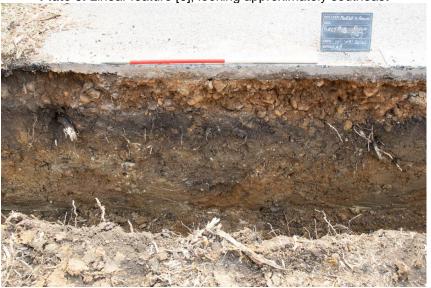
Plate 3. Linear feature [6], looking approximately southeast

5.2.4 Excavations for foundation trenches measured *c.* 0.45-0.75m wide and a maximum *c.* 1.3m deep and removed the remnants of topsoil (3) above *c.* 0.15m of subsoil (9) and undisturbed 'natural' deposits (10). Approximately north-south oriented linear feature [6] (at *c.* 47.0m) was observed within the southernmost foundation trench and extended beyond the north and south edges of excavation (*Plate 3*). It was not seen in any of the other foundation trenches, or in the drainage trench to the south. It measured *c.* 0.85m wide and *c.* 0.44m deep, with fairly steep irregular-shaped sides and a concave base. It contained upper fill (8) and lower fill (7) neither of which produced finds. The interface between fill (8) and subsoil (9) above was unclear.

- 6.2 The function of undated linear feature [4] recorded within the footprint of the new building is unclear. It may relate to drainage or possibly a plough-scar given the rural nature of the area surrounding the school, originally built in 1847. Undated linear feature [6] recorded in a foundation trench may relate to land partition prior to construction of the school, although its dimensions are quite small, or to activities associated with the school. It was not observed in other foundation trenches or the drainage trench excavations to the south where it was most probably truncated by the modern soakaway, and may have turned eastwards beneath the location of the school in which case it may have formed some kind of enclosure. It is possible these features relate to medieval and later remains observed in 2011. Feature [3] recorded in 2011 was the closest to the current works, identified as an artefact-rich area of topsoil, and may have represented a midden dating between the 17<sup>th</sup> and 19<sup>th</sup> centuries based on pottery finds, though no evidence of this was observed during the current works. The position of undated linear feature [16] and similar orientation to Deopham Road may relate to a ditch identified immediately to the north of the school buildings in 2011 and that these may be associated with boundaries shown on 19<sup>th</sup> century maps. It may also be a more recent former roadside ditch.

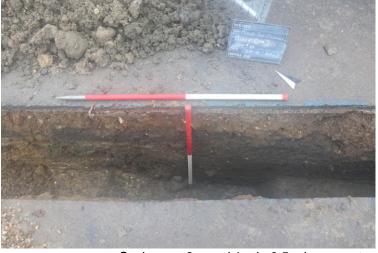
Plate 5. Linear feature [16], looking northeast

5.2.6 Approximately east-west oriented linear feature [16] (at *c*. 47.1m) extended beyond the edges of excavation (*Plate 5*). A modern soakaway to the east was breached and the trench quickly flooded with water at this location. The southeast edge of [16] was unclear but it appeared to measure *c*. 2.7m wide and a minimum 0.7m deep with a straight, fairly steep northwest side. It contained upper fill (14) and lower fill (15), neither of which produced finds though a small sherd of modern pottery was noted in (14), not retained. The interface between fills (14) and (15) was not overly clear.

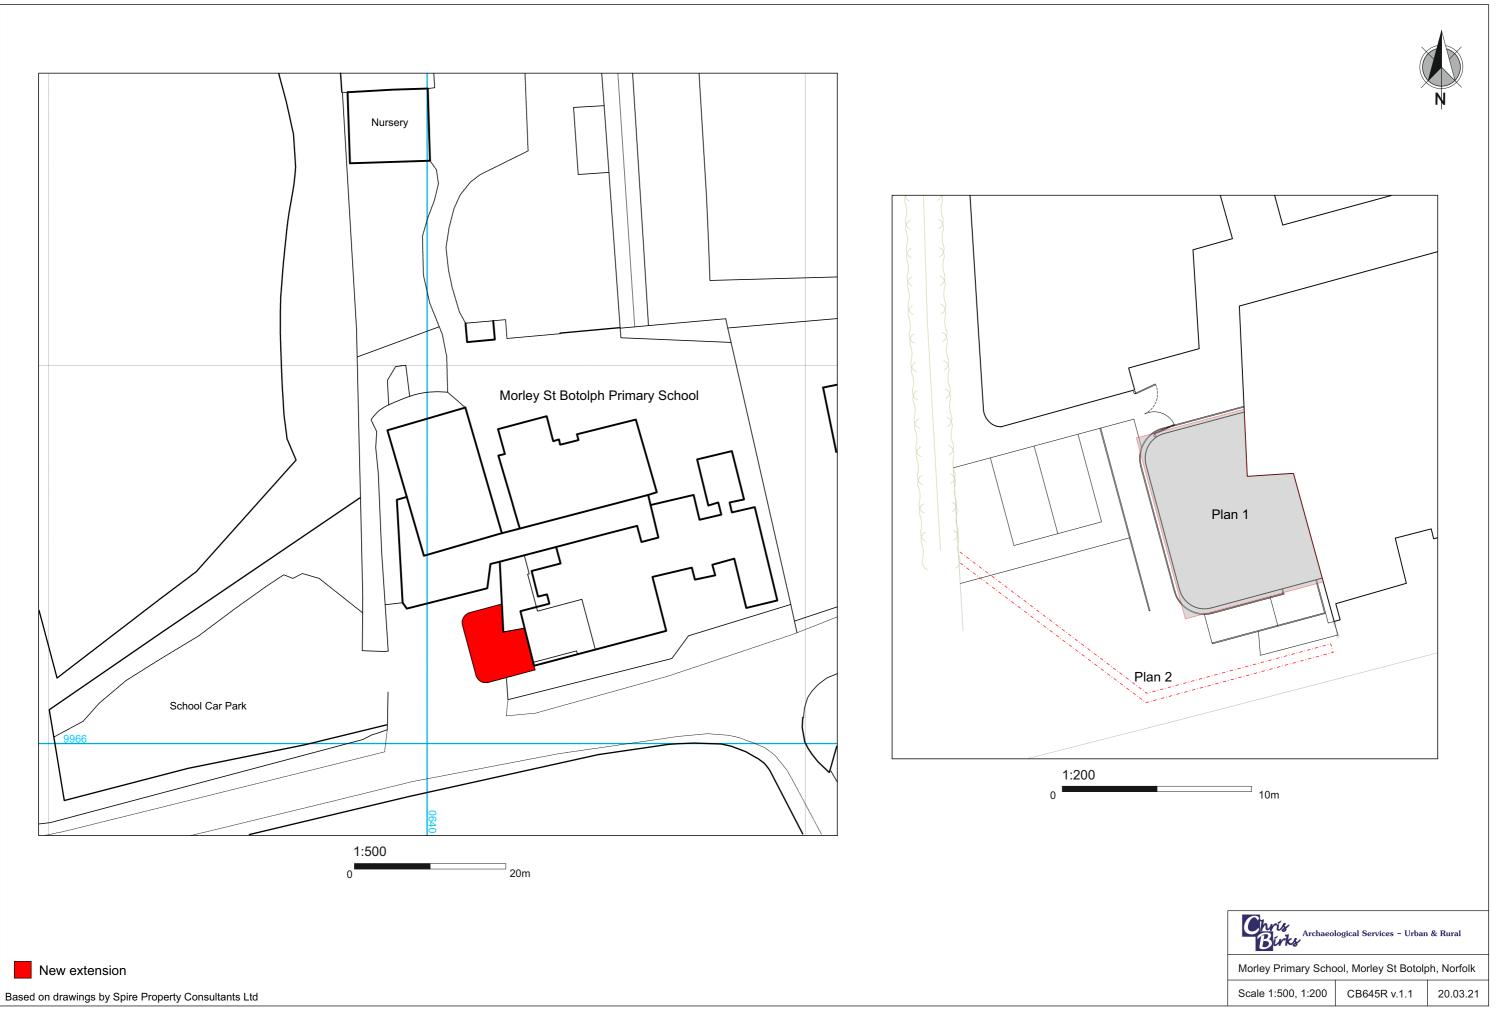
Figure 5. Site plan drawings

- The footprint of the new extension measured c. 10m by 7m and was initially reduced in depth by c. 5.2.1 0.4m removing c. 0.1m of asphalt (1) above c. 0.1m of associated hardcore deposits (2) and c. 0.2m of topsoil (3) (Plate 1).
- Two stumps from recently-felled trees required grinding-out. 5.2.2

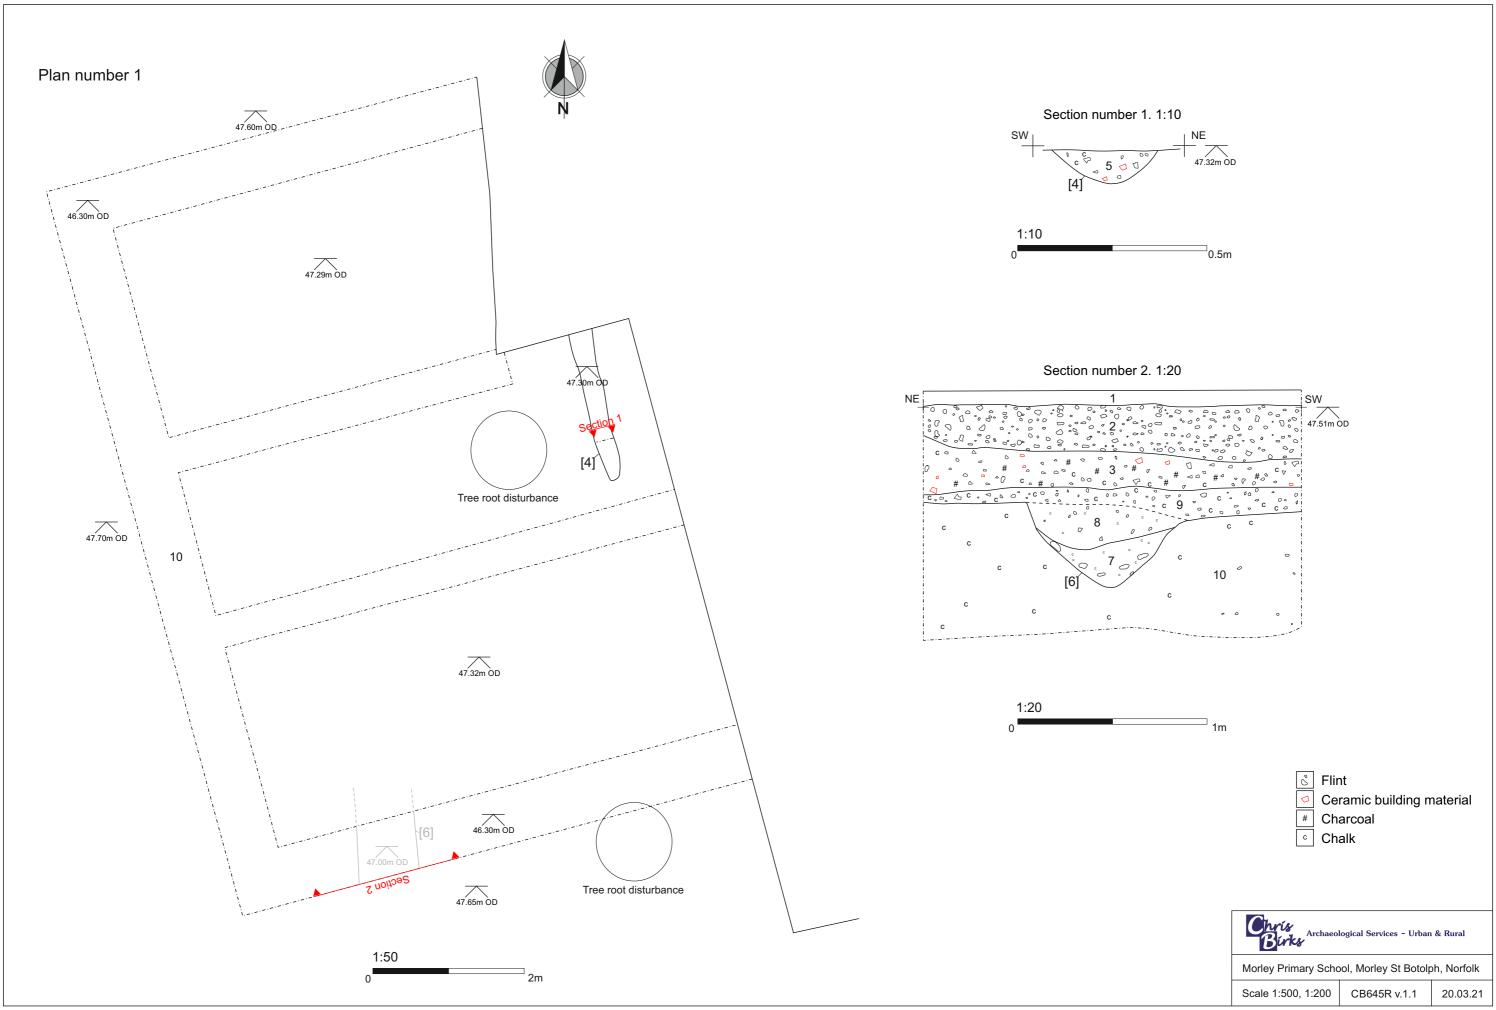
Figure 6. Plan number 1 and section drawings

Approximately northwest-southeast oriented linear feature [4] (at c. 47.3m) extended partly (c. 5m) 5.2.3 into the footprint of the new extension (*Plate 2*). It measured c. 0.3m wide and c. 0.1m deep with fairly steep slightly concave sides and a concave base. It contained fill (5) that produced no finds.

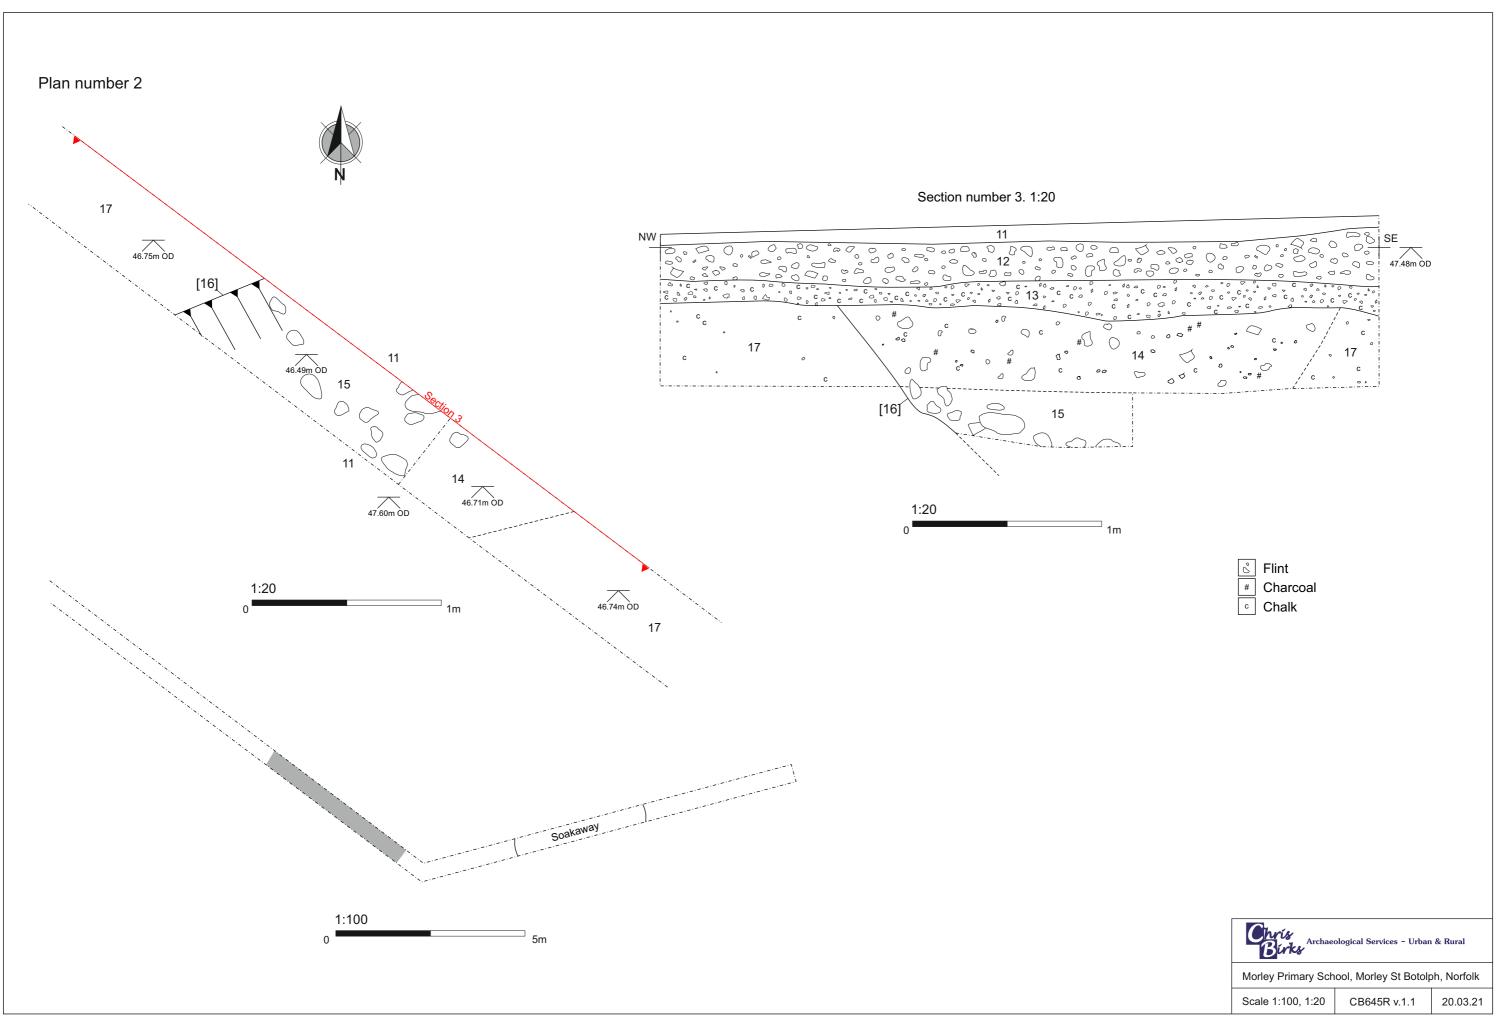
Figure 7. Plan number 2 and section drawing

5.2.5 Excavations for a surface water drain (to connect to existing) extended mostly across the car park *c*. 22.5m in length (*Plate 4*). The trench measured *c*. 0.45m wide and a maximum *c*. 1m deep and removed *c*. 0.1m of asphalt (11) above *c*. 0.2m of associated hardcore deposits (12) and *c*. 0.2m of subsoil (13) above undisturbed 'natural' deposits (17).

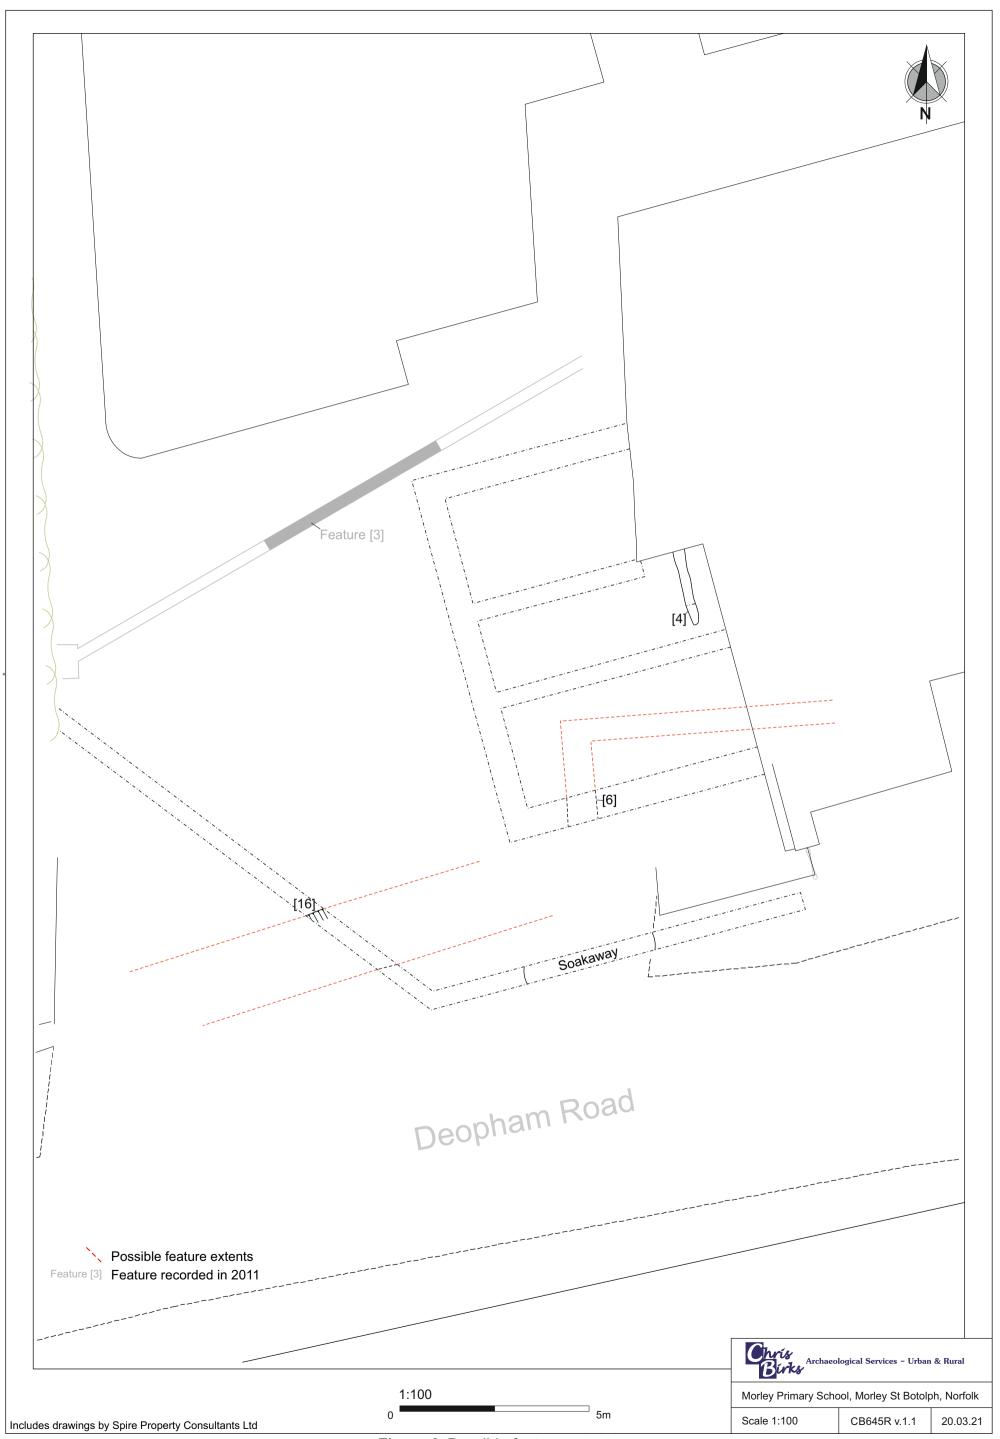
Figure 8. Possible feature extents

- 6.1 The author has a medium to high confidence rating of the results. The minimal areas of excavation associated with the construction of the new school entrance and administration area may be a reason why few archaeological remains were observed and other such remains beyond the excavations would survive *in situ*. The lack of dating evidence also precludes further interpretation of the recorded remains. Some difficulties were encountered in excavating/recording due to water ingress. Modern truncation of remains has been recorded during the current works, including root disturbance through 2 former trees, and during excavations in 2011. A figure has been prepared to show the possible extents of archaeological features (*Fig. 8*).
