**Report on an Archaeological Evaluation
by Trial Trenching at 'St Andrew's Church,
Framingham Earl, Norfolk'**

NHER ENF125826

Prepared for
GBM Architecture
4 Tombland
Norwich
NR3 1HE

Reference No. CB215R
© Chris Birks February 2011

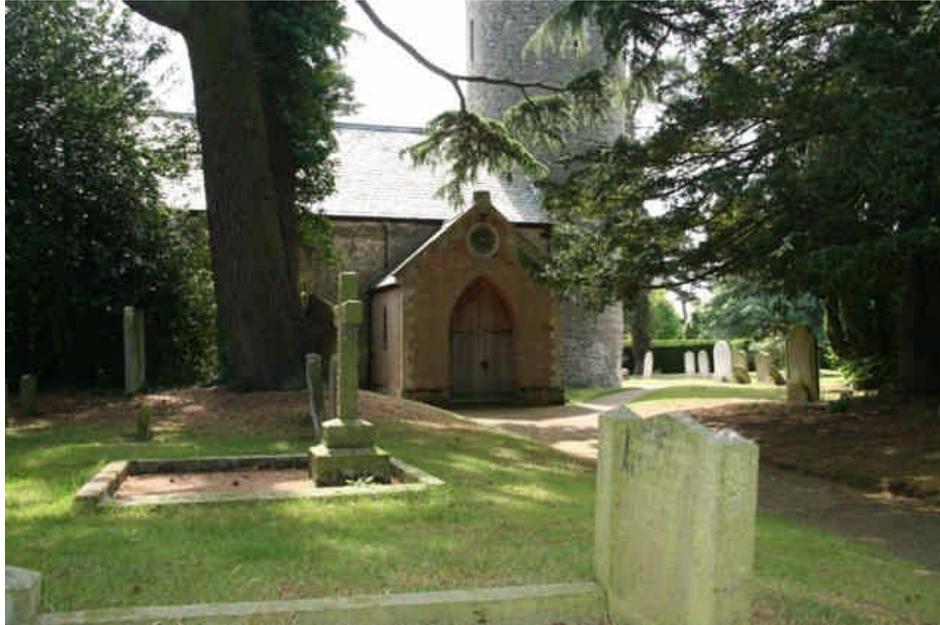
- 3.3 The proposed development affects a large mound adjacent to the north porch (*Plate 1*). A mound is visible at this location in a painting of the church by Cotman in 1817 (*Plate 2*), but its origin is not known. The mound is currently occupied by a large deodar tree (not visible on Cotman's painting).

Plate 1. Deodar tree and mound to northwest of the north porch, looking south/southeast. By D. Bonner

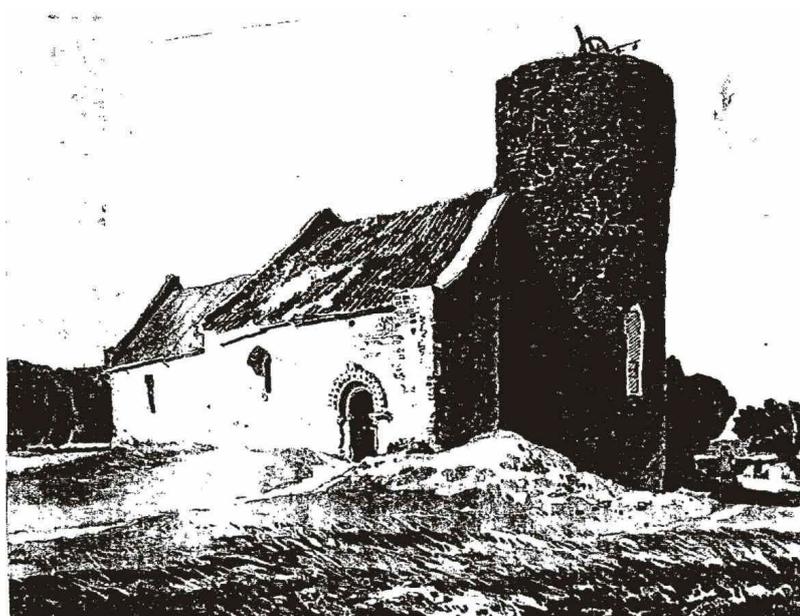
Plate 2. Mound shown in Cotman's painting, looking southeast

- 9.2 The present mound comprises deposits placed around the trunk of a tree and therefore does not relate to the mound shown in Cotman's 1817 painting as this deodar tree most likely dates to between 1870 and 1900, possibly slightly earlier. There appear to be two ill-defined mounds (one approximately at the location of the present tree and one to the northwest of the north door and tower) shown in the painting. The nature of these mounds remains unknown – they may relate to deposits remaining after grave digging (though there are no headstones shown in Cotman's painting) or other excavations such as the pathway leading from the north door, though this also is not shown in the painting. It is possible they relate to the burial of the victims of a smallpox epidemic in the early 19th century.

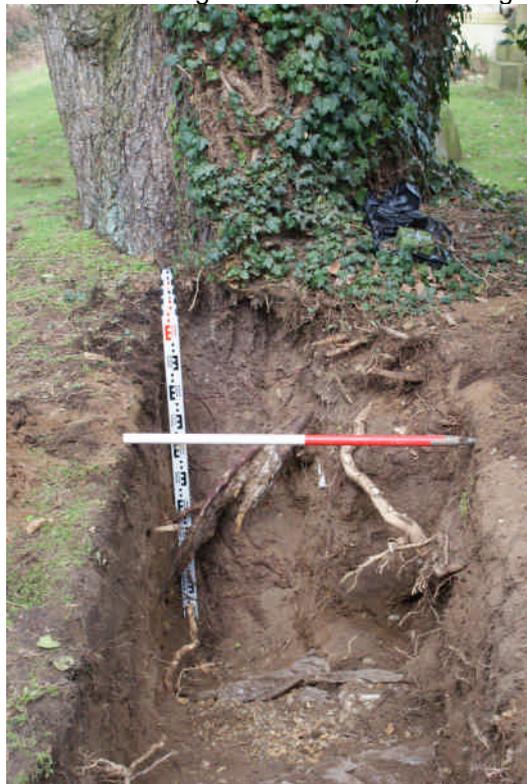
- 7.2.1 The trench was approximately north-to-south orientated, measured c. 3.4m by 0.7m and was located extending radially from the deodar tree (*Figs. 2 and 3*). It was excavated to a maximum depth of c. 1.04m (to c. 56.5m OD) from present ground level at the north end of the trench (*Fig. 4, Plate 3*) removing c. 0.2m of grass covered dark brown humic topsoil [1] that forms the present ground surface. Mid brown fine sand subsoil [2] was present closest to the tree, sealed by topsoil and extended beyond the maximum depth of excavation. A sherd of probable medieval pottery, disarticulated human bone fragments, roof tile, roof slate and modern glass were recovered from [2] that had been cut by modern soakaway [3]. This soakaway contained a mid brown fine sand fill [4],

similar to subsoil [2] but also contained plastic, rubble and disarticulated human bone fragments. Undisturbed 'natural' deposits were not encountered.

Plate 3. South-facing section of trench, looking north

Horizontal scale is 1m on 0.5m increments,
vertical scale in cm

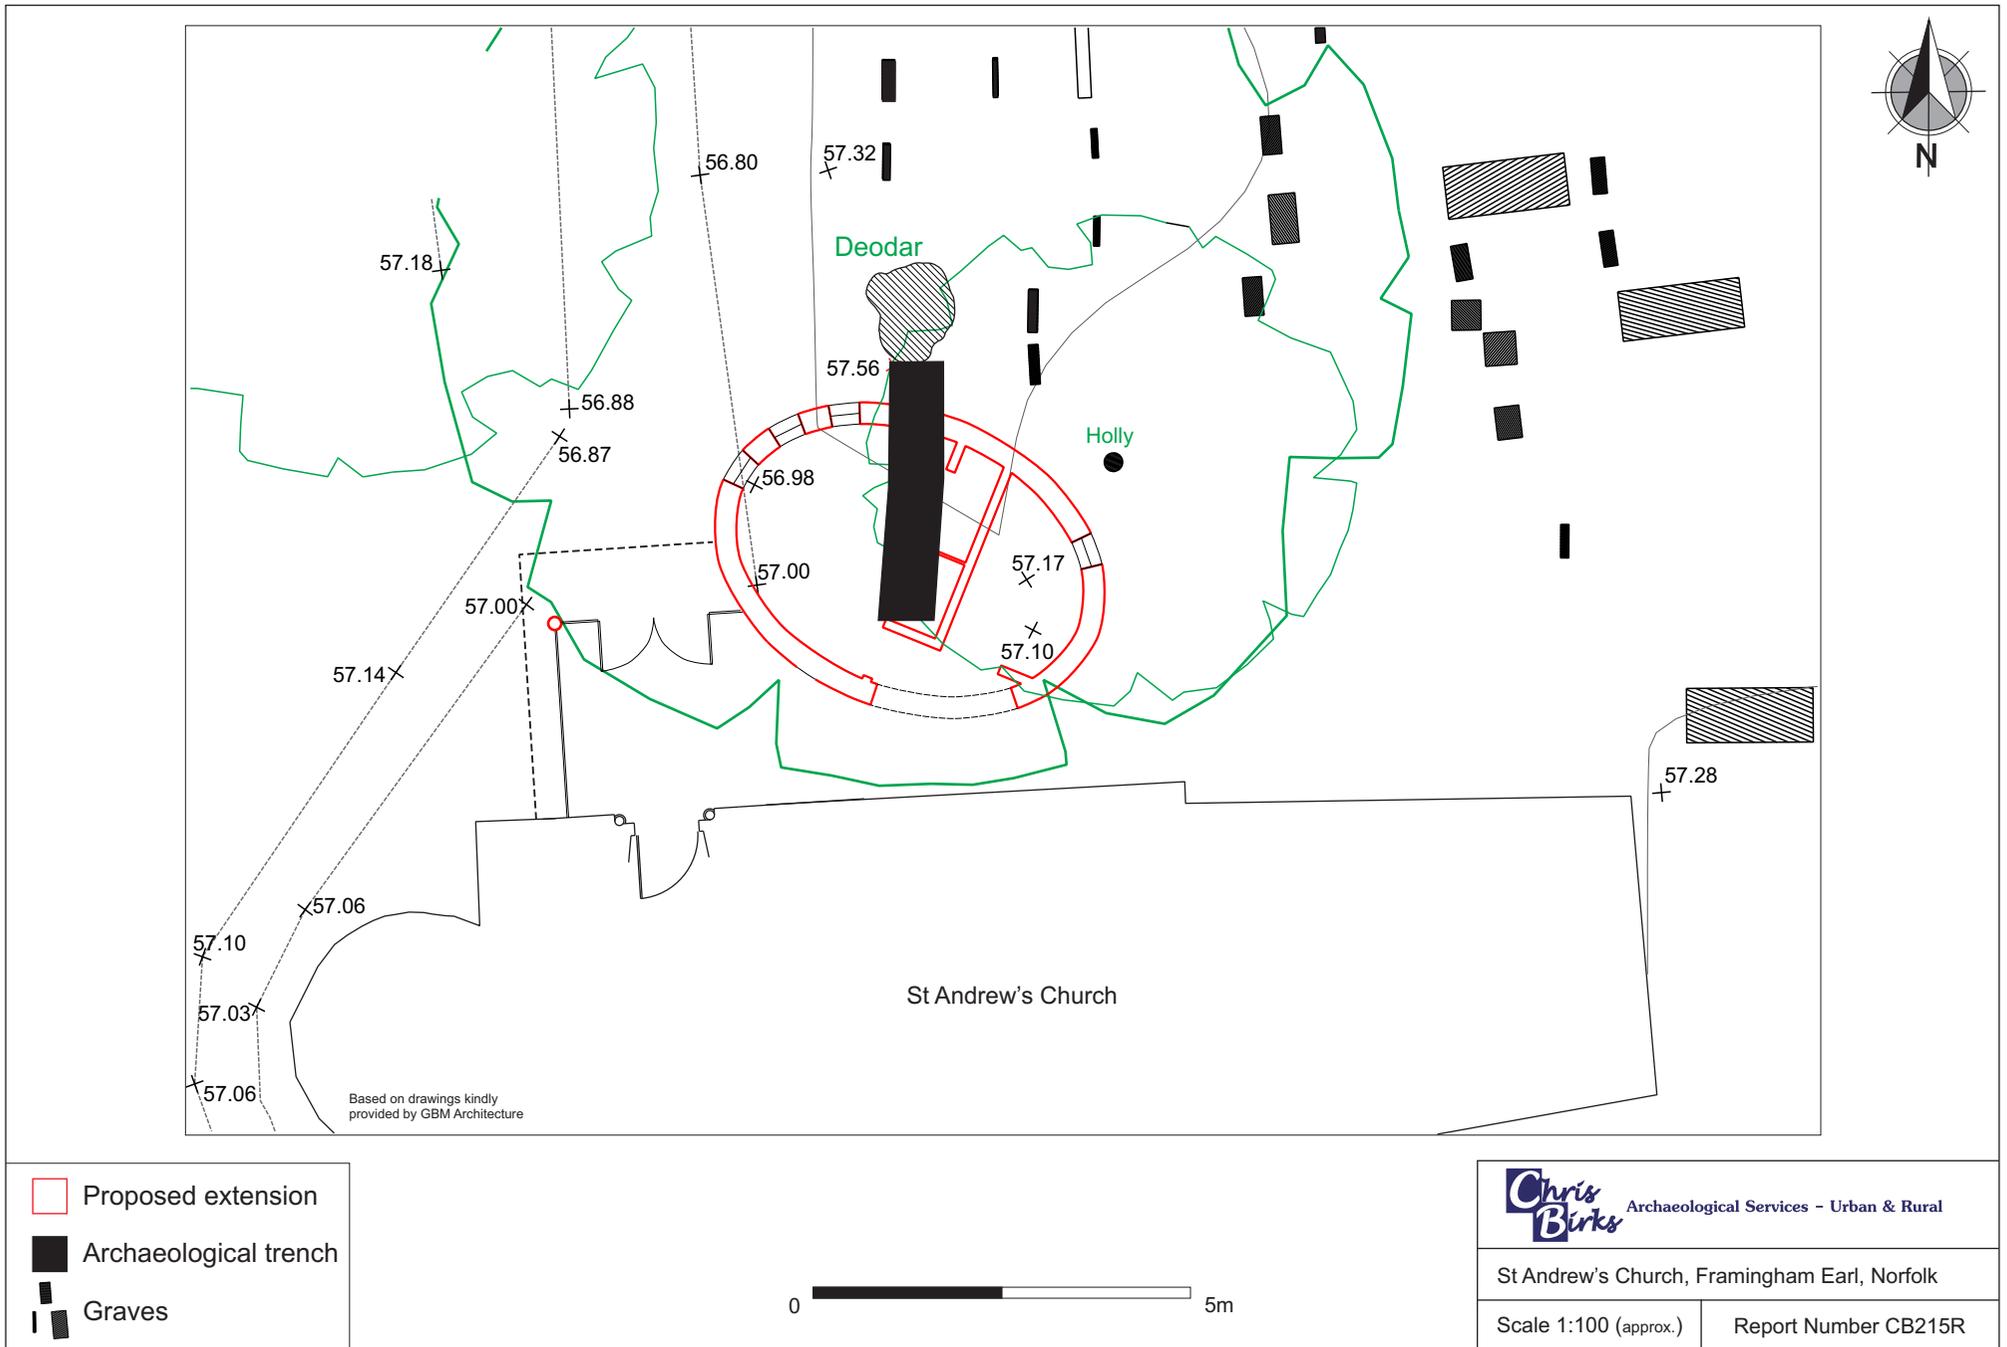
Figure 2. Site plan

- 6.2.5 At the agreement with Ken Hamilton, one trench was initially excavated as close to the centre of the mound as was practical and safe (*Fig. 2*) with the proviso to excavate a further trench if it weren't possible to positively establish the nature of the mound.

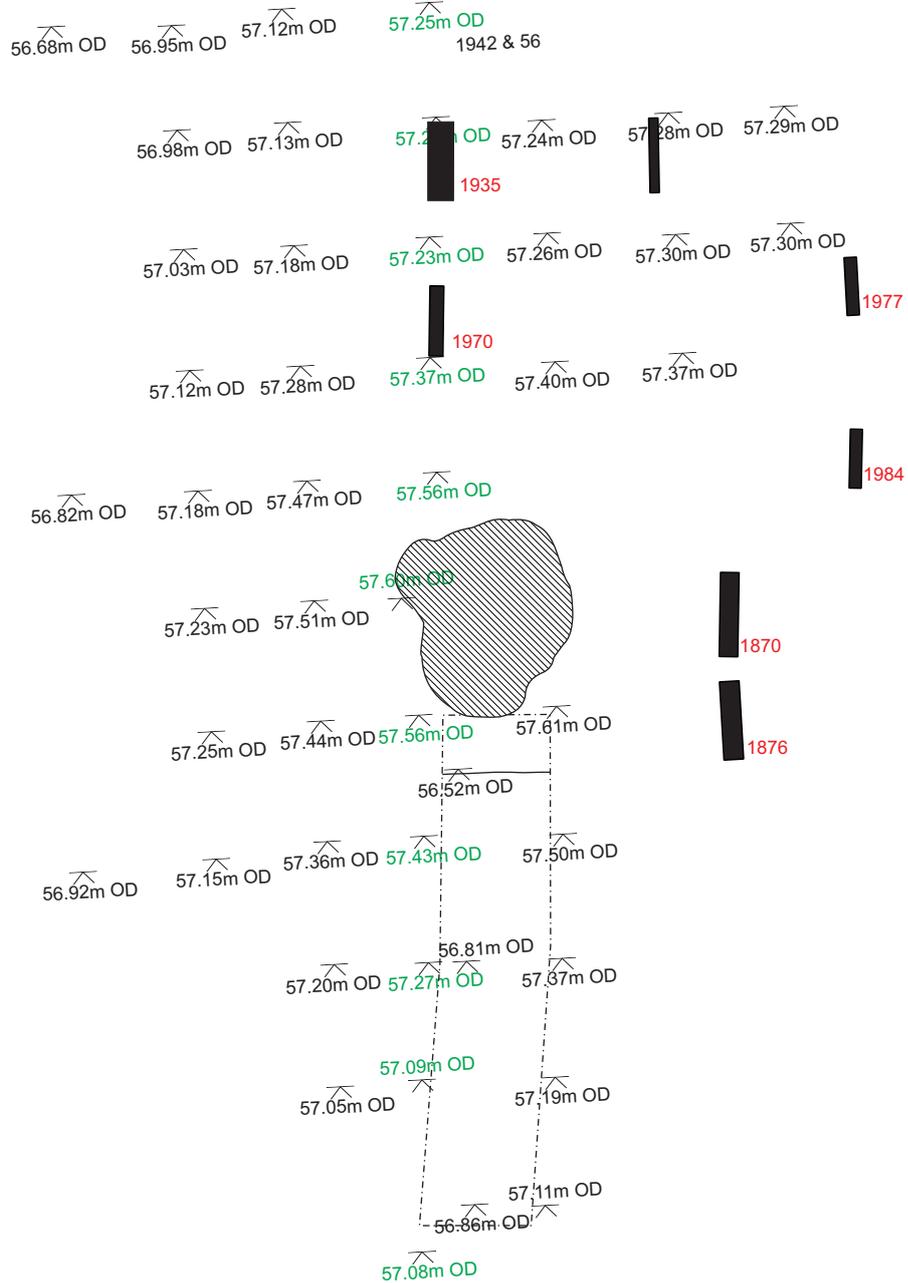
Figure 3. Trench plan

- 7.2.2 A brief topographical survey (by theodolite) of the mound was carried out during the present works (*Fig. 3*) which in conjunction with a previous topographical survey (drawing provided by GBM Architecture) demonstrates the mound rises from c. 57m OD to c. 57.6m OD at its highest point. A north-to-south profile of the mound is shown in *Fig. 4*, the datum used shown in green on *Fig. 3*.
- 7.2.3 The earliest graves in proximity to the tree (*Fig. 3*) date to 1870 and 1876, the headstones clearly sitting upon, and therefore postdating, the present mound. This indicates an earlier date for the planting of the tree or that a bank existed to the immediate east of the location of the tree prior to its planting.
