**Report on Works under Archaeological Supervision and
Control at
'Saint Mary's Church, Cranworth, Norfolk'
ENF142481**

**St Mary's Church, Cranworth,
Norfolk'**

ENF142481

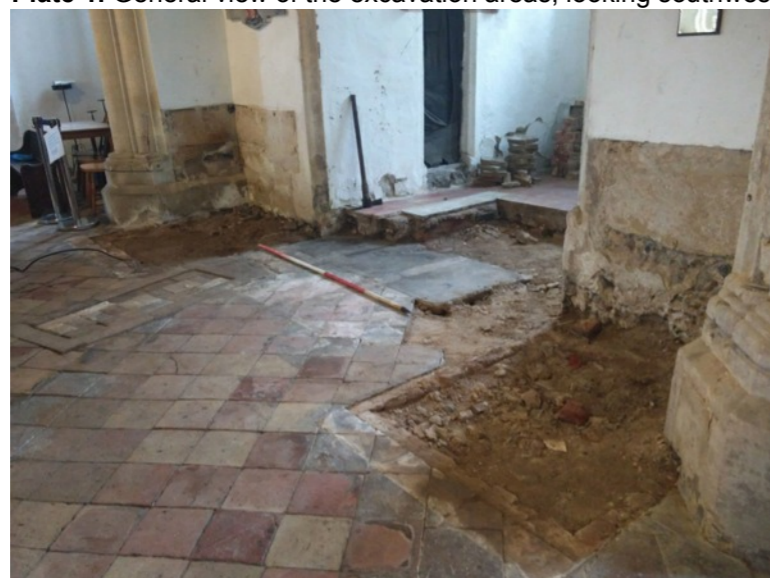
Plate 1. General view of the excavation areas, looking southwest

Excavations revealed probable 19th century pew foundations [2] and [4] and flue [9] and ledger stone [8] whose inscription was illegible.

Excavations to the north of the chancel arch measured c. 1m by c. 0.96m to a depth of c. 0.31m beneath present floor level removing dark greyish brown silty sand (1). Red brick foundation [2] measured c. 0.11m wide and 0.16m deep and extended c. 1m north-to-south and c. 0.95m east-to-west.

Excavations to the south of the chancel arch measured c. 1.3m by c. 1.28m to a depth of c. 0.33m beneath present floor level removing dark greyish brown silty sand (3). North-to-south orientated brick foundation [4] measured c. 1.02m long, c. 0.11m wide and c. 0.06m deep.

Excavations within the east side of the base of the tower measured c. 2.45m by c. 1.75m to a depth of c. 0.31m beneath present floor level removing pamment tiles on a cement and brick base (5) above dark greyish brown silty sand (6) that partly exposed compact mid brownish yellow sandy gravel (7). Timber joists from the former organ base were removed. Ledger stone [8] measured 1.86m by 0.81m and remained *in situ*. East-to-west orientated brick structure [9] measured 0.77m long and 0.58m wide and contained a flue pipe conduit.

- 6.1 The author has a high confidence rating of the results. The minimal depth of excavations revealed few remains. The red brick walls of probable 19th century date most likely functioned as foundations for pews removed prior to the commencement of the excavations. A brick flue is probably of the same date and these may relate to the restoration of the church in the 19th century. No finds or further features of archaeological significance were present.
