Archaeological strip map and sample excavation at  
Hanbury Hall, School Road,  
Hanbury, Worcestershire  
Worcestershire Archaeology  
*for The National Trust*

Archaeological strip map and sample report

Site name: Hanbury Hall café  
Local planning authority: Wychavon District Council  
Planning reference: 20/00416/FUL  
Central NGR: SO 94380 63750  
Commissioning client: The National Trust  
WA project number: P6169  
WA report number: 3007  
HER reference: WSM 77991  
Oasis reference: Fieldsec1-514814  
Museum accession number: -

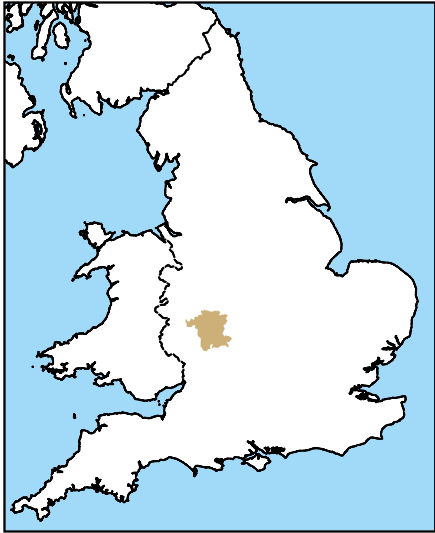
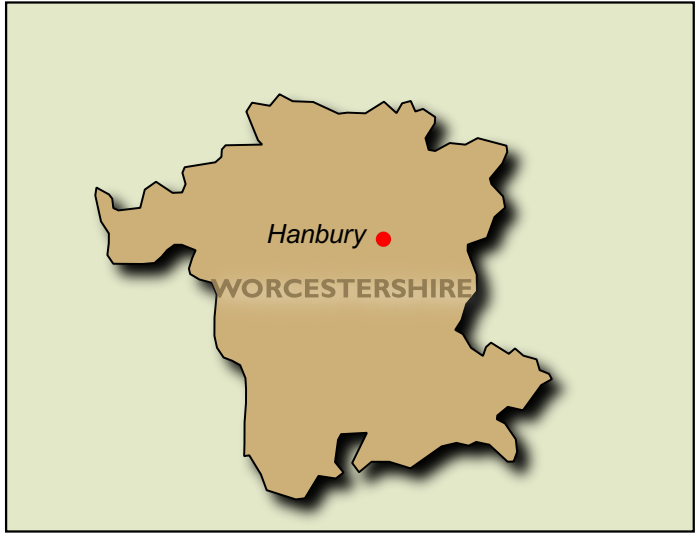
Figure 1

Location of the site

The excavation area is located alongside the parterre wall on the south-west side of the service yard, to the west of Hanbury Hall (Figure 1), with the coach house, stables and outhouses to the north-east. The excavation area covers 225m, the approximate footprint of the new café. The service yard is a flat terraced area, currently gravelled, with a turfed slope down to the Lower Yard to the north-west. The service yard lies within the wider landscape of Hanbury Hall park and gardens (Figure 1).

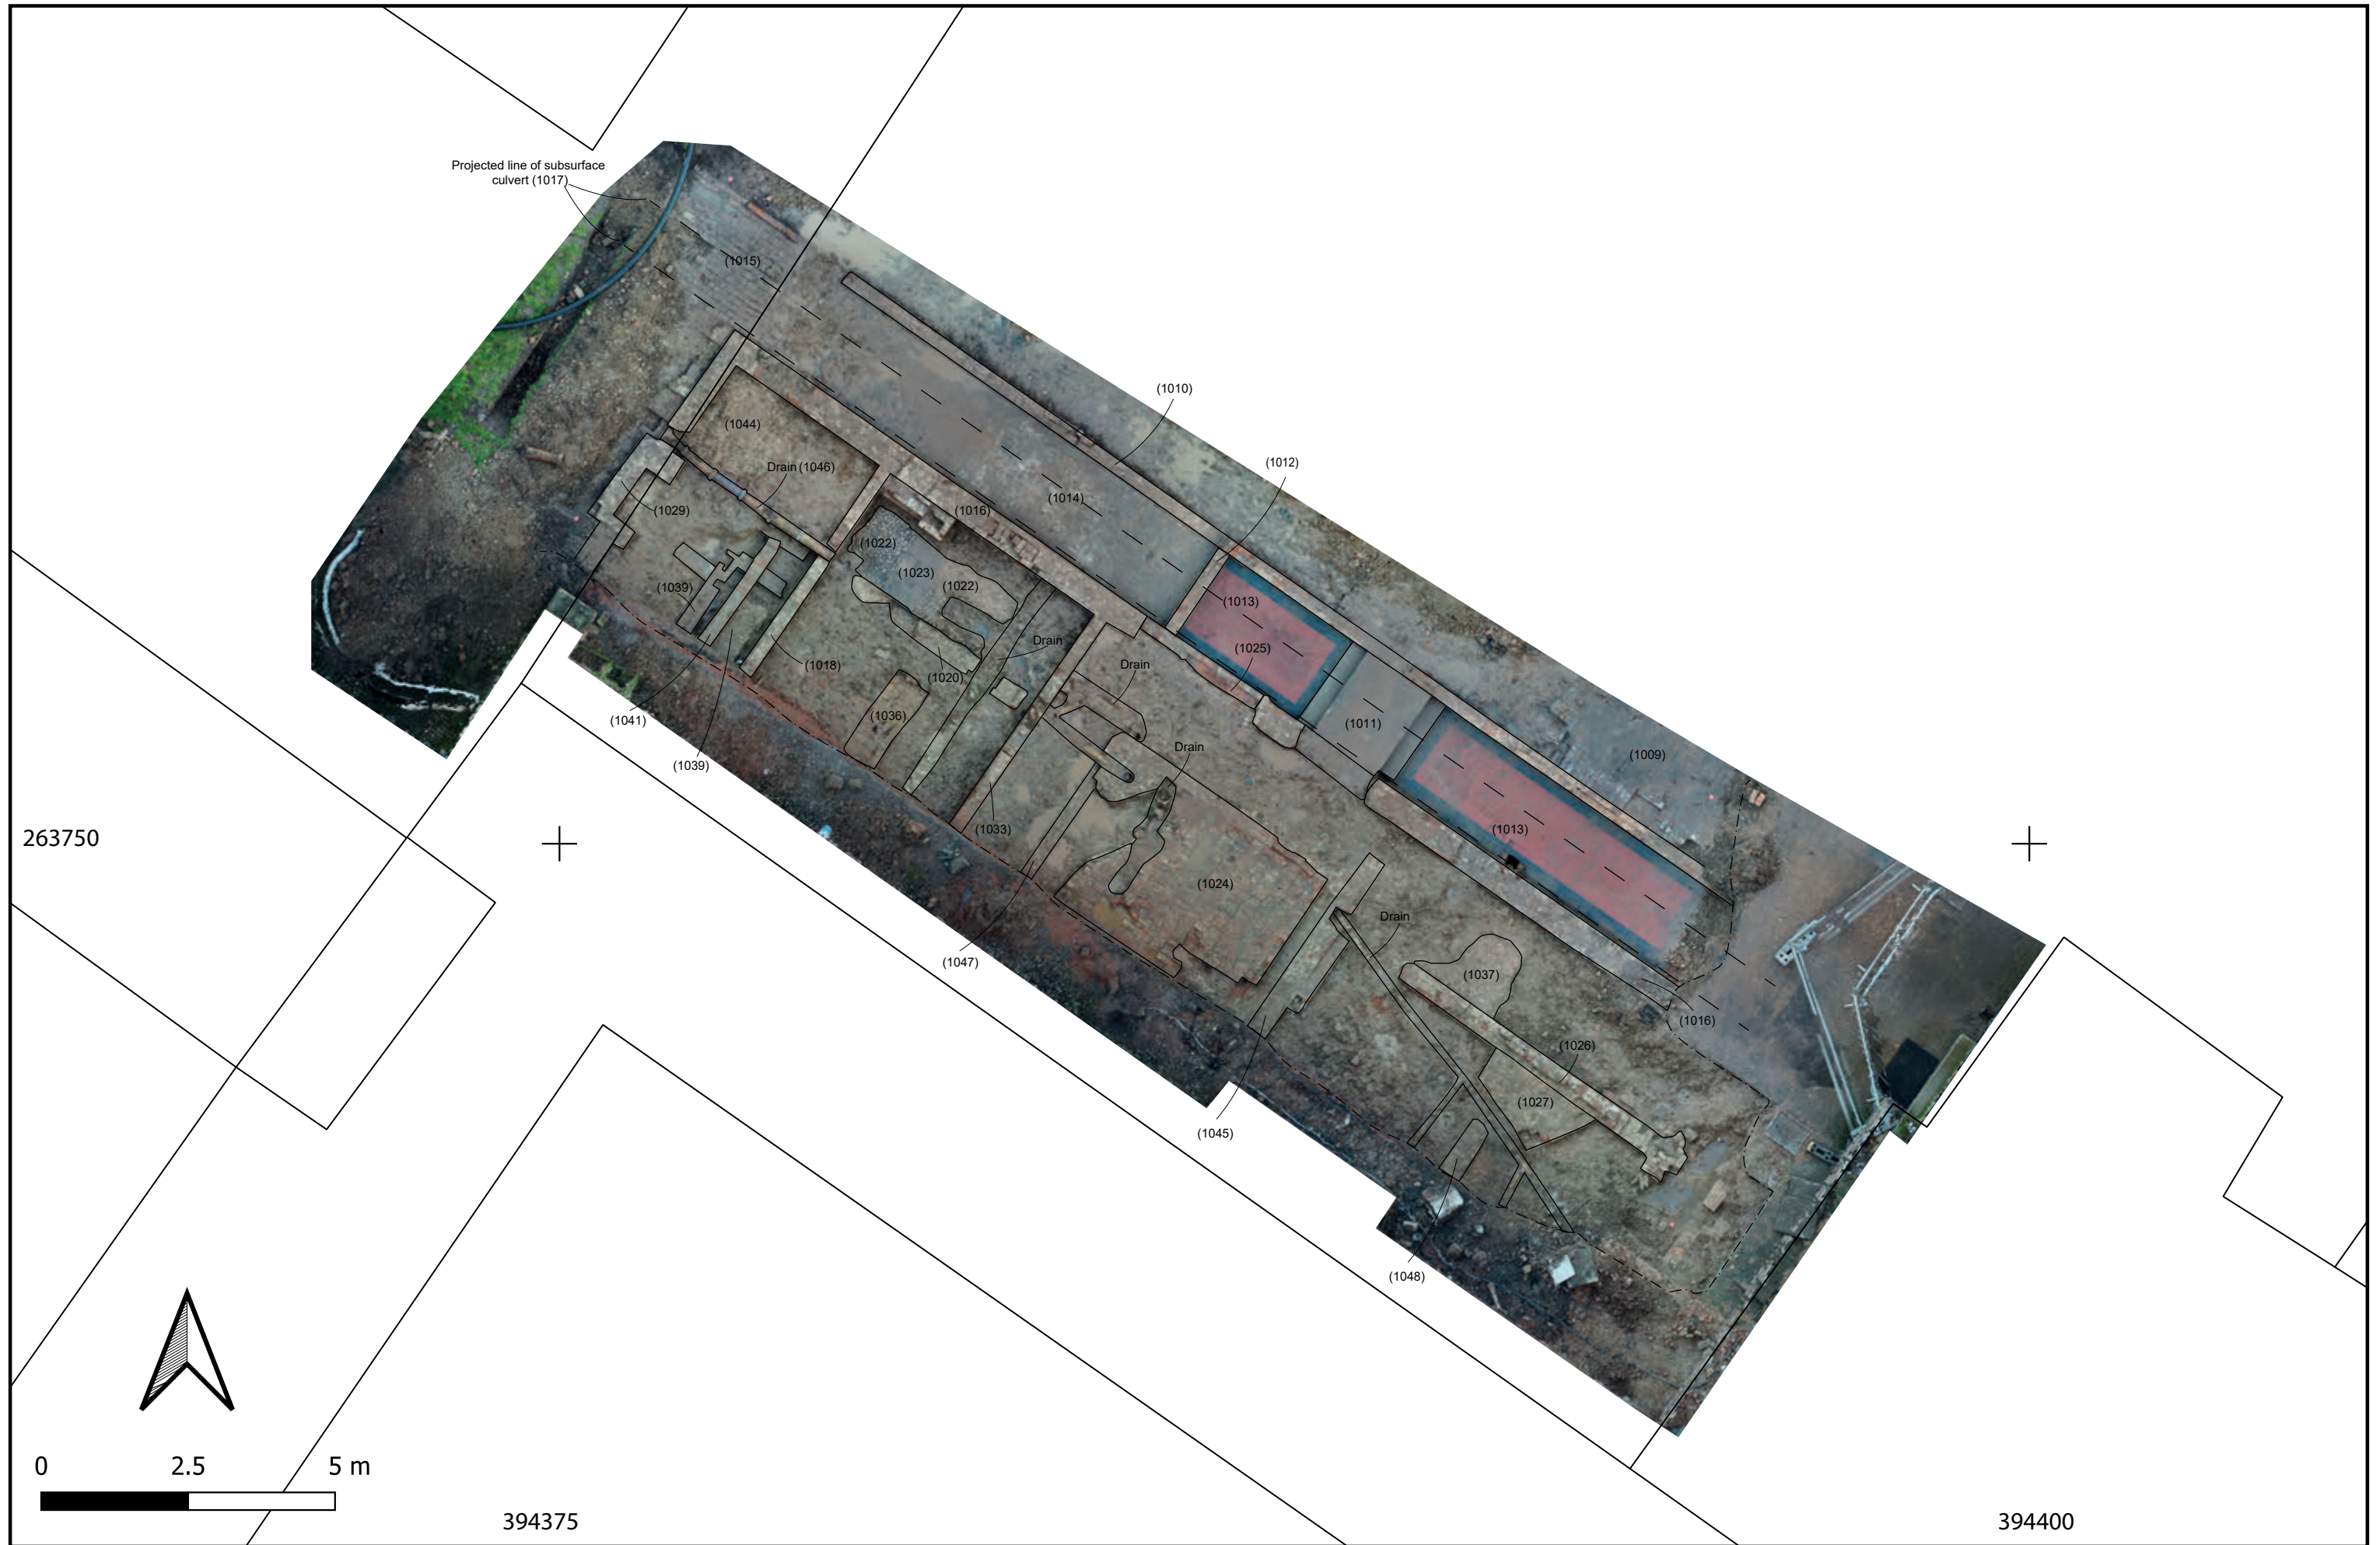
Figure 2

Photogrammetric plan with numbered features overlain onto modern map

The features and structures recorded in the excavation area are shown in Figures 2-5 and Plates 1-22. The trench and context inventory are presented in Appendix 1. This section is laid out in phases of the building, from earliest to latest and later modern deposits. A 3d model of the excavated features can be accessed here:

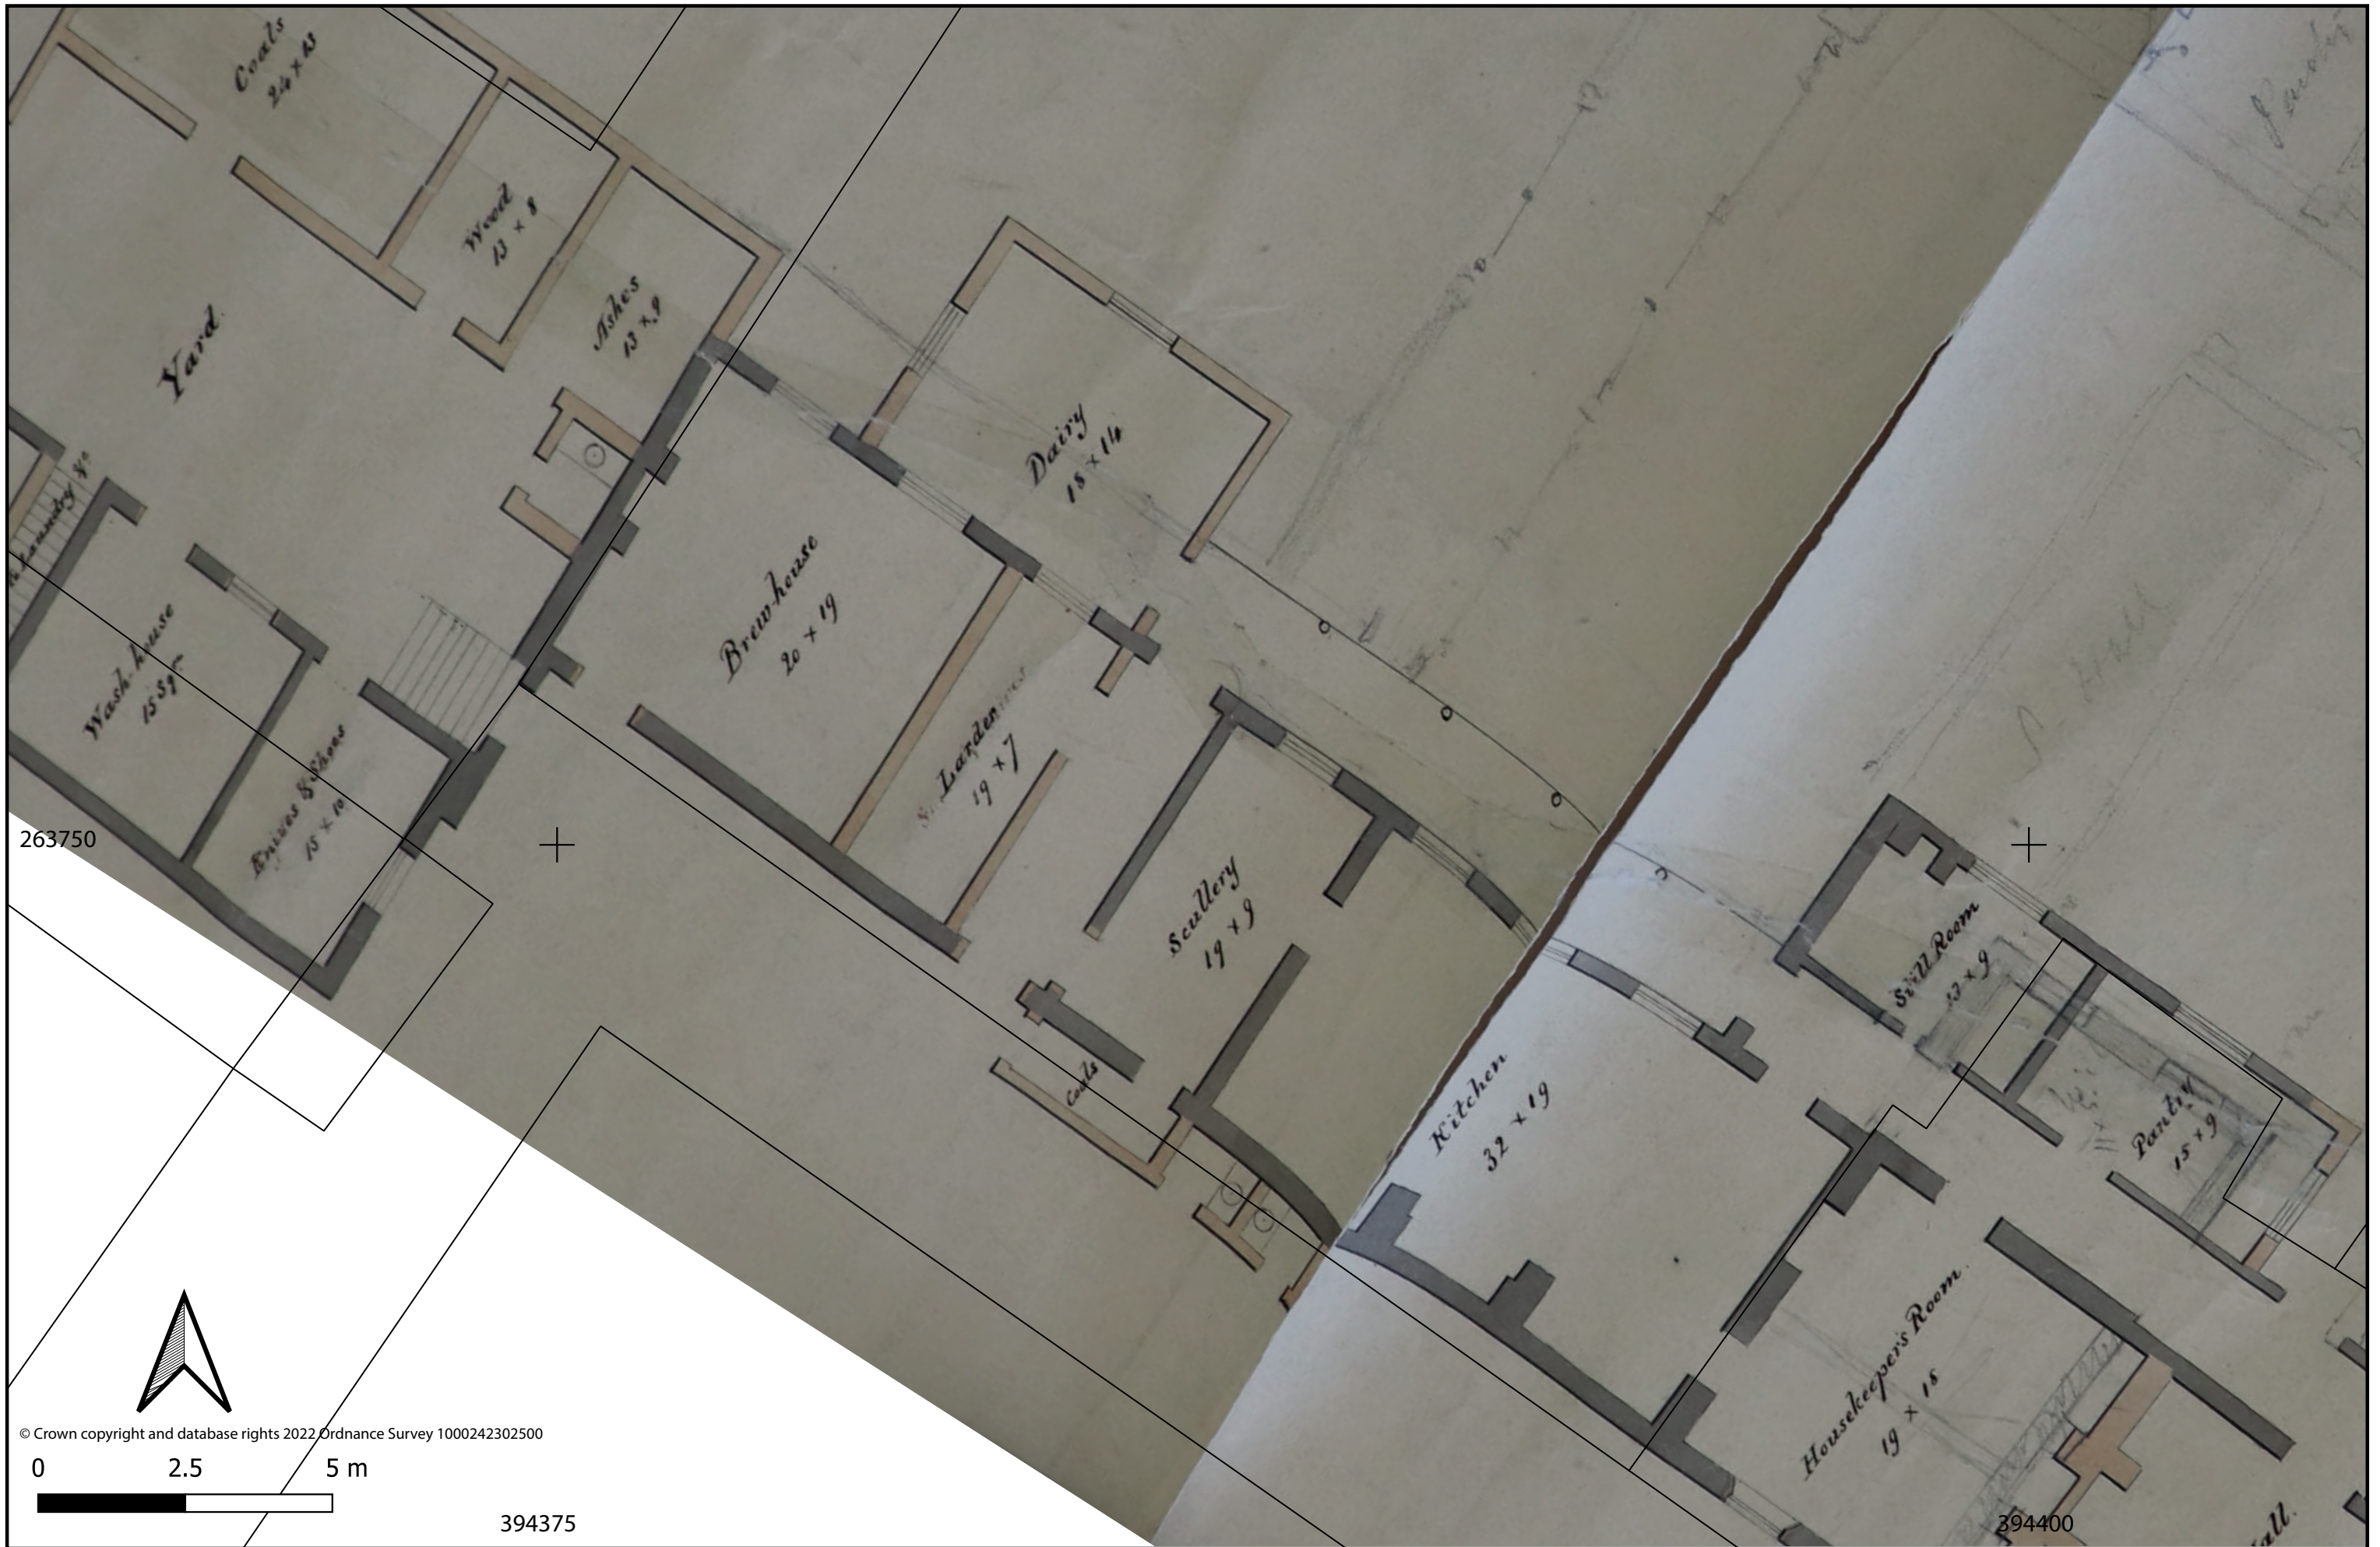
Figure 4

Matthew Habershon plan of 1830 (WRO 705:7, BA7335\_146), overlain on modern map

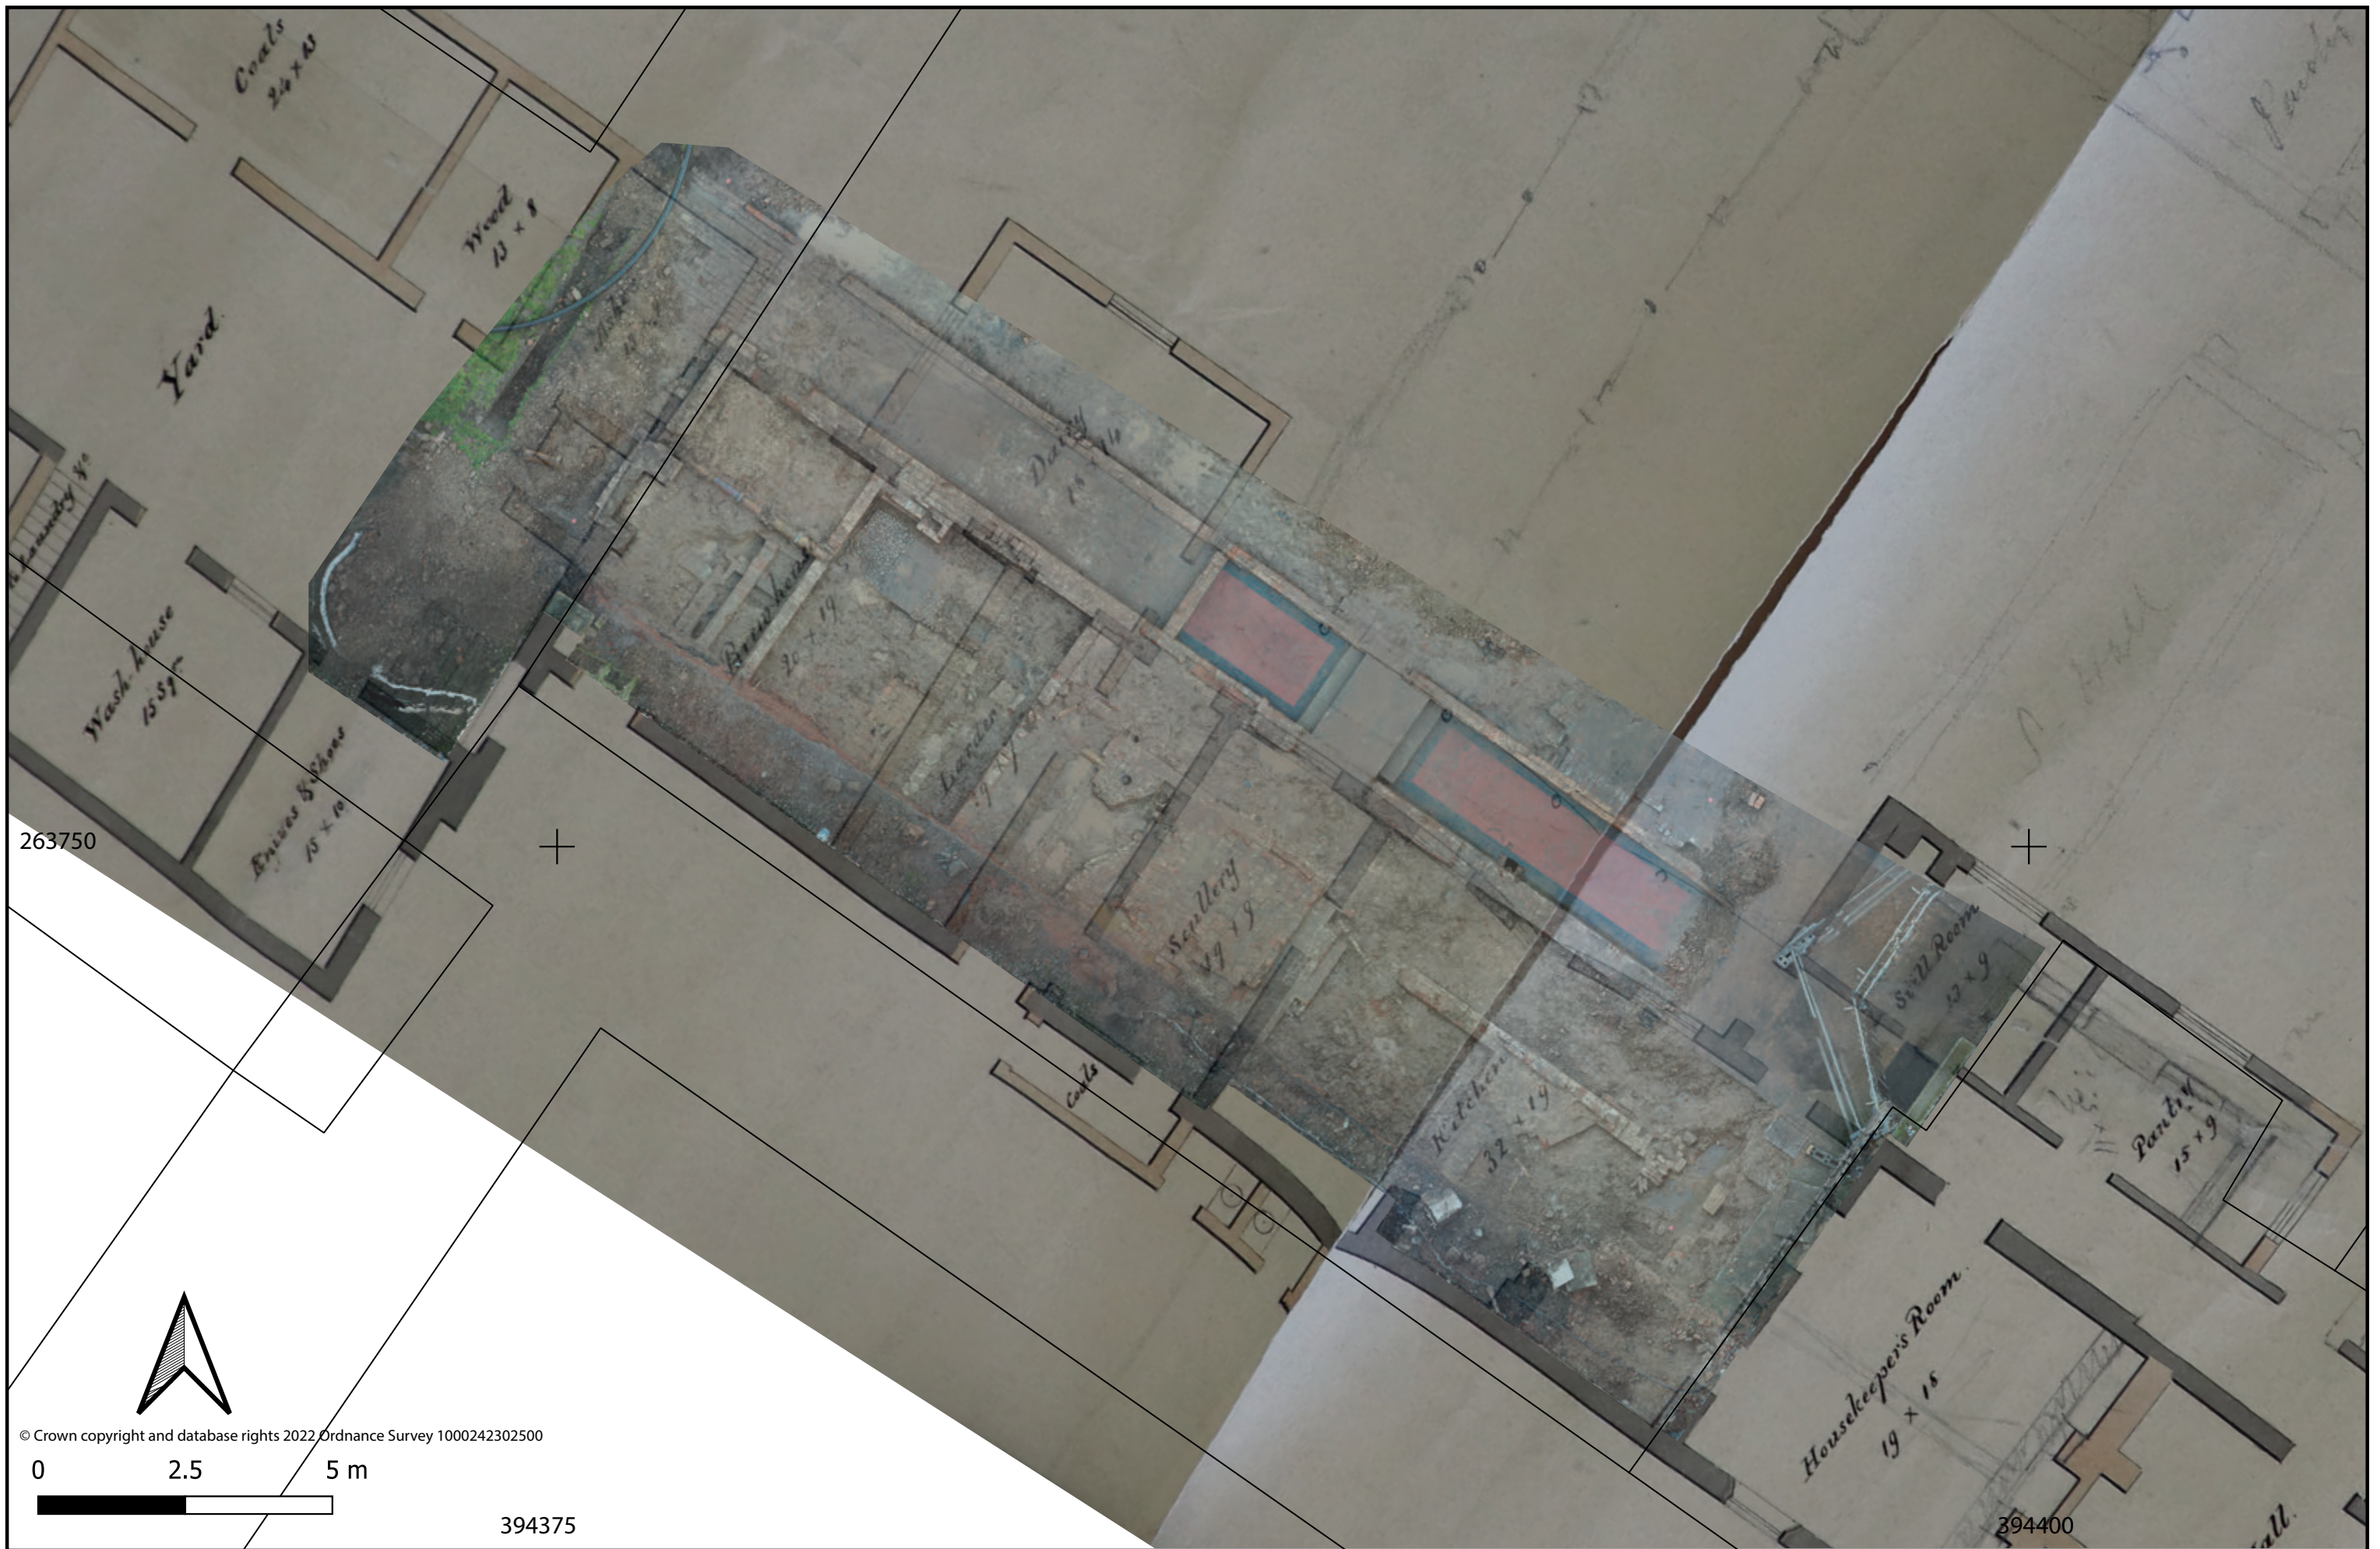
Figure 5

Matthew Habershon plan of 1830 (WRO 705:7, BA7335\_146)  
 with modern map and photogrammetric plan transparent overlay

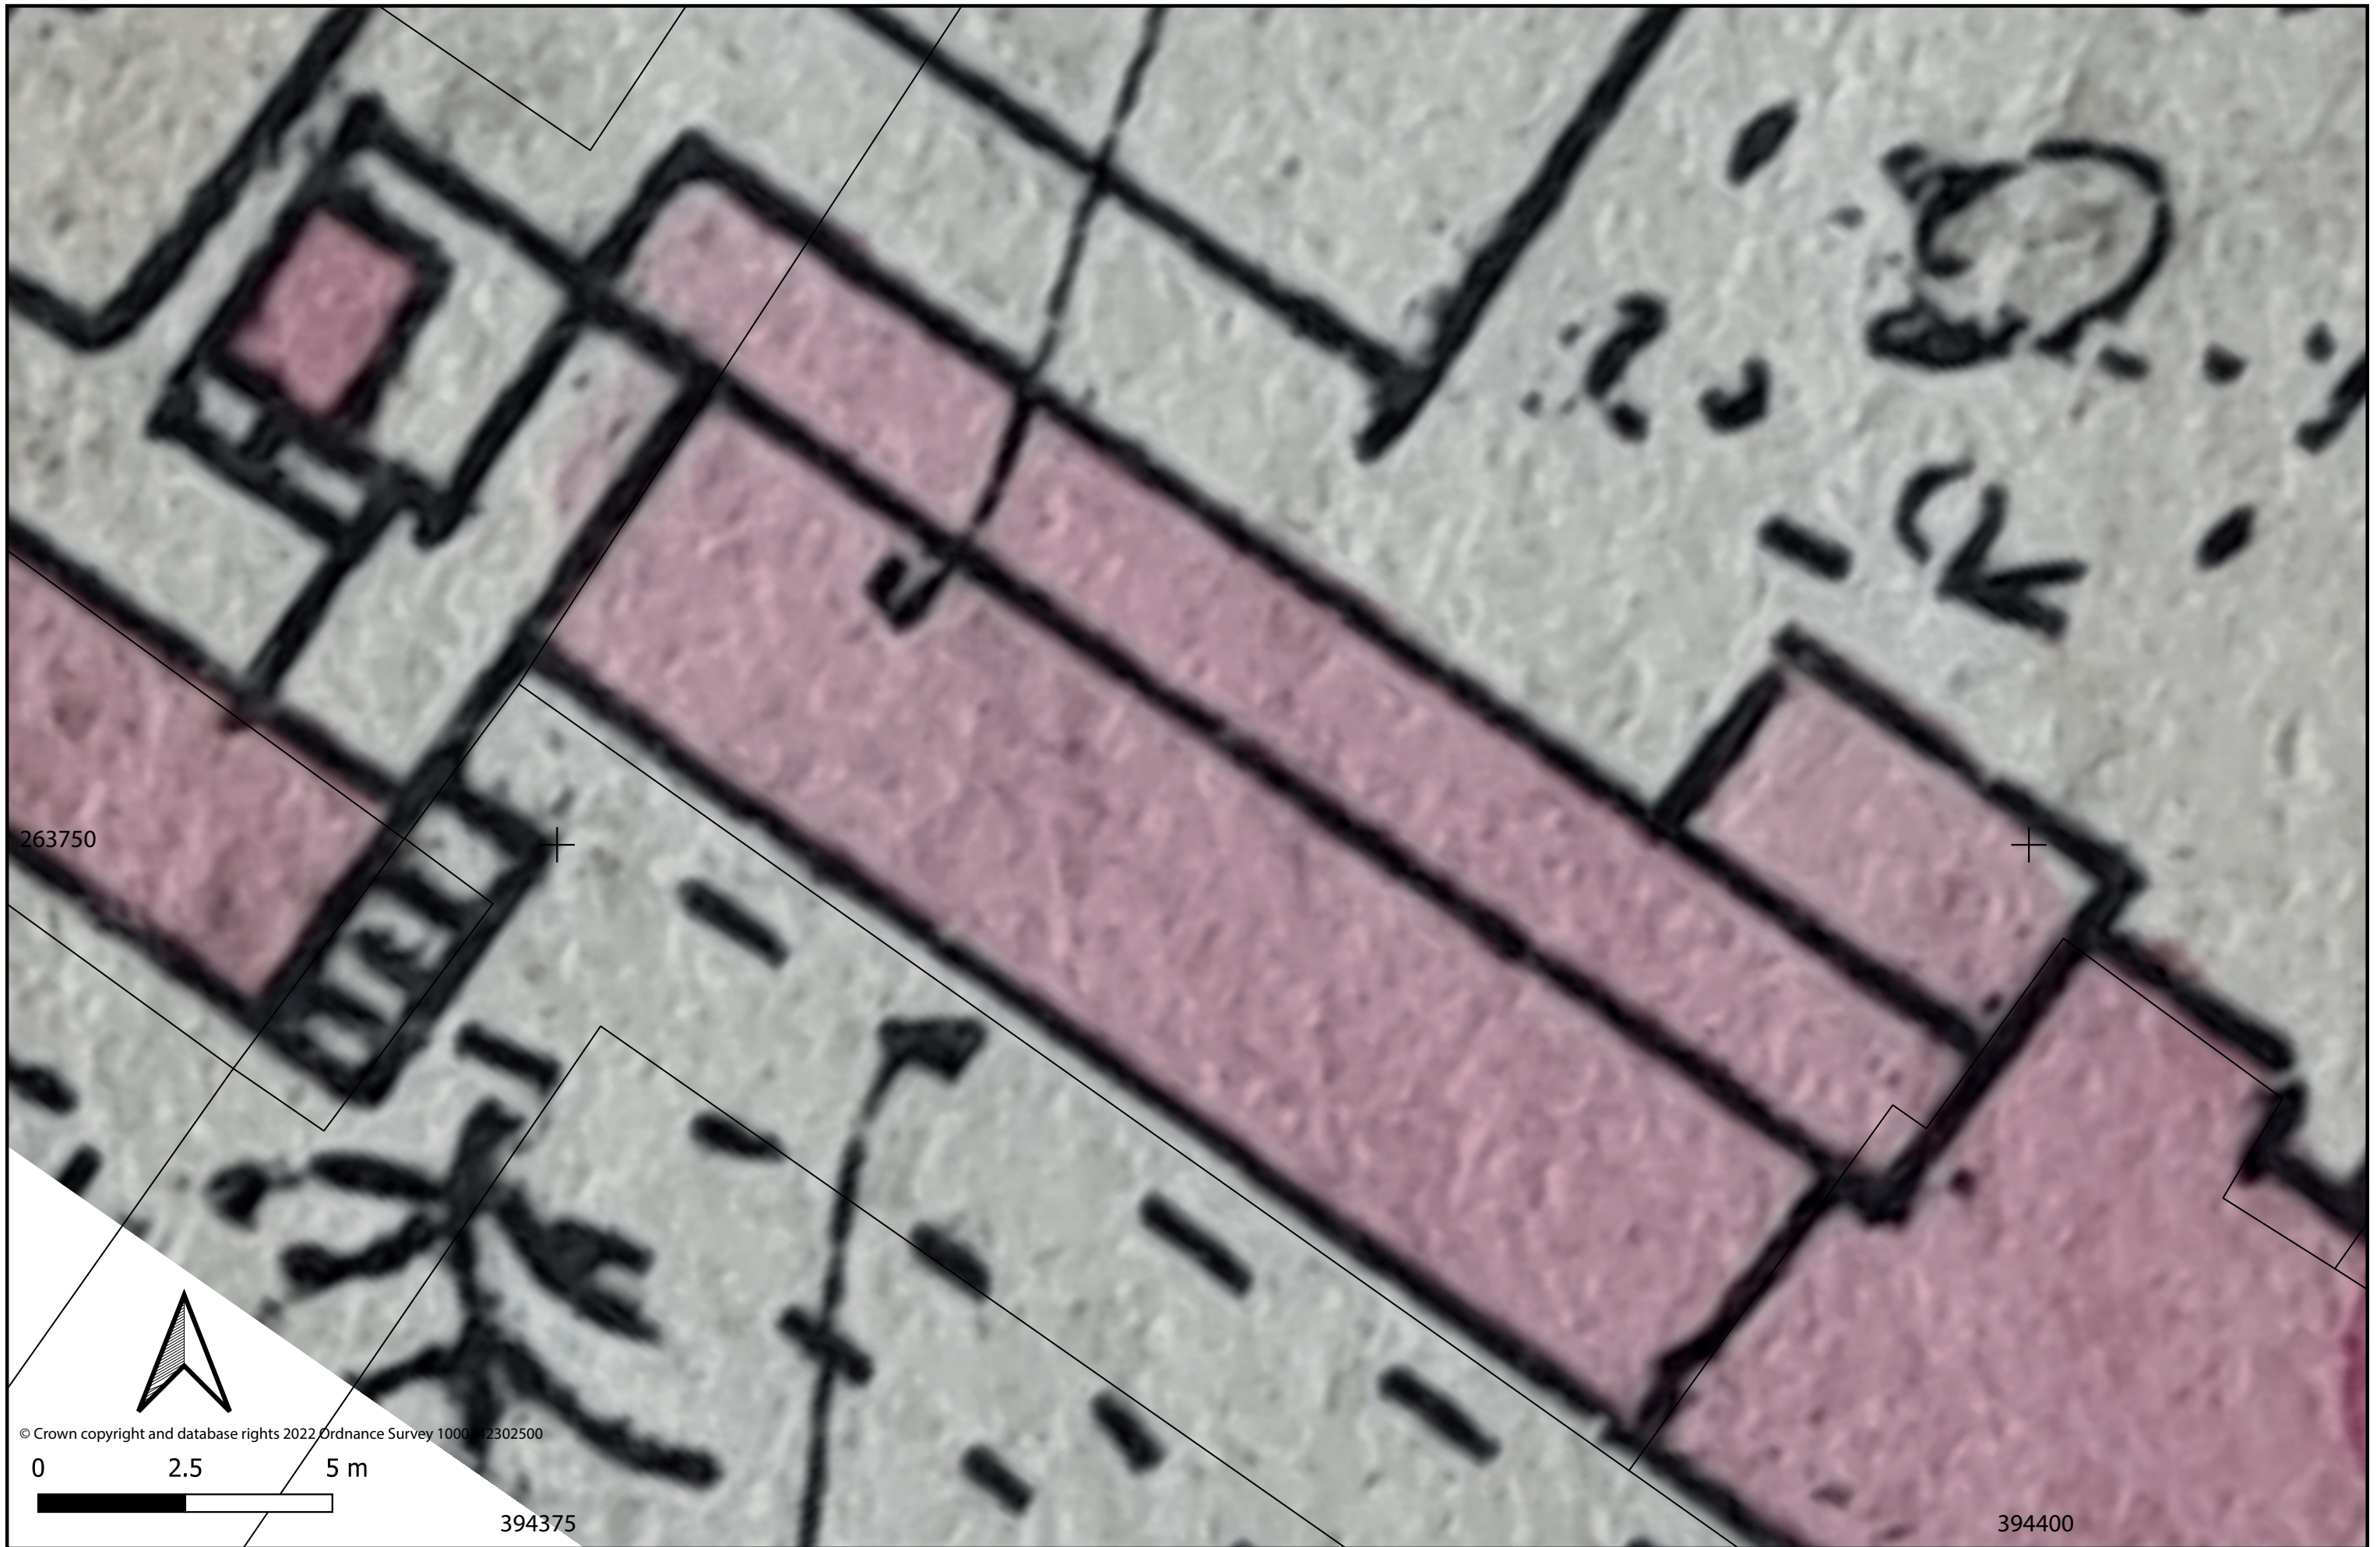
Figure 6

1885 Ordnance Survey map, overlain on modern map

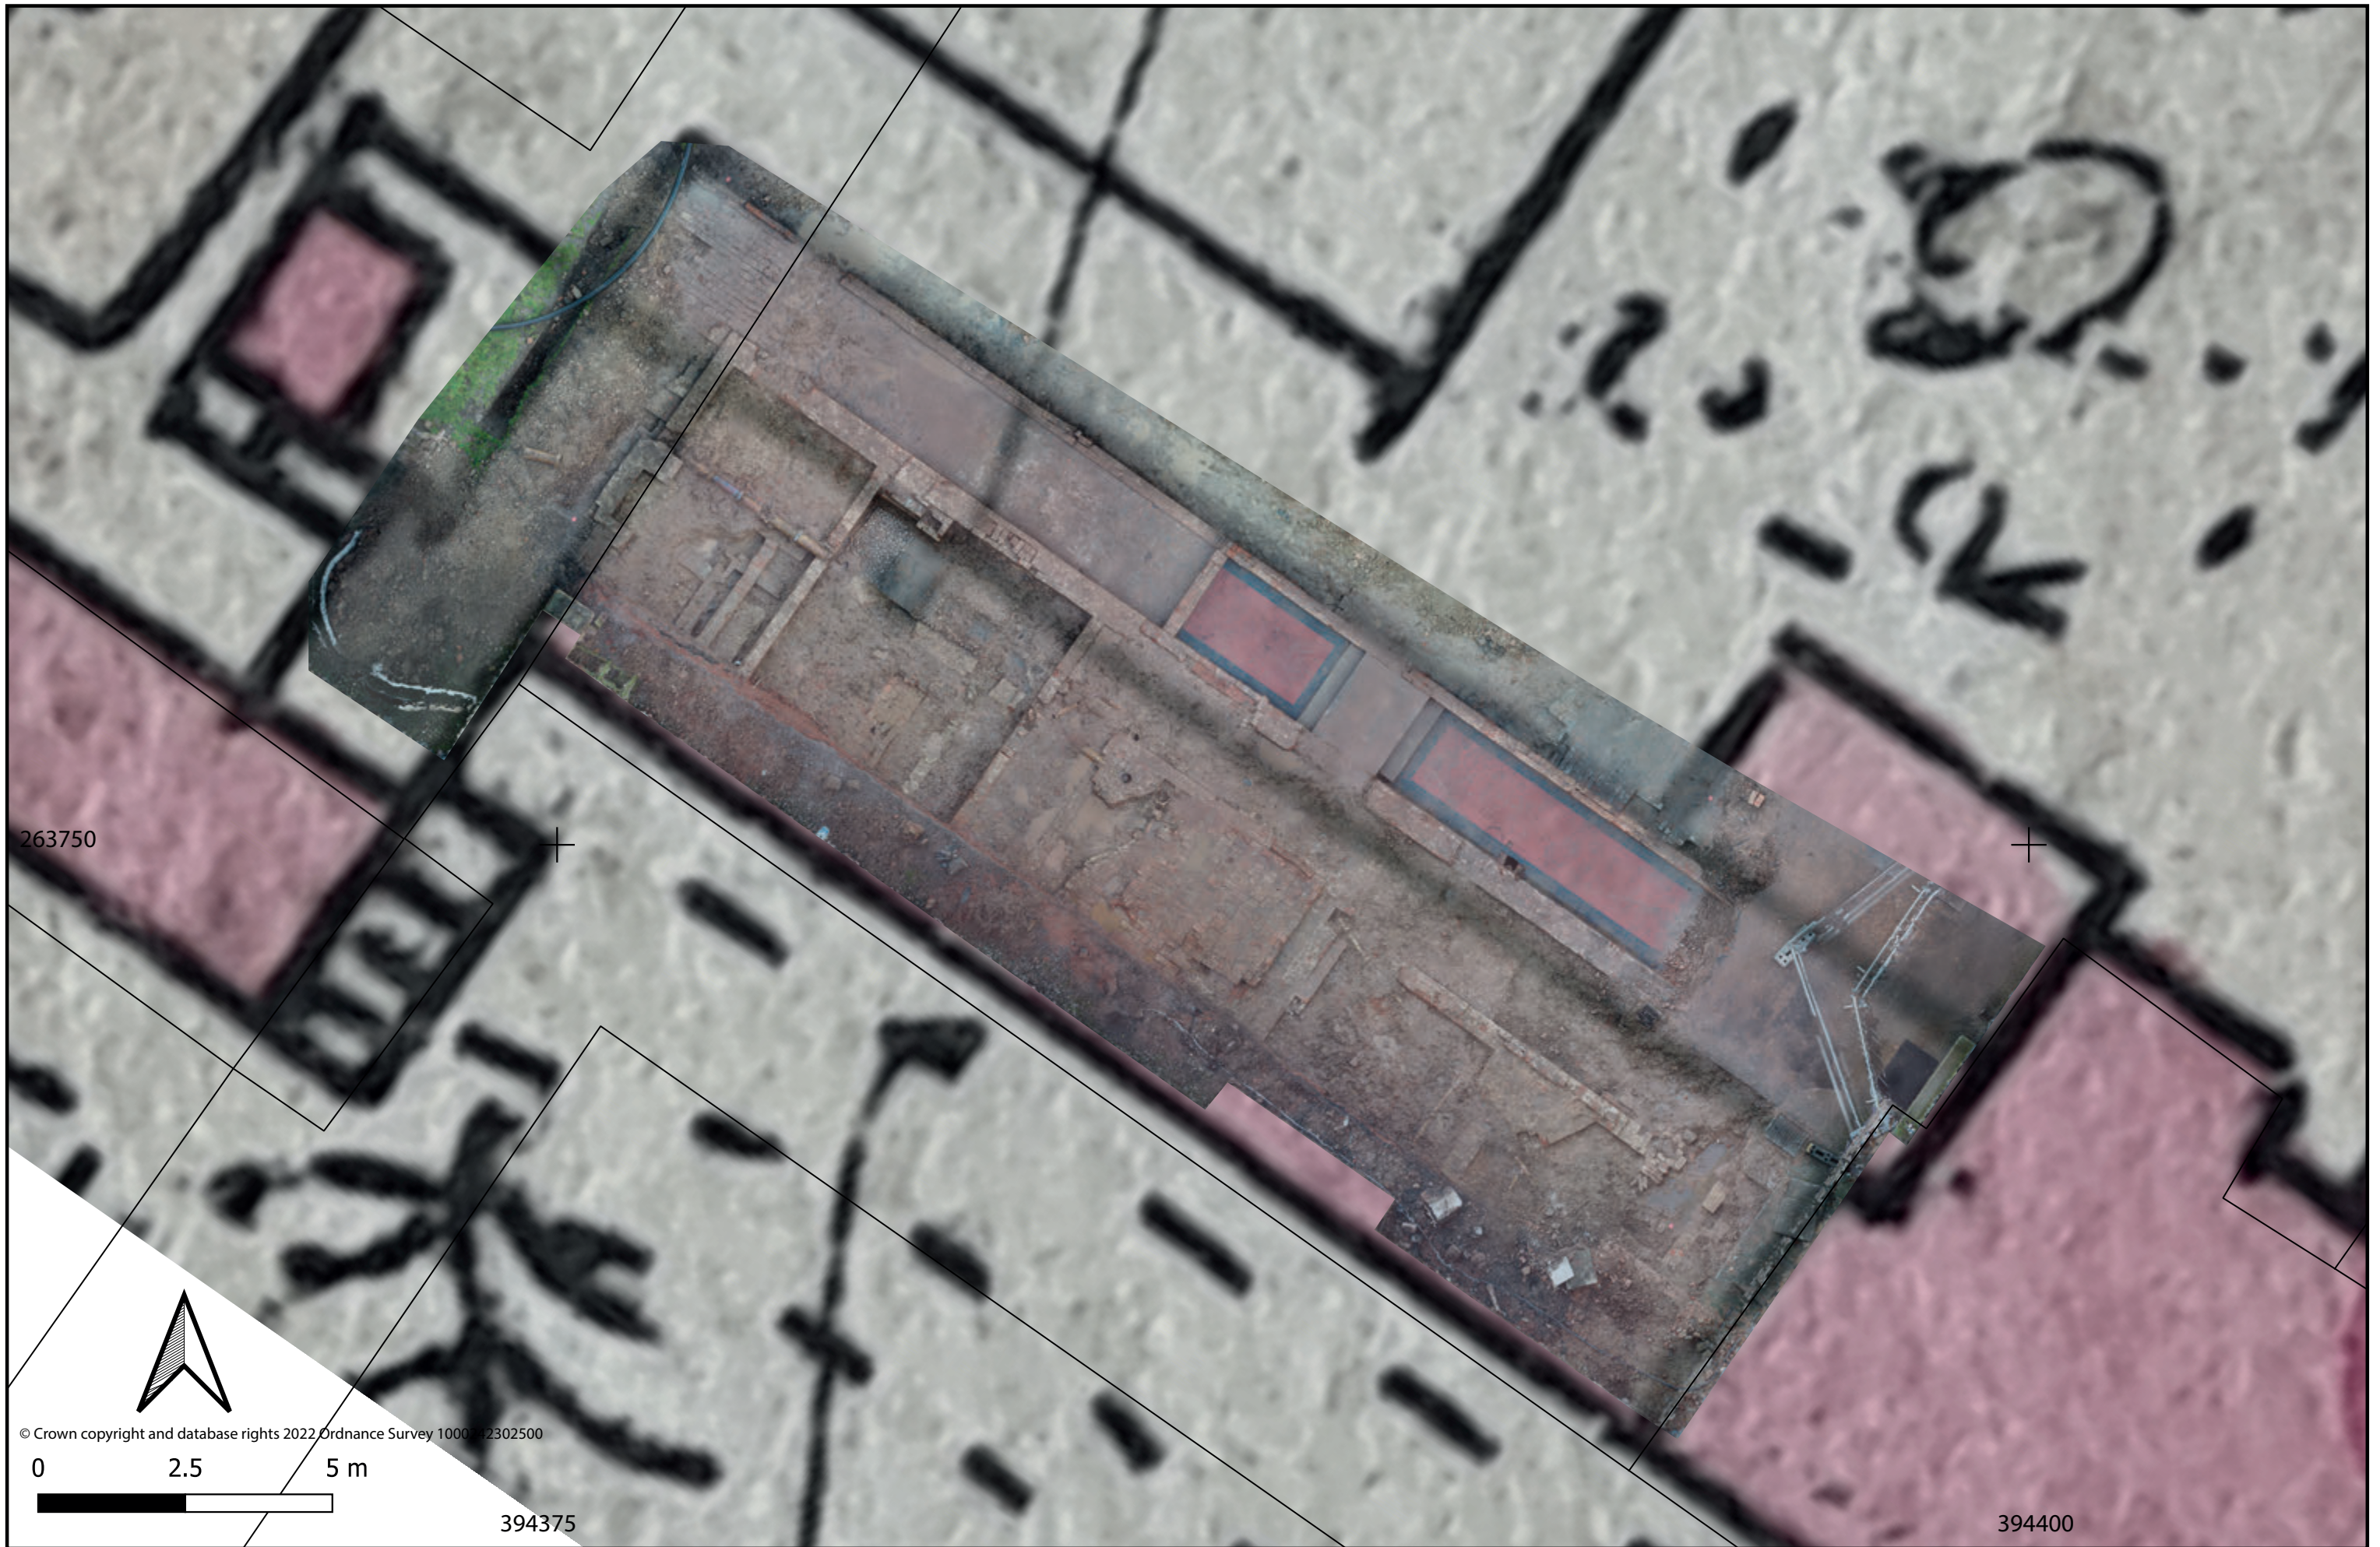
Figure 7

1885 Ordnance Survey Map with modern map and photogrammetric plan transparent overlay

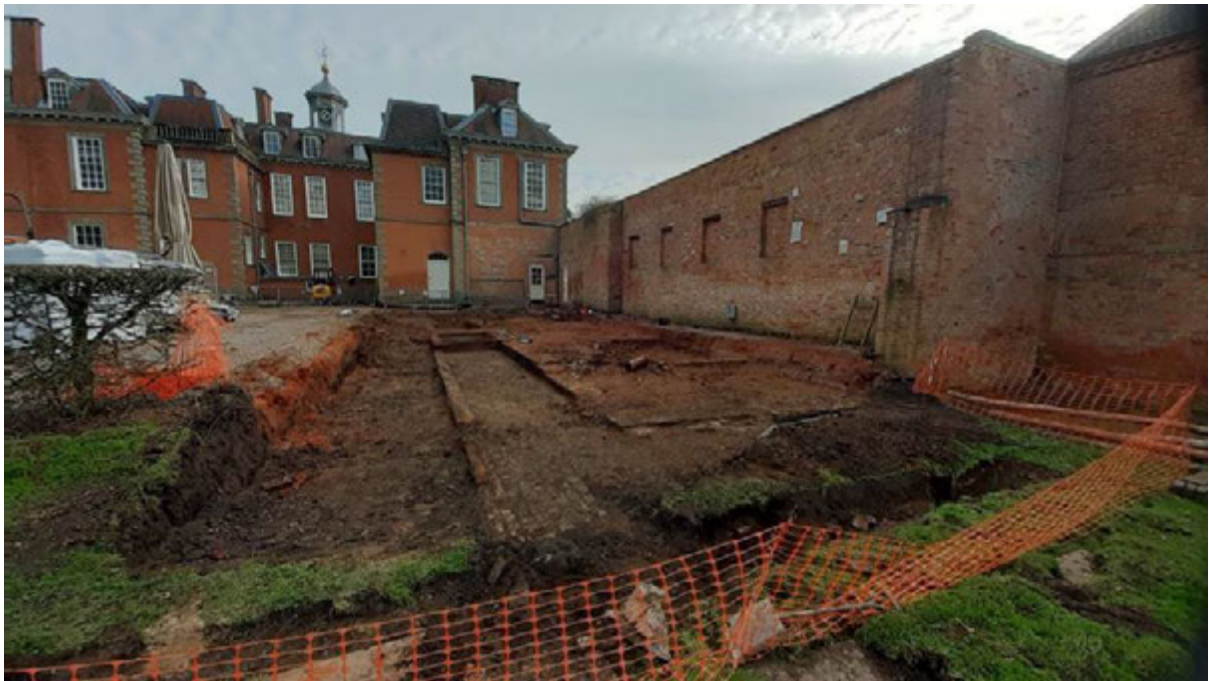
*Plate 1: General south-east view of the excavation area; no scales*

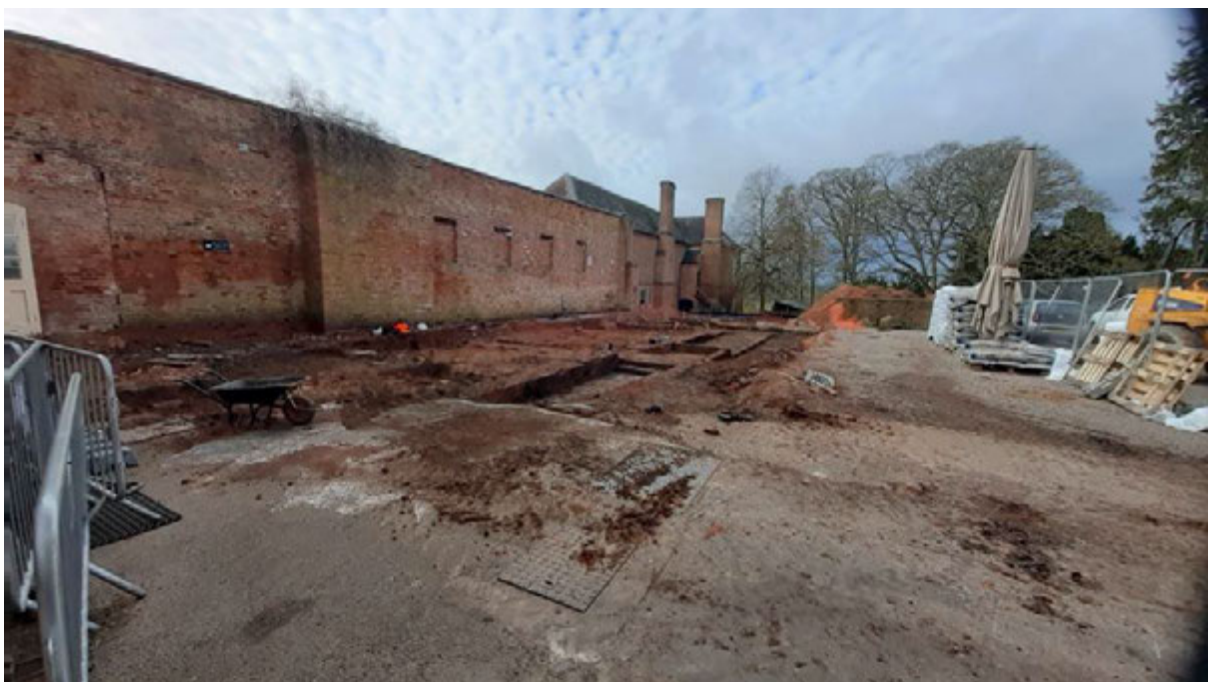
*Plate 2: General west view of the excavation area; no scales*

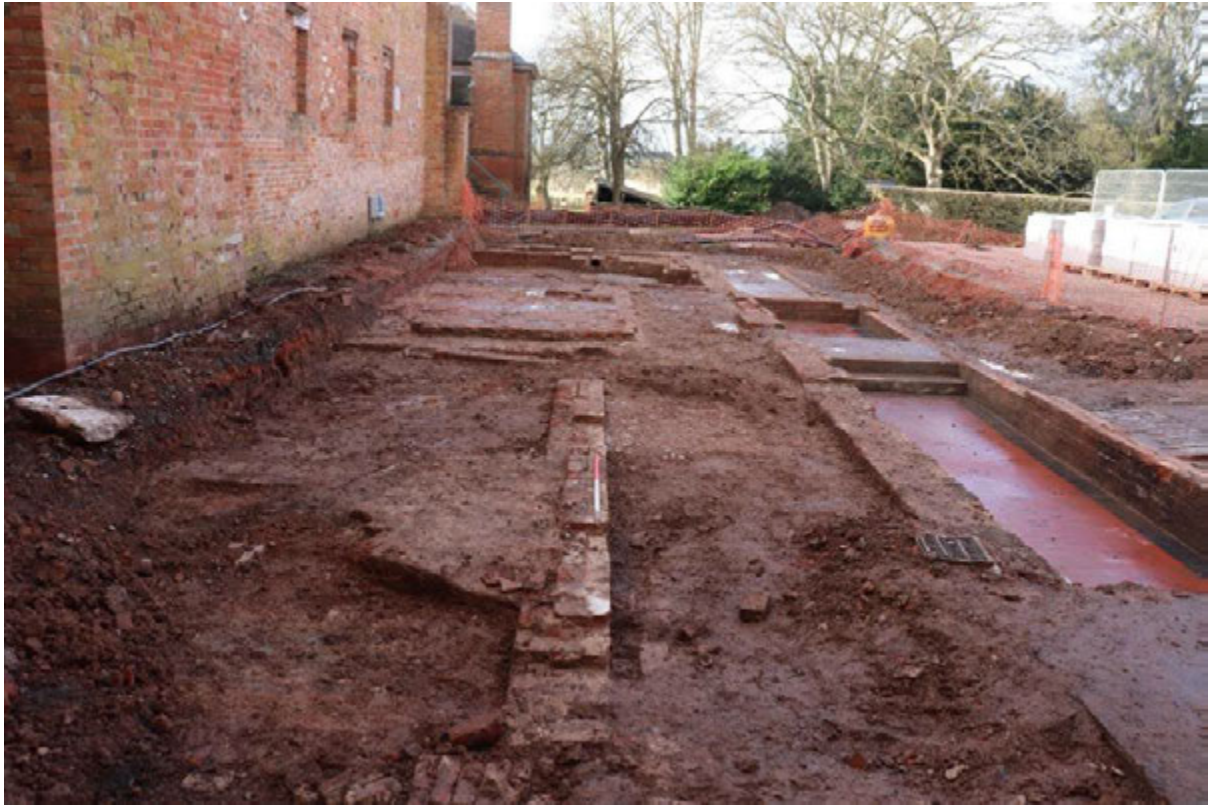
*Plate 3: Wall 2026 (south-east end) cut by later scullery floor 1024 and pipes, butted by cobbles 1037, view north-west; 1m scale*
