Archaeological strip map and sample excavation at  
Hanbury Hall, School Road,  
Hanbury, Worcestershire  
Worcestershire Archaeology  
*for The National Trust*

Archaeological strip map and sample report

Site name: Hanbury Hall café  
Local planning authority: Wychavon District Council  
Planning reference: 20/00416/FUL  
Central NGR: SO 94380 63750  
Commissioning client: The National Trust  
WA project number: P6169  
WA report number: 3007  
HER reference: WSM 77991  
Oasis reference: Fieldsec1-514814  
Museum accession number: -

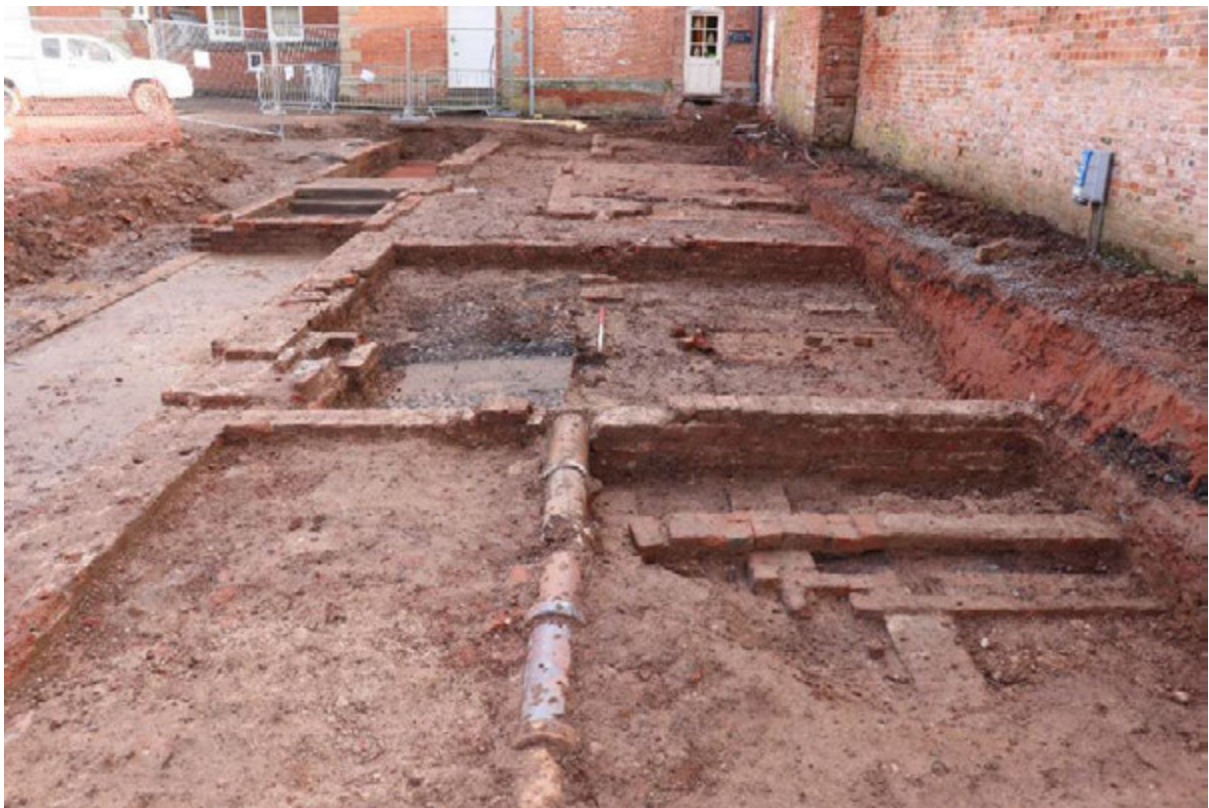
*Plate 4: Alignment of wall 1020, cut by later drainage 1046 from scullery, abutted by cobbles 1022 and slab 1023, in the background; walls 1018, 1039 and 1041 in the foreground; view south-east; 1m scale*

Walls (1039) (bricks 8 ½ by 4 ½ by 2 ¼ inch) and (1041) (bricks 9 ¼ by 4 ½ by 2 ½ inch) (Plate 4) may be related to these surfaces, their phasing was not clear, but the degree of overall truncation suggests a relatively early date.

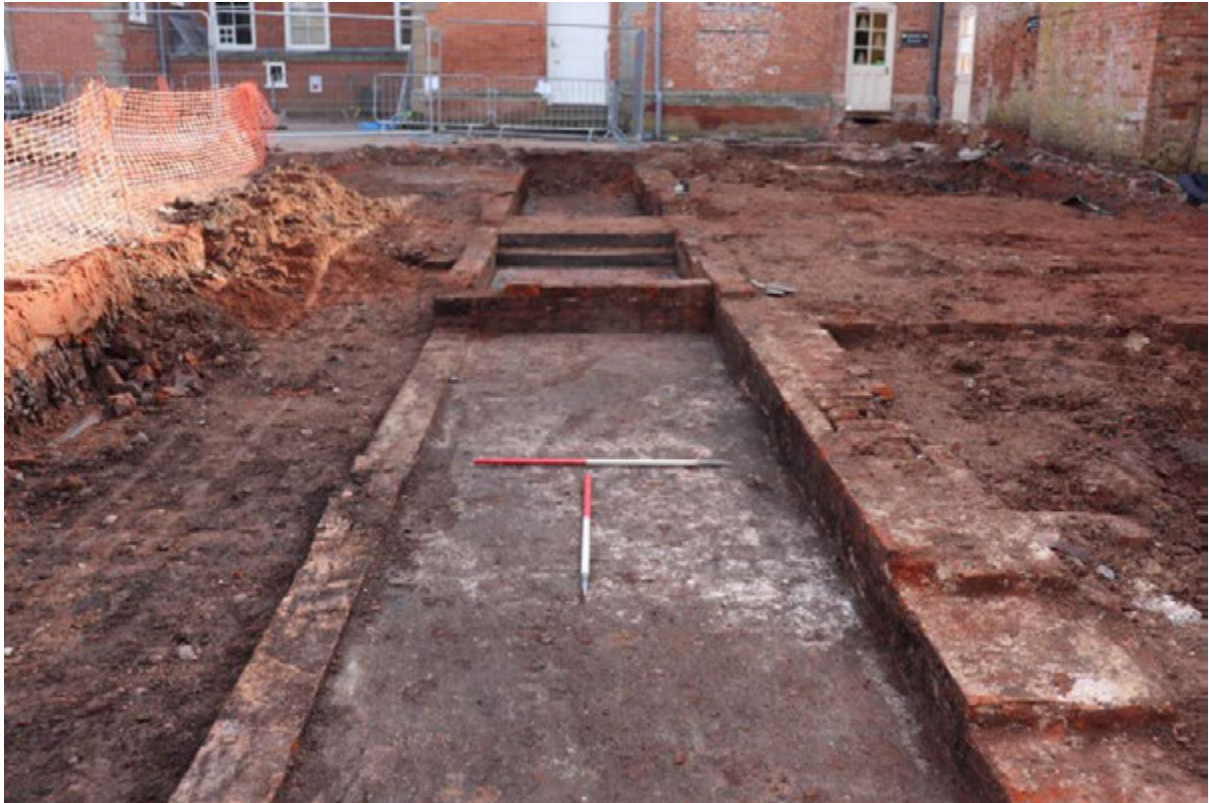
*Plate 5: North-west end of corridor, subsurface 1014, view south-east; 2x 1m scales*

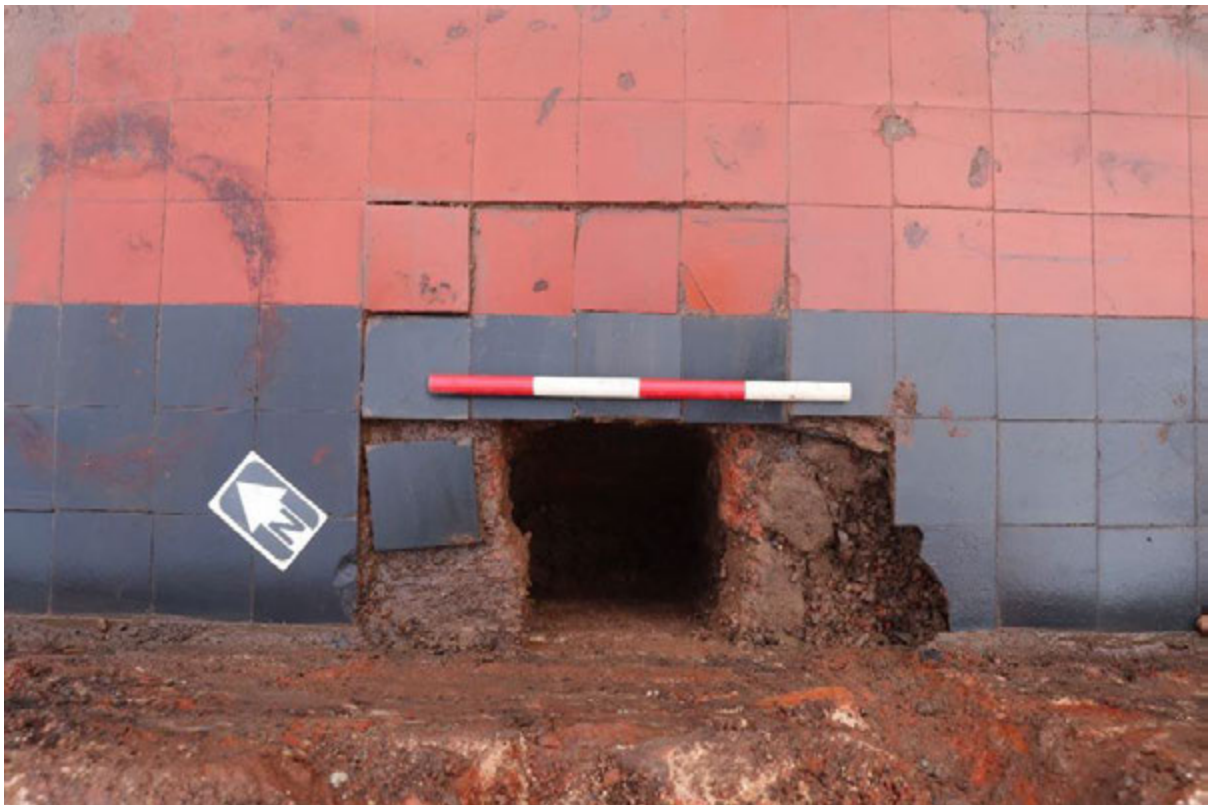
*Plate 6: Tiled surface of porch corridor 1013 (south-east), with BA evaluation sondage to culvert 1017, view north-east; 0.4m scale*

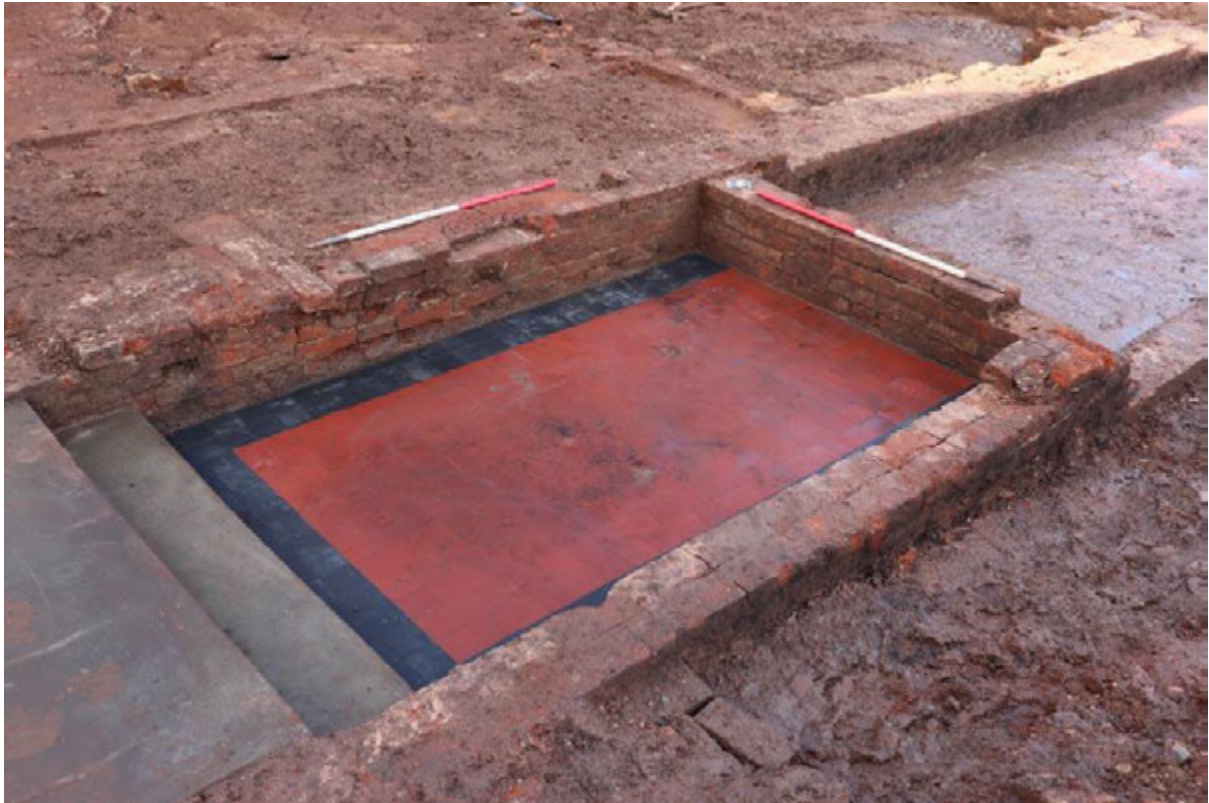
*Plate 7: Tiled surface of porch 1013 (north-west) and later wall 1012, view west; 2x 1m scales*

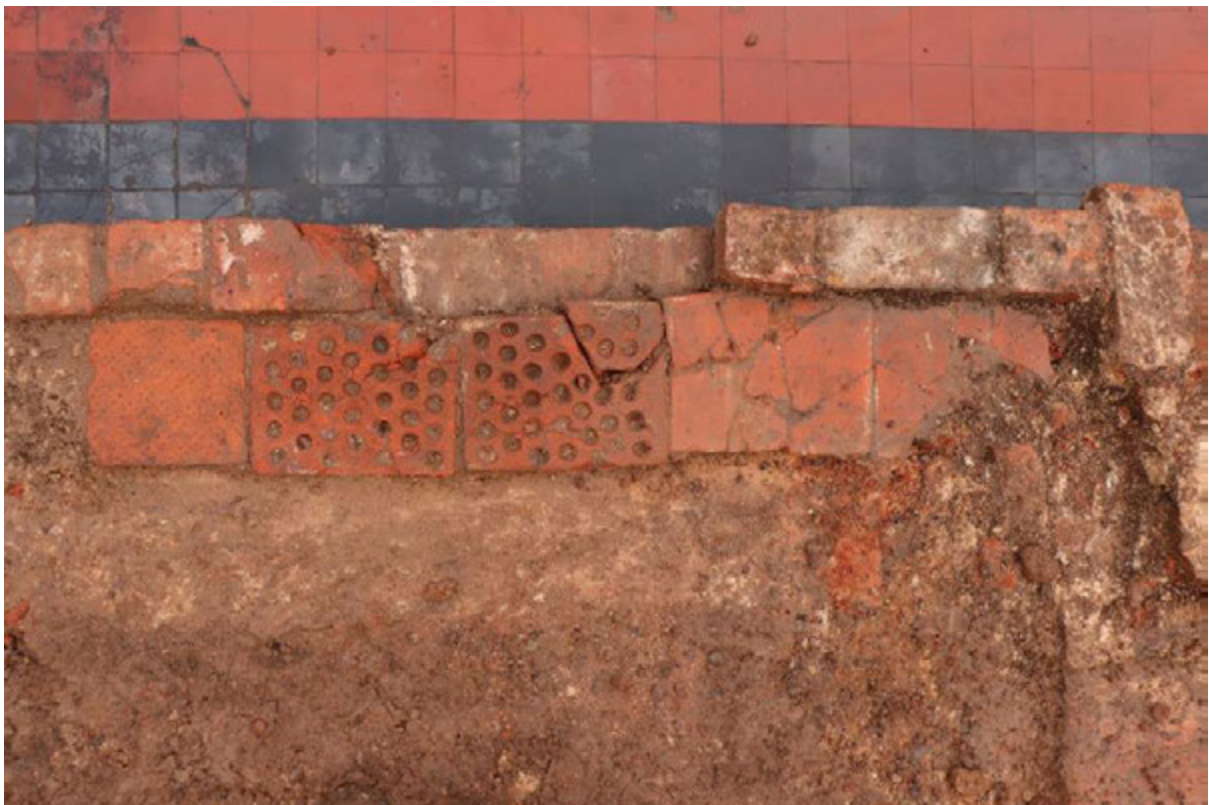
*Plate 8: Reused brewery tiles in wall 1025, adjacent to porch corridor 1013 (north-west), view north-east; no scale*

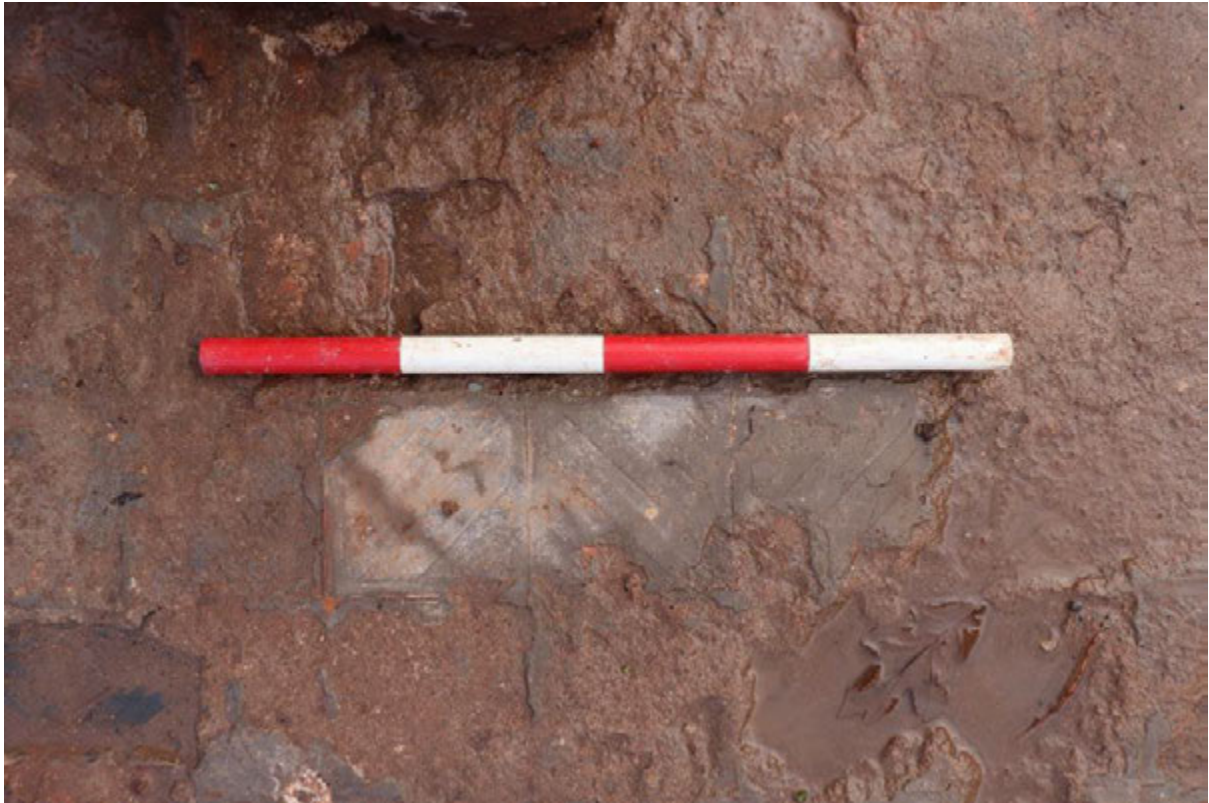
*Plate 9: Corridor subsurface 1014 to north-west where tiles had been removed; 0.4m scale*

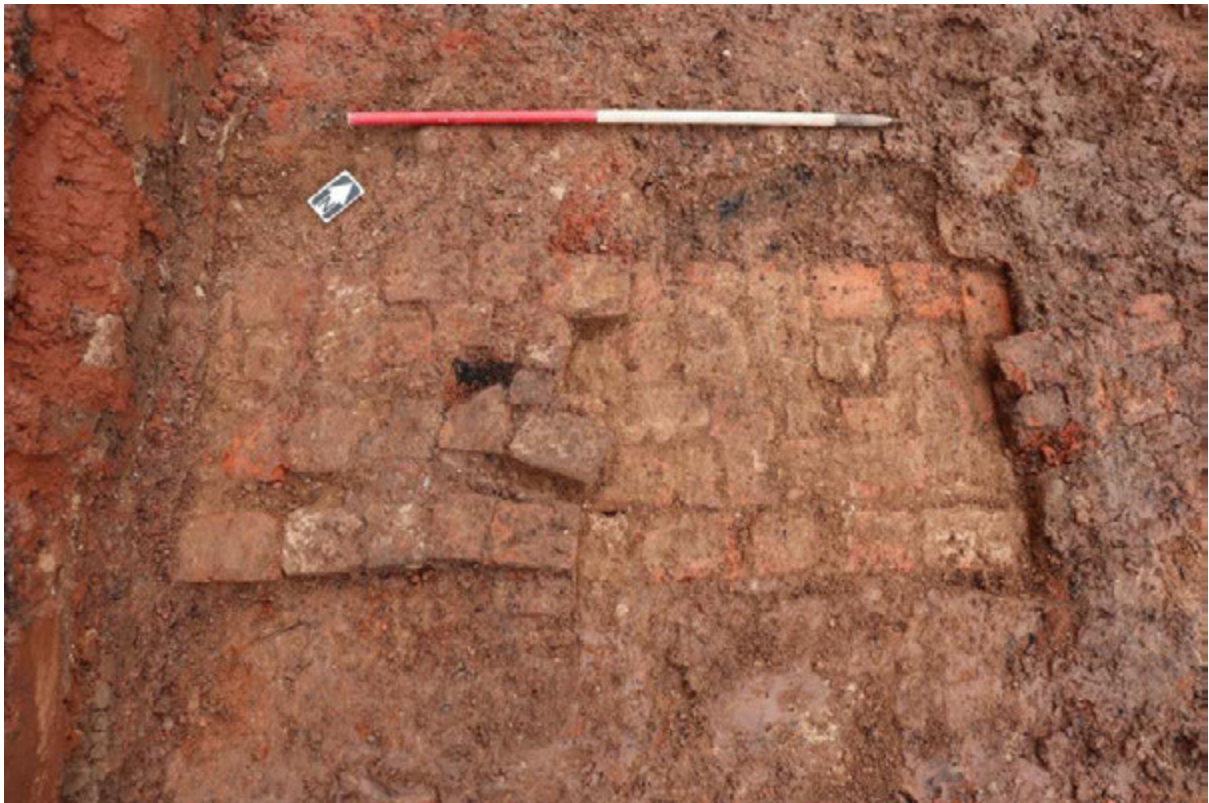
*Plate 10: Earlier brick surface 1036 in north-west half of site, view north-west; 1m scale*

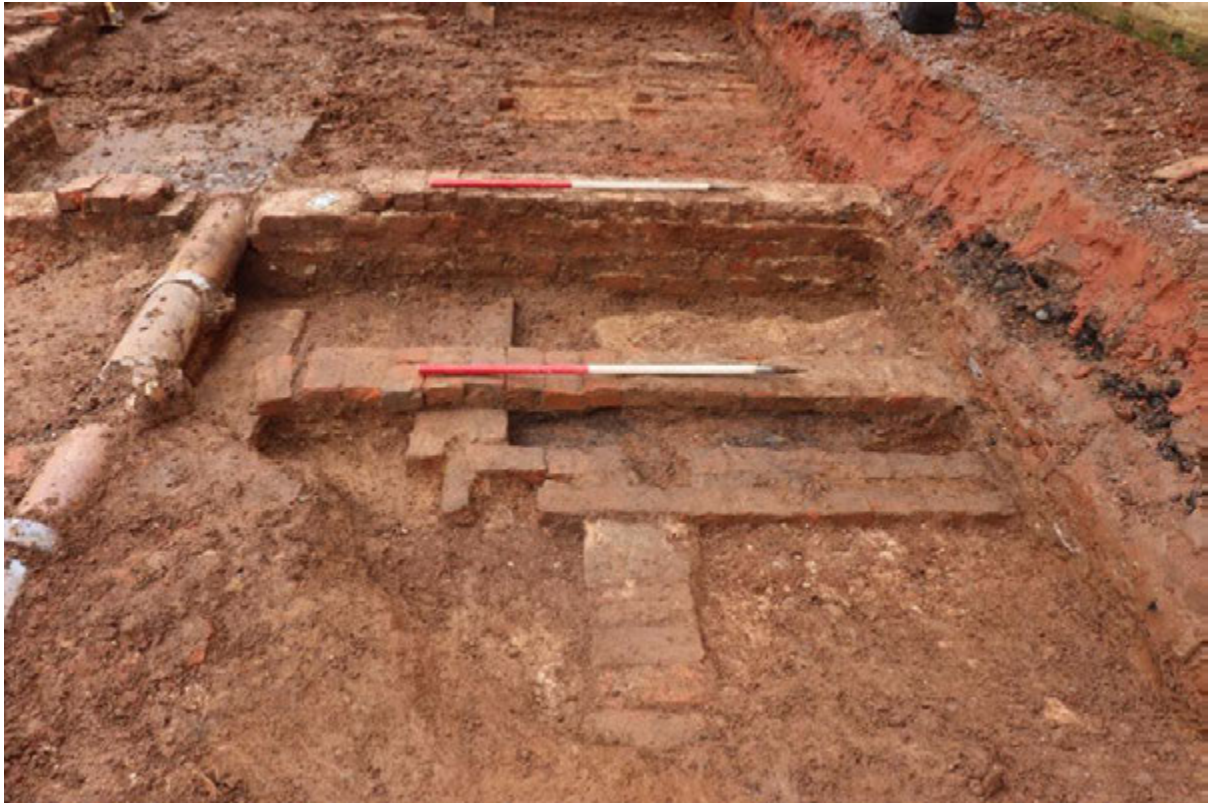
*Plate 11: Earlier intercut walls 1039 and 1041 in north-west end of site, with sand and gravel either side, view south-east; 2x 1m scales*

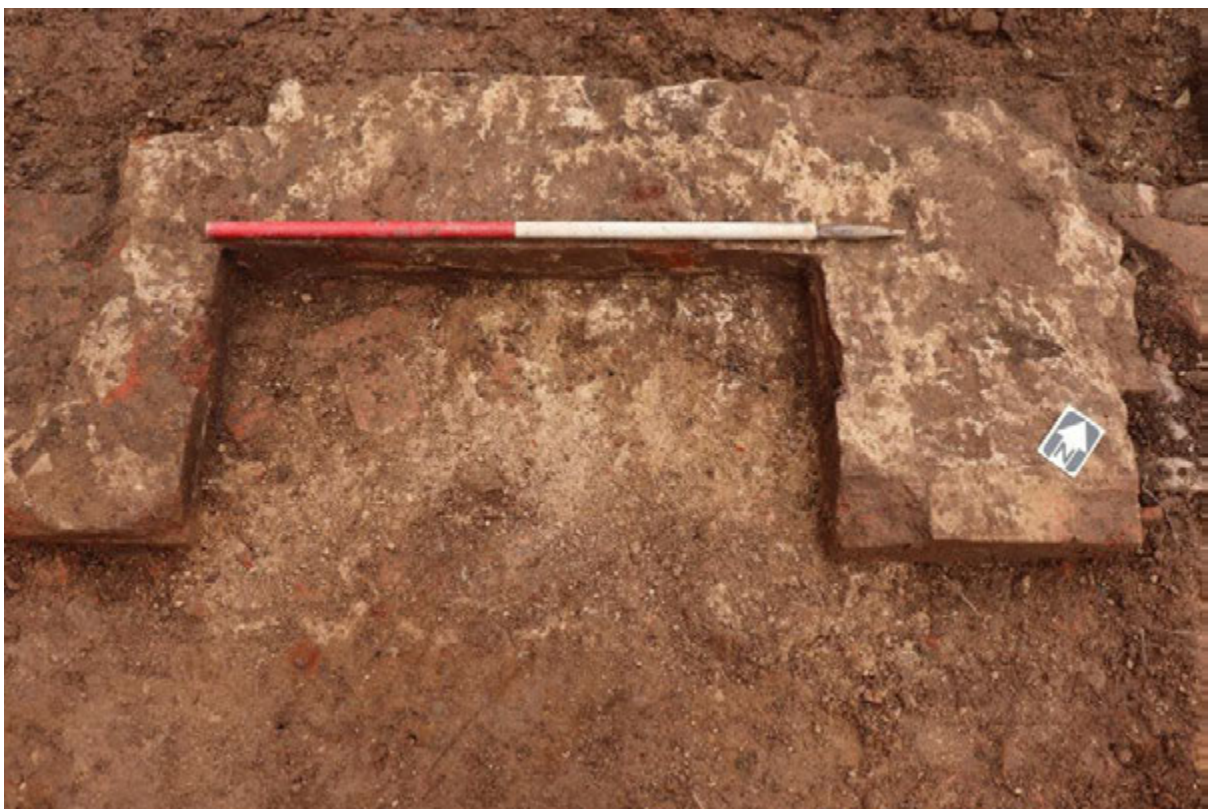
*Plate 12: Fireplace 1029 at north-west end, in area previously used as brewhouse, view north-west; 1m scale*

At the north-west end was a fireplace (Plate 12) which would have heated a room labelled as a brewhouse in 1830, with a scullery and kitchen to the south-east. It is likely that the scullery was defined by walls (1045, 1047) with brick floor surface (1024) a slightly later addition (see Section 5.2.5). Walls (1018, 1033, and 1048) (bricks 9 by 4 ¼ by 2 ¾ inch) did not fit closely with any of the planned walls, though it is possible that these were for supports for flooring.

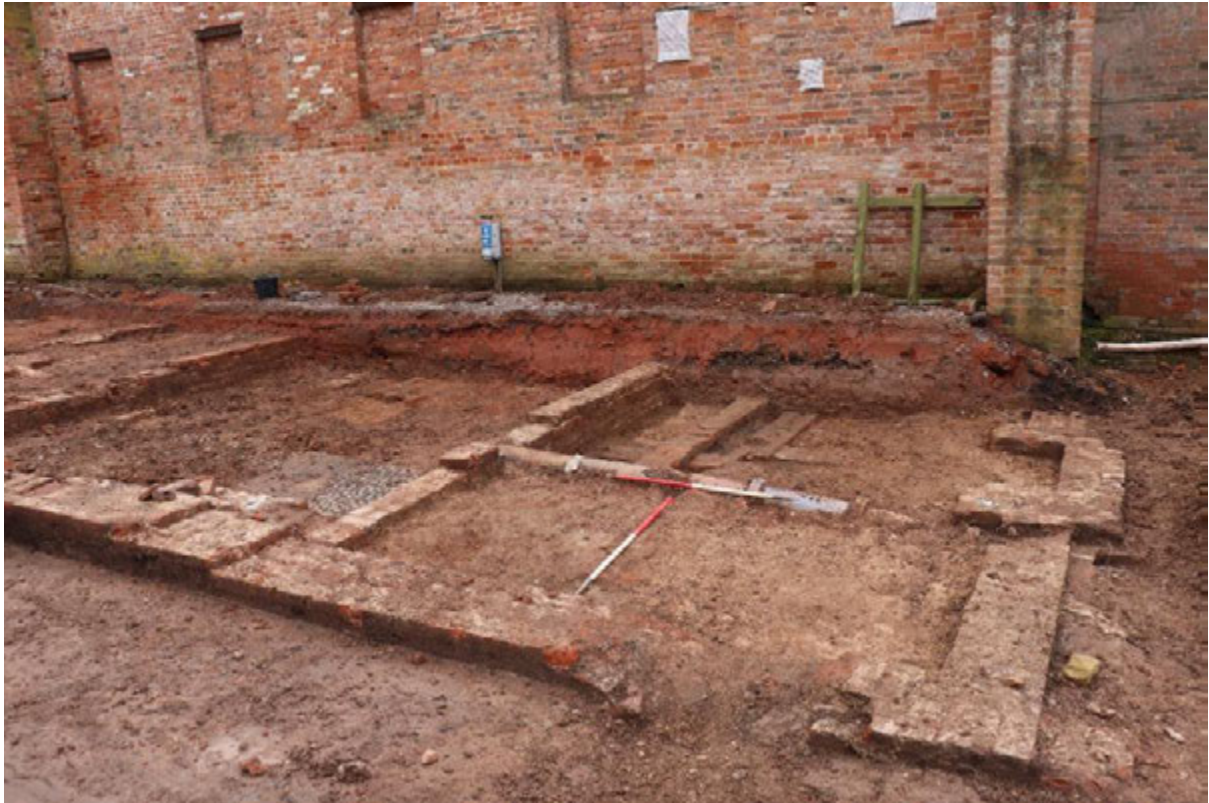
*Plate 13: North-west end of building with rooms, hearth and earlier cobbled floor, view south; 2x 1m scales*

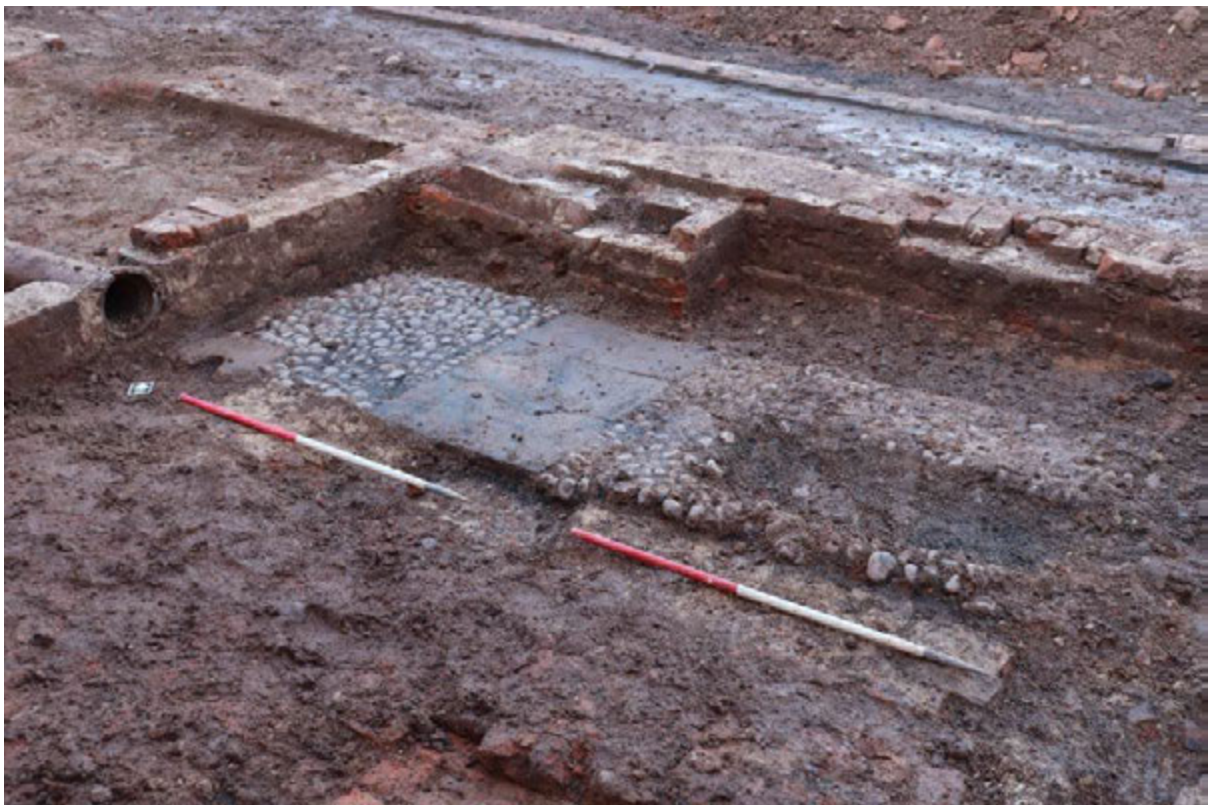
*Plate 14: Cobbled floor 1022 and footpath 1023 to former entrance of the building, and wall footing 1020, truncated by drainage 1046, view north; 2x 1m scales*

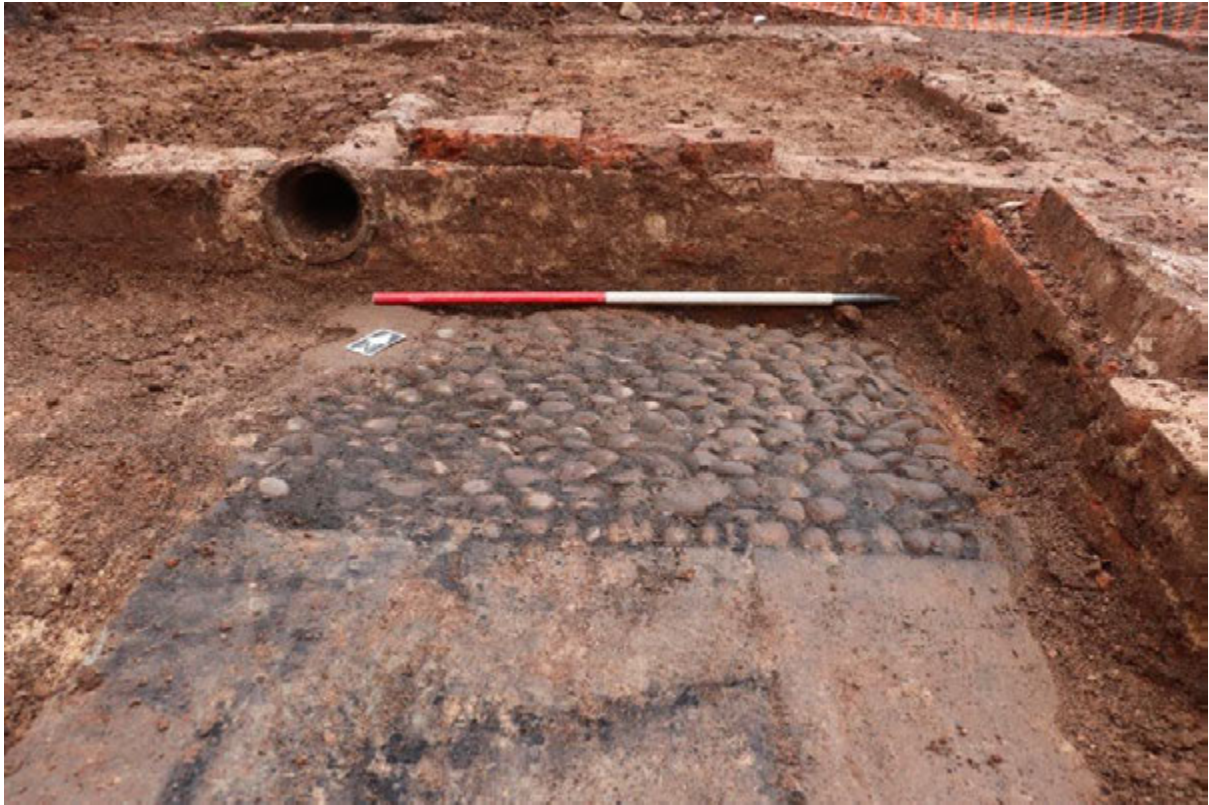
*Plate 15: Cobbled floor 1022 and footpath 1023 to former entrance of the building, truncated by drainage 1046, view north-west; 1m scale*

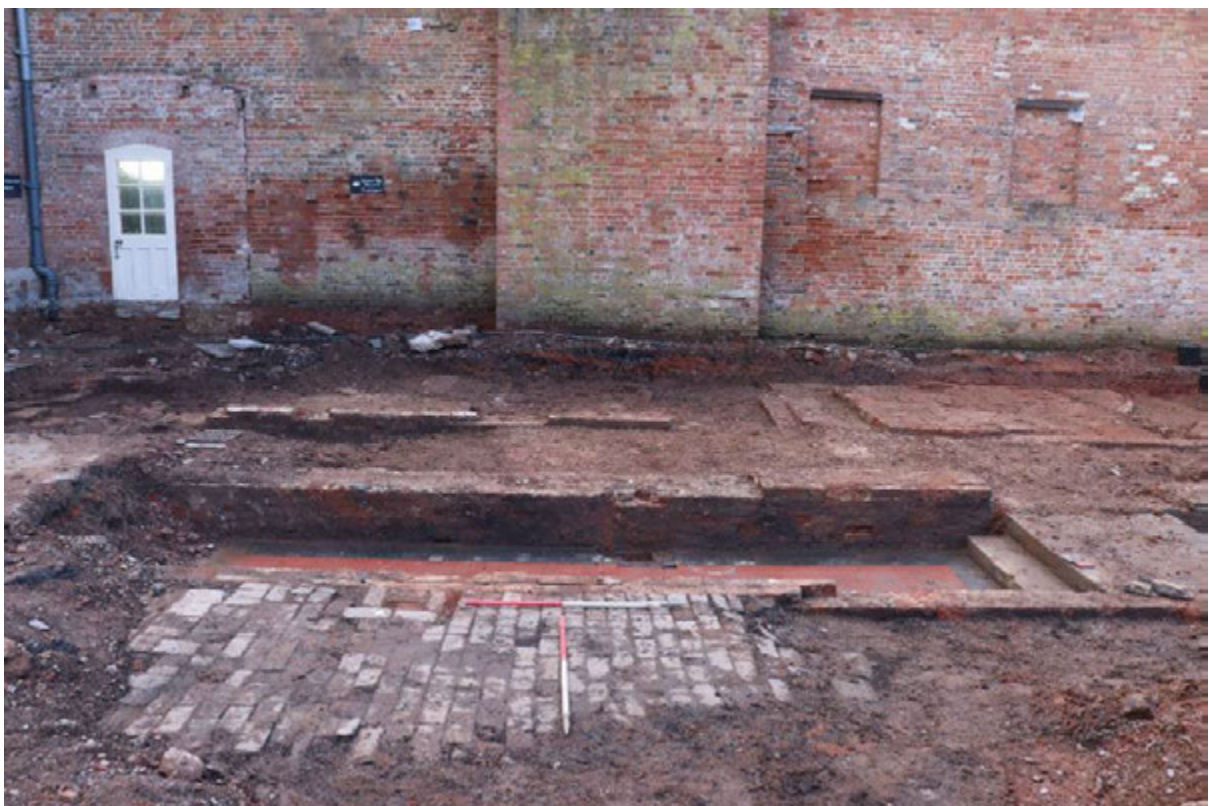
*Plate 16: Coal stained grey brick floor 1009 to north-east side of building, view south-west to parterre wall; 2x 1m scales*

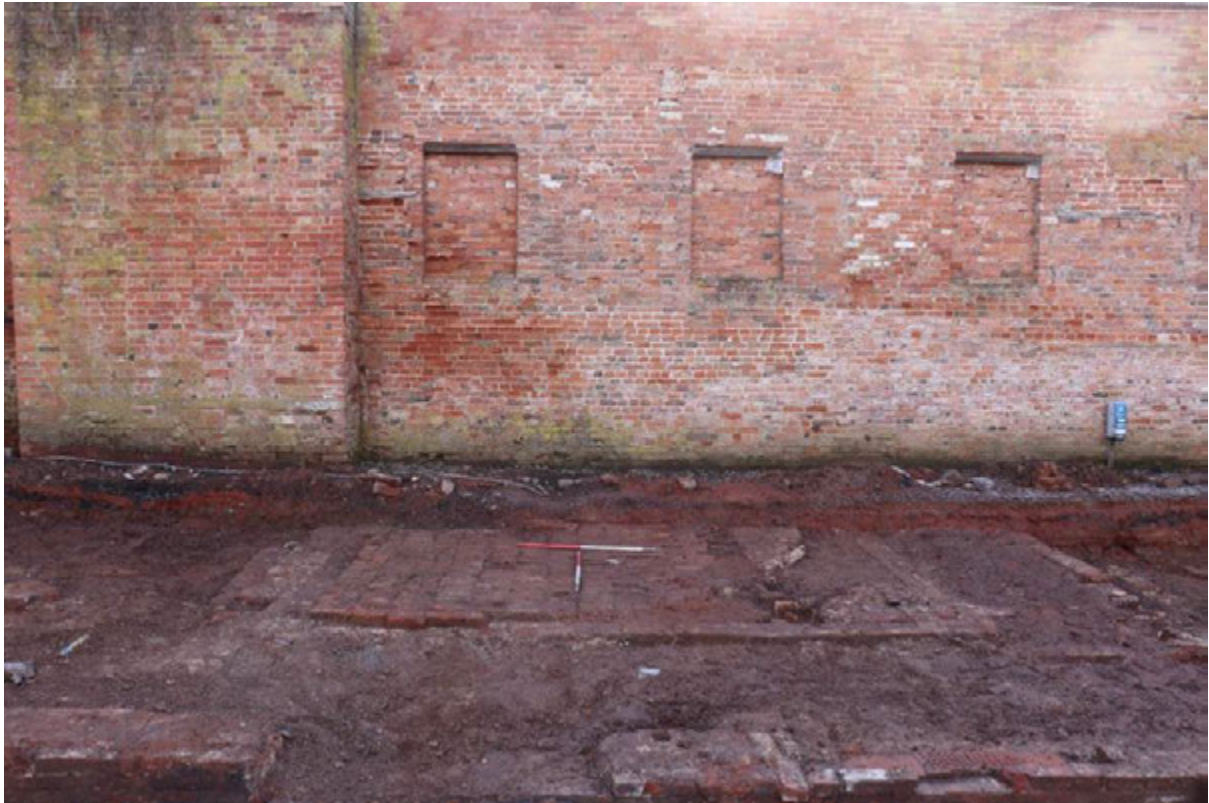
*Plate 17: Brick floor of Scullery 1024, view south-west to parterre wall; 2x 1m scales*

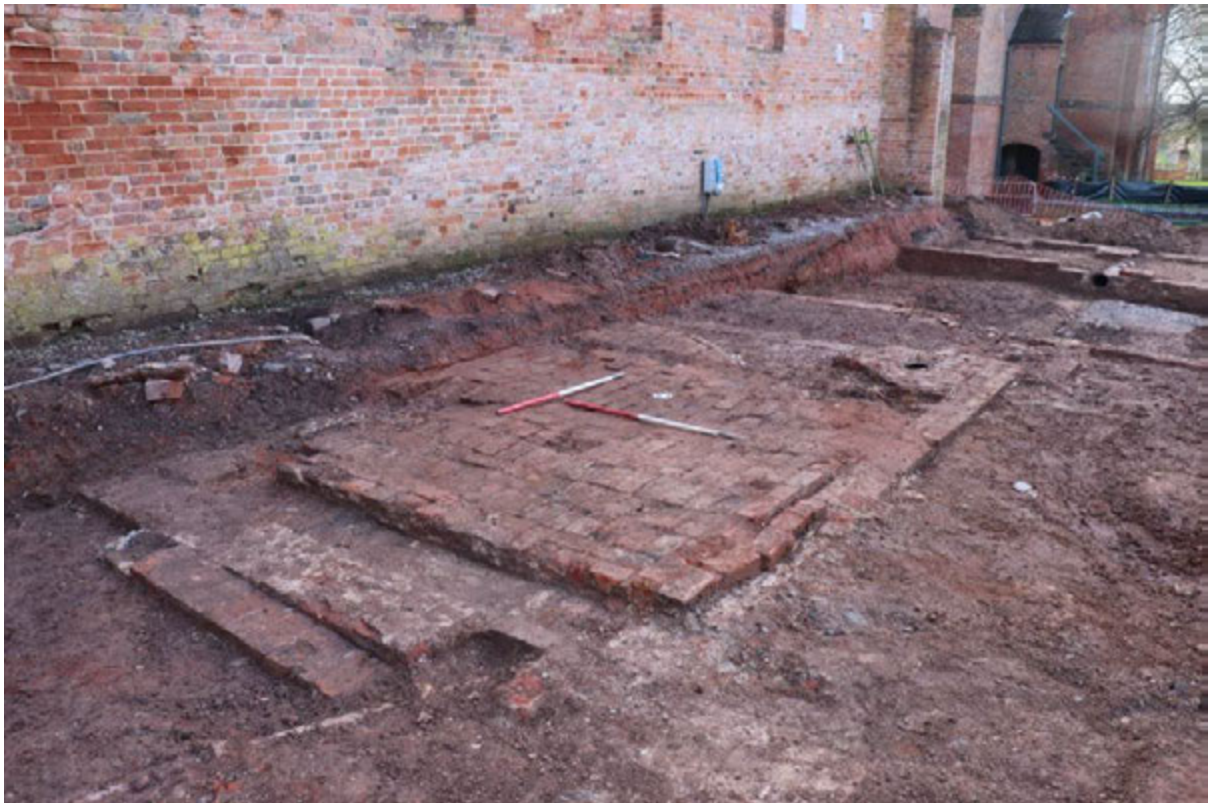
*Plate 18: Brick floor of Scullery 1024, view west to parterre wall; 2x 1m scales*

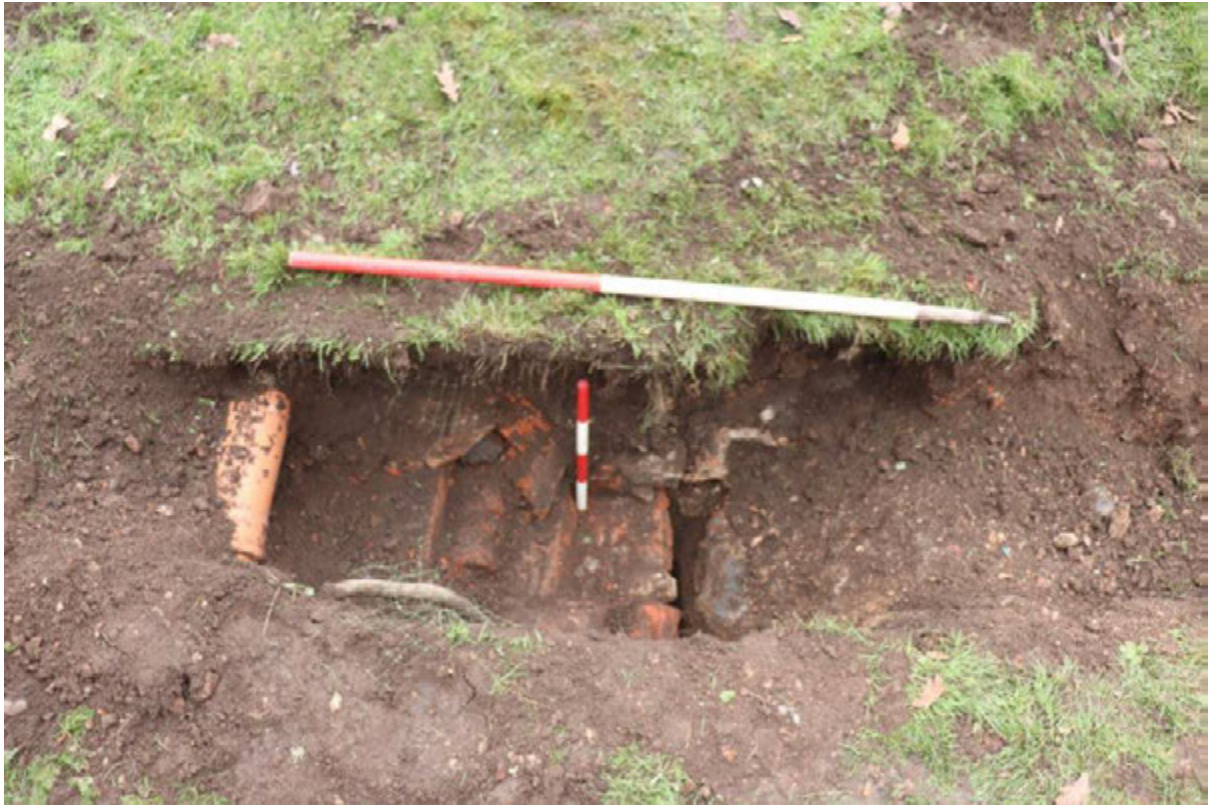
*Plate 19: Top of culvert brick arch 1017, disturbed by modern services, on turfed slope at north-west edge of main excavation area, view south-east; 0.4m and 1m scales (initially exposed during the watching brief for the Biomass Boiler; WSM 77814; Arnold and Vaughan 2022)*

The brick culvert (1017) (Plates 19 to 22) was 0.60m wide and 1.20m deep internally, and c 1.00m wide externally. It had an arched top, constructed of a double skin of bricks, constructed of red bricks 9" x 4" x 3" in a cement mortar. The base was lined with slate. Pipes had been inserted into it, but it was otherwise in a very good state of repair. The culvert had been blocked at its north-west end with a brick wall in the Lower Yard. The course of this feature has been mapped and discussed in the watching brief report (Arnold and Vaughan 2022: Trench 5, 503) and is known to have run under the Phase 3 corridor.

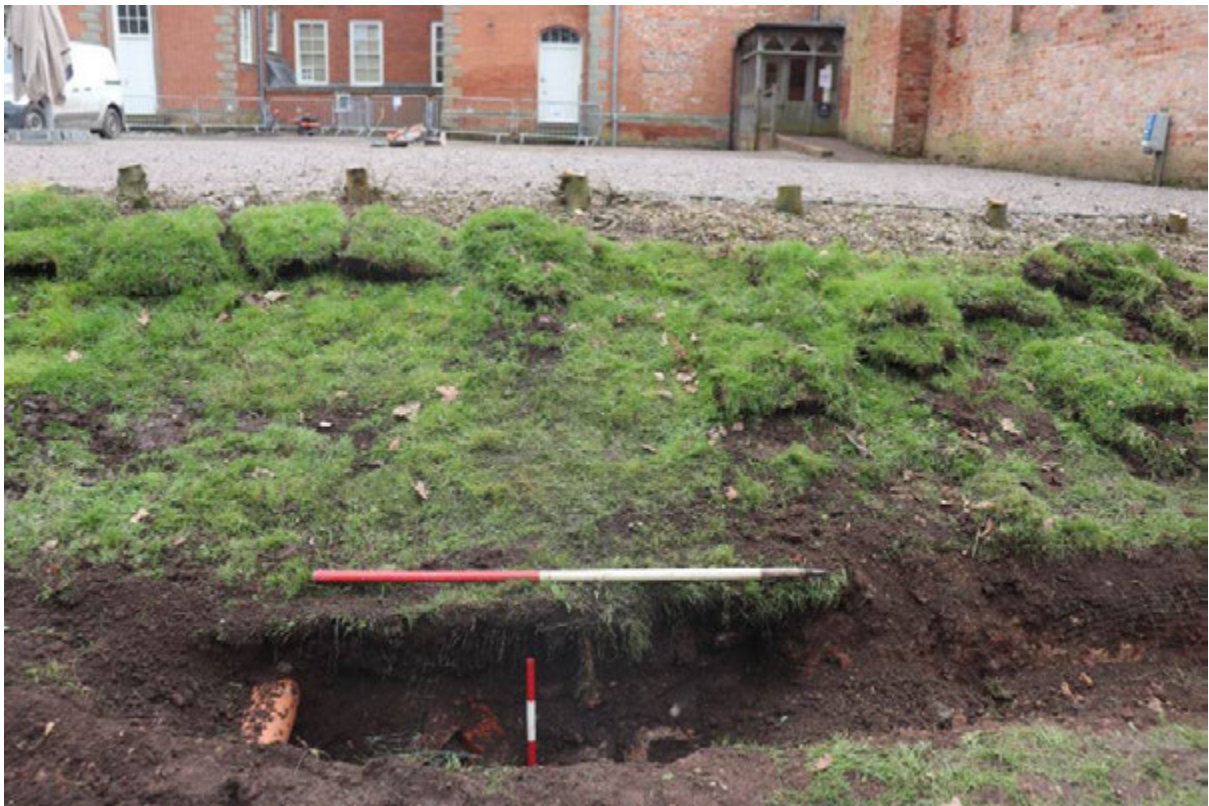
*Plate 20: Top of culvert brick arch 1017, disturbed by modern services, on turfed slope at north-west edge of main excavation area, view south-east; 0.4m and 1m scales (initially exposed during the watching brief for the Biomass Boiler; WSM 77814; Arnold and Vaughan 2022)*

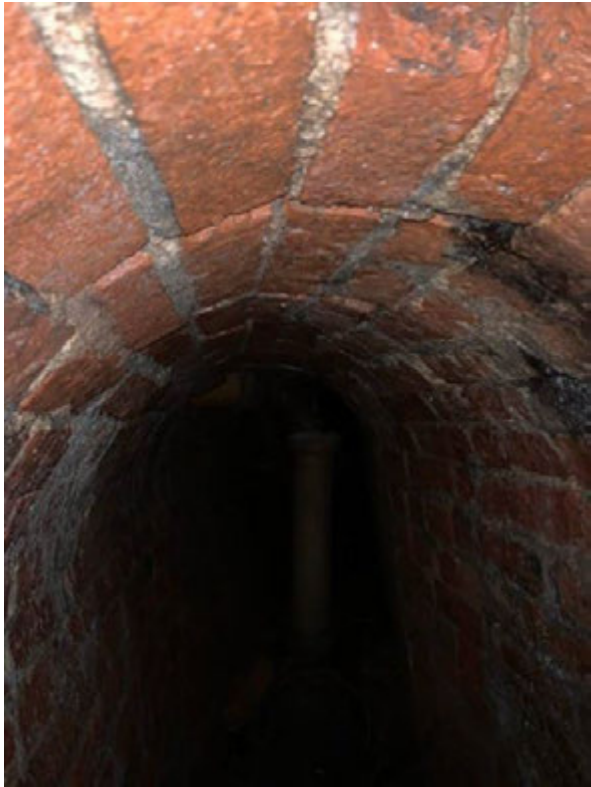
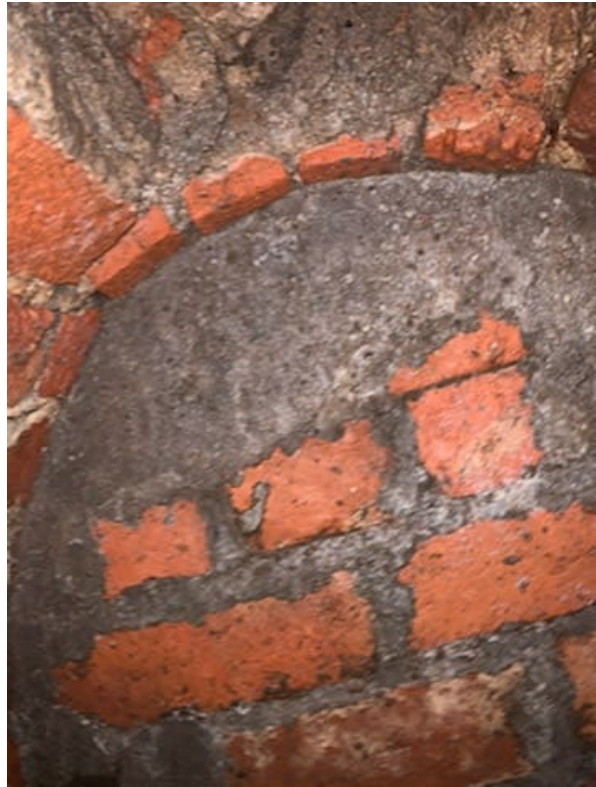
*Plate 21a/b: Internal views of brick culvert 1017: (a) inserted pipe to south-east; (b) brick wall blocking to north-east, possibly inserted due to damage from modern drainage*

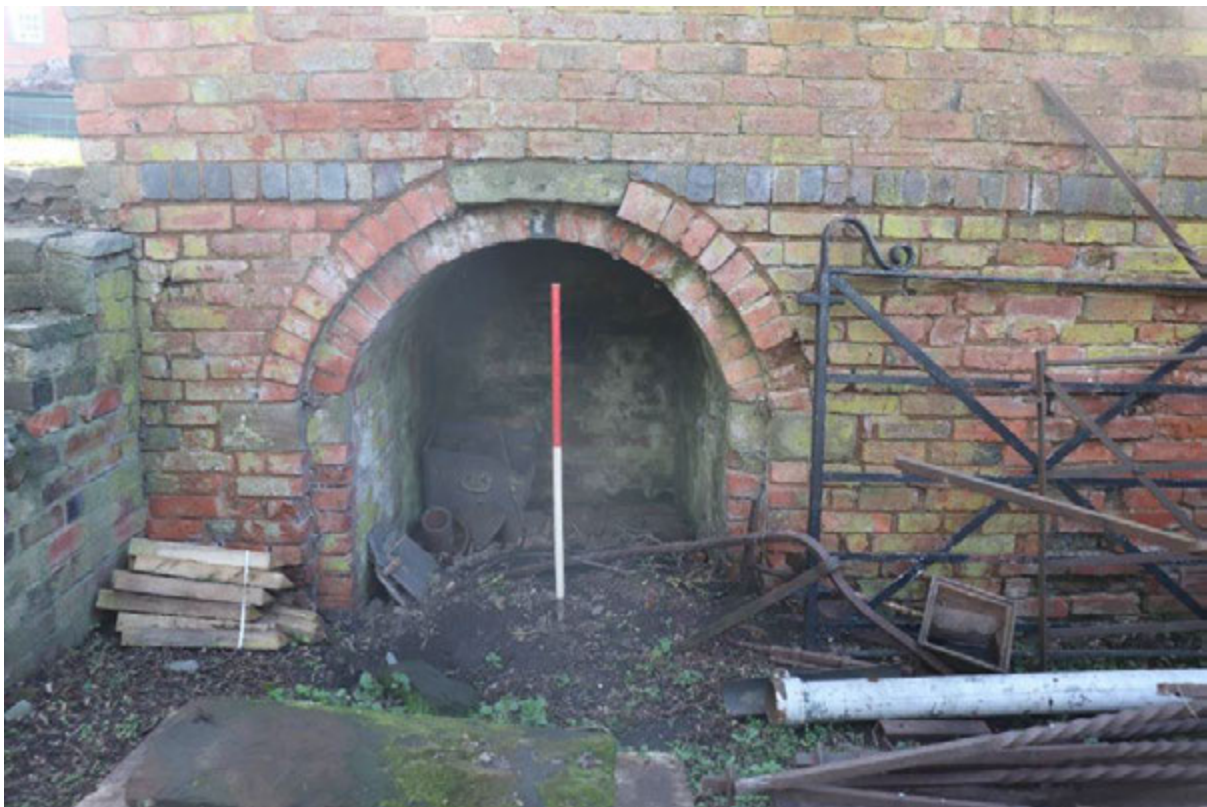
*Plate 22: Blocked former outlet of brick culvert 1017 in Lower Yard to the north-west, view south-east; 1m scale*
