**Building recording at
Goldness House,
Torton,
Worcestershire**
Worcestershire Archaeology
for RPS Consulting

GOLDNESS HOUSE, TORTON, WORCESTERSHIRE

Building recording report

Building recording at Goldness House, Torton, Worcestershire

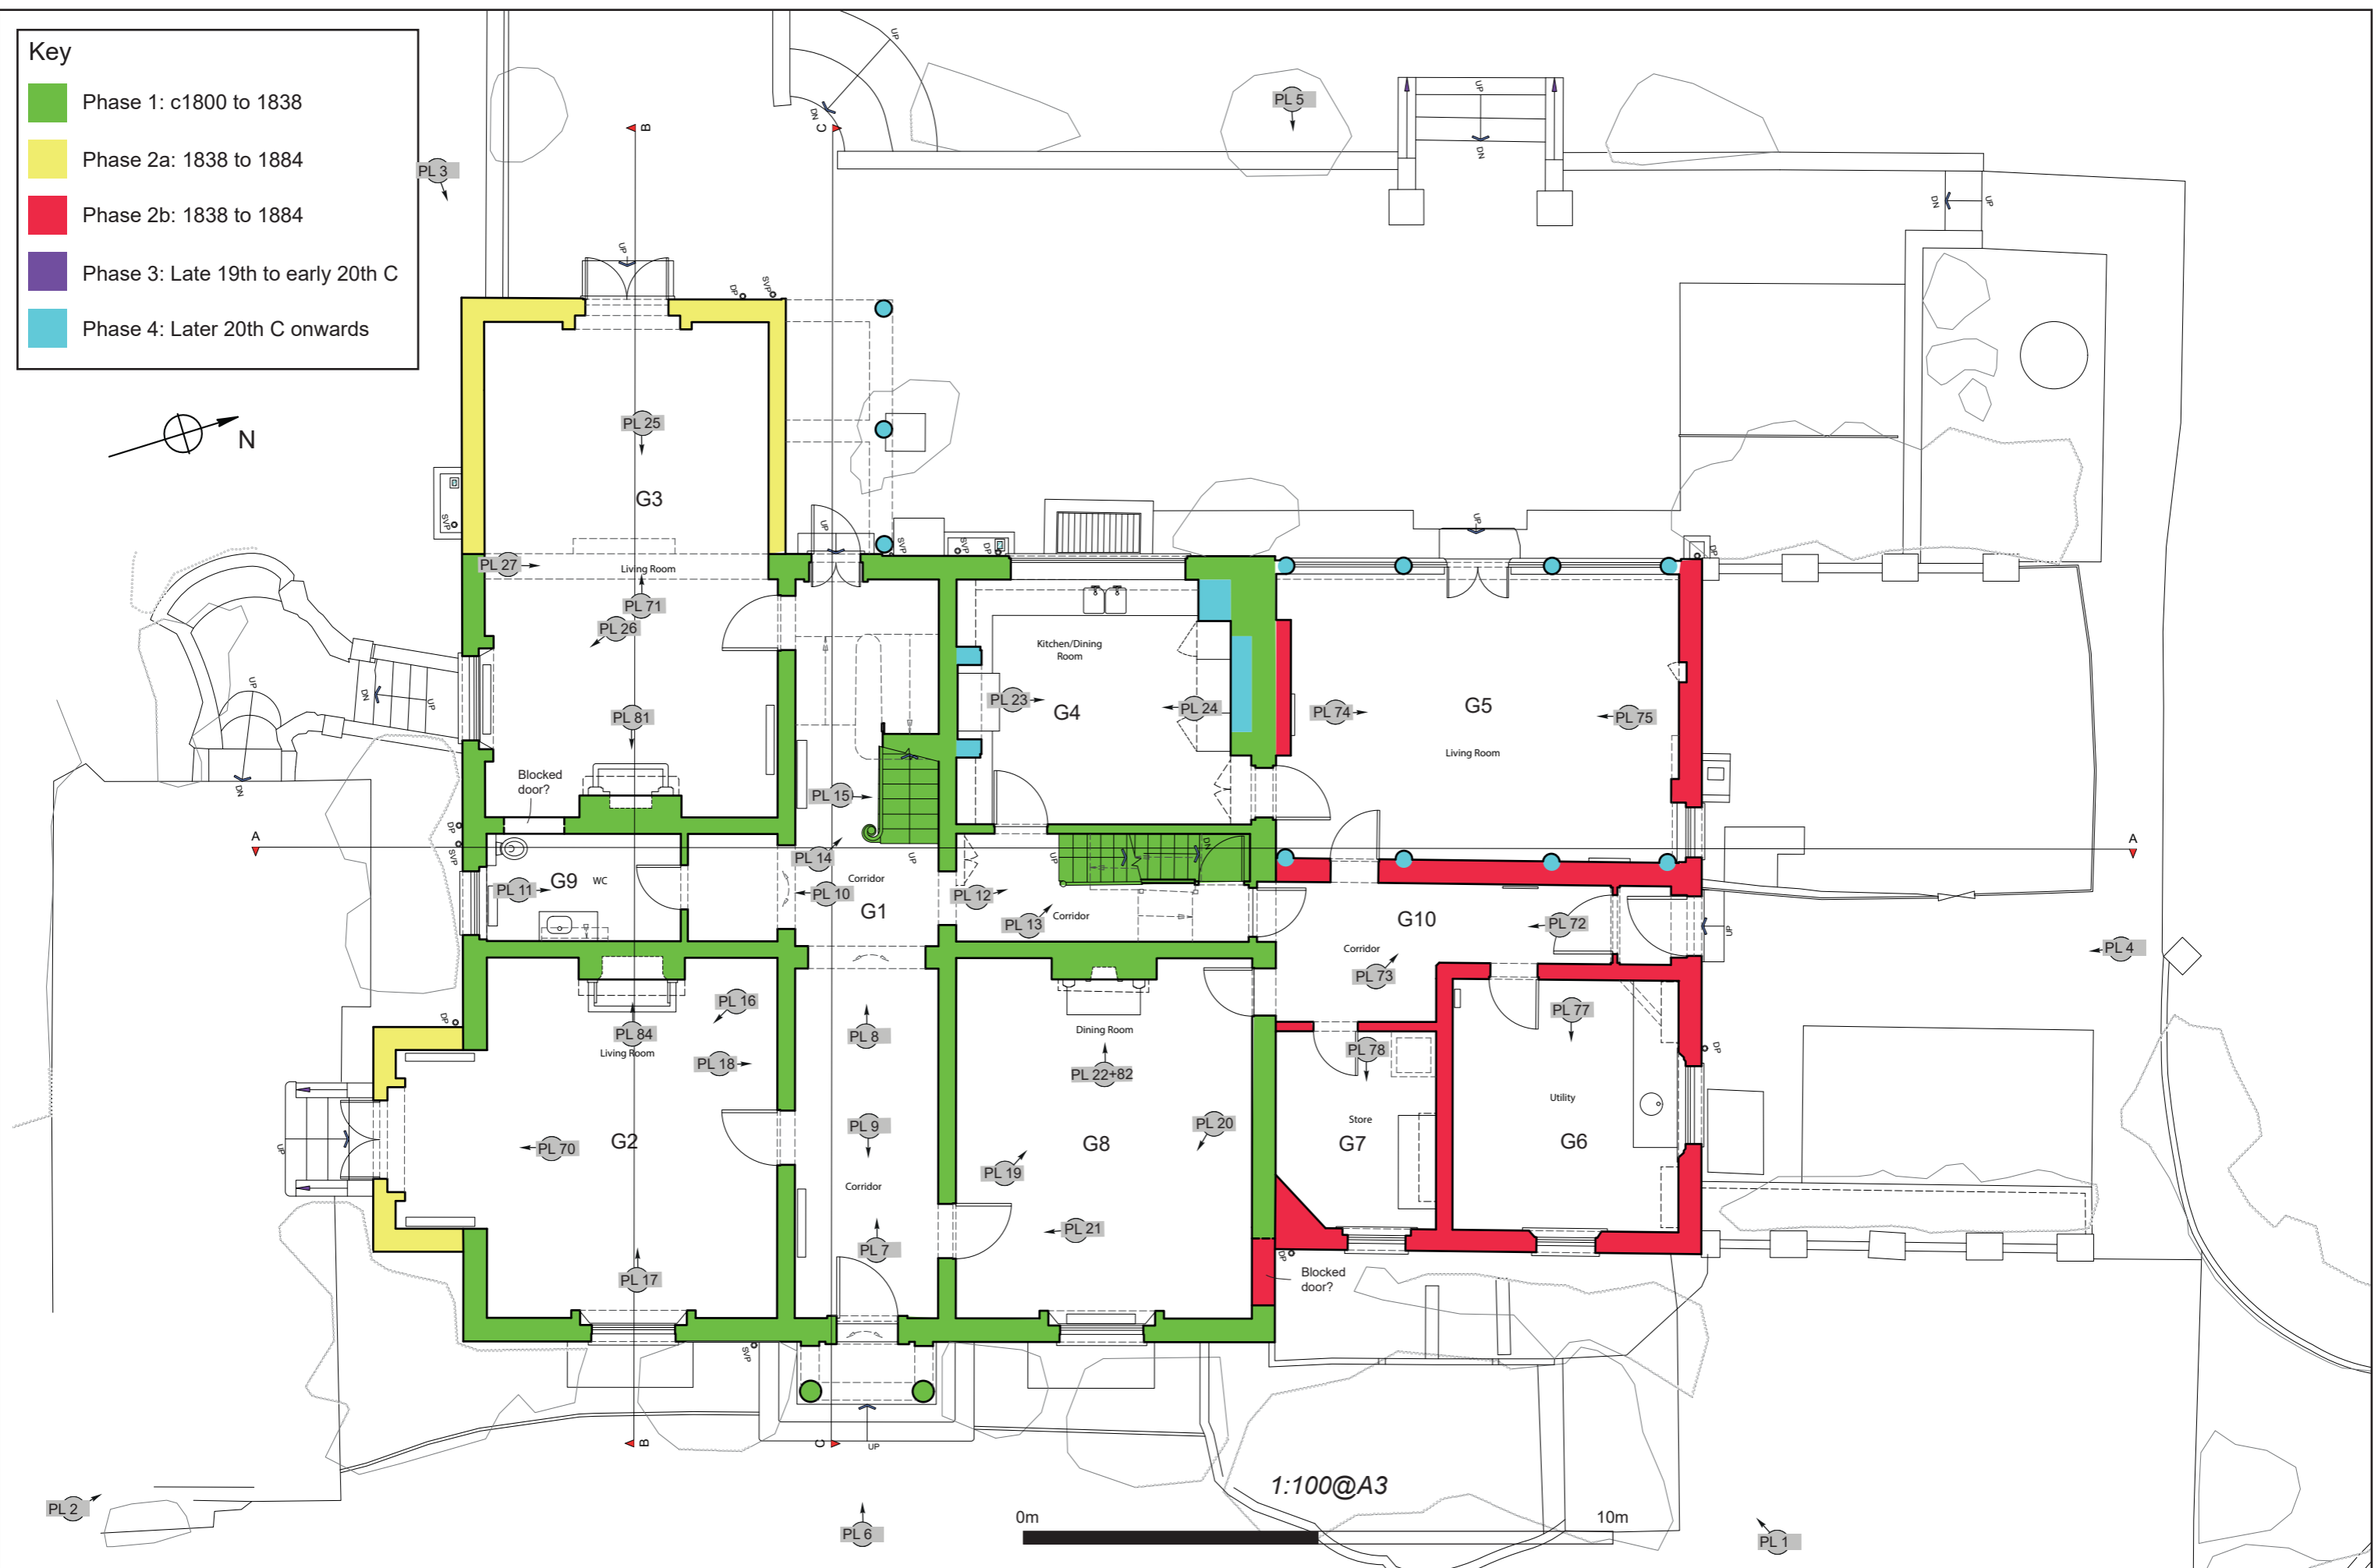
Figure 2

- Phase 1: c1800 to 1838
- Phase 2a: 1838 to 1884
- Phase 2b: 1838 to 1884
- Phase 3: Late 19th to early 20th C
- Phase 4: Later 20th C onwards

Groundfloor plan (After e-gg Job No. 078, Dwg No. P-003)

By the map of 1884, the building was as existing at the end of Phase 3 as outlined below and on Figure 2, with the element identified within the evaluation trenching (Lovett 2023) illustrated as standing also. This plan form remained the same up until aerial imaging in 1994, but by some aerial imaging of 1999, the element identified within the trenching had been removed. This suggests a 5 year range for its demolition.

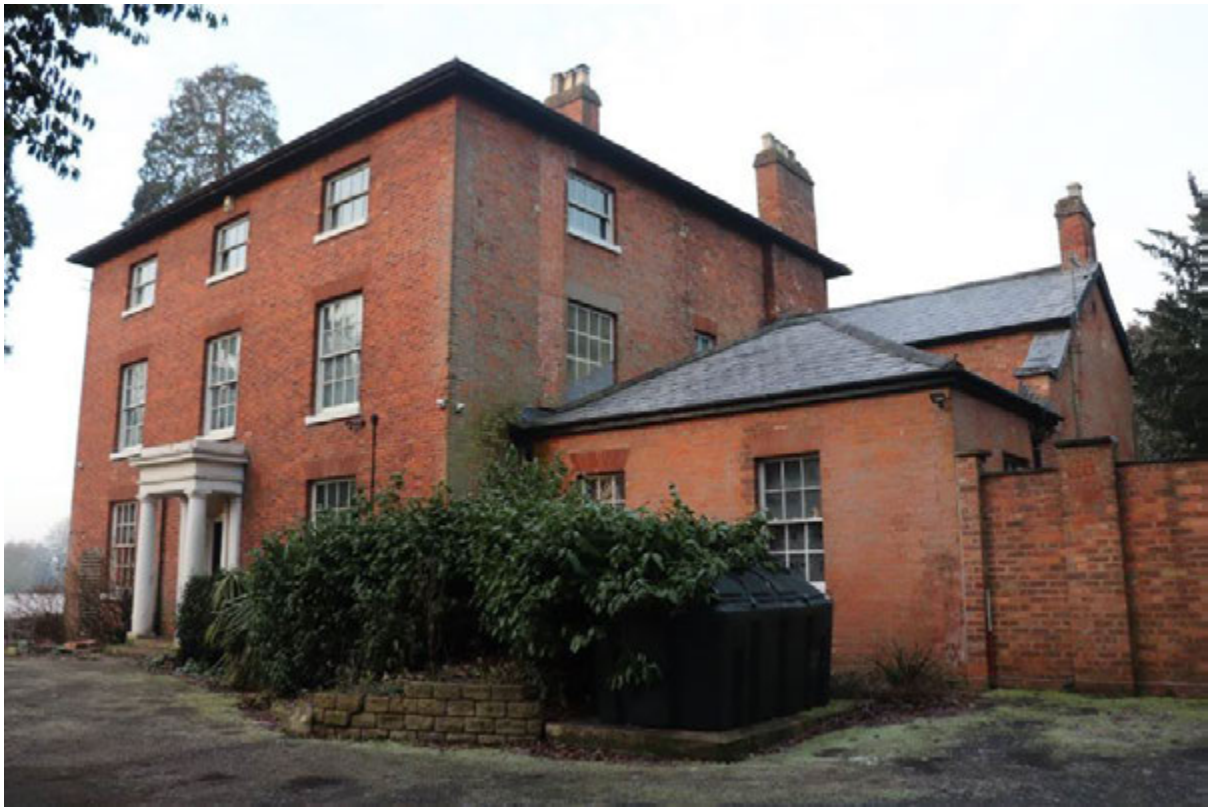
Plate 1 External, looking south-west, 1m scale

The building (Plate 1 to Plate 5) currently comprises a brick structure with low pitch slate covered roof of square plan with multi pitched roof extensions to the west and north, all brick built. The main facade of the house with entrance faces onto the drive to the east.

This extension is again in brick, though of a more variable bond pattern. Its rubbed brick window lintels are of lower height on the rear of the building to the west, with 12 pane sash windows, where not later replaced. The structure has two external doors, though only that on the north side is original (Plate 1, Plate 4 and Plate 5). Internally, a door was inserted to join corridors G1 and G10 (Plate 72 and Plate 73) with a large room G5 (Plate 74 and Plate 75) to the west connected to G4 with a new doorway. This connection to the Phase 1 kitchen again suggests a service function. Above this room F3 was a likely further bedroom (Plate 76).

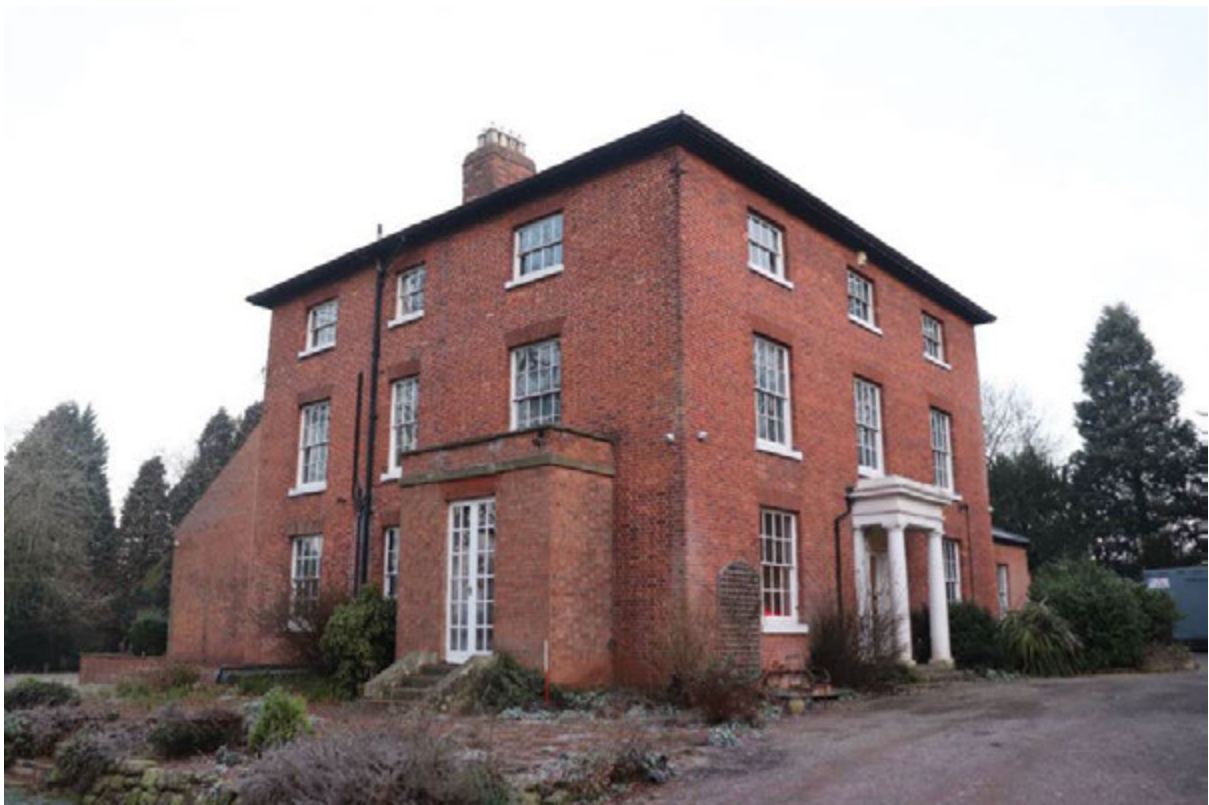
This phase consists largely of two elements, a flat roofed entrance porch added to the south side of room G2 (Plate 2 and Plate 70) and a single pitch slate roof extension to room G3 (Plate 3 and Plate 71), though this was originally a separate room, combined into a single room later on. Broadly, these additions retain the character of the Phase 1 building, using a Flemish bond, slate roof for the western extension and rubbed brick lintels. One variation is on the porch where sandstone string courses are present.

Plate 2 External, looking north-west, 1m scale

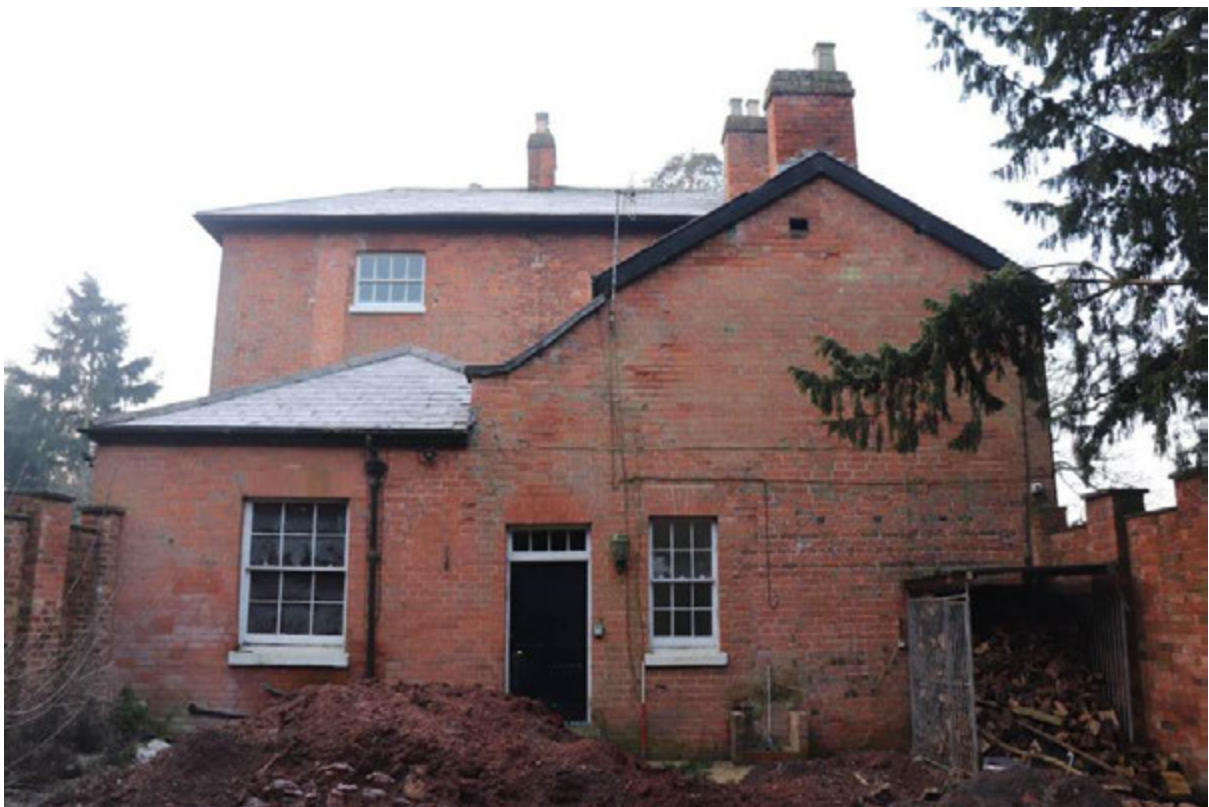
On the northern elevation of this building (Plate 4) the double roofline of at least one further building was present in the form of a wear pattern. It is possible that one of the remaining sash windows was altered to be made thinner at this time. The remains of this building were also seen in the evaluation trenching (Lovett 2023).

Plate 4 External, looking south, 1m scale

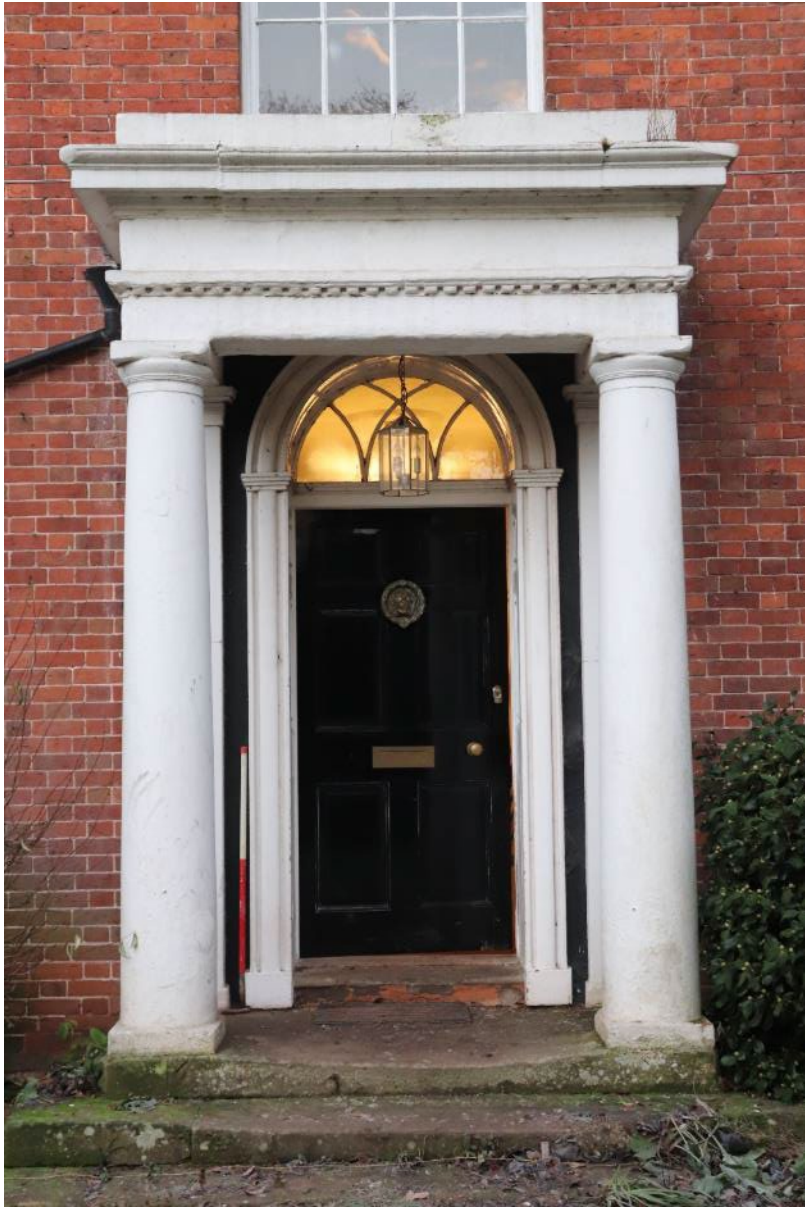
The first phase of the building consists of a brick, square structure with its porticoed entrance facing east (Plate 6). The entrance is flanked by 16 pane sash windows with three further at first floor level. These all have rubbed brick lintels. On the second floor, the sashes are reduced in height and with eight panes. The same pattern was originally present on the southern elevation though with one removed by a later bay window. The pattern to the west was probably similar originally, though is unclear due to later alterations. Its difference was in having a tall central window lighting the staircase internally over the ground and first floor. There were certainly also windows at first and second floor level, blocked after the insertion of the later chimney.

Plate 6 External, looking west, 1m scale

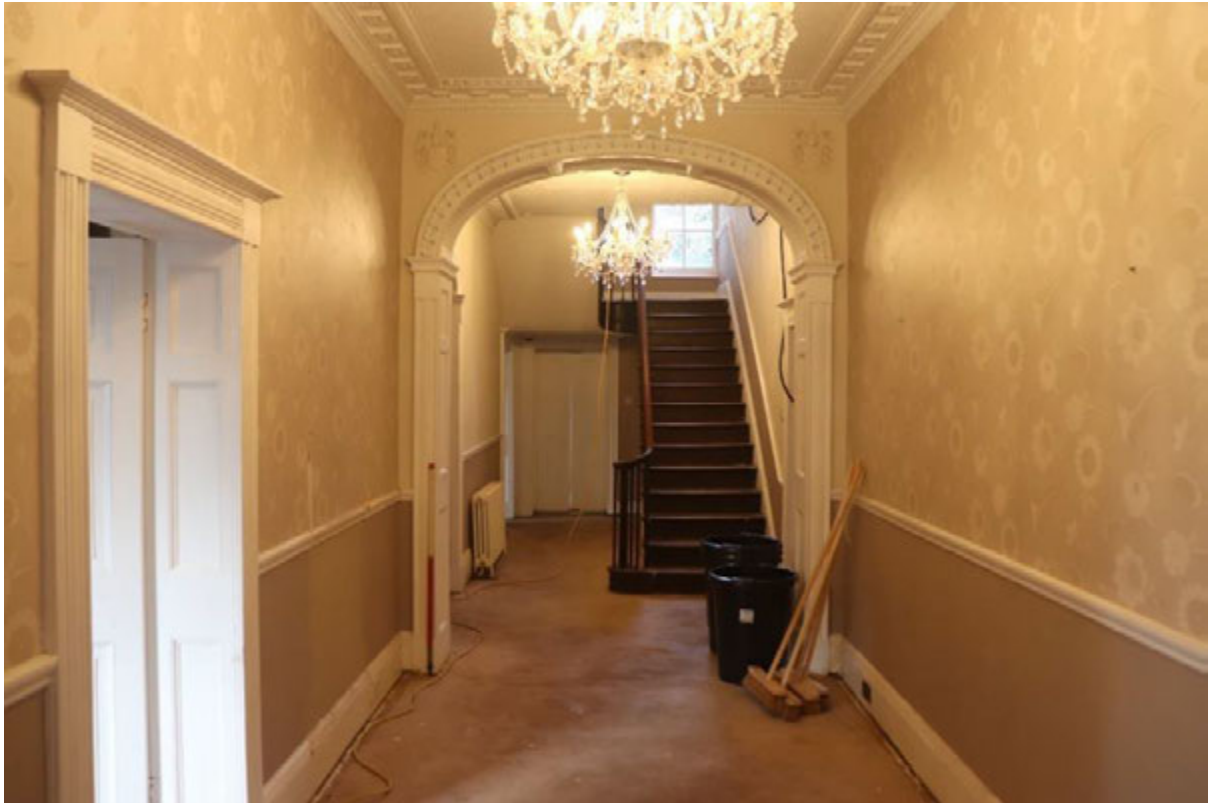
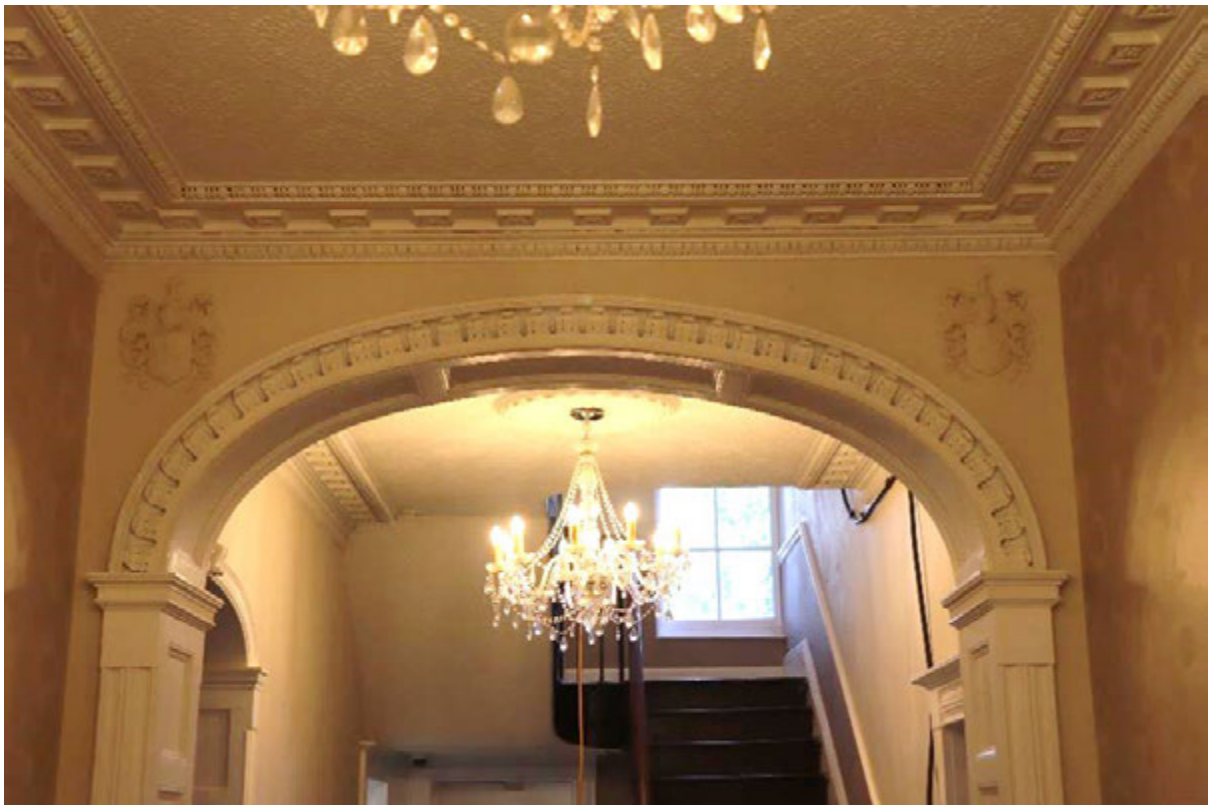
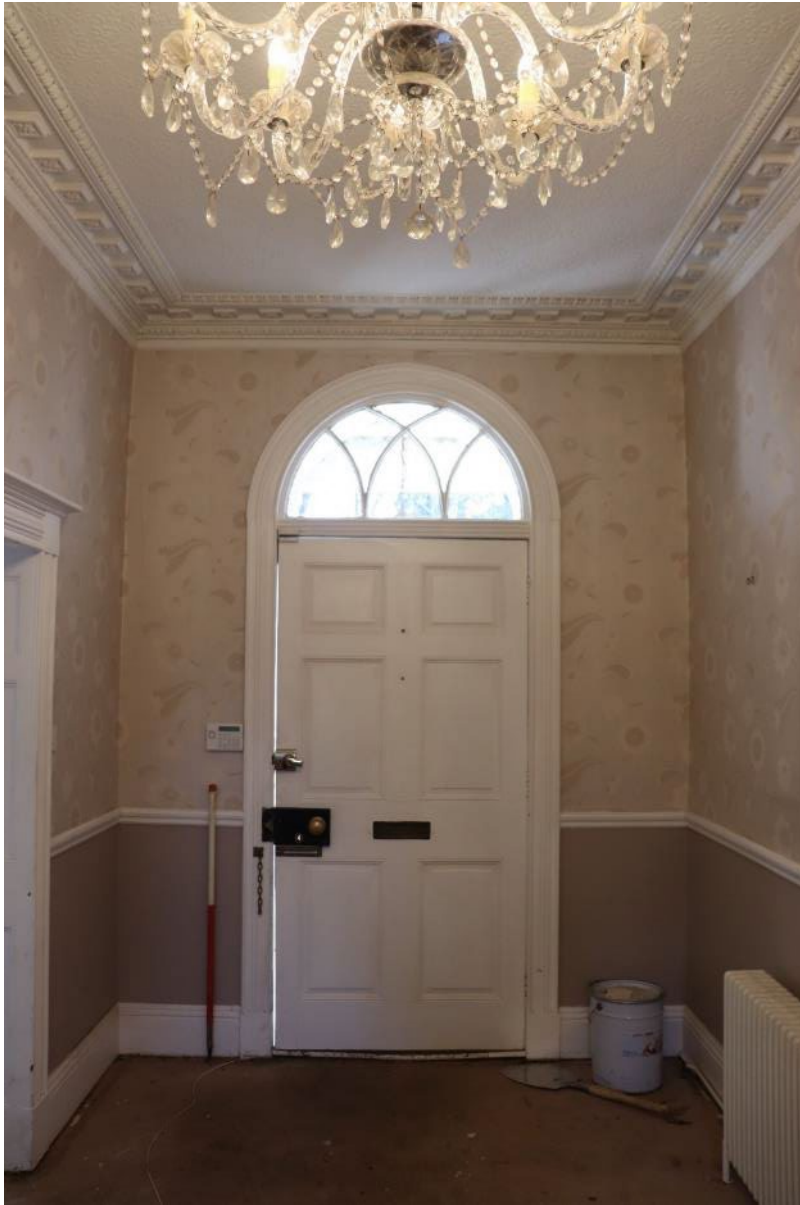
At **ground floor** level, corridor G1 (Plate 7 to Plate 9) contains a significant amount of original detailing such as coving, a survival rate replicated through much of the building. This cruciform corridor leads into G9 to the south (Plate 10 and Plate 11) and the staircase to first floor and basement to the north as would have been used primarily by service members of the household (Plate 12 and Plate 13). To the west is the main staircase leading to the first floor (Plate 14 and Plate 15).

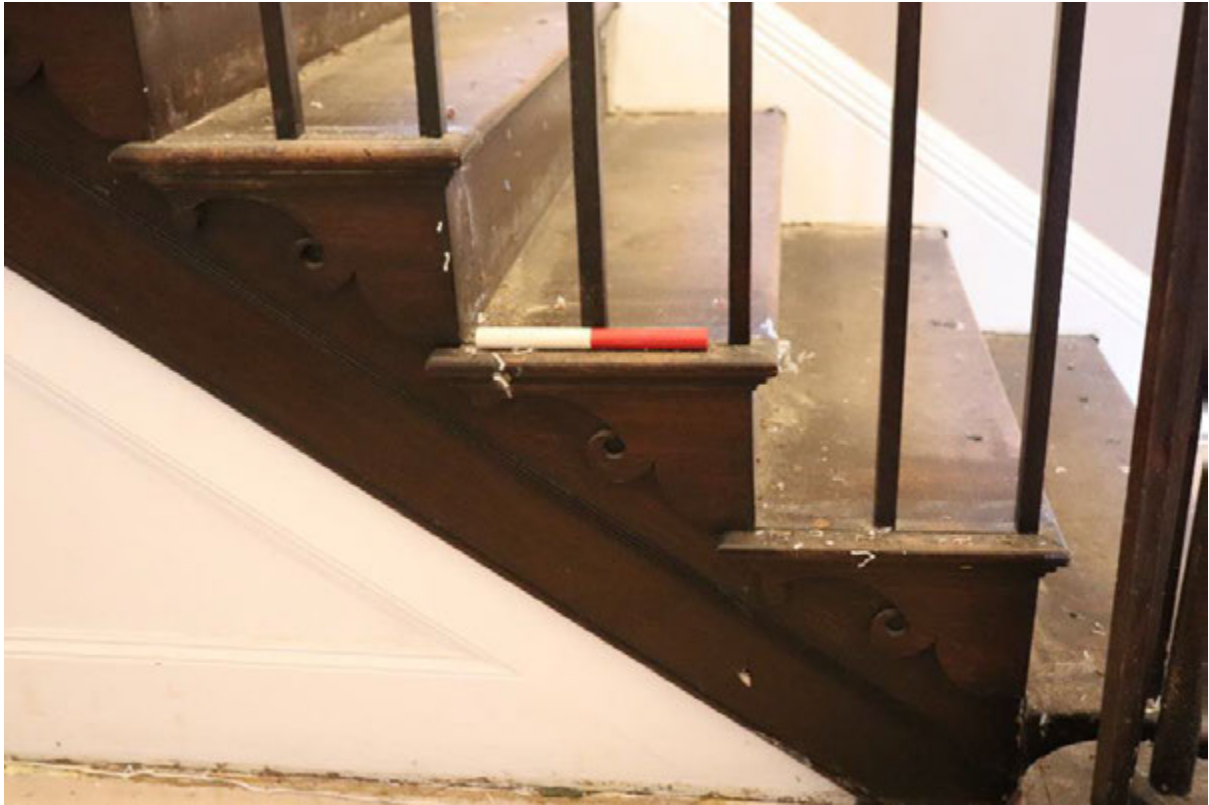
Plate 15 Room G1, looking north, 0.2m scale

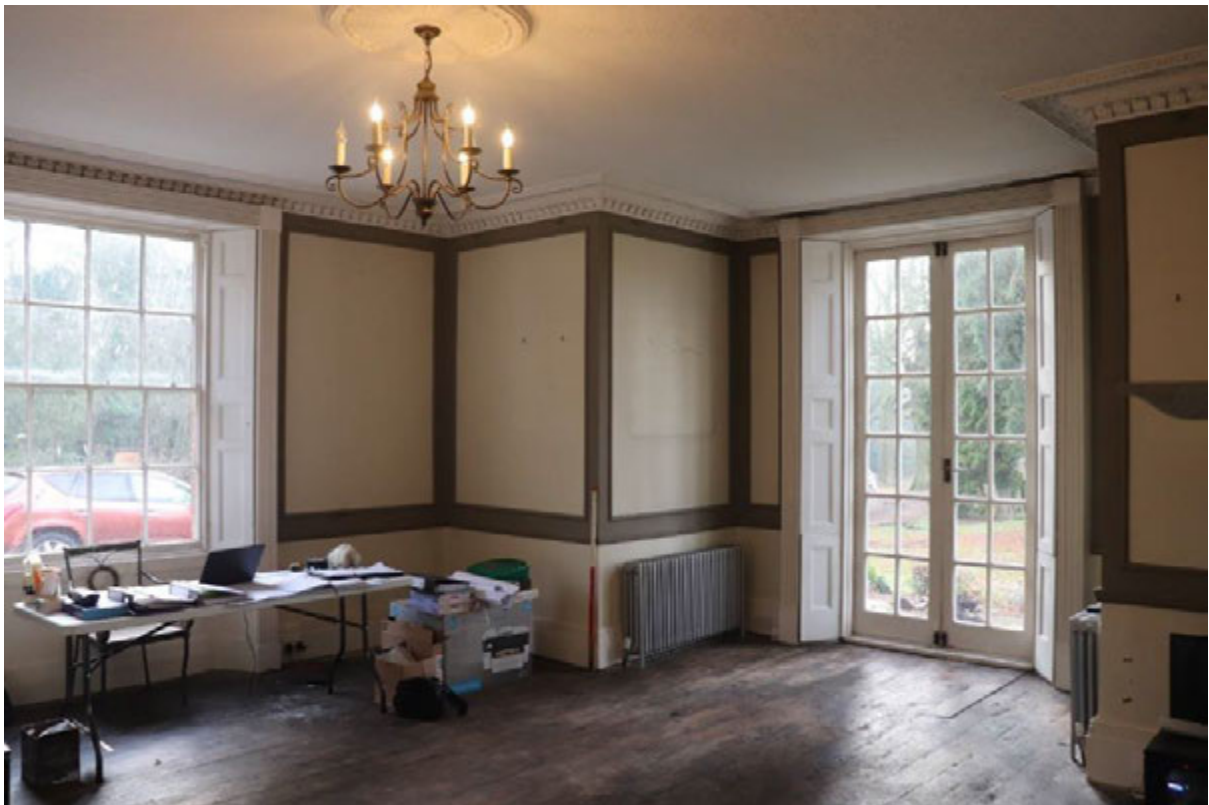
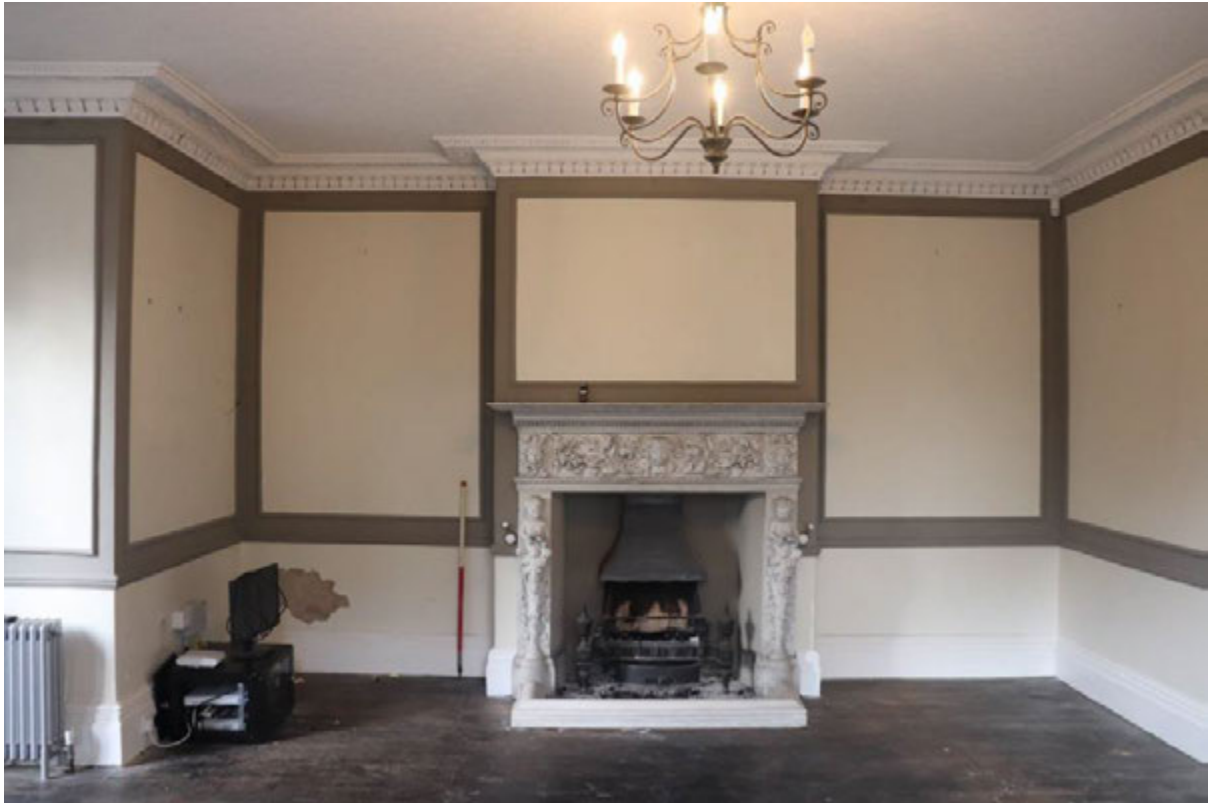
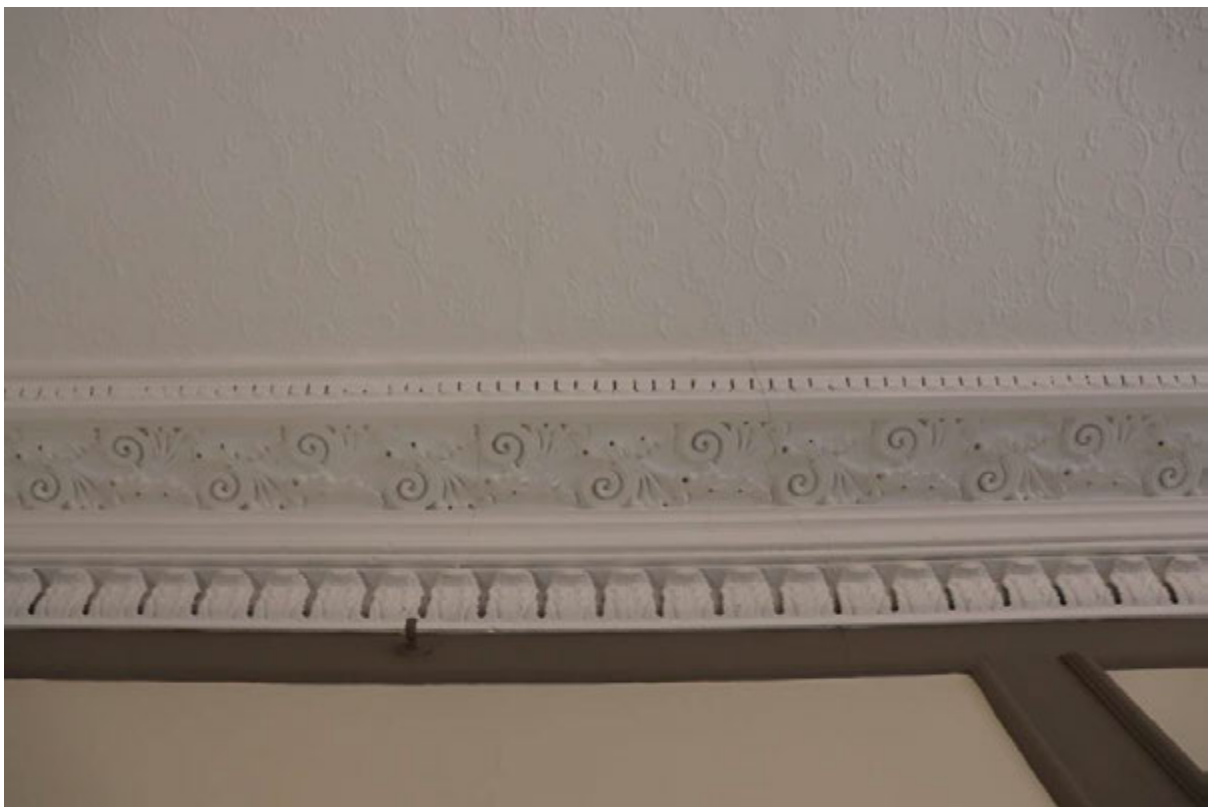
The main rooms of the ground floor, and all other floors, are split around the cruciform central corridor. Rooms G2 (Plate 16 to Plate 18) and G8 (Plate 19 to Plate 22) are the largest rooms with a highest level of detailing, though it is possible that the architrave details are Phase 2, as they continue through the bay window of that phase. These form the main living rooms of the house, with G8 likely to have been a dining room. Room G3 (Plate 25 to Plate 27) is plainer in its detailing, with simpler moulded architraves, suggesting a slightly more intimate function for the household than the more

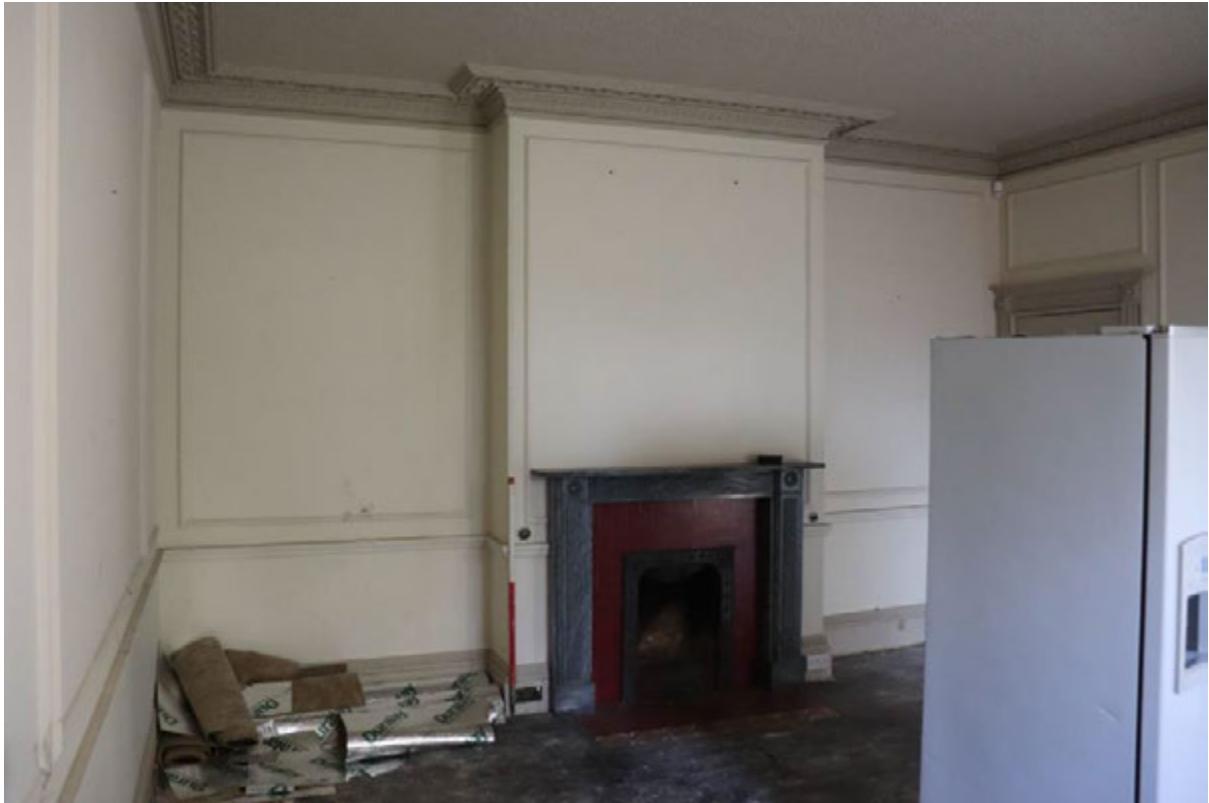
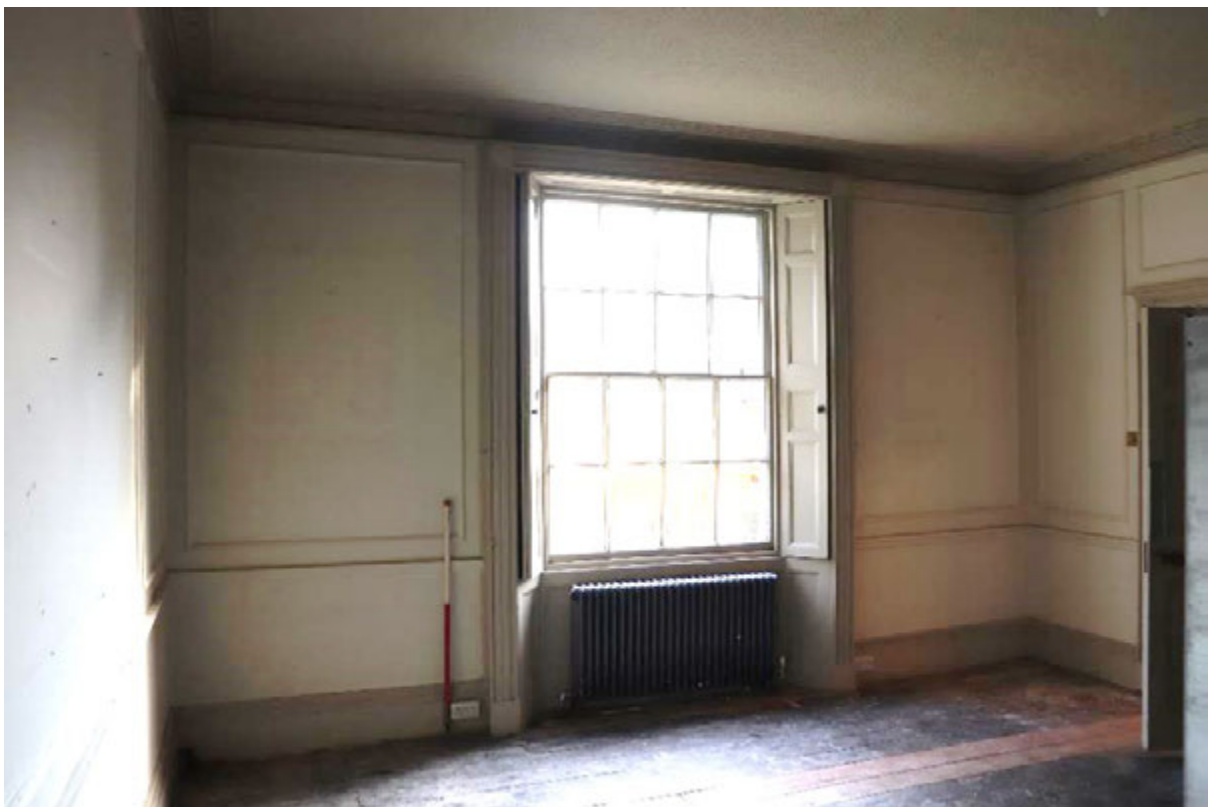
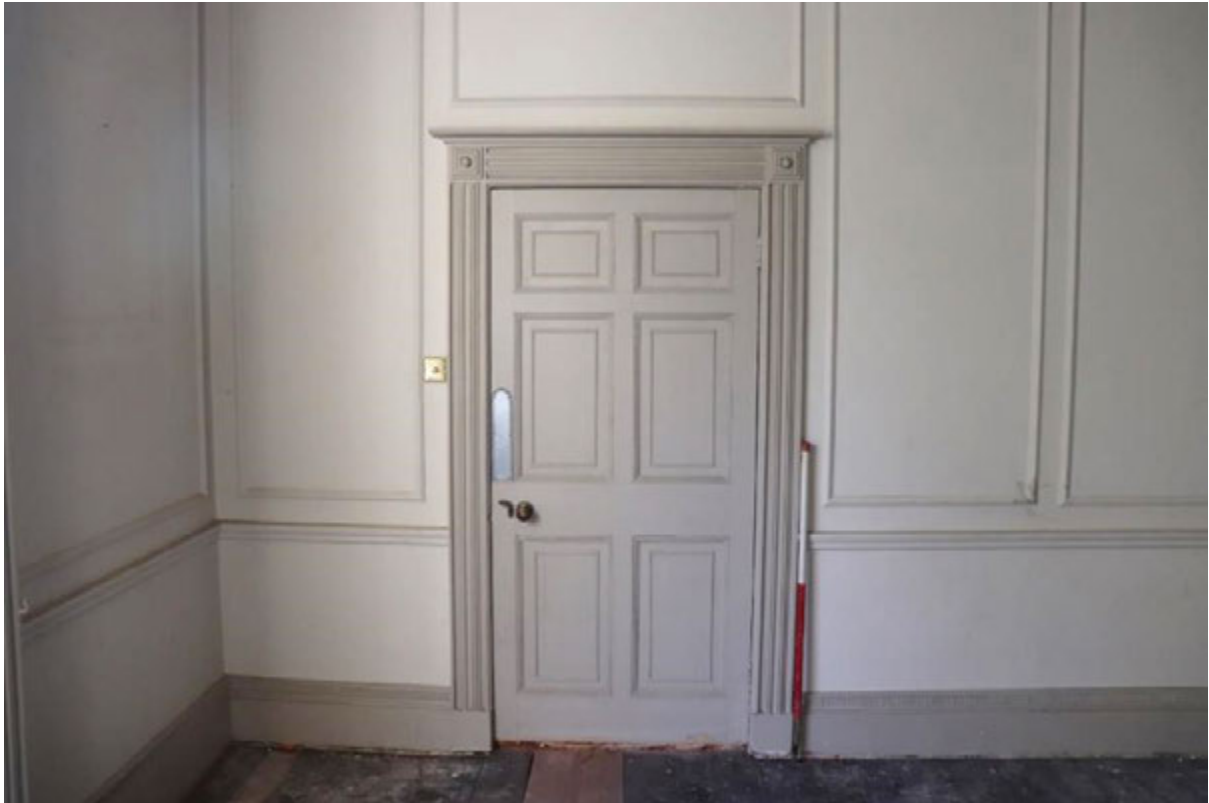
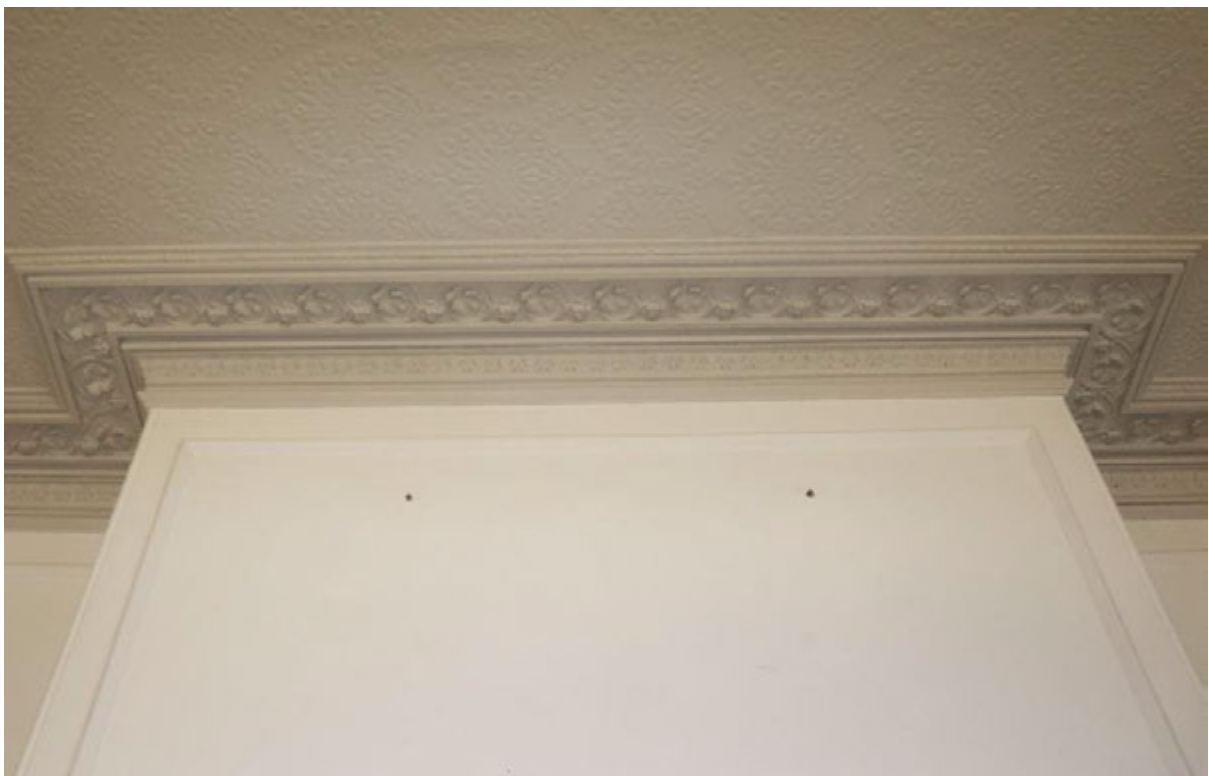
decorative reception rooms G2 and G8. Part of the central corridor is partitioned off to form room G9 with a stud wall, whether this was an original wall or slightly later addition it was not possible to ascertain. Room G4 (Plate 23 and Plate 24) retains minimal original detailing, and possibly never had any as an original function as a kitchen is likely. This interpretation is supported by its wide fireplace and position in the north-west of the building associated with the service staircase.

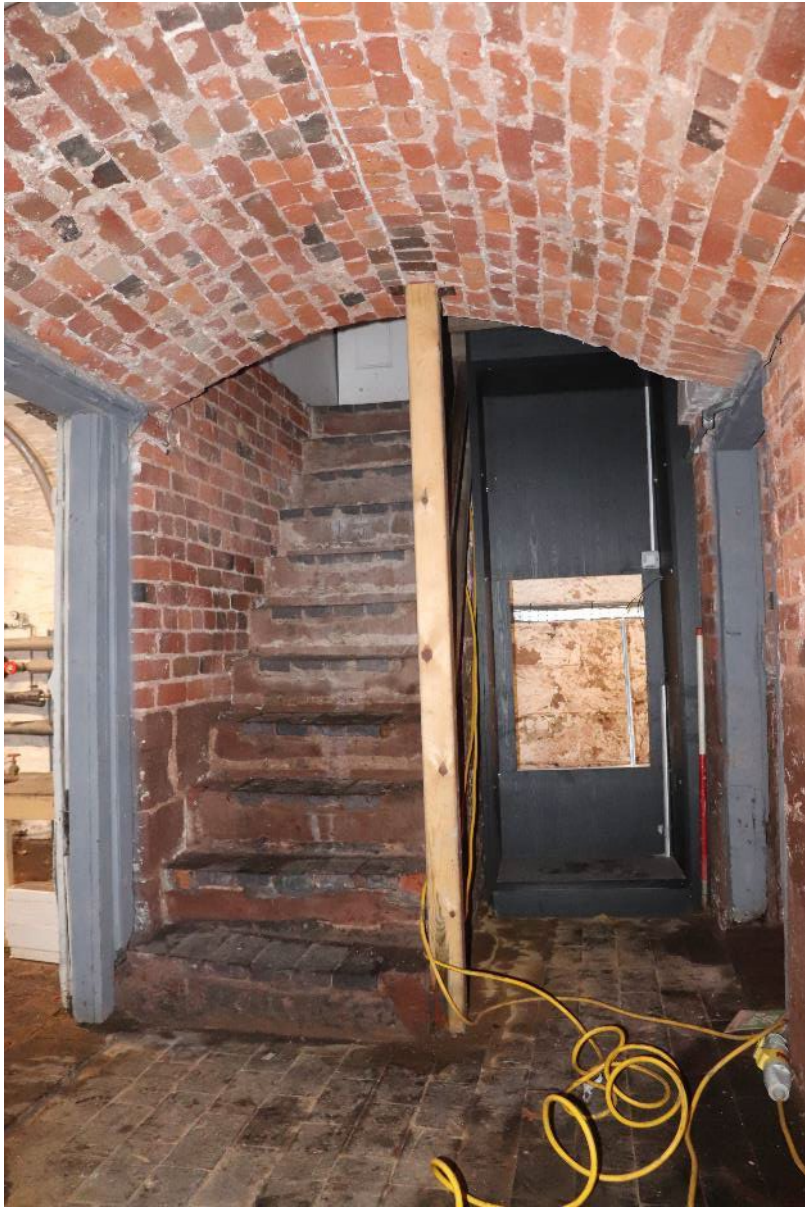
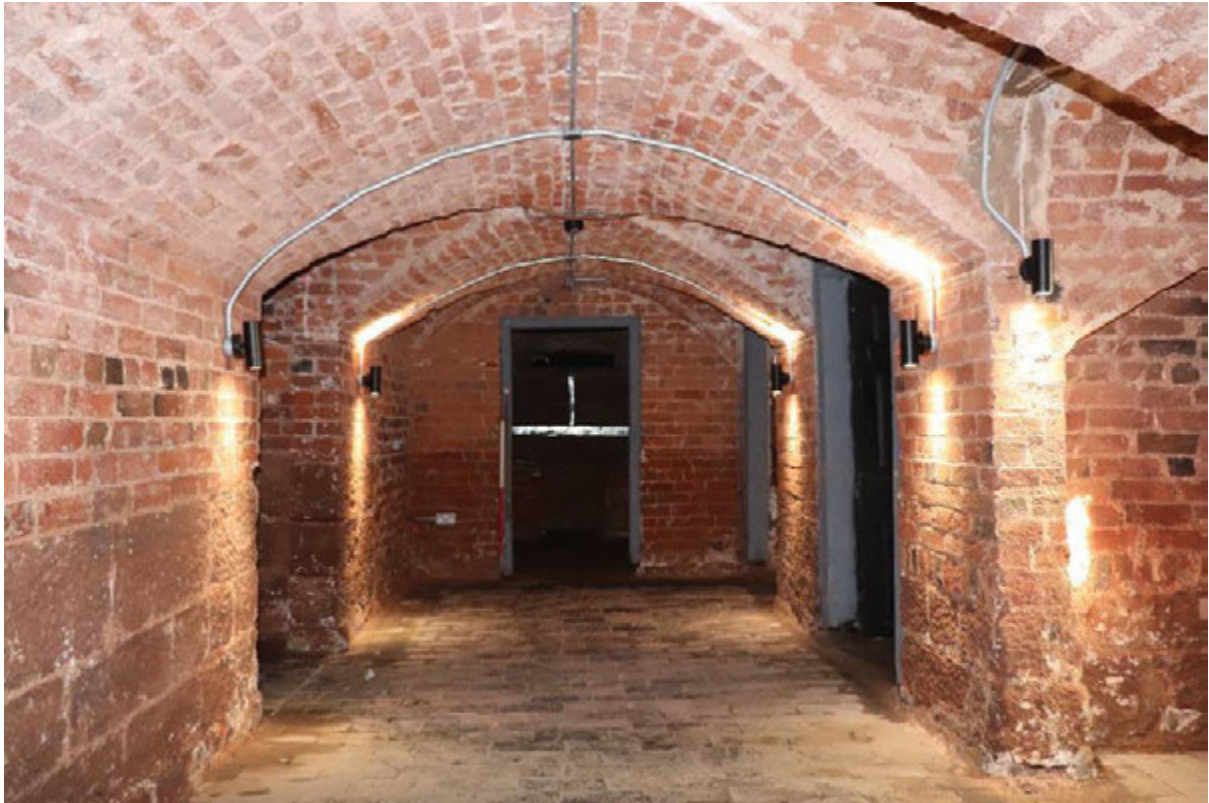
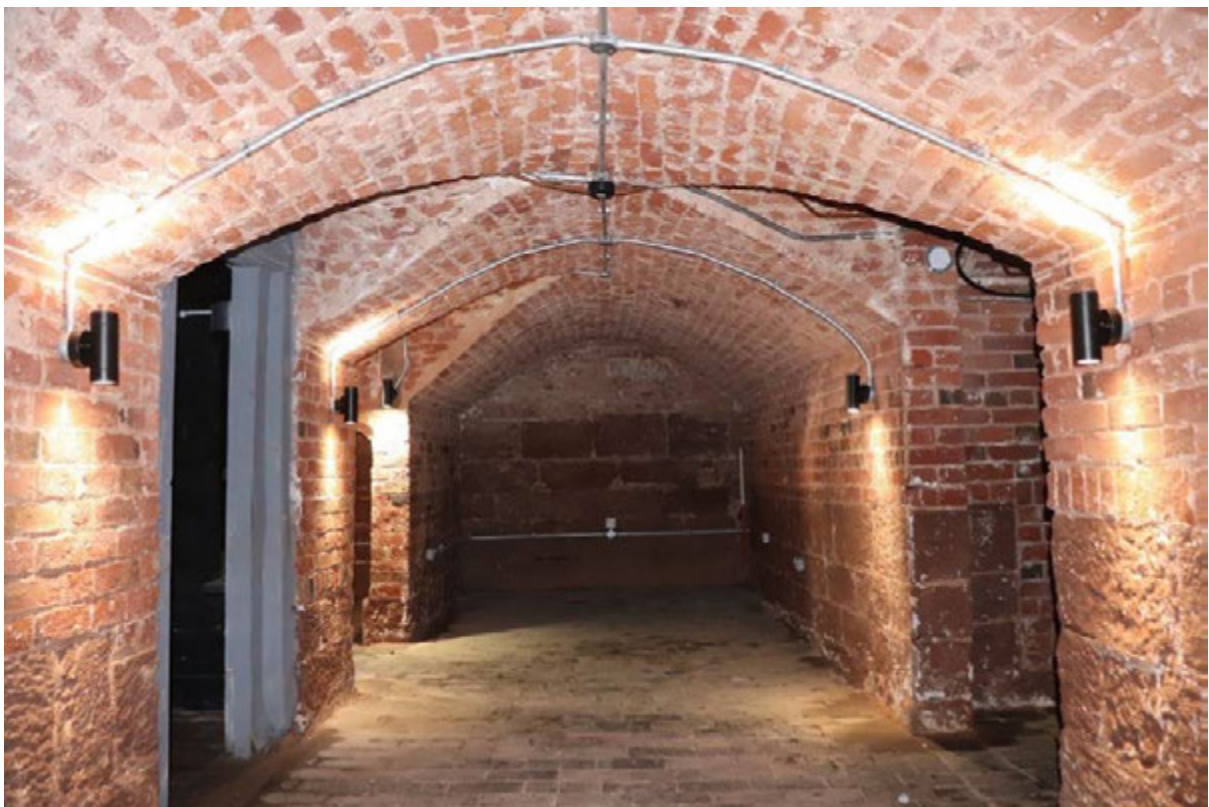
The service stairs lead down into the **basement** and corridor B2 (Plate 28 to Plate 30), which originally ran through room B7 (Plate 31). Behind the staircase is a probable small rectangular former well (Plate 32). Room B (Plate 33 and Plate 34) probably also contained a fireplace with a service function such as a washroom, also with a blocked window on the western wall. No other fireplaces remain in rooms B1 (Plate 35 and Plate 36), B6 (Plate 37 and Plate 38), B4 (Plate 39 and Plate 40), B5 (Plate 41) and it is likely that these were used for varying forms of cold storage and lit by windows from the east and west respectively. Room B4 is also accessed by an external door in its southern side, though it is possible that this was a secondary insertion. Room B1 has a blocking of a scale indicative of a door in its external northern wall.
