**Building recording at
Goldness House,
Torton,
Worcestershire**
Worcestershire Archaeology
for RPS Consulting

GOLDNESS HOUSE, TORTON, WORCESTERSHIRE

Building recording report

Building recording at Goldness House, Torton, Worcestershire

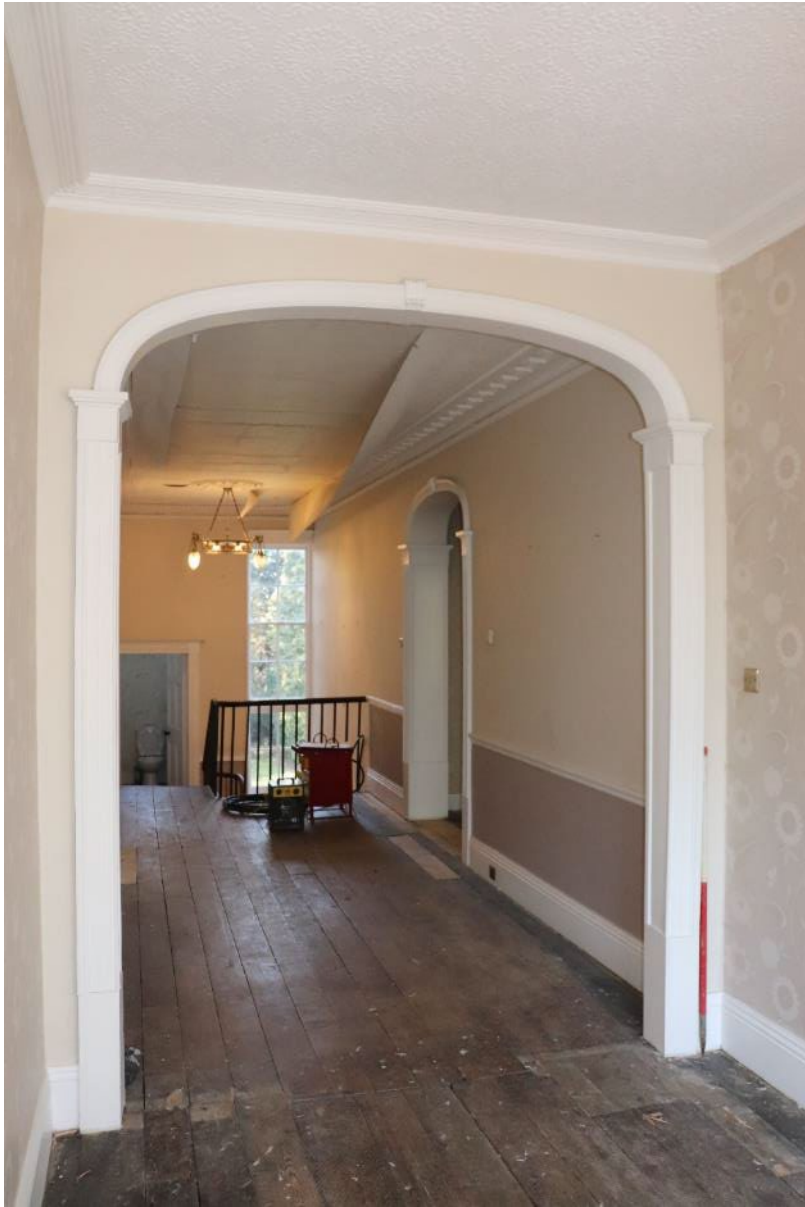
Plate 42 Room F1, looking west, 1m scale

On the **first floor**, which is accessed from both the main staircase and the service staircase, the building repeats its cruciform central corridor F1. This again contains original detail, albeit simpler than on the ground floor (Plate 42 to Plate 45). As on the floor below, room F6 (Plate 46 to Plate 47) and F5 (Plate 48 and Plate 49) form the main bedroom spaces, with F6 leading into F7 (Plate 50). This latter most likely formed a dressing room or boudoir originally. Rooms F2 (Plate 51 and Plate 52) and F8 (Plate 53) were smaller but like F5 and F6 are heated by fireplaces so again were probably bedrooms.

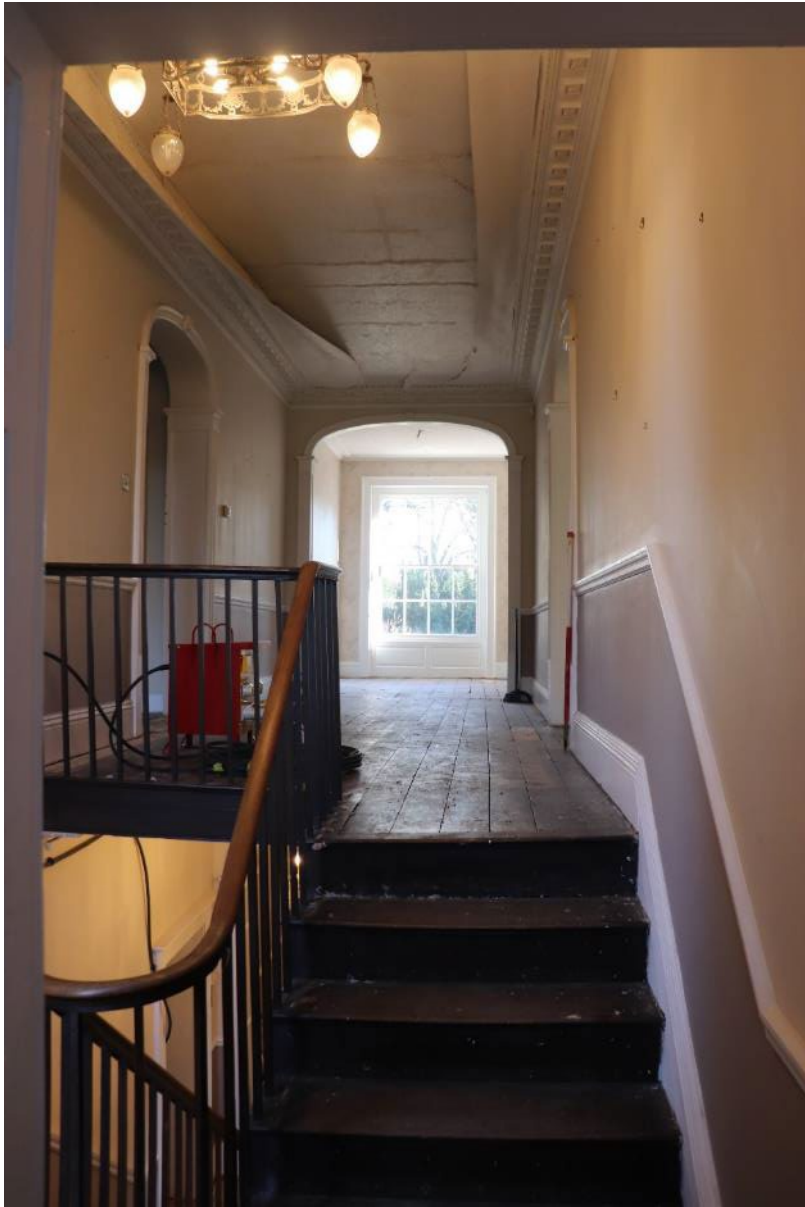
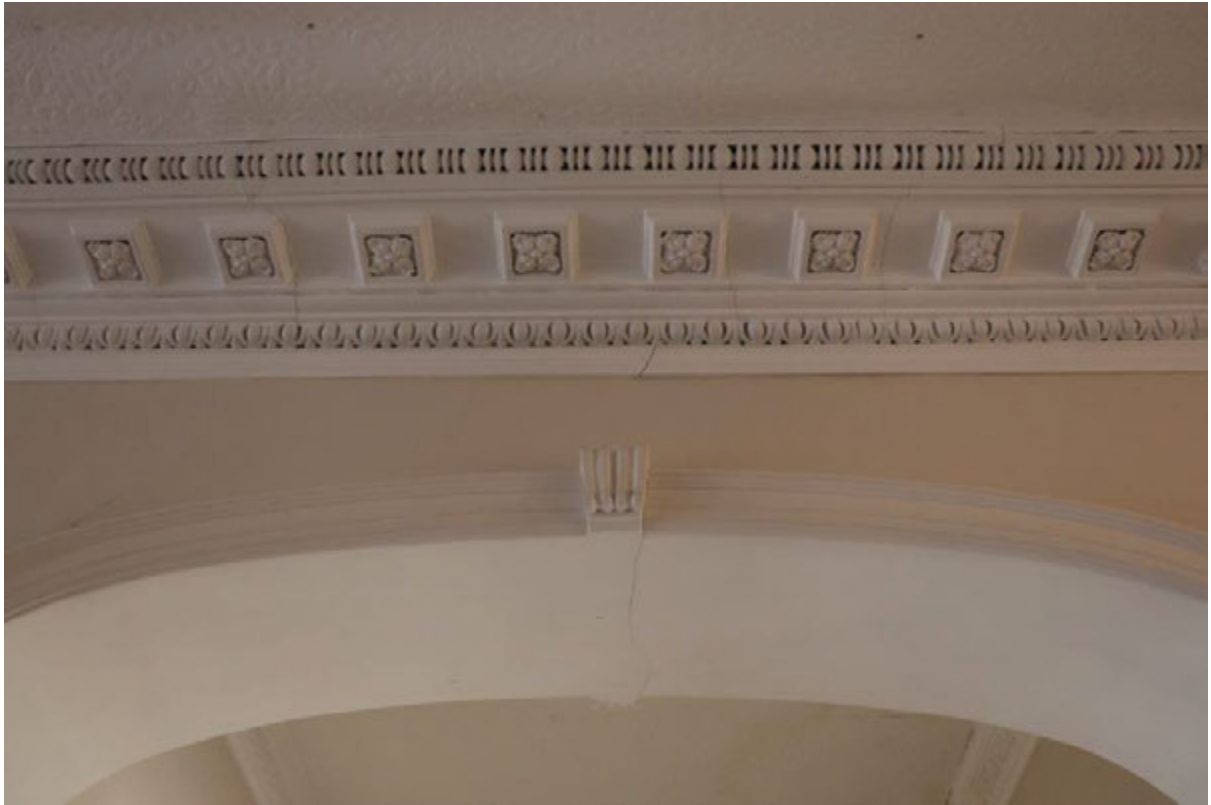
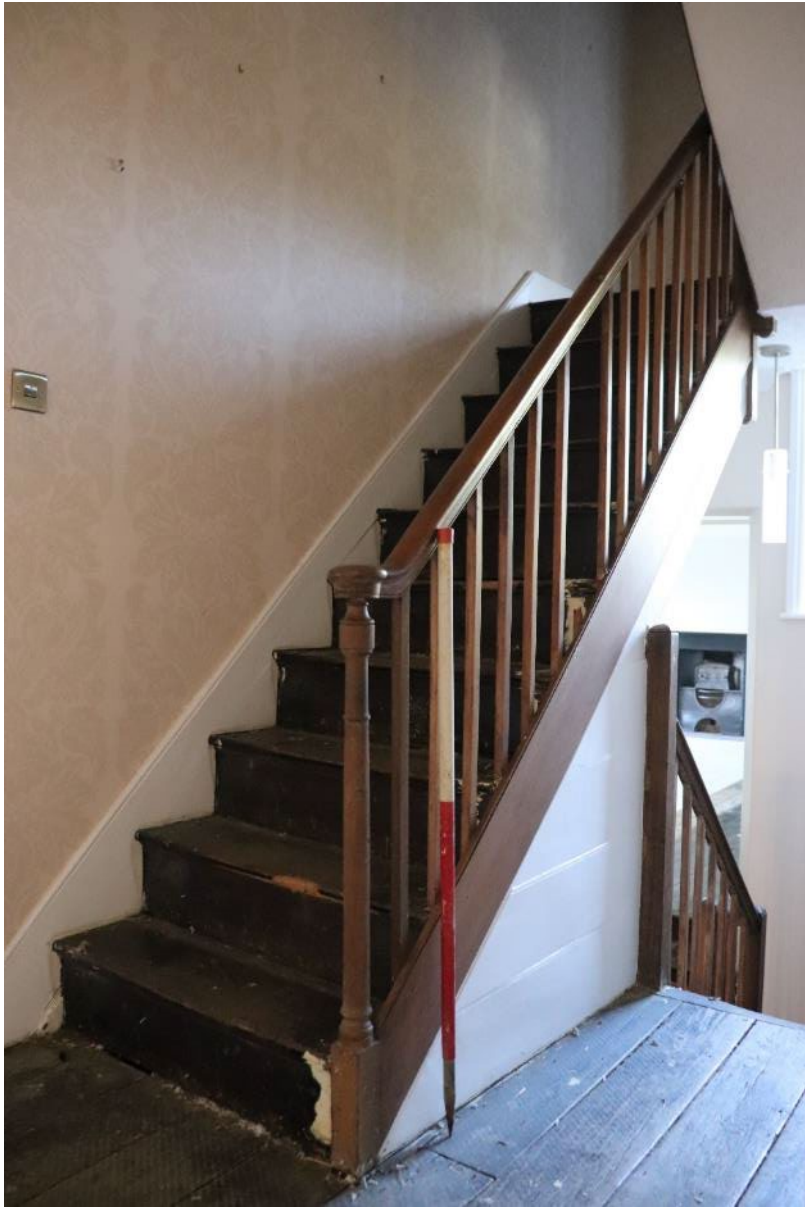
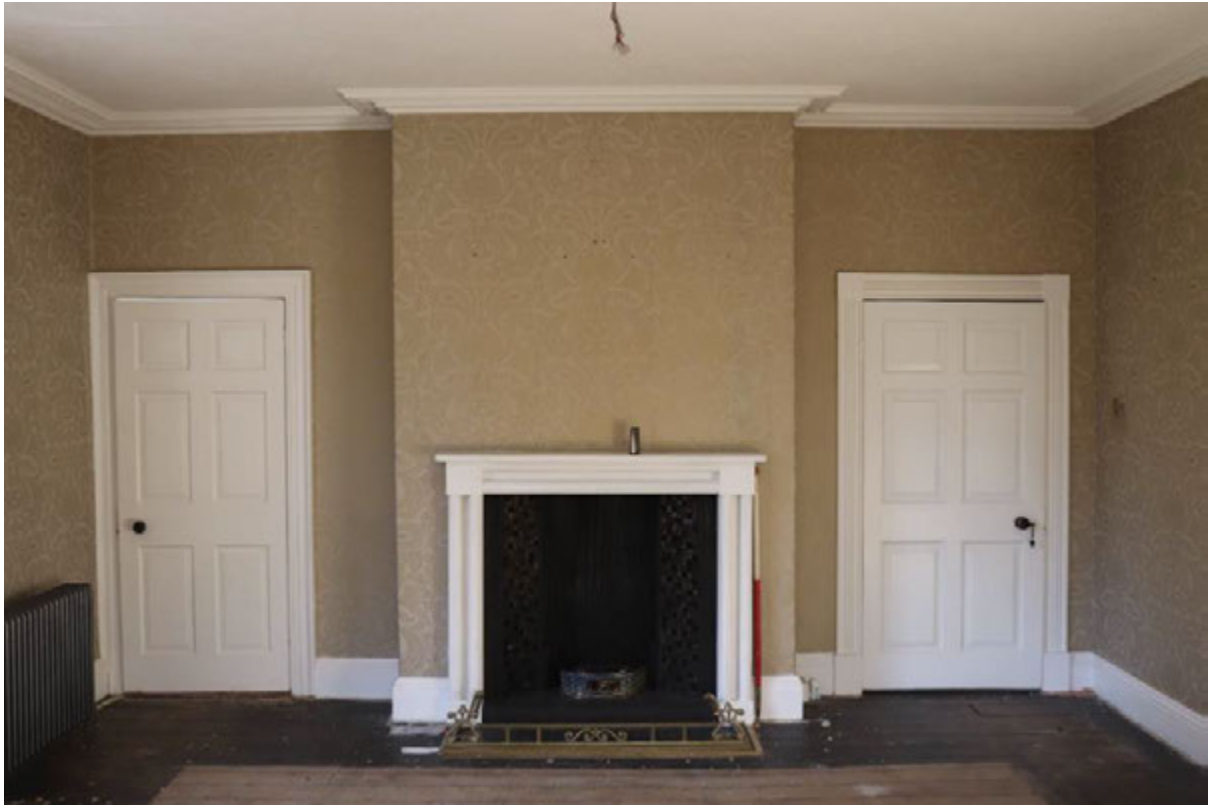
Plate 43 Room F1, looking east, 1m scale

Plate 44 Room F1, looking east

Plate 45 Room F1, looking north-west, 1m scale

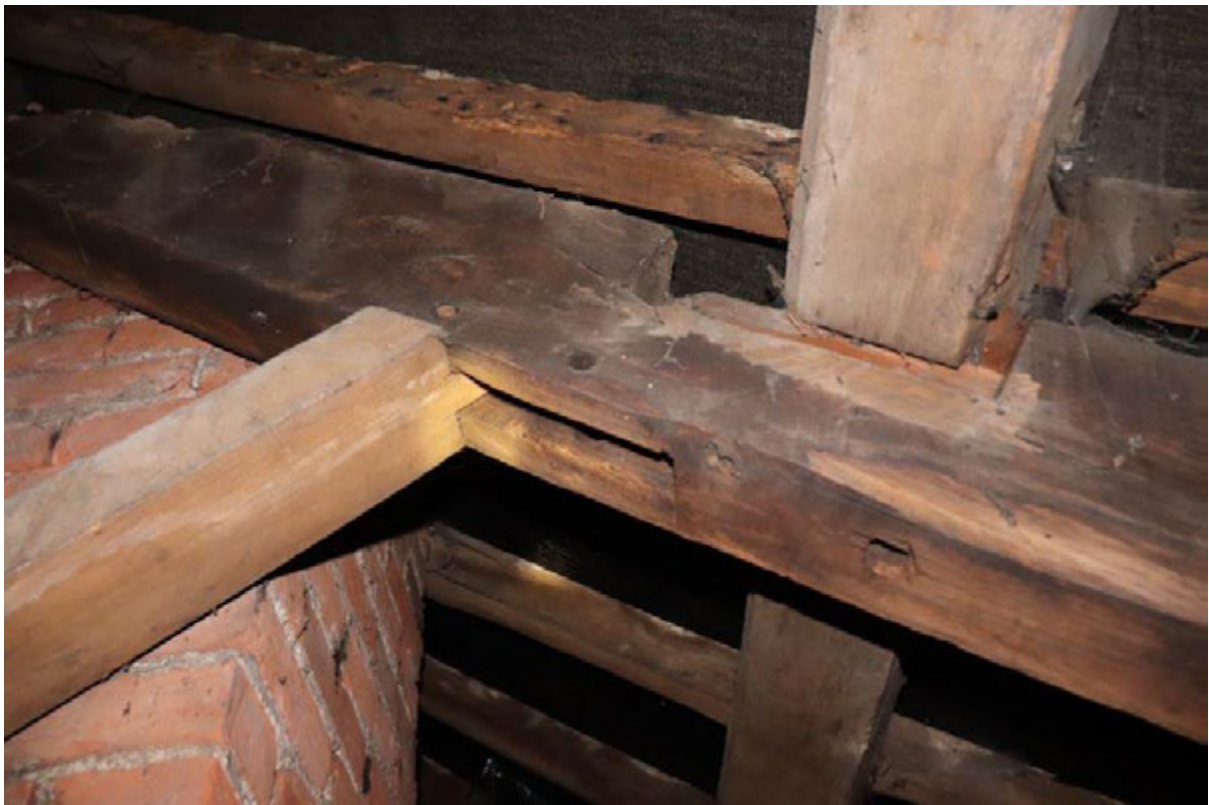
Plate 67 Roof space above Room S1, looking north-east

In terms of broad structure and material, the brick is of Flemish bond coursing with ruled jointed lime mortar. Rubbed bricks have been used for lintels and, where visible, the structural timbers are of oak. These are noticeable in the roof space, where the King post trusses can be seen (Plate 66 and Plate 67). Noticeable within these is the extent of reused timber, with empty mortices at many points, as well as wattle stave holes and more. Further reused timber can also be seen in the door structures of the basement (Plate 68). The staircases are largely of oak, though the original floorboards where visible are of elm (Plate 69).

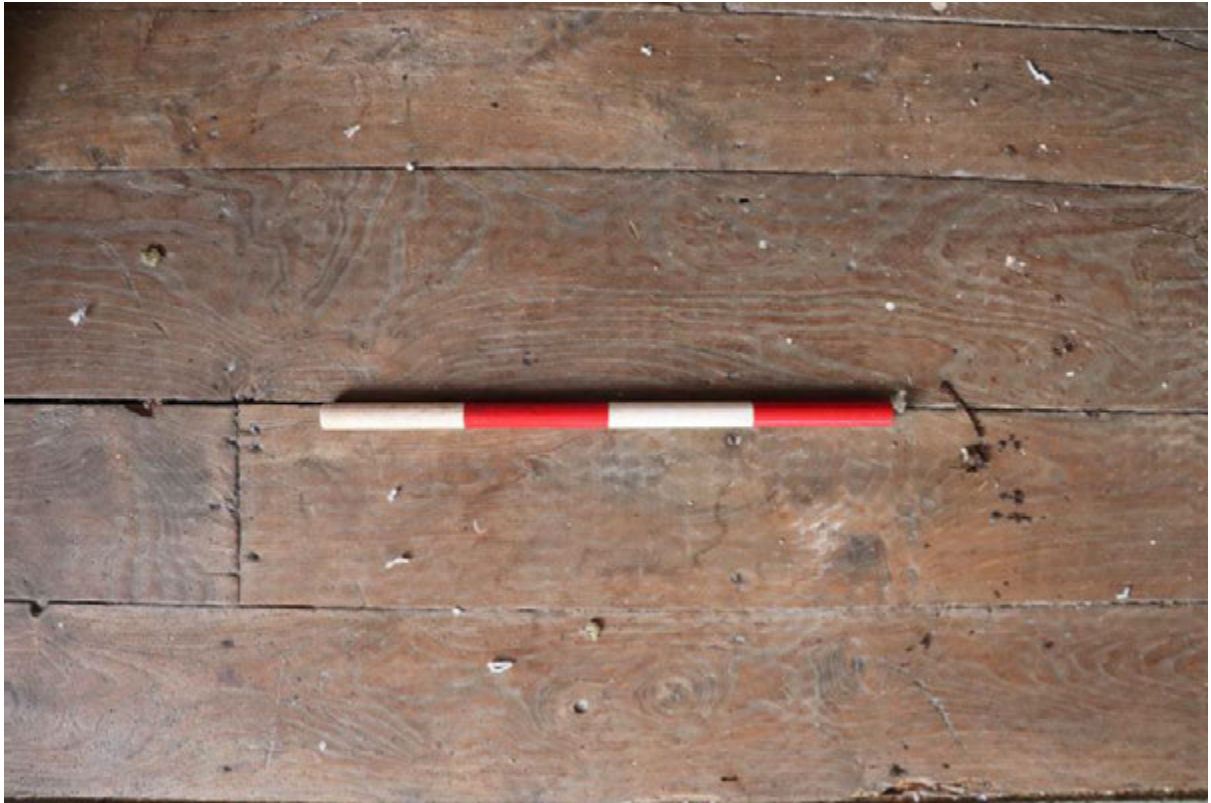
Plate 69 Elm floor boards room S4, 0.4m scale

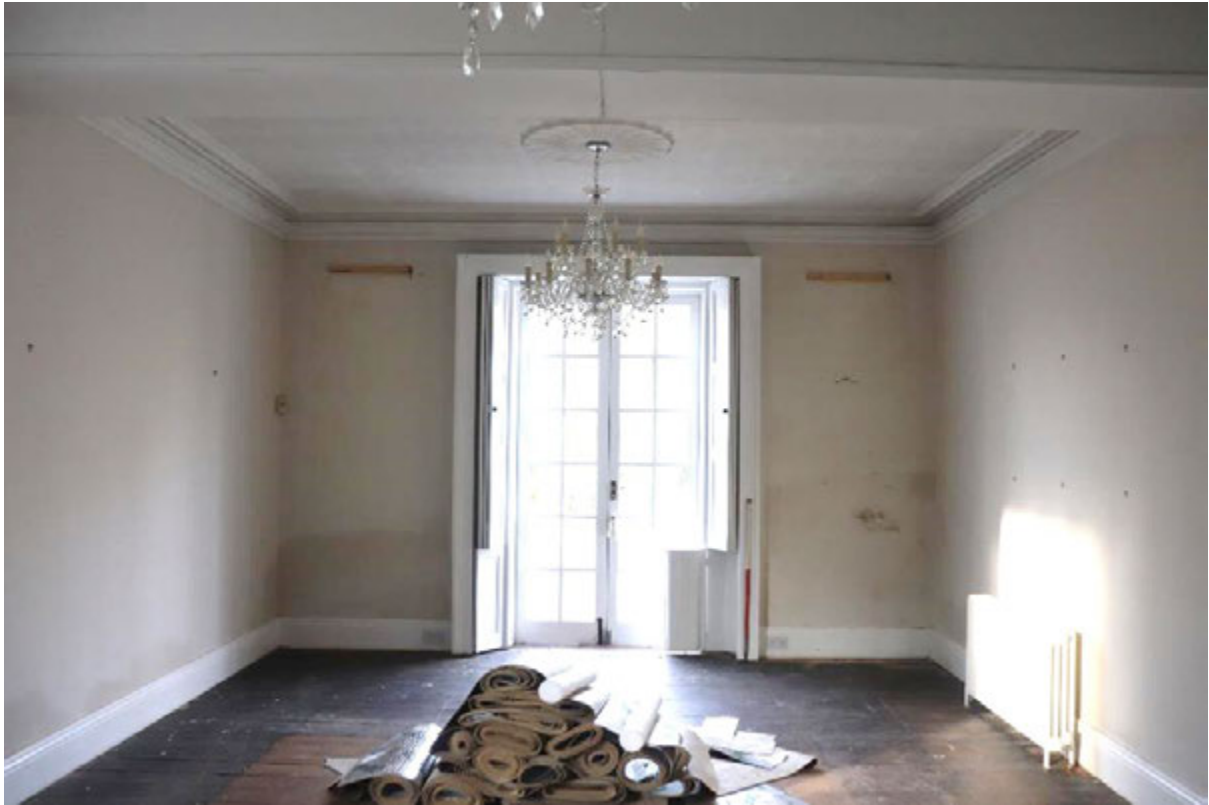
Plate 71 Room G3, looking west, 1m scale

This phase consists largely of two elements, a flat roofed entrance porch added to the south side of room G2 (Plate 2 and Plate 70) and a single pitch slate roof extension to room G3 (Plate 3 and Plate 71), though this was originally a separate room, combined into a single room later on. Broadly, these additions retain the character of the Phase 1 building, using a Flemish bond, slate roof for the western extension and rubbed brick lintels. One variation is on the porch where sandstone string courses are present.

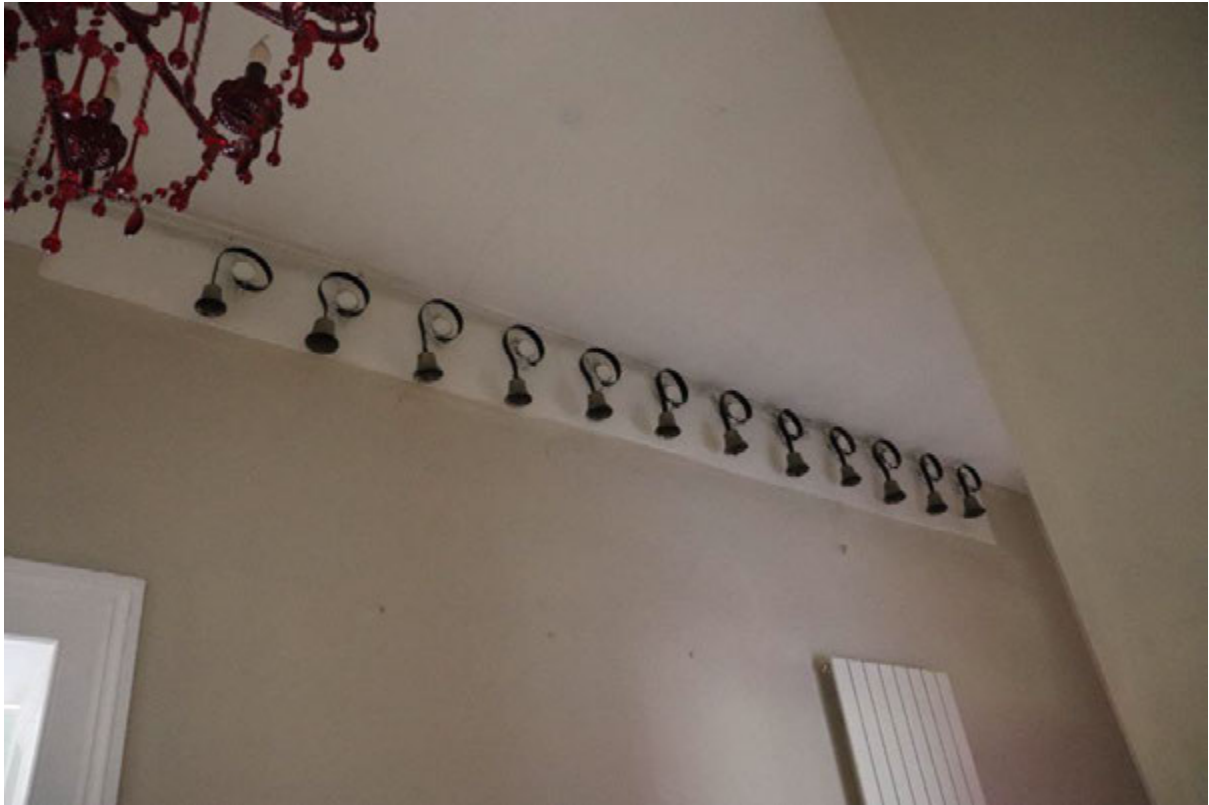
Plate 73 Room G10 service bells, looking north-west, 1m scale

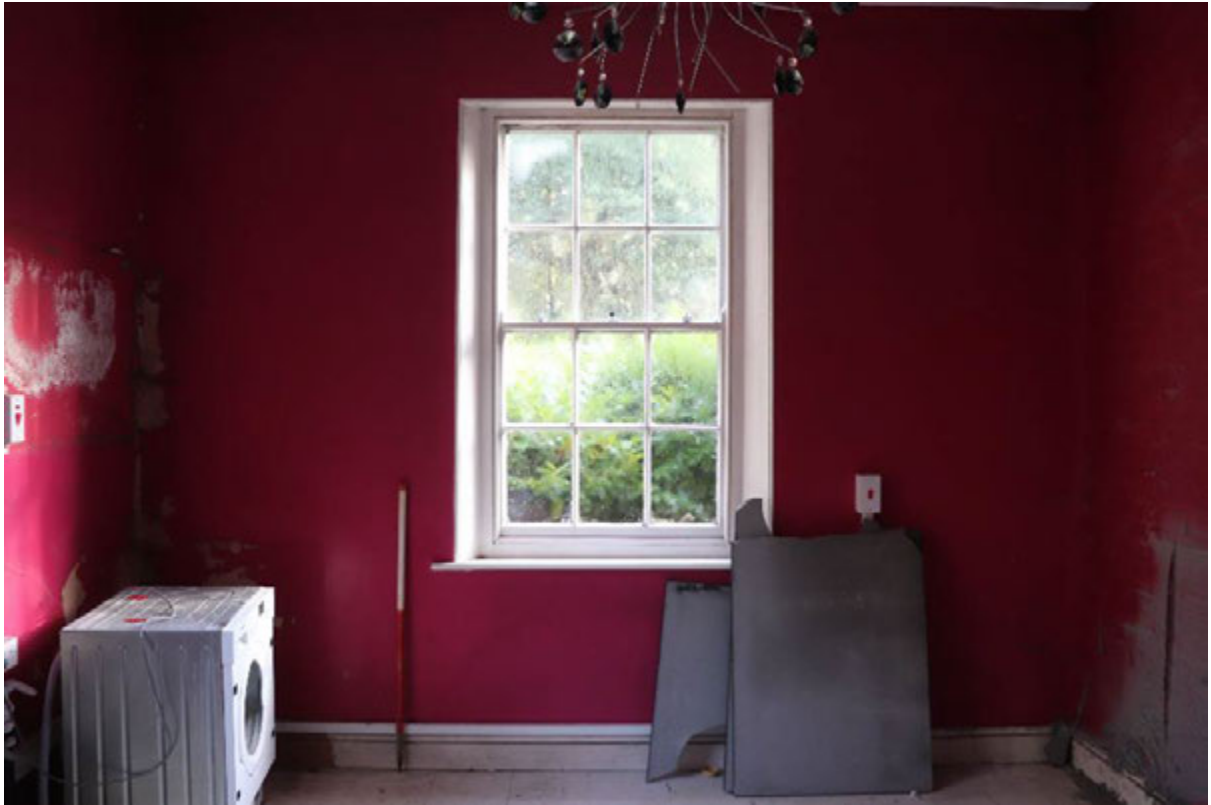
To the east of corridor G10, room G7 (Plate 78) has a former corner fireplace, with no known heating in room G6 (Plate 77). This lack of heating would suggest cold storage.

Plate 77 Room G6, looking east, 1m scale

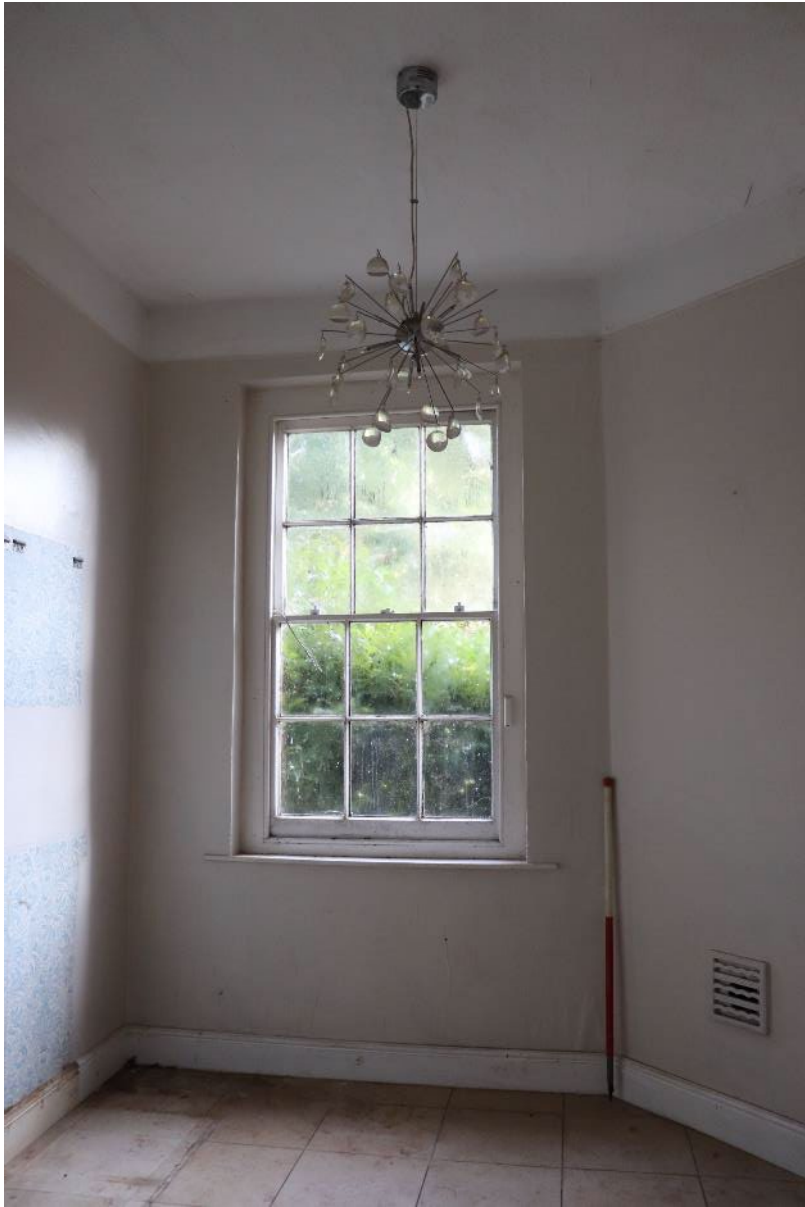
Plate 78 Room G7, looking east, 1m scale

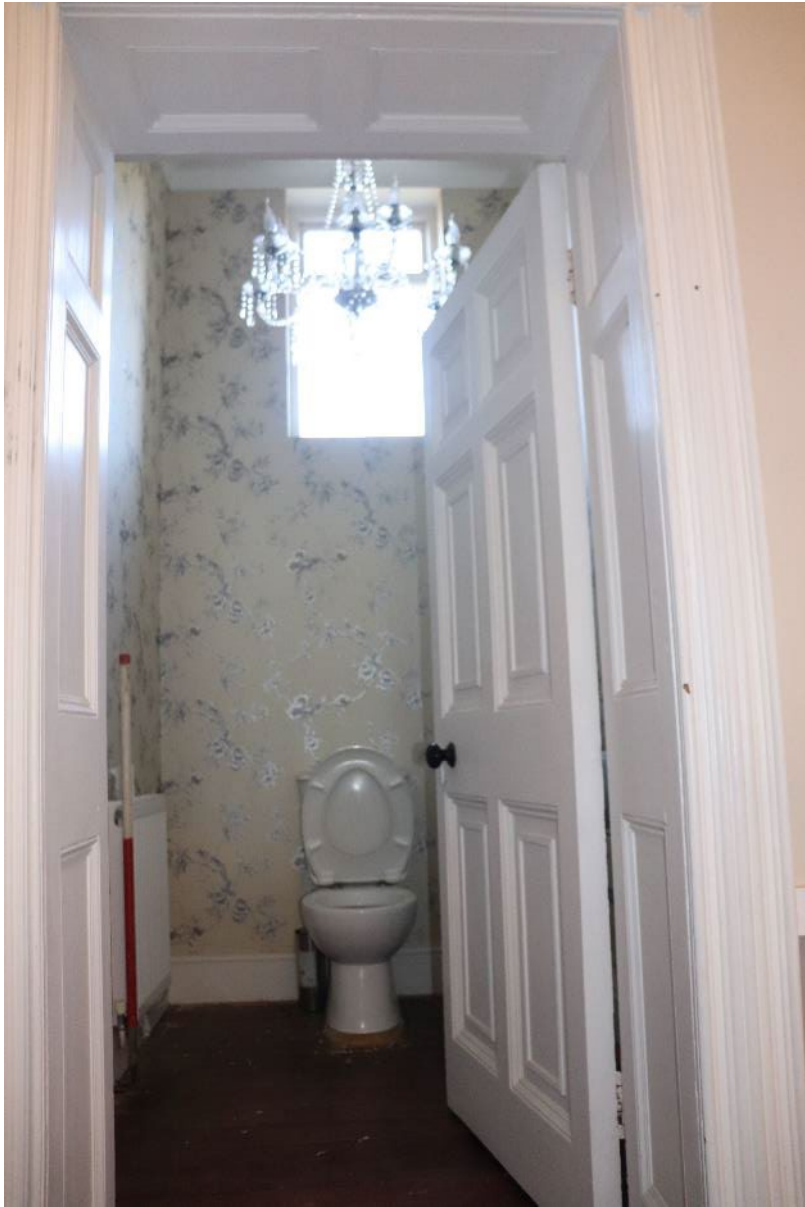
The only structural change was the addition of a small brick extension to the Phase 2a extension (Plate 5). This would have created a room on the ground floor originally though this was later removed. Two small rooms were created on the first and second floors, rooms F9 and S8 (Plate 79 and Plate 80).

Plate 79 Room F9, looking west, 1m scale

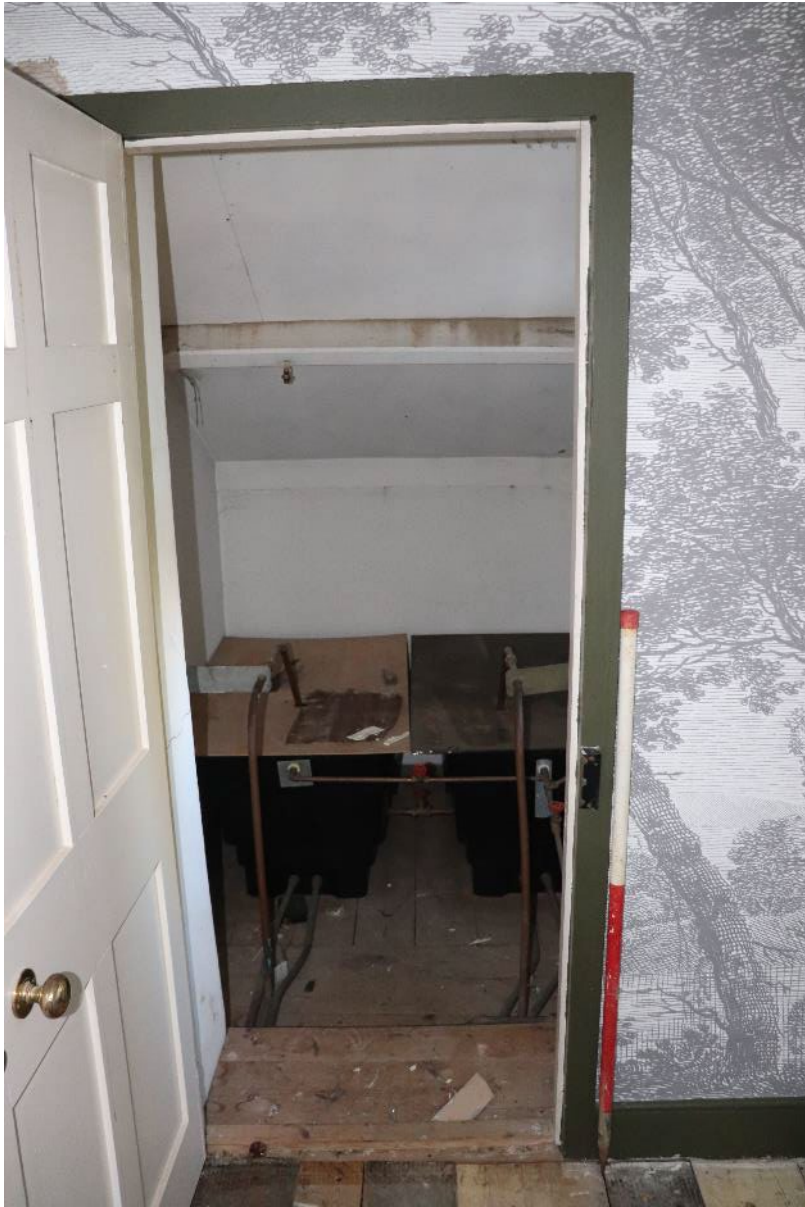
Plate 80 Room S8, looking west, 1m scale

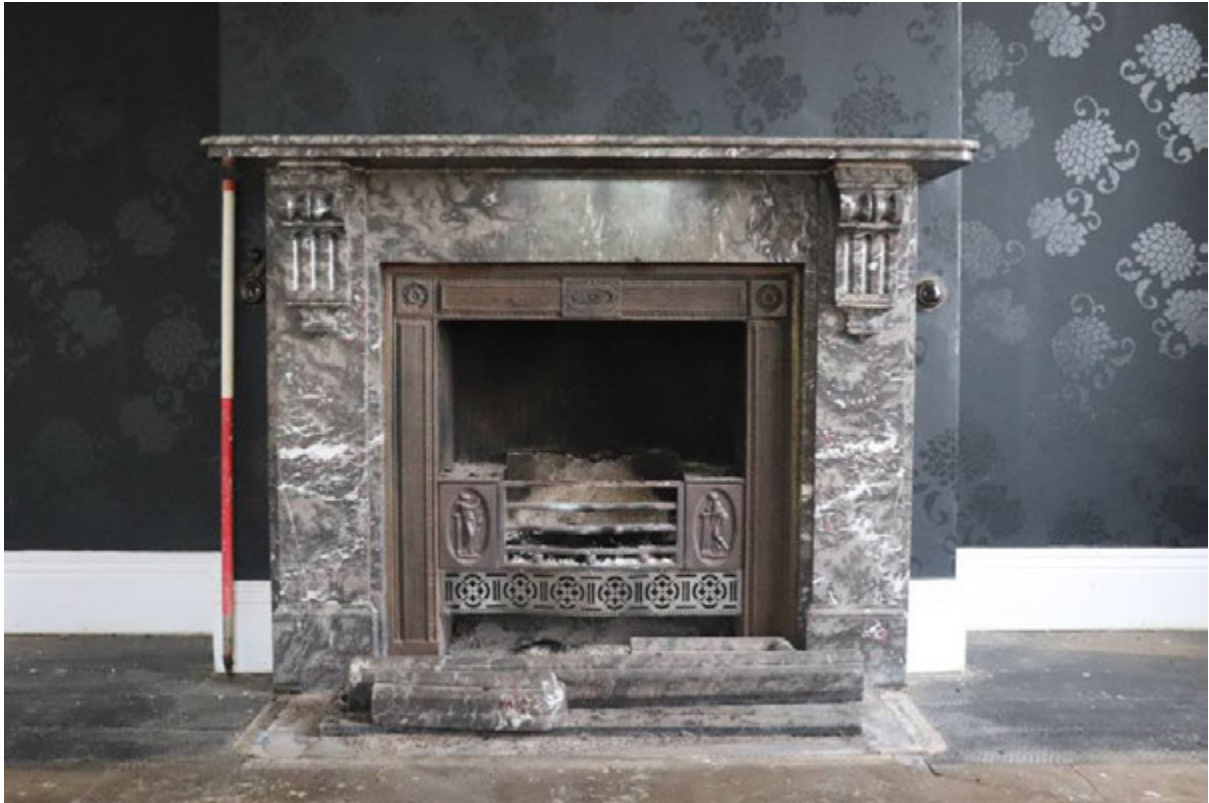
Plate 81 Room G3, looking east, 1m scale

None of the fireplace surrounds can be clearly assigned to Phase 1 or 2, with some of early 20th century character (Plate 81 to Plate 83). That in room G2 is an even later 20th century addition (Plate 84).

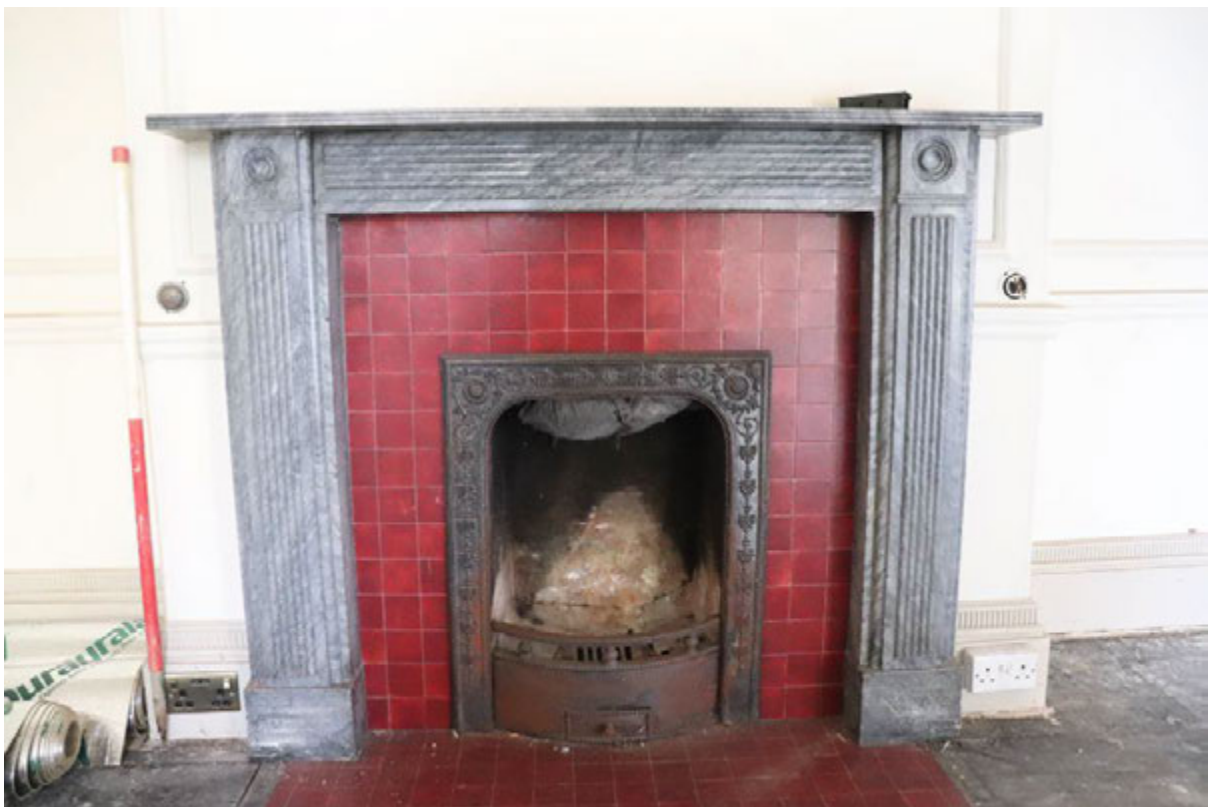
Plate 82 Room G8, looking west, 1m scale

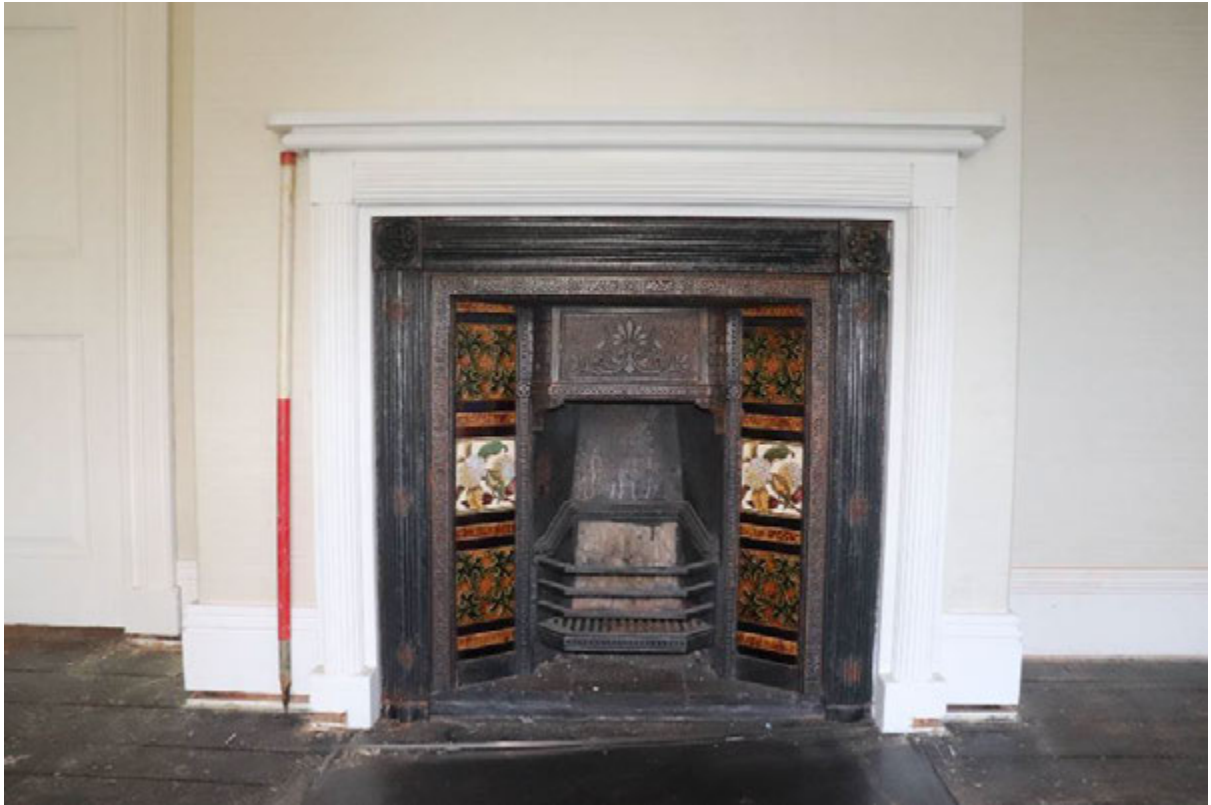
Plate 83 Room F5, looking west, 1m scale

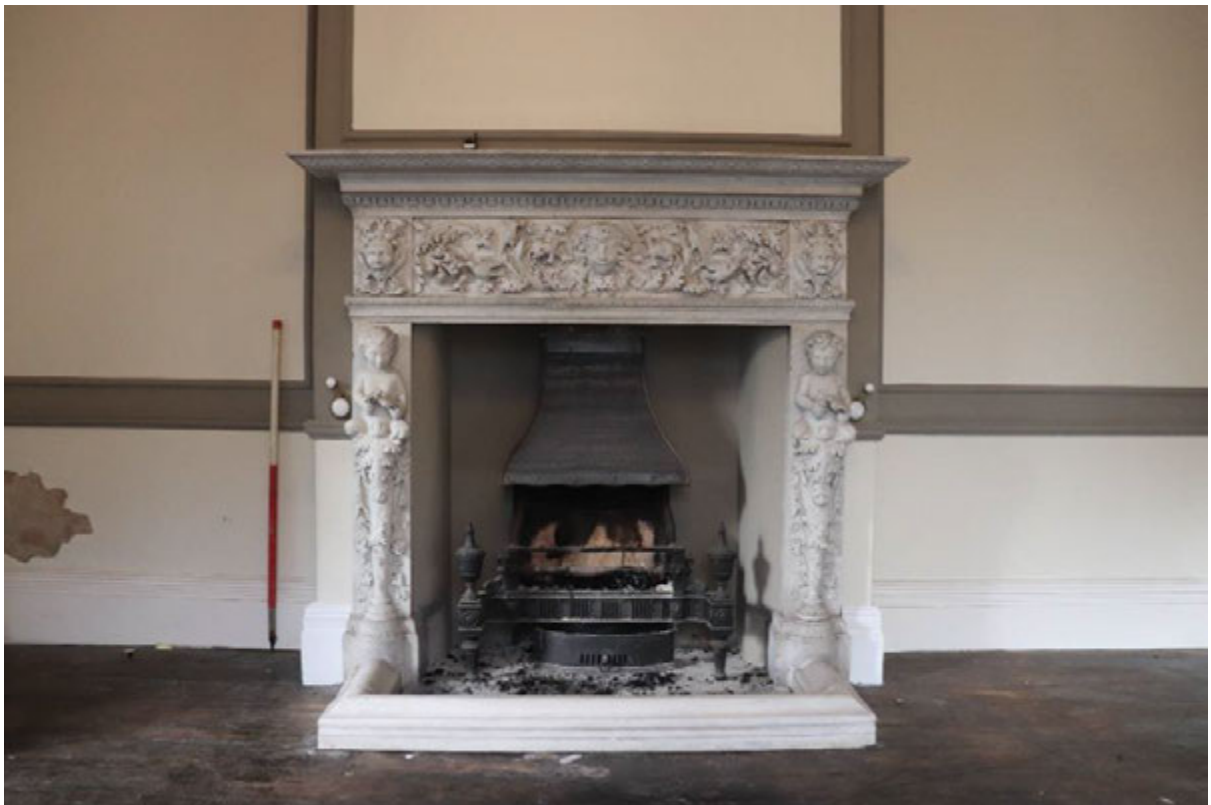
Plate 84 Room G2, looking west, 1m scale
