# ASSESSMENT OF ENVIRONMENTAL REMAINS FROM A BOREHOLE SURVEY AT BLACKGREVES FARM, WYTHALL, WORCESTERSHIRE

05 April 2012

Project 3796 Report 1916 WSM 46453

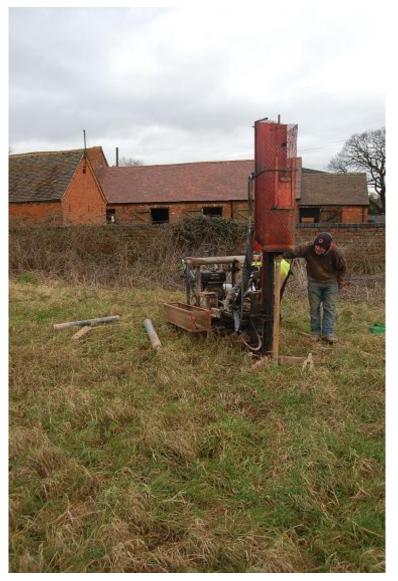
Figure 1 Borehole 1 facing north

Bank deposits might be represented in BH1 in which a large fragment of red brick was recovered along with charcoal fragments between 166.44m OD and 166.25m OD of the same borehole which also contained charcoal and extended to 0.86m BGL might be a further bank stratum. Although BH3 was drilled in a location where bank material might have been expected, the uppermost 1.20m core of the borehole was not present due to hand excavation of the upper deposits for health and safety reasons.

The bank deposits are of a probable post-medieval date, but on the basis of the borehole data alone they have an UNCERTAIN archaeological potential. The bank deposits are also assessed as having a LOW palaeoenvironmental potential as even were biological material that present, its derivation is uncertain.

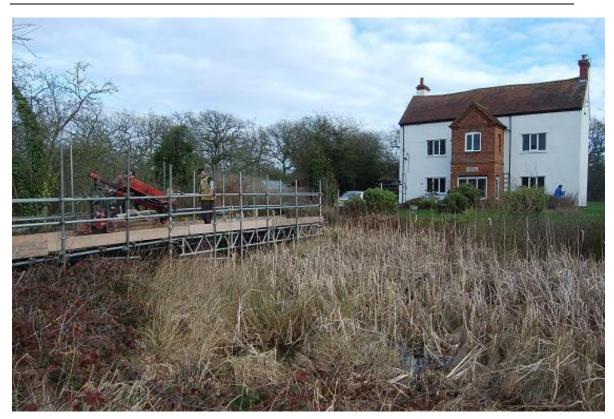
Figure 2 Borehole 2 facing northeast

0.12m of organic sediment/soil was recovered from BH2 (although given that the top 0.14m of core contains no sediment this stratum is likely to have been compressed during the drilling operations), including a large quantity of unhumified reeds, leaves and roots, all of modern appearance. The underlying stratum has a grey (5 Y 5/1) colour as a result of reduction of iron minerals during waterlogging, but otherwise consists of the compact, clayey, matrix-supported gravels that are typical of the alluvial fan deposits. The stratum continues to the end of the borehole at 163.36m OD. It would therefore seem that the moat is infilled by at most 0.26m of sediment at the point sampled by BH2, although percolating water from the moat has had the effect of diagenetically modifying (reducing) iron minerals in the underlying alluvial fan strata. The paucity of infilling sediment might indicate that the moat was dredged, but it might also be a result of the borehole location which was in close proximity to both the causeway and the outer bank

The moat deposits are assessed as having a LOW palaeoenvironmental potential on account of their thinness (0.26m) and proximity to the ground surface (meaning that they will have been affected by recent bioturbation). Their archaeological potential is UNCERTAIN on the basis of the borehole evidence report here.

The second possibility is that the location of Borehole 2 was too close to the causeway and the edge of the moat and has subsequently limited the collection of deposits of palaeoenvironmental significance. The closeness to the causeway and the bank are regrettable but the former was determined by the planned location of future works whilst the latter was determined by the scaffolding platform and the resulting health and safety for access. Avoiding applying excessive force whilst sinking and withdrawing the borehole and avoiding structural supports were major considerations in this decision.

- If further works were to occur on the site, locating the borehole(s) more centrally in the moat and further from the causeway would be the most obvious method for improving recovery. This method may be combined with the survey of the moat created by Demidowicz and Price (1986) which indicates that the northern and southern arms of the moat may be in excess of 1m deep although discussion with the tenant suggested that the eastern arm may be the deepest and least disturbed of all locations

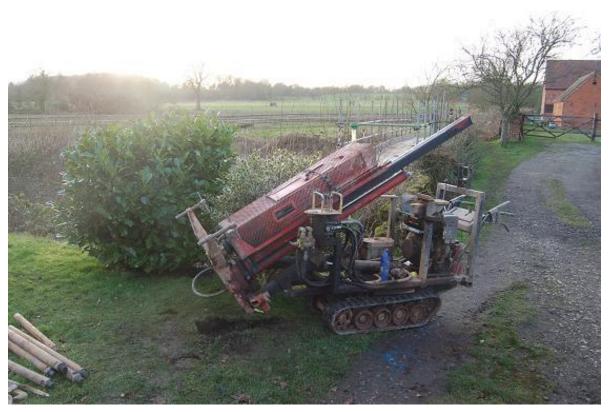
Figure 3 Borehole 3 facing southwest

Due to the potential presence of services in the location of the borehole, the top 1.20m of BH3 was excavated by hand and recorded archaeologically following standard Service recording methods (CAS 1995) with the results being presented in Appendix 2.

During the excavation, no archaeological deposits or features of archaeological significance were encountered in plan or section and the sole artefactual remains were occasional to rare fragments of post-medieval/modern ceramic building material which became absent below 0.30m.
