ARCHAEOLOGICAL WATCHING
BRIEF
AT
GLOUCESTER FOLK MUSEUM
GLOUCESTER

Project 3711
Report 1889

Archaeological Watching Brief at Gloucester Folk Museum, Gloucester

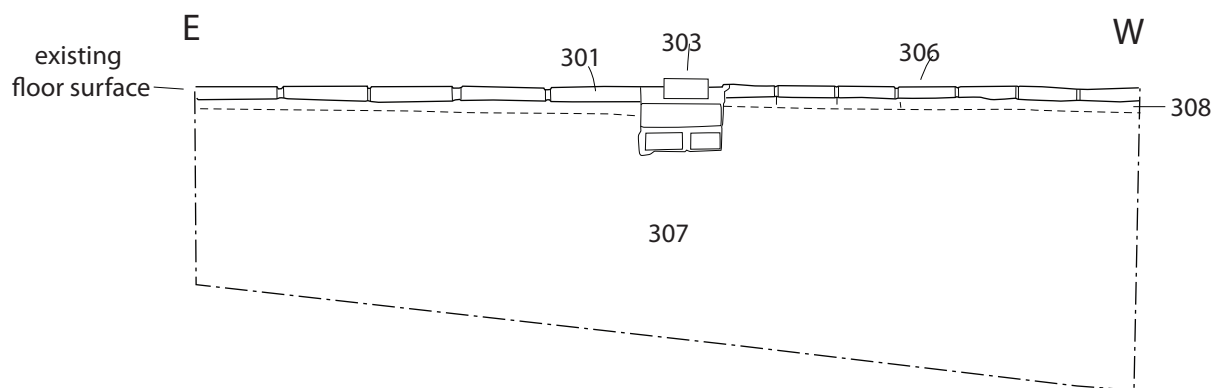
SECTION 26

Section showing floor surfaces and interior wall of Cider House Cottage

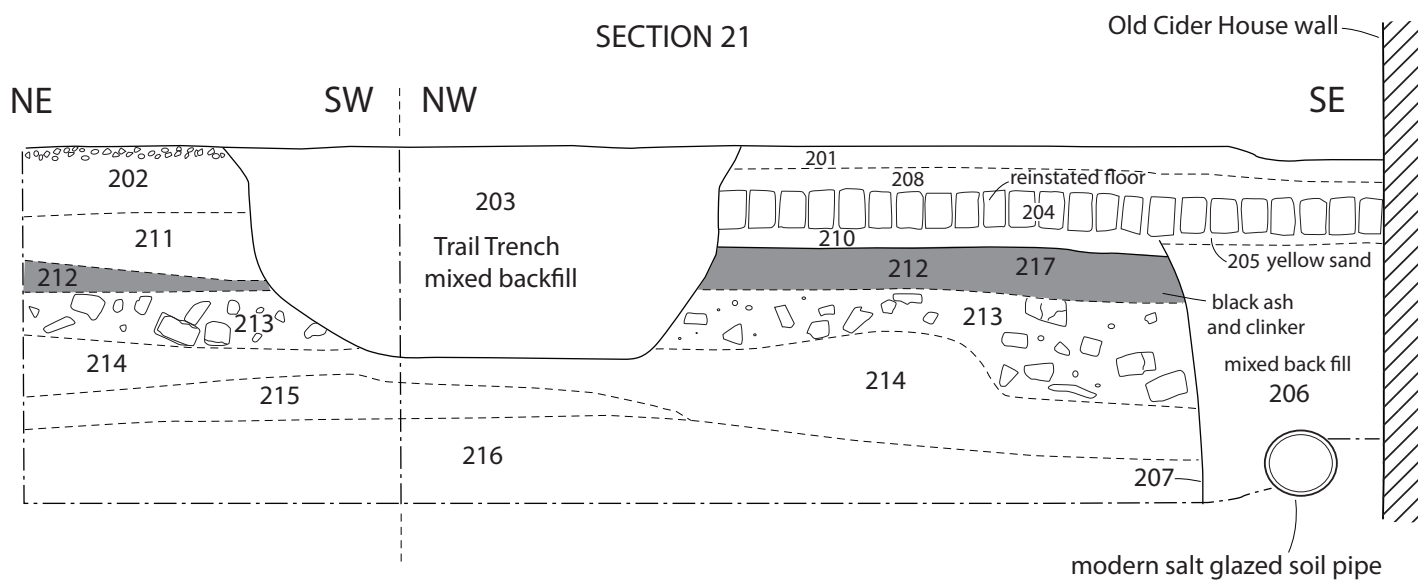
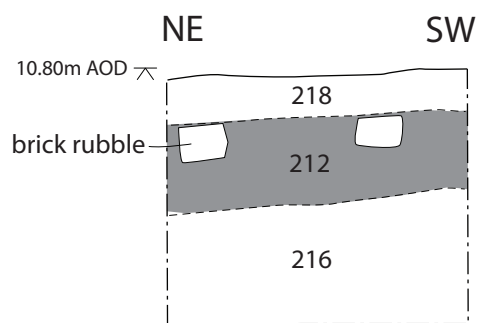
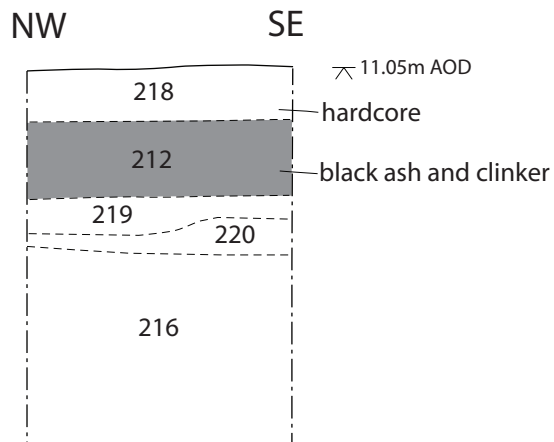
Figure 4

Sections

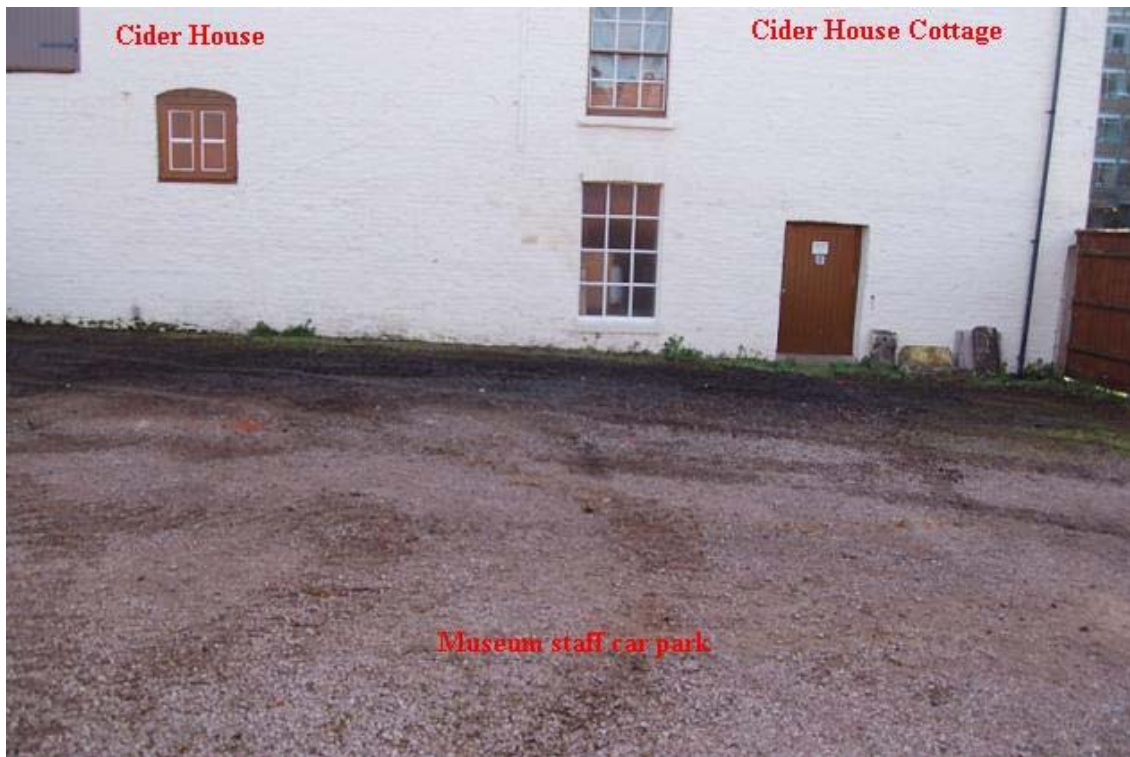
Plate 1- View of Cider House Cottage facing South (Sarah Phear, 2008)

Trench 2 (outside the Cider House, plate 1) was excavated to a maximum depth of 1.20 metres and partially revealed, in section, a thick deposit (216) of homogenous mid grey brown silt. This is thought to be deposit (107) recorded in the earlier evaluation.

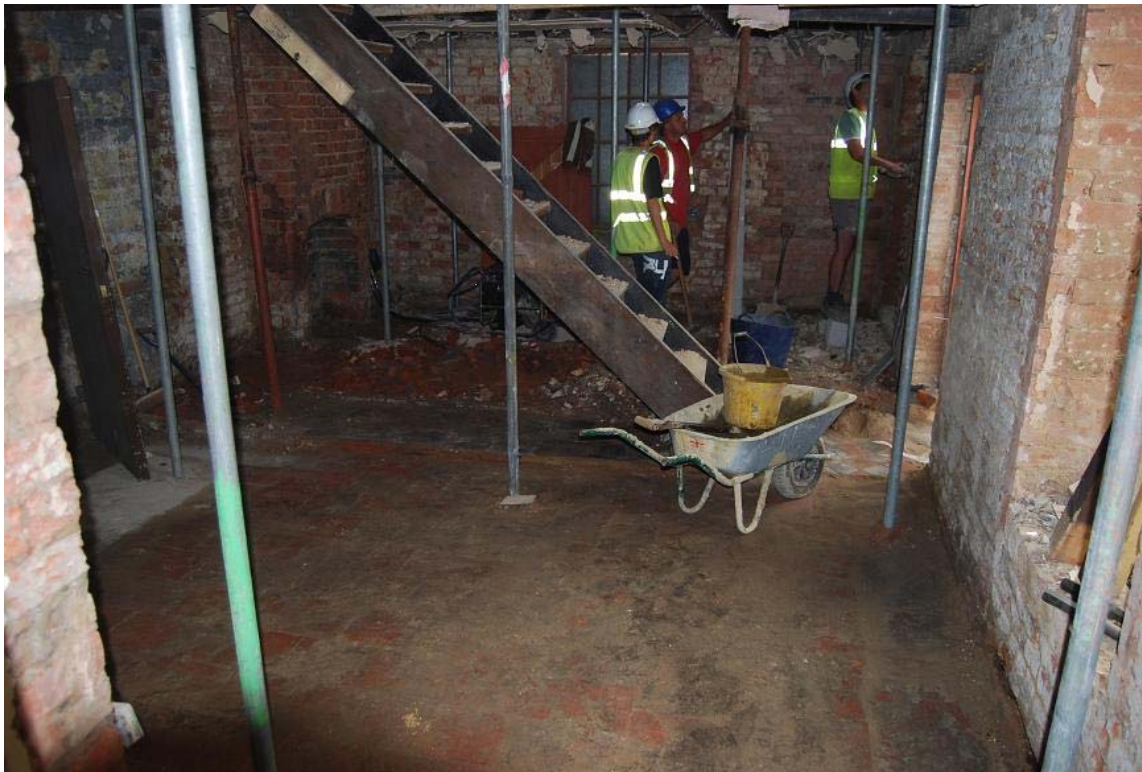
Plate 2- General shot of Cider House Cottage interior

Modern layers within the Cider House and adjoining cottage consisted of original, repaired and additional cobbled, flagged and tiled floors surfaces (plates 2 & 3). Trench 3 (inside the Cider House Cottage) uncovered the remains, a single course of two brick width, of two interior walls (303), located either side of floor surface (300) and under the stairs).

The flagged floor surface (300) was not excavated and left in situ, and was thought to be the earliest of the interior floors. It comprised of Yorkshire stone and was probably laid during construction of the building. Floor structure (301) comprising of red sandstone was also thought to be original whereas floor structures (302) red tiled and (306) diamond patterned red and black was thought to be a modern 1850-1950 replacement and (306) a modern concrete repair.

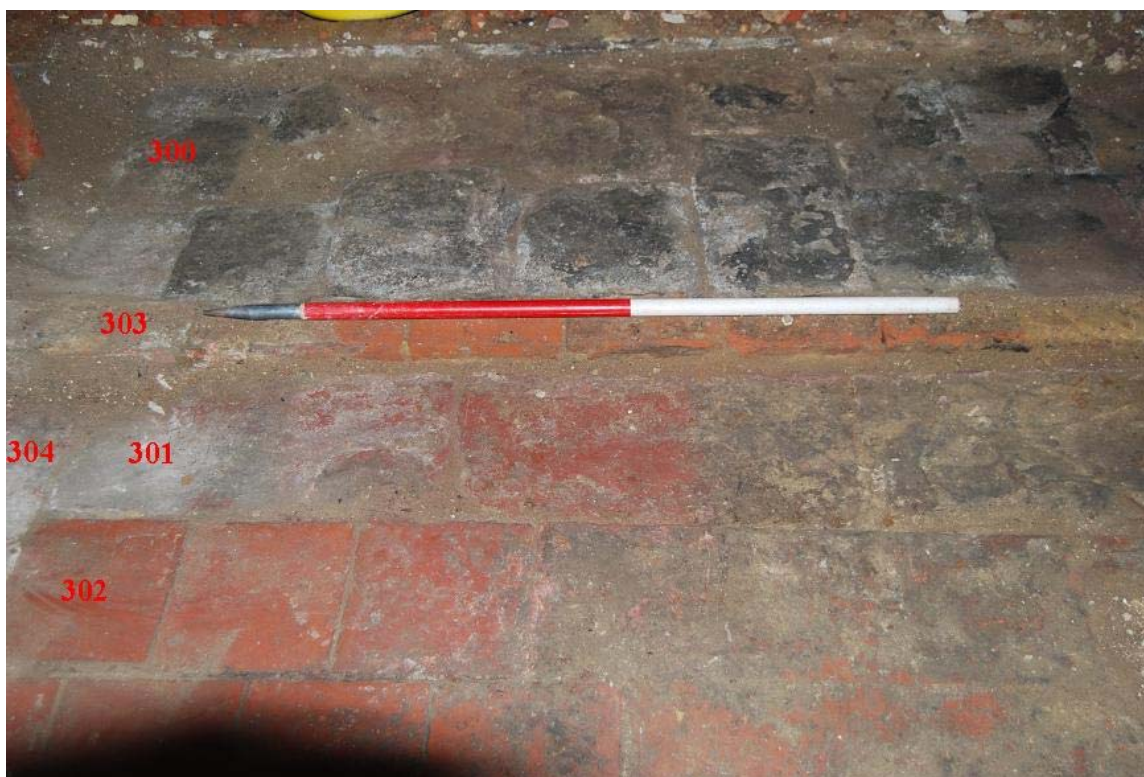
Plate 3- Oblique plan shot inside Cider House Cottage showing various features

Trench 3 (inside the Cider House Cottage, plate 2) was excavated to various depths from 0.30 to 0.80m revealing a layer of mixed made ground (307), (plate 3) including building demolition debris, stone ware, buffware and some 19th or early 20th Century mass produced china pot sherds. Additionally, residual late 17th early 18th Century clay pipe and fragments of badly corroded and undateable metalwork were also recovered.

by the dates 1850-1950 from the artefactual evidence of the tile (306) (plates 2 & 3) recovered from trench 3.

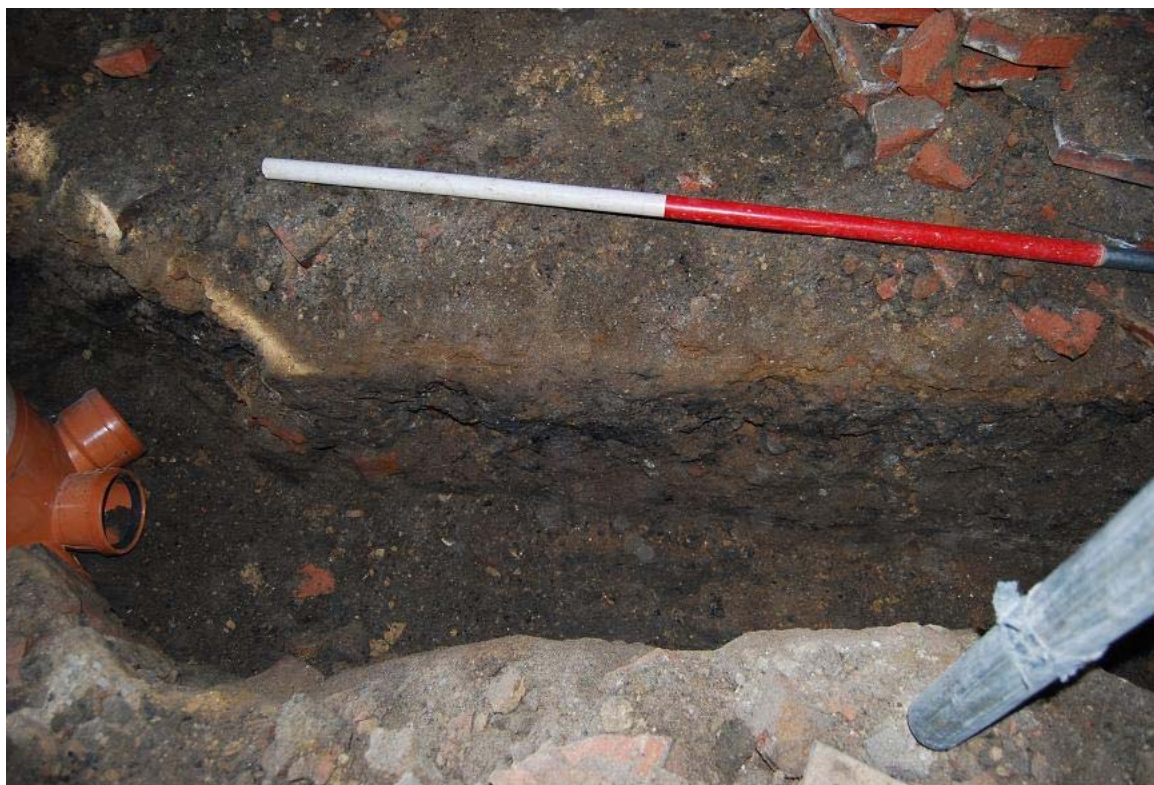
Plate 4- North facing section service trench 3 inside Cider House Cottage

Trench 3, inside The Cider House Cottage, was only excavated to a depth of 0.80m at its deepest, with the base of layer (307), (plate 4), not reached. It is described as a mixed made ground layer and contained ceramic pot with a terminus post quem date range of 1800-1950, earlier and later than the building construction (post 1881). This suggests that the made ground, probably for foundation levelling prior to construction, has been disturbed by later interior repairs. This is supported by the different floor surfaces found within the structure, (300, 301, 302, 304 and 306), (plates 2 & 3).

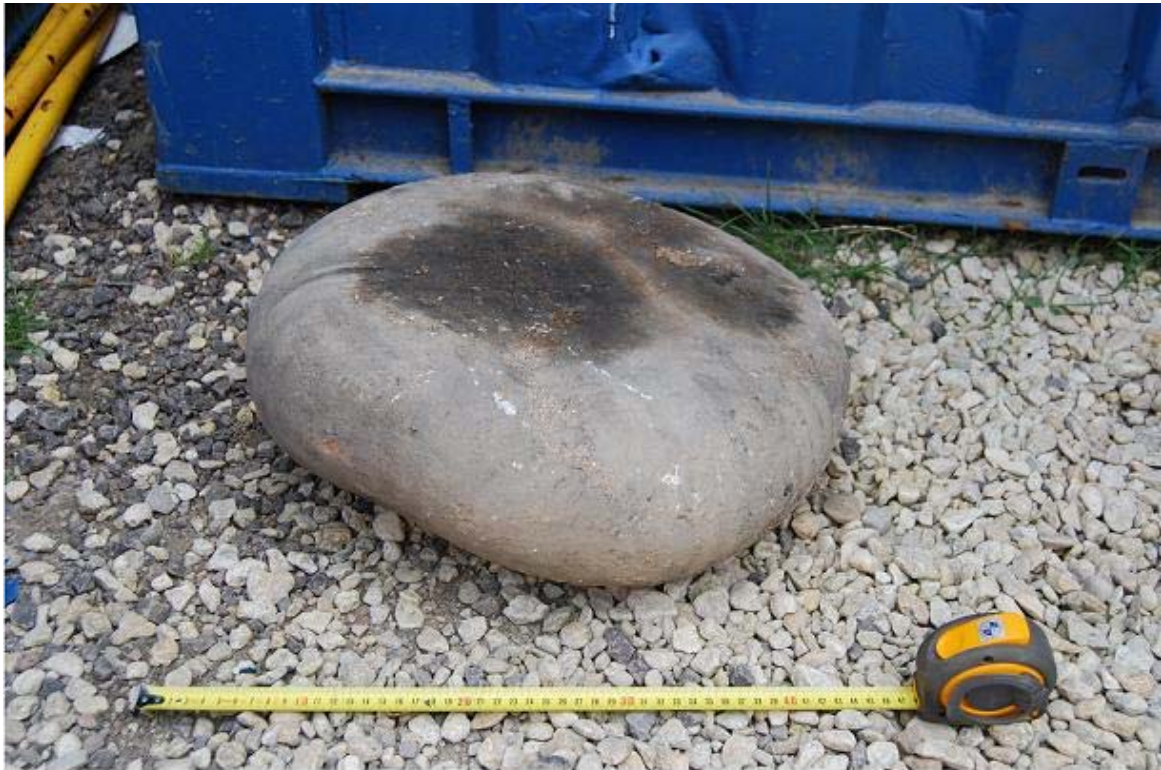
Plate 5 – Grinding stone recovered from (307) and left on site

A large grinding stone was recovered from a fill inside the Cider House Cottage (307), due to its weight it was left on site and it is understood it will be incorporated within the museum garden area.

Notably, a large sub-rounded regular shaped smooth stone was recovered from (307), interpreted, on site, as a grinding stone of industrial use and unknown date, (plate 5).
