ARCHAEOLOGICAL
EVALUATION
AT NEW CENTURY PARK,
STOKE, COVENTRY
(ATTENUATION POND)

Revision 2
22th December 2011

Project 3797
Report 1887

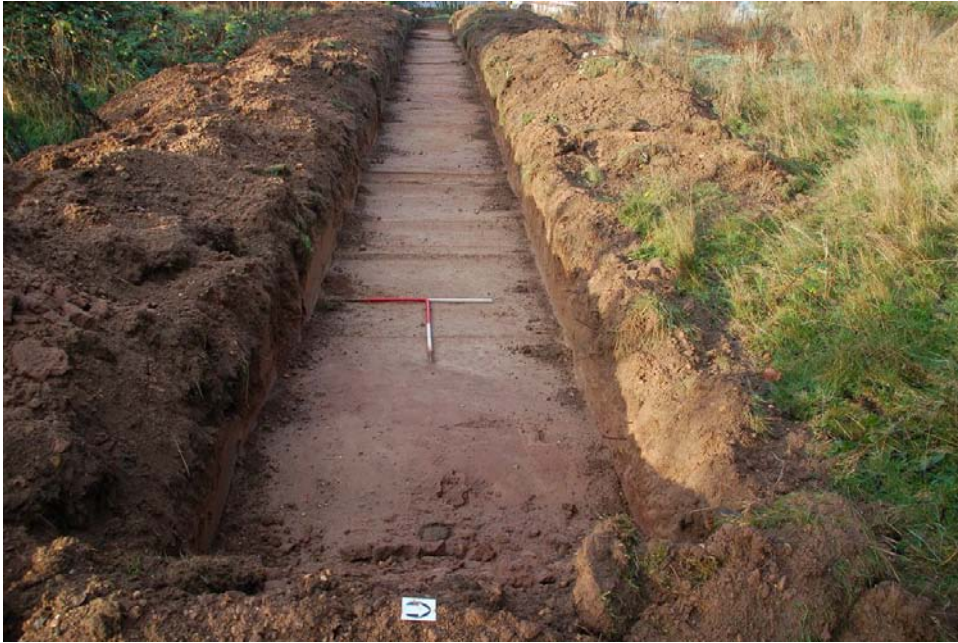
Plate 1; Trench 3 facing west, 2 x 1m scale

The natural deposits were fairly uniform throughout the evaluation trenches. These consisted of firm and cohesive light pinkish red and light yellow clayey sands. In areas there were small veins of loose small rounded gravels (Plate 1).

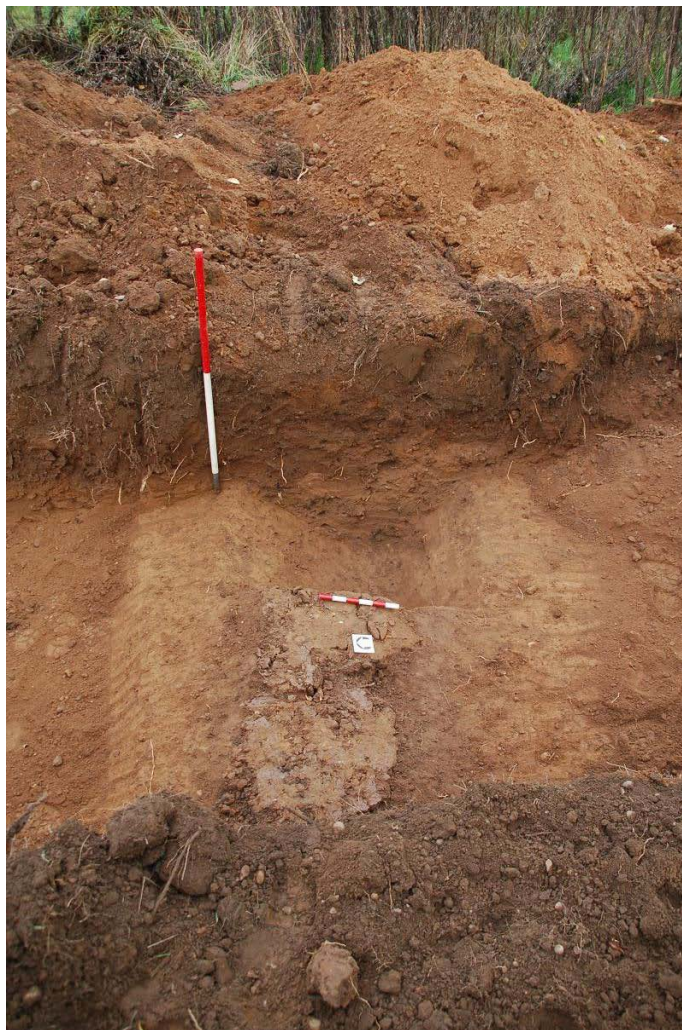
Plate 2; ditch [4005], facing east, 0.30m and 1m scales

The earliest dated artefacts and features are from the post-medieval period. The only dated feature was an east to west aligned ditch [4005] which contained post-medieval ceramic building material (CBM) (Plate 2; Fig 4, Section 9). The upper homogeneous clay fill within this ditch (4003) is thought to have been deliberately backfilled.

The only dateable archaeological feature, ditch [4005], is dated to post-medieval period and only post-medieval artefacts were found within the topsoil and subsoil layers in Trench 4. No earlier remains, either structural or artefactual, were found in either of the two trenches. The ditch is likely to be a field boundary ditch that had been backfilled during remodelling of the land surrounding Copewood Grange and is therefore likely to be contemporary with it. This ditch does not however appear on any post 1888 map so is considered to predate 1888.

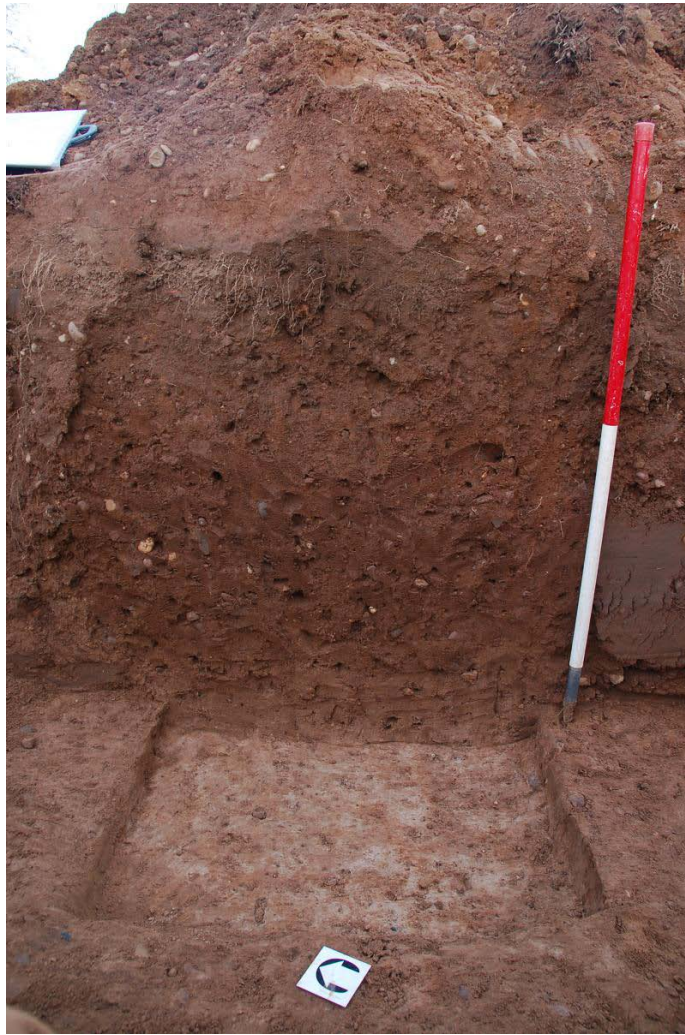
Plate 3; sondage through layer (4008), facing north-north-east, 1m scale

Two archaeological deposits are undated. These include layer (4008) and ditch [4007]. Layer (4008), a moderately compact and cohesive light greyish yellow silty sand was located in a natural depression within the centre of Trench 3 (Plate 3). This lay directly below the current subsoil (4001) and contained occasional small charcoal flecks and smears. The origin of this layer is not clear although it may represent former subsoil that has survived disturbance within a natural hollow.

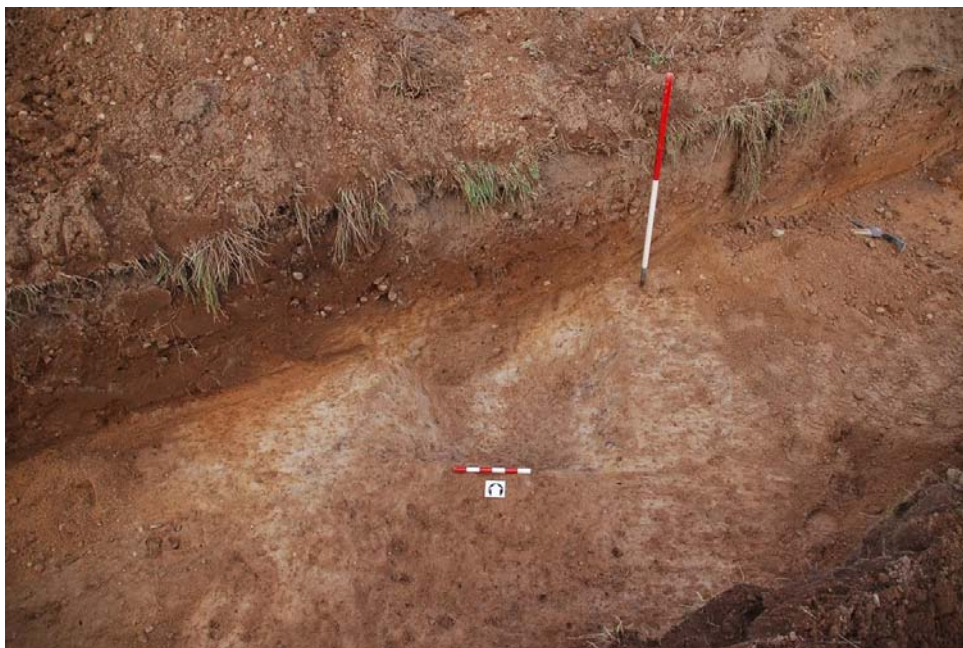
Plate 4; ditch [4007] facing north, 0.30m and 1m scales

To the east of Layer (4008) there was a slightly curved ditch [4007], which was only visible in the spur of Trench 3. It was not observed in the southern end of the trench, suggesting it terminates or turned to the east (Plate 4; Fig 4, Section 11). The interface between the fill of this ditch and the natural was diffuse and was more visible in plan than section. This may suggest that either the ditch was rapidly infilled or that a degree of natural formation processes was involved.

The remaining ditch [4007] and layer (4008) within Trench 4 are undated. Layer (4008) and the ditch fill (4006) are similar, which may imply a degree of contemporaneity between the two. The lack of artefacts within both of these deposits does however suggest that they are unlikely to be associated with domestic settlement. The apparently rapidly backfilled ditch may therefore only represent a field boundary ditch similar to [4005] above.
