ARCHAEOLOGICAL  
EVALUATION  
AT NEW CENTURY PARK,  
STOKE, COVENTRY  
(ROAD INFRASTRUCTURE)

Project 3797  
Report 1890

## **Archaeological evaluation at New Century Park, Stoke, Coventry**

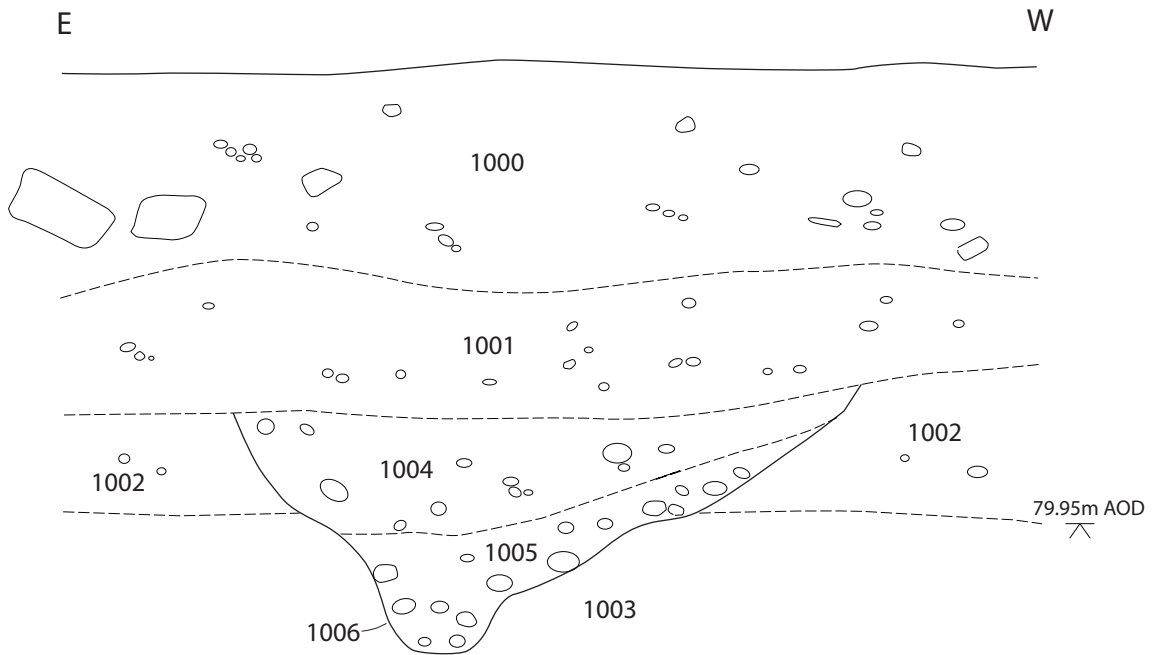
SECTION 2: NORTH FACING SECTION OF DITCH 1006

The remainder of the features are undated. These included two small north to south aligned ditches within the western ends of Trenches 1 and 3. The larger of the two [1006] in Trench 1 was almost V-shaped in profile and contained a firm sandy clay sterile fill (Fig 4, Section 6). Ditch [3006] again V-shaped in profile contained a more humic gravelly fill, more similar to the topsoil (Plate 3).

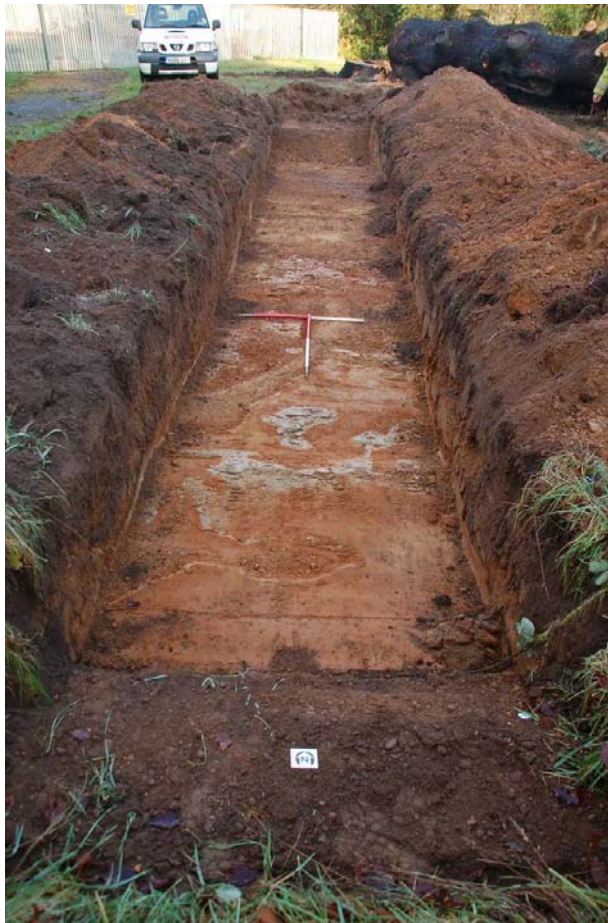
Trench 2 was the only trench that did not contain any archaeological features (Plate 1).

*Plate 1; Trench 2, facing north, 2 x 1m scale*

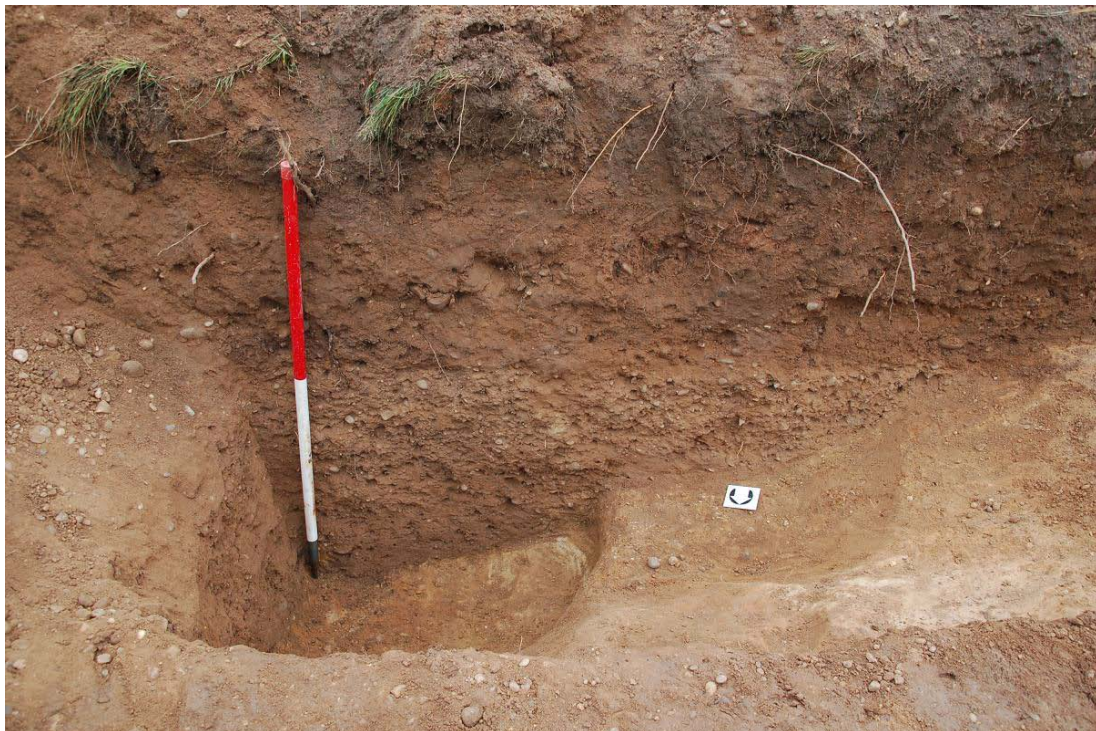
The earliest dated deposits and features are from the post-medieval period. These included a pit [1010] within the eastern end of Trench 1 (Plate 2). This sub-circular pit contained three gravely fills, the upper and lower of which contained small amounts of ceramic building

material (CBM). The secondary fill of this feature was a very homogenous gravelly deposit, suggestive of a deliberate backfilling episode.

The only dateable archaeological feature, pit [1010], is dated to 1700-1800 AD. The purpose of this feature is unclear although the lack of domestic material within it suggests it was not simply a rubbish pit. Within Trenches 1 and 2 the natural gravel seams are more common and the pit may therefore be a quarry feature. Whatever the purpose of the pit, it is likely to be associated with the house that predates Copsewood Grange, and is depicted on the Stoke Tithe plan.

*Plate 2; pit [1010] facing south, 1m scale*

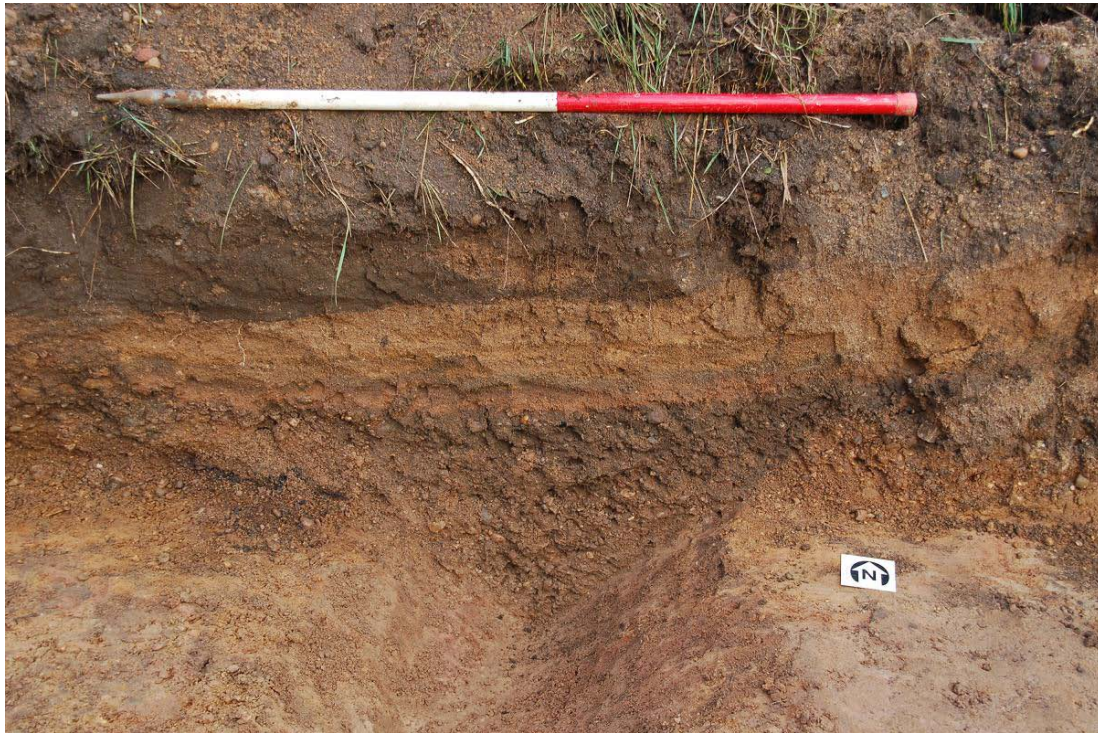
*Plate 3; ditch [3006] and levelling layers (3003) and (3004), facing north, 1m scale*

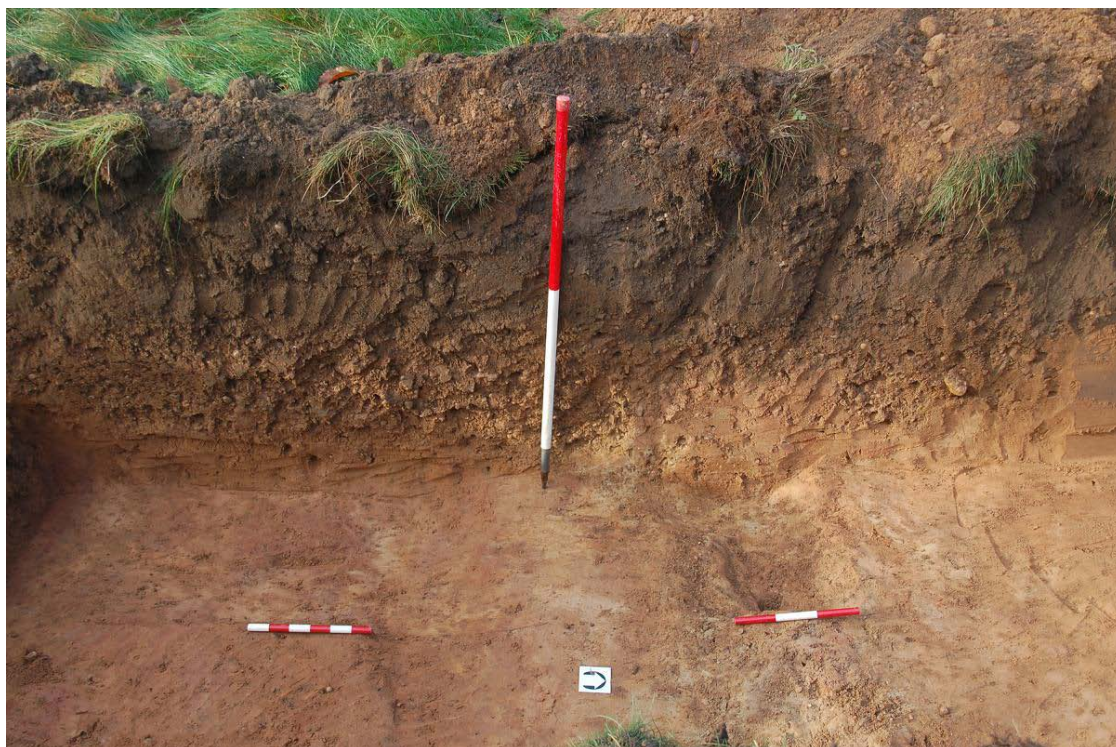
Two other ditches [3009] and [3011] within Trench 3 were aligned approximately east to west (Plate 4; Fig 4, Section 6). The earliest and smallest of the ditches [3011] again was almost V-shaped and was cut by the larger ditch [3009]. Both of these ditches contained a very sterile clayey sand fill, very similar to the surrounding natural. This implies that these features were not open for long or that a degree of natural formation processes was involved.

*Plate 4; ditches [3009] and [3011], facing west, 1m and 2 x 0.30m scales*
