ARCHAEOLOGICAL
EVALUATION,
AT
NORTHFIELD FARM,
THE FORMER JAGUAR PLANT,
BROWNS LANE, COVENTRY

17 February 2010
Revised 29 April 2010

Project 3461
Report 1749
BRL 10

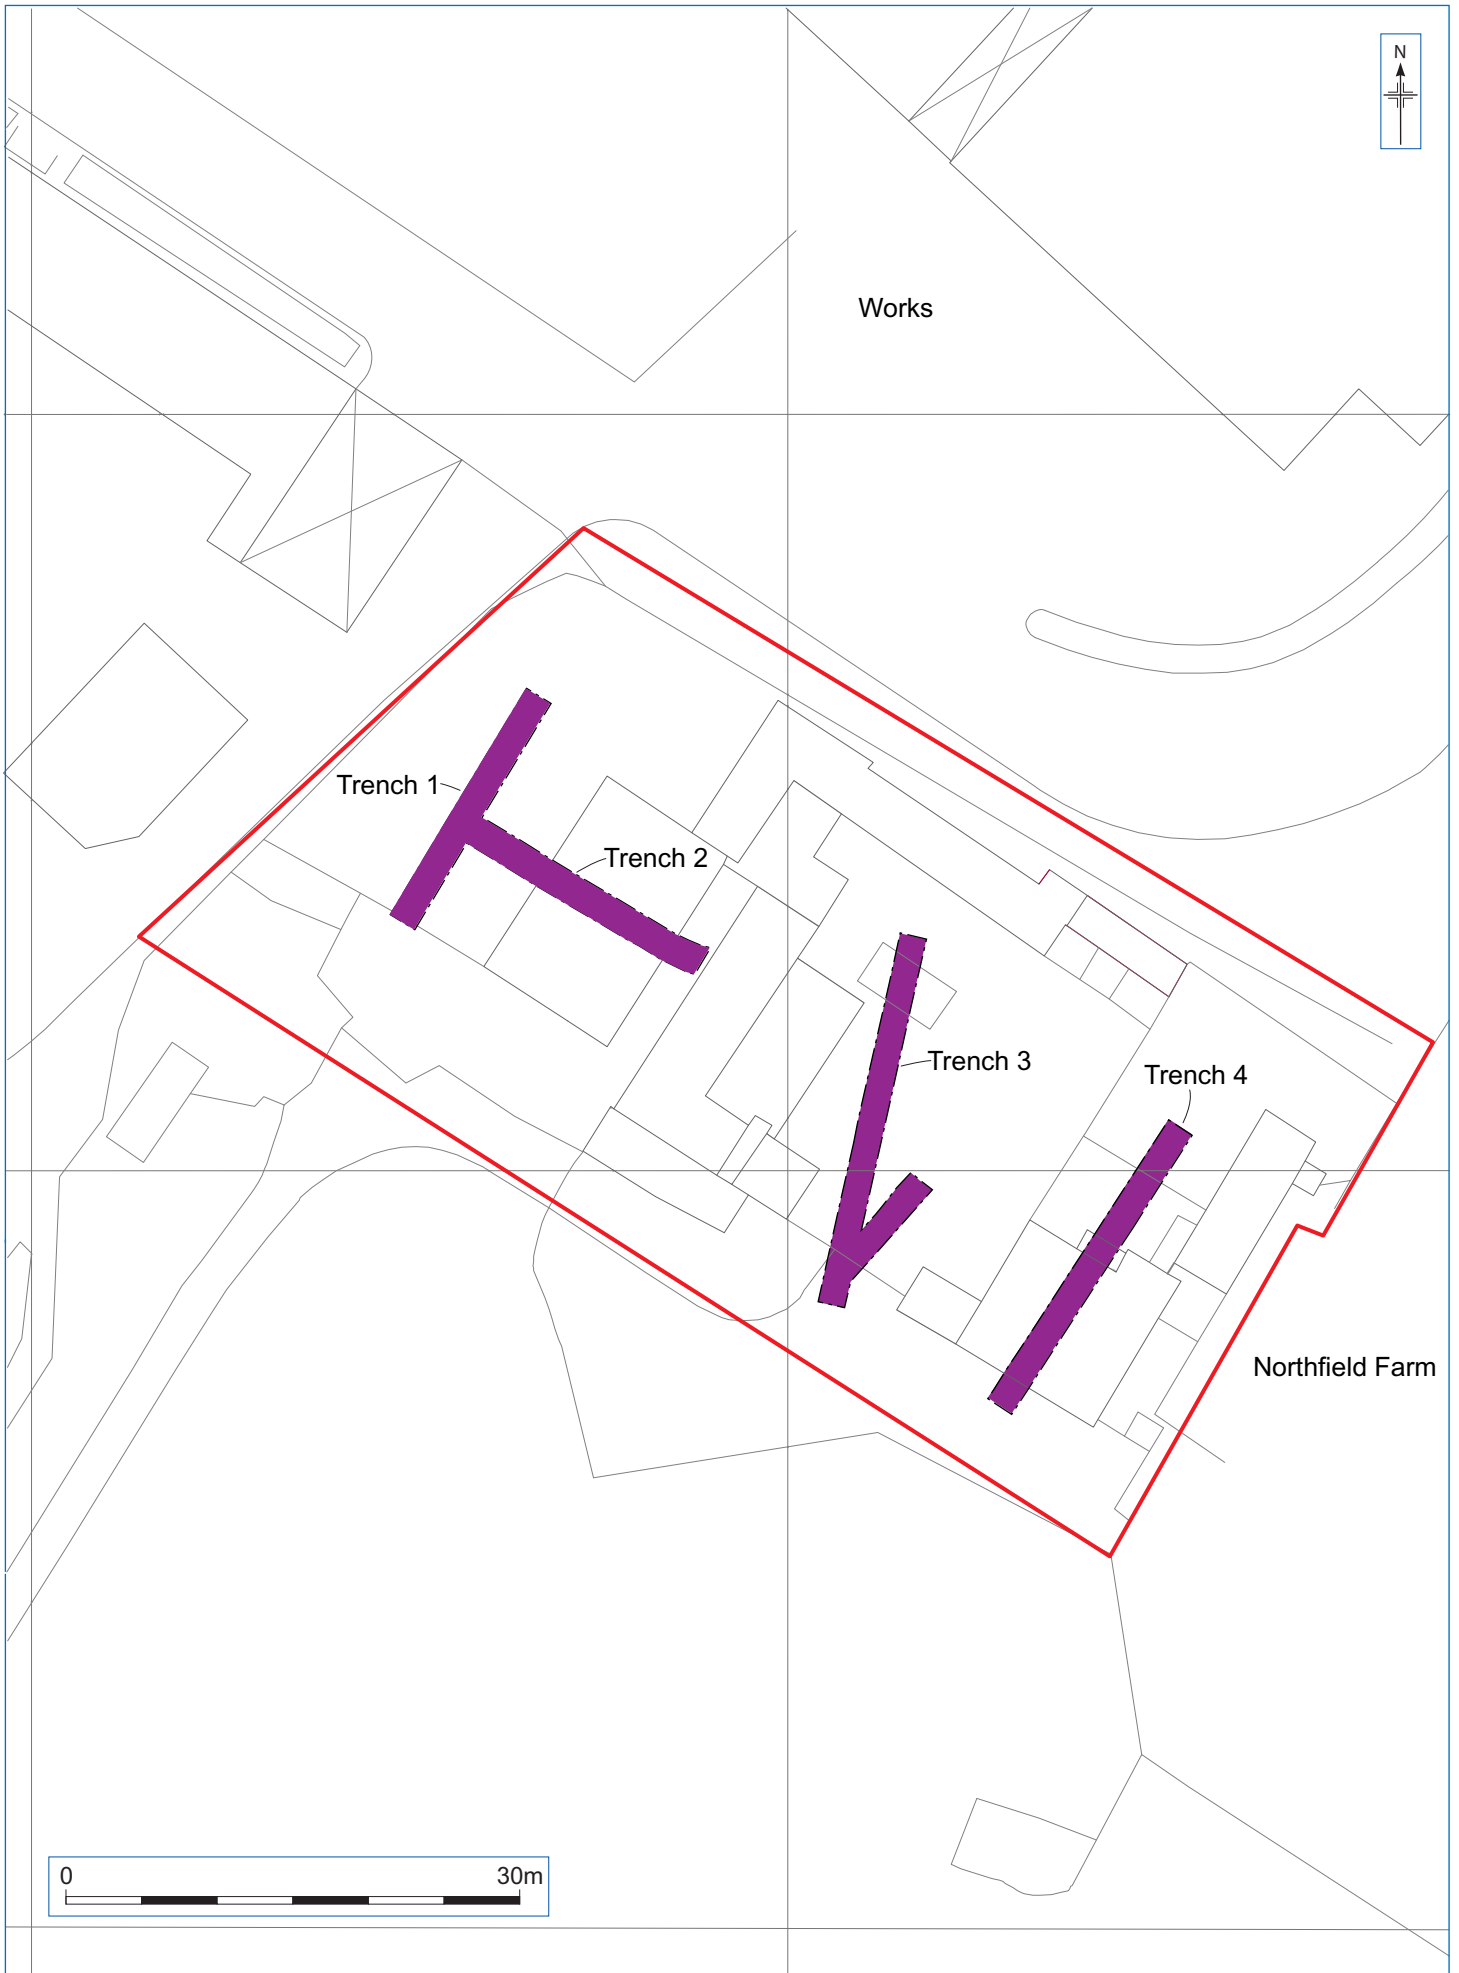
Figure 2

Trench location plan (based upon CgMs Consulting Ltd 2010: Fig 2)

Four trenches, amounting to just over 180m² in area, were excavated over the site area of approximately 3,000m², representing a sample of 6%. The location of the trenches is indicated in Figure 2. All trenches were placed to investigate elements of the former farm complex and any earlier phases of occupation on the site.

Trench 1 was located at the west end of the site on an area of grass that was hoped to be unaffected by the development of Northfield Farm. Trench 2 investigated former outbuildings within the farm complex in an attempt to reveal any earlier foundations. Trench 3 targeted the central courtyard of the farm, whilst Trench 4 investigated the 19th century farmhouse itself and related gardens to the immediate north of the building.

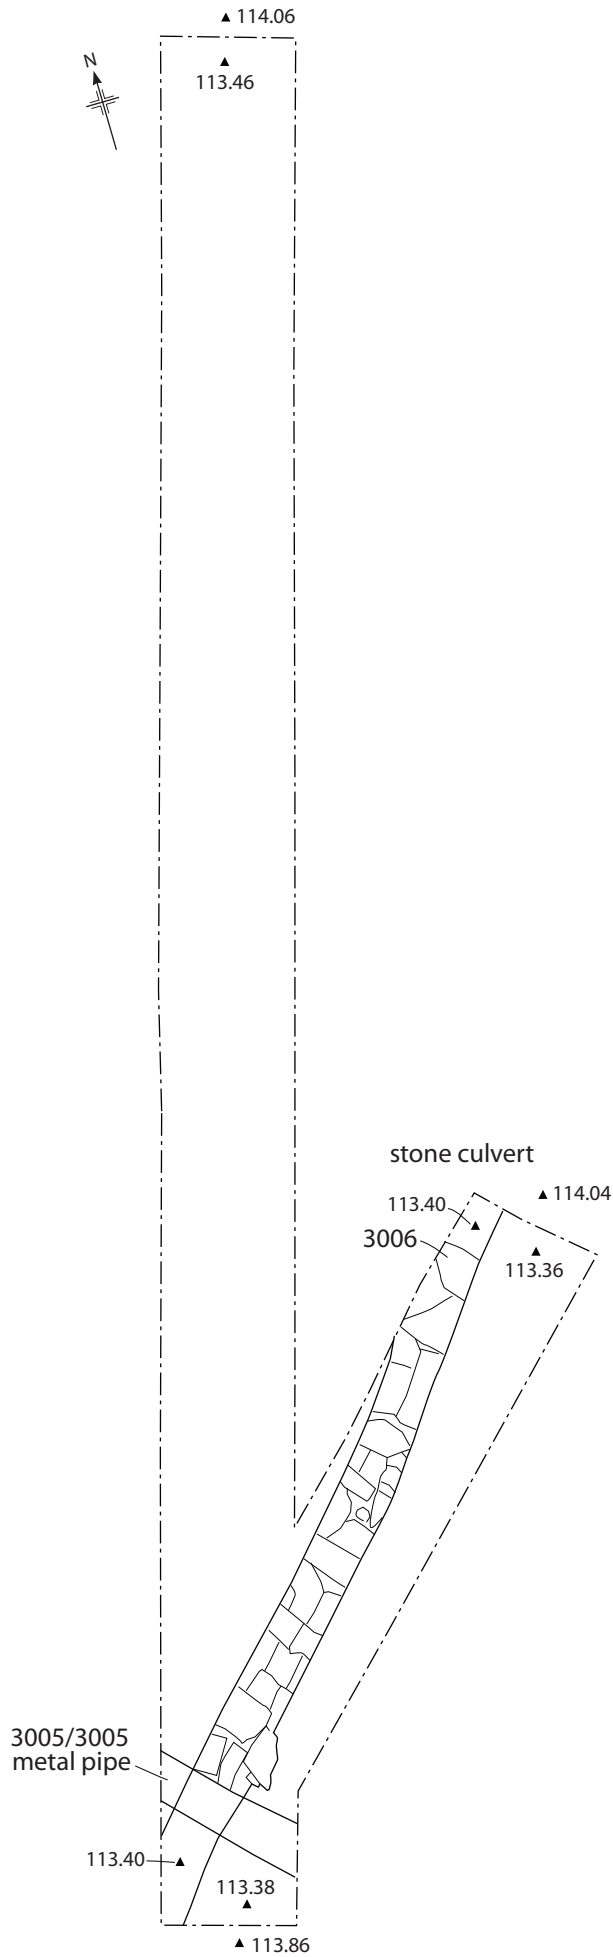
Figure 5

TRENCH 3: PLAN

TRENCH 4: PLAN

Trenches 3 and 4: plans

In Trench 3 structure 3006 truncated the underlying natural substrate and was constructed using naturally fractured fragments of local sourced sandstone. The structure had no base and was built with blocks lain on end against each other to create a channel that averaged 0.23m in width. This was then covered by slabs placed over the void creating a culvert. No mortar or bonding agent was used in the construction of this structure. The fill of culvert 3006 was a silt rich clay 3007. It was sterile, with no mixing present, suggestive of deposition by a constant low energy fluvial action (Fig 5, Plate 2).

Remnants of the former Northfield Farm were revealed in the southwest end of Trench 4 at an average height of 113.50m AOD, sealed by topsoil 4001. Wall foundation 4004 truncated the

underlying natural substrate and was constructed using large blocks of locally derived sandstone, bonded together using a firm yellow grey mortar with frequent charcoal flecks. No facing or coursing was noted and all evidence suggested that the structure had been constructed in a single event (Fig 5, Plate 1).

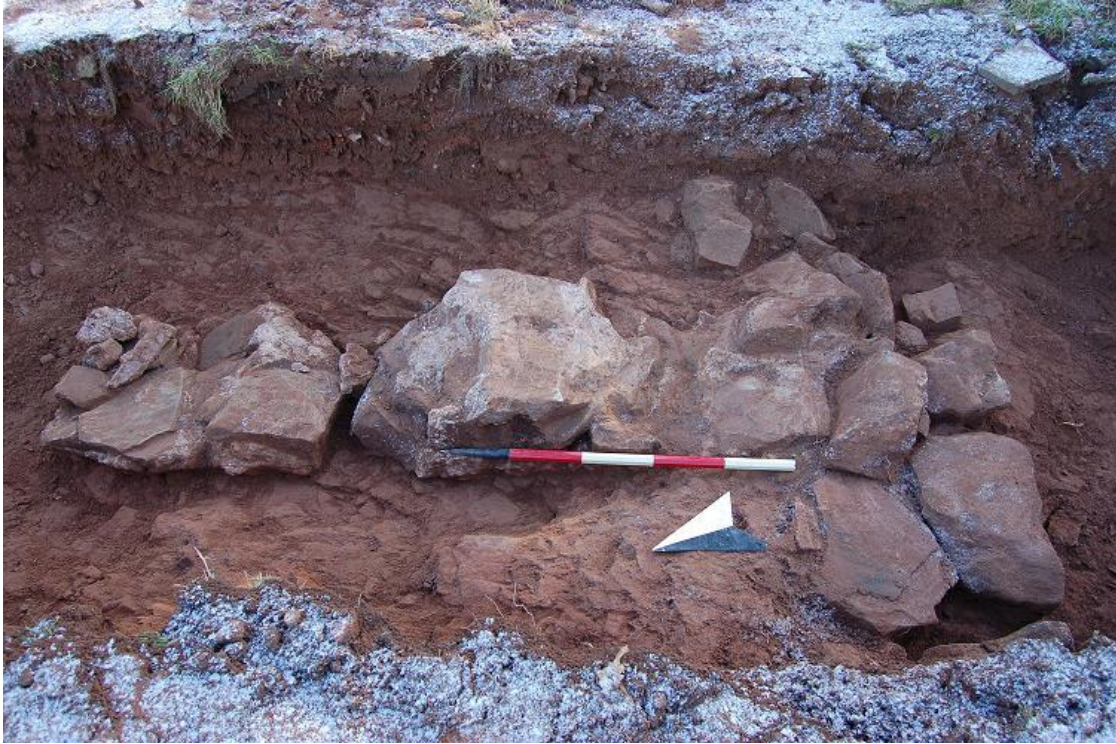
Plate 1, Wall foundations 4004 of former farmhouse; looking southeast; scale 1m

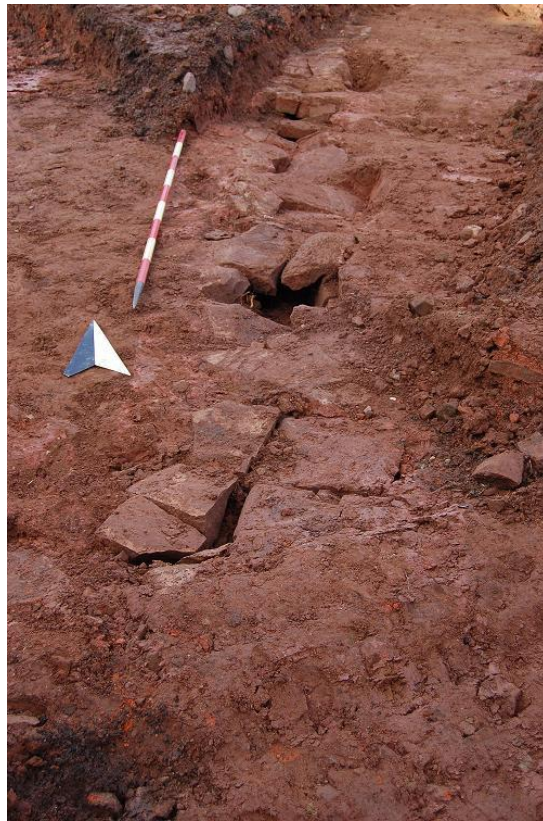
Plate 2, Sandstone culvert 3006 truncated in foreground by modern service 3005; looking northeast; scale 2m

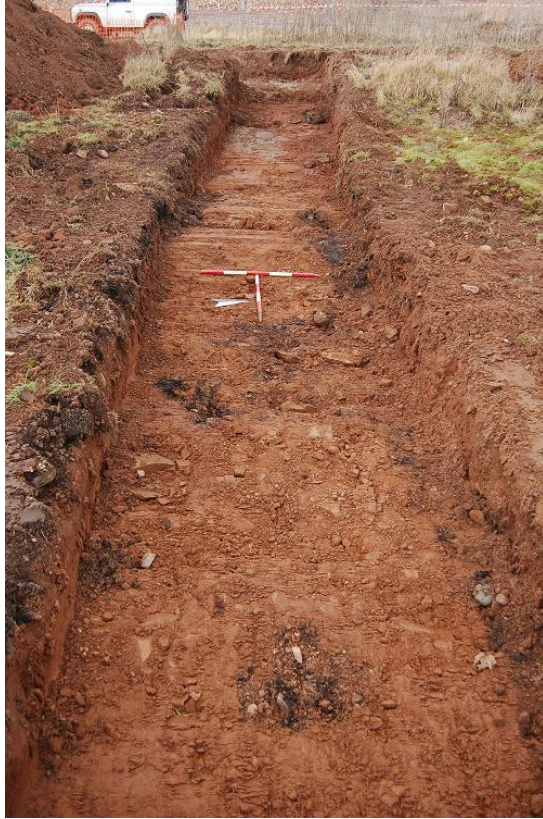
Plate 3, General shot of Trench 2 showing natural substrate 2004; looking west; scales 1m

Whilst no evidence remained from any of the other buildings within the farm complex the junction between Trenches 1 and 2 revealed a modern intrusion 1008 roughly rectangular in shape and 4m by at least 3m in plan. 1008 truncated the underlying natural substrate before being sealed by 0.71m of overburden, This in turn was covered by a thin spread of topsoil. To the immediate southwest a small gully, 1004, 0.36m in width and a maximum depth of 0.14m, was filled by a single silty sand fill 1005. Gully 1004 was truncated by a pit, 1006 that was 0.50m by 0.70m in size and 0.08m in depth and filled with a single silt rich deposit 1007, before being covered by 0.27m of overburden (Fig 4, Plate 3).

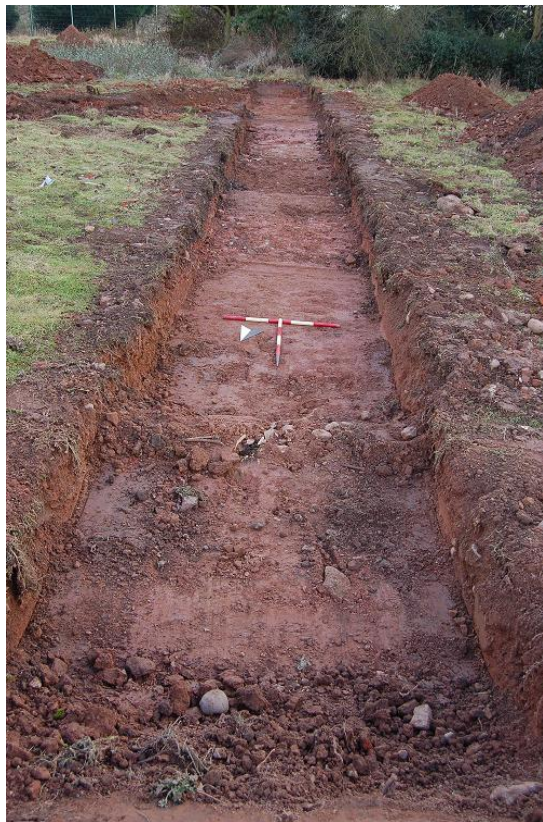
Plate 4, General shot of Trench 3 showing natural substrate 3003; looking southeast; scales 1m
