ARCHAEOLOGICAL WATCHING  
BRIEF  
AT  
WELLINGTON ROAD,  
BURTON-UPON-TRENT,  
STAFFORDSHIRE

24 April 2008

Project 3063  
Report 1613

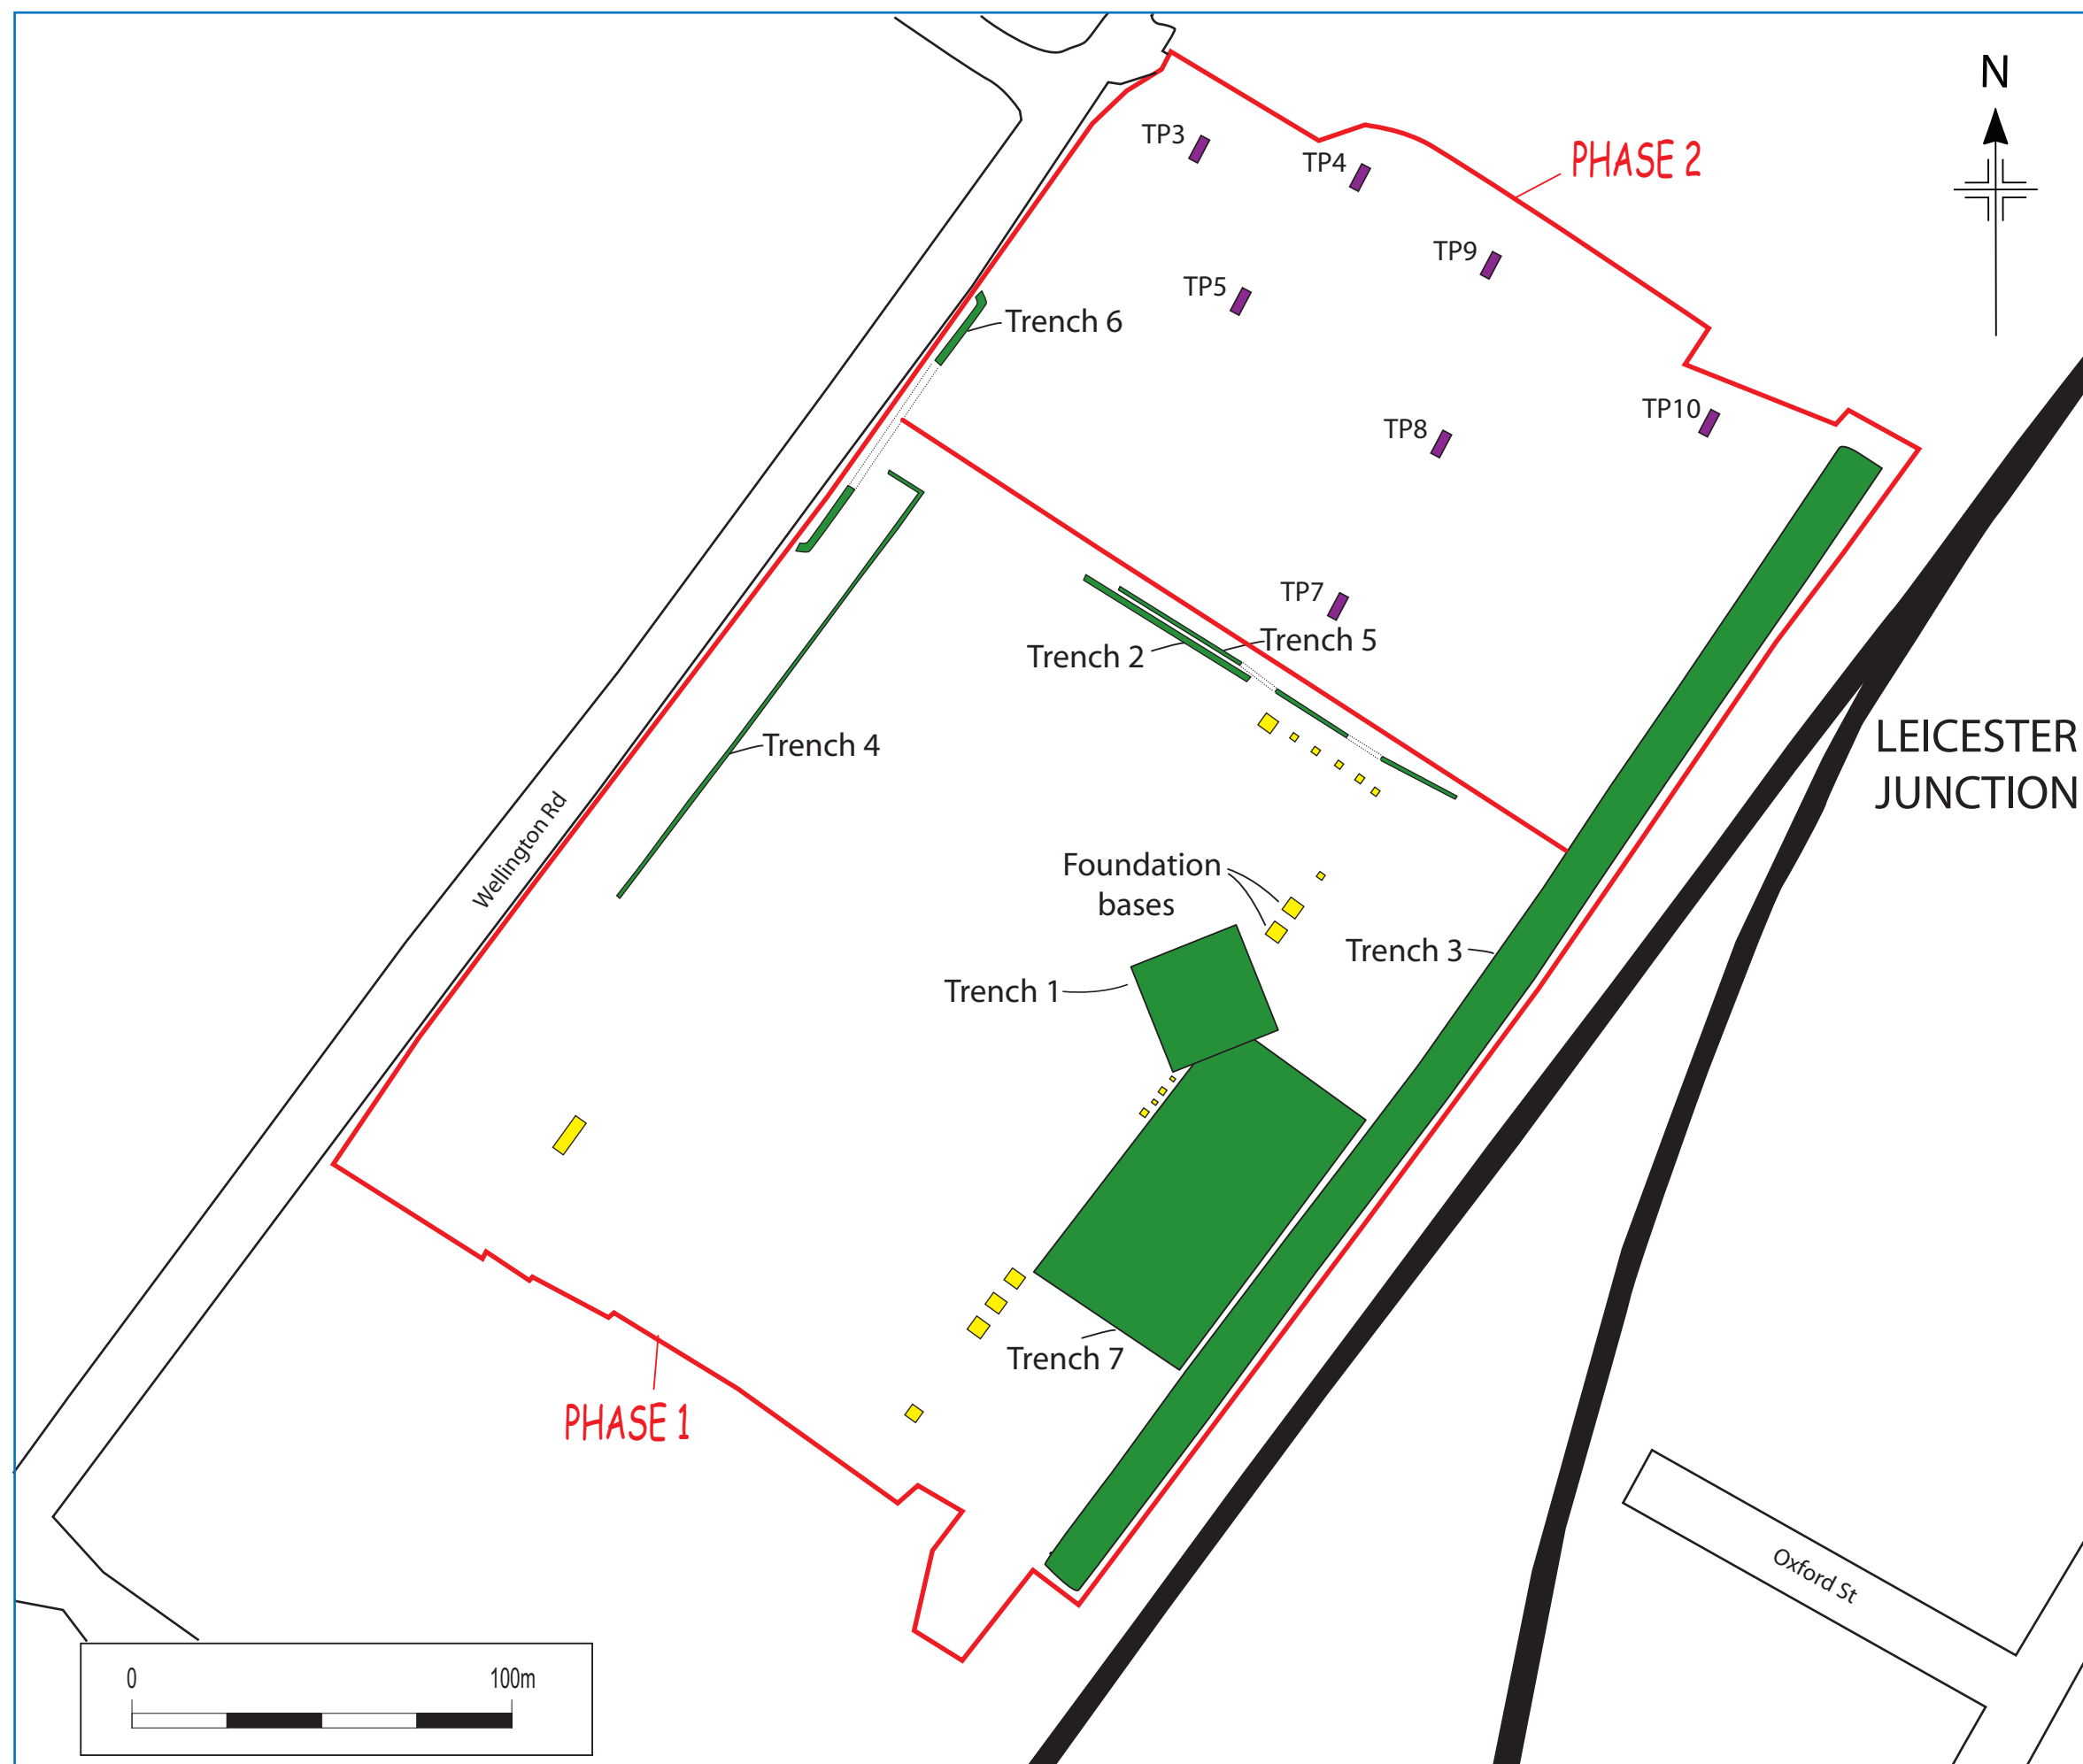
Location of areas observed

Observation of the excavated areas was undertaken during and after machine excavation. The exposed surfaces were sufficiently clean to observe well-differentiated archaeological deposits, although any less clear may not have been identified. It should be noted that Figure 2 identifies the only those areas monitored, not the full extent of ground disturbance associated with the development.

Only a small proportion of the total excavated areas were monitored (Fig 2). Initial monitoring determined that the majority of these groundworks would not impact below the level of the deposits laid down during the demolition of the former foundry and the deep modern overburden layers.

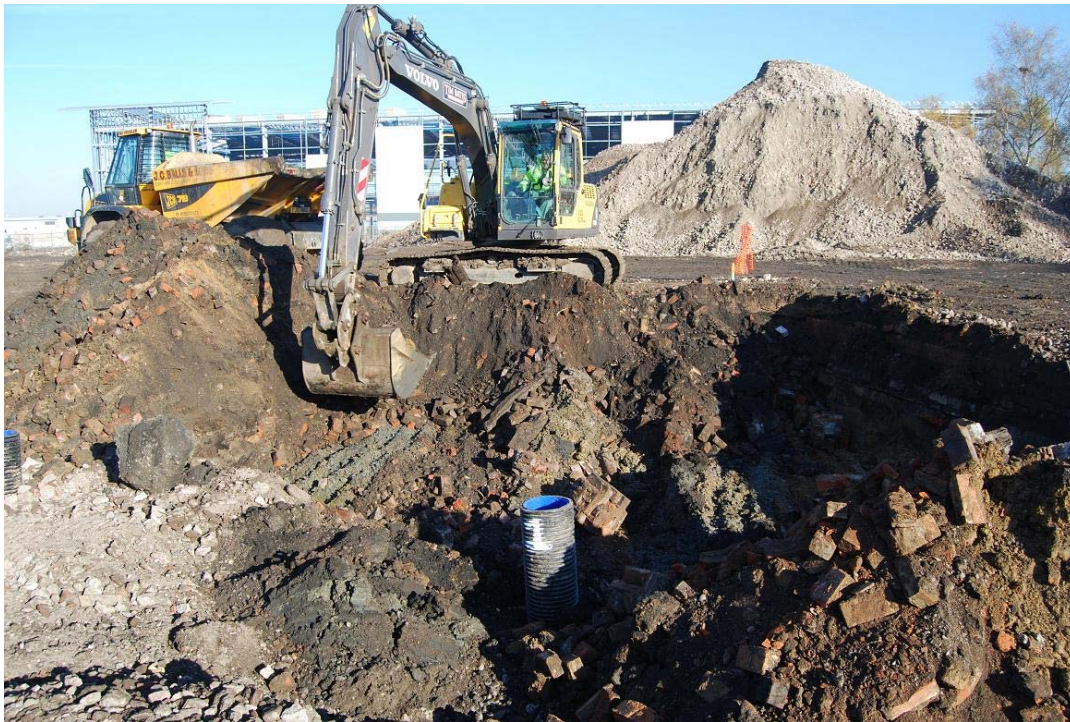
| Context | Classification | Description | Depth below ground surface (b.g.s) – top and bottom of deposits |
|---|---|--|---|
| 1000 | Modern overburden | Mixed modern deposit comprising firm dark brown black sandy silt with frequent large fragments of modern CBM. This deposit contains material from the demolition of the foundry. | 0.00 - 1.60m |
| 1001 | Subsoil | Loose mid green silty sands and gravels. Possible alluvial deposit. | 1.60 - 2.10m |
| 1002 | Natural | Loose mid to light orange yellow sands and gravels. | 2.10m + |

*Plate 1: Trench 1, during excavation; looking north*

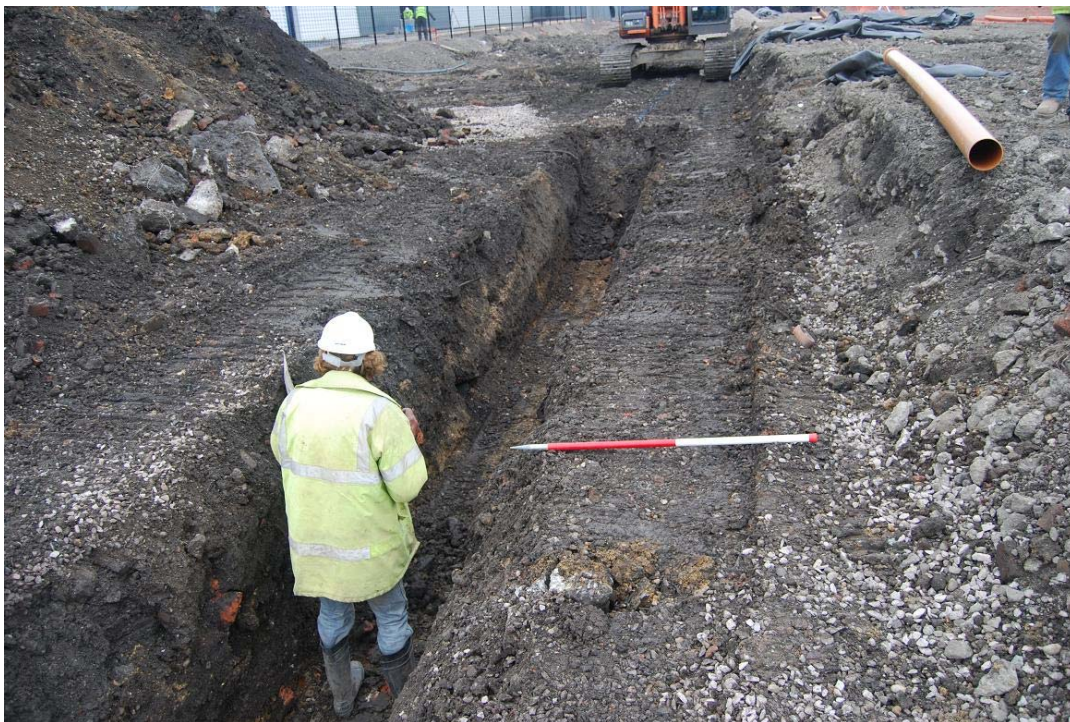
| Context | Classification | Description | Depth below ground surface (b.g.s) – top and bottom of deposits |
|---|---|--|---|
| 2003 | Modern overburden | Disturbed ground. Mixed deposit consisting of firm dark black sandy silt with patches of re-deposited natural sand and gravel. Frequent rounded stones and fragments of modern CBM and concrete. Deposit appears in Trenches 2, 5 and 7. | 0.00 - 1.40m |

*Plate 2: Trench 2, through modern overburden deposit 2003; looking southeast*

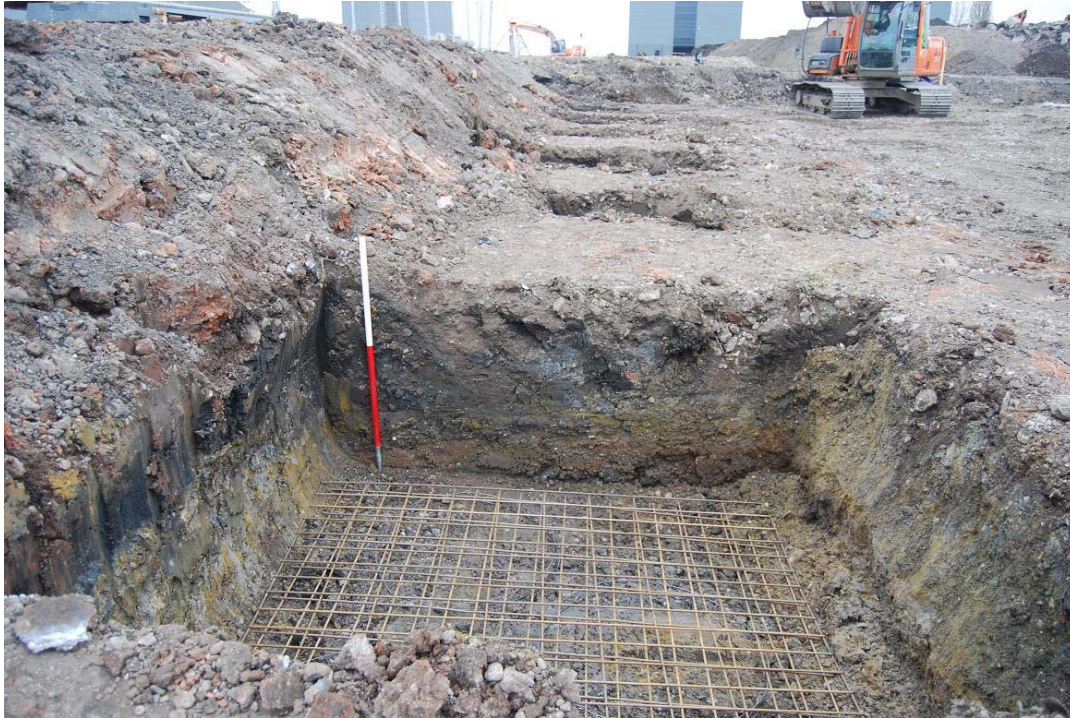
| Context | Classification | Description | Depth below ground surface (b.g.s) – top and bottom of deposits |
|---|---|---|---|
| 2000 | Modern overburden | Layer of crushed concrete and brick; deposit only appears under building footprint. | 0.00 - 0.80m |
| 2001 | Modern overburden | Disturbed ground. Dark black mixed deposit consisting of firm dark brown black sandy silt. Frequent moderate fragments of modern CBM. This deposit contains material from the demolition of the foundry. | 0.80 - 1.40m + |
| 2002 | Modern overburden | Mixed deposit, lumps of orange clay, patches of yellow brown silty sands and gravels, patches of black brown silt with moderate rounded stones. Moderated fragments of modern CBM and concrete. | 0.75 - 2.10 |
| 2004 | Natural | Loose mid to light orange yellow sands and gravels with patches of firm light orange yellow silty/clayey sands and gravels. This deposit was only observed in the deeper bases on the southeast side of the new building. | 2.10m + |

*Plate 3: Sample foundation base; with natural deposits at the base; looking northeast*

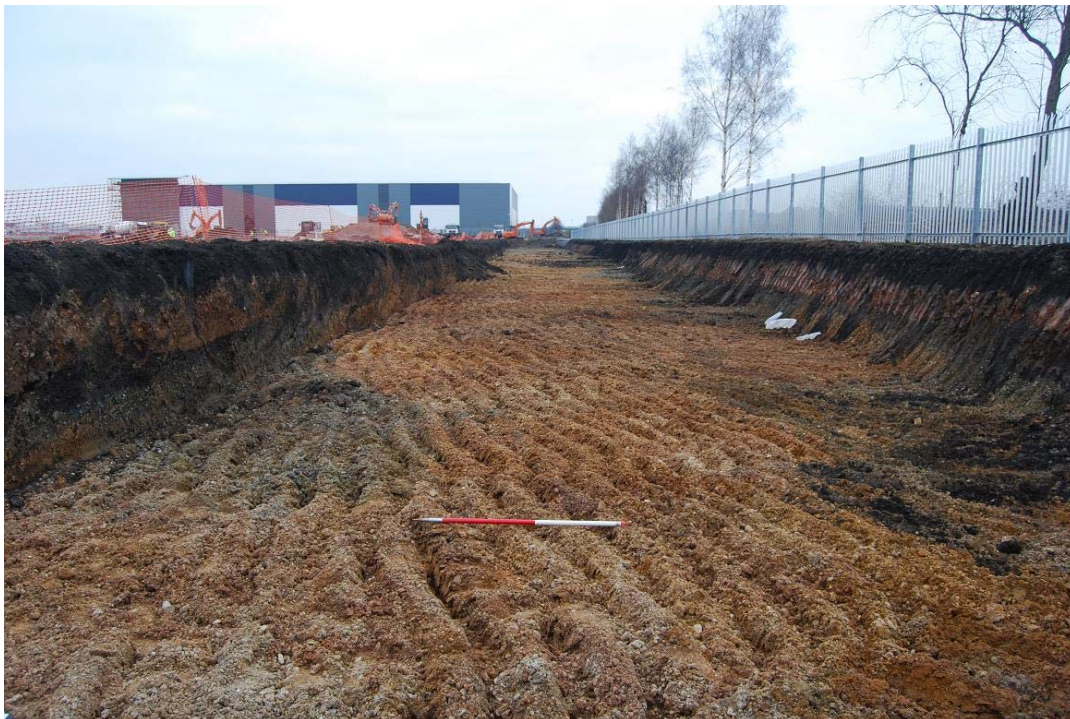
| Context | Classification | Description | Depth below ground surface (b.g.s) – top and bottom of deposits |
|---|---|---|---|
| 3000 | Modern overburden | Loose silty ash and clinker deposit consisting of dark brown black sandy silt with a high level of ash and clinker. Frequent large lumps of coal, occasional modern brick and glass. | 0.00 - 0.65m |
| 3001 | Modern overburden | Mixed modern makeup deposit. Firm mid brown sandy silt with patches of orange sand and mid brown/yellow orange sandy clay. Frequent small to medium rounded stones. | 0.65 - 1.15m |
| 3002 | Modern overburden | Firm mid brown sandy silt. Moderate small to medium stones, occasional charcoal flecks and occasional fragments of modern glass. In the SW part of trench 3 this deposit is grey brown with frequent charcoal flecks. | 1.15 - 1.45m |
| 3003 | Natural | Loose mid mottled yellow/grey orange silty sands and gravels. Some areas are more brown yellow. | 1.45m + |

*Plate 4: Trench 3, modern overburden deposits overlying natural deposits; looking northeast*

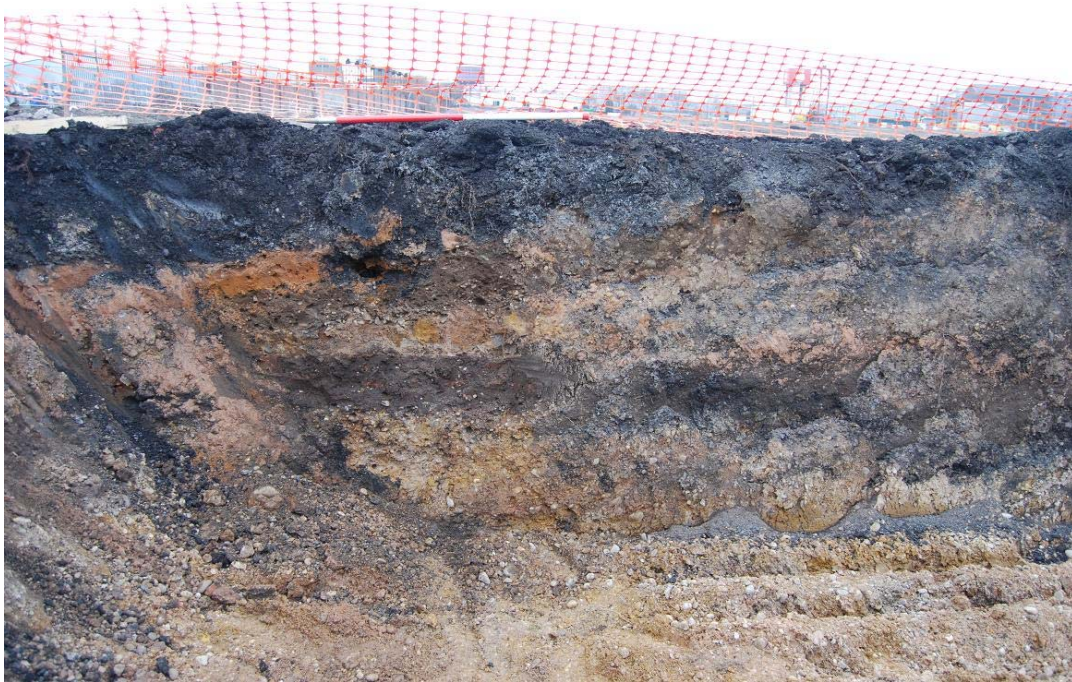
*Plate 5: Trench 3, modern overburden overlying natural deposits, looking northwest*

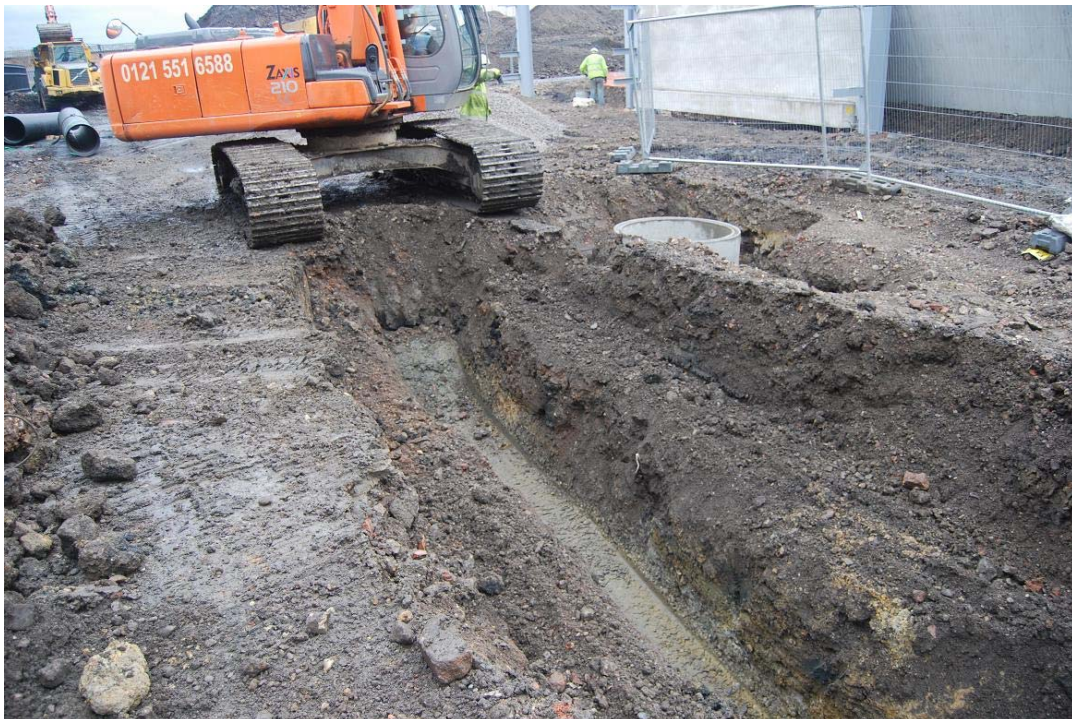
| Context | Classification | Description | Depth below ground surface (b.g.s) – top and bottom of deposits |
|---|---|--|---|
| 2004 | Natural | Loose mid to light orange yellow sands and gravels with patches of firm light orange yellow silty/clayey sands and gravels. Deposit appears in Trenches 2 and 5. | 1.40m + |

*Plate 6: Trench 5, modern overburden 2003 overlying natural deposit 2004; looking southeast*

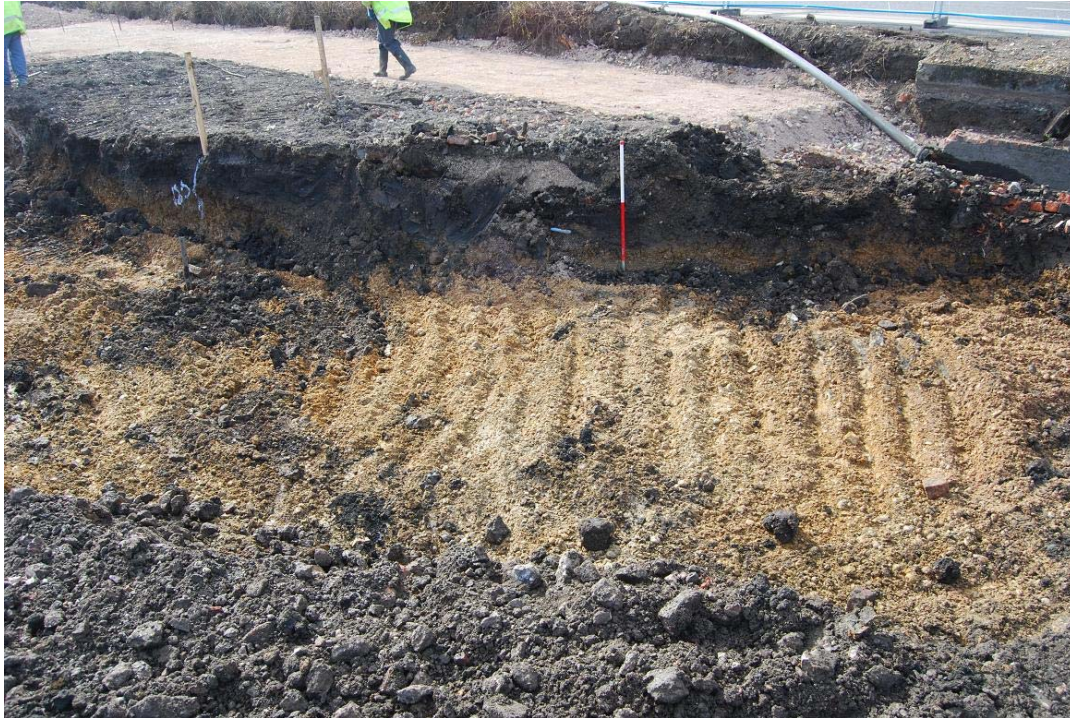
| Context | Classification | Description | Depth below ground surface (b.g.s) – top and bottom of deposits |
|---|---|--|---|
| 2005 | Modern overburden | Mixed modern deposit. Firm dark brown sandy silt with patches of mid orange brown stony silt, mid orange silty clay and light brown yellow stony clay. Deposit appears in Trenches 4 and 6. | 0.00 - 1.70m + |

*Plate 7: northeast stretch of the Trench 6; modern overburden 2005 overlying natural deposit 2004; looking west*

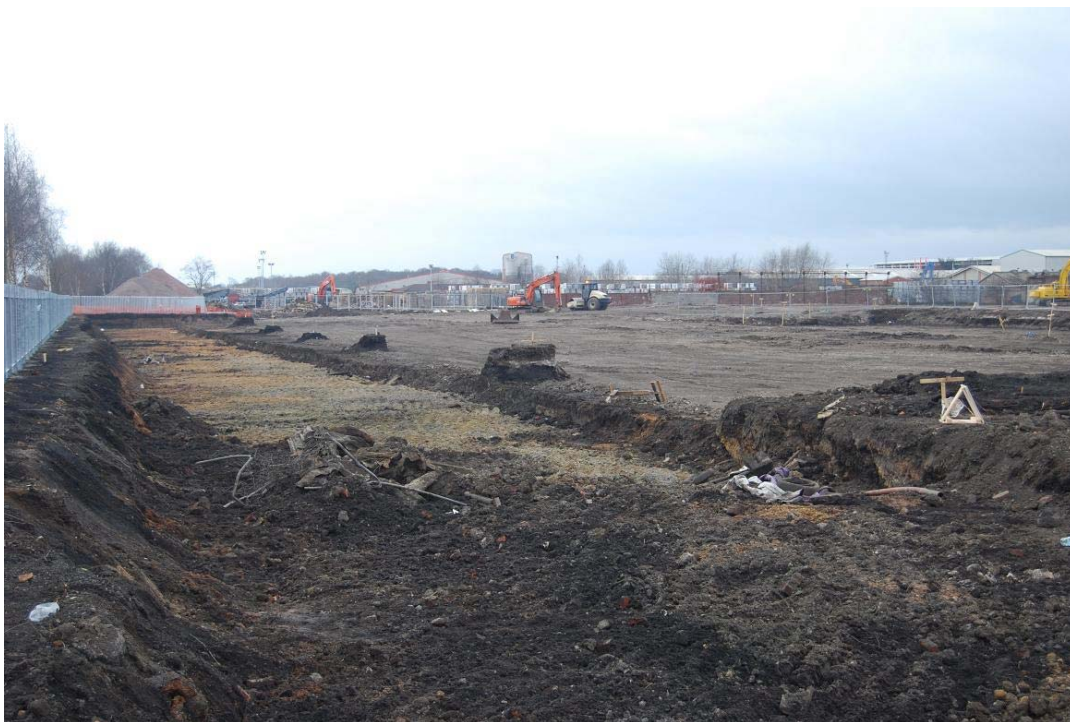
*Plate 8: General view of the site and Trench 7; looking northeast*
