ARCHAEOLOGICAL  
EVALUATION  
AT  
THE CATTLE MARKET,  
UTTOXETER,  
STAFFORDSHIRE

22<sup>nd</sup> November 2006  
revised 27<sup>th</sup> November 2006

Project P2966  
Report 1482  
EST 1409

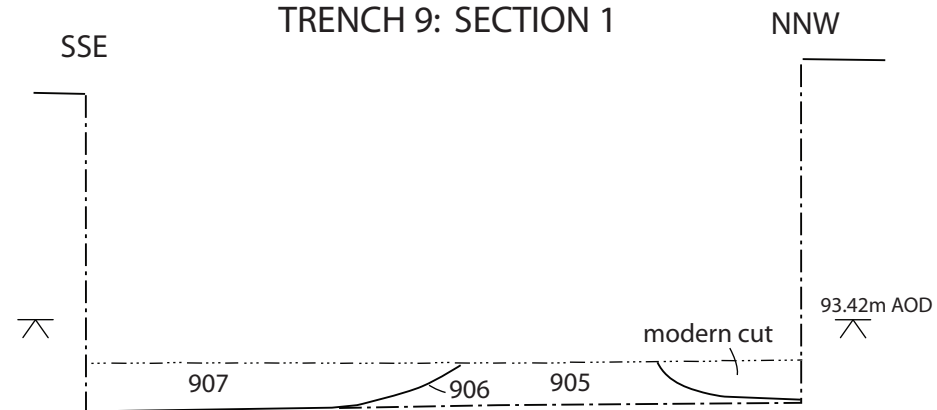
Figure 4

Within the middle of the site a group of four associated postholes were identified, on a east-north-east to west-south-west alignment (Trench 10) They were of differing size and profile but with comparable fills, and were cut into the subsoil, from the level of the topsoil and were without any apparent post-pipes or packing material. One contained later 18<sup>th</sup> century material, the rest were dated by association (Plates 40 and 41).

A wide shallow hollow was identified within the natural toward the north-west side of the site (Trench 9). The homogeneous fill was very similar to the subsoil and was without finds. It is considered to be a natural undulation rather than a deliberately cut feature (Plates 38 and 39).

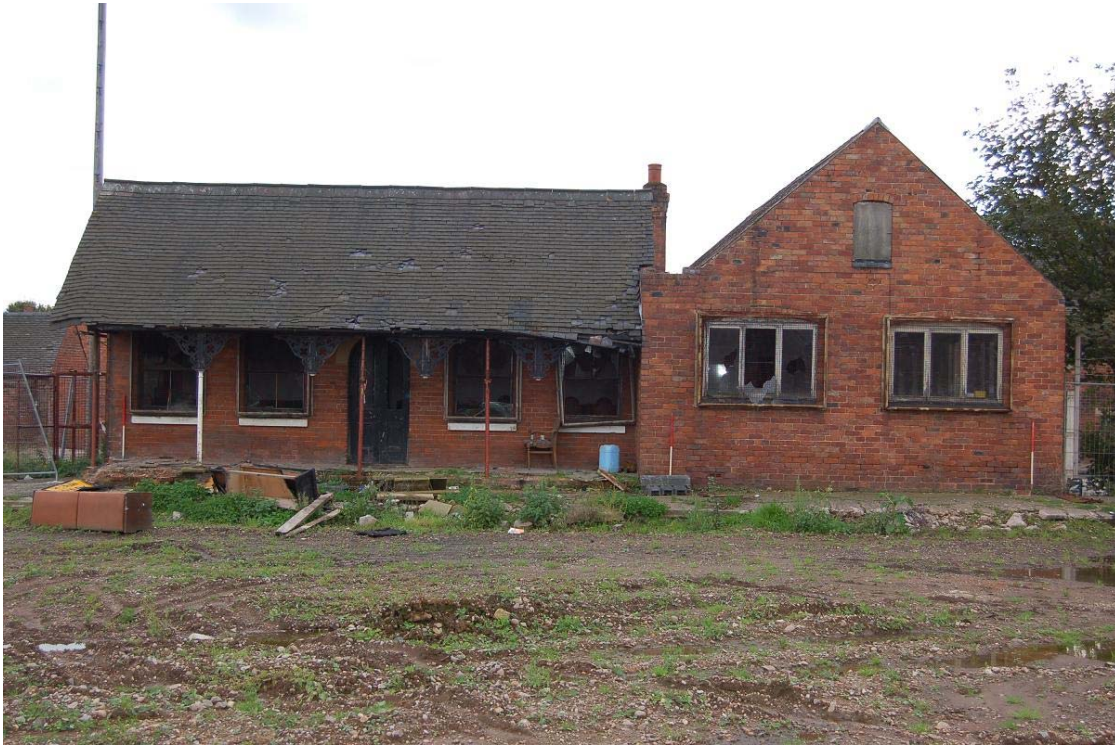
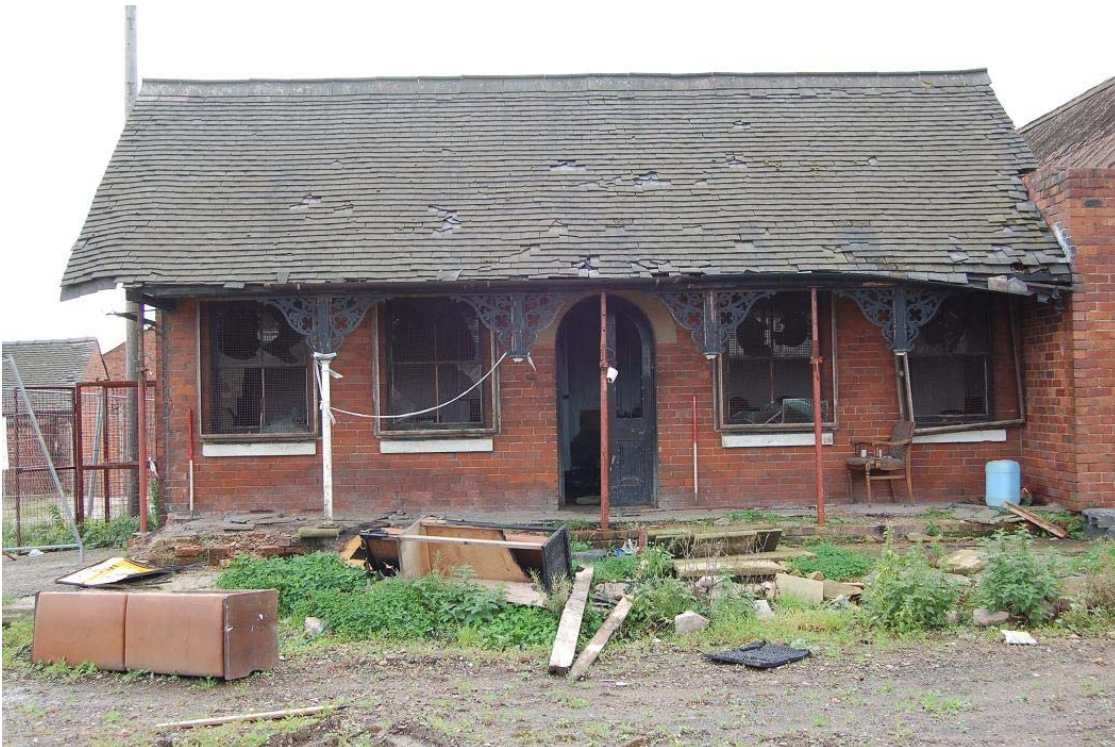
*Plate 1. The public house, east and west wings, north elevations, general view south*

*Plate 2. The public house, east wing, north elevation and porch, view south*

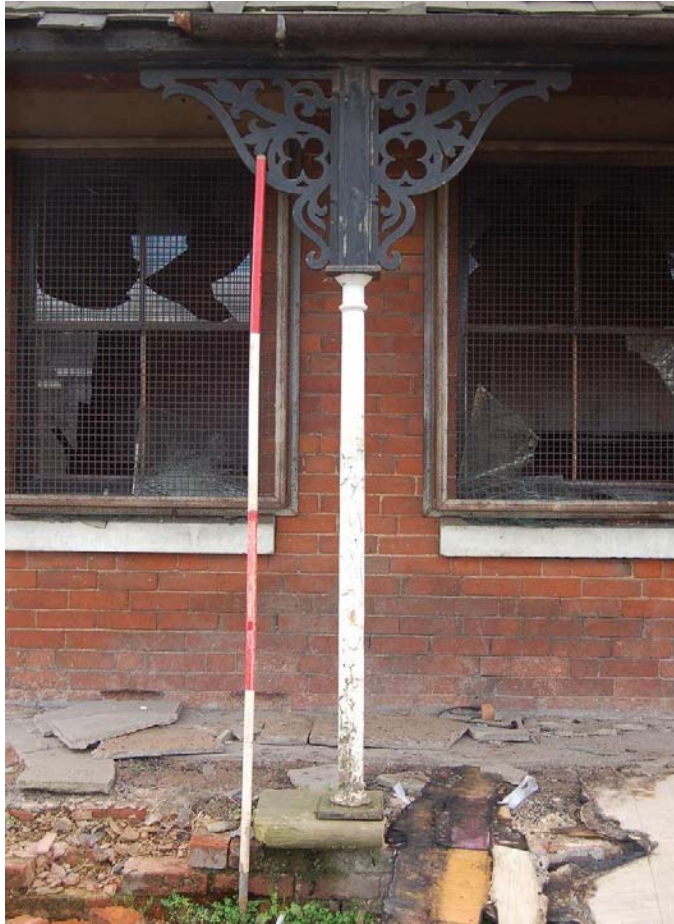
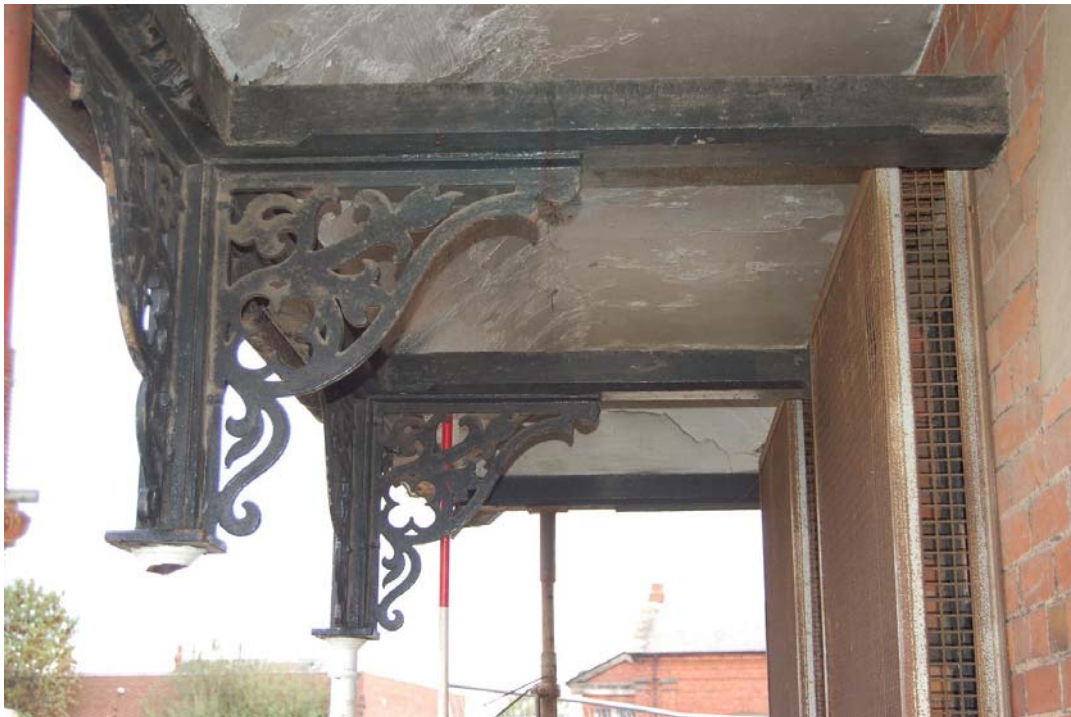
A photographic survey was also undertaken of the extant public house building toward the south side of the site, behind the White Hart Hotel. It appears to have been constructed in two phases, the earlier wing of which retains later 19<sup>th</sup> century decorative ironwork along the porch.

*Plate 3. The public house, east wing, decorated iron pillar on north porch, view south*

*Plate 4. The public house, east wing, detail of decorated iron pillars on north porch, view east*

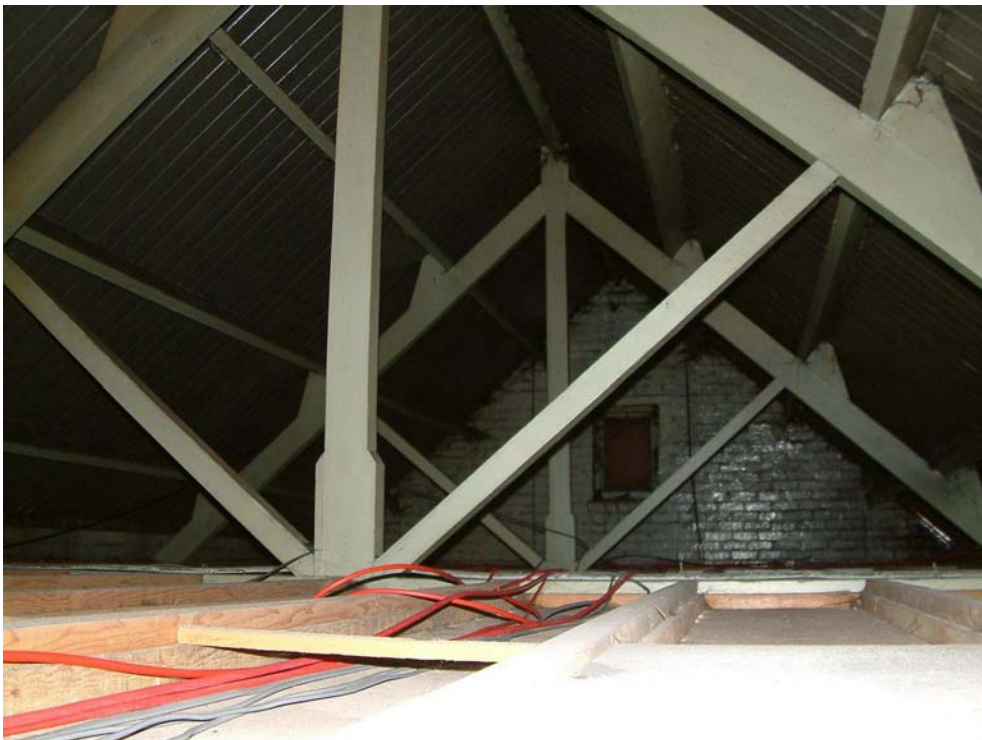
*Plate 30. The public house, west wing, loft space and roof joists, view north*

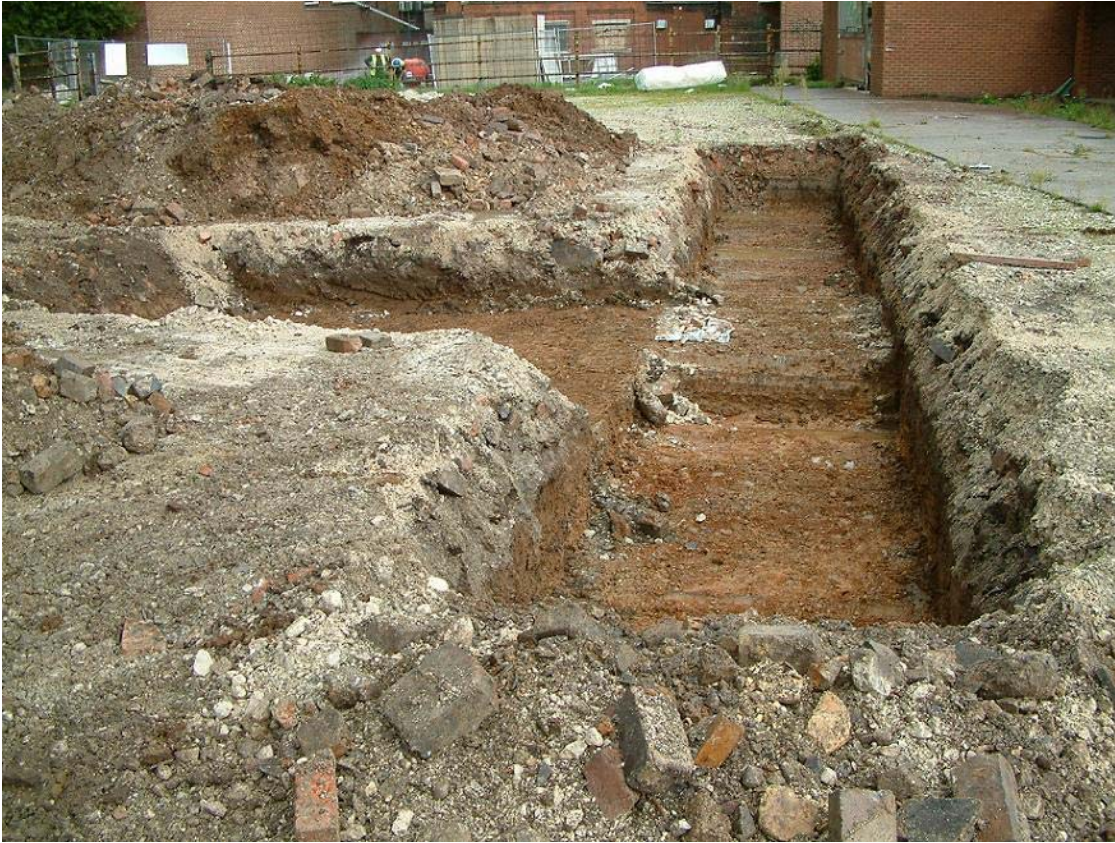
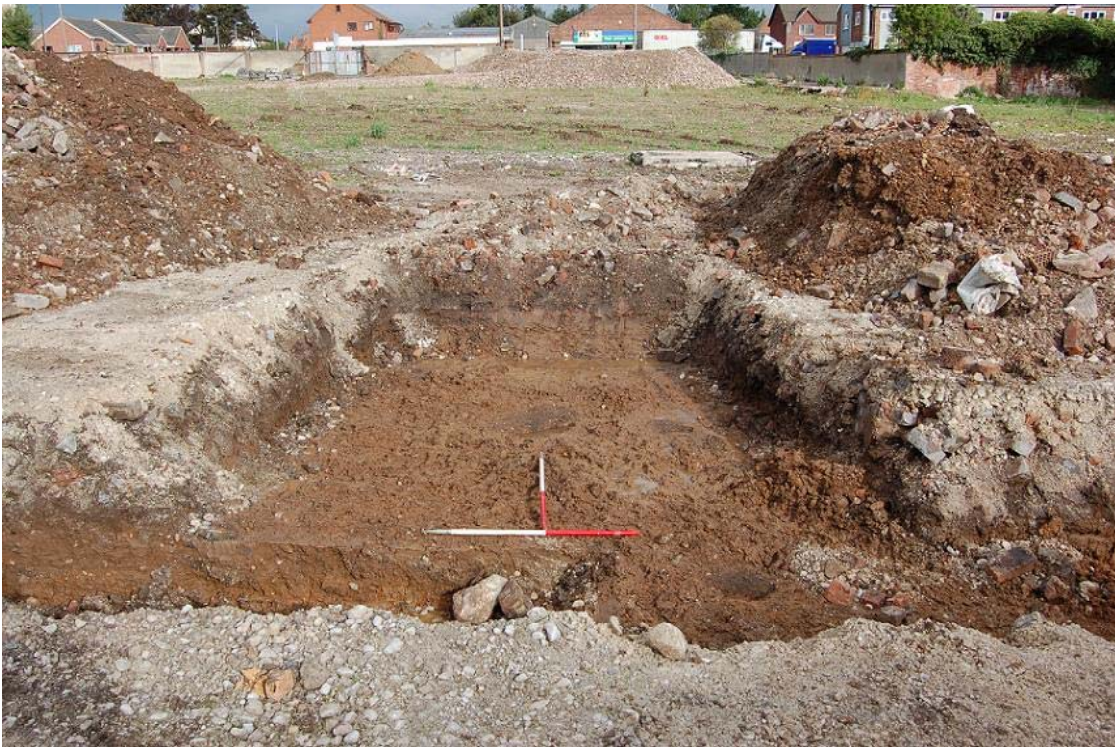
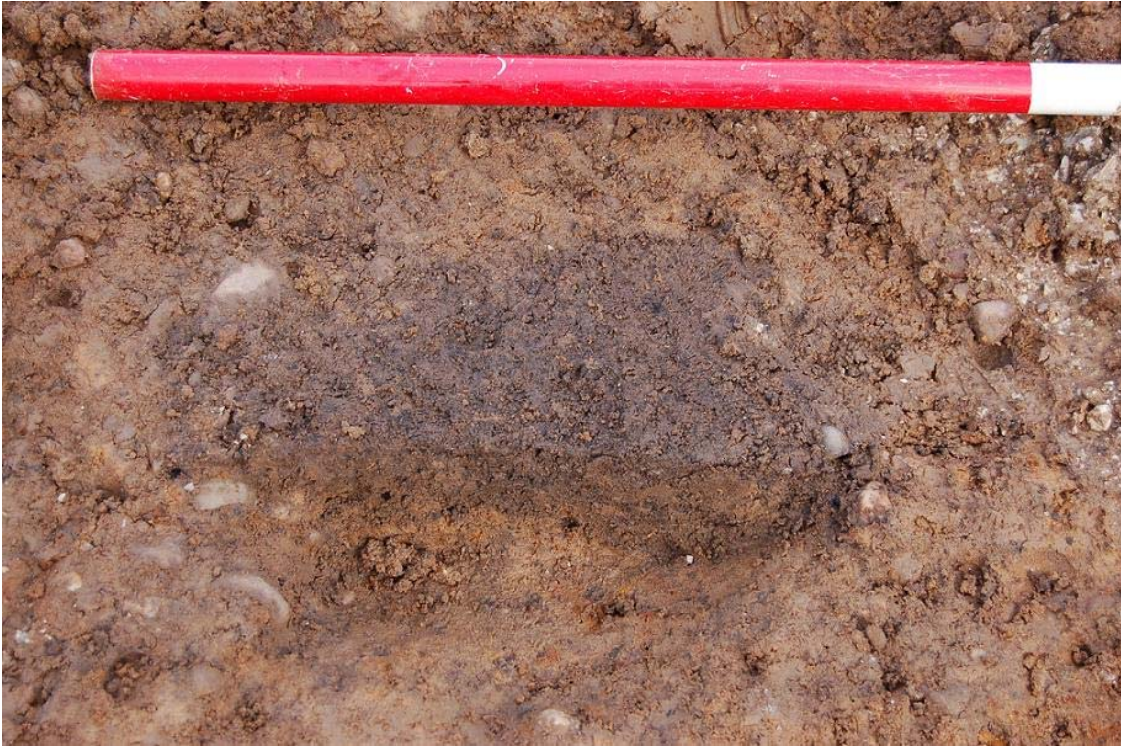
Toward the south-east corner of the site a group of five small associated postholes and a ditch were identified (Trench 6). All were cut into the subsoil from the level of the topsoil. The postholes contained comparable fills, without any clear post-pipes or packing material. Within the area exposed there was no apparent alignment or structural form, although the ditch appeared to define their eastern extent. Two contained 18<sup>th</sup> century material, the rest were dated by association (Plates 31-33).

*Plate 31. Trench 6, general view east*

*Plate 32. Trench 6, posthole group, view north-north-west*

*Plate 33. Trench 6, posthole 609, view north-north-west*

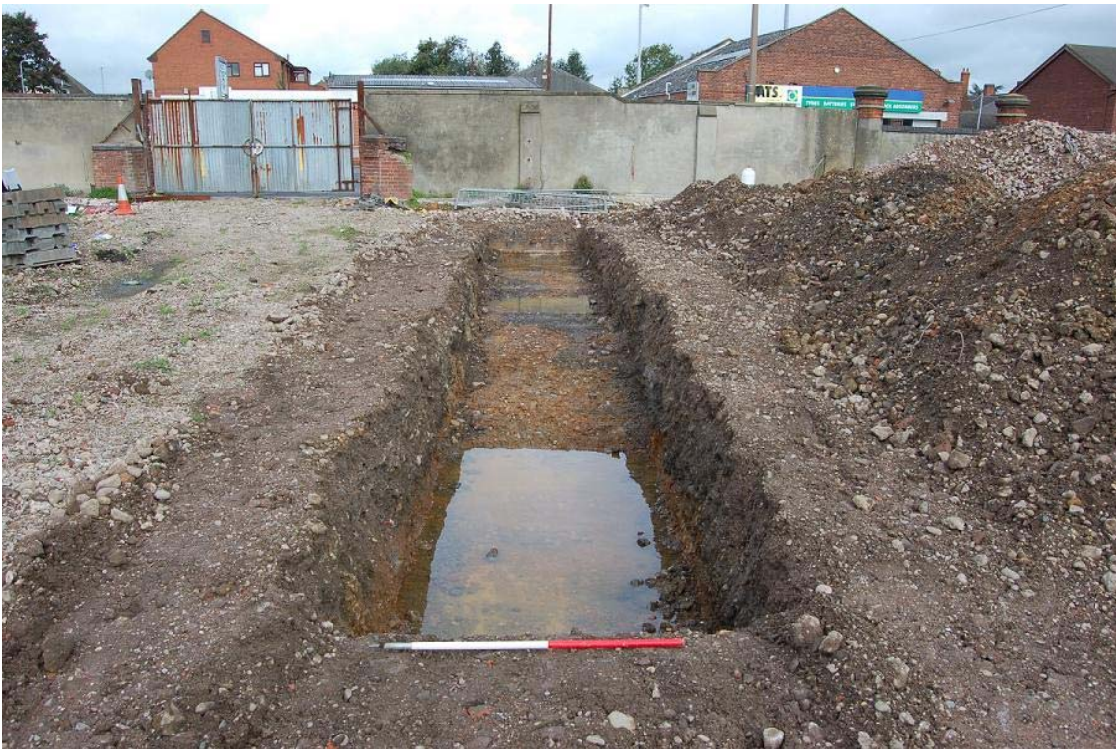
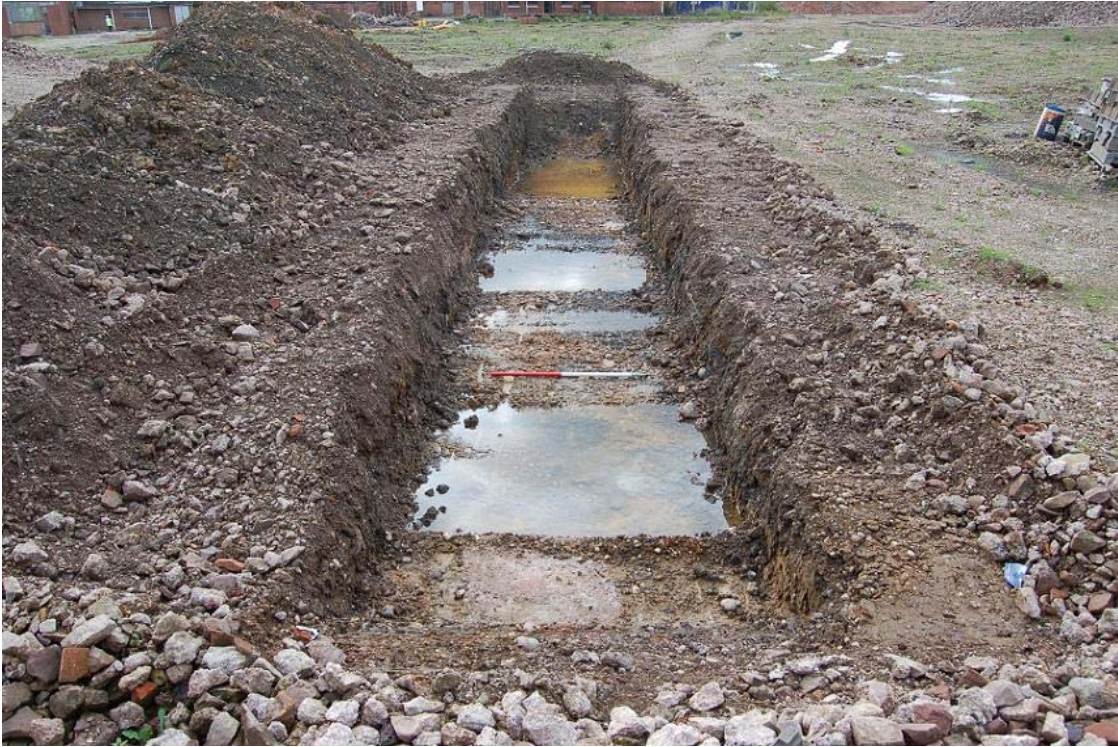
A topsoil and subsoil profile was observed in all trenches, with the exception of Trench 7, where modern overburden lay directly over the natural matrix (Plates 34 and 35). These soil horizons were however frequently disturbed and truncated, containing charcoal and occasional post-medieval and modern artefacts (Section 4.1.2 below).

*Plate 34. Trench 7, general view north-north-west*

*Plate 35. Trench 7, general view south-south-east*

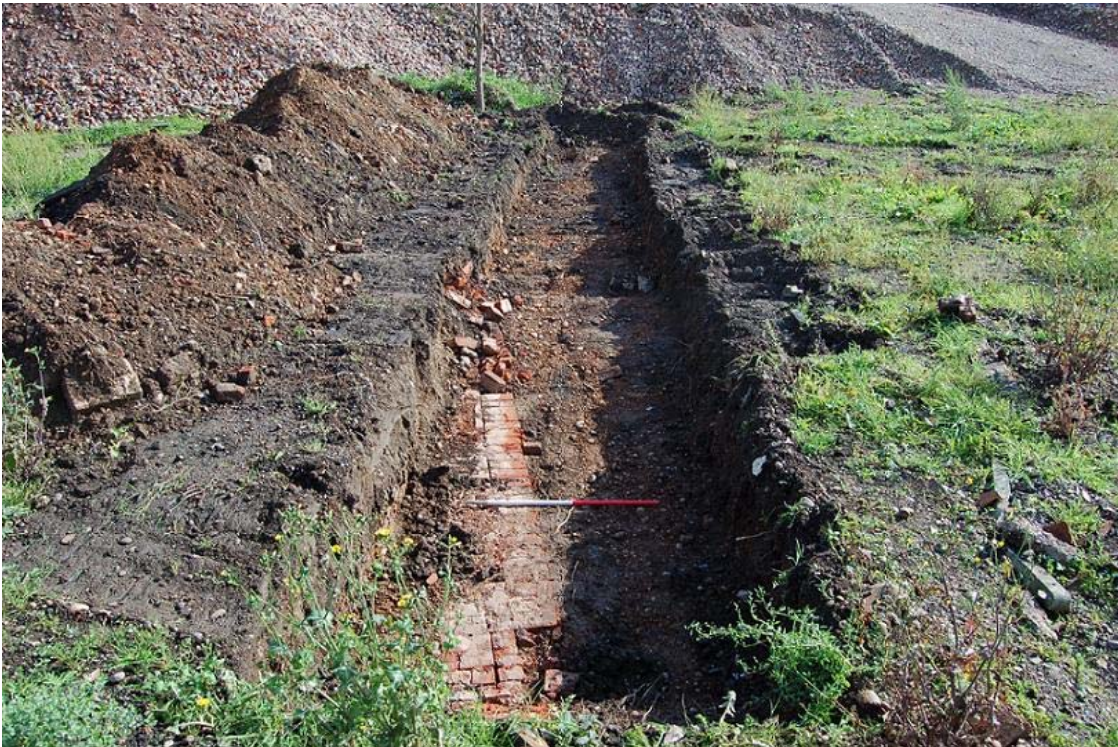
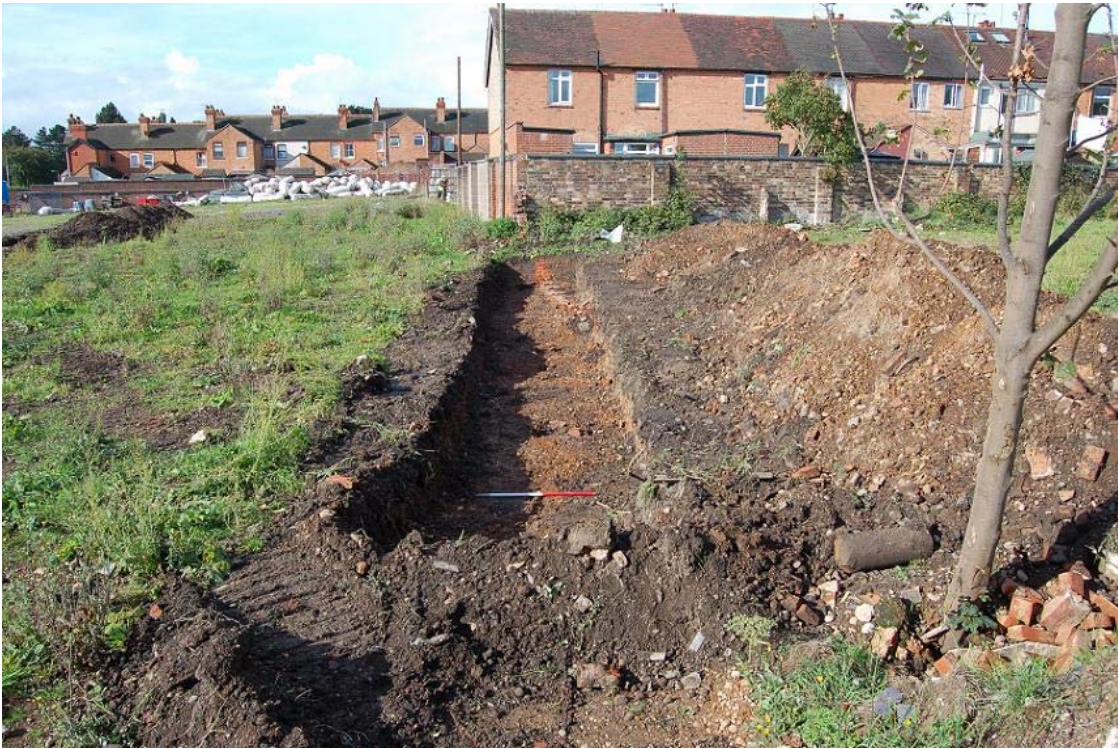
The overburden, including topsoil and subsoil were frequently disturbed and contained post-medieval/modern material. A layer of modern hardcore (gravel, building rubble, crushed tarmac, etc) with variable disturbed soil and redeposited natural was spread over the surface of the site generally. Toward the north site of the site, off Smithfield Road, this horizon lay directly over the natural matrix (Trench 7; Plates 34 and 35). To the rear of James Street, the natural was truncated by frequent post-medieval/modern dump deposits to the south and the footing for a modern east-west aligned brick wall, defining a former builder's yard (Trench 8; Plates 36 and 37).

*Plate 36. Trench 8, general view east-north-east*

*Plate 37. Trench 8, general view west-south-west*

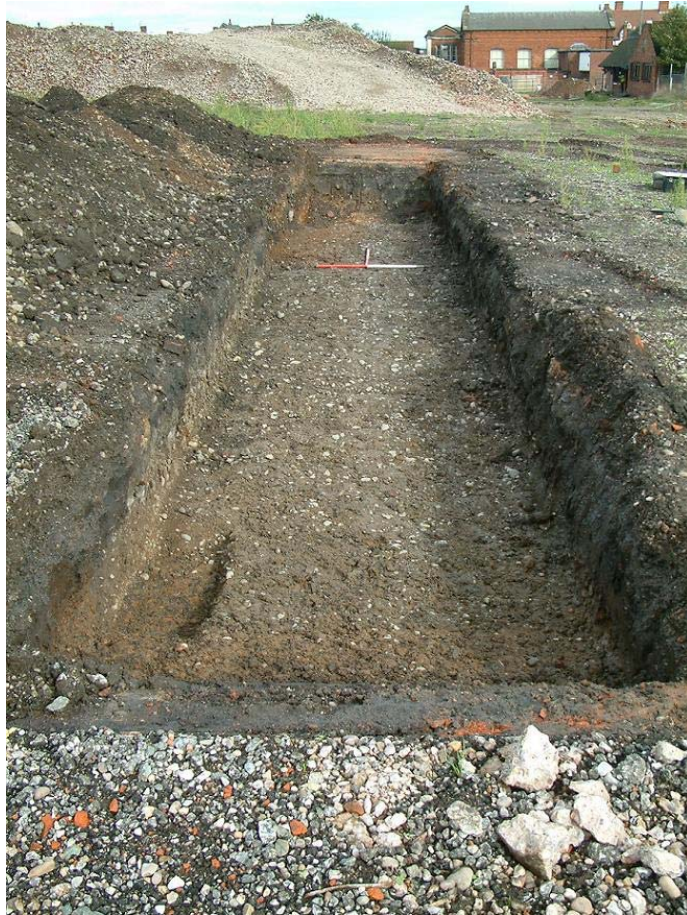
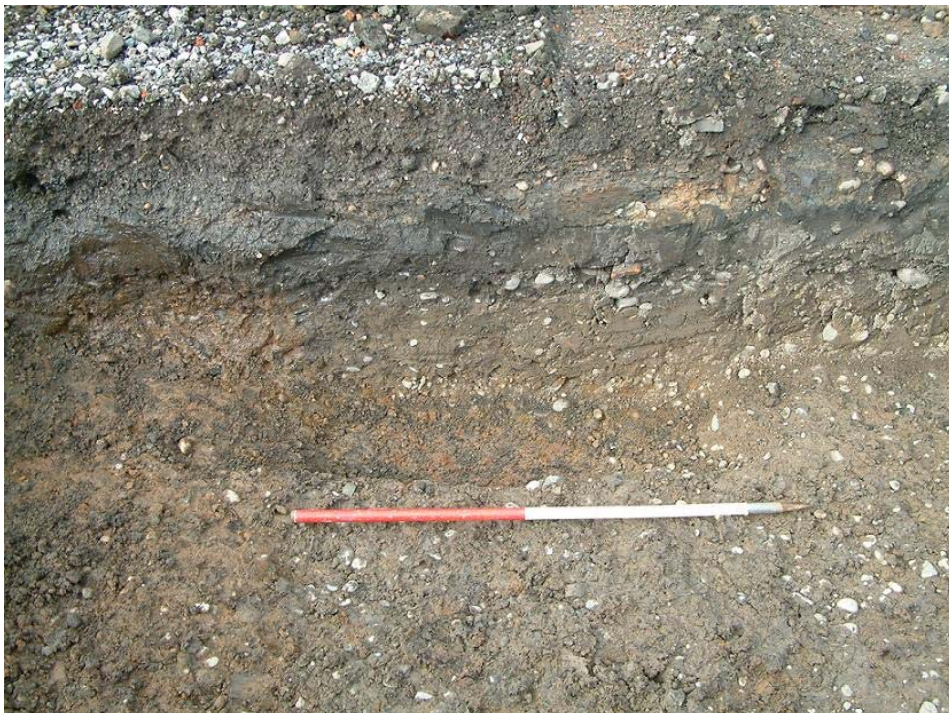
*Plate 38. Trench 9, general view east*

*Plate 39. Trench 9, hollow 906, section, view north-north-west*

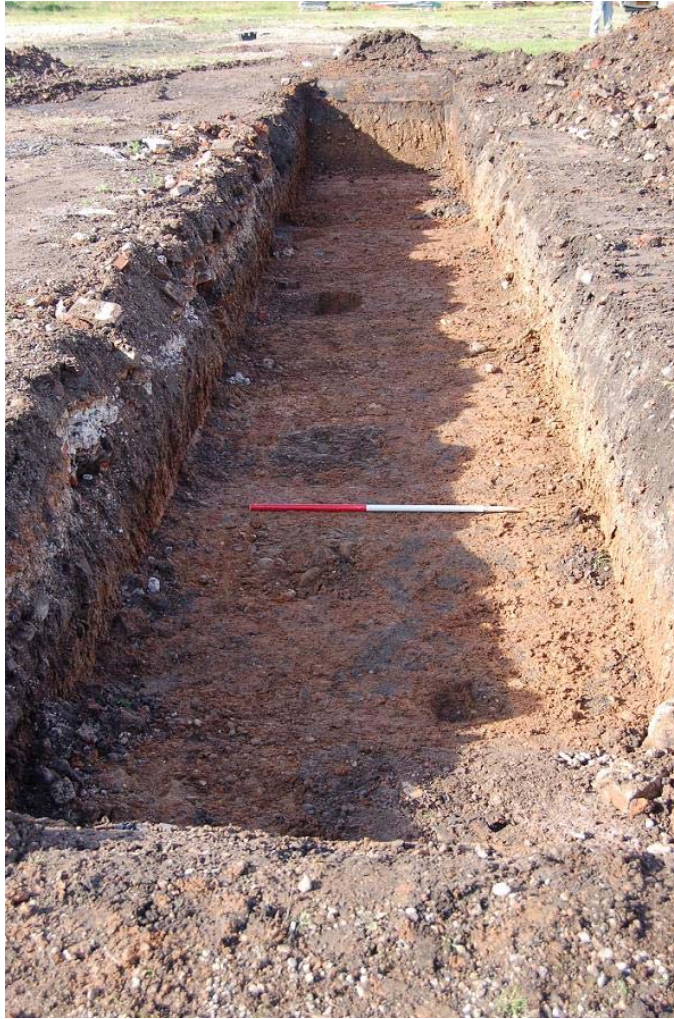
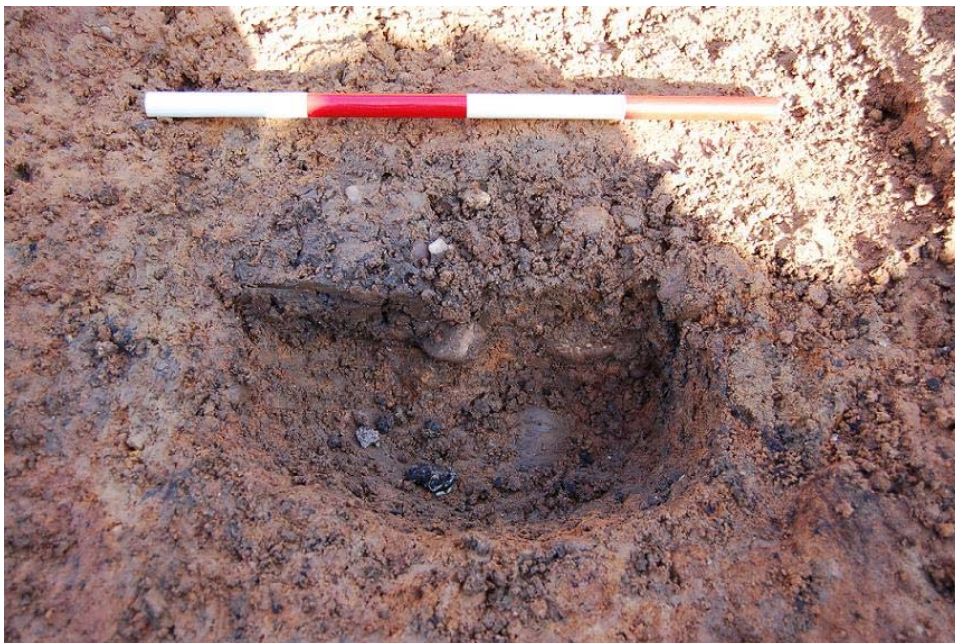
*Plate 40. Trench 10, general view west-south-west*

*Plate 41. Trench 10, posthole 1017, view north-north-west*

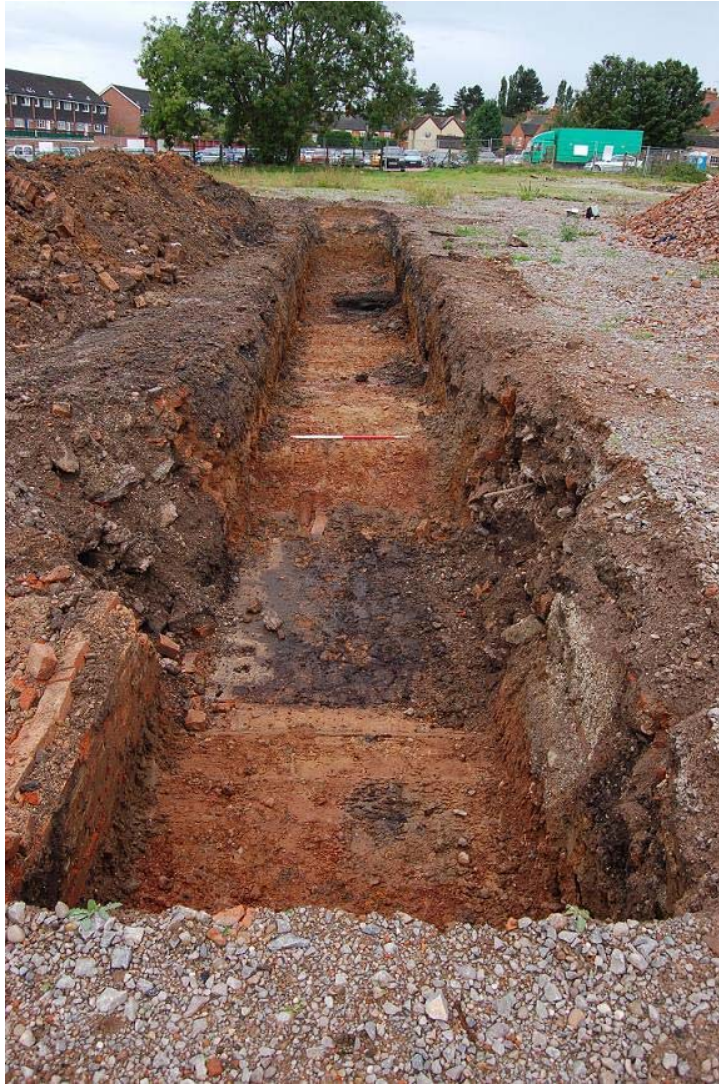
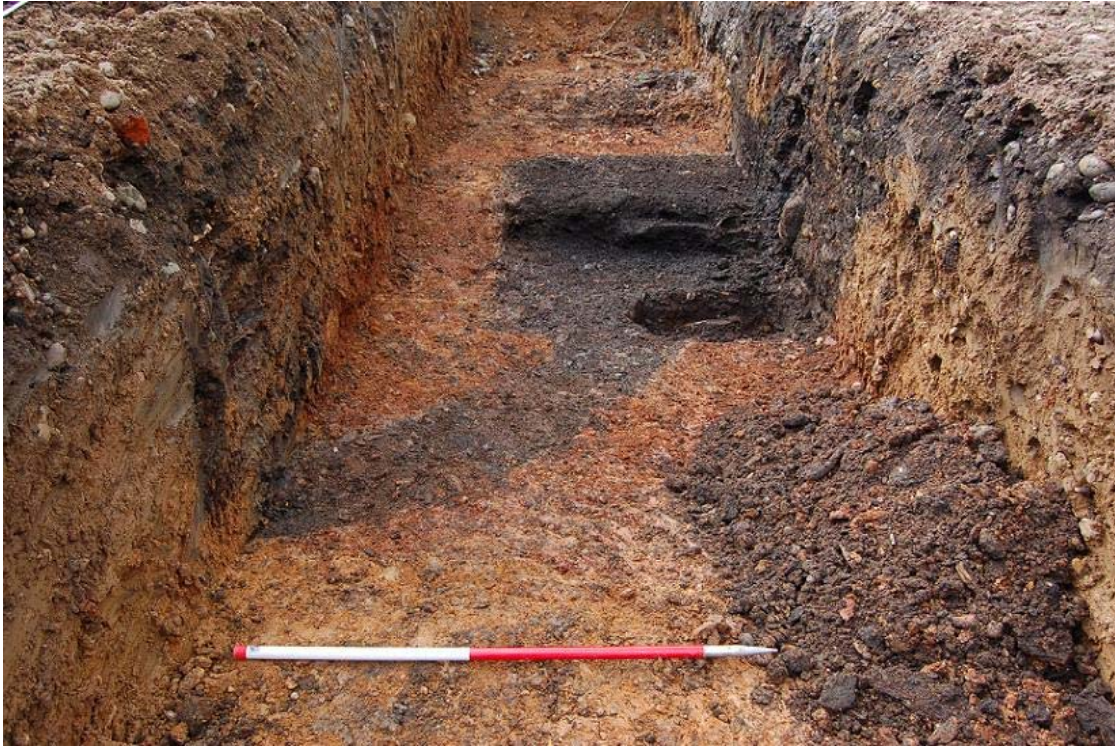
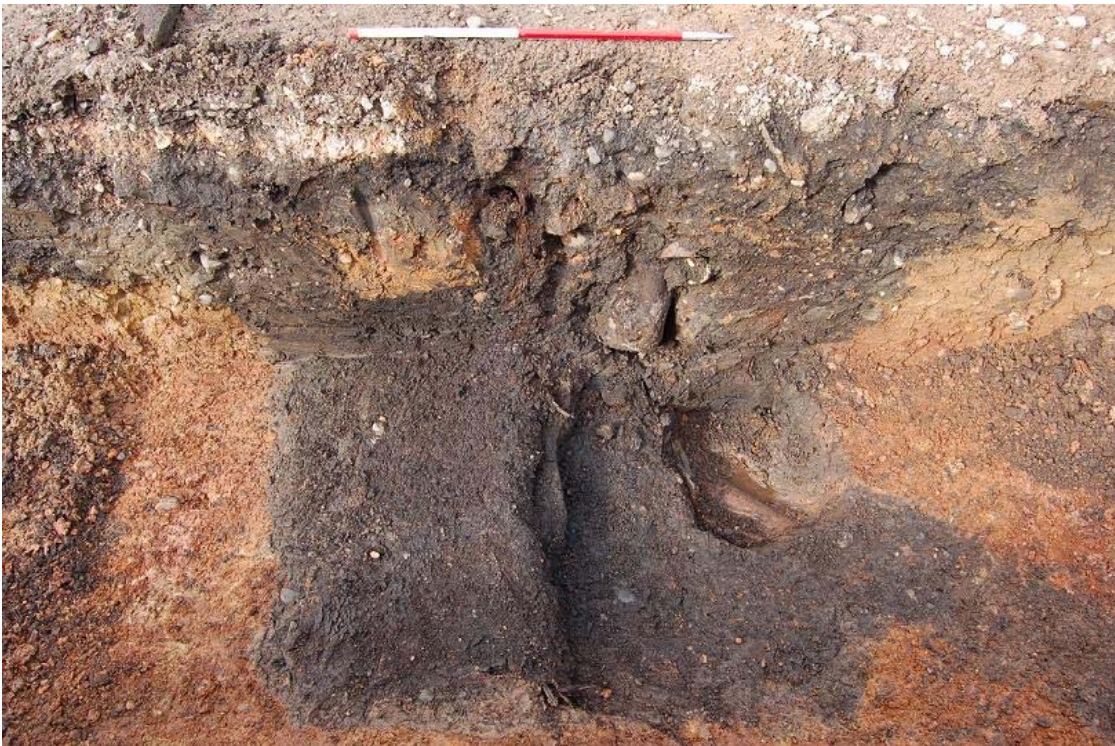
Along the south side of the site, to the rear of the Heritage Centre, a concrete and brick structure was observed, cut to more than 2m into the natural (Trench 11). It comprised double skin walls of machine made red bricks and a thick concrete base. A large deep sub-rectangular pit was identified to the west, with sheer sides and a flat base, a probable wooden lining, and a drainage pipe leading off from the east corner. The lower fill contained 18<sup>th</sup> and 19<sup>th</sup> century material including sawn timber fragments (Section 4.3 below). It had been truncated by a 20<sup>th</sup> century intrusion (Plates 42-44).

*Plate 42. Trench 11, general view west-south-west*

*Plate 43. Trench 11, pit 1104, view west-south-west*

*Plate 44. Trench 11, pit 1104, view north-north-west*

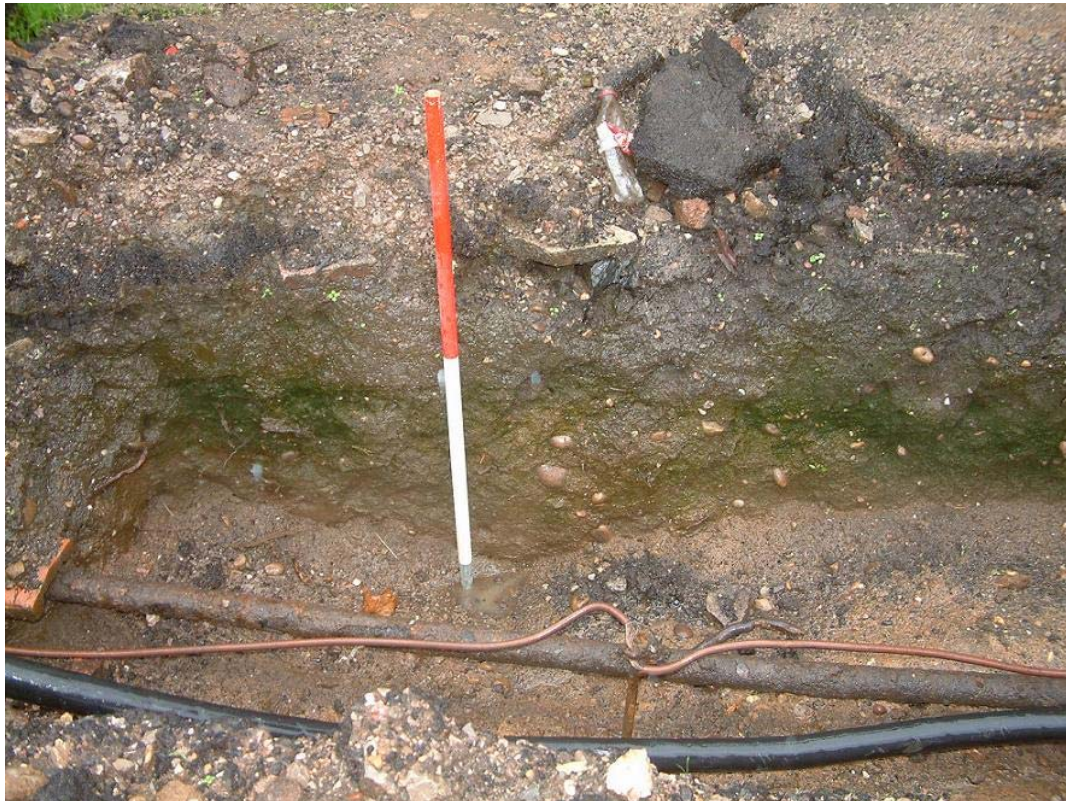
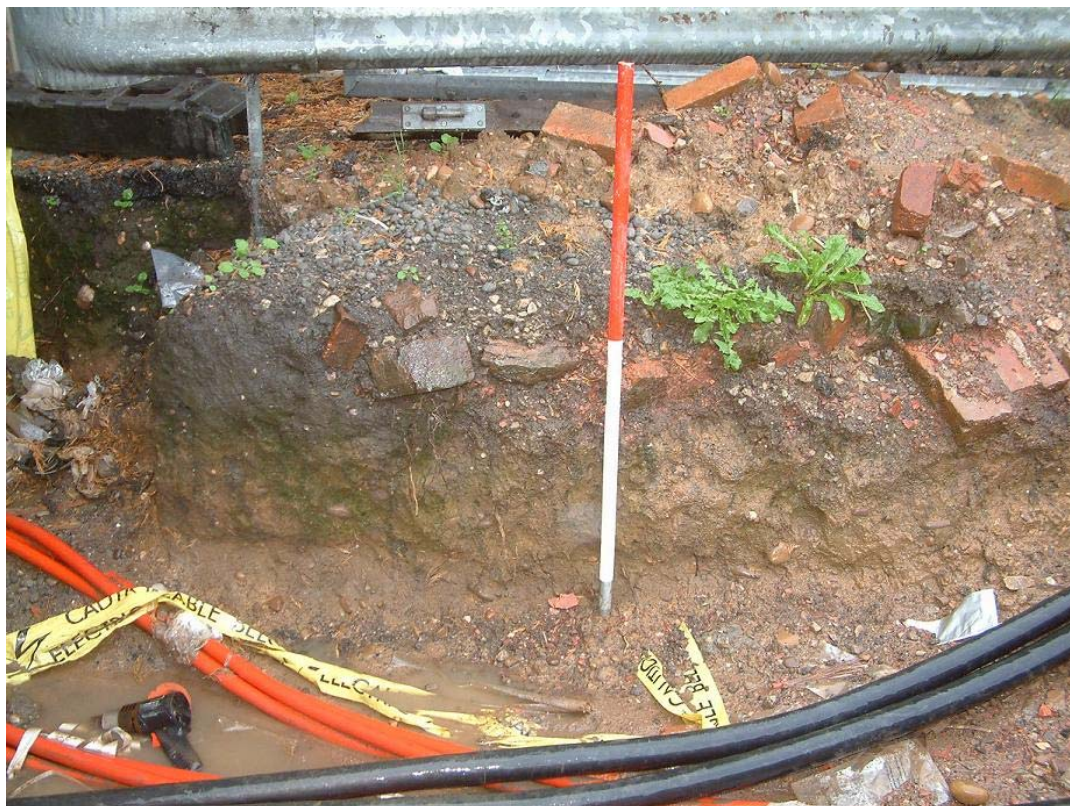
Within the trench associated with the electrical sub-station to the west end of the car park on the west side of the site, the natural matrix of sandy clay with pebble gravel was observed at less than 0.30m depth, below disturbed soils containing modern building debris (Plates 47 and 48).

*Plate 47. Trench associated with electrical sub-station within car park on west side of site, south section, view west-south-west*

*Plate 48. Trench associated with electrical sub-station within car park on west side of site, north section, view west-south-west*
