ARCHAEOLOGICAL EVALUATION
AT
BUSHBURY HILL PRIMARY
SCHOOL,
OLD FALLINGS LANE,
BUSHBURY, WOLVERHAMPTON

Project 3391
Report 1713

Archaeological evaluation at Bushbury Hill Primary School, Old Fallings Lane, Bushbury, Wolverhampton

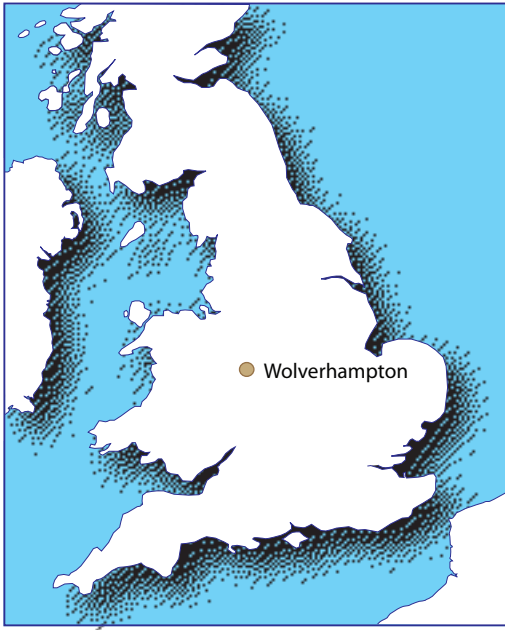
Figure 1

Location of the site

An archaeological evaluation was undertaken at Bushbury Hill Primary School, Old Fallings Lane (NGR SJ 9268 0213), Bushbury, Wolverhampton (Fig 1), on behalf of Jacobs UK Ltd whose client, Wolverhampton City Council (WCC) intends to demolish the current school buildings and rebuild to the south and south-west, as part of the Primary Capital Programme (PCP). A desk based assessment and geophysical survey (HEAS 2009) were undertaken prior to the evaluation. Following the results of these exercises it was considered by Mike Shaw, Black Country Archaeologist, Wolverhampton City Council (The Curator) that the development had the potential to affect underlying archaeological remains (BCSMR ref. MBL 1835).

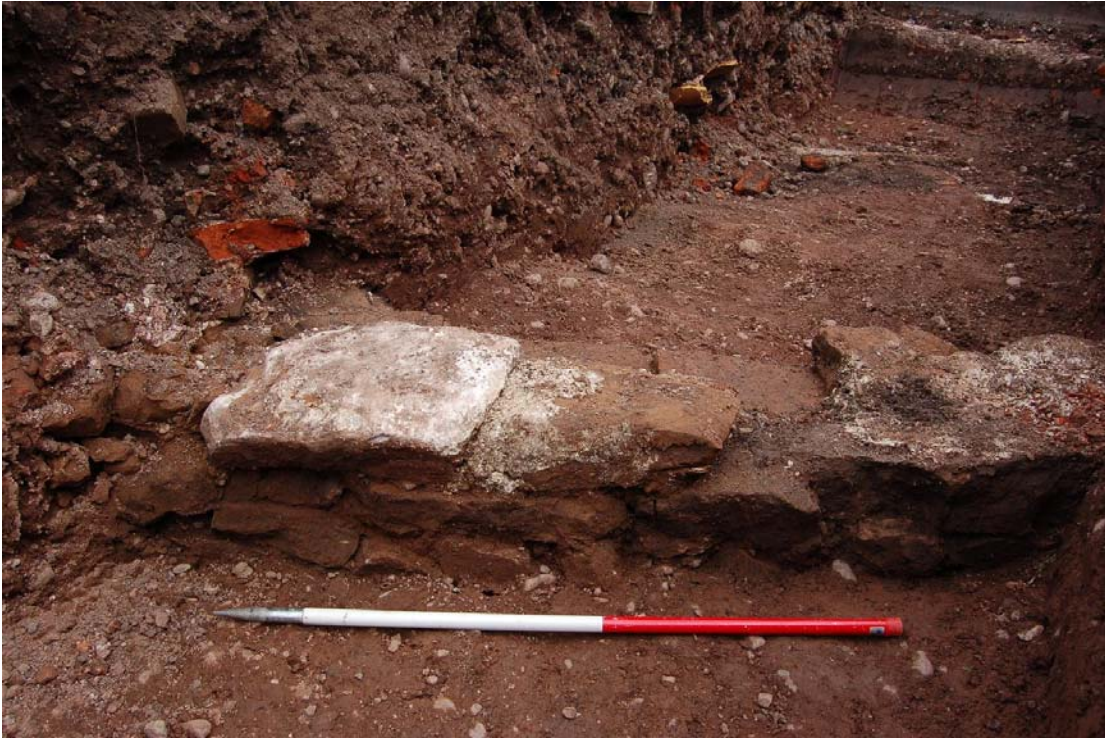
Plate 3, Wall foundation 103 showing remnants of later mortar associated with later brick addition 110.

The earliest features noted on site were two sandstone built foundation bases 103 and 104 that appear to represent part of a single large building. Whilst no artefactual material was recorded with these structures the construction style and mortar type suggest a late medieval or early post-medieval date. The foundations of the earlier building may have been re-used for farm buildings at the later period.

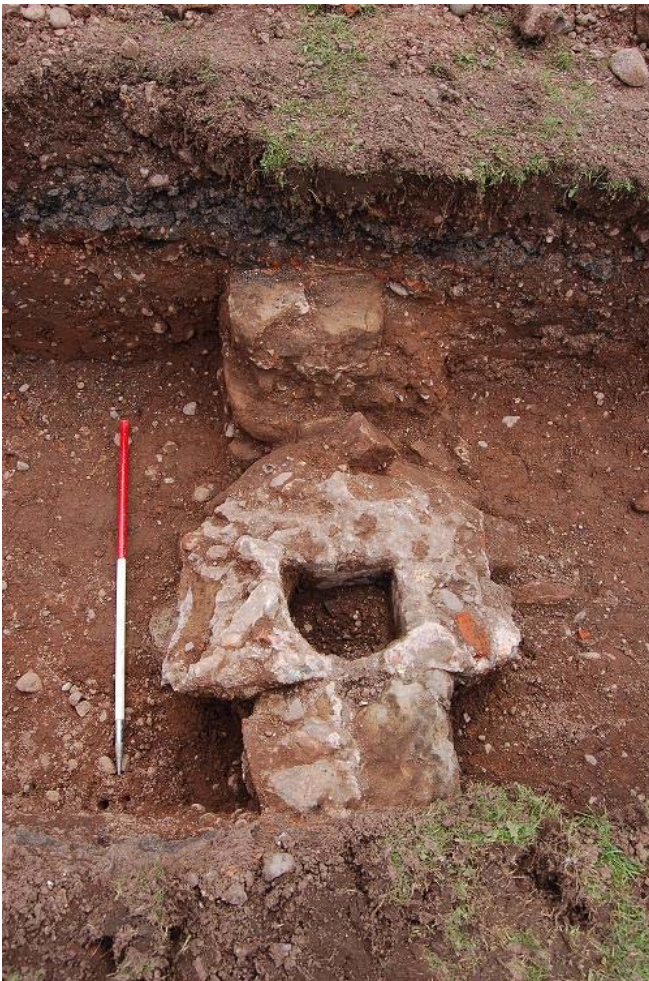
Plate 4, Wall 104 showing later truncation by concrete post base 107.

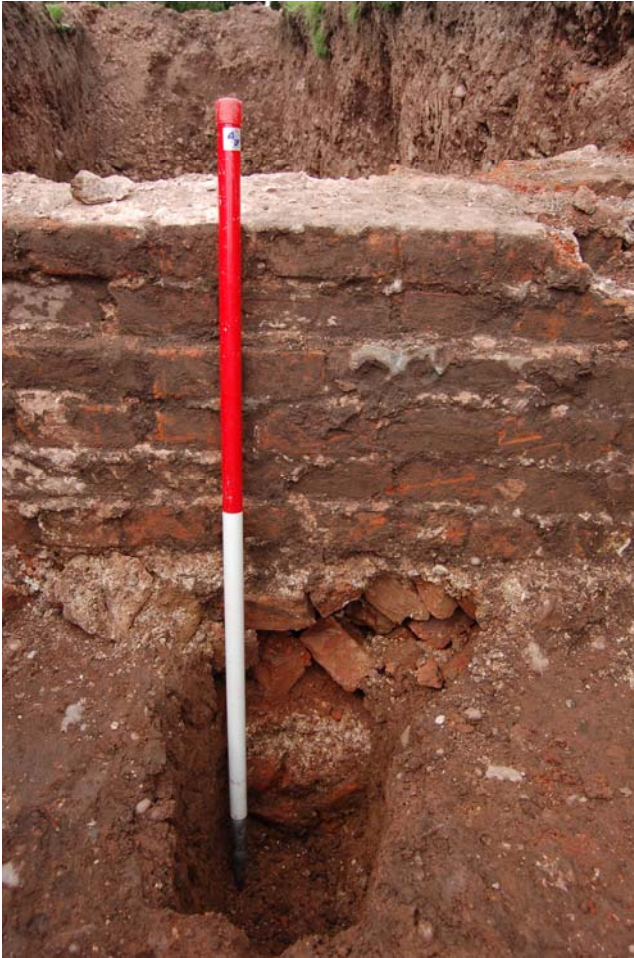
Plate 5, Wall 204 showing brick rubble foundation 206.

To the northwest three brick walls 109, 110 and 204 revealed the known location of various outhouses associated with the farm complex. Whilst later truncation made interpretation difficult, it was noted that all had substantial foundations (either through the use of earlier ones 103, 104 or contemporary built 206) had been constructed within foundation trenches as opposed to being free standing. The attempt to make load bearing structures suggests that these outhouses must have been fairly substantial in design, and more than a simple lean-to or stable affair. The top of a barrel shaped brick arch 507 was noted at a depth of 1.70m BPGL towards the southern extent of the area of investigation, at present it is thought that this may represent the roof of a culvert however due to the unsafe nature of the trench and depth of feature this cannot be confirmed at present.

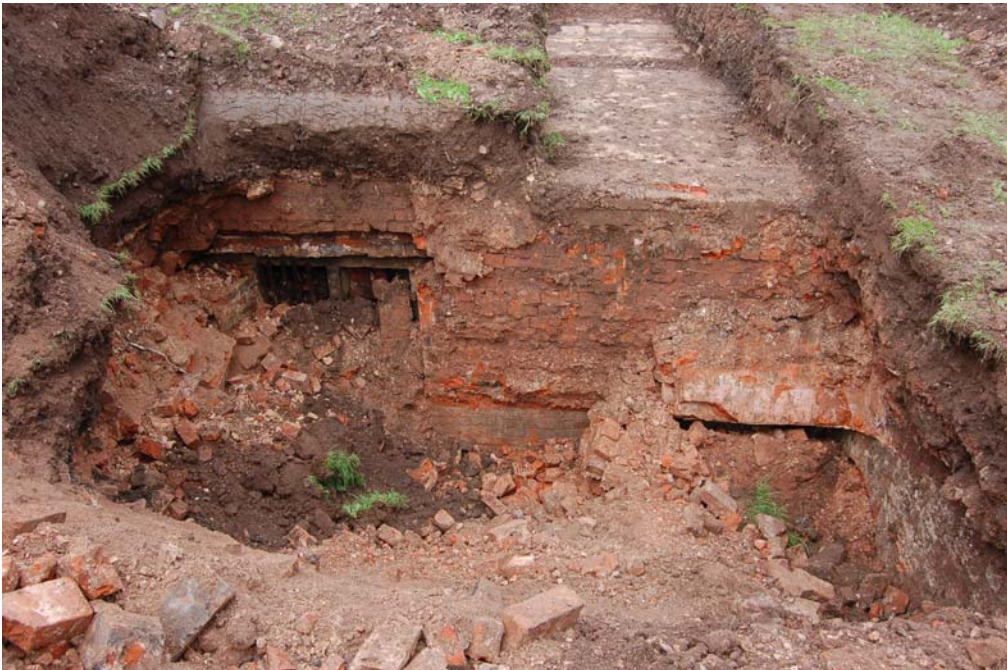
Plate 6, Bushbury Hill Farmhouse cellar 313 and external wall 310 with external surface 308 in background. Note window/coal chute at left of image.

Bushbury Hill Farmhouse appears to have been constructed in a single phase 310 and 313 with a later yard surface 308 being added to the northeast of the building in the middle to late 19th Century. The yard surface was edged with bricks 309 to the northeast and had a potential entrance 311 to cellarage 313 to the immediate north. Unfortunately due to the limit of excavation this cannot be confirmed at present. Cellarage 313 although badly truncated during demolition displayed evidence of a large vaulted cellar with what appears to be a Norman style arched doorway in the southeast wall. This was overlain by wall 310 that revealed the presence of a window or coal chute type opening into the cellarage area that would have been parallel to surface 308. Again due to the limit of excavation this cannot be confirmed.
