ARCHAEOLOGICAL WATCHING
BRIEF AND EVALUATION
(STAGE 2) AT
BUSHBURY HILL PRIMARY
SCHOOL, OLD FALLINGS LANE,
BUSHBURY, WOLVERHAMPTON

12 November 2009

Project 3407
Report 1727

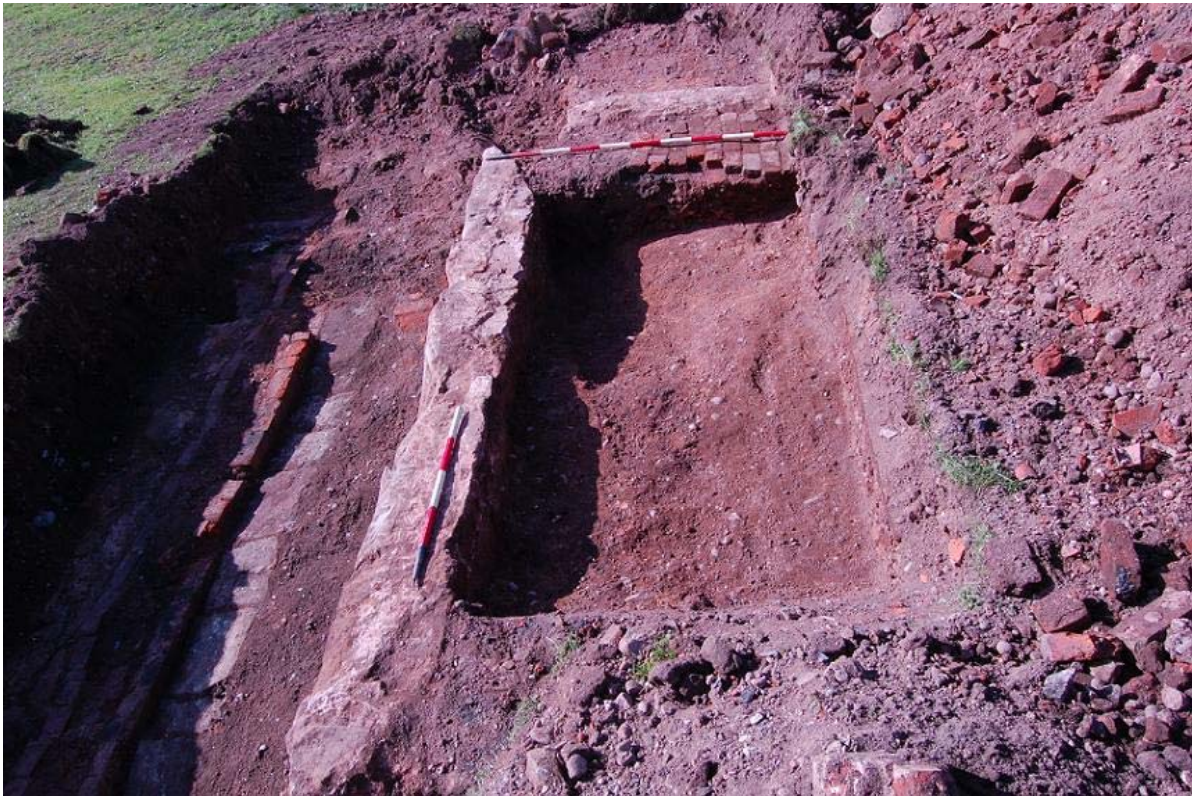
A brick floor surface, 8004, abutted the northeast face of the southern arm of wall 8002. It was bedded on a levelling deposit of sandy silt with frequent stones, 8030. Both the wall and the floor surface had been truncated by a modern service trench, 8029, aligned approximately north-south, which had removed the corner of the wall.

Plate 3, Trench 8, general view southwest of wall 8002 and floor 8004

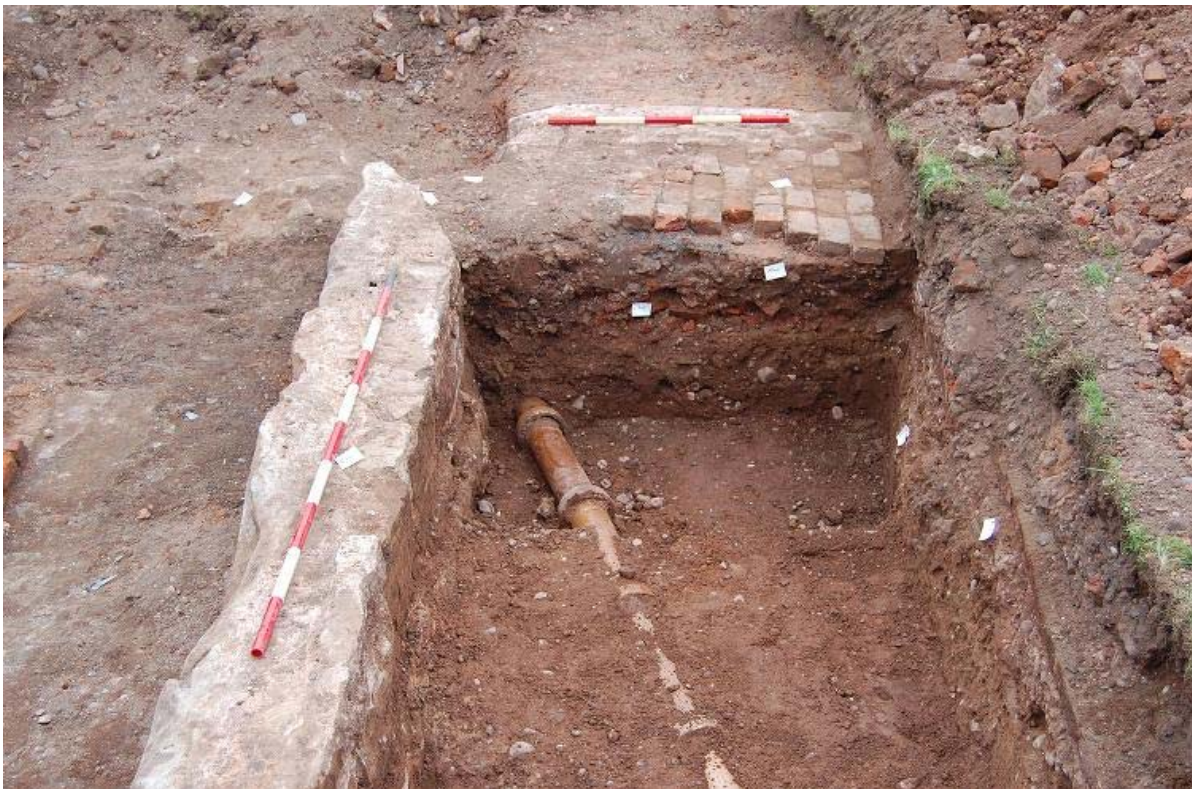
Plate 4, Trench 8, view southwest of wall 8004 and floor 8004, truncated by modern service pipe

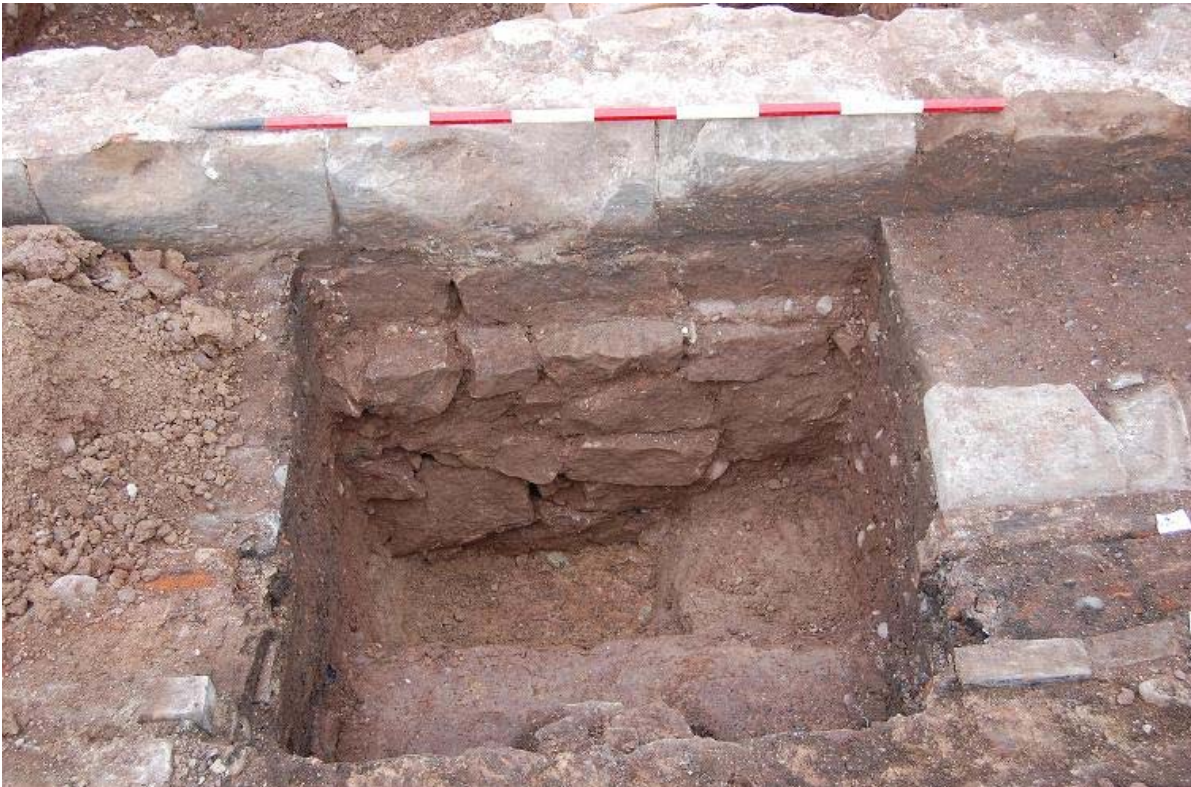
Plate 6, Trench 8, view northwest of foundation 8047 and wall 8002 in sondage

in length, northeast-southwest. As it was on a foundation of rough sandstone blocks dug to just over 1m deep, 8047, it is conjectured to have been two storeys high. Although intrinsically undated, the butting internal floor, 8004, to the northwest comprised bricks dated to 1784-1803, bedded on layers of made ground, 8032 and 8042, which also butted against the wall, and contained material of 18th century date. This would suggest that the building is of 18th century or earlier date. It is considered likely to have been constructed at the same time as Bushbury Hill House in the 1780s but may equally represent a more substantial building pre-dating the more ordinary farm buildings recorded in this area.

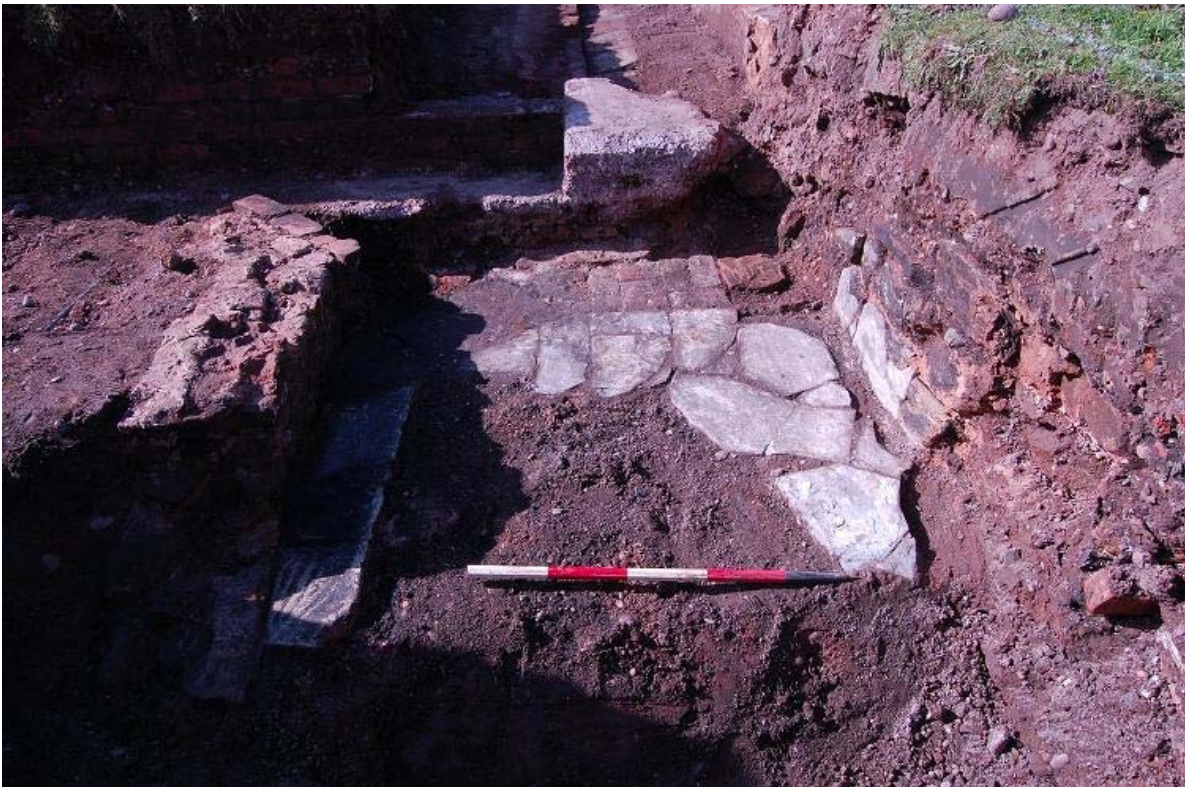
A flagstone and brick floor surface, 8003, abutted walls 8000-8002. It was bedded on a levelling deposit, 8048, of silt with extension charcoal and brick rubble inclusions. Both walls 8001 and 8002 and the adjacent floor 8003 had been truncated to the northeast by modern landscaping, 8013.

Plate 8, Trench 8, view southwest of floor 8003 with wall 8001 to southeast and 8002 to northwest

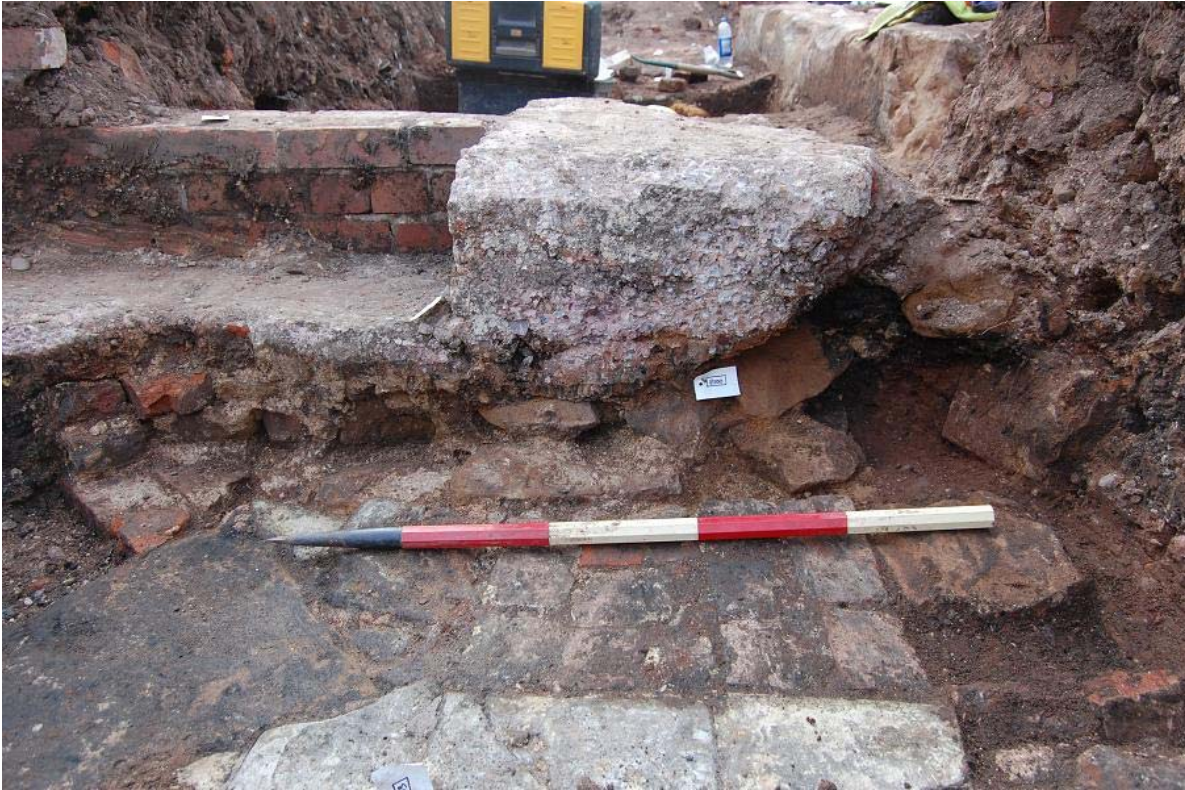
Plate 9, Trench 8, view southwest of wall 8000 truncated by concrete base 8017

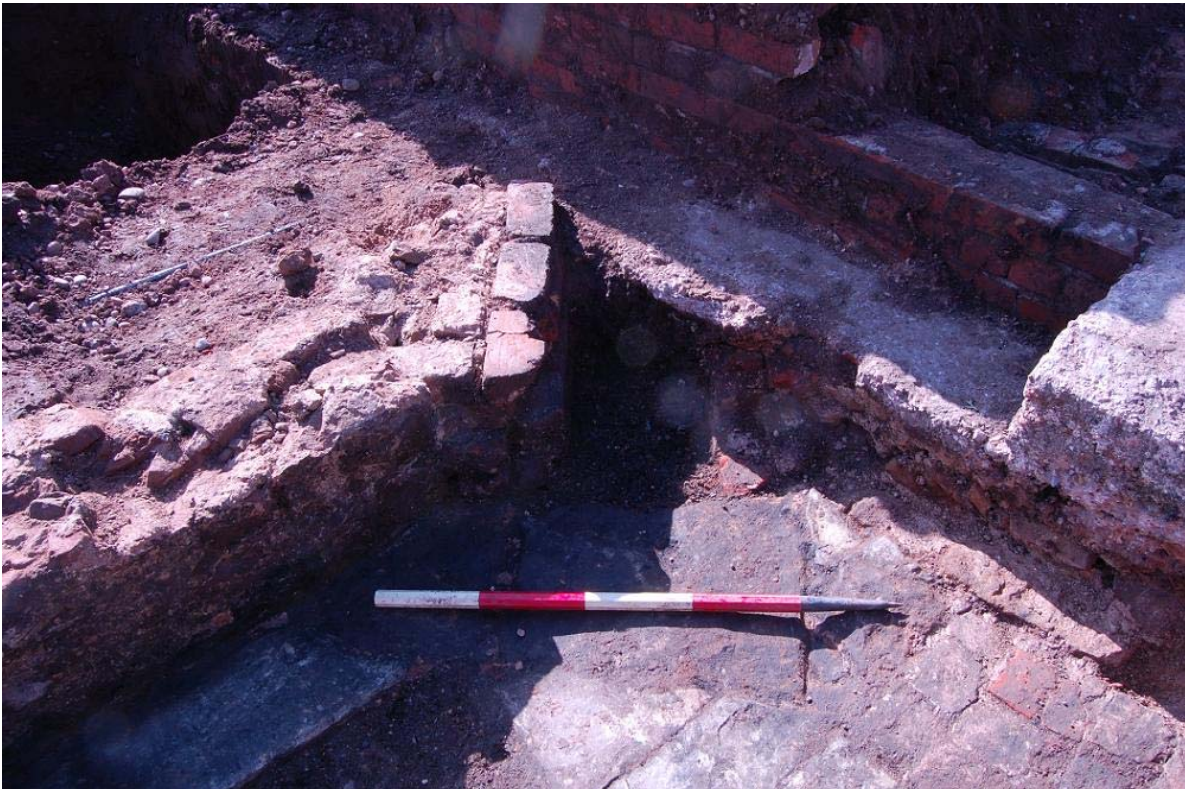
A north-south aligned brick lined drain, 8015, lay to the northeast of drain 8020. Their relationship is unclear. The drain was found to truncate wall 8001 to the northeast and flagstone floor 8003 to the north. It was truncated by modern concrete foundation 8017 to the south and a modern service trench aligned northeast-southwest.

Plate 10, Trench 8, view south of brick drain 8015 adjacent to floor 8003, truncated by concrete base 8017

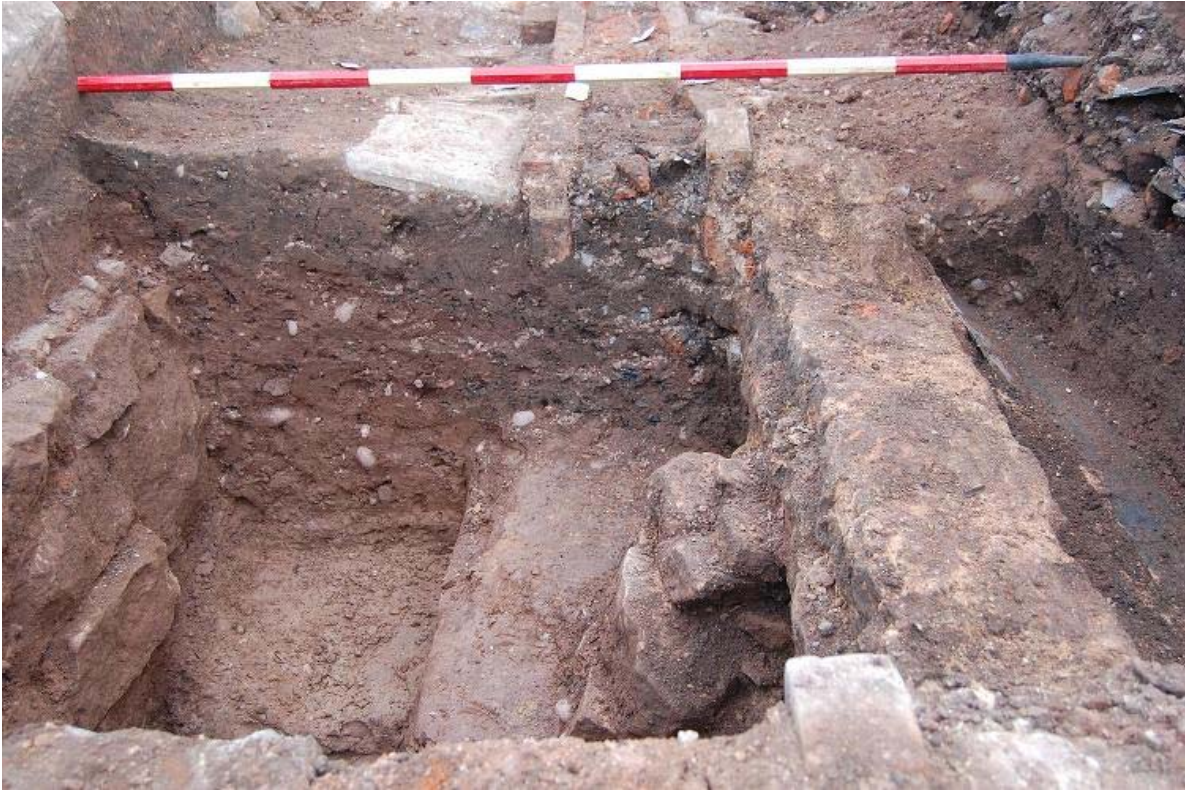
A slate lined drain, 8053, lay along the southeast side of wall 8007. It was up to 0.42m deep, sealed by a silty clay layer, 8025, with occasional charcoal brick rubble and pebbles.

On the northwest side of wall 8007/8046, lay a floor surface, 8006, comprised of a single line of flagstones, 5.75m in length. Between this floor and the wall lay a brick lined drain, 8005, and 8024. The drain was filled with building debris, 8028. The drain turned a right angle to the southeast at either end.

Plate 11, Trench 8, view northeast of section through floor 8006, brick drain 8005/8024, wall 8007 and slate lined drain 8053

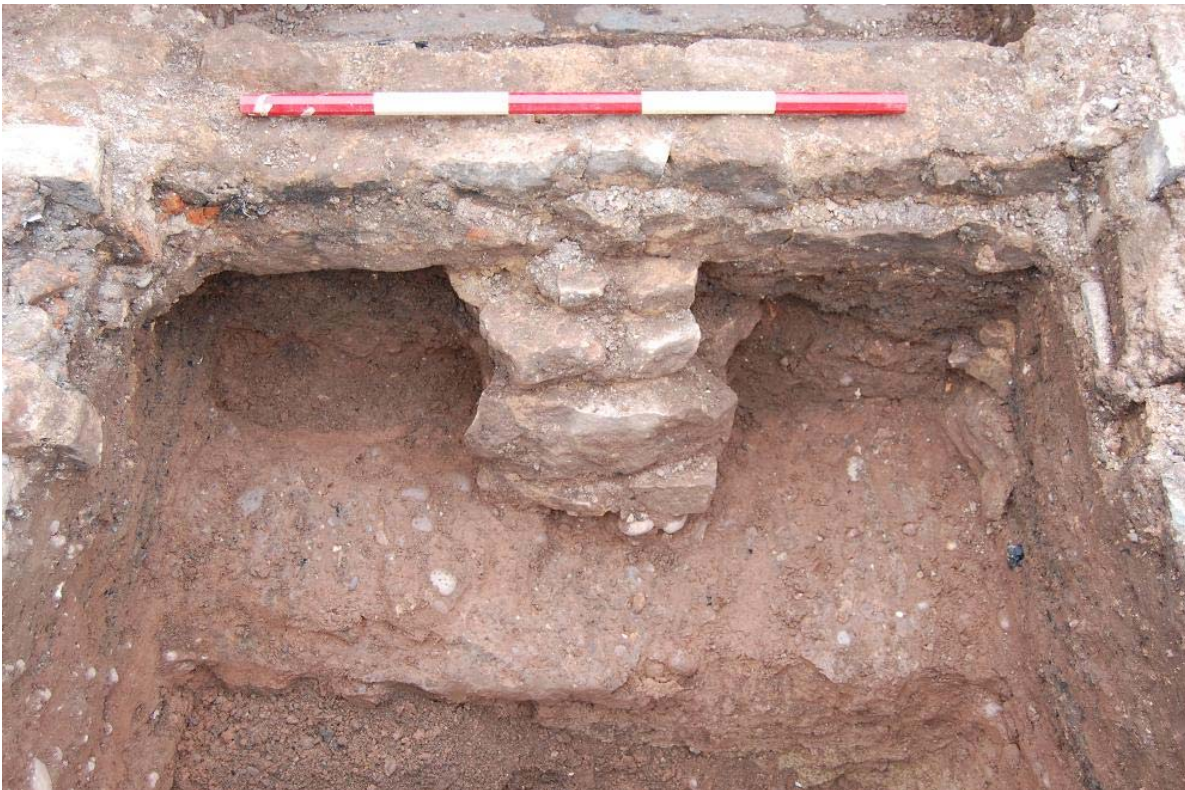
To the southeast of 8002, another wall, 8007/8046, was recorded running parallel, 4.50m in length and 0.30m wide, surviving to 0.22m high. It was bedded on a levelling deposit of slightly clayey, silty sand with occasional pebbles and charcoal, 8050, overlying the natural matrix. The levelling deposit had also been dug through to insert a column of masonry rubble, 8052, approximately 0.50m in height. This formed an additional foundation for wall 8007, although it is unclear if it related to an earlier structure.

Plate 12, Trench 8, view southeast of masonry pile foundation 8052 below wall 8007 in sondage

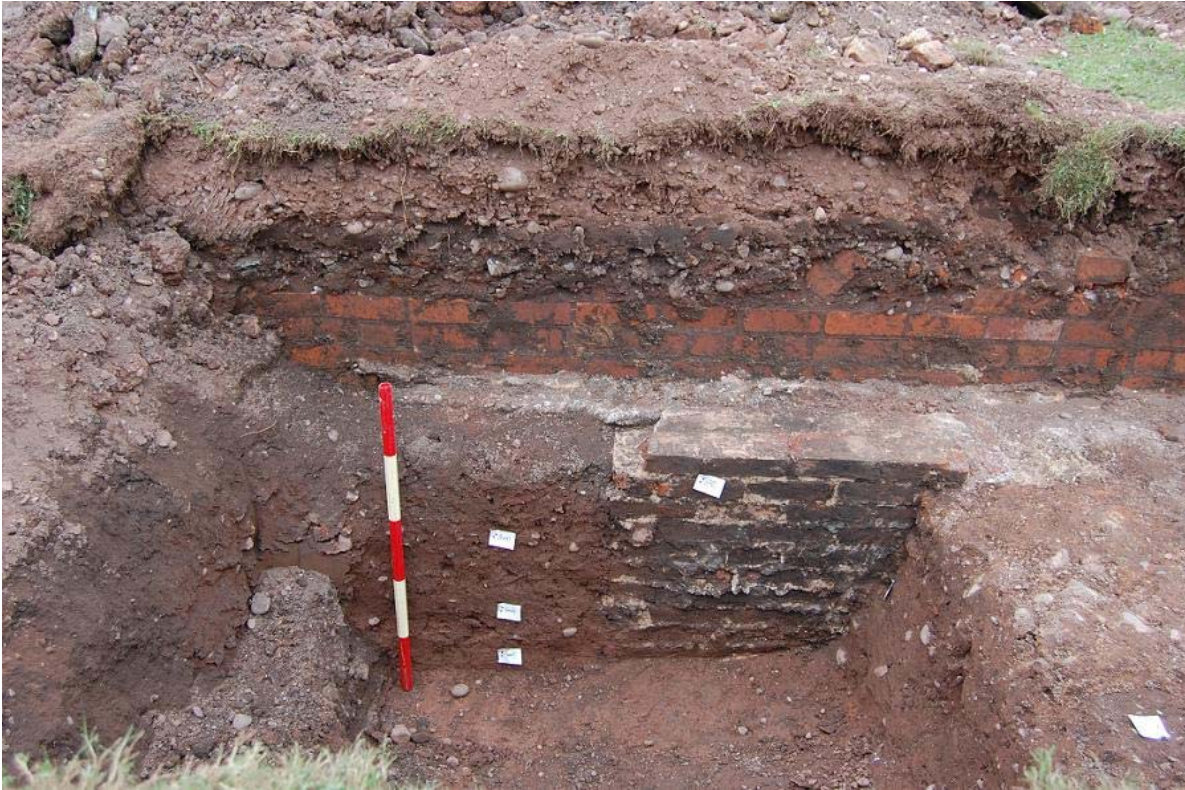
A modern structure comprising a section of brick wall, 8037, and on a concrete foundation, 8017, was observed aligned northwest to southeast. It lay over the modern service trench and drain 8015. It truncated drain 8005 and wall 8000 which lay on the same alignment to the northeast. It comprised at least ten courses of very roughly mortared brick and formed the foundation for a later red brick wall, 8018, which survived to up to five courses and lay on the same alignment but was recessed back to the southwest.

Plate 13, Trench 8, view southwest of brick 8037 and concrete foundation 8017 below brick wall 8018

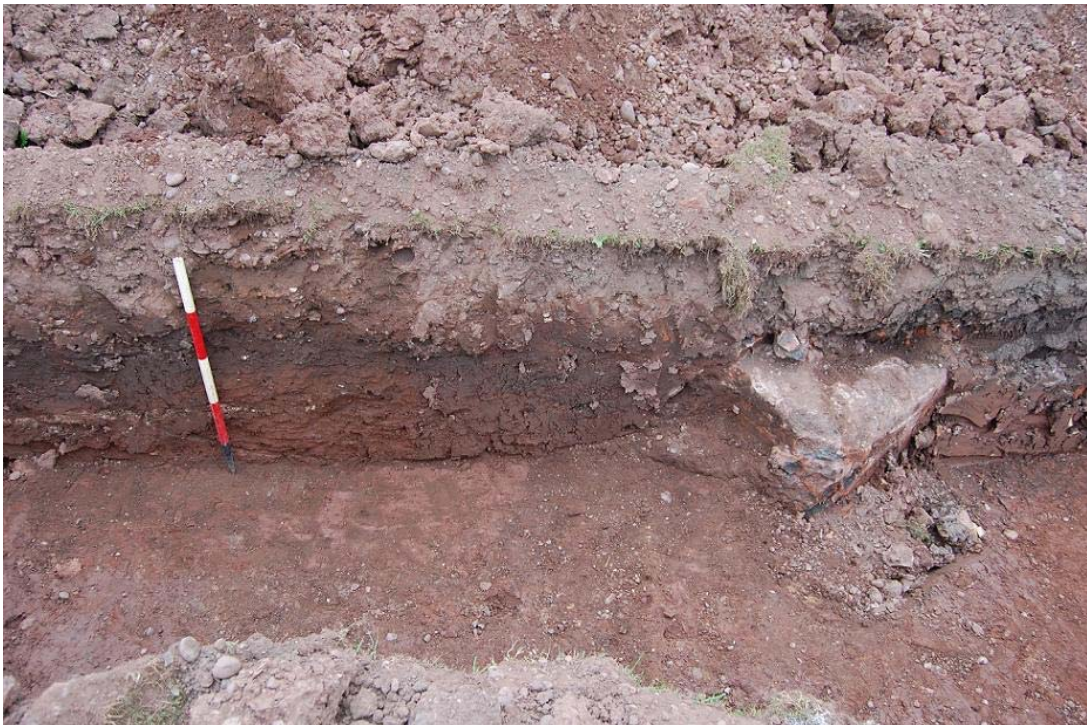
The natural sand and gravel, 9005, was revealed at a depth of 0.60m. This lay below a sequence of levelling deposits, 9002-9004, sealed by a shallow turfed sandy silt topsoil, 9001. The levelling deposits comprised sandy silts with mixed inclusions of stone and brick rubble. These were truncated by a 20th century brick manhole, 9006, and a drainage pipe, 9009.

Plate 15, Trench 9, view southeast of natural matrix 9005 and manhole 9006

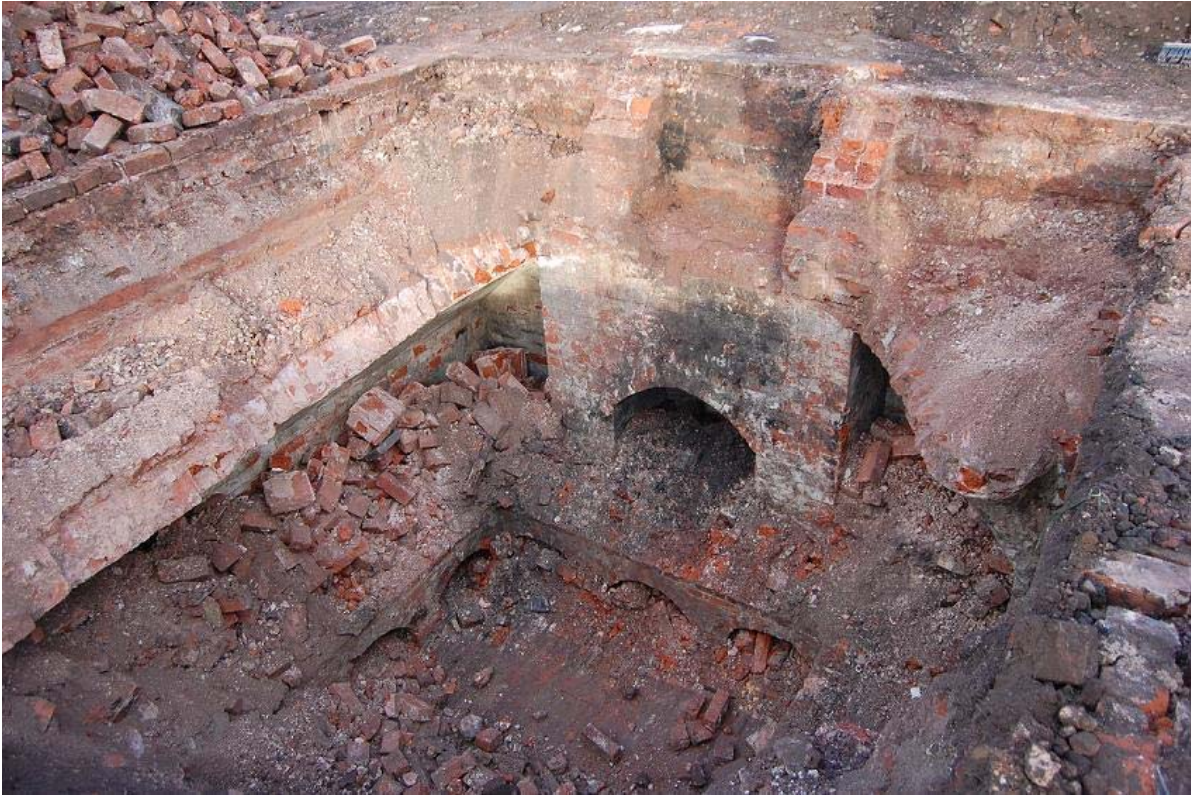
Plate 18, Trench 10, general view west of chimney base and storage benches in north compartment

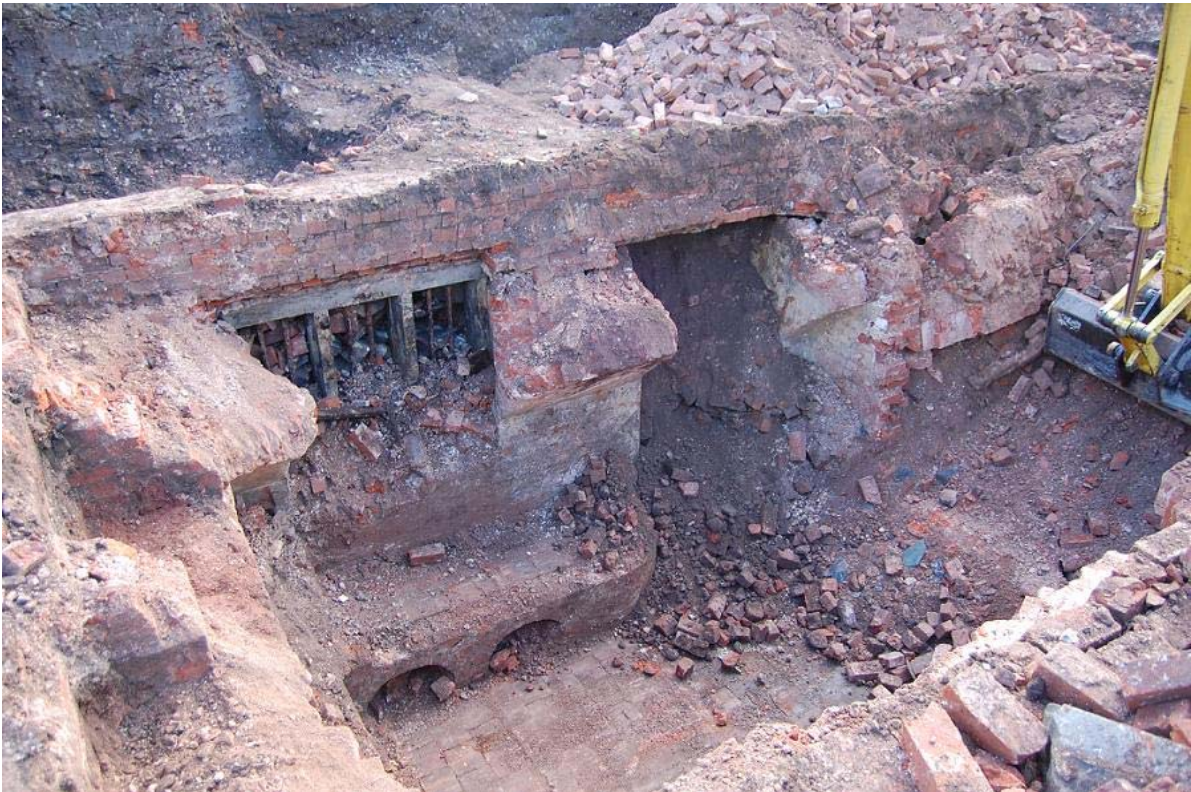
Plate 19, Trench 10, view northeast of light-well and coal shute in north compartment

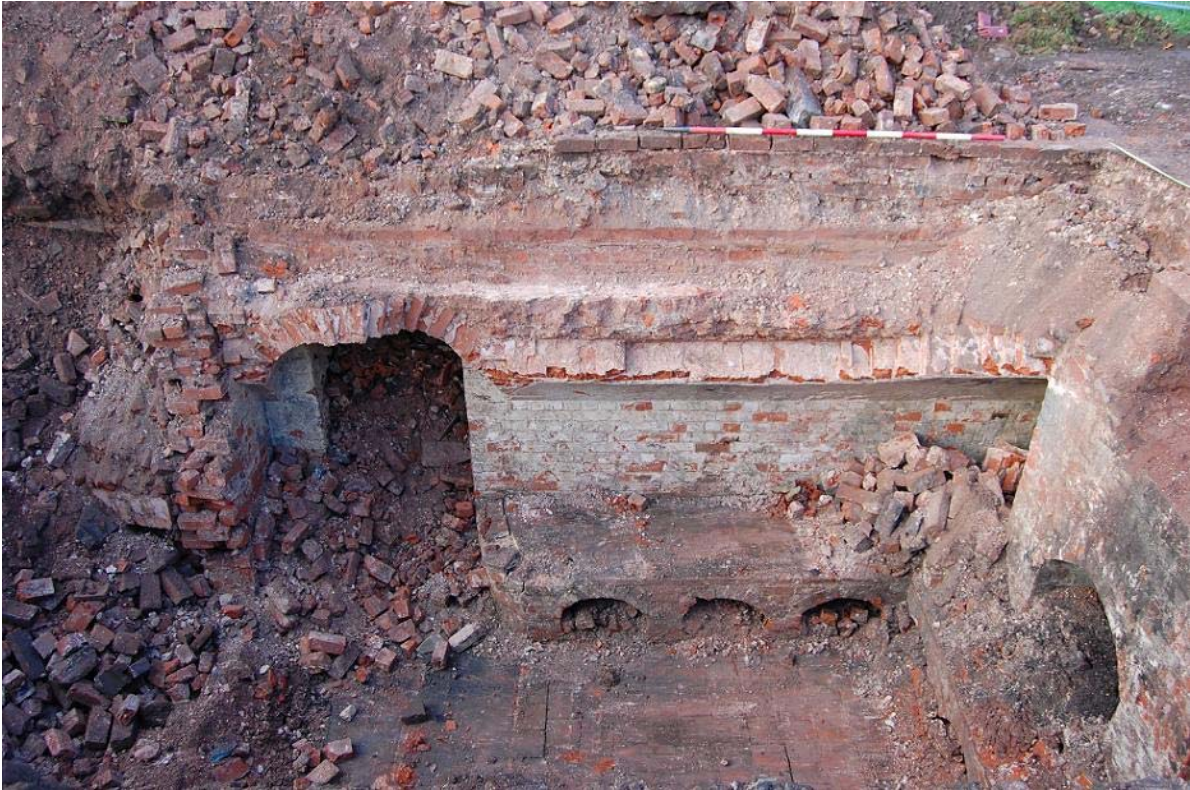
Plate 20, Trench 10, view southwest of storage benches with brick arches below and doorway to corridor

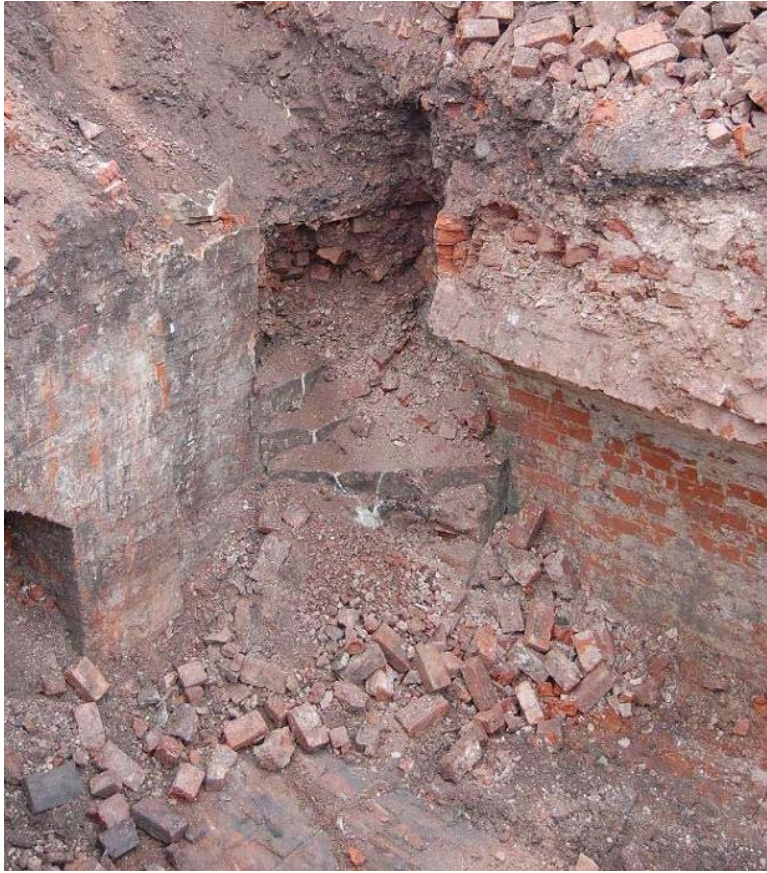
Plate 22, Trench 10, detail of stone spiral staircase in south corner of east compartment, view south

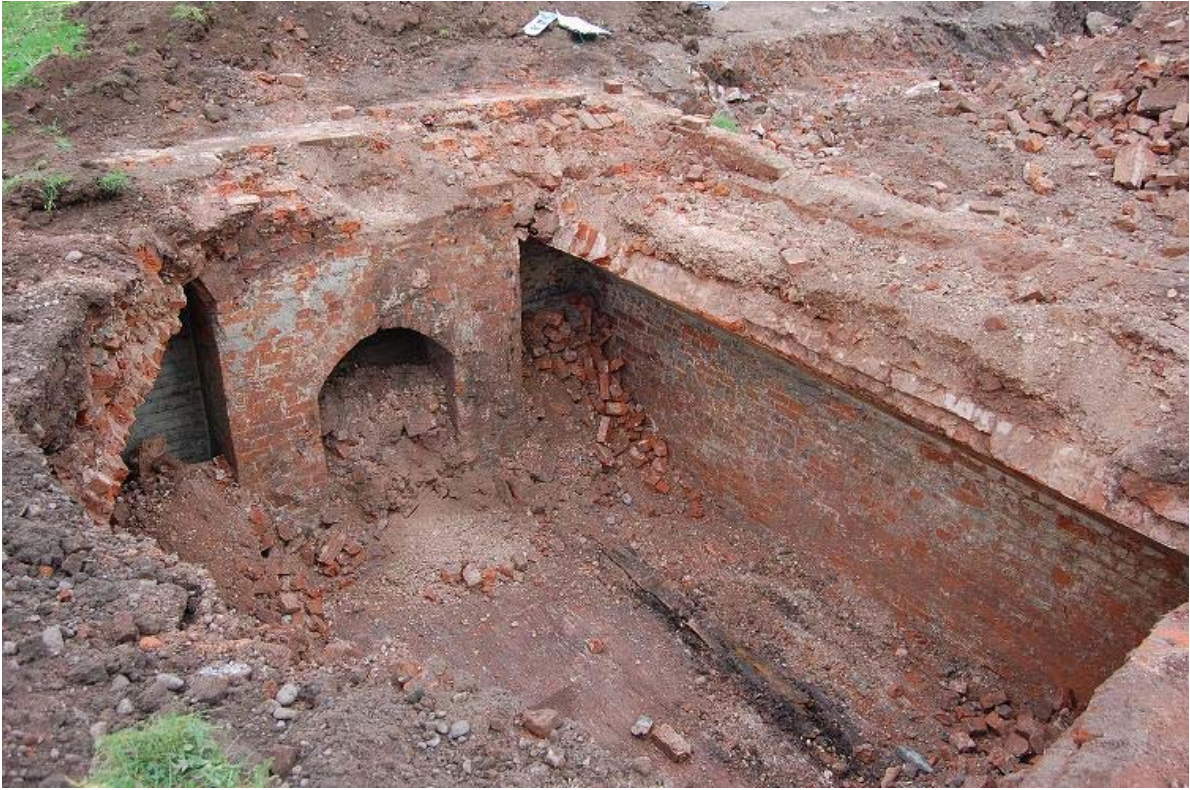
Plate 28, Trench 10, general view north of west compartment with chimney base and alcove
