ARCHAEOLOGICAL
EXCAVATION AT
BUSHBURY HILL PRIMARY
SCHOOL,
OLD FALLINGS LANE,
BUSHBURY, WOLVERHAMPTON

26 October 2010

Project 3482
Report 1799

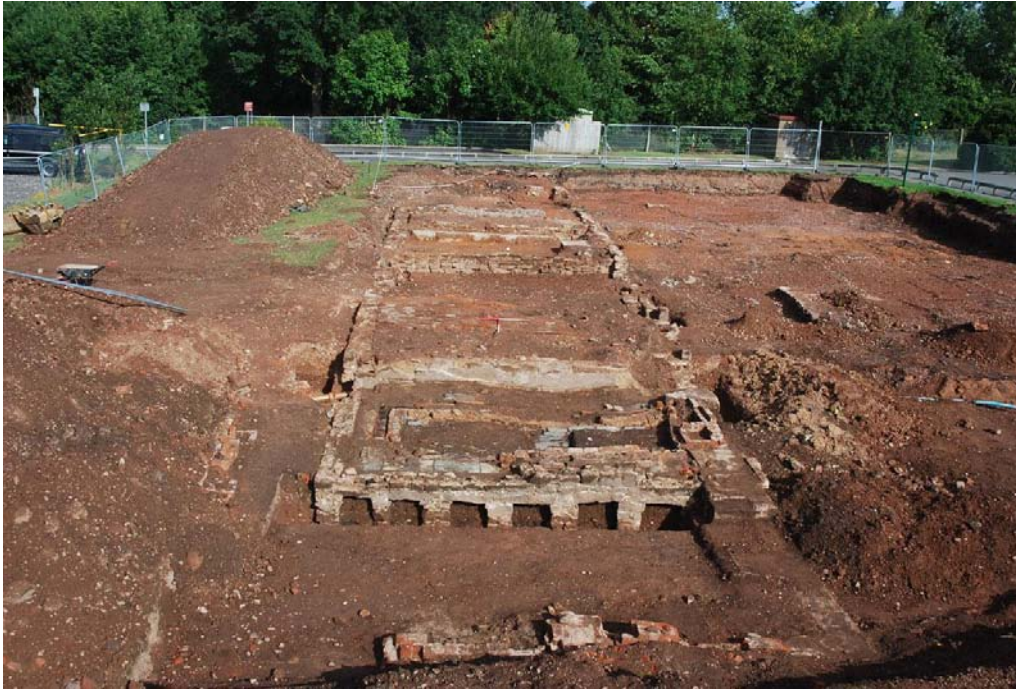
Plate 1: General view of site, facing north-west. Showing main sandstone building with the later southern extension sandstone wall on piers in the foreground. Scales at 2m.

The earliest evidence of usage on the site was indicated by a dark buried soil (1063), dated to the 18th century. This soil horizon was truncated by a building, constructed from roughly hewn sandstone foundations with brick walls overlying the substantial sandstone footings. This building was constructed in two phases (Phases 1 – 2). The first phase of building consisted of three external walls (the northern extent of the building was not visible as it continued beyond the limit of the excavation) and four internal walls, dividing the structure into five separate rooms (Rooms 1 – 5, Fig 3), with a later sandstone wall extension (Phase 2) to the south-east corner (Plates 1, 6 and 9).

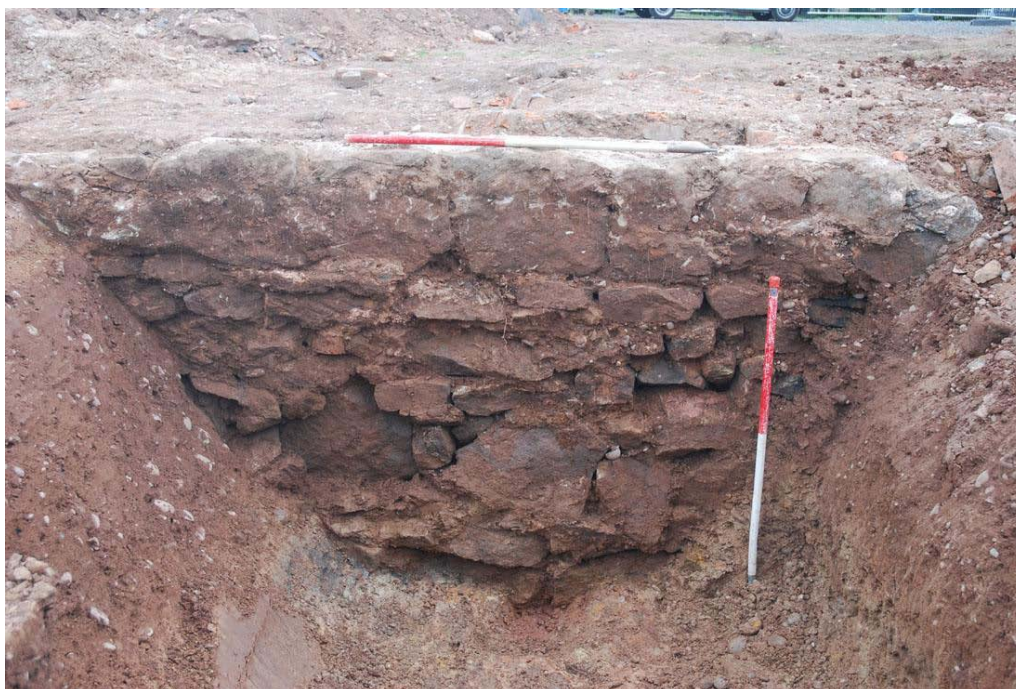
Plate 2: Foundations of the Phase 1 sandstone wall at the southern extent, capped with a single course of ashlar blocks. Here showing the internal face. Scale at 1m, facing south-west

The first phase of construction (Phase 1) is indicated by the main sandstone walls. The building, aligned north-west to south-east, consisted of two external walls with four contemporary internal walls. The main outer walls (1005 and 1006) ran parallel to each other in a north-west to south-east direction. These walls extended beyond the limits of the excavation to the north-west, although the southern extent of the building was recorded in the excavation area. These external walls, constructed from roughly hewn sandstone blocks (c 0.3m x 0.2m x 0.1m) were roughly 0.5m wide (Plate 2). The stones were bonded with a very hard dark yellow mortar. To the north-west the footing were 0.8m deep and at the southern extent of the building they were up to 1.6m deep. To the far south-east corner the sandstone footings with very occasional 18th century brick fragments were topped with mortared ashlar sandstone blocks. The ashlar blocks were visible on the western, eastern and southern walls of Room 5. These blocks, carefully laid on the underlying foundations measured roughly 0.50m x 0.25m x 0.25m (Plates 2 and 8; Figs 4 – 6) and bonded with a soft yellow lime mortar. There were up to two courses remaining.

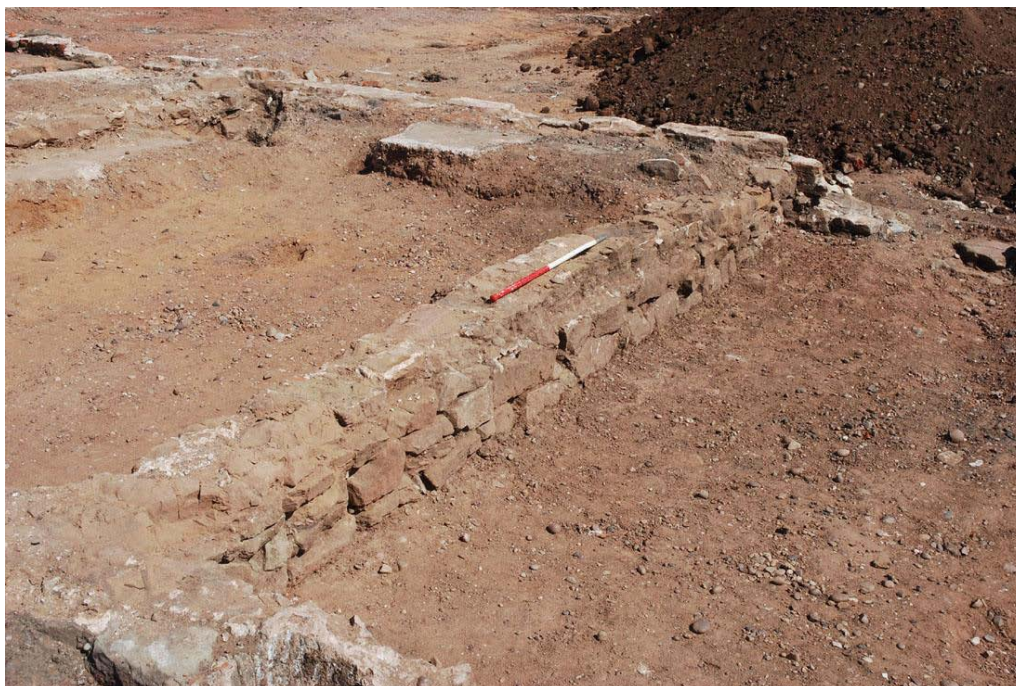
Plate 3: Detail of one of the sandstone internal walls (1009). Scale at 1m, facing north.

The two external walls were connected by four internal walls (1036, 1007, 1009 and 1048), and an external wall (1049) to the south-west, forming five separate room spaces (numbered 1 – 5, Figs 3 and 6, Plates 1 and 3). These internal walls were also constructed from roughly hewn sandstone blocks and the walls were keyed into the outer external walls, showing that the entire sandstone structure was built in a single phase. These walls were roughly 0.6m deep. The walls were 6m long, defining the internal room width. All the walls of this structure were constructed within vertical sided, flat based foundation trenches. The walls were quite flush with the edges of the cuts, leaving little room for any backfill with dateable material. There was no sign of any variations in the construction of the walls or the cuts, bar the deeper footing to the south, again suggesting that this first phase was constructed at the same time.

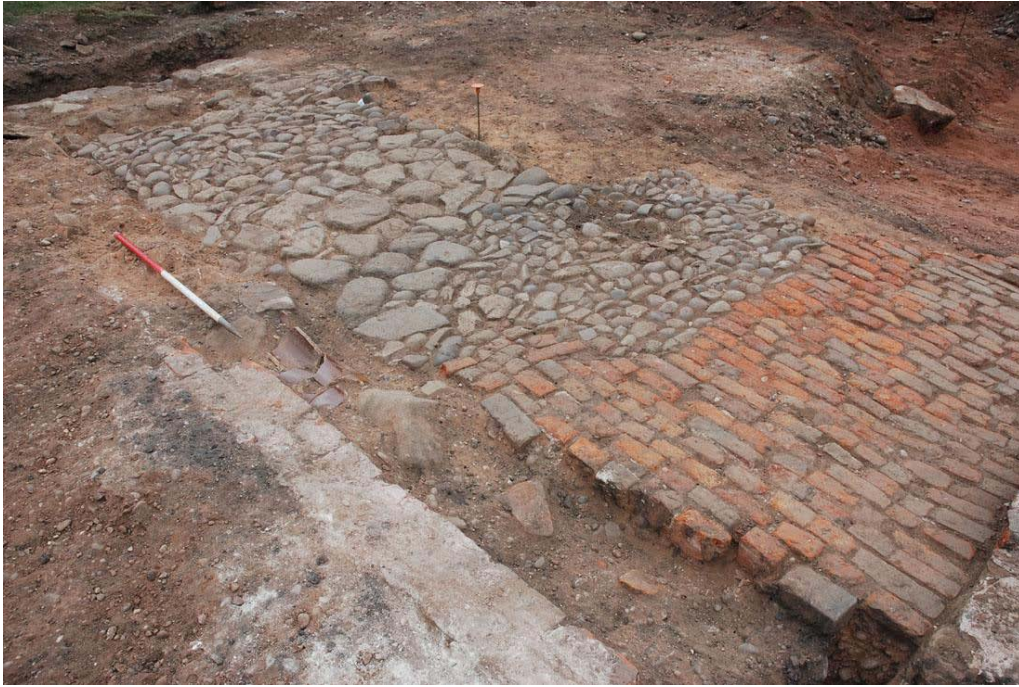
Plate 4: Brick and cobble internal floor surfaces in Room 2(1012, 1013 and 1014) with associated brick wall (1017) in the foreground. Scale at 1m, facing west.

Within Rooms 2 and 5 were the remnants of existing floor surfaces. In Room 2 the floor surfaces consisted of both brick (1012) and cobbles (1013 and 1014) of varying sizes (Figs 3 and 5). The cobbles were rounded and both showed considerable signs of wear. The floor was roughly 0.15m thick and was bedded on a levelling deposit of clean sand (1015). This floor had been truncated heavily to both the north-west and the south-east. The bricks from this floor (1012) were dated to the late 18th – early 19th century.

Another brick floor surface survived in Room 5 (Plate 4). This floor (1050) was constructed solely of bricks which were dated to the late 18th – early 19th century (c 1784 – 1803). This floor surface was also bedded on a thin clean sand layer. The brick floor was cut to the south-east by a modern ceramic waste pipe with internal electric cable (1066) and to the north-west it partially overlaid the sandstone wall footing (1048).

Within two of the rooms brick and cobble floors had been laid. In Room 2, a floor had been laid that consisted of both bricks and large rounded cobbles (1012, 1013, and 1014). This floor related to one of the internal brick walls (1017) and appeared to be of a relatively poor construction. These brick and cobble surfaces appear to be similar to those used in stables in the 19th century (Shona Robson-Glyde *pers comm*). The brick floor in Room 5 (1050), clearly overlaid the sandstone footing (1048), but butted against the ashlar stones that would have existed above ground level. It was unclear as to whether both the floors were contemporary with the original main sandstone structure or were a later addition.

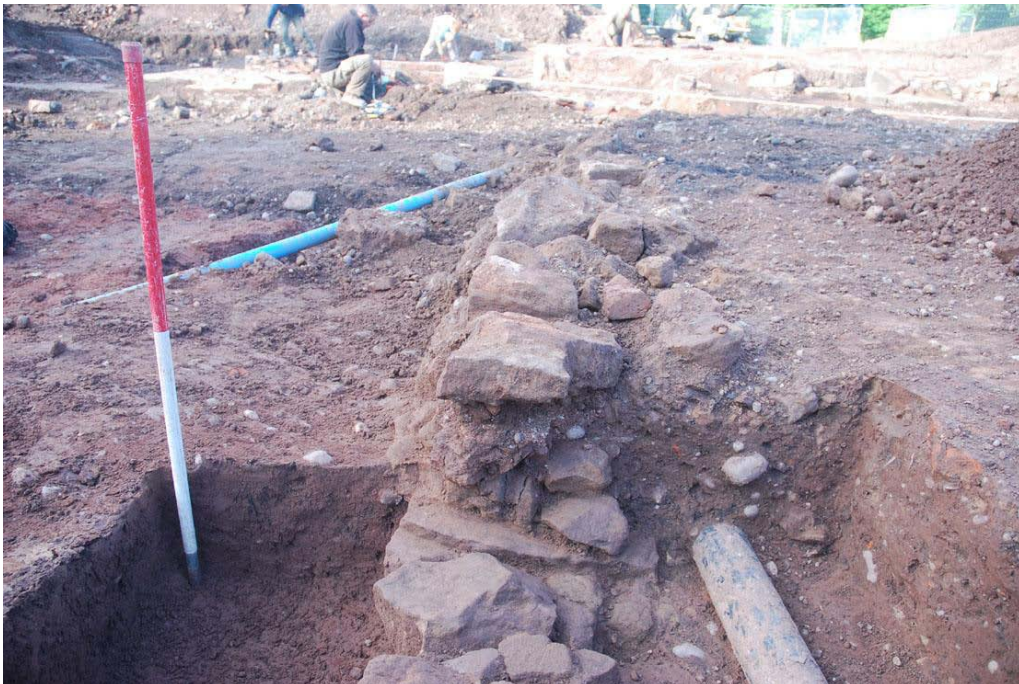
Plate 5: External sandstone garden wall (1039, 1041) cut by later service pipe. Scale at 1m, facing south-west.

To the east of the main range, but not attached to it, was a single roughly hewn sandstone wall (1039, Plate 5, Fig 5), which had been heavily truncated by later cast iron and plastic water pipes. The wall was aligned north-east to south-west. This wall appeared to have been constructed in two parts, similar to the main sandstone structure. The lower part of the wall was constructed primarily of sandstone (1039), and then the upper part of the wall was constructed of sandstone and bricks, with a harder mortar (1041).

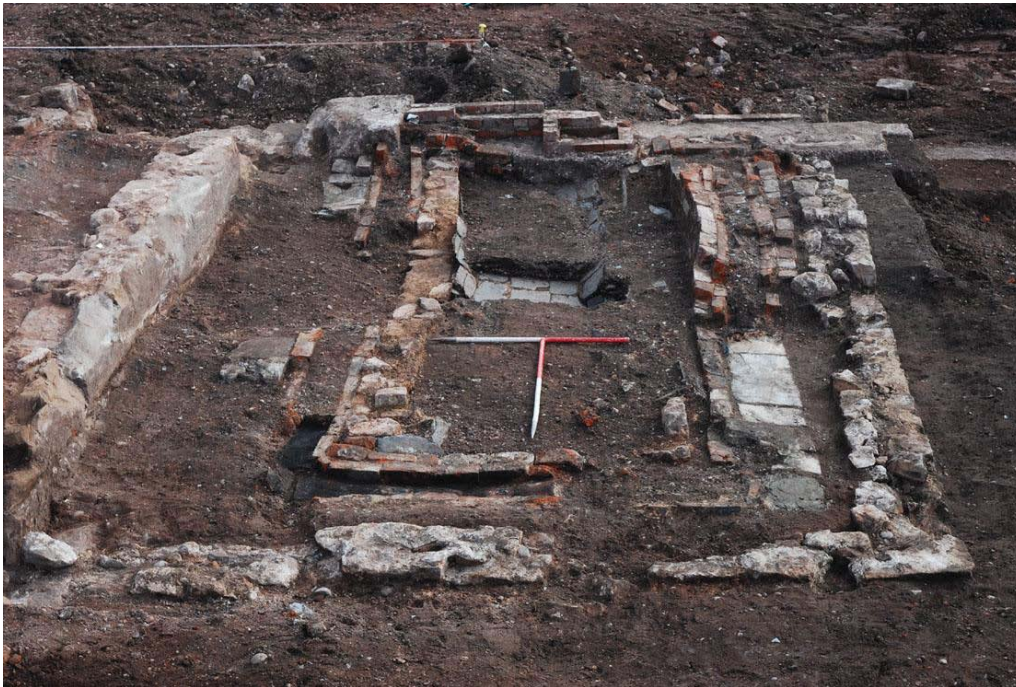
Plate 6: The southern (phase 2, 1052), extension possibly used as a dairy, showing internal brick wall and slate lined drain. Scale at 2m, facing north-east.

To the southern extent of the early range, a later extension had been added (Fig 3). This extension consisted of a sandstone wall (1052), constructed on integrated sandstone piers (Plates 1, 6 and 9) built within a continuous construction trench. The foundations for this extension were cut through deposits (1054 and, 1055) which contained late 19th – 20th century material. This extension, contained an internal structure, of 6.30m x 4.25m, constructed from brick and slate (1038) consisting of a narrow brick wall with a shallow brick channel around the outside. Adjacent to the internal brick wall were the remains of a flagstone floor, consisting of blue lias stones. Inside this brick structure was a slate lined feature. The slates were bonded with a hard yellow mortar but were only partially exposed during the excavation. This has been interpreted as a drain. It lay along the north-west side of the square internal brick structure. The drain was up to 0.45m deep and sealed by a silty layer (1037) which contained a high proportion of building rubble. The bricks from the surrounding channel dated to 1725 onwards, although the made ground below (1054) contained material from the late 19th century. The internal features in this later southern extension were heavily truncated by a later electric cable and the concrete footings (1008) for a later 20th century building.

This later room contained a rectangular slate drain, extant flagstone floor, a brick channel and wall. The wall may have either supported a cattle feeding trough or other water related features. The slate drain may have formed drainage for cattle waste possibly as part of a milking/dairy room. However the room appeared small for this practice and no large entrance was identified.

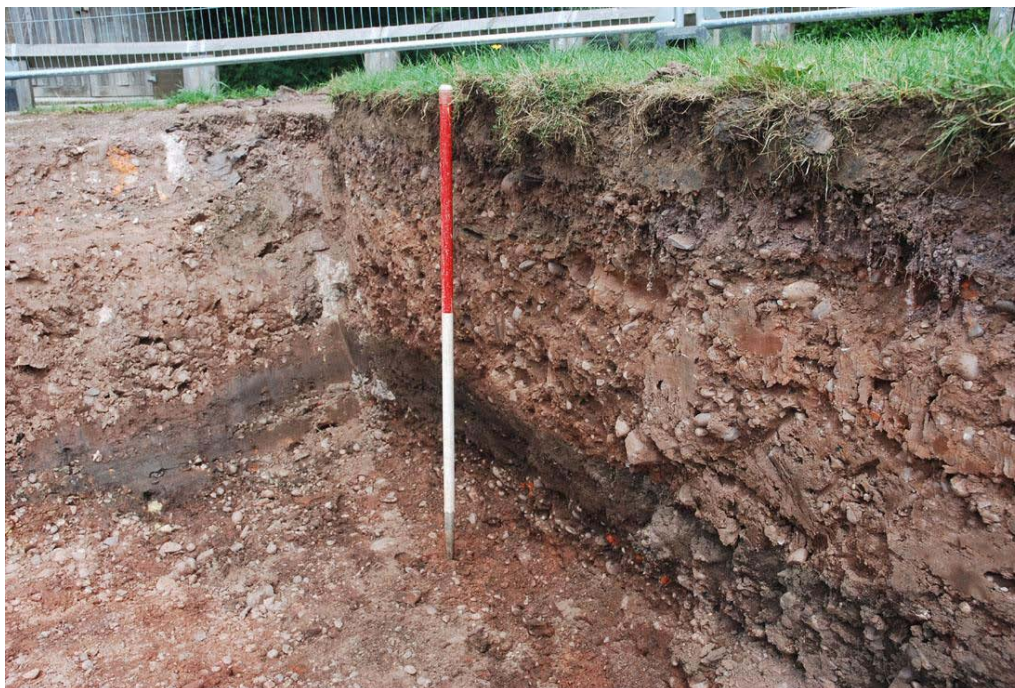
Plate 7: Buried soil horizon and demolition layers (1000-1003) seen here in the northern corner of site. The dark soil horizon (1002) can be seen as a dark band towards the base of the section. Scale at 1m, facing north.

Across the entire site, and sealing the archaeology, was a layer (1003), roughly 0.3m thick that contained a large amount of building rubble. Sealing this was a 0.2m thick humic soil (1002) that in turn was overlain by further rubble material (1001), up to 0.6m thick. The present surface was a very thin layer, 0.08m, of turfed topsoil that extended across the entire site (Plate 7).

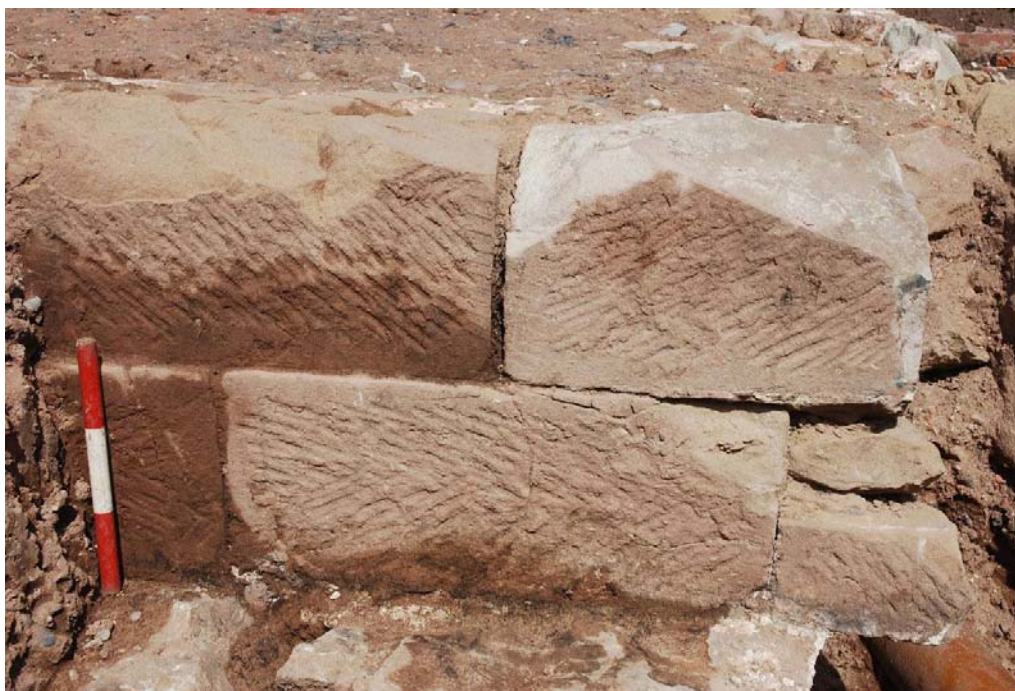
Plate 8: Detail of the ashlar blocks sat on rougher foundations to the south-eastern corner of the Phase 1 structure. Scale at 0.3m

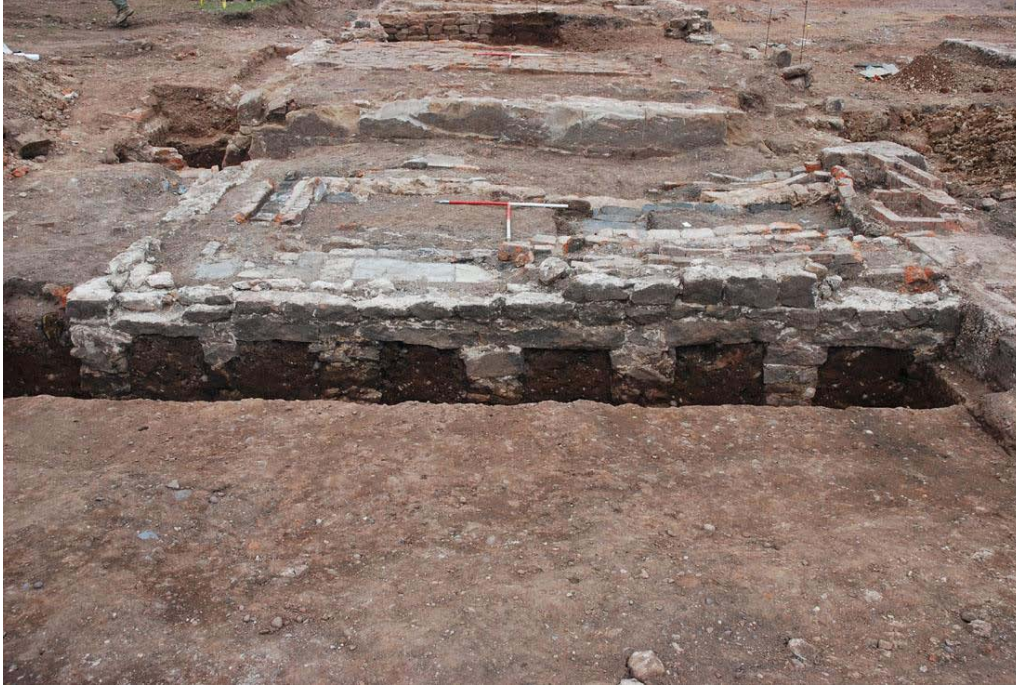
Plate 9: Detail of the sandstone piers supporting wall 1052. Scales at 2m, facing north-west.

The original sandstone structure was subsequently altered and extended. Towards the later part of the 19th century an extension at the south-eastern end was added (Phase 2, 1052). This was dated from finds recovered from the deposits that the wall truncated. The foundation trench for the later wall (1052) clearly cut the backfill of the earlier structure (1049). This southern sandstone wall, unusually constructed on sandstone piers, provided a single room extension (Plate 9). The footing did not abut the original structure, although was clearly a later addition, added whilst the original building was still in use.

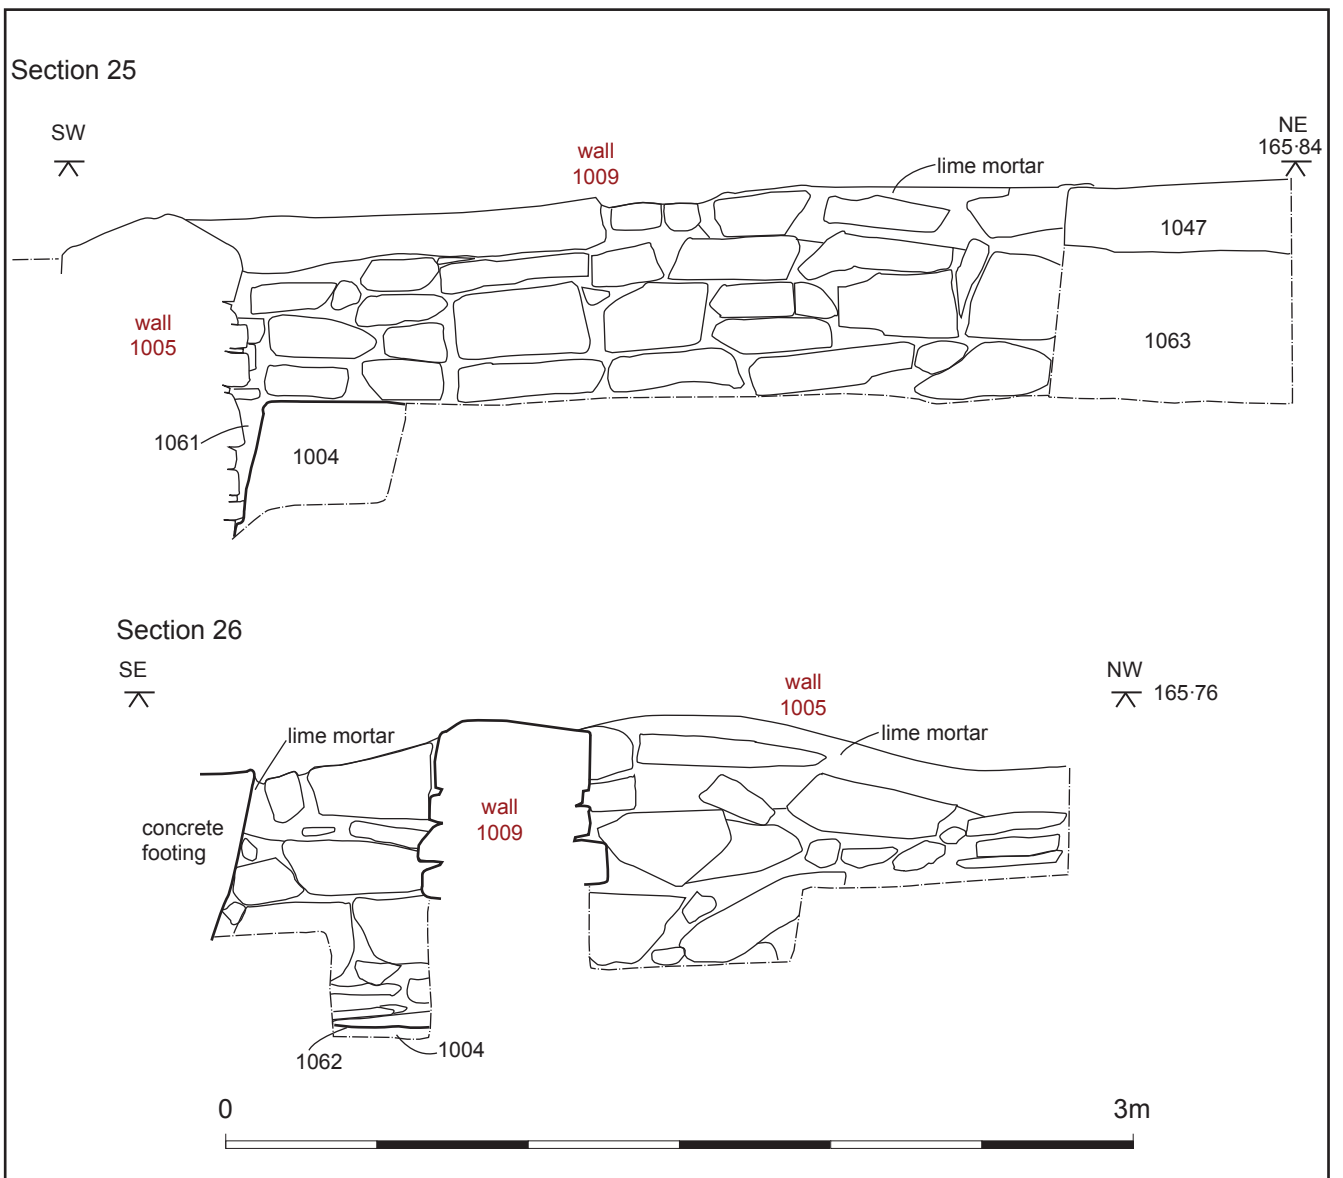
Figure 6

Sections 25 and 26

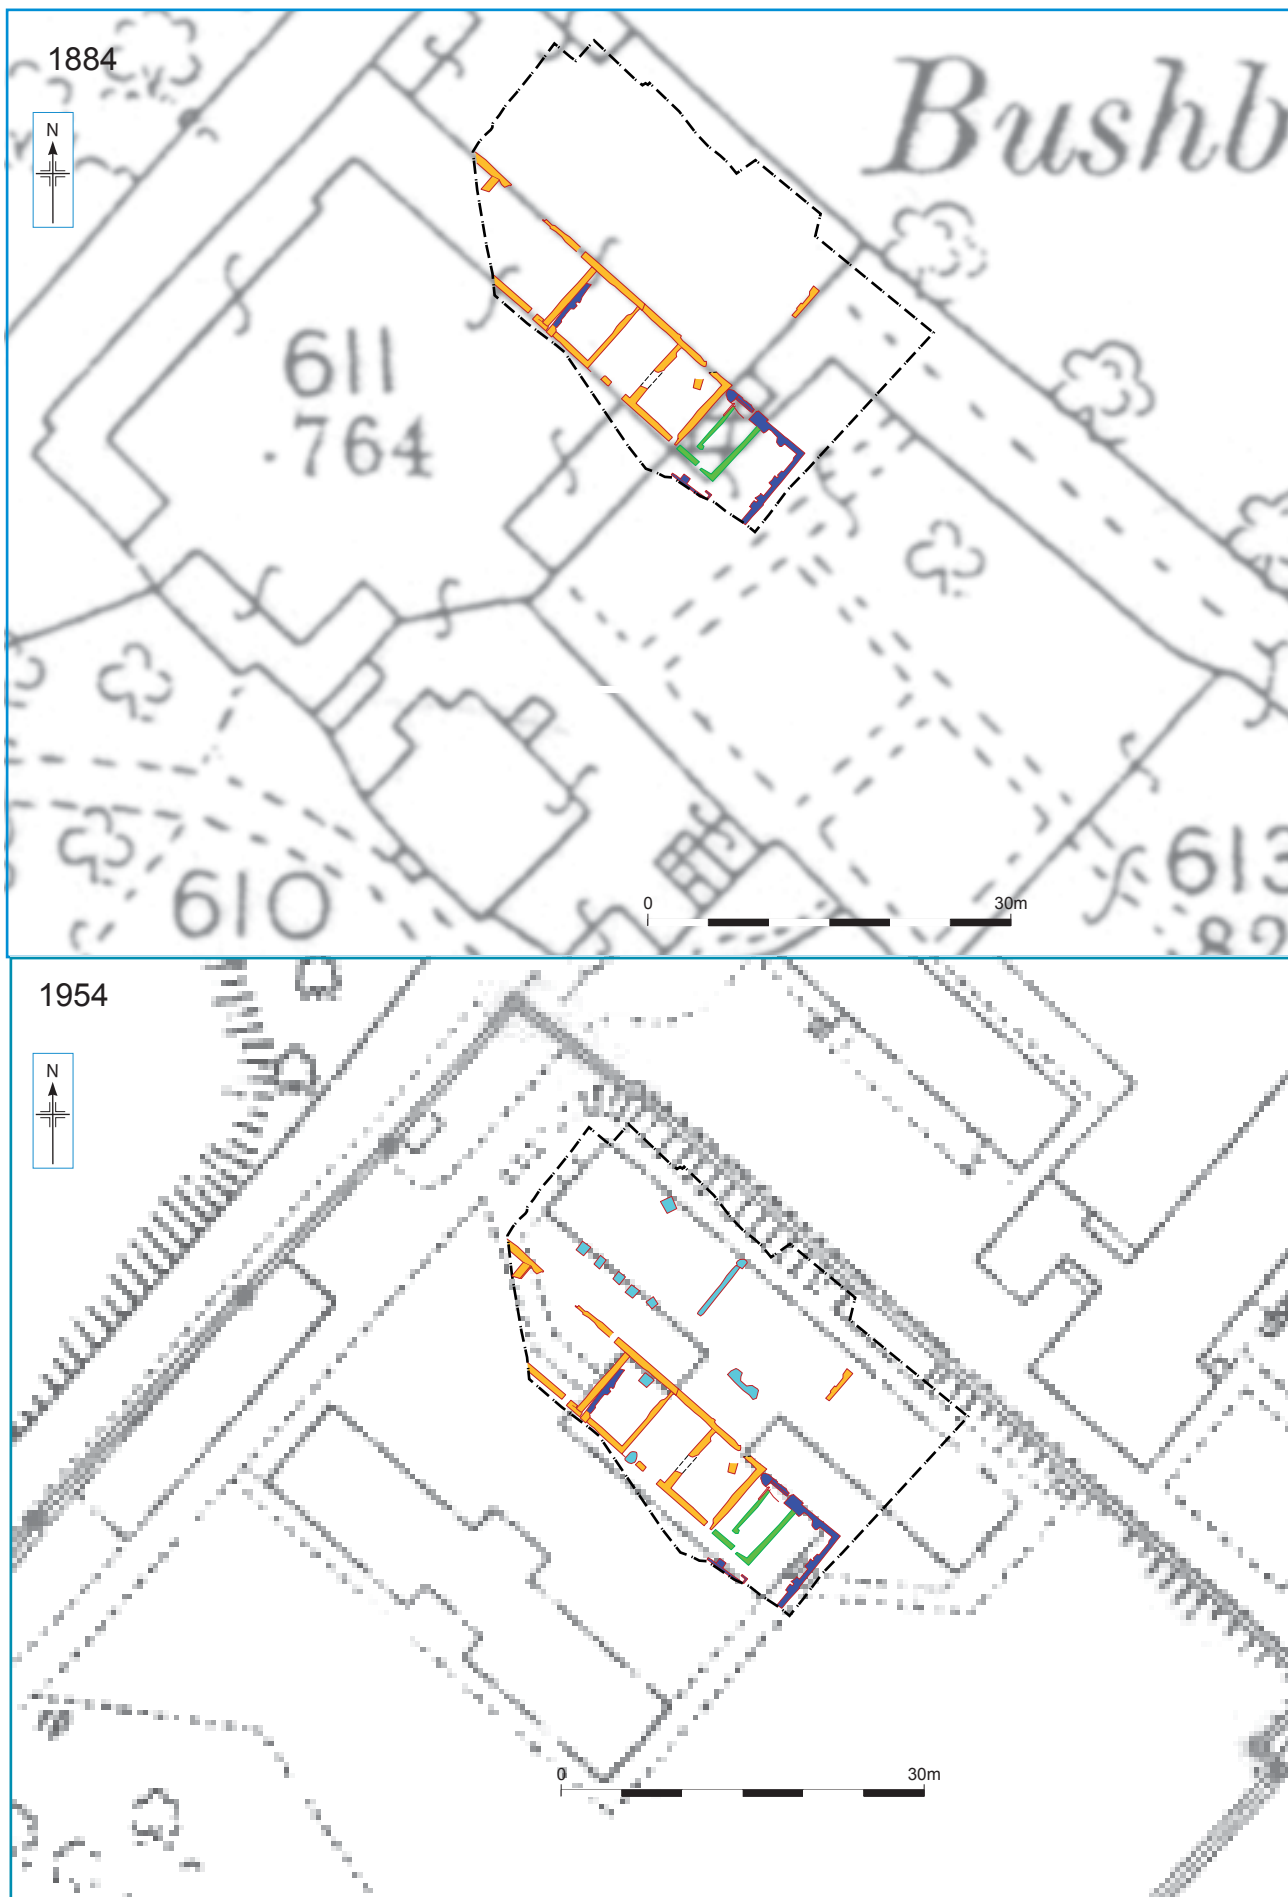
Figure 7

The excavated walls shown on the 1884 and the 1954 Ordnance Surveys.
