ARCHAEOLOGICAL
MONITORING
AT
SAINTBURY CROSS FARM,
SAINTBURY, GLOUCESTERSHIRE

Project 2504
Report 1252

Archaeological monitoring at Saintbury Cross Farm, Saintbury, Gloucestershire

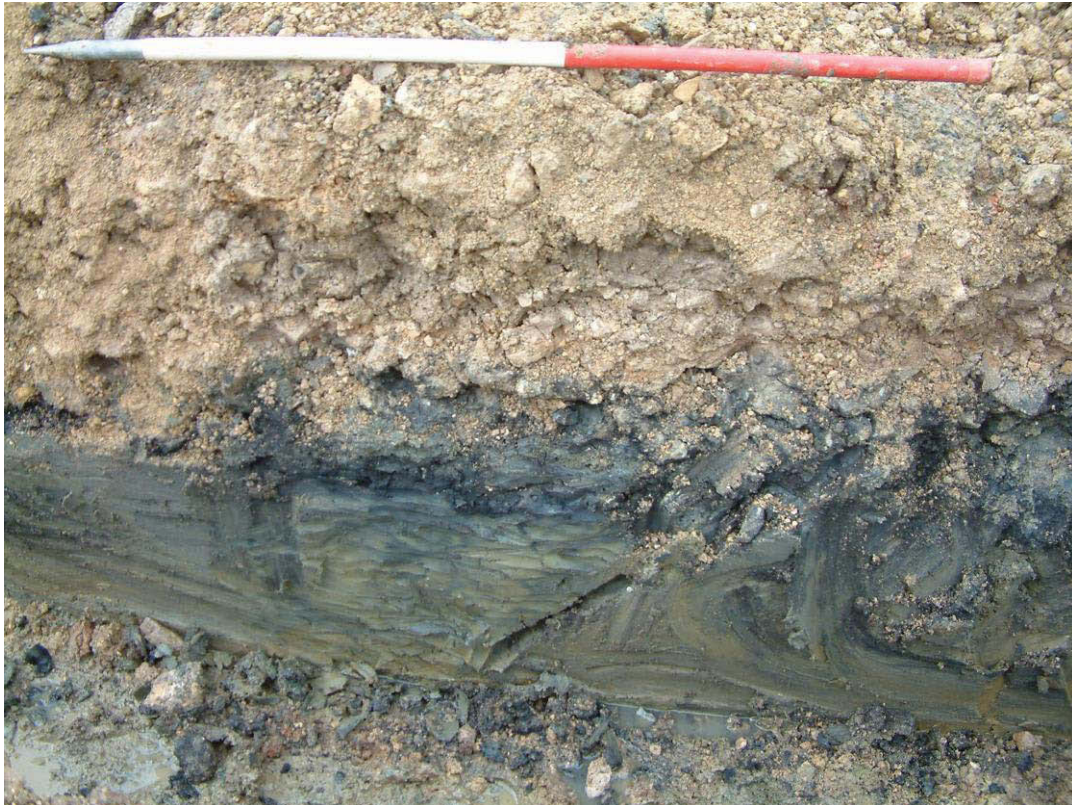
Context	Description	Interpretation	Depth (below ground level)
1000	Compact dark brown silty clay with frequent roots. Occasional charcoal flecks.	Topsoil	0.00-0.18m
1001	Compact blue grey clay/alluvium with 10% charcoal flecks, 2-5% rubble and concrete.	Alluvial deposit - former pond?	0.16-0.64m
1002	Compact yellow grey clay.	Natural	0.48m +
1003	Mixed dark brown silty loam and grey/yellow clay with 10% brick rubble.	Building foundation	0.00m +

Plate1: Barn C foundation: Trench 1, east section

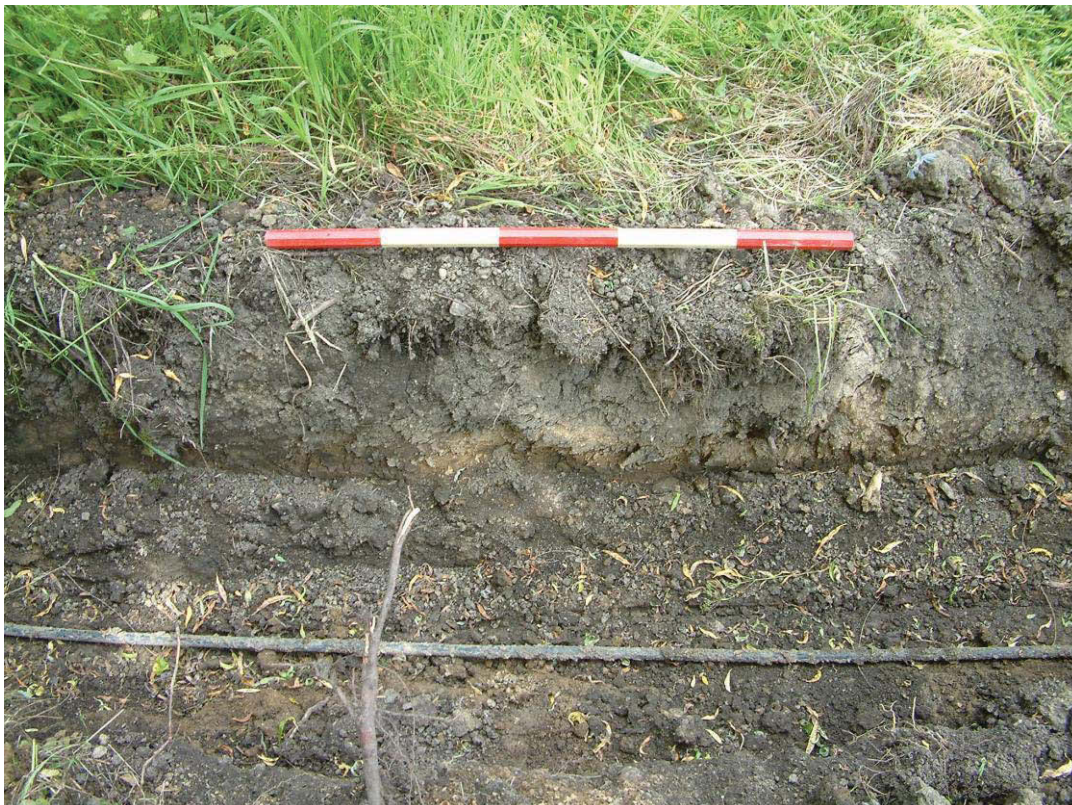
Context	Description	Interpretation	Depth (below ground level)
2000	Compact dark brown silty clay with frequent roots. Occasional charcoal flecks.	Topsoil	0.00-0.30m
2001	Compact mid yellow grey sandy silt loam with 5% charcoal flecks and 1% brick and tile.	Subsoil	0.30-0.60m
2002	Compact fawn yellow clay with occasional limestone frags	Natural	0.60m +

Plate 2: Farmhouse service: Trench 2a, north section

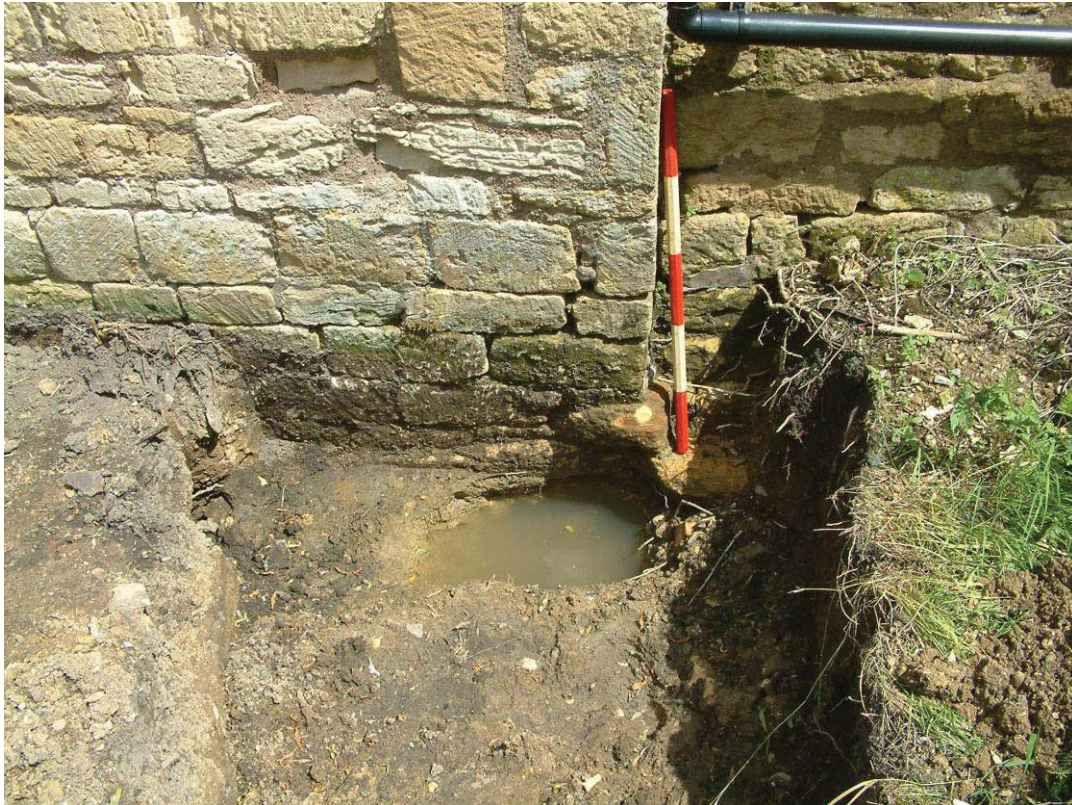
Plate 3: Farmhouse service: Trench 2b, view east

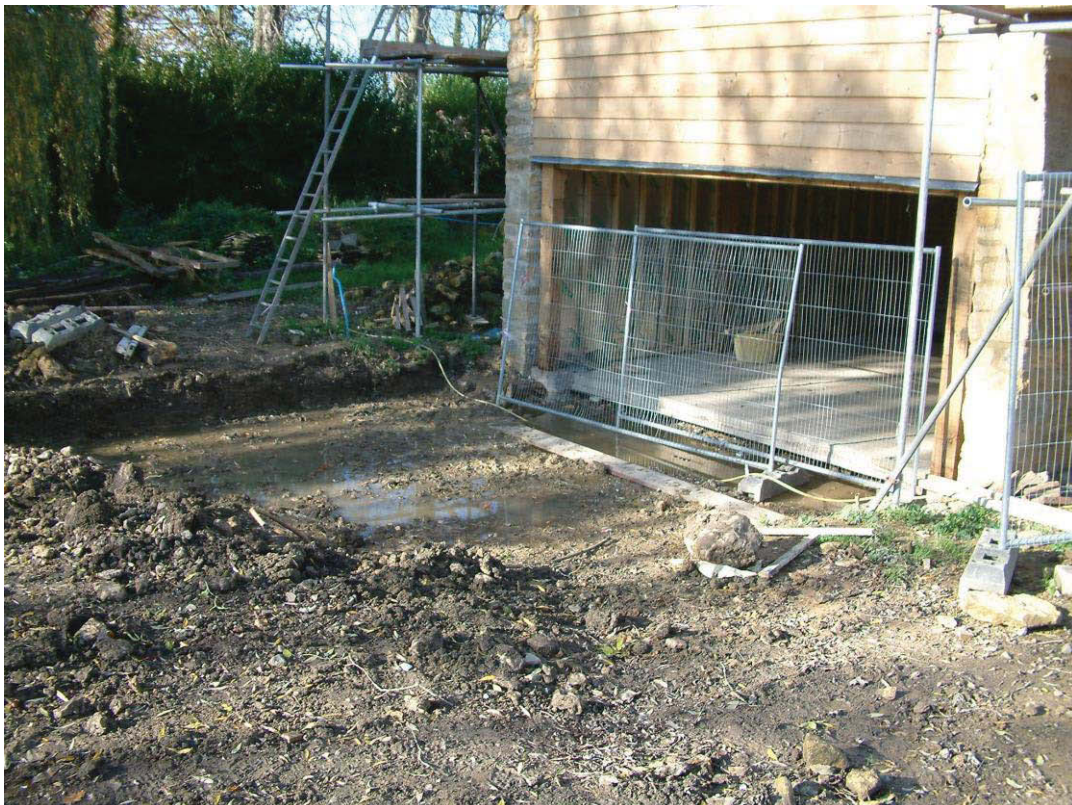
Context	Description	Interpretation	Depth (below ground level)
3000	Compact fawn yellow clay with occasional brick and limestone frags.	Redeposited clay	0.00-0.12m
3001	Compact dark brown silty clay with frequent roots. Occasional charcoal flecks, brick and limestone frags.	Top/subsoil	0.10-0.45m
3002	Compact fawn yellow clay with occasional limestone frags	Natural	0.25m +

Plate 4: Farmhouse patio strip: Area 3, view north-west

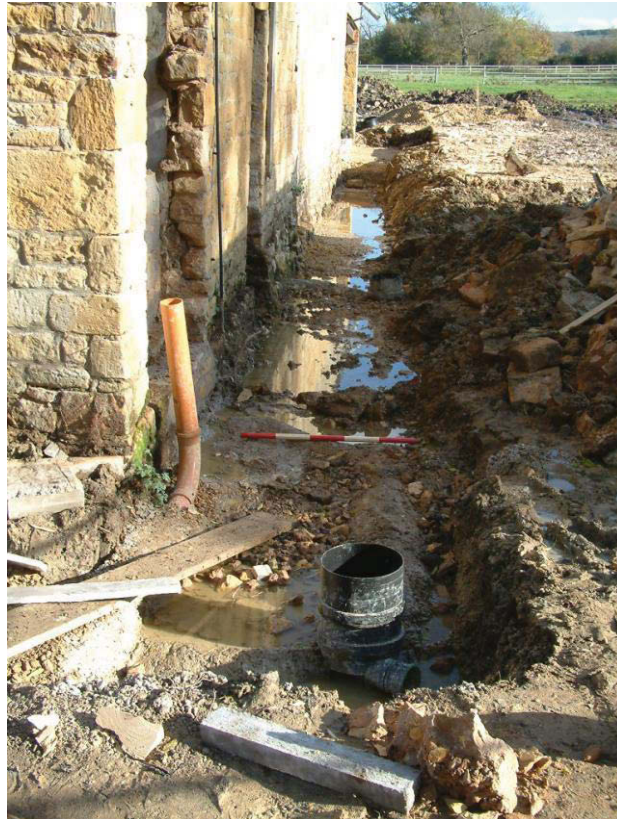
Context	Description	Interpretation	Depth (below ground level)
4000	Light grey concrete.	Modern yard surface	0.00-0.20m
4001	Compact dark brown silty clay with frequent roots. Occasional charcoal flecks, brick and limestone frags.	Top/subsoil	0.10-0.45m
4002	Compact greyish yellow clay.	Natural	0.27m +

Plate 5: Barn B service: Trench 4, south of barn, view east

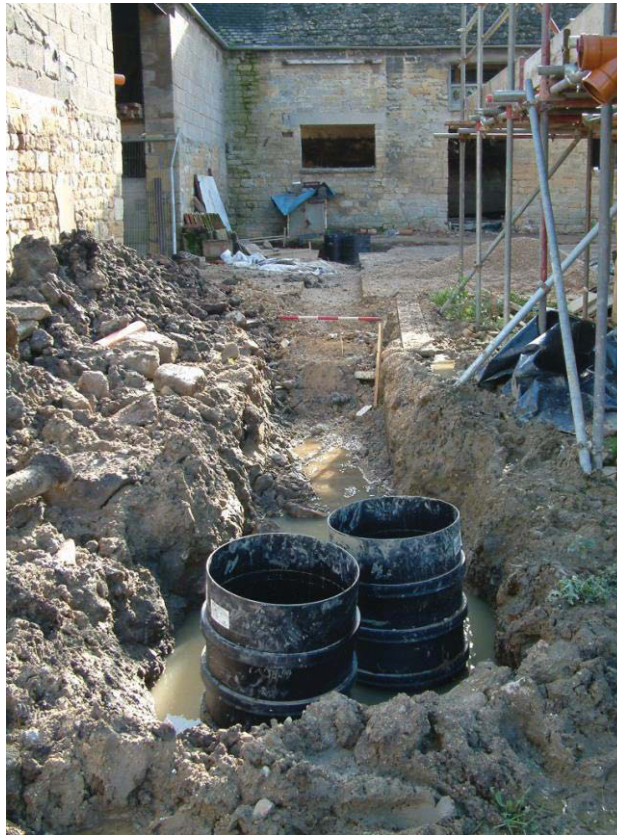
Context	Description	Interpretation	Depth (below ground level)
5000	Compact fawn yellow clay with occasional brick frags and limestone gravel. Only obs. to east of barn.	Redeposited clay	0.00-0.12m
5001	Large sub-angular limestone blocks. Only obs. to east of barn. Part of former Barn C.	Foundation/floor	0.12-0.30m
5002	Compact green grey clay.	Natural	0.25m +
5003	Compact dark brown silty clay. Occasional roots, charcoal flecks, brick and limestone frags. Only obs. to north and east of barn.	Top/subsoil	0.00-0.25m

No foundations or surfaces were observed predating the existing buildings. The rough course of large limestone blocks observed in the western leg of Trench 5 may represent the floor or foundation of the former Barn C.

Plate 6: Barn A service: Trench 5, west of barn, view south

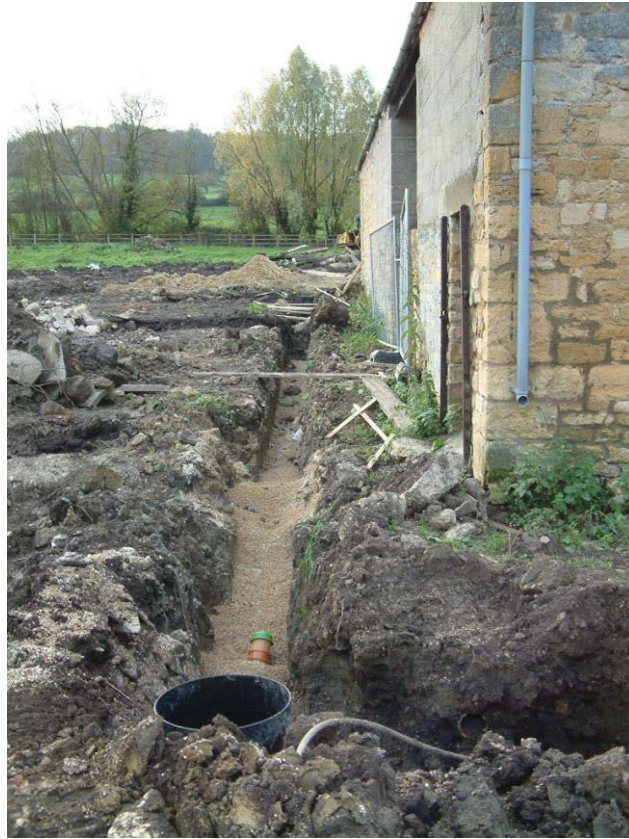
Plate 7: Barn A service: Trench 5, east of barn, view south

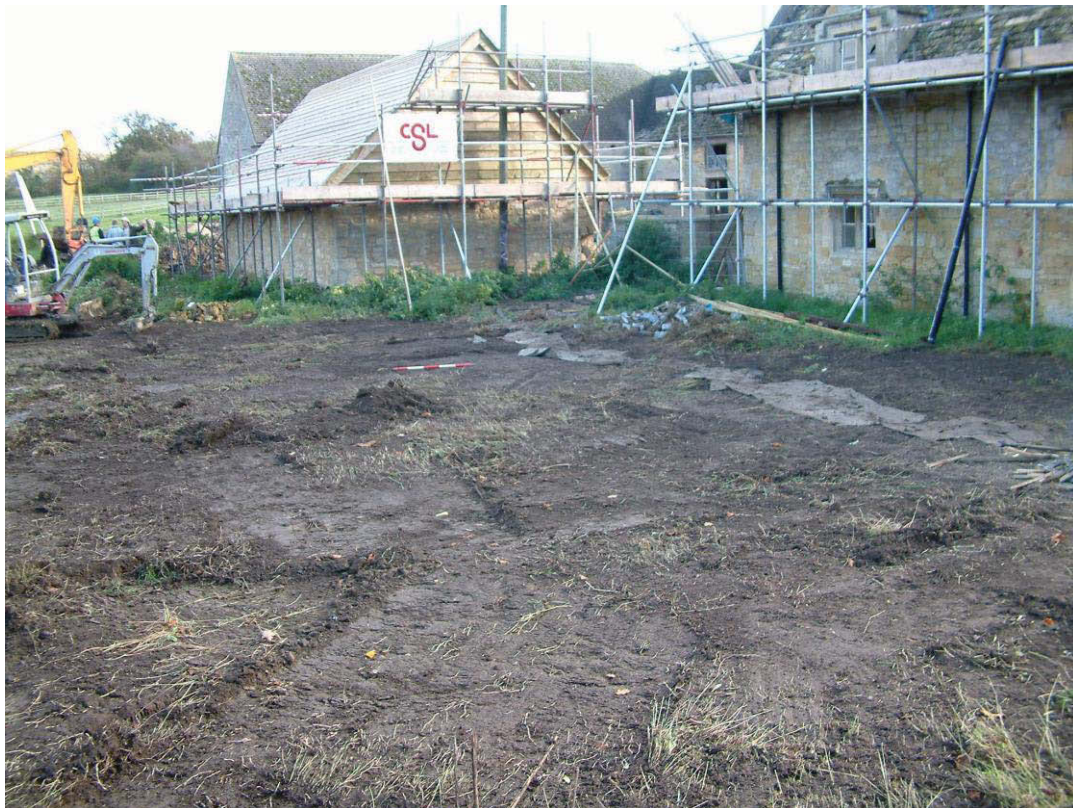
Context	Description	Interpretation	Depth (below ground level)
6000	Compact dark brown silty clay. Turfed. Occasional charcoal flecks, brick and limestone frags.	Topsoil	0.00-0.32m +

Plate 8: Farmhouse lawn strip: Area 6, view south-east

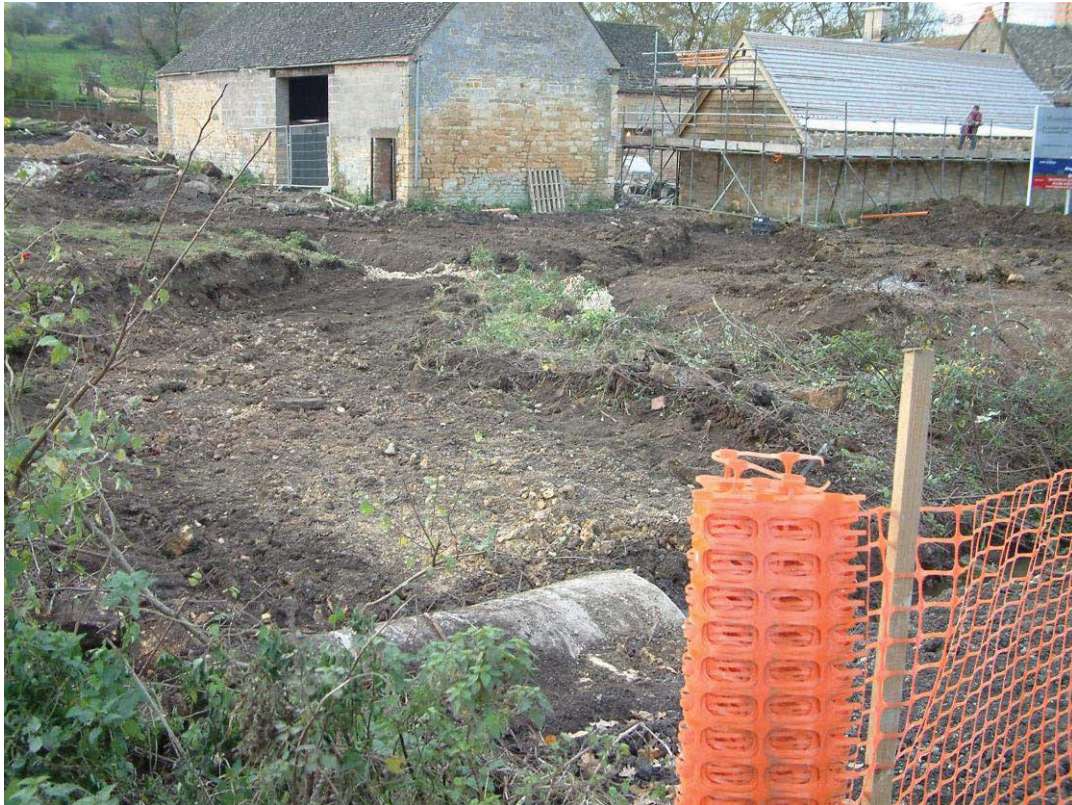
Context	Description	Interpretation	Depth (below ground level)
7000	Compact dark brown silty clay. Turfed. Occasional charcoal flecks, brick and limestone frags.	Topsoil	0.00-0.50m +
7001	Mixed layer of dark brown silty clay and limestone fragments. Within 7000. Only obs. to north end of strip.	Hardcore	0.20m +

Plate 9: Drive strip: Area 7, view south-west

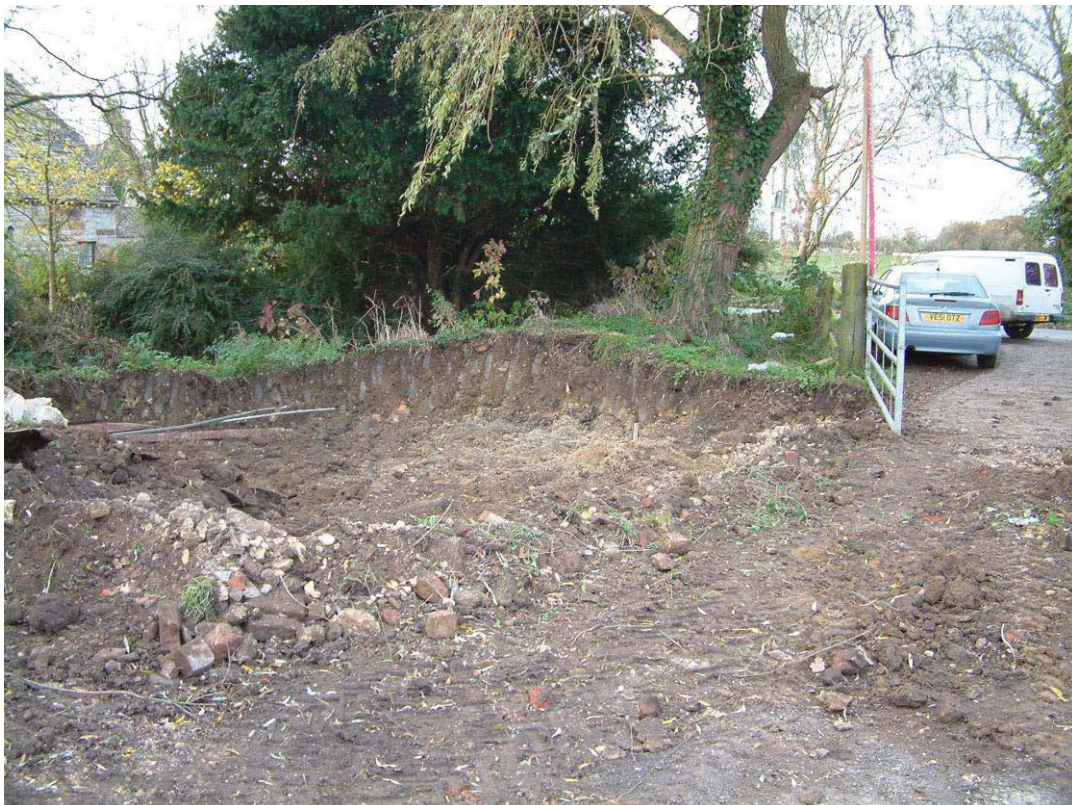
Context	Description	Interpretation	Depth (below ground level)
8000	Compact dark brown silty clay. Turfed. Frequent modern brick and concrete frags.	Topsoil	0.00-0.45m
8001	Compact mid yellowish brown silty clay. Turfed. Occasional charcoal flecks, brick and limestone frags.	Subsoil	0.30m +

Plate 9: Car park strip: Area 8, view south-west
