ARCHAEOLOGICAL  
EVALUATION  
AT  
BURFORD ROAD, LECHLADE,  
GLOUCESTERSHIRE

Project 2856  
Report 1360

An archaeological evaluation was undertaken at Burford Road, Lechlade Gloucestershire (SP 2184 0072). It was undertaken on behalf of Westbury Homes, who intend to excavate a pond on an area of land adjacent to Horseshoe Lake. The project aimed to investigate the preservation and nature of cropmarks. An evaluation trench demonstrated that gravel quarrying and associated works in the area had destroyed any pre-existing archaeological deposits.

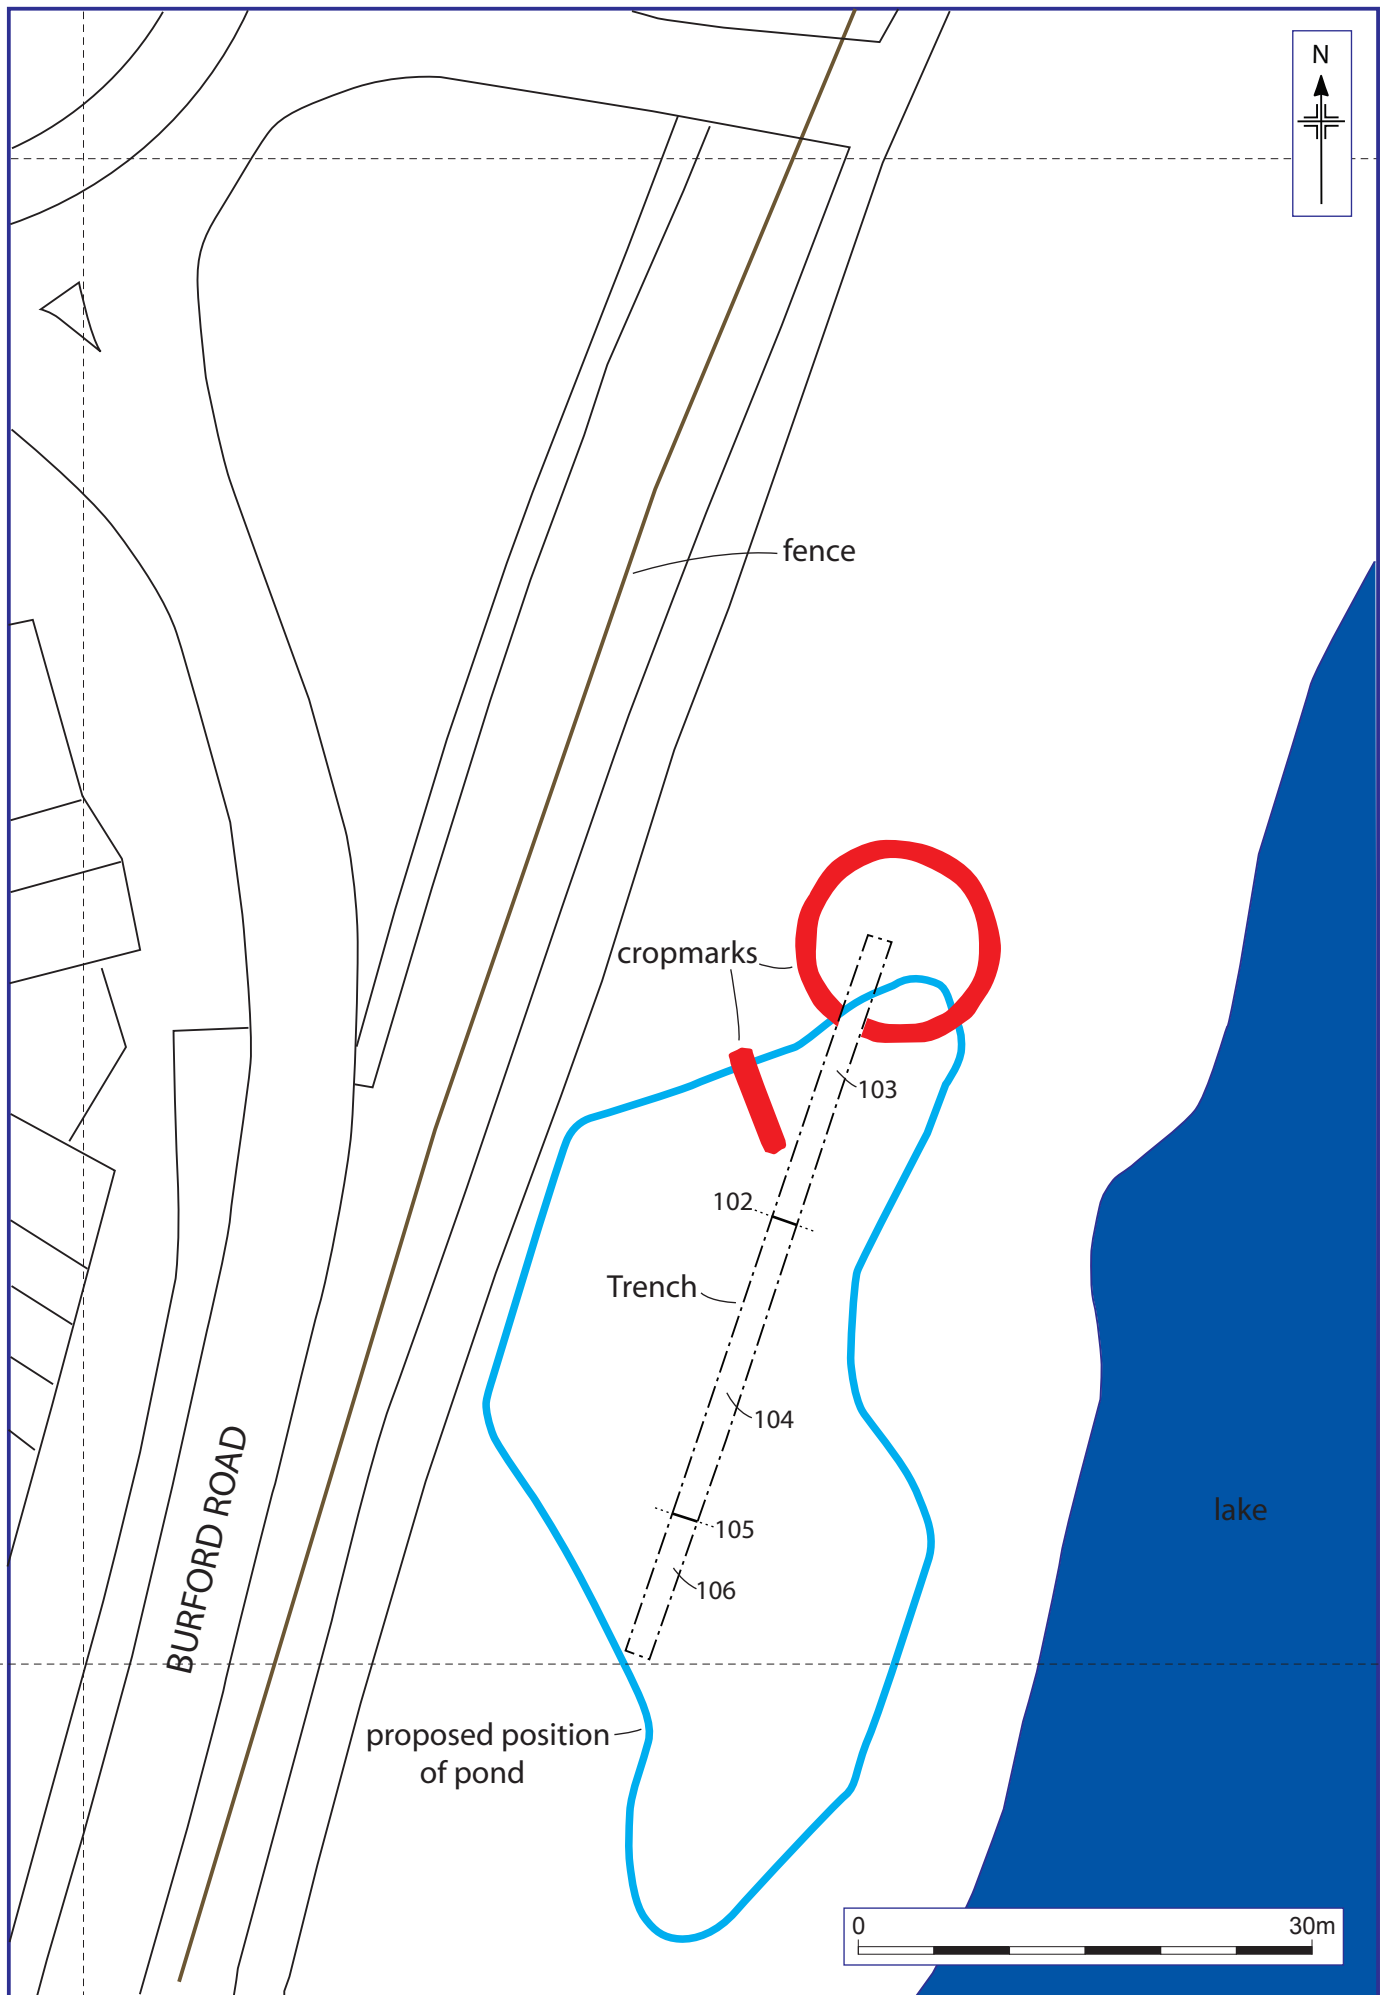
Figure 2

Trench location plan

A single trench amounting to just over 75m<sup>2</sup> in area, was excavated. The location of the trench is indicated in Figure 2. The trench was located to test specific cropmarks, the location

The trenches and features recorded are shown in Fig 2. The results of the structural analysis are presented in Appendix 1.

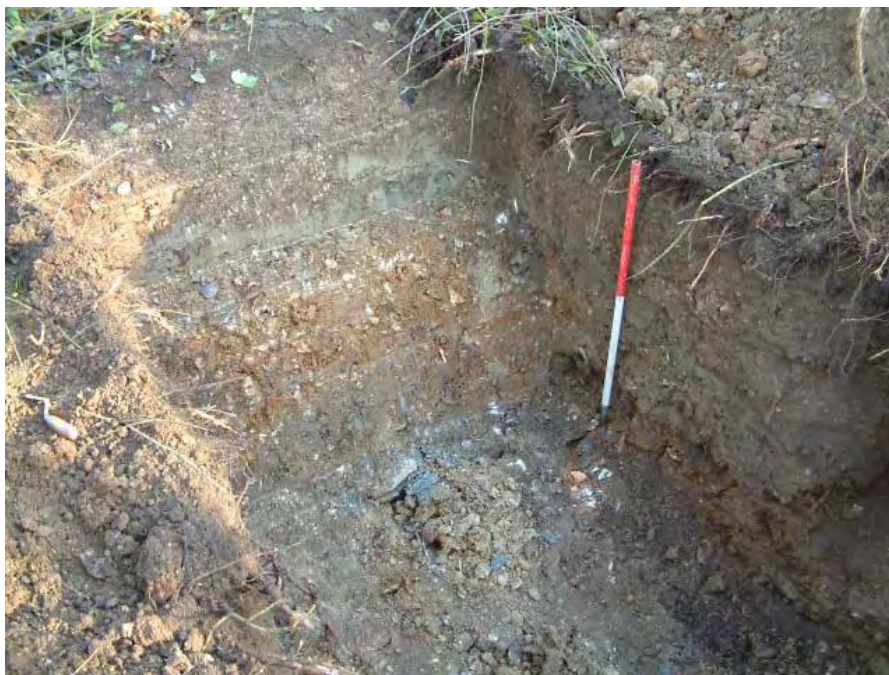
*Plate 1 North end of trench showing backfill material 103, facing NE.*

Evidence for landscaping of the land during and prior to the gravel quarry now represented by Horseshoe Lake was evident in the trench. At the north of the trench, and in the expected location of any feature relating to the circular cropmark, an area of backfilling was encountered (Plates 1 and 2). A length of 20m of mixed waste material was present (103) which included some topsoil, a large amount of white gravelly clay and orange sub-angular gravels and some bluish clay. This was mixed with modern ceramic building material and metal and plastic refuse. The depth of this material was tested by machine to determine whether any archaeological deposits may have survived beneath. This was not the case as it extended to a greater depth than 1.2m. The southern boundary of 103 was recorded 20m into the trench (Fig 2). This feature was capped by a soil layer (101), which consisted of a light grey brown friable silty clay with abundant small-medium sub-rounded gravels. This in turn was beneath a thin redeposited topsoil approximately 0.15m deep.

It was evident from the evaluation that the whole of the area in the location of the proposed pond had been severely disturbed during the quarry works in the second half of the 20<sup>th</sup> century. It is possible that 102 reflects the original extent of the quarry and represents an area backfilled during groundworks to convert the quarry into a lake. Feature 105 is also highly likely to have been associated with quarry activity.

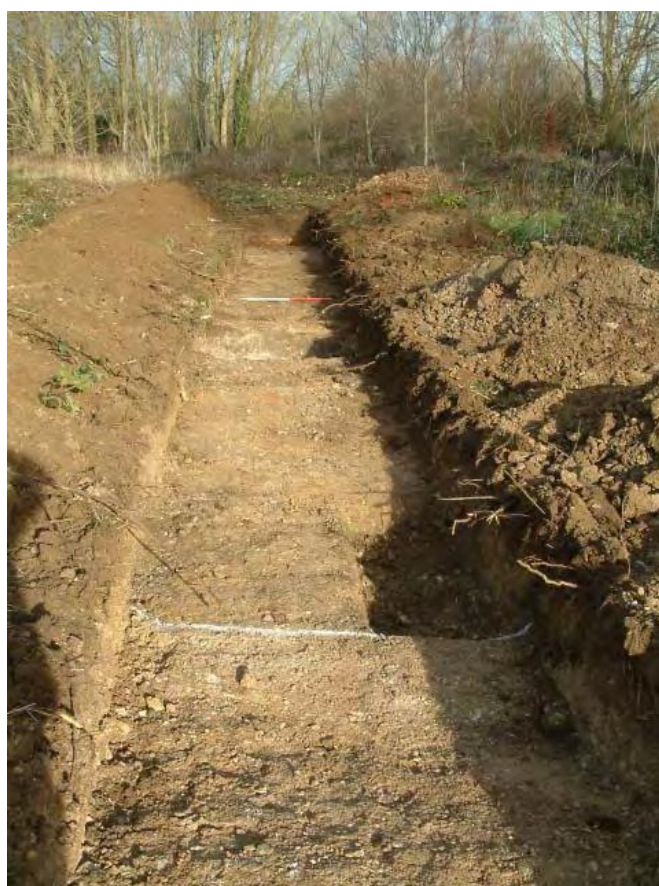
*Plate 2 Showing extent of backfilled material 103 (from white line in foreground to end of trench.), facing north.*

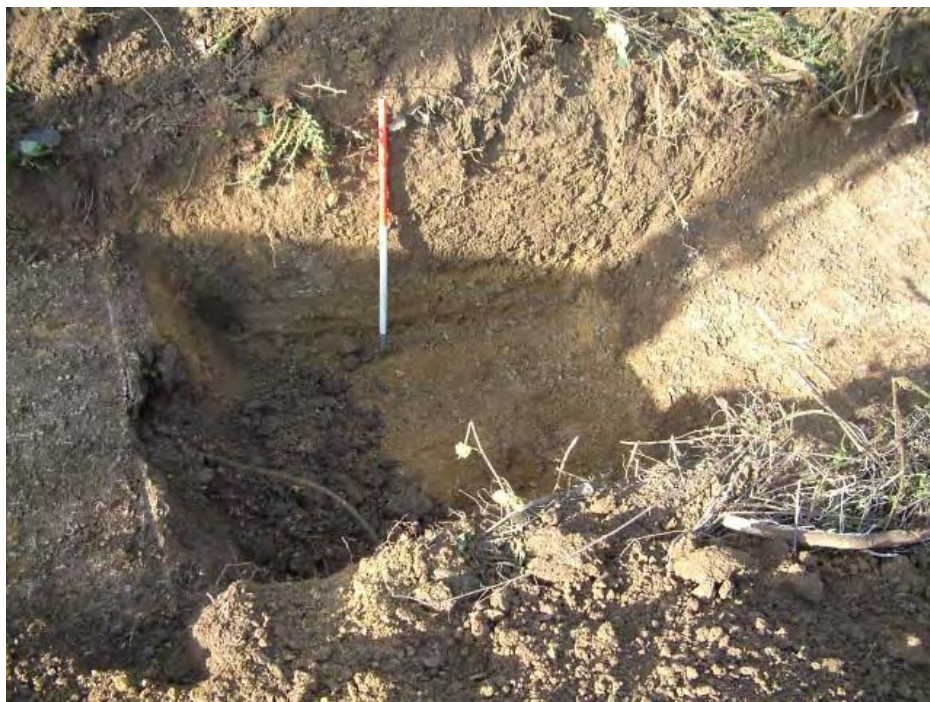
*Plate 3 Feature 105 at southern end of trench, facing north west.*

At the southern end of the trench a further large feature was identified (105). This was greater than 9.8m in length as it extended beyond the trench boundary. An area of this feature was excavated by machine which proved to be 1.05m deep and contained a steel cable 1.5cm thick (Plate 3). This was filled by 106 which was very similar to 101 covering the backfill of 102.

105	Feature	Large undiagnostic feature containing a 1.5cm steel cable.	0.15 – 1.05m
106	Fill	As 101.	0.15 – 1.05m
