ARCHAEOLOGICAL  
WATCHING BRIEF ALONG  
THE ROUTE OF THE  
NORTHFIELD RELIEF ROAD,  
BIRMINGHAM

15 March 2007

Project 2646  
Report 1393  
NRR05

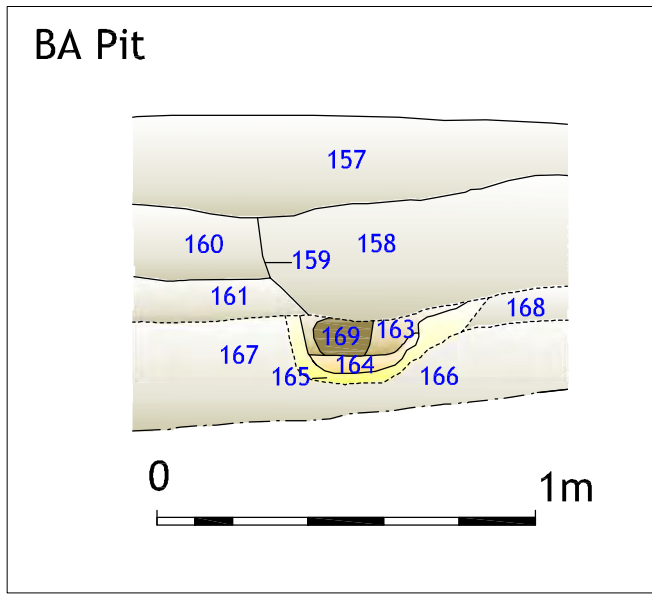
Figure 3 Prehistoric and Roman features

The most significant feature on the site was found on the west section of the west carriageway, at a point opposite Rochester Road. This was a small pit filled with a mixture of redeposited clay, charcoal, and ash (Figure 3, context 166: Plates 2 and 3). Unfortunately, the feature was not observed in plan, and part of it was removed by machine. However, the remainder was excavated by hand, and most of the fill was sampled. No artefacts were recovered, but the two samples of charcoal were radiocarbon dated to a period in the late 3<sup>rd</sup> or early 2<sup>nd</sup> millennium BC (see Appendix 2).

The Bronze Age pit was sealed by orange brown silty clay (contexts 161; Figure 3). This in turn was sealed by olive silty clay with dark grey mottles (context 160). These deposits are likely to represent the lower part of a soil formed since the Bronze Age. As elsewhere, the upper part of the soil had been removed by modern landscaping.

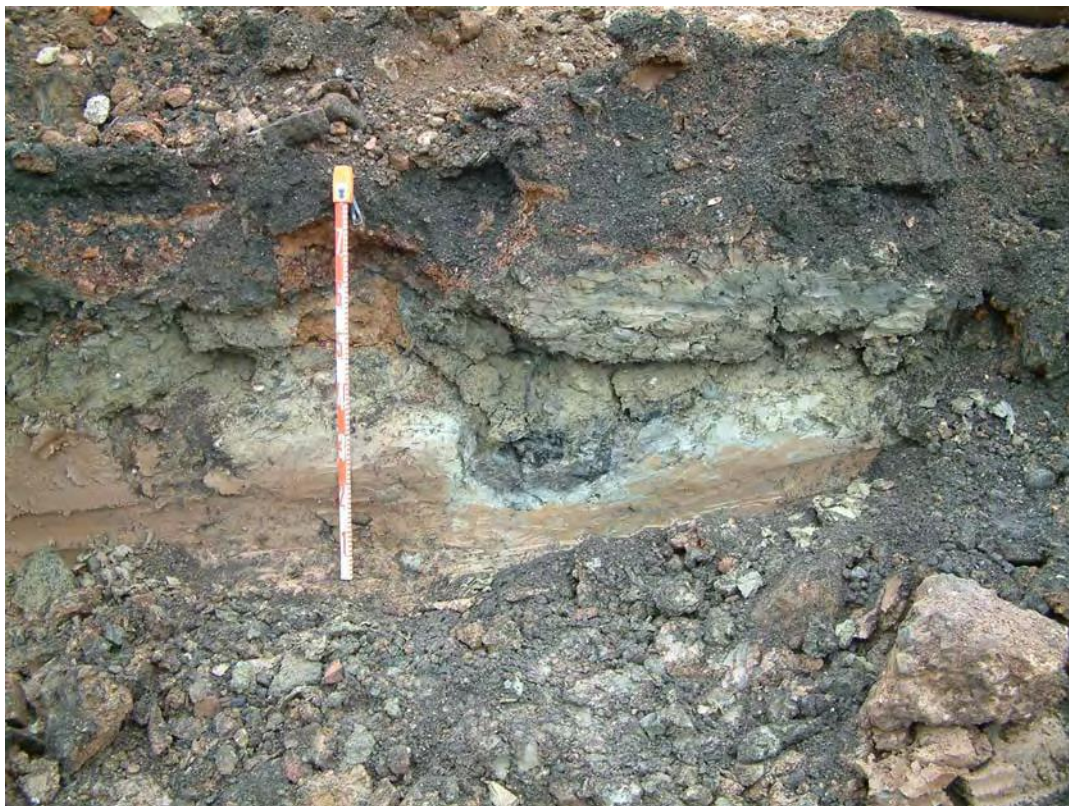
*Plate 2: Bronze Age pit (context 166)*

The Bronze Age pit is an important find, but difficult to interpret due to the lack of associated remains and the discrepancy between the radiocarbon dates. On the first point, is uncertain whether the pit was an isolated feature, or whether it existed alongside other features that have been removed by modern landscaping. And on the second point, while the pit appeared to represent a single deposit, the radiocarbon dates suggest material dating to *c* 2000 BC and a period several centuries later. Assuming the radiocarbon dates are correct, it appears that residual material was included in the fill.

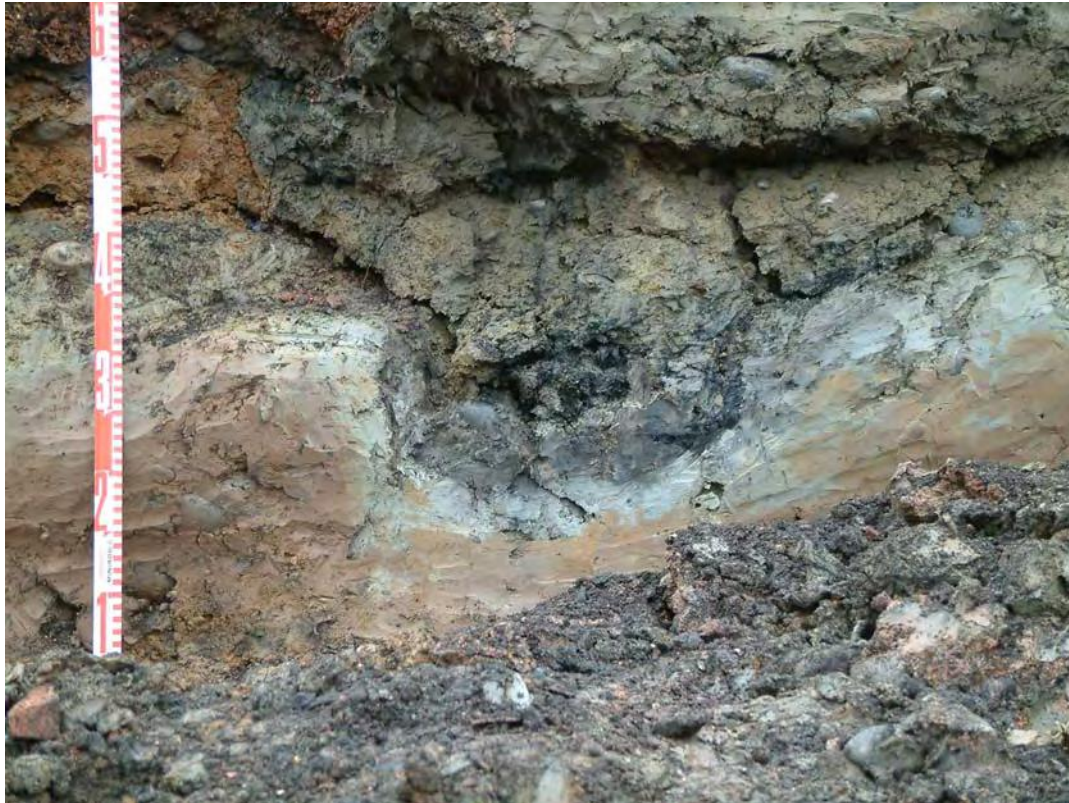
*Plate 3: Detail of Bronze Age pit*

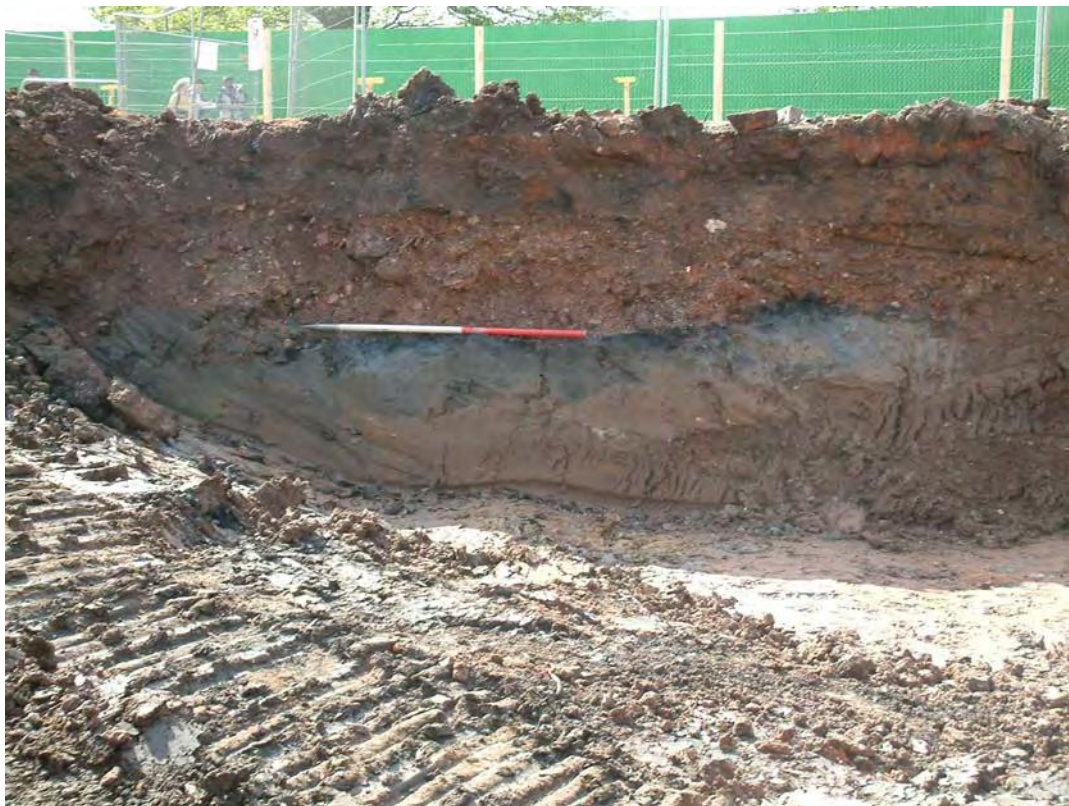
Two features found along the route almost certainly existed in the post-medieval period. One of these was a pond near the north end of the route (Figure 4, context 145; Plate 4). The pond appears on the tithe map of 1845, and was represented in the field by deposits of blue/grey silt filling a shallow declivity in the marl (contexts 140, 141, and 145:). The pond had been severely truncated by modern pits, but according to the tithe map and later Ordnance Survey maps it was originally oval, and measured *c* 33m by 20m.

*Plate 4: Pond deposits exposed in excavations for east carriageway (contexts 140 and 141)*

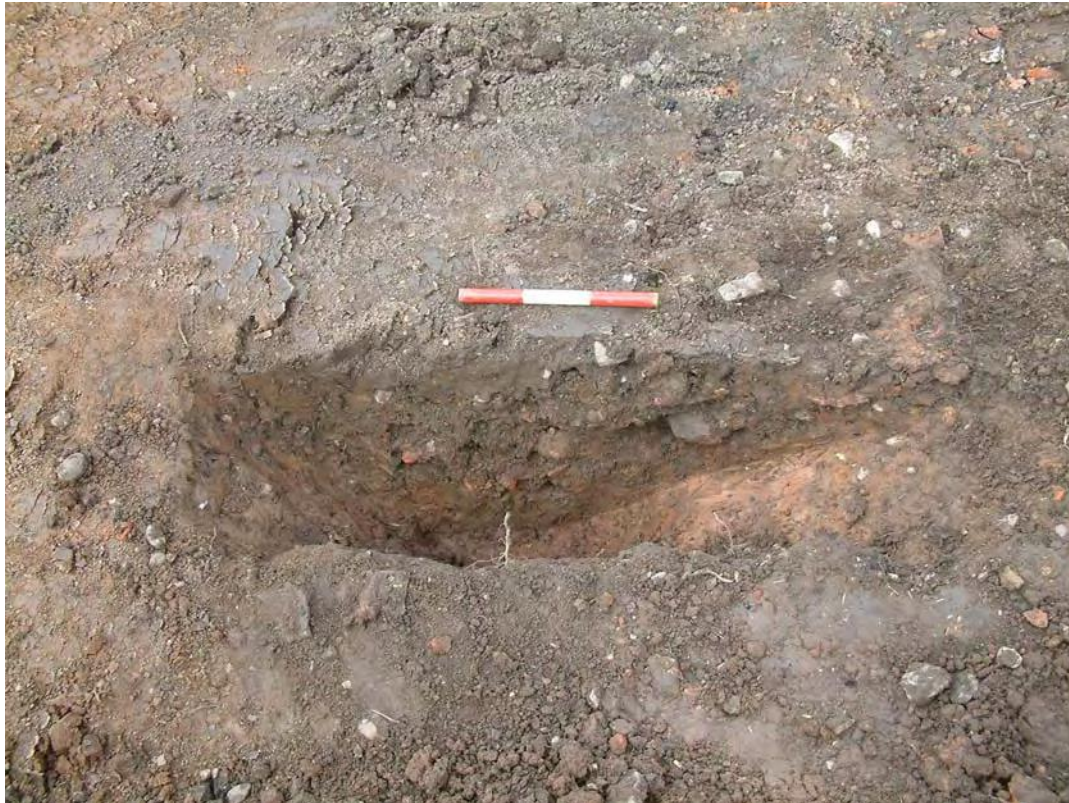
The second feature was a ditch *c* 100m to the north of the pond (Figure 4, context 110; Plate 5). This ran parallel to a field boundary mapped in 1845 and was almost certainly a drainage ditch. It had been deliberately backfilled with soils containing modern material (context 108).

*Plate 5: Post-medieval drainage ditch (context 110)*

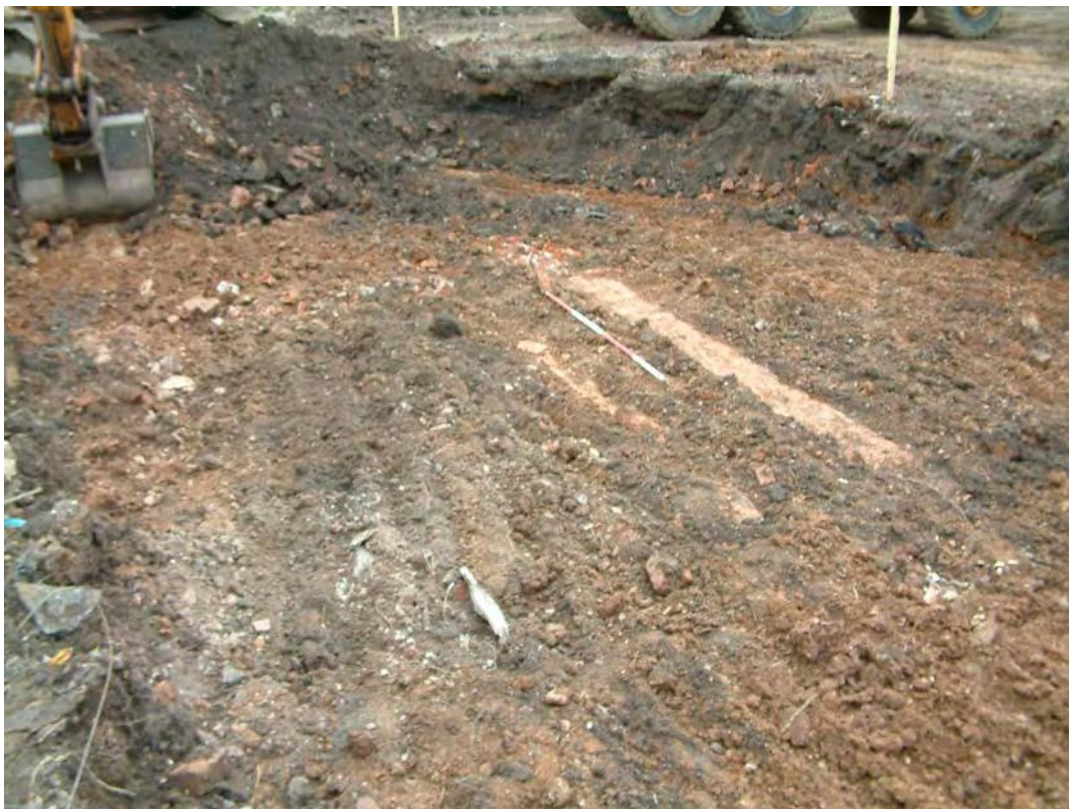
The most significant features were the brick foundations found *c* 50m north of Lockwood Road (Figure 4, contexts 148-153; Plate 6). These defined parts of a sub-divided building with a small extension to the north. The main building appears on the one-inch map of 1832, at the north end of an irregular enclosure. However, the bricks are typically Victorian, suggesting that the building was recent in 1832. No floor surfaces survived to indicate how the building was used, although the subdivisions observed in the field shown on later Ordnance Survey maps suggest an agricultural or industrial function.

*Plate 6: Foundations of early 19<sup>th</sup> century building (contexts 148-154)*

The modern features described above reflect the transformation of Northfield after 1800. The brick building to the north of Lockwood Road reflects encroachment behind a fully developed street frontage. This development belongs to the period from *c*1800 to 1832, and was probably associated a rapid growth in population and manufacturing. The other features represent later development of a residential character. The well found on the west side of Bell Hill was probably associated with a short-lived house (built by 1845 but demolished by

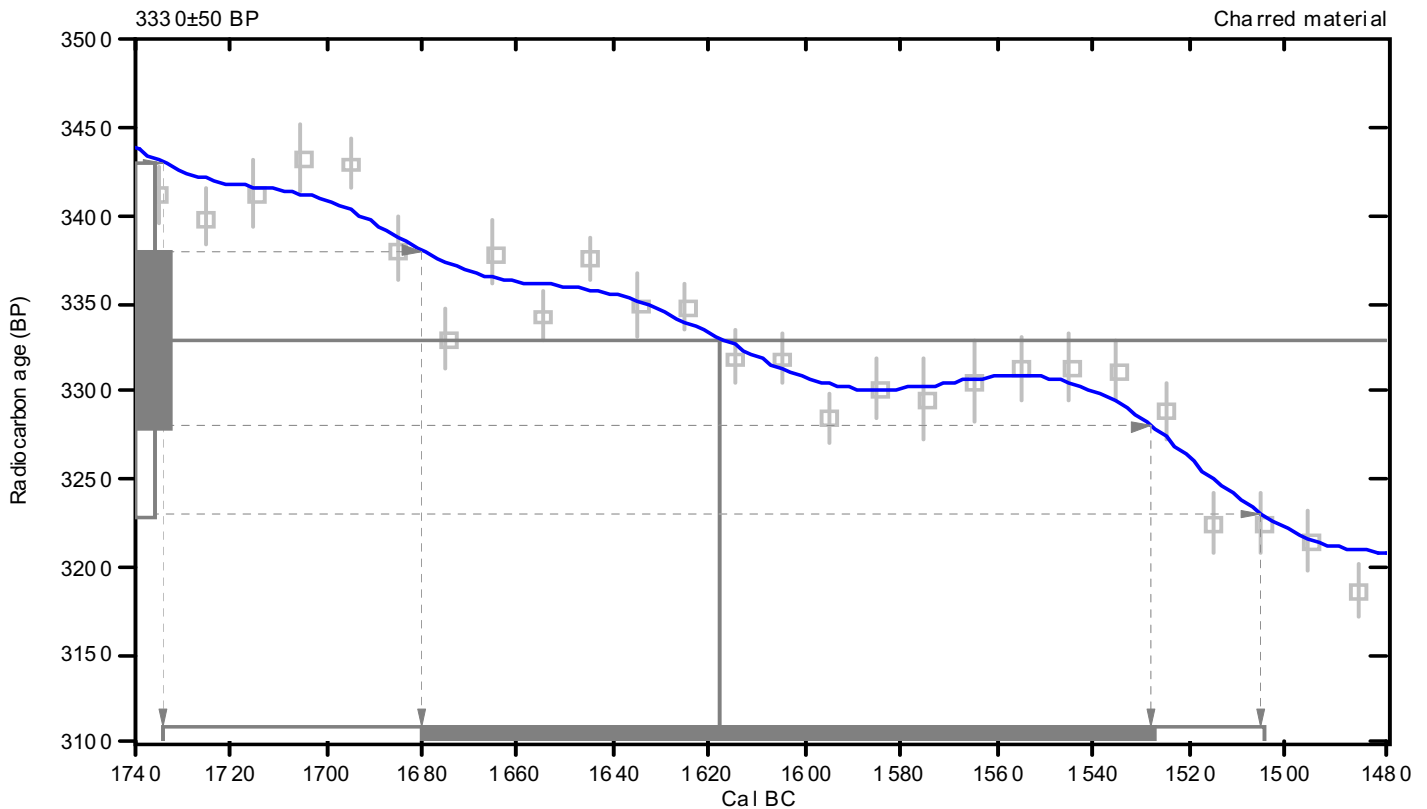
Intercept of radiocarbon age  
with calibration curve: **Cal BC 1620 (Cal BP 3570)**

1 Sigma calibrated result: **Cal BC 1680 to 1530 (Cal BP 3630 to 3480)**  
(68% probability)

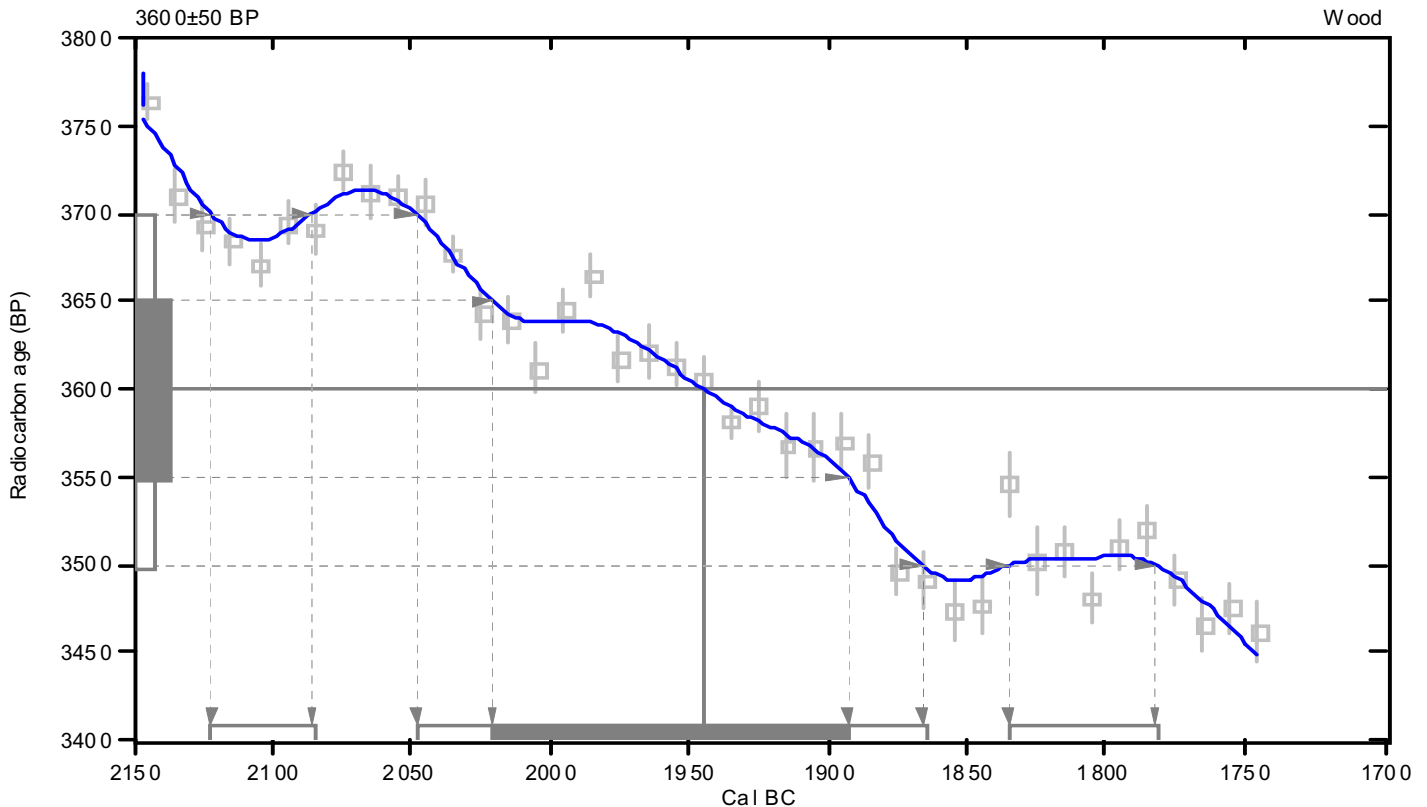
Intercept of radiocarbon age  
with calibration curve: Cal BC 1940 (Cal BP 3900)

1 Sigma calibrated result: Cal BC 2020 to 1890 (Cal BP 3970 to 3840)  
(68% probability)
