ARCHAEOLOGICAL WATCHING
BRIEF
OF THE TAME SCHEMES:
BAYSTON ROAD,
KINGS HEATH,
BIRMINGHAM

Project 3133
Report 1607
EBM 358

Archaeological watching brief of the Tame Schemes: Bayston Road, Kings Heath, Birmingham

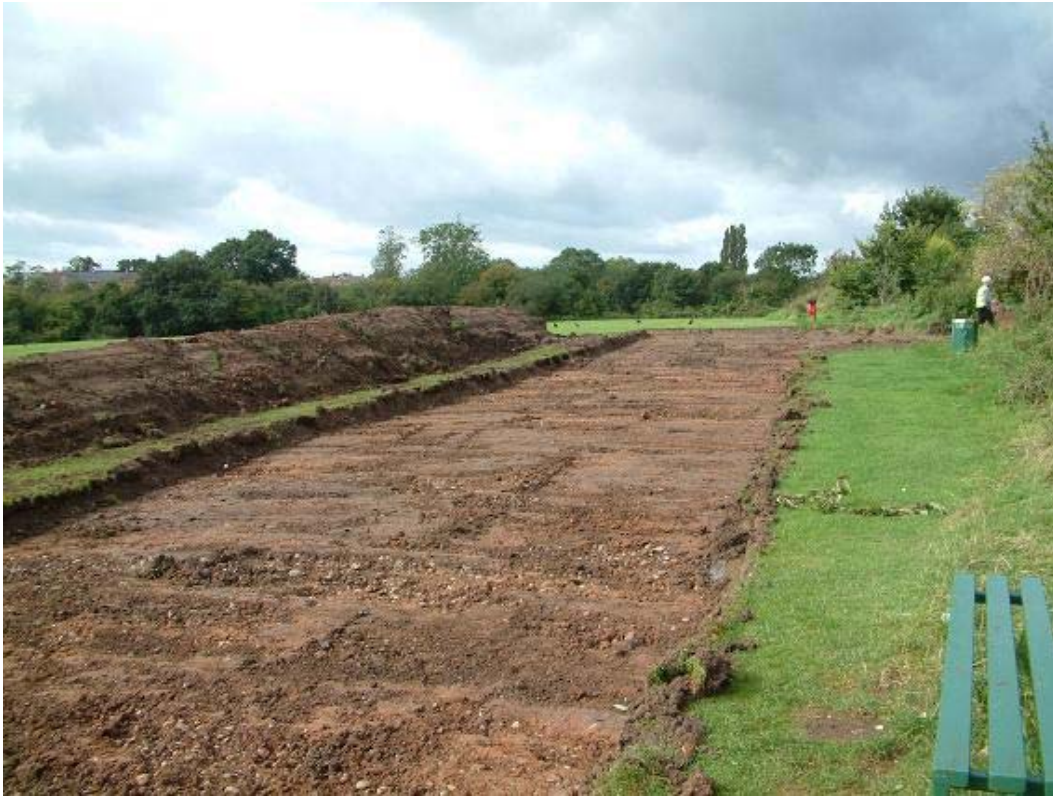
Plate 1: West end of initial strip for access road, facing west

The access road was revealed a mid grey brown silt loam topsoil (101), recorded as 0.25m deep. Below the topsoil the observed subsoil did not suggest any archaeological features or deposits. The subsoil overlay and sealed the natural matrix. The underlying natural deposit 103 comprised of very

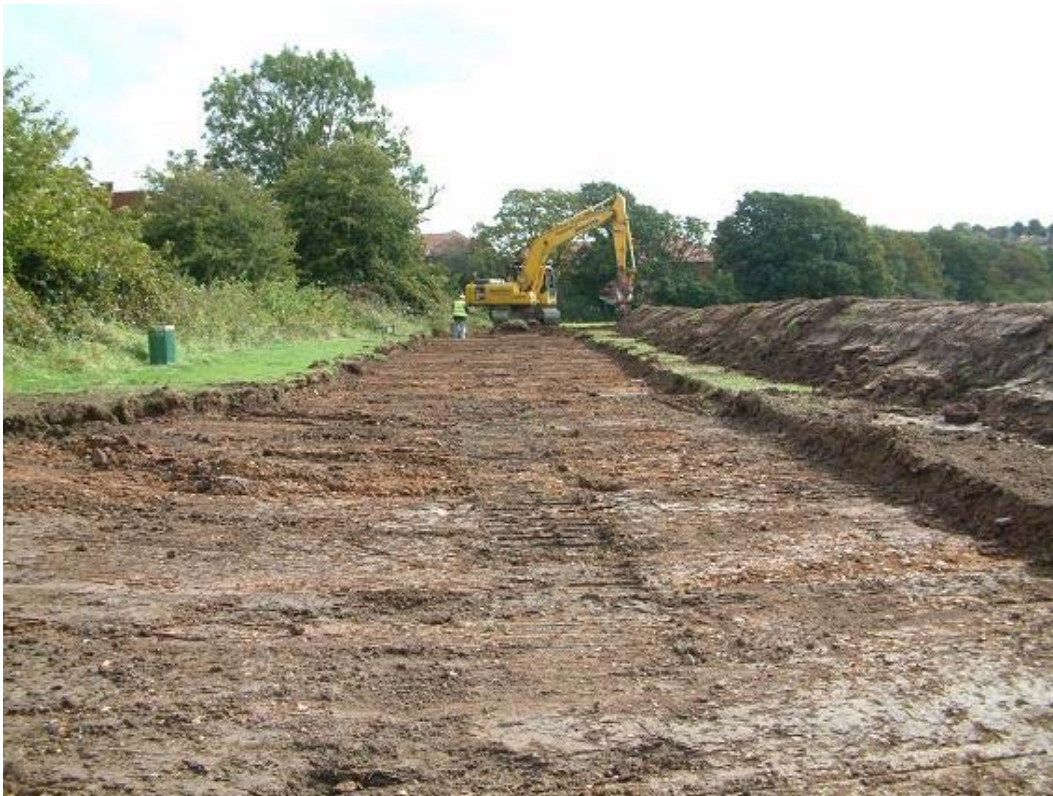
Plate 2: Area at south of access road, facing north east

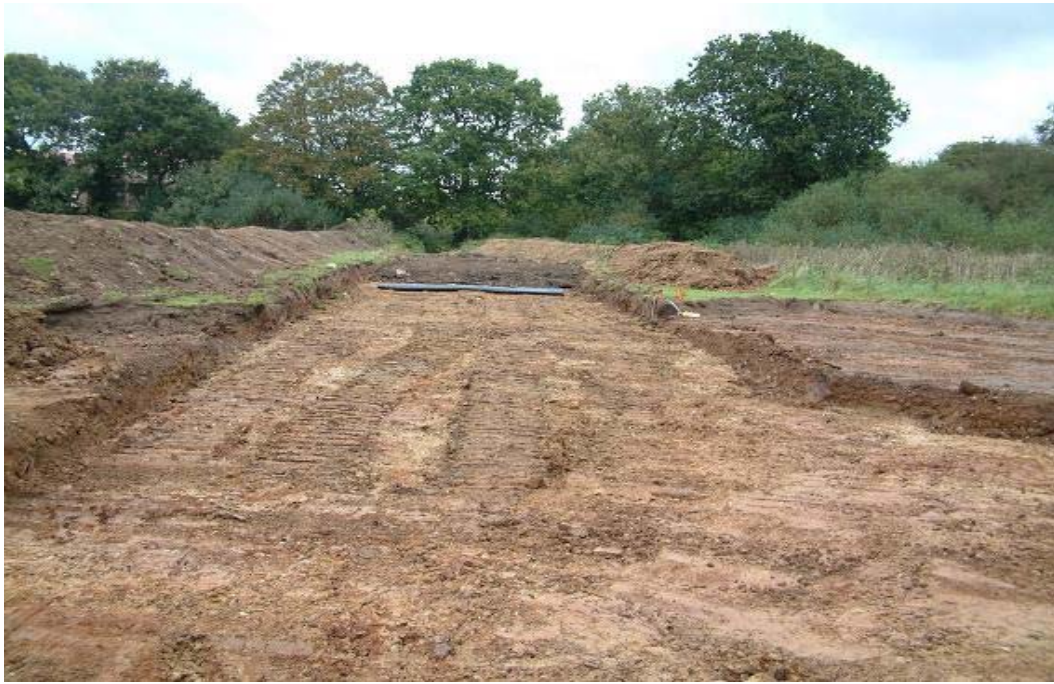
Plate 3: Area at south of access road, facing south west

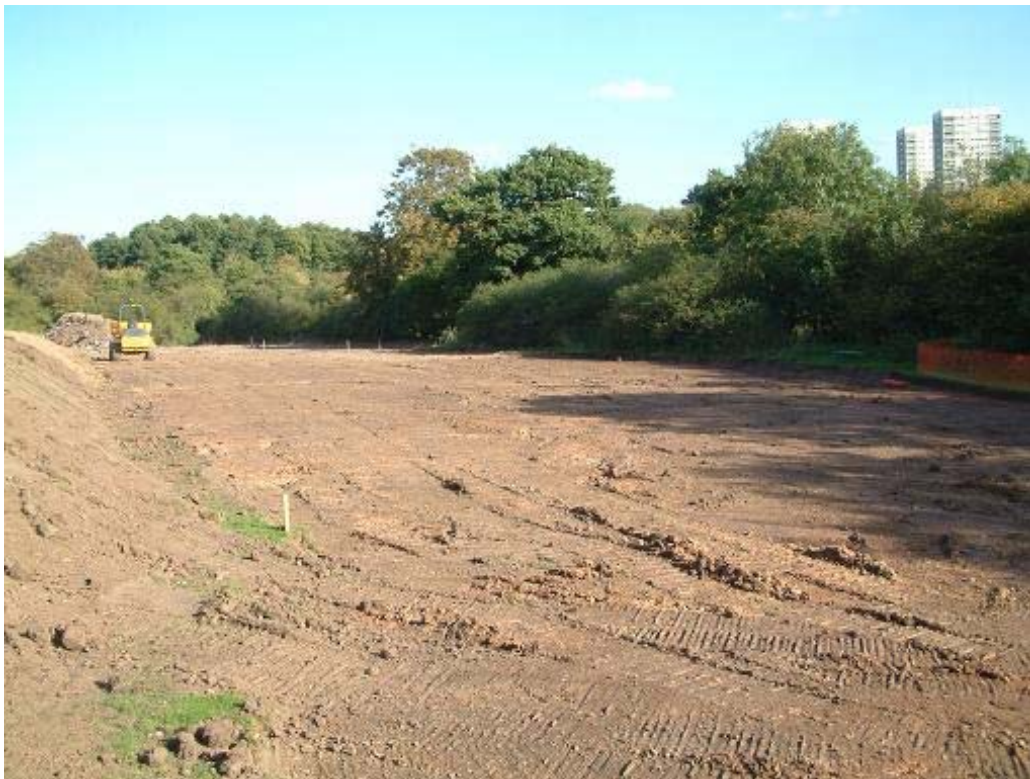
Plate 4: General shot of Site after topsoil strip, facing east

The topsoil strip only removed 0.20m of topsoil enough to expose some subsoil, but not natural or any pre-modern deposits. It was necessary to monitor the deeper excavations of the manholes to meet the aims of the project.

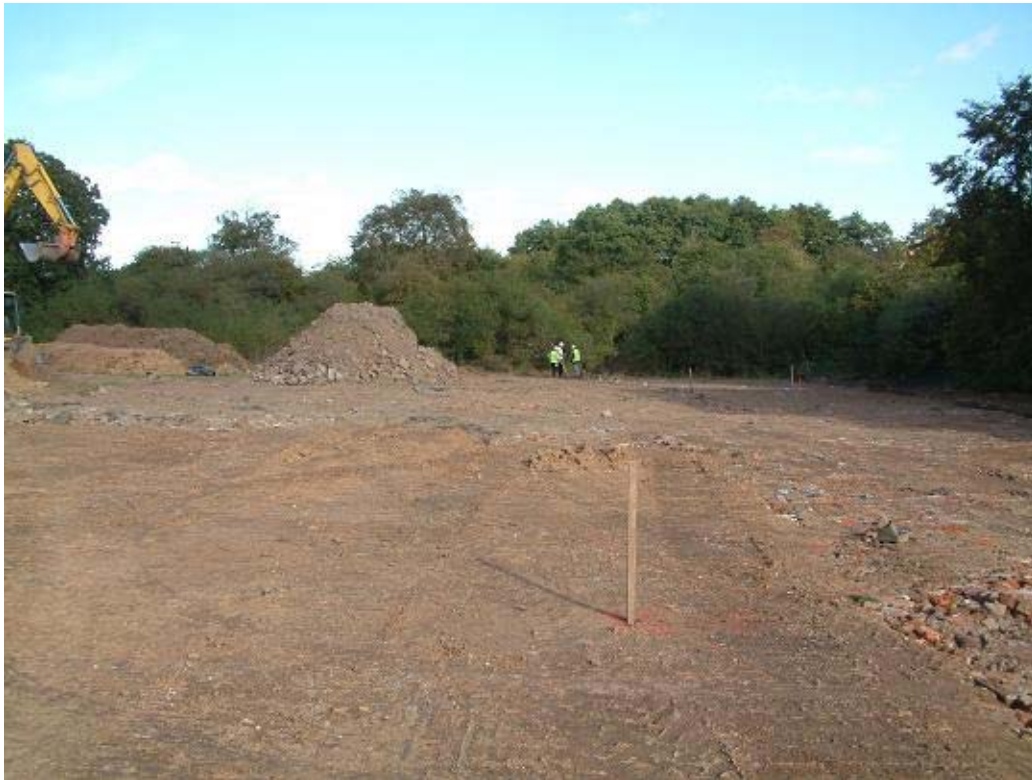
Plate 5: General shot of Site after topsoil strip, facing east

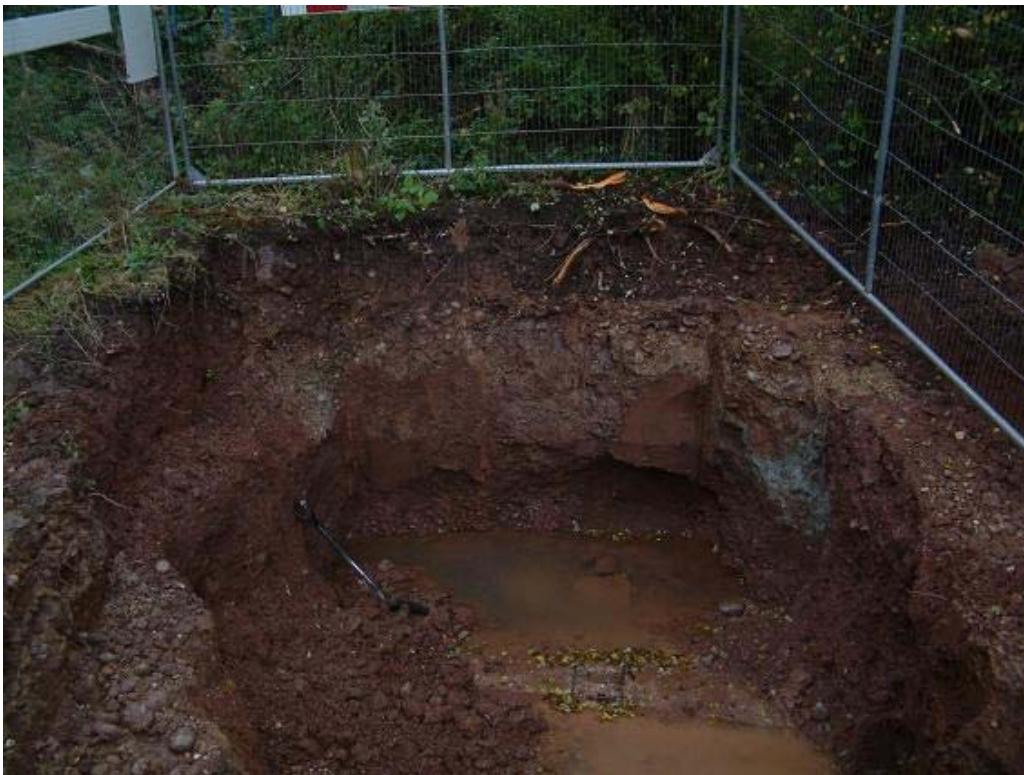
Plate 6: Northwest facing section of excavation for Manhole F1

The sections of the excavated Manhole F1 were visible to observation and recording. Here the topsoil had been previously removed during the stripping, except in the south east side. The boundary between context 1100 and 1101 was irregular and defuse. 1101 comprised of compact silty orangey brown clay. Below this was a layer of cobbles 0.25m thick and was bedded on top of natural clay. No associated archaeological deposits were identified and no artefacts were retrieved.

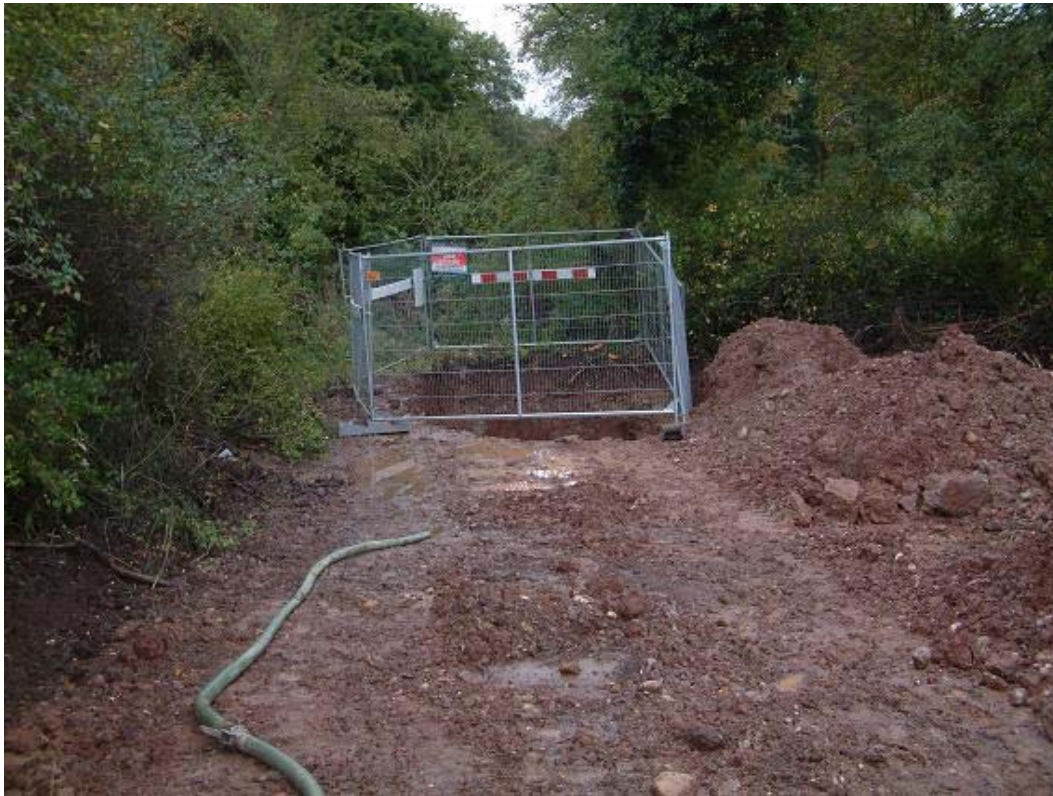
Plate 7: General shot of manhole F1, facing south east

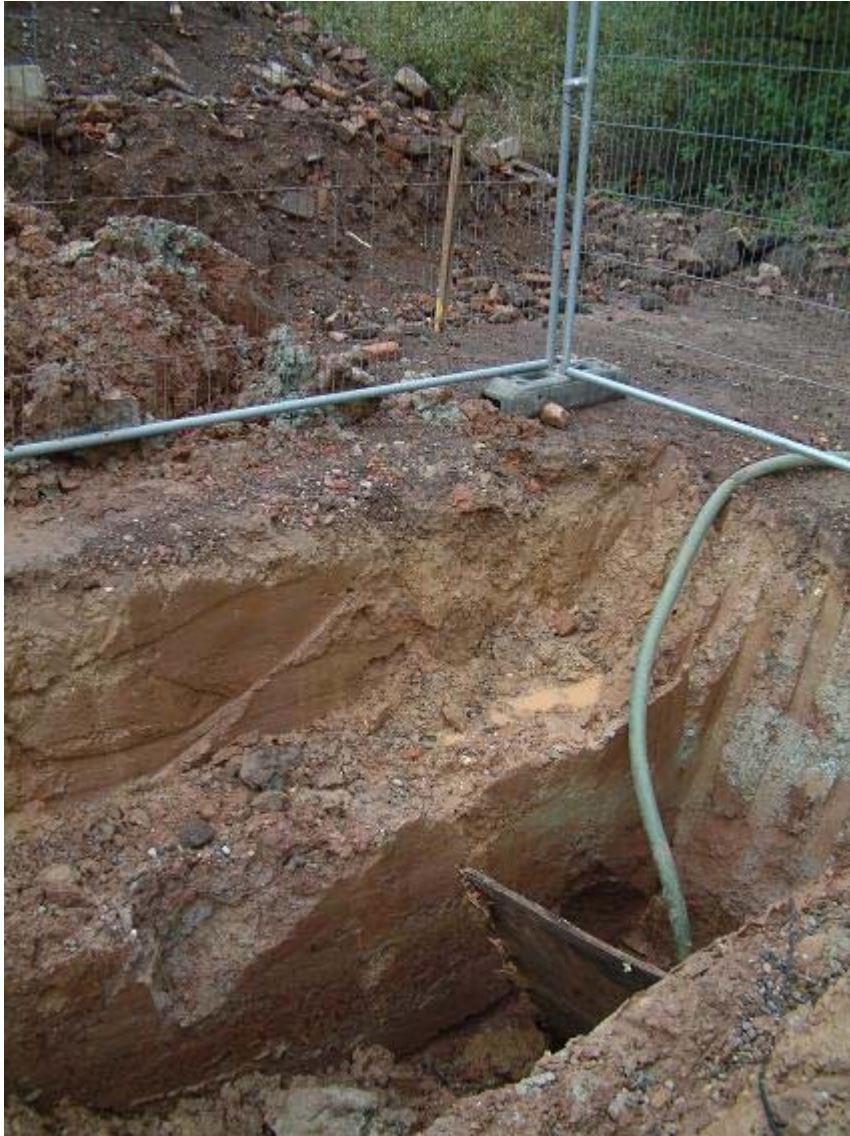
Plate 8: South facing section of trench for Manhole F2

During the excavation of Manhole F2 there was little scope for observation and recording because the trench was narrow and being simultaneously backfilled after excavation. Part of the sections revealed undisturbed subsoil over red clay Keuper Marl.

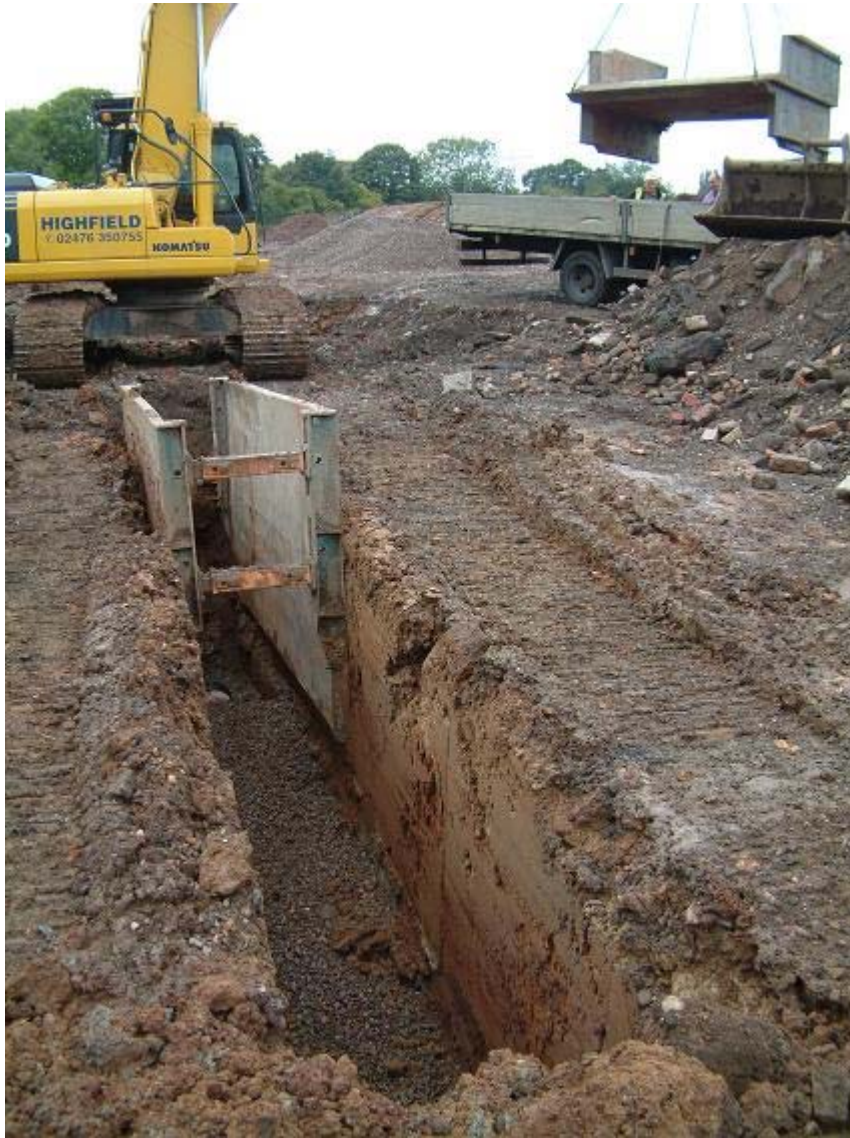
Plate 9: General shot of trench with box, west of Manhole F2
