HISTORIC BUILDING
RECORDING AND
GROUNDWORKS AT
EATON FARM, STOKE PRIOR,
HEREFORDSHIRE

29th September 2004

Project 2343
Report 1218
HSM 37315

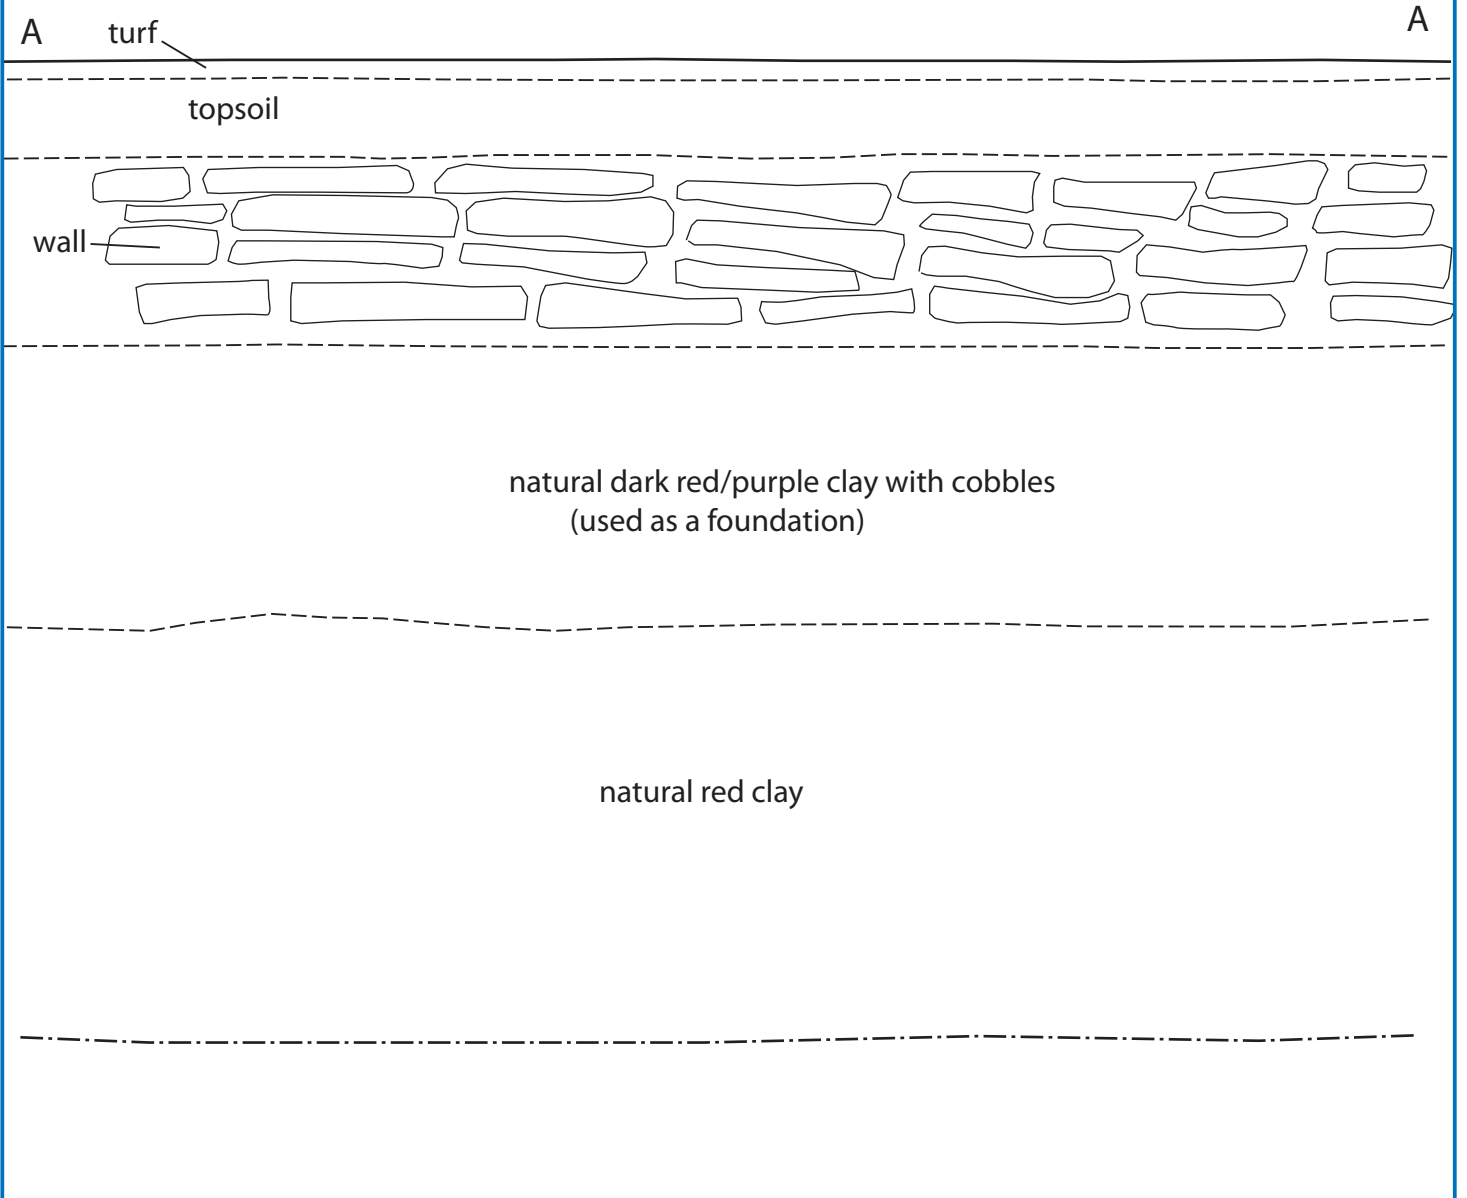
Figure 7

Schematic sections of wall..

The watching brief consisted of a large area outside the barn that was cleared to level the ground in preparation for the development. Three trenches were also excavated for drainage and a septic tank. These trenches are indicated on Figure 2. Section drawings of the trenches are reproduced in Figure 7.

Trench 1 revealed an undated stone wall. This wall was constructed of large faced stones on both sides and with a rubble core. It was 1.1m wide and was sitting on a foundation of re-deposited natural clay with cobbles tamped into it. The subsoil in the surrounding layer had built up against the wall rather than being cut through to construct the wall.

The wall extended along the trench and into the large sump excavated for the septic tank. Here the full width of the wall was revealed and also a return to the north. The construction of the wall was very different to that of the barn. The stones of the wall were much larger than those of the barn and were properly faced. The wall of the barn is only half the width of this stonewall. Even though there was no dating material within the surrounding soils, the construction of the wall would suggest a date prior to the 17th century.

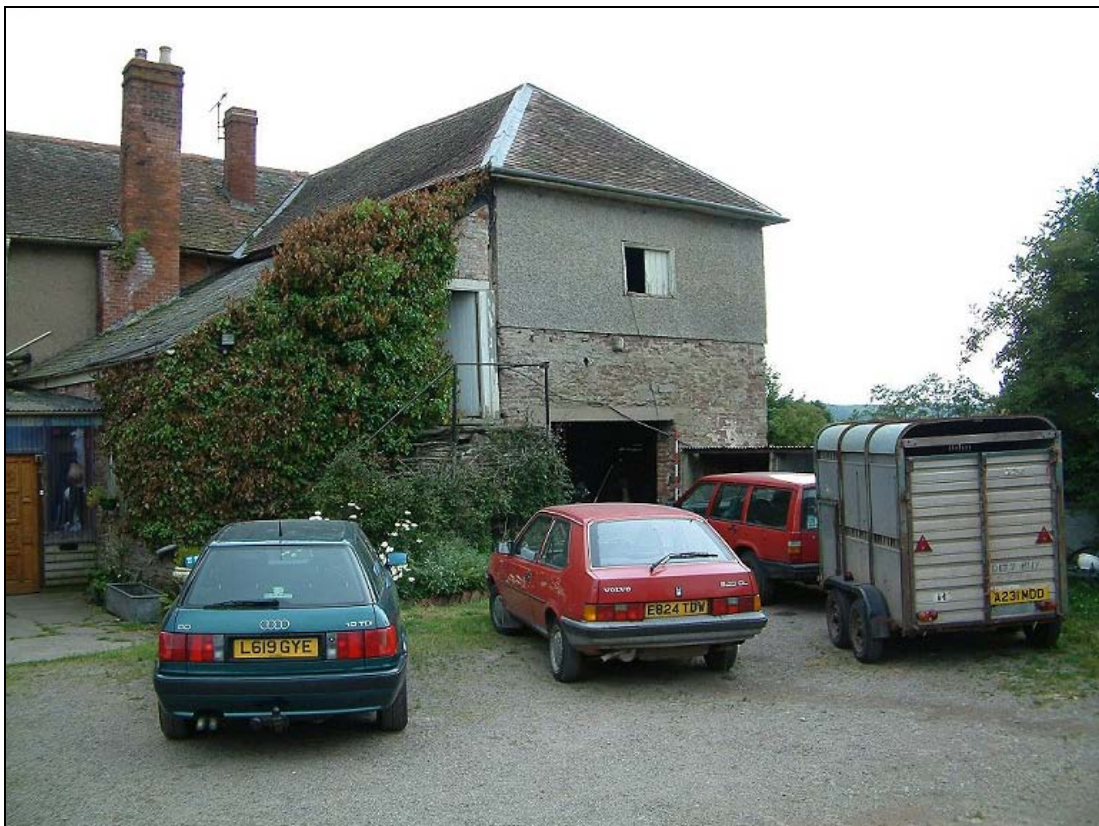
Plate 2: Barn attached to Eaton Farmhouse

The barn is built of coursed rubble lias and sandstone on the ground floor (Plate 2) and timber-frame above which has brick infill. The first floor timber-frame is rendered on the exterior but the timber and brickwork is visible inside (Plate 3). The timber-frame is of square panels. The roof is hipped with plain tiles, the windows are rectangular and the doors have wood frames.

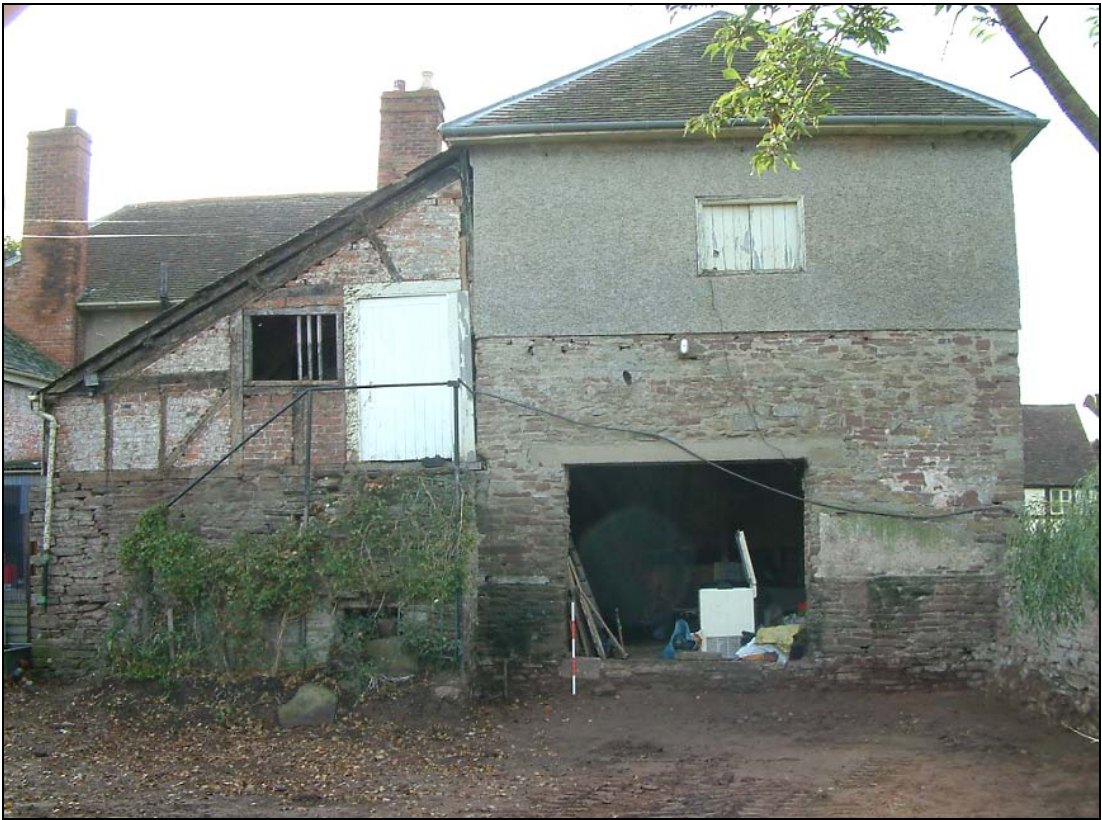
Plate 4:Lean-to extension to barn

The lean-to has a stone plinth, like the barn, with timber-frame above (Plate 4). The stone is coursed rubble lias and sandstone and the timber frame is a mixture of tall and square panels. The roof has slates, the windows are square and the doors have wood frames. One of the windows is a small casement with leaded lights.

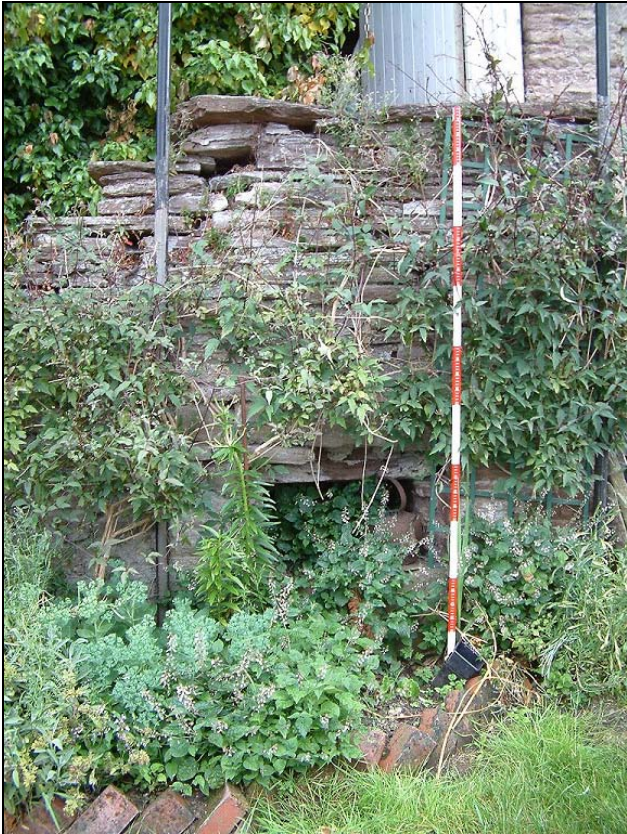
Plate 7: Kennel below stairs

The granary that was created in the 18th century lean-to had an important function for the farm. The granary was used to store the grain after it had been threshed. The threshed grain would originally have been stored in the farmhouse but as yields and farming profits grew the granary became an independent building on the farm. Granaries were raised above the ground to keep the grain dry and vermin free. Threshed grain required safe storage for it was both the main cash crop and the seed for future crops. If the grain got damp, was eaten by rats or stolen by thieves then the farm could fail financially. Therefore the granary was generally located on the first floor in a building that would allow air circulation and had a staircase that could be protected either by being locked or, if external, then by incorporating a kennel, as in this case.

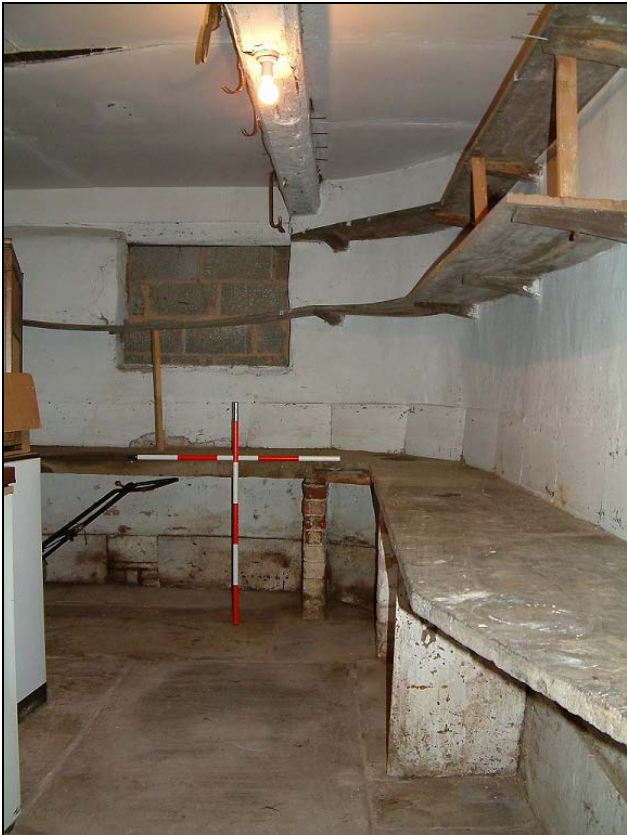
Plate 8: Dairy

In the 18th century the barn was extended along its north elevation. The extension was constructed of roughly coursed rubble stone on the ground floor and a mixture of tall and square panels of timber framing on the first floor. The panels were infilled with brick. Access into the extension was through doors in the north-east face of the building (Plate 5). The access to the first floor was by exterior stone steps (Plate 6) with a built in kennel below them (Plate 7). A doorway was inserted through the framing on the first floor to allow access into the main barn from the extension. The building was used as a granary on the first floor and for grain processing or storage on the ground floor. A separate room on the ground floor was used as a dairy. This had a flagstone floor with a stone bench on brick piers (Plate 8).

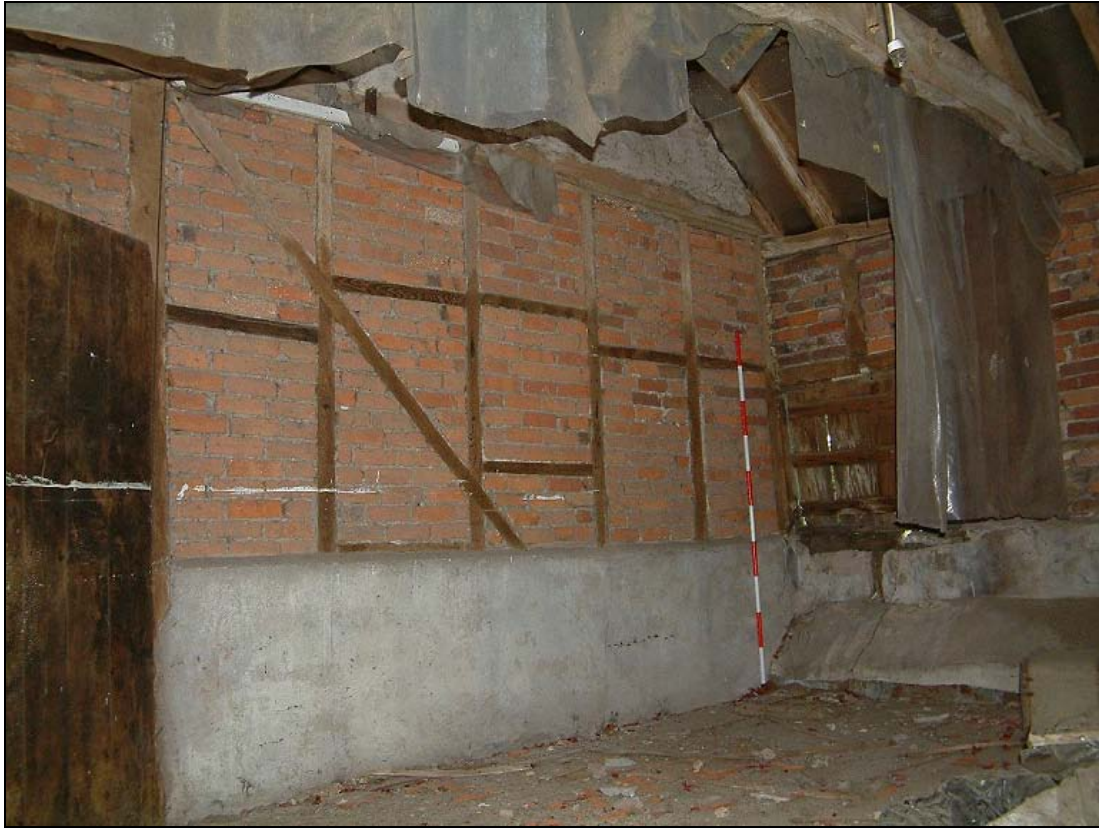
Plate 9: Inserted dividing wall in barn

Also in the 18th century the first floor of the barn had an internal timber frame division added (Plate 9). This division allowed different items to be stored on the same floor but in separate conditions, such as apples and grain or hay. At this time the building was being used as a cider mill and for the storage of the fresh cider. The first floor was used for the storage of apples. The cider mill still exists within the garden of the farmhouse.

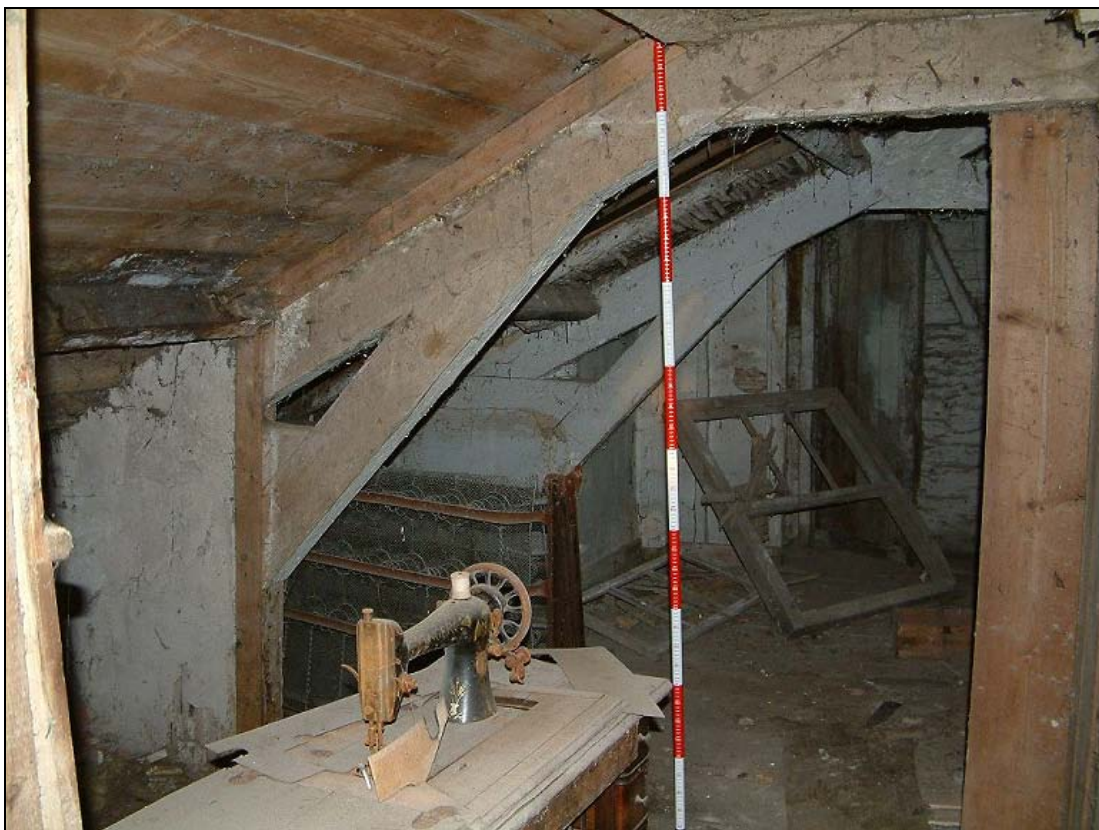
Plate 10: workmen's room

In the 19th century the first floor of the granary was partially converted into a workmen's room (Plate 10). This was used for the workmen of the farm to sleep in probably during harvest or threshing time.

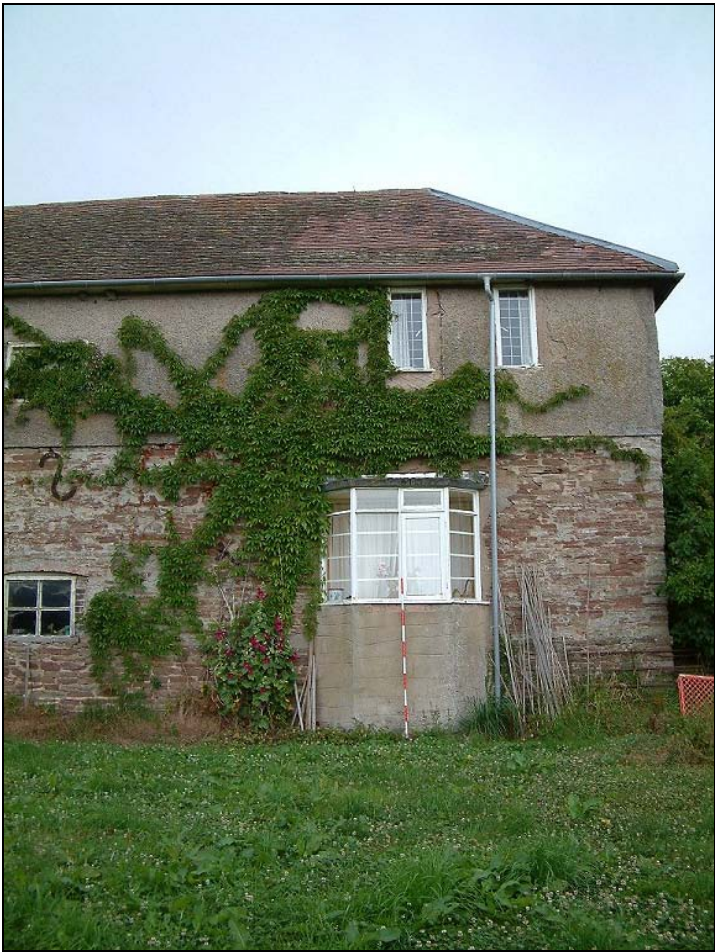
Plate 12: Added bay window to converted section of barn

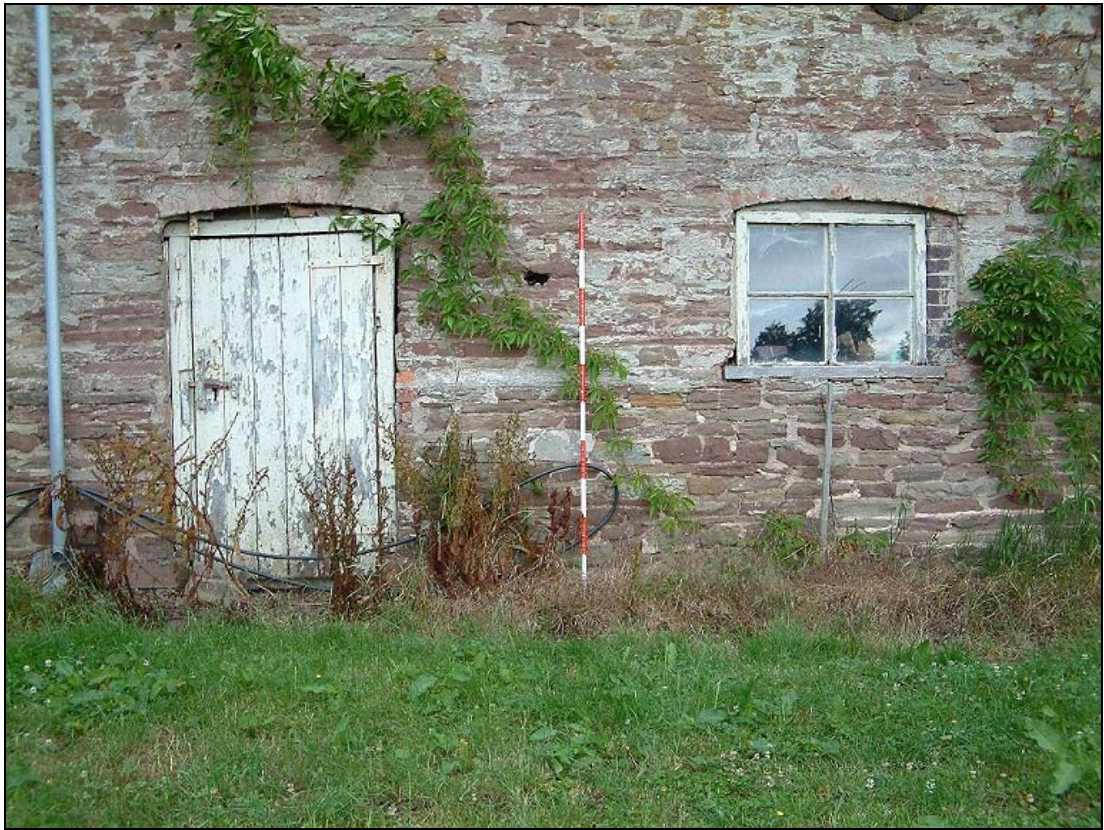
Plate 13: Inserted windows in barn

Also in the 20th century a number of doors and windows were inserted or replaced in the buildings. On the southwest elevation taking-in doors were added on the ground and first floors and shuttered windows were added.
