HISTORIC BUILDING  
RECORDING  
OF TIPTON POLICE STATION,  
SANDWELL  
WEST MIDLANDS

Project 2858  
Report 1402  
TGTPS05

# **Historic Building Recording of Tipton Police Station, Sandwell Metropolitan Borough**

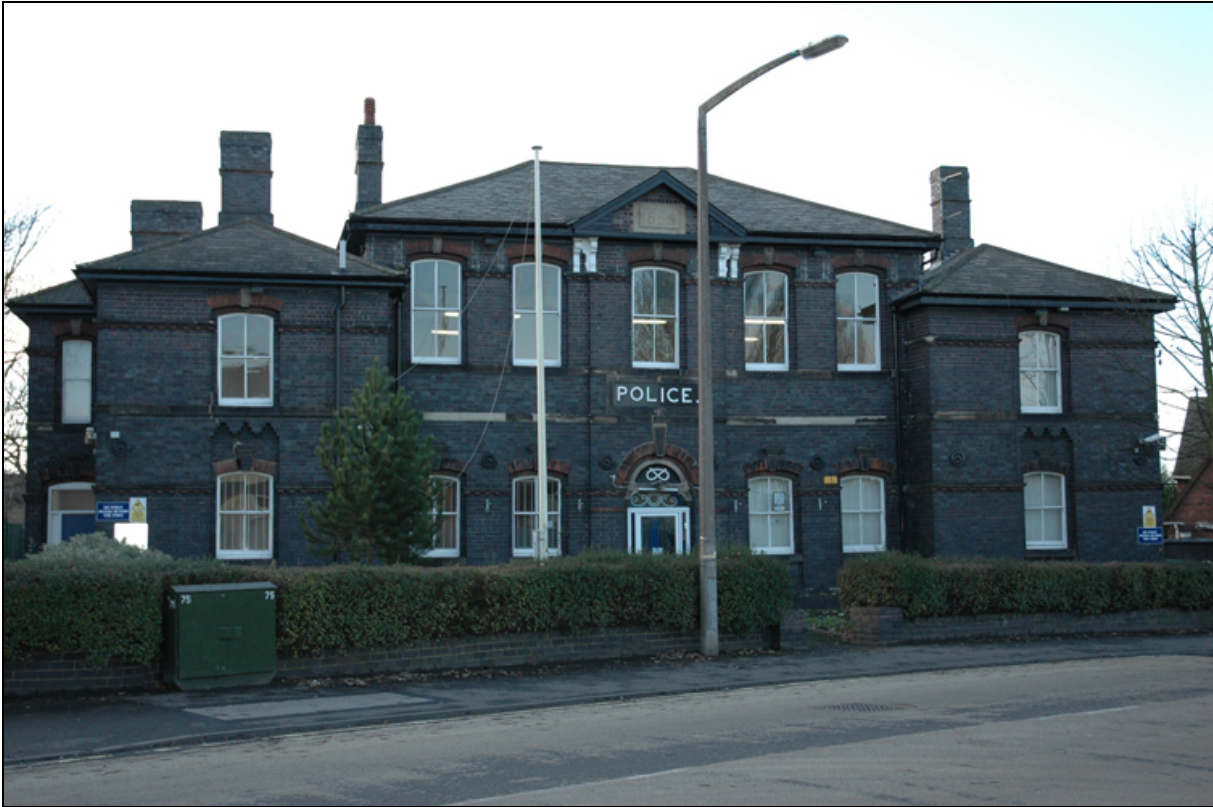
*Figure 8: Front elevation of Tipton Police Station*

Tipton Police Station is an imposing, elegant building that was fully symmetrical on its front elevation (Fig 8). It was five bays wide with large segmental-arched sash windows (Fig 9), corbels, dentil cornice and string courses (Fig 10). It had a central gable pediment (Fig 11) with eaves brackets (Fig 12) over an arched entrance way (Fig 13). The two outside bays formed projecting single bay wings. Behind the central part of the building was a two-storey cell block (Fig 14). The projecting wings also had extensions to the rear.

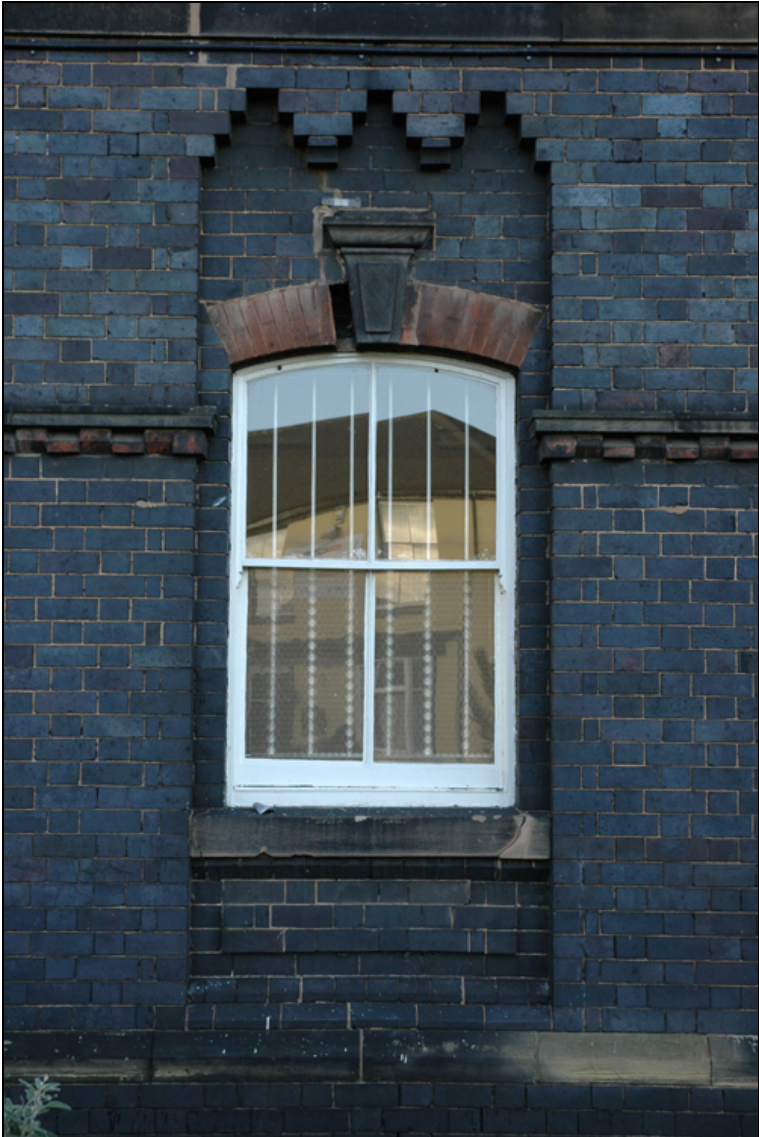
*Figure 9: Sash window on Tipton Police station*

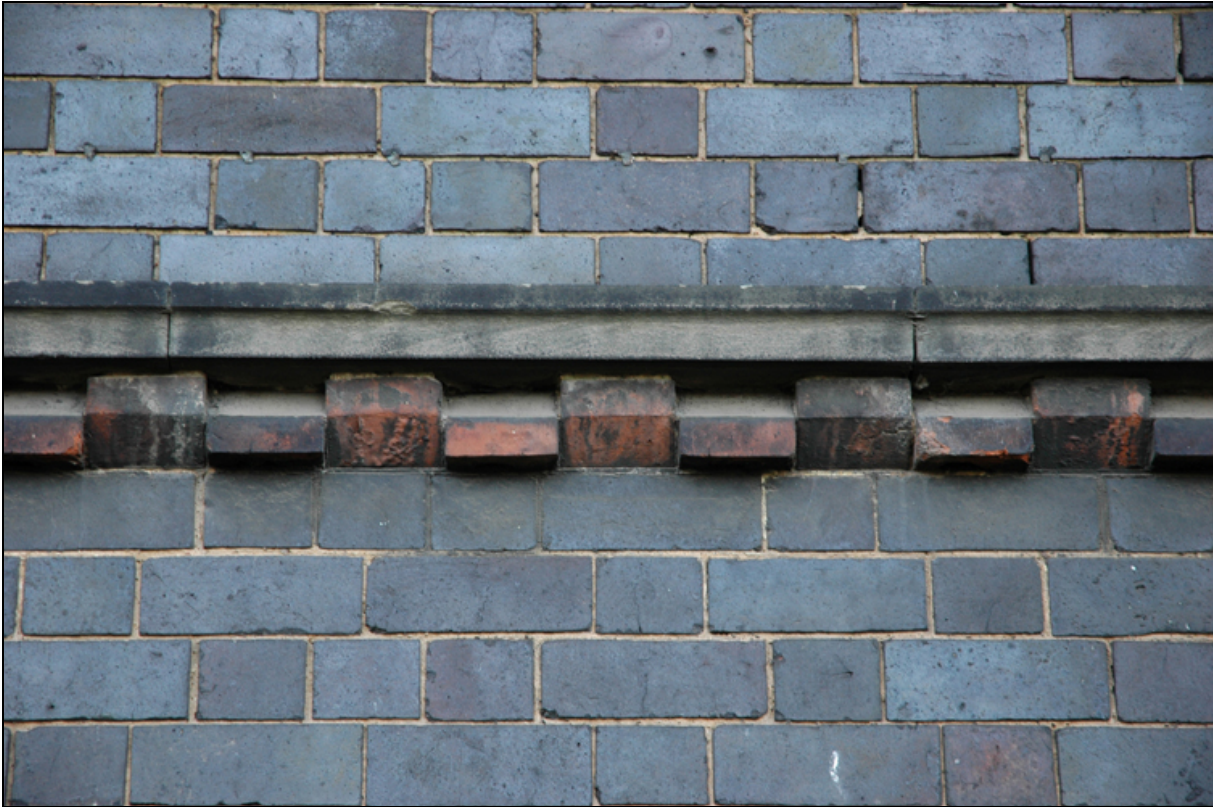
Figure 10: Dentilated string course

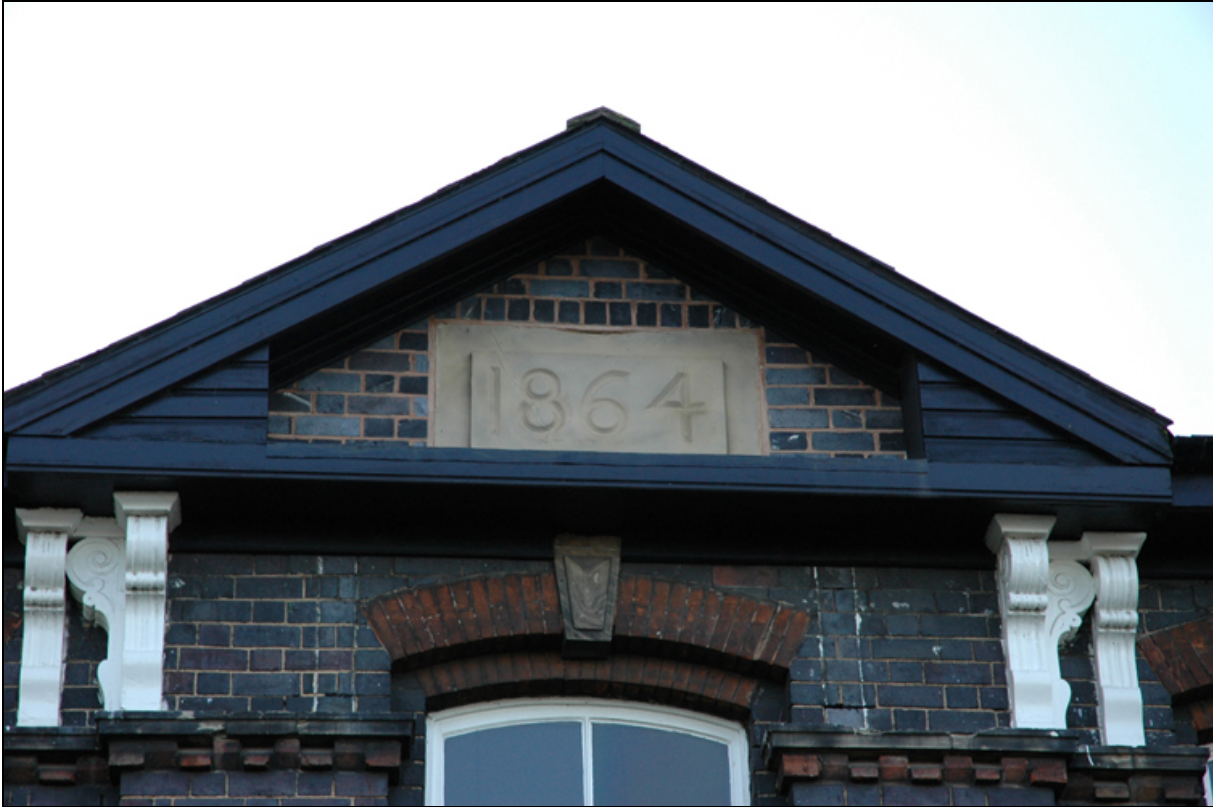
Figure 11: Gable pediment

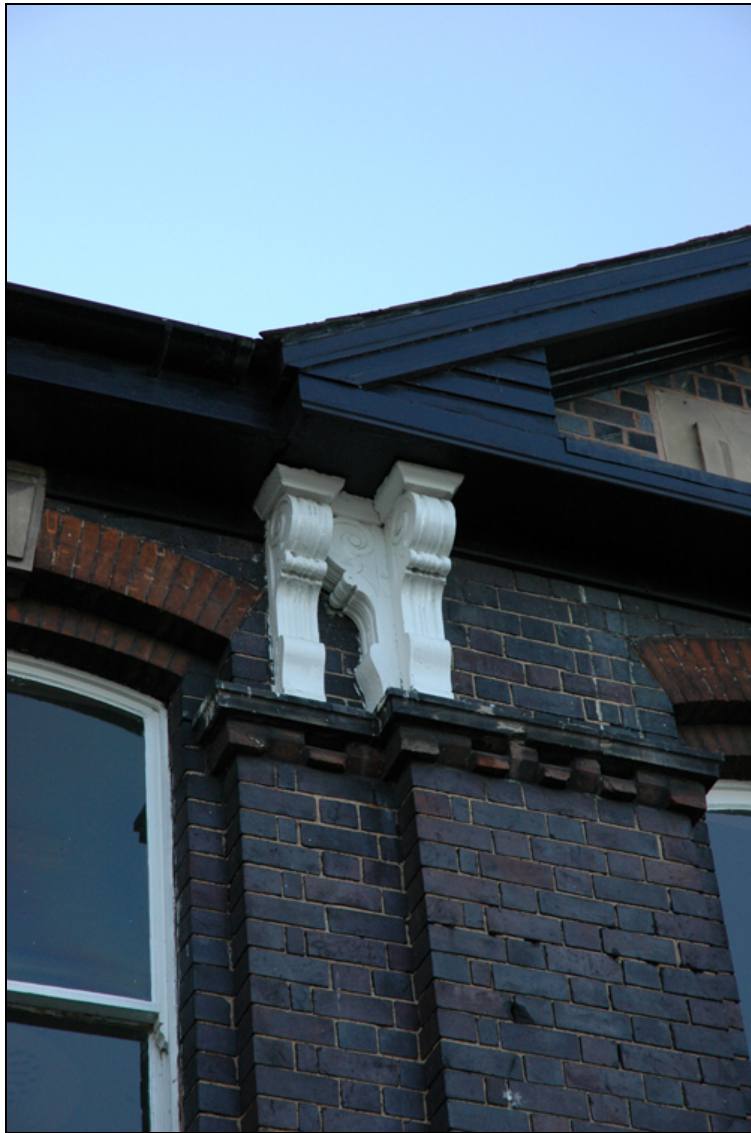
*Figure 12: Eaves brackets*

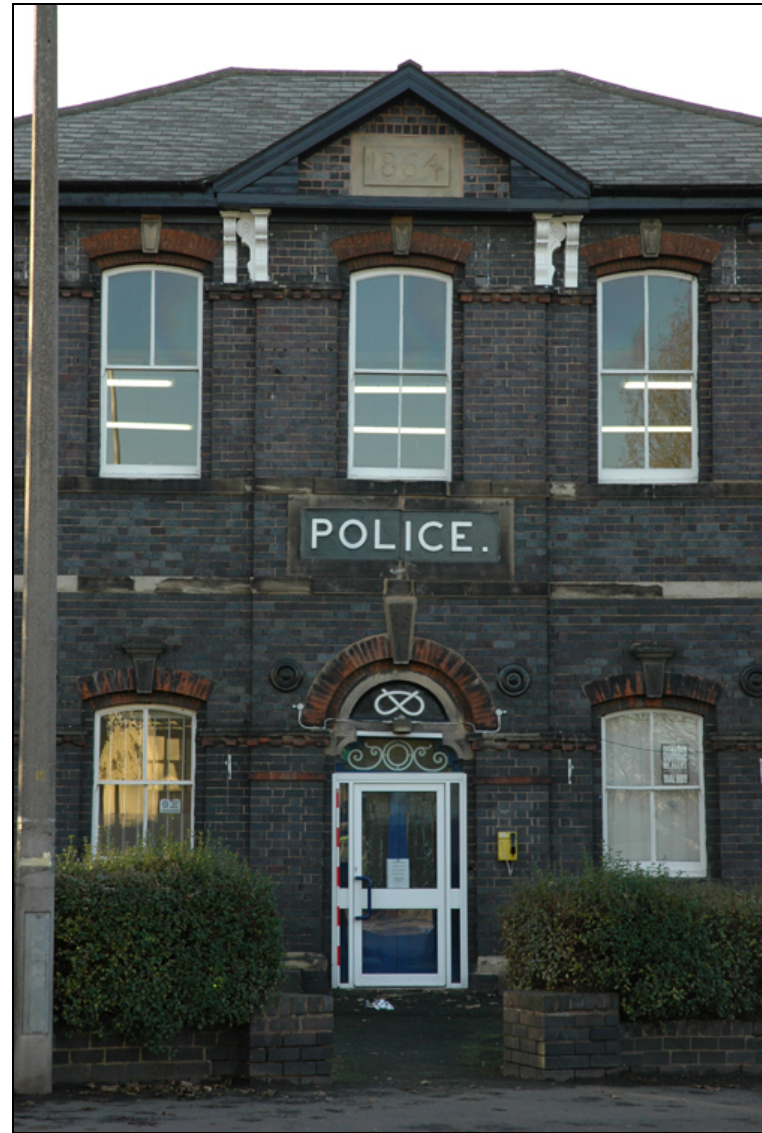
*Figure 13: Front entrance bay*

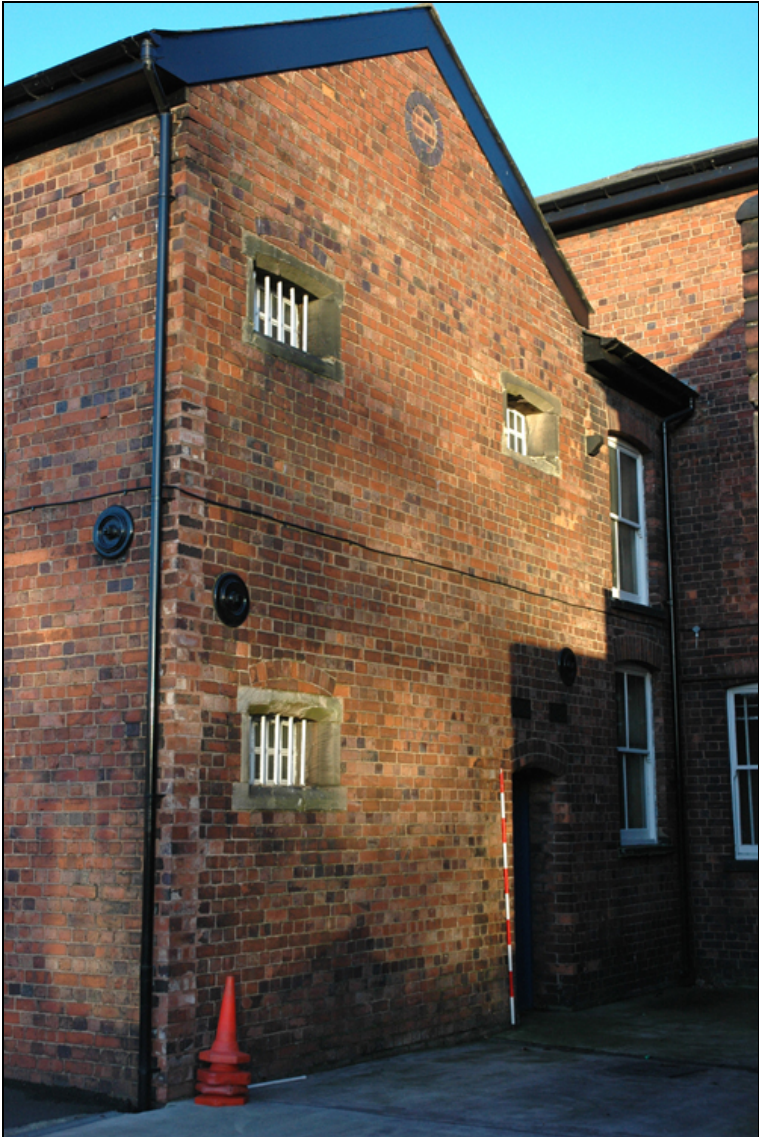
*Figure 14: Two storey cell block*

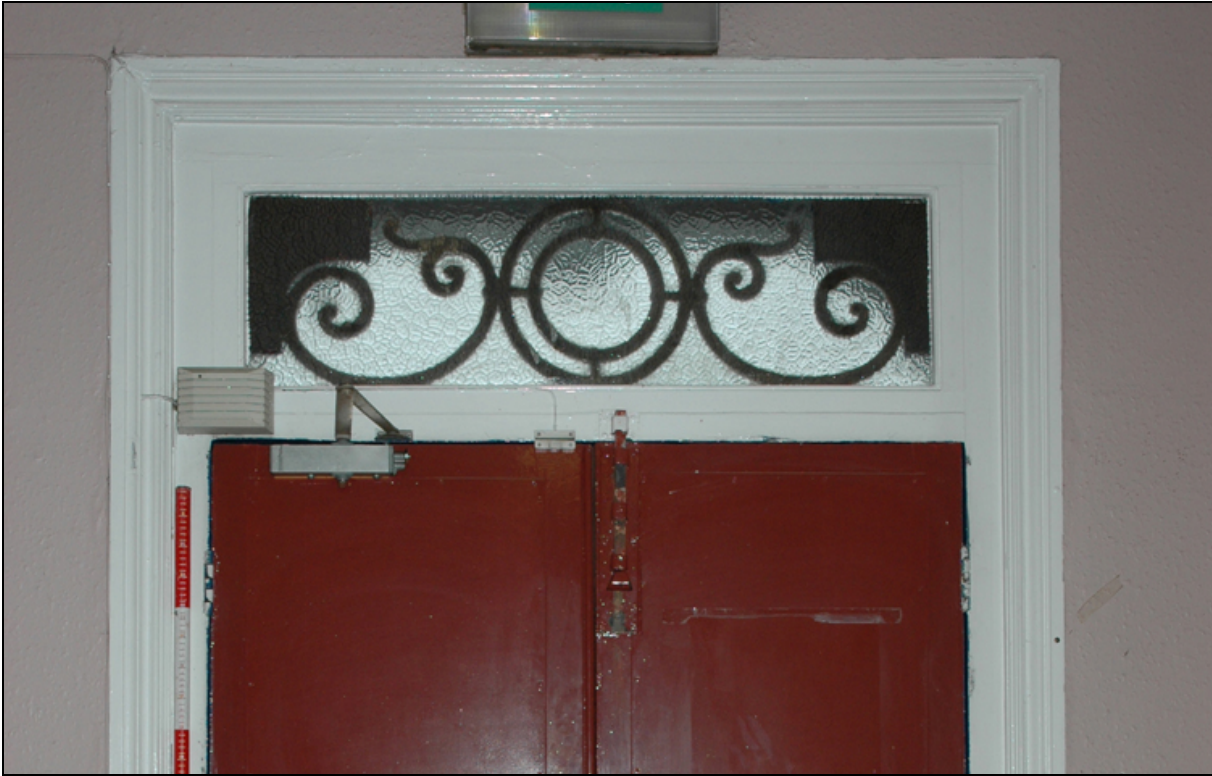
Figure 15: Decorative ironwork above front door

The frontage of the building incorporated decorative elements that give the building a distinctive appearance. One of these was the inclusion of ironwork on the front door (Fig 15) - of which only that above the door survives - and the decorative knot above the door (Fig 16). This is the Stafford Knot, the symbol for the County. There are a number of possibilities for the origin of the knot. One of the most popular stories originated following the sentencing of three criminals to death by hanging in Stafford. When the executioner arrived he found he only had one piece of rope. He could not just hang one of the criminals and it would be unfair to the other two to give precedence to only one of the

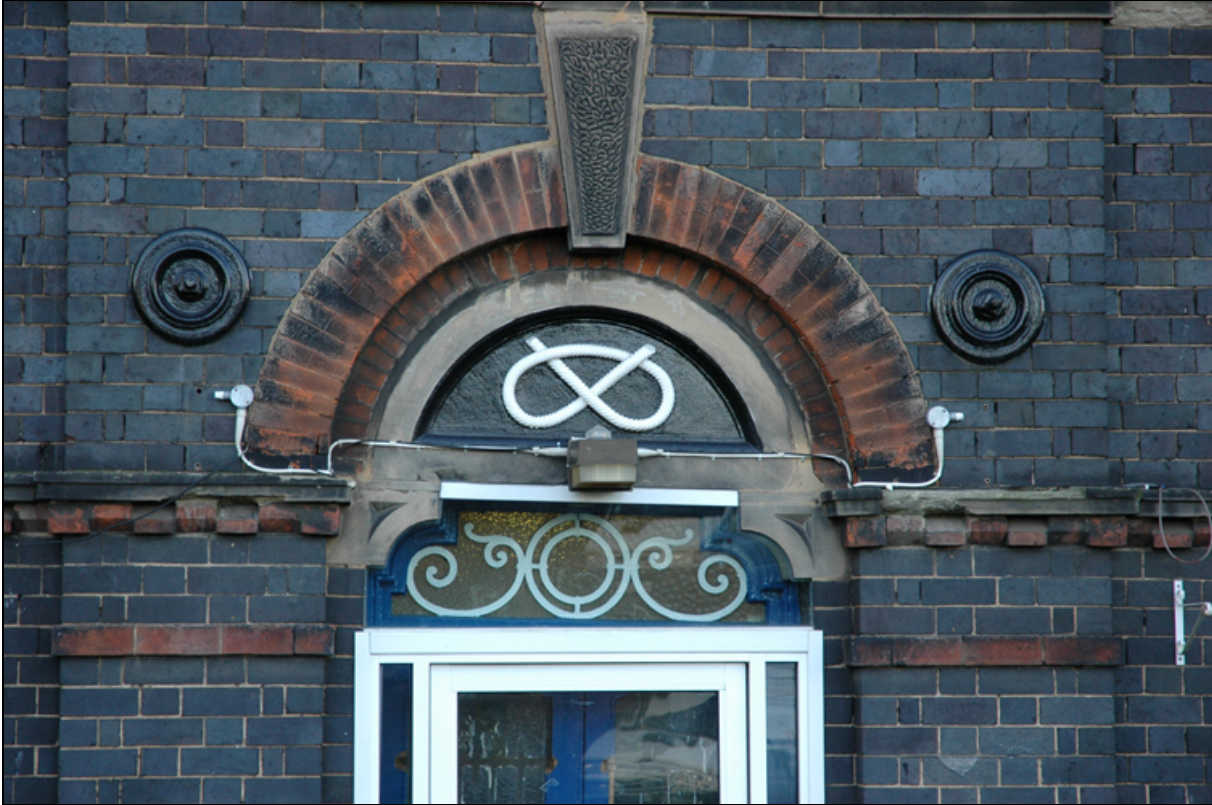
Figure 16: The Stafford Knot

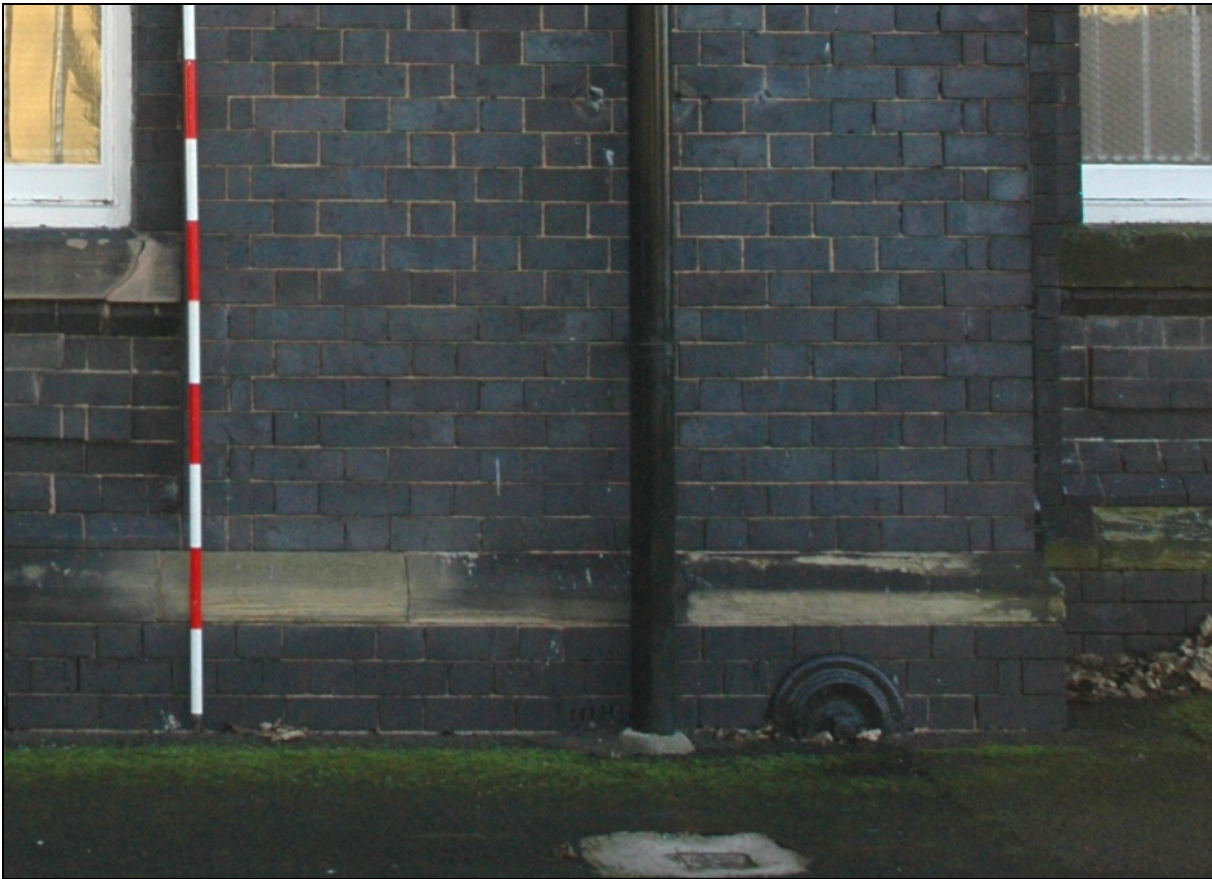
*Figure 17: Buried tie rod*

The building was constructed incorporating tie rods. There are number of letters from Mr Heveningham to Robert Griffiths discussing the adding the of the tie rods (Q/APs/1). These are usually only used after a building has been constructed and suffered from subsidence. However it seems that the area was known to suffer from subsidence due to the nature of the local industry, coal mining. It is important that the building was constructed with these tie rods. Staffordshire Police and Mr Heveningham knew the area suffered from subsidence and were trying to counteract the possibility of it occurring to the building once constructed. Even though the tie rods were used the building still suffered from subsidence in the 1890s (Q/APs/1) and possibly at later dates also. The evidence of some of the subsidence can be seen in Figure 9, which shows a crack running from the top of the window out of the top of the picture, and Figure 13 which shows a crack in the 'POLICE' sign and window cill above it.

A number of the tie rods included in the building whilst it was being erected are now partially below ground level (Fig 17) and others were included against the back walls immediately prior to the construction of the cells that were then cut by the entrance wall to the cells. It was because of this feature that it was originally believed the cells were constructed at a later date than the police station building, as at Bloxwich Police Station (Hurst *et al* 2000). However, documents relating to the construction of Tipton Police Station show that the cells were planned and built from the start (Figs 18 and 19).

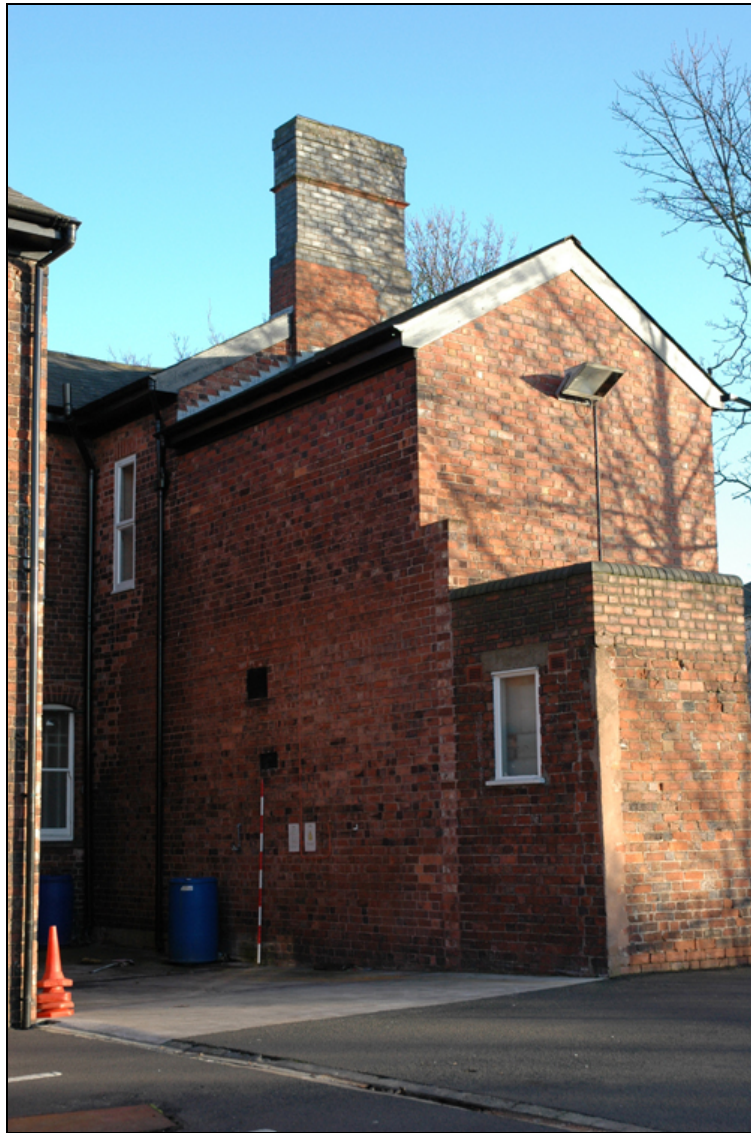
*Figure 22: Chimneystack, partly built in wrong colour brick*

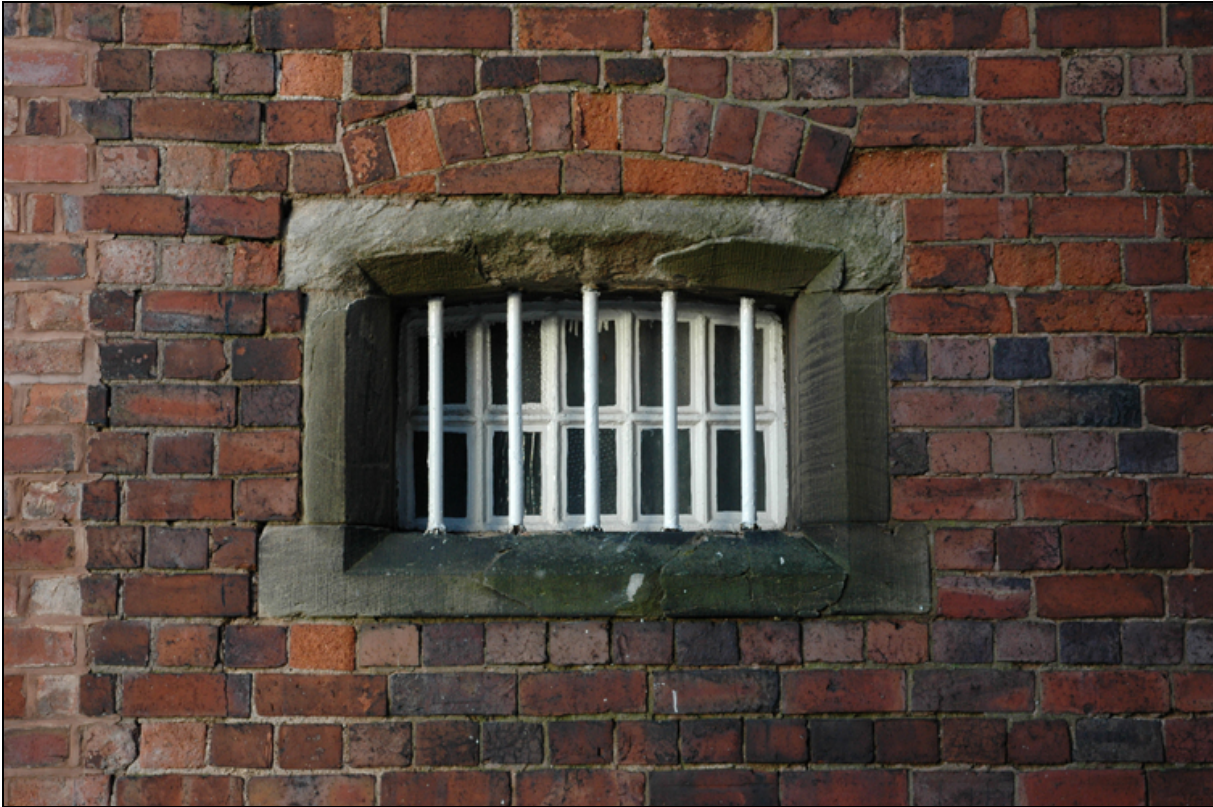
*Figure 24: Cell window*

There were six cells altogether, three on each floor, and they had wooden benches and toilets. Each cell had a stone small window opening with small panes of glass and iron bars on the outside (Fig 24). The cell doors were thick and had two openings, one to pass things through and one to look through (Fig 25). There were two staircases, one linking the ground and first floor cells with the courts (Fig 26) and one linking the Court to the Offices. The cells on the first floor were used for the holding of prisoners waiting for their appearance in Court. The staircase from the Court was then used to take prisoners to the ground floor cells, ready for transportation to Stafford gaol. The ground floor cells were used as a 'lock-up' for holding prisoners when arrested.

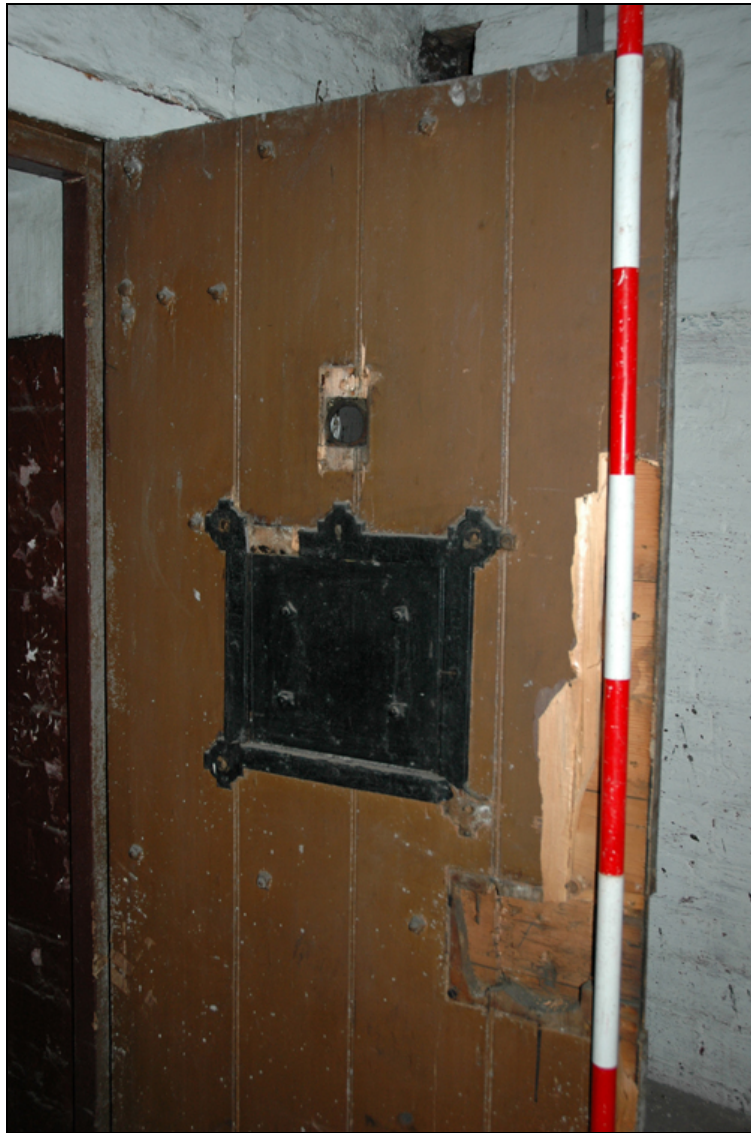
*Figure 25: Cell door showing openings*

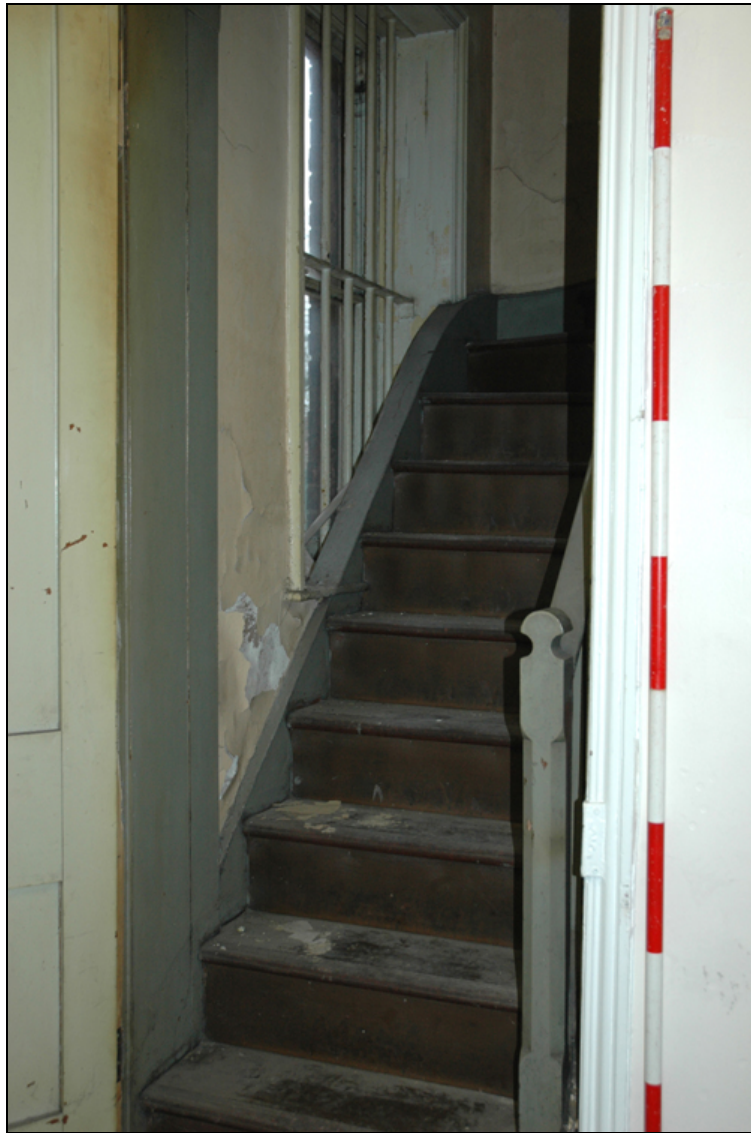
*Figure 27: Staircase to Court from Offices*

The other Law Courts staircase (Fig 27) had wooden instead of stone steps and a simply decorated, newel post (Fig 28). This staircase was used to take free prisoners from the court and led down to the offices on the ground floor. The Law Court was to be fitted with the same type of fixtures as Bilston Court (Q/APs/1, Fig 29). It is probable that the fittings were similar to those still surviving in Kidderminster Town Hall Court (Cook in prep; Fig 30). The public gallery may have been situated at the north end of the room (Fig 31) as the moulding is missing at this end of the room (Fig 32). The Court had its own external entrance. This was from the north wing of the building (Fig 33) and allowed first floor access to the Courtroom up a set of stone stairs (Fig 34), now worn with age. There was a large doorway into the Court (Fig 35) that was presumably for the Magistrate to enter through.

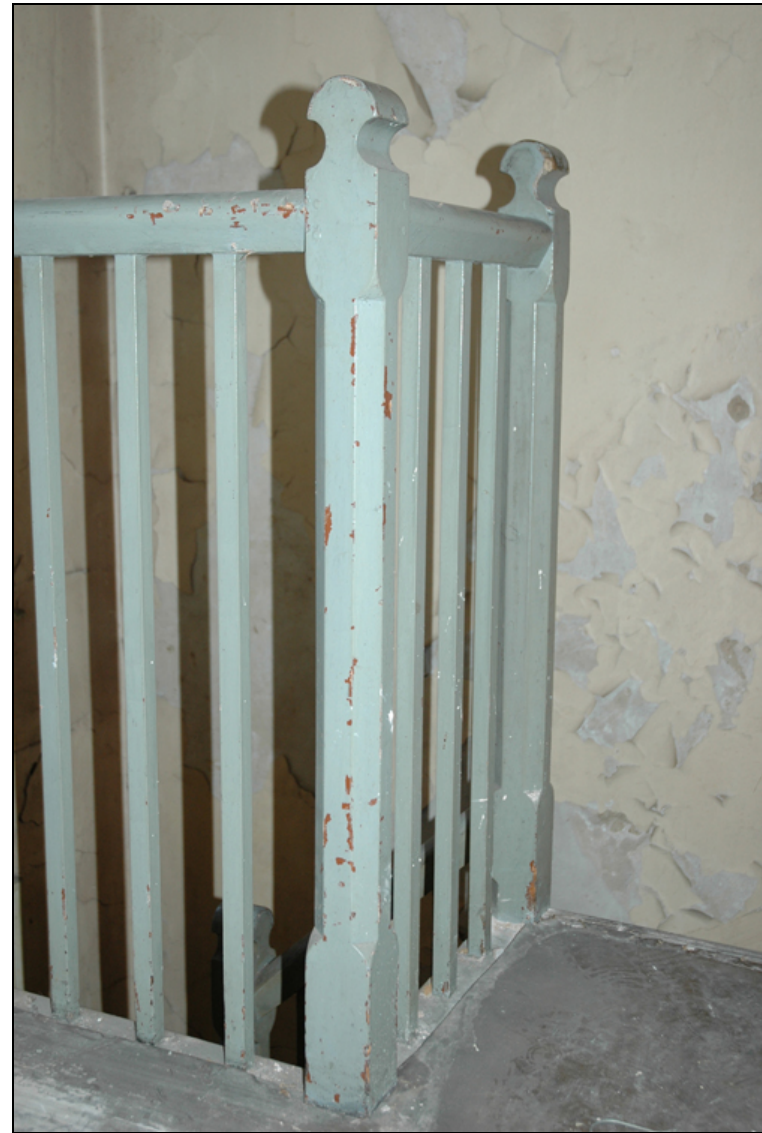
*Figure 28: Wooden newel post*

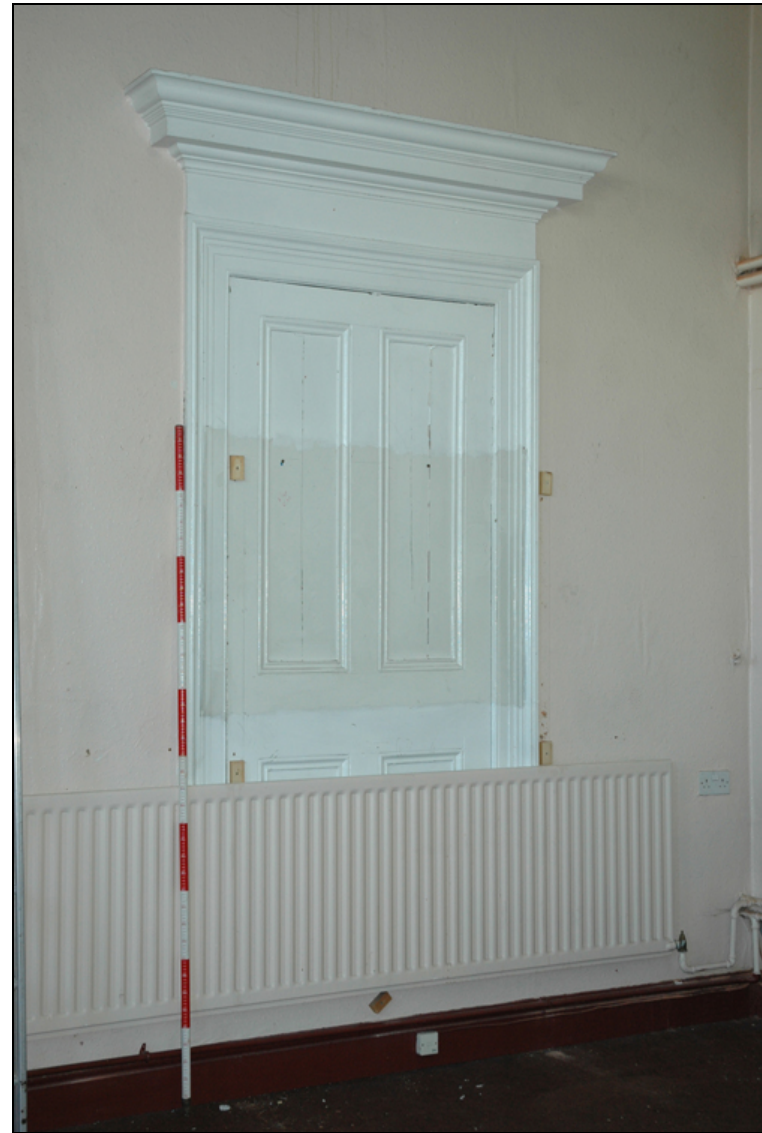
*Figure 35: Magistrate's doorway in Court*

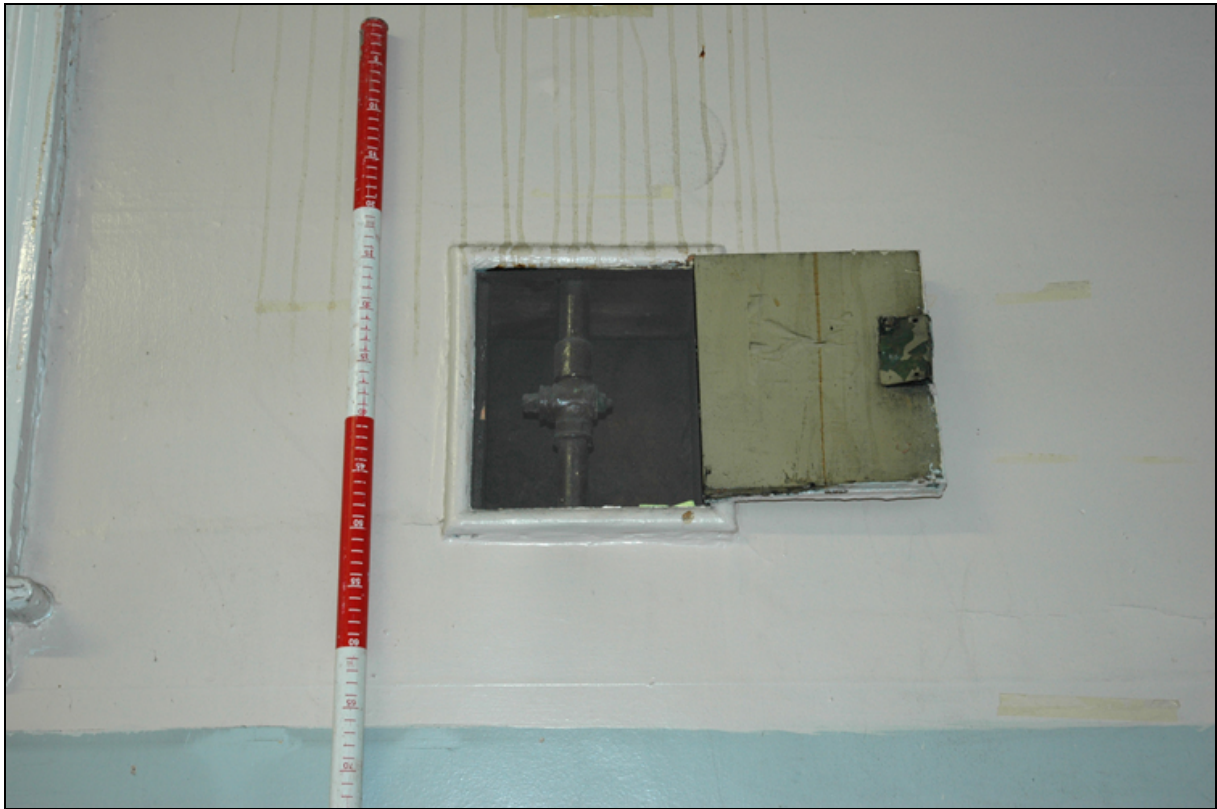
*Figure 36: Gas tap in Magistrate's Court*

In the ceiling of the Court were two grills from which were suspended gas-lit chandeliers. The supply to these was controlled through a tap set in the wall of the Court (Fig 36). The Court held sessions once a week and included Bloomfield, Dudley Port, Horseley Heath, Ocker Hill, Prince's End, Summerhill, Tipton Green, Burnt Tree and Toll End within its division.

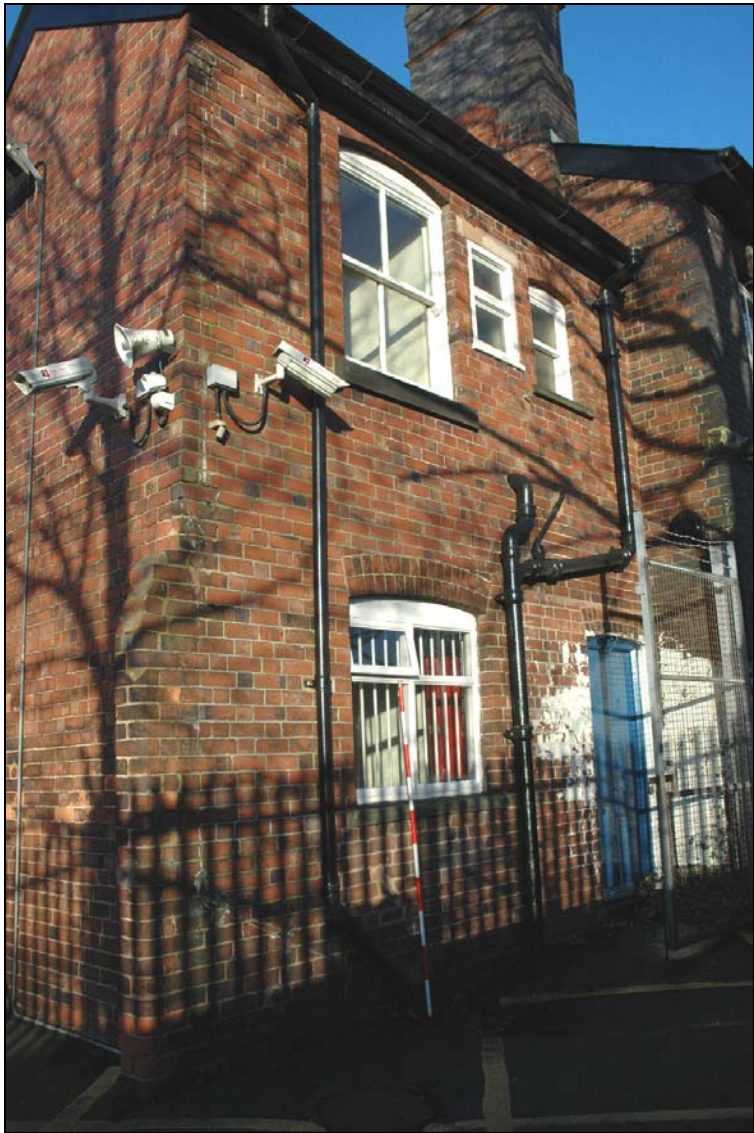
Figure 37: south wing extension

Very little changes appear to have been made to the build since it was constructed. By 1888 there were extensions to the rear of the two wings (Figs 37 and 38) as they are shown on the Ordnance Survey first edition map of that date (Fig 39). These extensions to the building are constructed of red brick and coursed in Flemish Bond measuring  $8\frac{3}{4}$ " long by 3" deep and  $4\frac{3}{8}$ " wide. The function of these buildings is not known and their construction style and materials do not give any possibilities for their use.

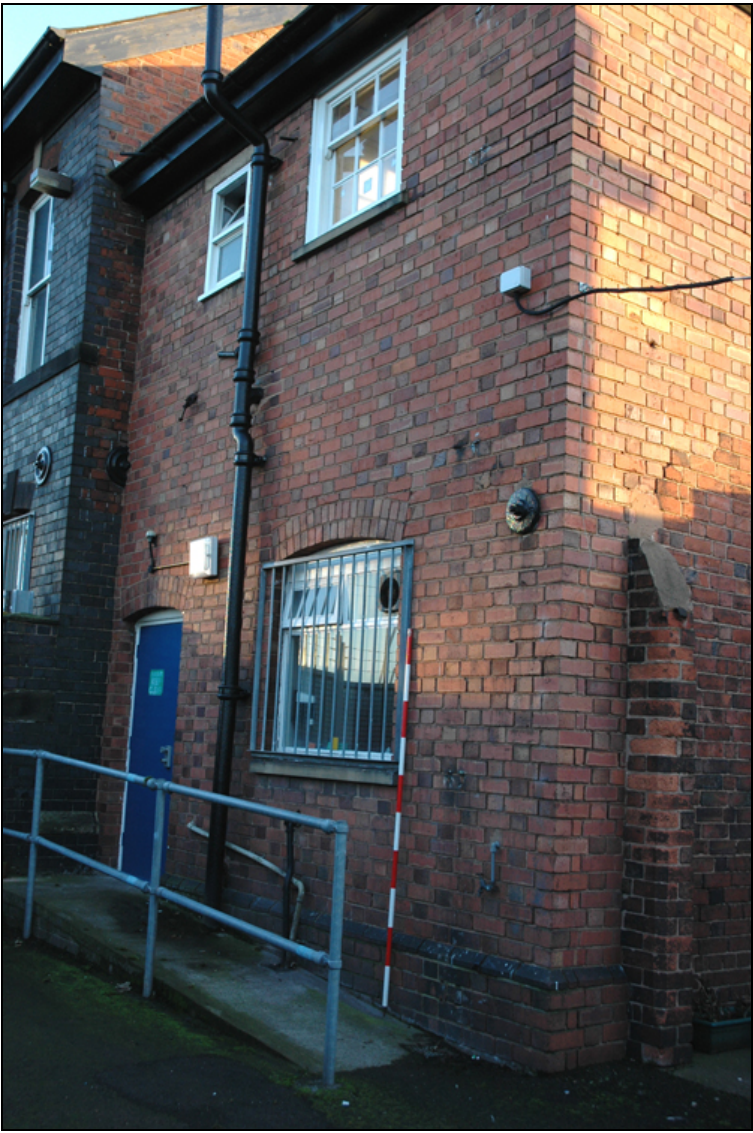
Figure 38: north wing extension

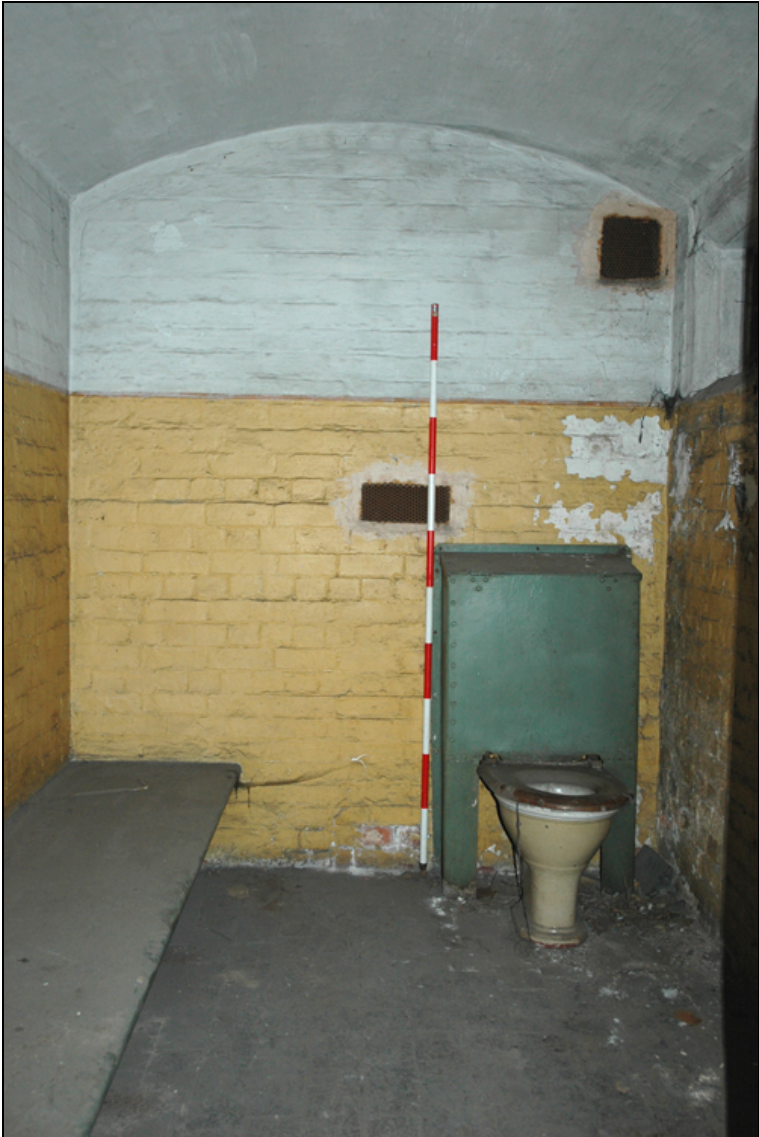
*Figure 41: Interior of cells showing bench and 1892 toilets*

In October 1892 repairs and alterations to the building were carried out. The majority of these repairs were to the toilet and plumbing system and they are detailed in specifications of this date (Q/APs/1; Fig 40). The alterations were mainly to the cells and involved moving the benches from one of the cell to the other and the removal of the old and fitting of new toilet pans. Those that were fitted appear to be the ones still in place in some of the cells (Fig 41). Changes were also made to the kitchen and magistrate's toilet.

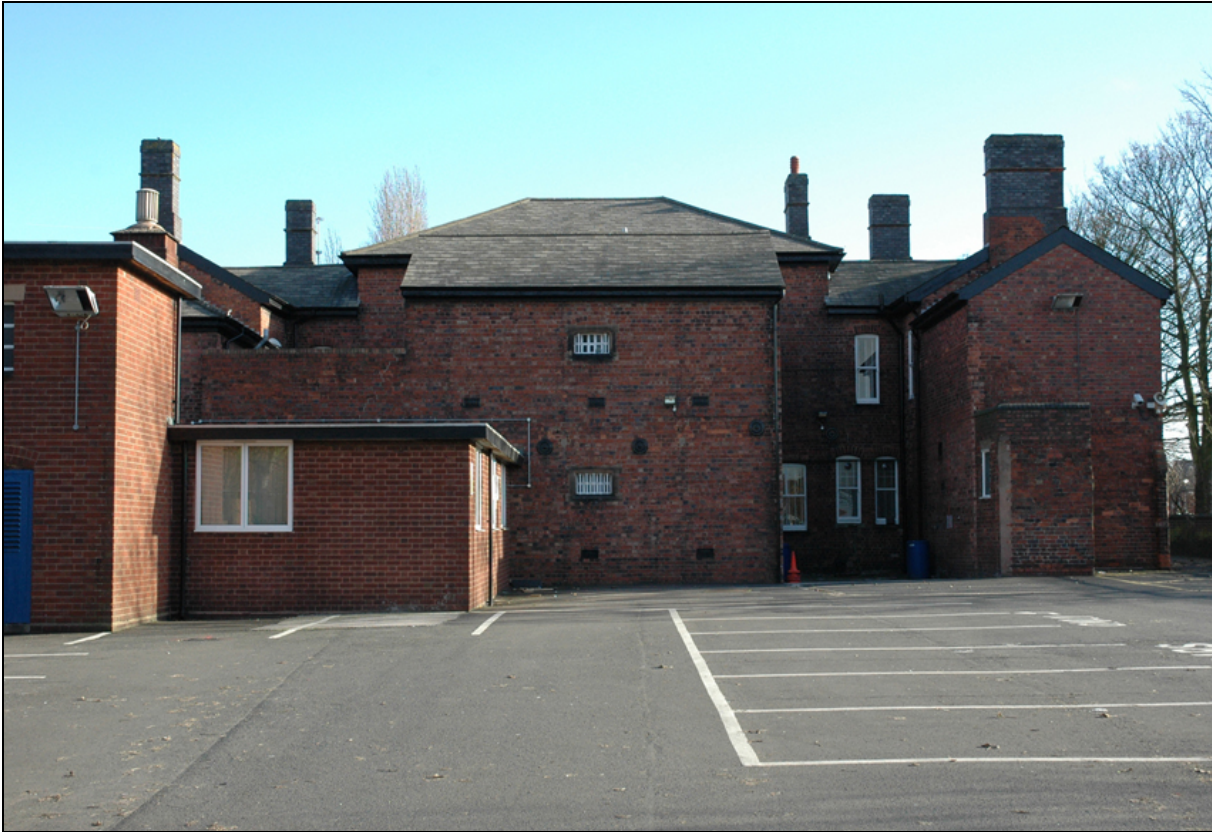
*Figure 42: Extensions to rear of cells*

The 20<sup>th</sup> century saw the biggest changes to the building. To begin with extensions were built to the rear of the cells and north wing (Fig 42). These were constructed using modern machine made brown and brown-red bricks coursed in Flemish Bond. The bricks measure  $8\frac{7}{8}$ " long by  $2\frac{3}{4}$ " deep by  $4\frac{1}{4}$ " wide. The extensions were used as a boiler room (Fig 43), a parade room (Figs 44 and 45), an office (Figs 43 and 46) and a store (Figs 47). Also around the same time a toilet block was built in the exercise yard (Fig 48), with the entrance inside the building. The usage of this brick appears to date from around 1950 although these structures may have been constructed at a later date.

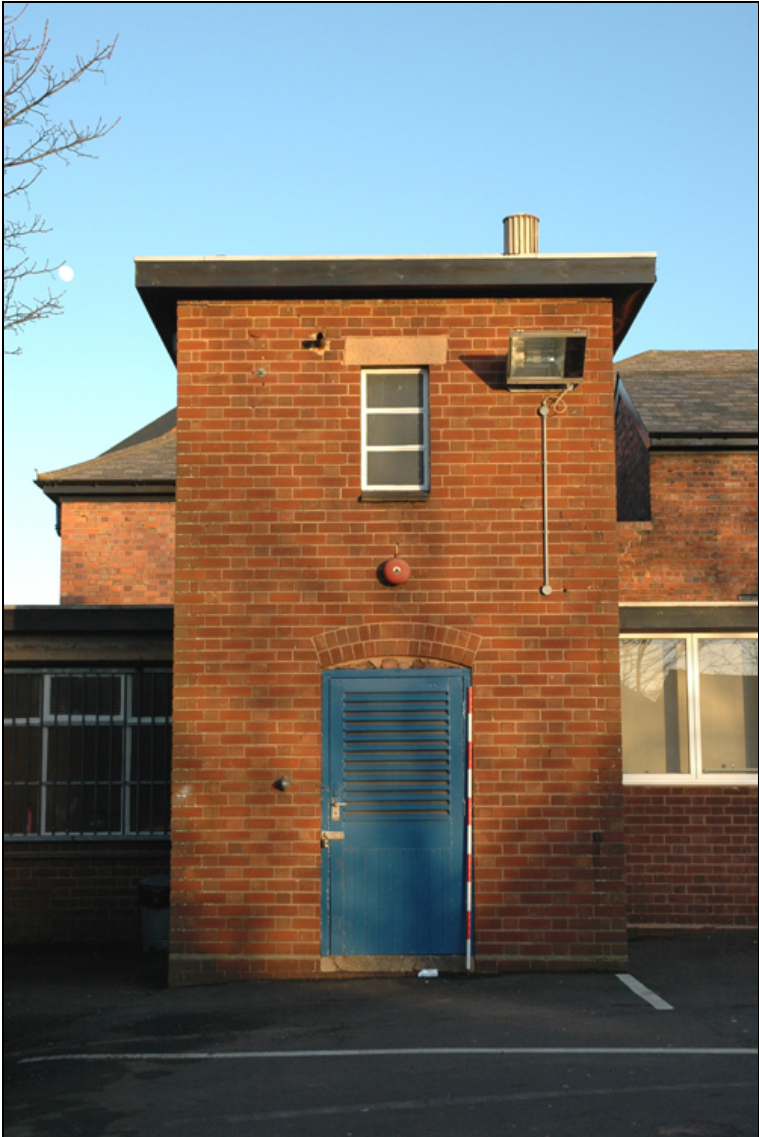
*Figure 43: Boiler room extension*
