HISTORIC BUILDING  
RECORDING  
OF TIPTON POLICE STATION,  
SANDWELL  
WEST MIDLANDS

Project 2858  
Report 1402  
TGTPS05

# **Historic Building Recording of Tipton Police Station, Sandwell Metropolitan Borough**

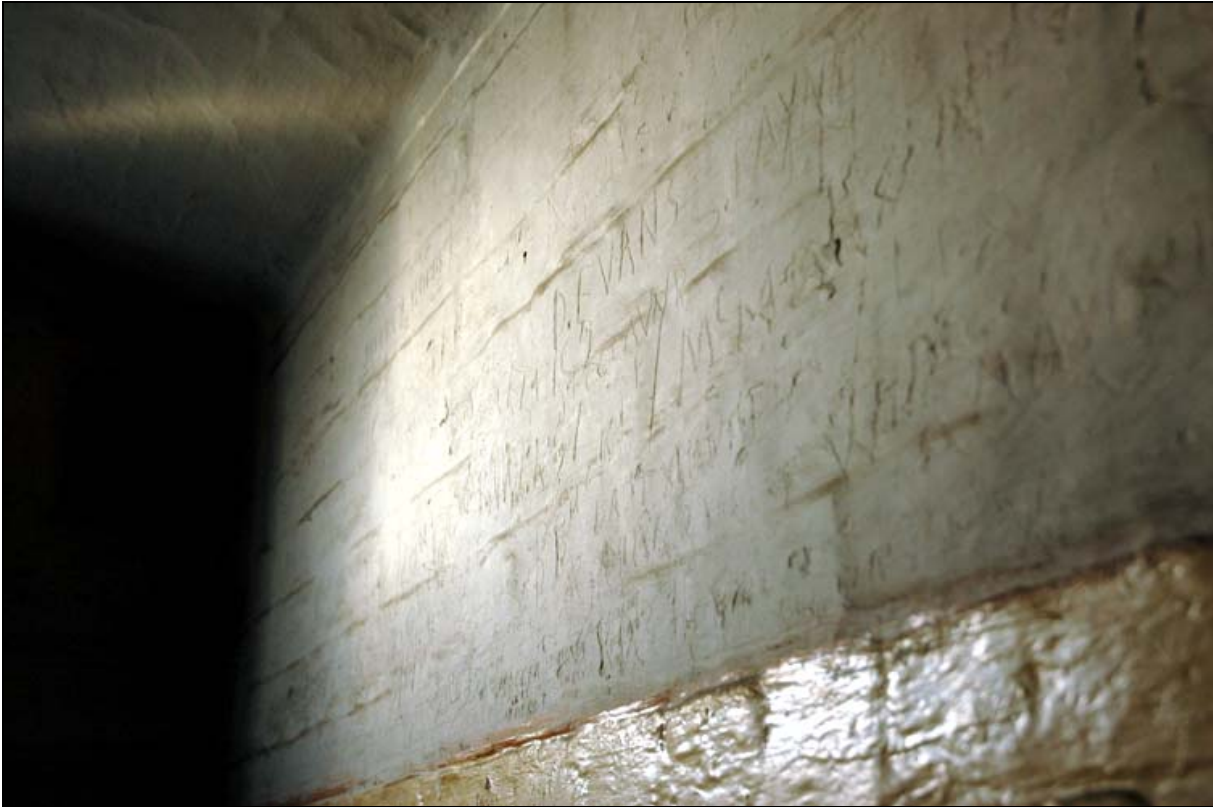
*Figure 51: cell graffiti*

The cells at the police station have remained intact due to their being blocked off in the 20<sup>th</sup> century. Which makes them a very good example of the late 19<sup>th</sup> century style of imprisonment. The first floor cells were locked first, possibly in the late 1920s, and the ground floor cells were locked in the 1960s but not before prisoners had made their marks on the walls (Fig 51).
