Archaeological Evaluation of land south of Blackfriars Street, Hereford

Status: Revision 1
Date: 28th June 2013
Author: Graham Arnold garnold@worcestershire.gov.uk
Illustrator: Laura Templeton
Project reference: P4138
Report reference: 2022
HER reference: EHE 2121

An archaeological evaluation was undertaken at land at Blackfriars Street, Hereford, (NGR SO 5098, 4033). It was undertaken on behalf of Western Power, who intend to construct a new control building and install two transformers to expand the current electricity sub station for which a planning application has been submitted.

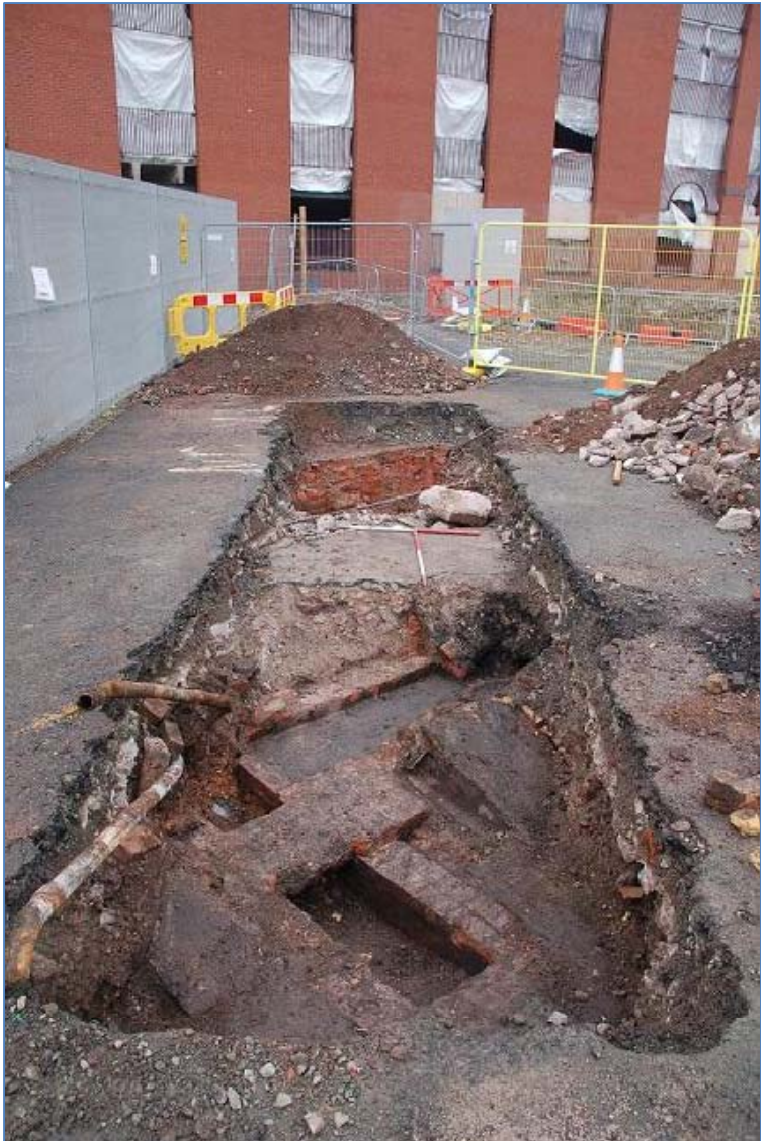
Plate 1 Trench 1 looking southwest showing 20th Century brick and concrete structures

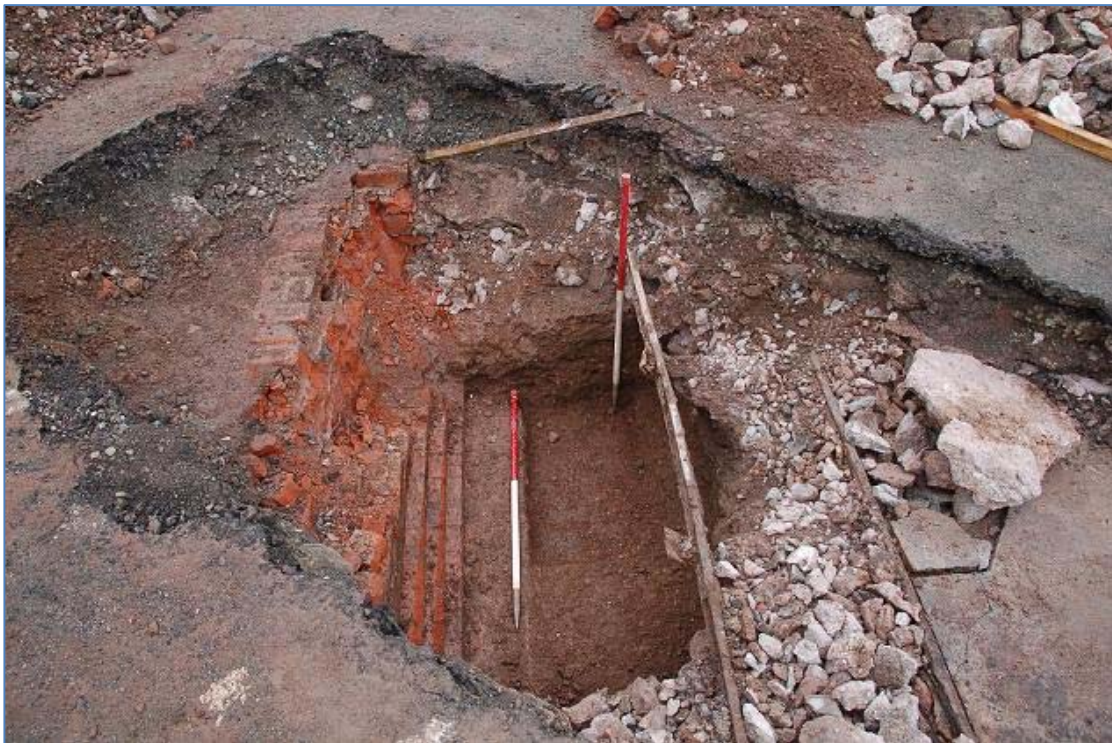
The natural strata consisted of a compact reddish orange sandy clay with frequent rounded river gravels. The natural deposits were encountered in trenches 1 and 3 at a level of 52.70m OD and 53.91m OD (plates 2 + 6). This is consistent with levels encountered across the Cattle Market that is adjacent to the site.

Plate 2 Trench 1 at southwest end, facing south, showing sondage through made ground into natural, the narrow gauge rail tracks (104) and brick wall (105, part of the 20th Century industrial buildings).

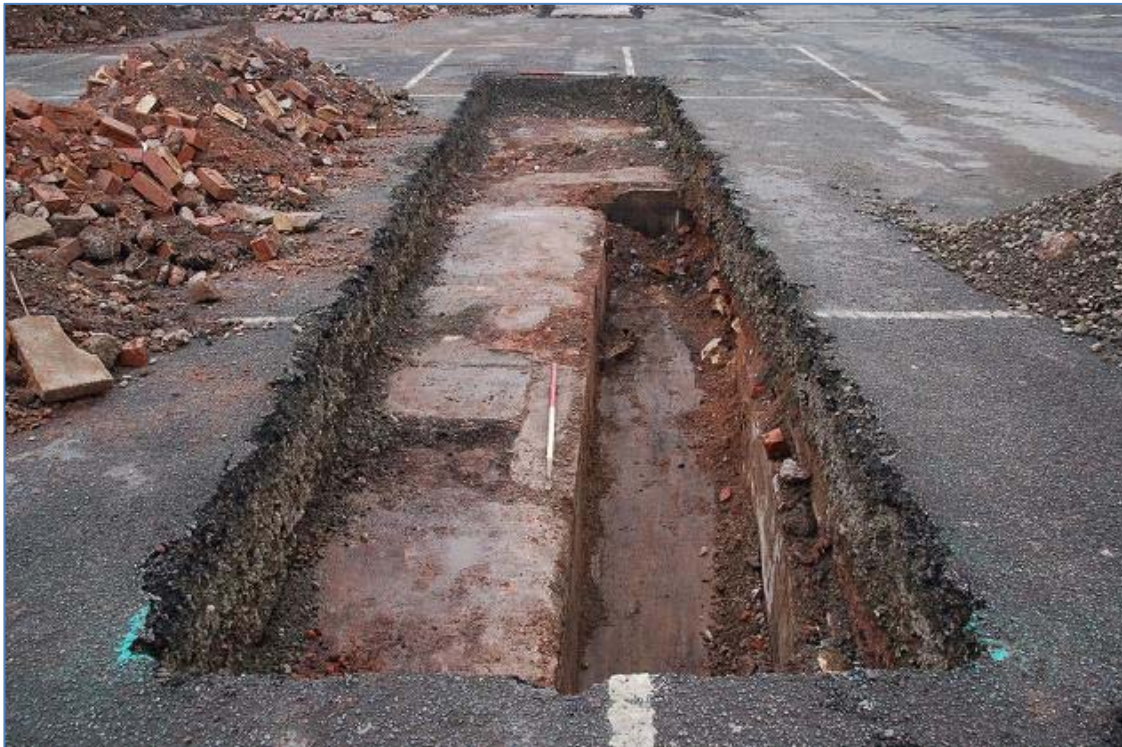
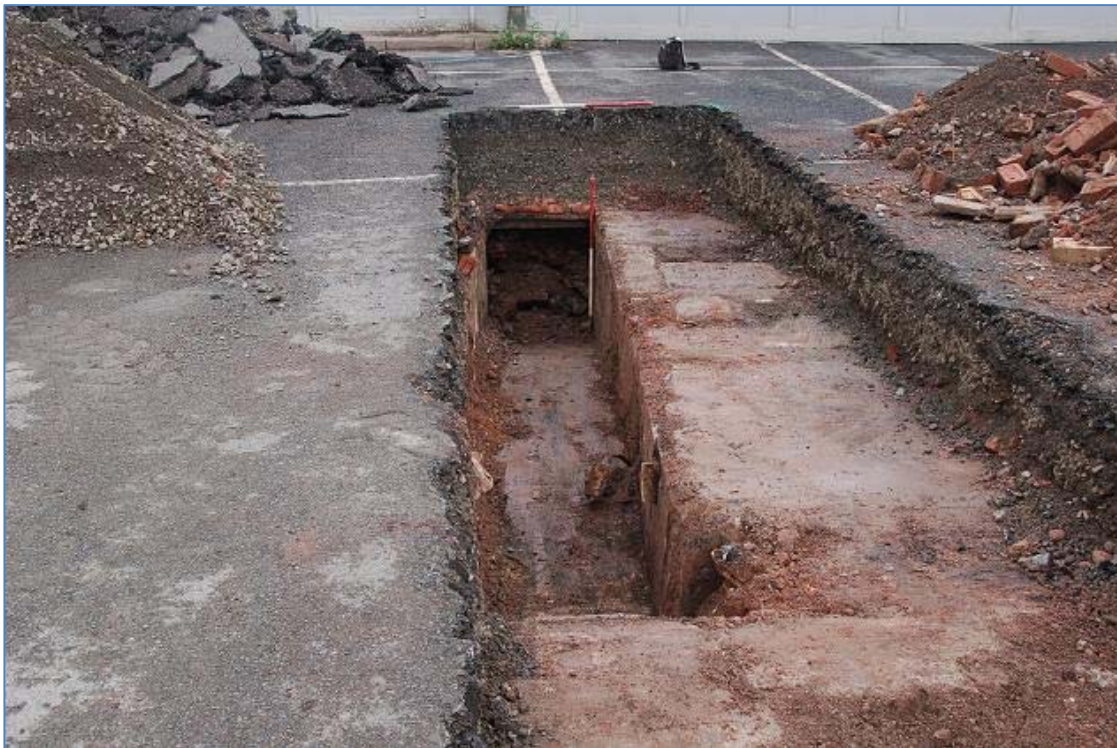
Trench 2 was entirely covered by a brick and concrete industrial cellar structure (plates 3 + 4), with the structure cut by a later modern service trench on the north side. The structures were backfilled with rubble and type 1 levelling material.

Plate 3 Trench 2 looking North showing modern 20th Century structure and truncation by a service trench to the north.

Plate 4 Trench 2 looking North showing modern 20th Century structure and truncation by a service trench to the north.

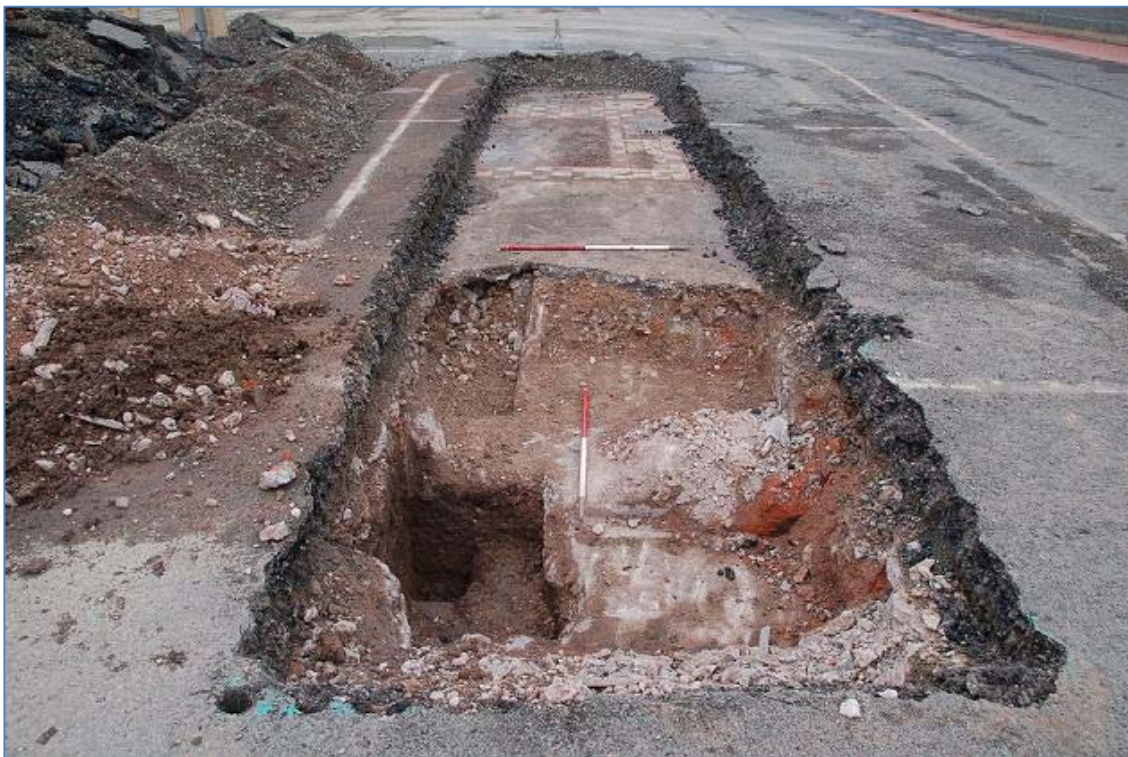
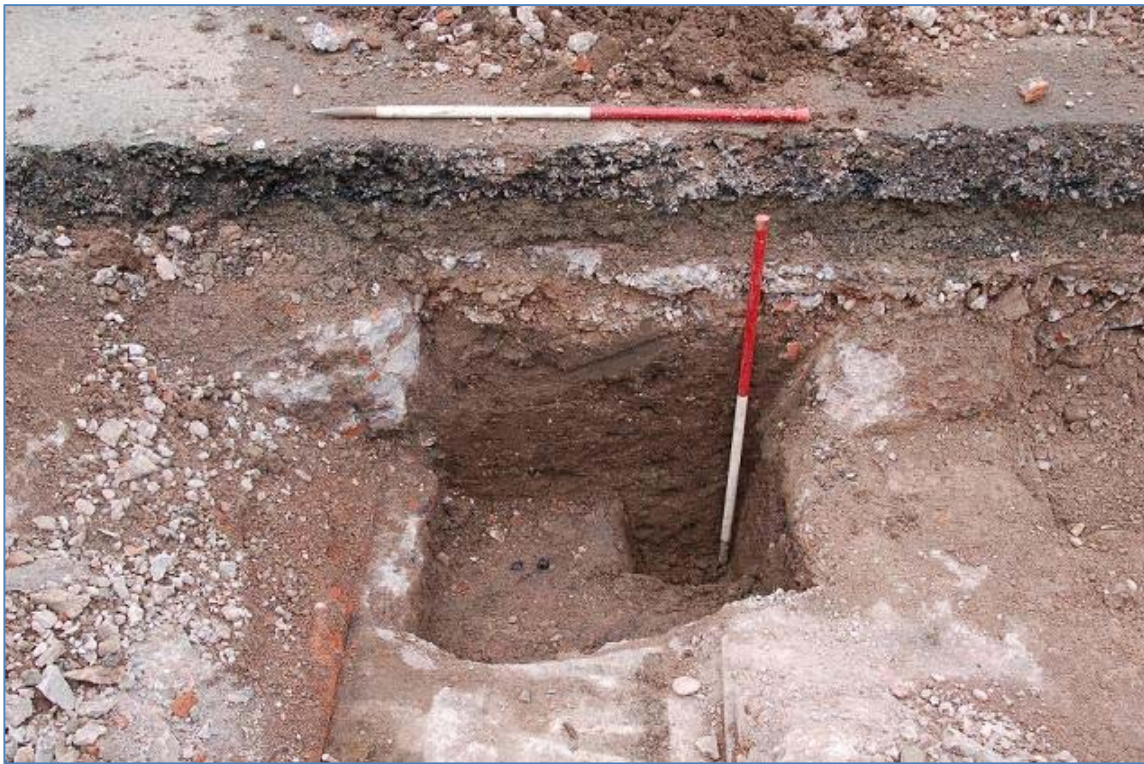
Trench 3 (plate 5) had further 20th Century concrete and brick structures [303], overlying the made ground (304) and sealed by a concrete floor surface [302] of the previous early 20th Century building on site.

Plate 5 Trench 3 looking North showing modern 20th Century structure (304) and sondage into natural.

Plate 6 Trench 3 looking North showing modern 20th Century structure (304) and sondage into natural.
