ARCHAEOLOGICAL WATCHING
BRIEF AT
CHURCH LANE
AND HIGH STREET,
STANTON,
GLOUCESTERSHIRE

Status:
Date: 31 May 2013
Author: Jonathan Webster – jwebster@worcestershire.gov.uk
Contributors: Dennis Williams
Illustrator: Carolyn Hunt
Project reference: P3862
Report reference: 2015

An archaeological watching brief was undertaken at Church Lane and High Street, Stanton, Gloucestershire (NGR: SP 068 342). It was commissioned by WSE Limited on behalf of their client Western Power Distribution, who intends to replace the existing overhead electric cables with underground cable routes.

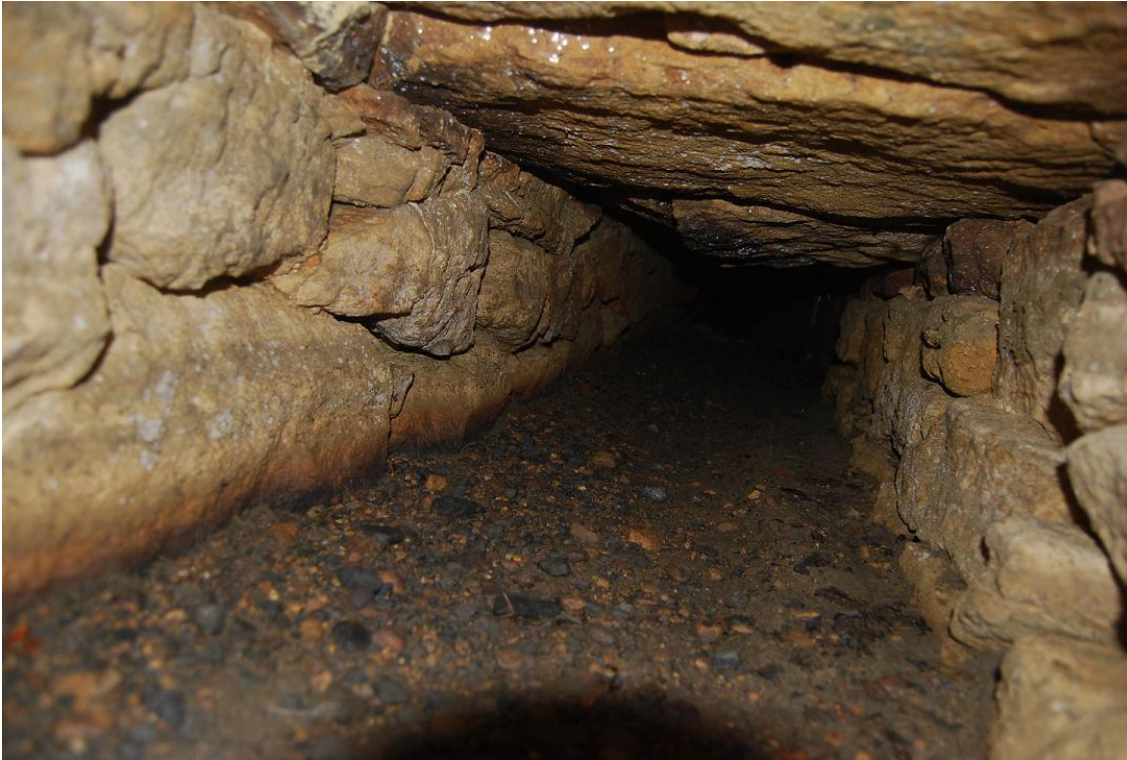
Plate 1; Sample view of stone culvert construction, looking west

The underlying natural substrate was seen in Trench 3 to the immediate south of the current properties and was noted as being a heavily weathered limestone brash typical of the Cotswold escarpment. This was overlain by a mixed deposit of limestone and clays that was seen in all of the investigation trenches and was clearly post-medieval in date. Highly worked and turned over, this deposit was used as a bedding layer for the overlying street surfaces. Of note running roughly east to west along the High Street and north-east to south-west along Church Lane were large

stone culverts, averaging an internal width of 0.45m. These structures were constructed from large roughly hewn limestone blocks that were bedded together in a dry stone form with no bonding agent (Fig 3; Plate 1). It is clear that they were designed and are still used to aid in the drainage of storm water. They truncated the aforementioned post-medieval deposits and are considered to be 19th century in date.

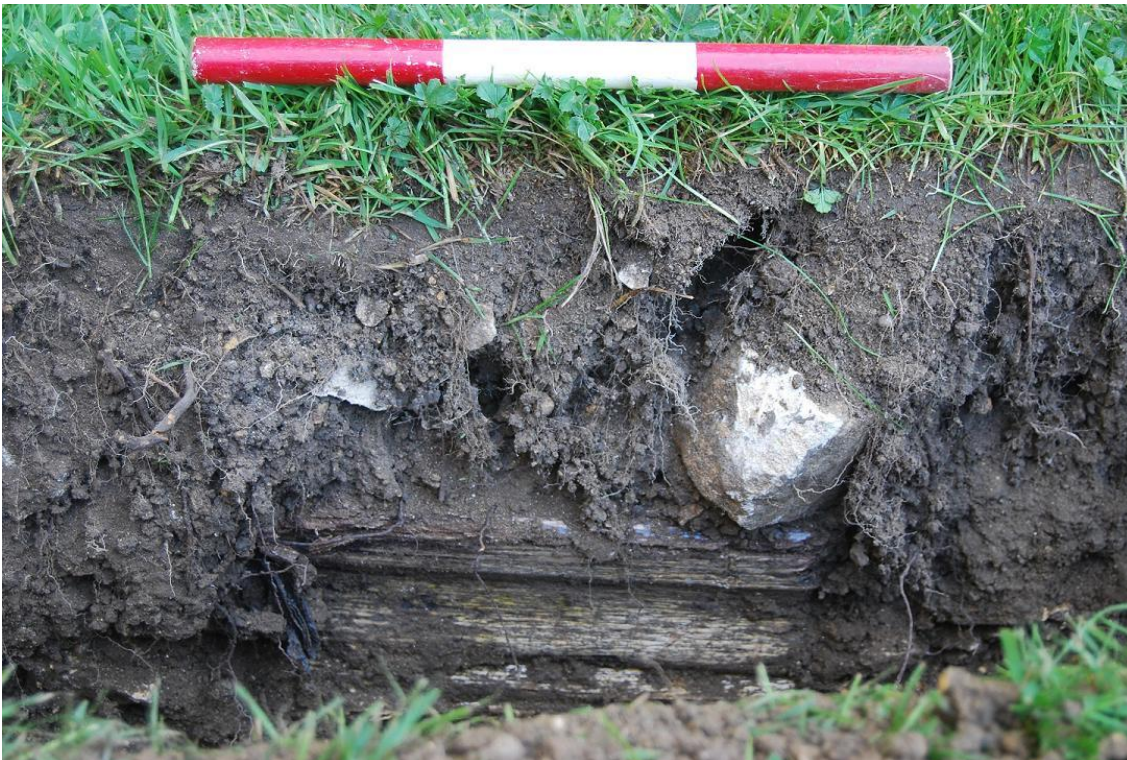
Plate 2; Trench 2, coffin side noted within graveyard, looking east, Scale 0.3m

Investigations within the churchyard revealed a highly mixed humic graveyard soil that was loosely compacted and contained a moderate amount of disarticulated human bone. Of particular note was a piece of wood noted in the eastern section of the Trench 2 (Plate 2). Although only 0.2m below the present ground level, the wood was ornately carved and suggestive of a coffin side associated with the grave of Rosemary Horeford.

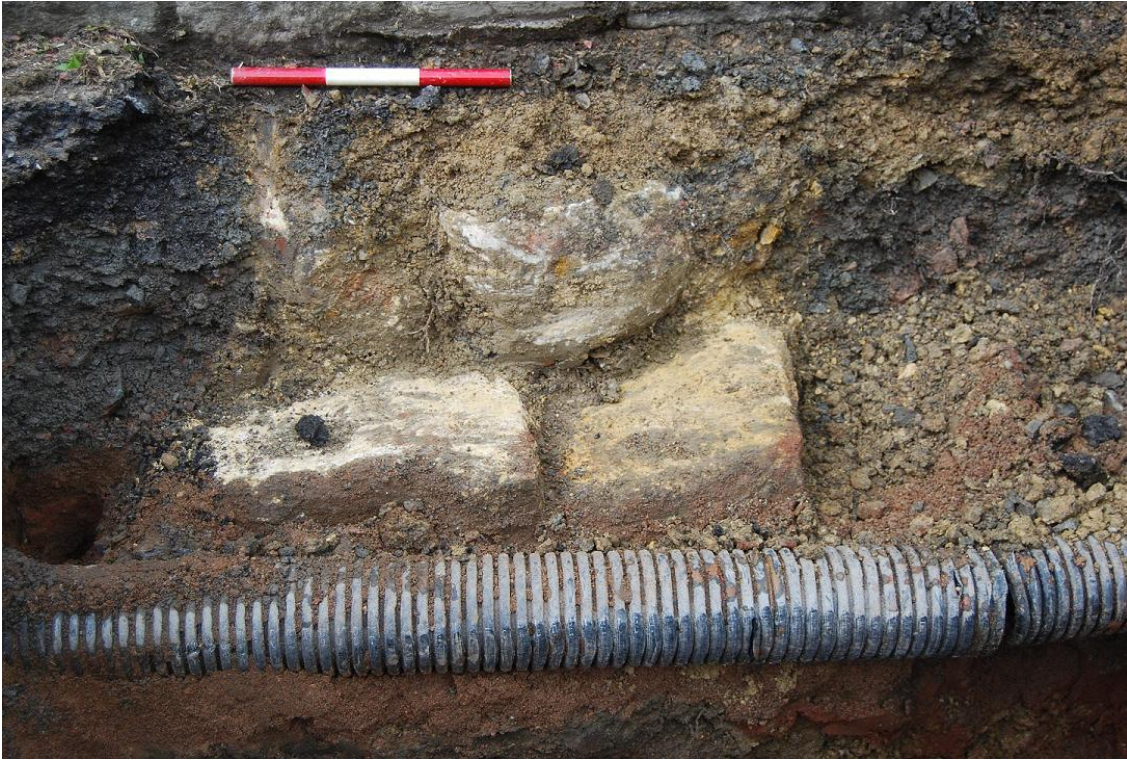
Plate 3; Trench 4, stone structure 407, looking south, Scale 0.3m

Finally a stone structure 407 that may relate to the Old Manor Farmhouse was recorded in the southern limit of investigation of the westernmost inspection chamber (Trench 4). At least two courses in height, it was built from large roughly hewn limestone blocks with no bonding visible (Plate 3). Unfortunately no date can be ascribed to this stonework as it was truncated to both the east and west by modern intrusions whilst the base was masked by a modern service.
