**DESK-BASED ASSESSMENT  
AT FLANESFORD PRIORY,  
GOODRICH,  
HEREFORDSHIRE**

Status: Revision 1  
Date: 30 July 2013  
Author: Simon Woodiwiss 01905 765508 [swoodiwiss@worcestershire.gov.uk](mailto:swoodiwiss@worcestershire.gov.uk)  
Contributors:  
Illustrators: Carolyn Hunt and Laura Templeton  
Project reference: P4150  
Report reference: R2030  
HER reference: EHE 2124

## **Desk-based assessment at Flanesford Priory, Goodrich, Herefordshire**

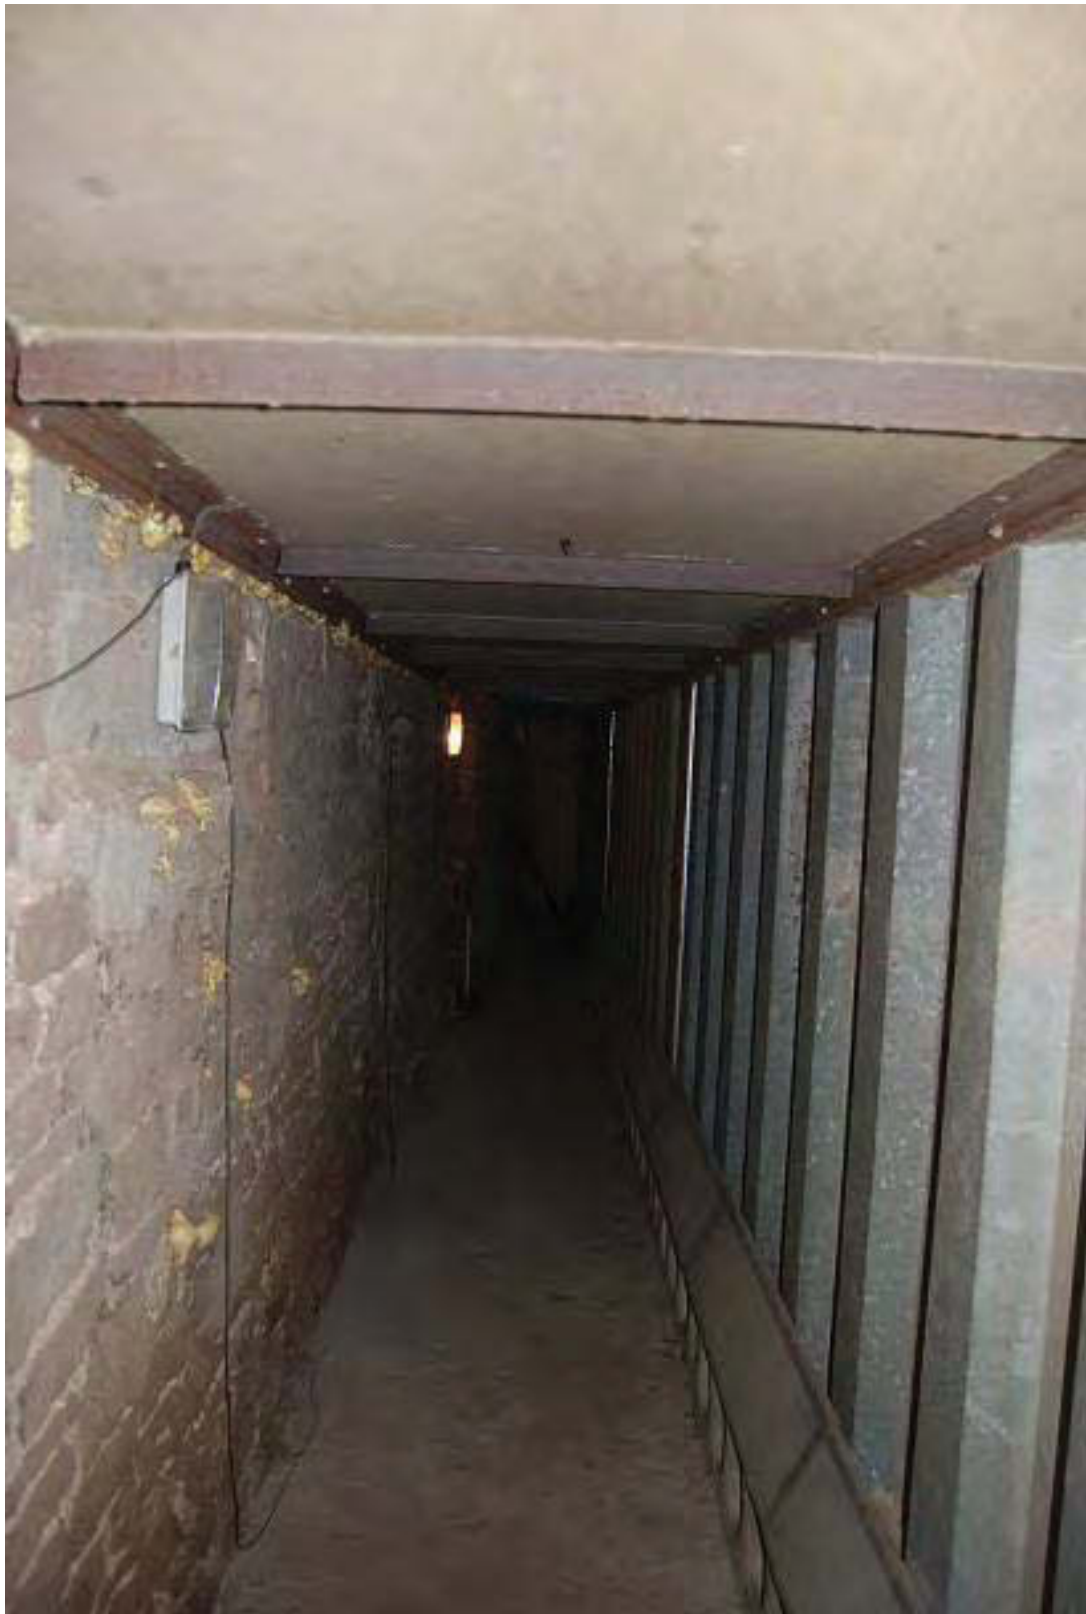
*Plate 5 Wall of historic barn on left to be exposed. Wall of modern barn on right to be demolished*

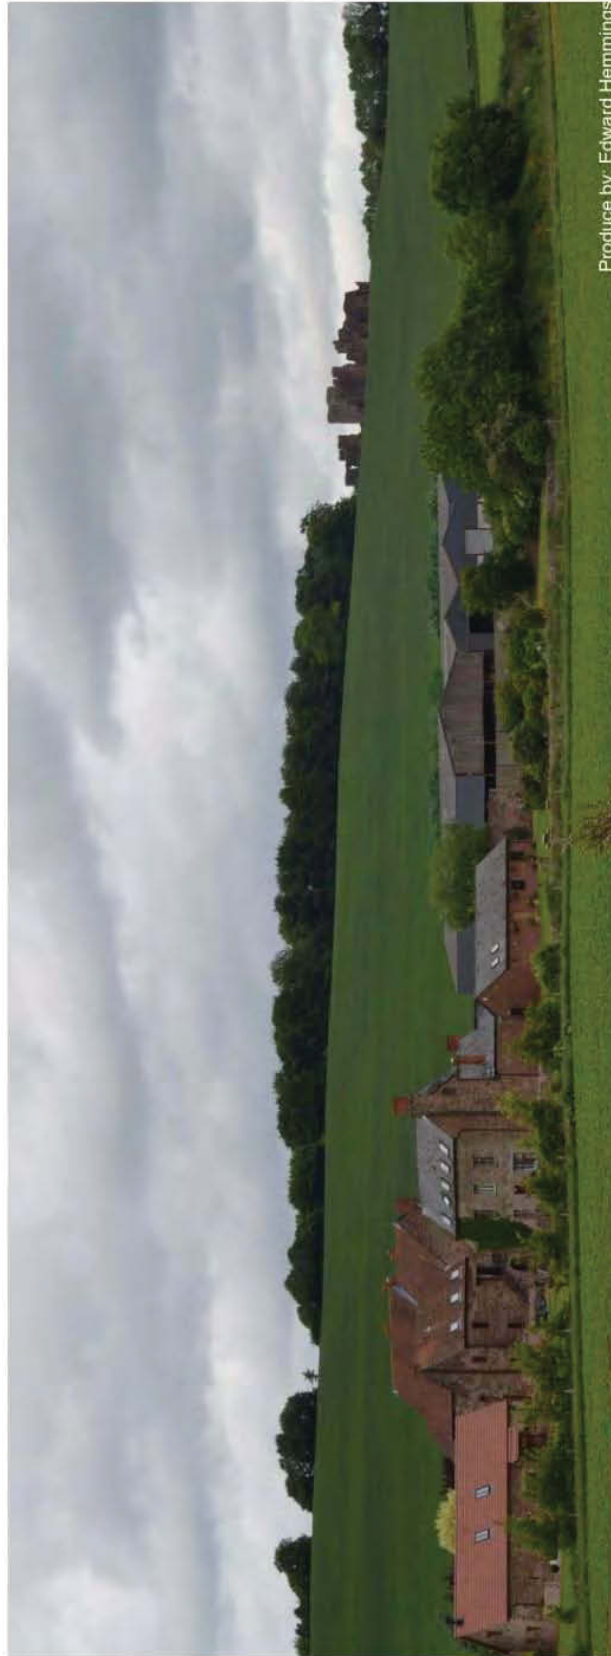
Plate 6 The existing view, from a point between the bridge and the priory, towards the priory and castle, enhanced to show the proposed new buildings, and the tree/hedge screen, by Edward Hemmings

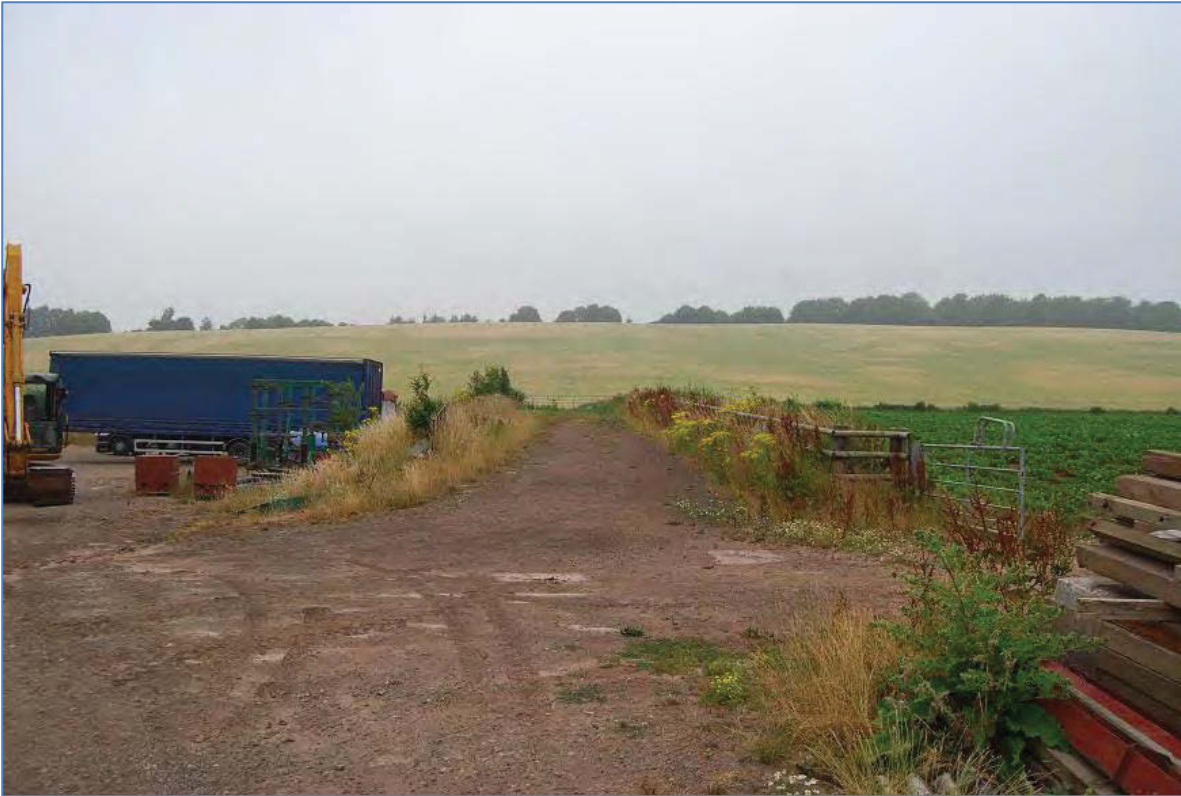
*Plate 1 Trench 1 location before excavation, looking west*

A hardcore surface (Plate 1) for a farm track overlaid the red clay, consisting of imported broken stone, and gravels, with occasional concrete, charcoal and tarmac. The natural marl and clay was cut by one modern gate post in the sondage at the western end of trench 1 (Plate 5), whilst a modern animal burial was uncovered at the centre of Trench 1 (Plate 4). This was unexcavated due to health and safety issues. whilst a thin topsoil and turf mat overlaid the hardcore on the south side of Trench 1.

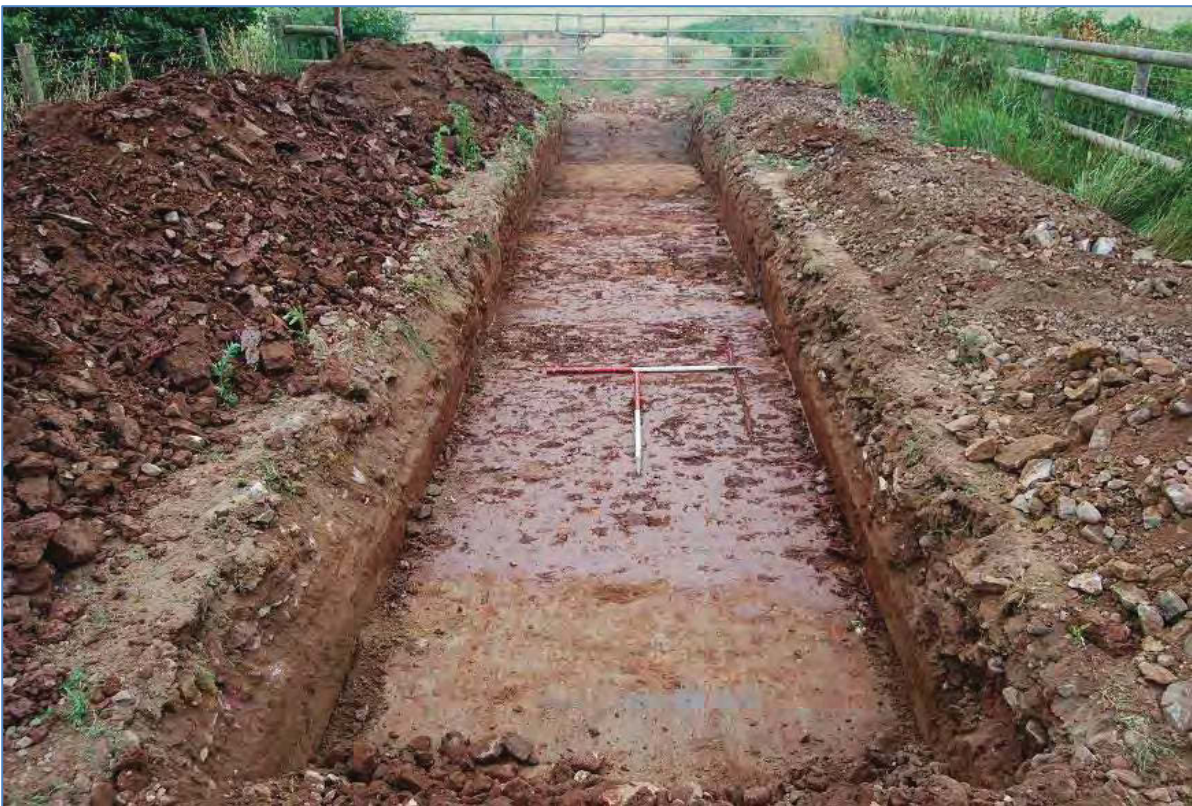
*Plate 2 Trench 1 15m stretch showing natural sandy marl and clay bands*

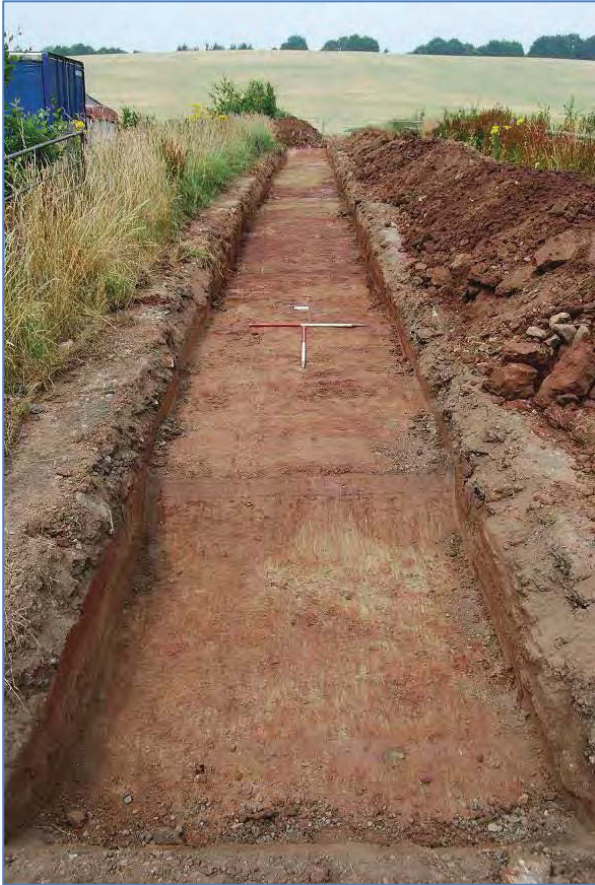
*Plate 3 Trench 1 35m stretch showing natural sandy marl and clay bands*

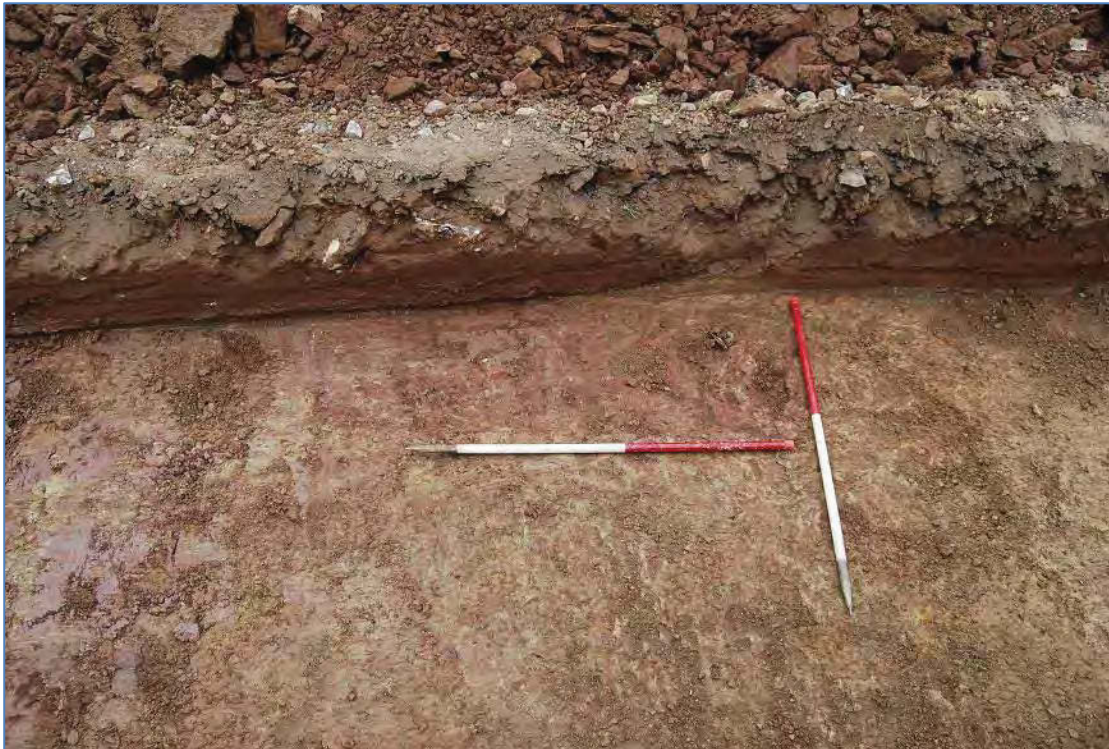
*Plate 4 Cut for modern animal burial containing sheep teeth in Trench 1. Unexcavated and bones not retained*

There were no significant artefacts apart from fragments of modern brick found during the works so no further work was required. Animal bone was left in situ and not excavated for health and safety reasons.

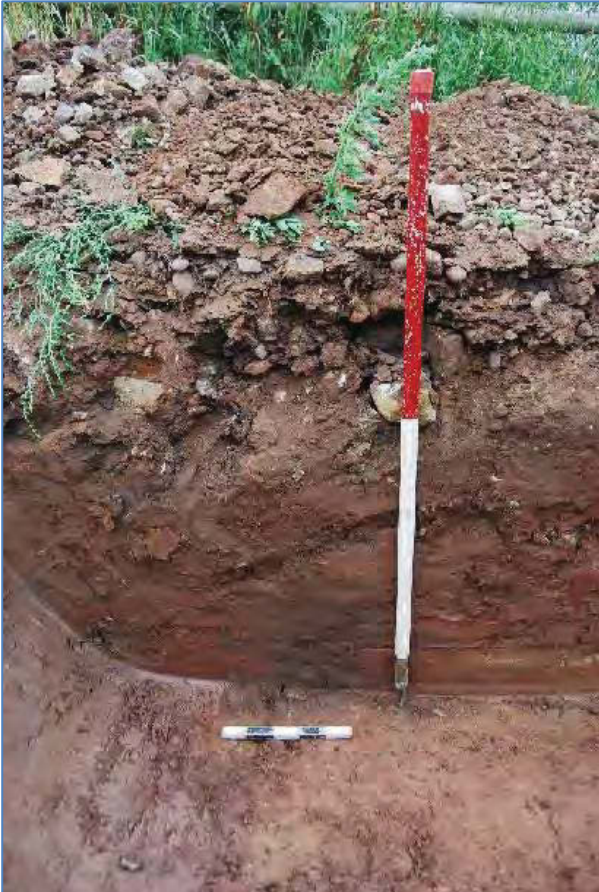
*Plate 5 Modern gate posthole in western sondage south facing section*

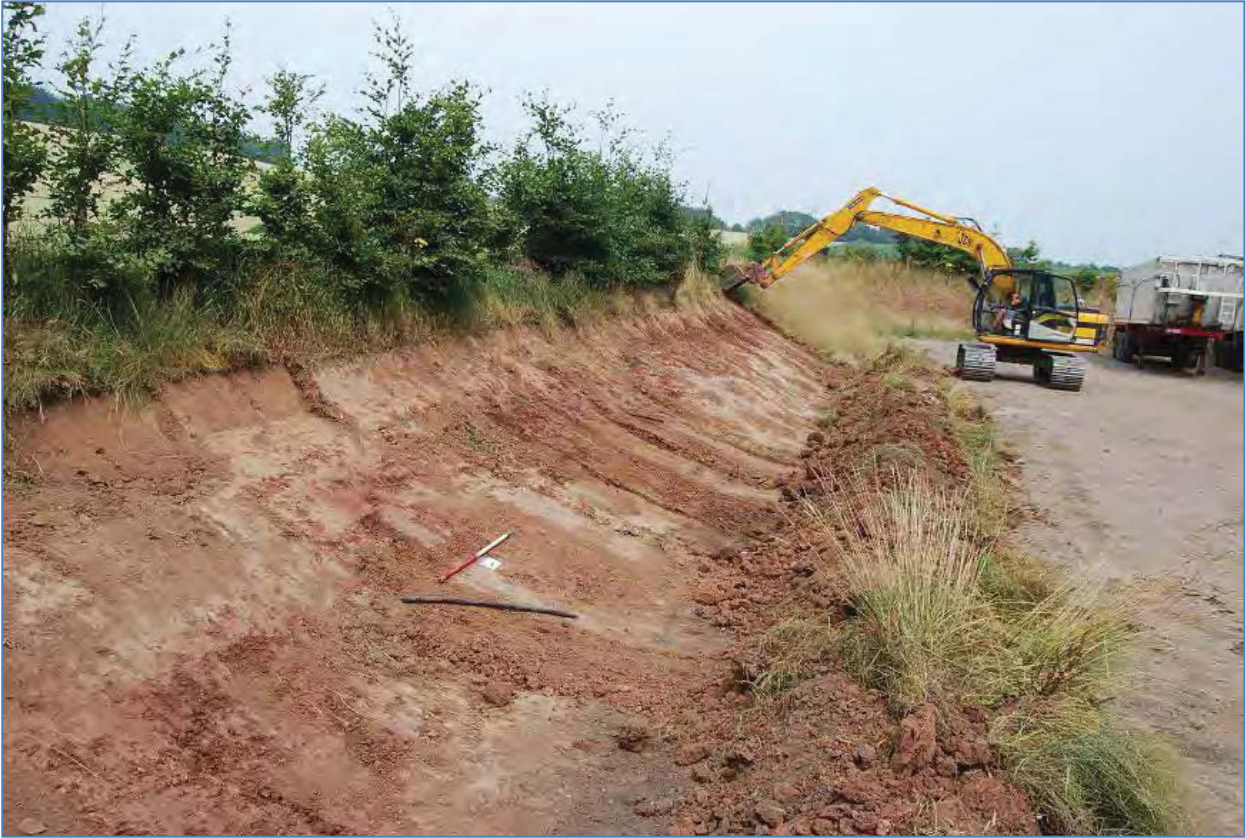
*Plate 7 Soil profile of western bank exposed showing modern disused water pipe trench. View north-west*

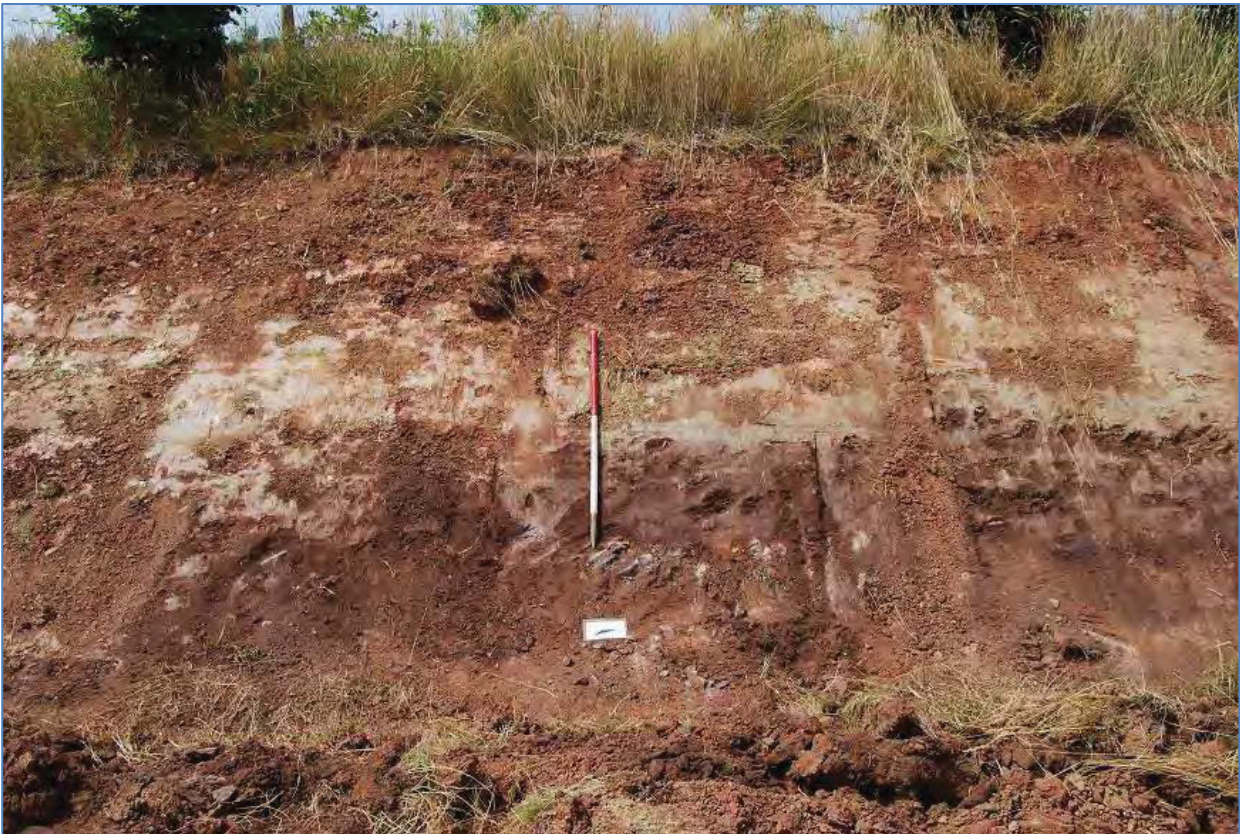
*Plate 8 Soil profile of western bank exposed showing natural deposits looking west*
