ARCHAEOLOGICAL  
WATCHING BRIEF AT THE  
MASTER'S HOUSE, LEDBURY

Project P3801  
Report 1898  
EHE 1929

An archaeological watching brief was undertaken during Phase 1 of a project to restore and refurbish the Master's House in Ledbury (NGR SO 71033 37653; EHE 1929). The watching brief was commissioned by Butler Hegarty Architects, in accordance with a brief prepared by Herefordshire Archaeology.

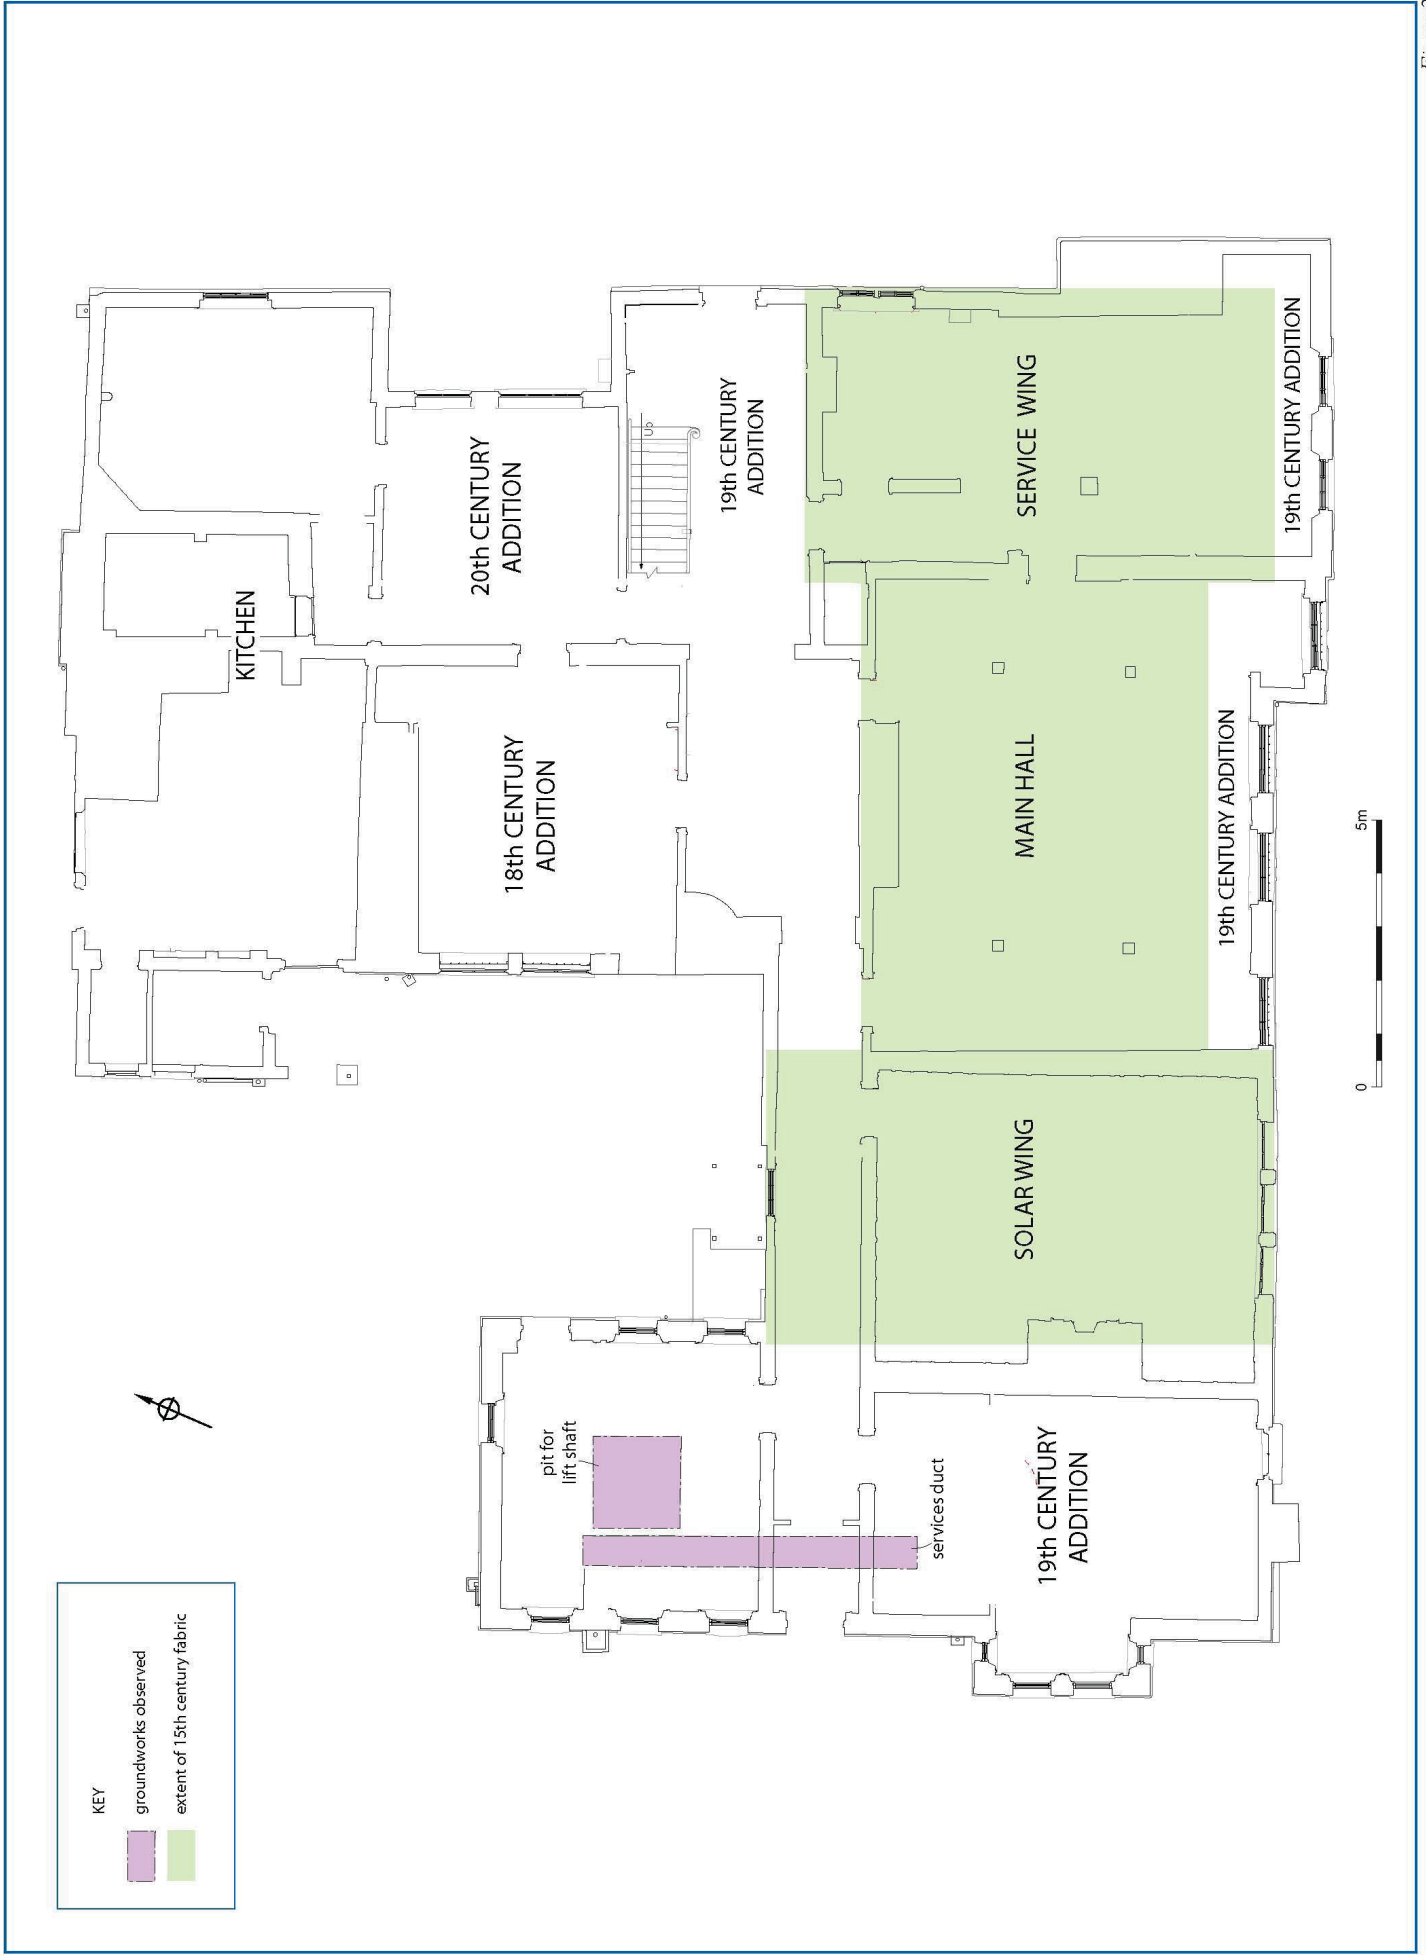
Figure 2

Location of groundworks (plan of the Master's House based upon Butler Hegarty Drg. No. co00378128/0512509/Sk101A)

The watching brief focused on groundworks inside the west wing of the Master's House (Fig 2). The excavation of a pit for a lift shaft and a duct for services was considered to have a potential impact on archaeological deposits.

In this context, the watching brief provided an opportunity to add more information on medieval and post-medieval arrangements. As shown on Figure 2, the groundworks were located inside a wing to the west of the 15<sup>th</sup> century solar.

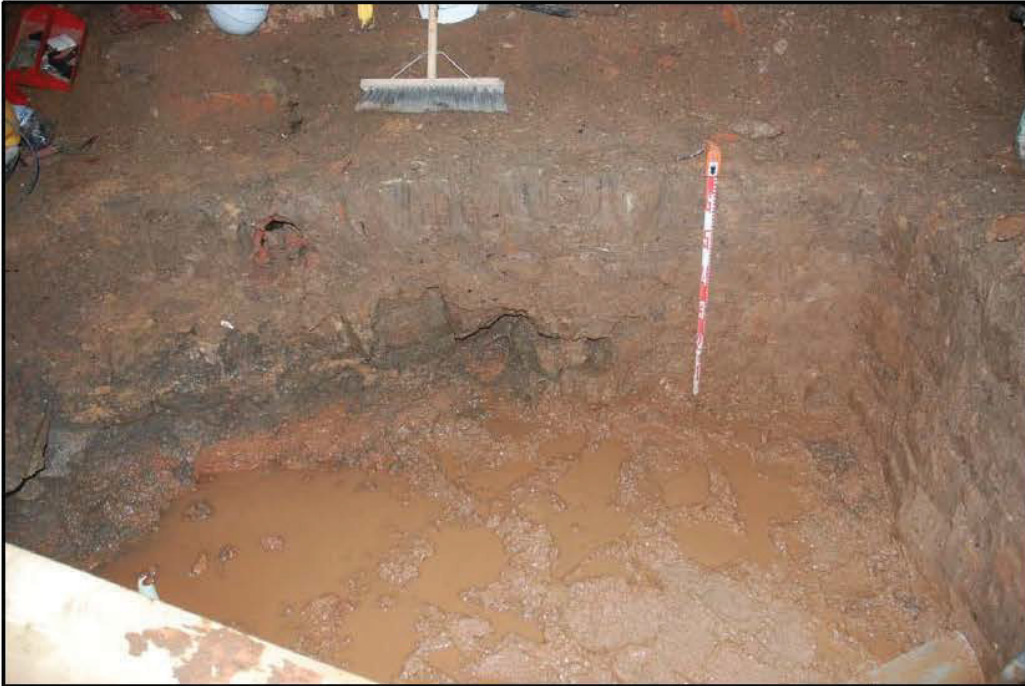
*Plate 1: West side of drain 110, facing west*

The sides of the drain were made of roughly-hewn stones laid on stretchers of handmade brick (context 110; Plate 1). They formed a channel that was approximately 0.15m wide and 0.15m deep. The dimensions (in inches) of three measured examples were 8¾ x 4½ x 2¾, 9 x 4¼ x 2¾, and 8¾ x 4 x 2½. The sides of the drain were capped with large roughly-hewn stones laid edge-to-edge (context 104; Plate 2).

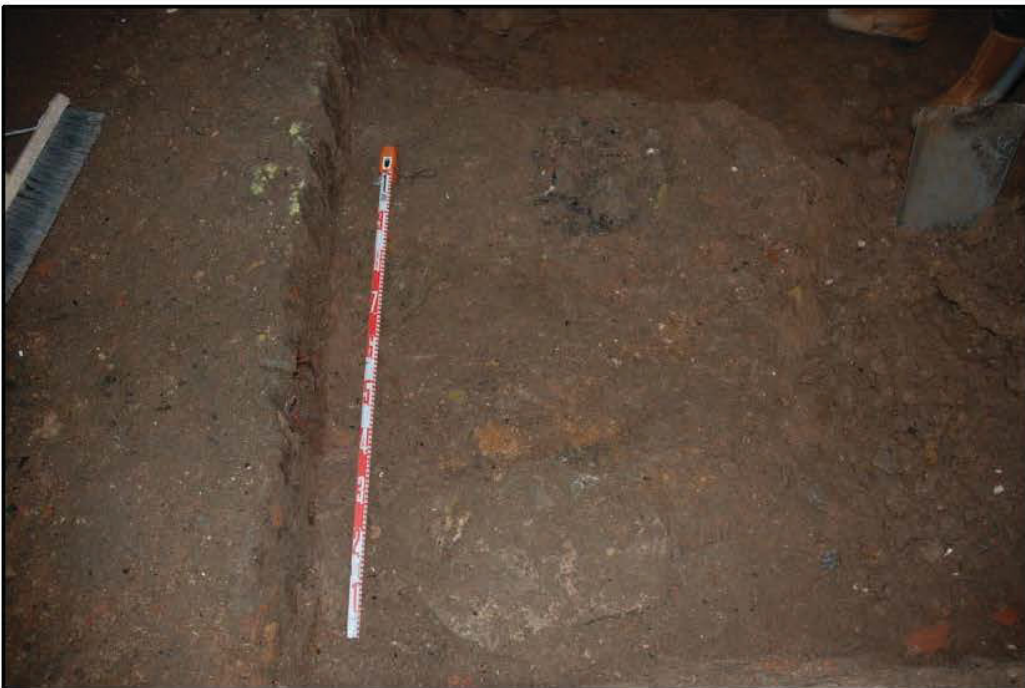
*Plate 2: Capping stones 104 above drain 110 (posthole 103 in background, pit 106 to right)*

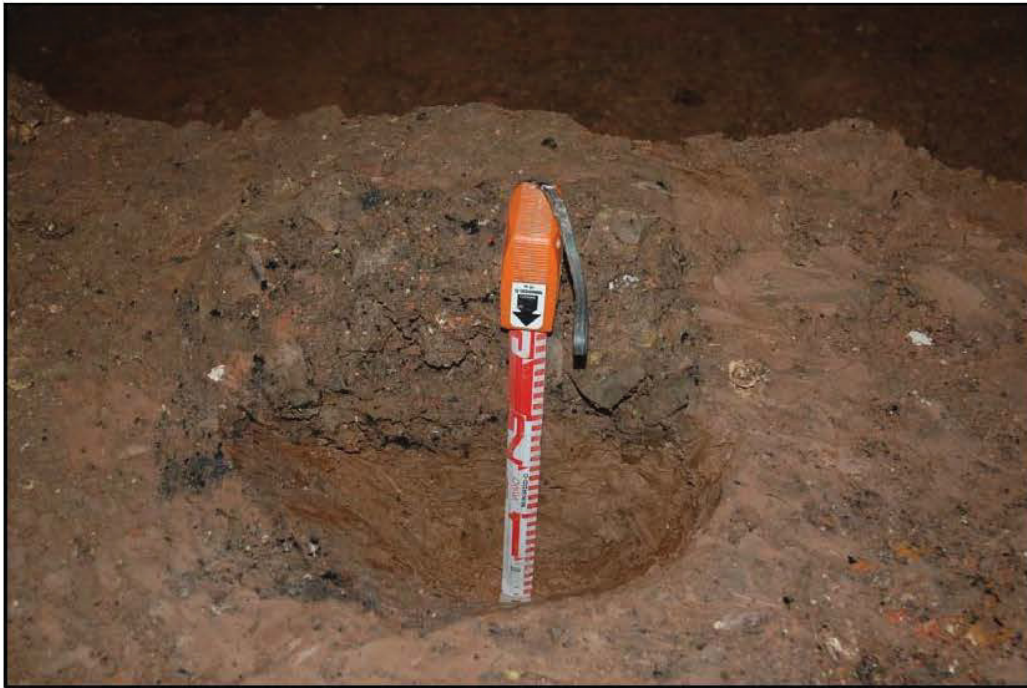
*Plate 3: Posthole 103, facing north*

The posthole lay between the pit and the drain (context 103; Plate 3). It was sub-circular in plan, with a diameter of c 0.30m. The sides were irregular, sloping more or less steeply to a flat base. It had a lower fill of redeposited marl (context 108) and an upper fill of marl mixed with common charcoal, mortar, and stone inclusions (context 102).

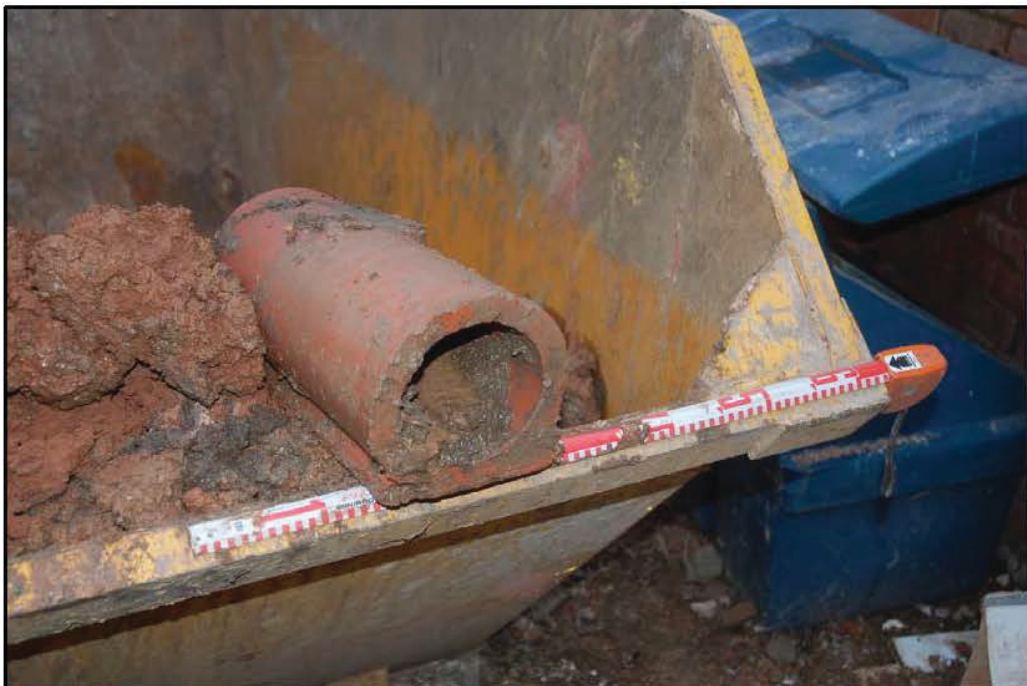
*Plate 4: Section of drain 112*

The deposit was cut by a ceramic land drain (context 112). The drain was made up of identical sections laid end to end in a narrow trench (context 116). Each section was 14 inches long, and comprised an extruded 5-inch diameter pipe on a flat, 5½-wide base (Plate 4). According to a well-informed amateur archaeologist, these characteristics suggest a date after 1850, perhaps 1860-70 (Vanda Bartoszuk, pers comm).
