Archaeological Watching Brief
of works at
Blueschool Street and
Newmarket Street,
Hereford

Date: 1st May 2014
Status: Revision 1
Author: Graham Arnold – garnold@worcestershire.gov.uk
Illustrator: Carolyn Hunt
Project reference: P4280
Report reference: R2106
HER reference: EHE 80004

Archaeological watching brief at Blueschool Street and Newmarket Street, Hereford

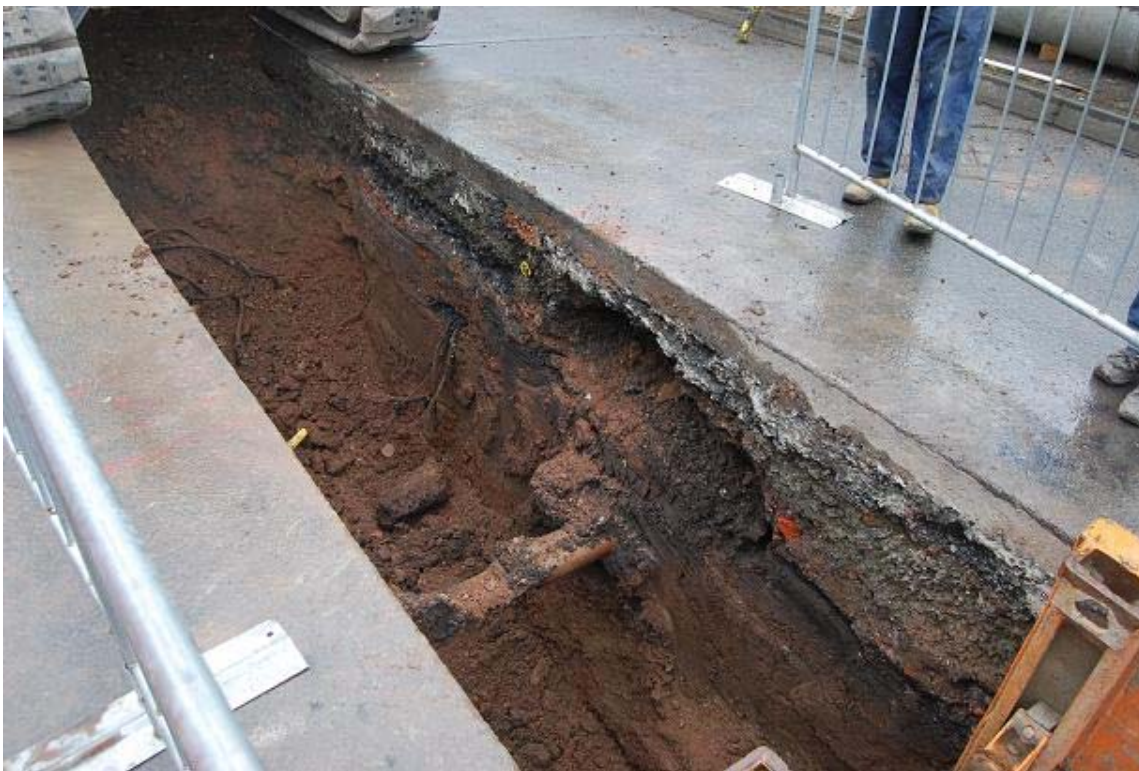
Plate 2 North facing section of trench 1, showing truncation by modern services. View South-east.

This trench was for the relocation of the water pipe (marked in blue on Fig. 2) and lay just to the north of the scheduled area, on the northern carriageway of Newmarket Street and was a total length of 90.00m, 2.10m wide and up to 3.00m in depth (Plates 1-4). The stratigraphy observed included natural gravels at 1.80m below ground level (103), overlain by made ground (102) and the modern road surfacing (100 and 101). The made ground was heavily truncated by a series of service trenches and the subway construction (Plate 4).

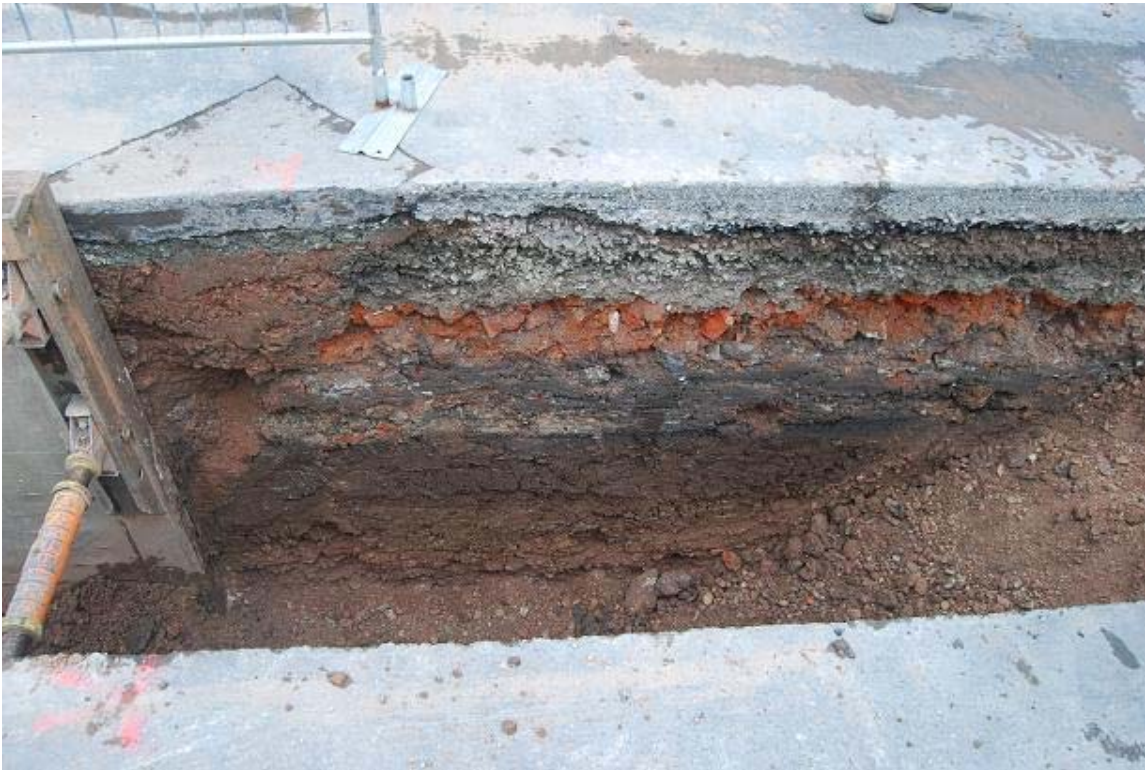
Plate 3 South facing section of trench 1.

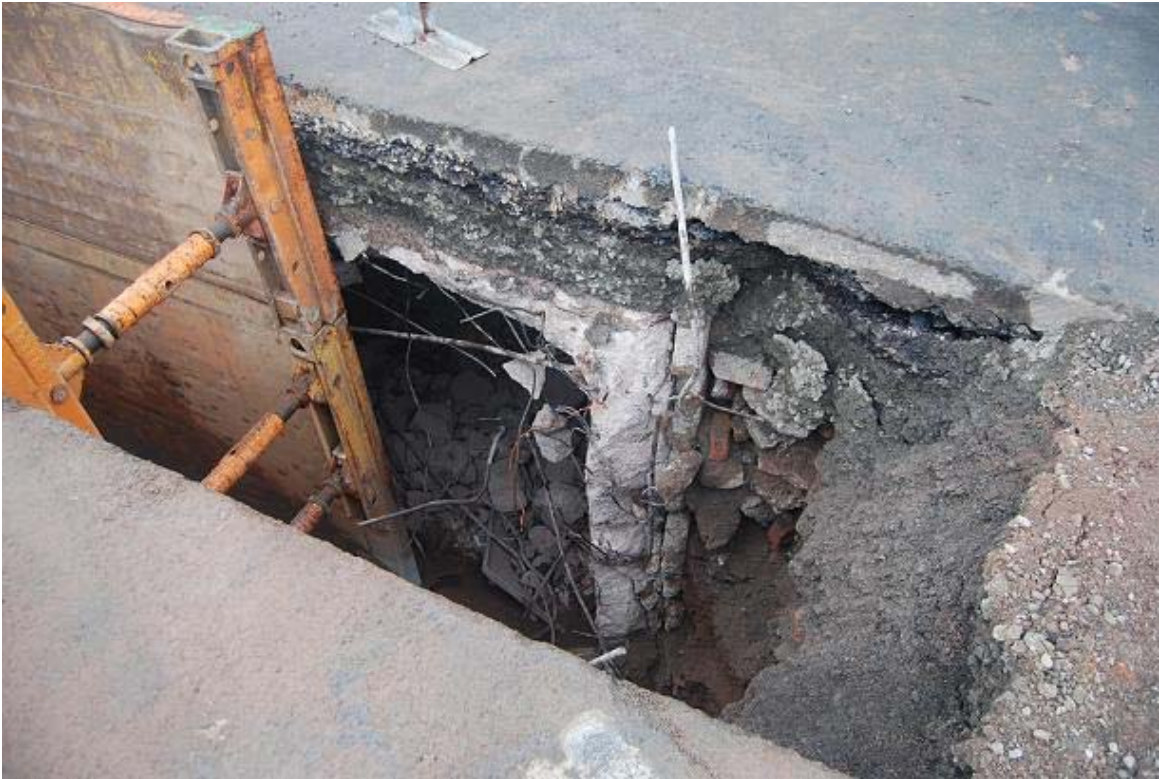
Plate 4 part of the modern subway under the road made of reinforced concrete.

Some grey sandstone ashlar blocks encountered during excavation of tree pits in Area 7 may have derived originally from the City Wall or related structures, but were clearly not in their original location. They may have been disturbed during excavations for a subway beneath this road during the mid 20th Century.

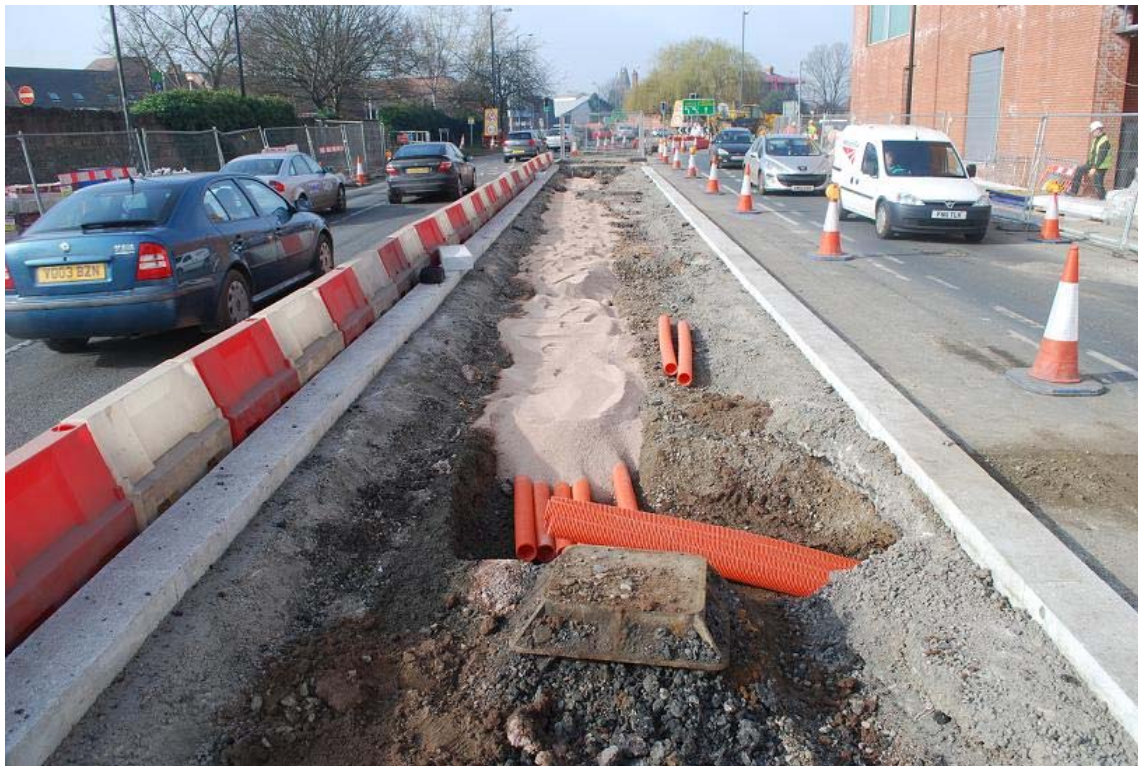
Plate 8 Example depth of ducting in central reservation and across carriageways after installation and backfilling.

Drainage gullies and traffic light ducting (shown in orange on Fig. 3) were only monitored along the footpaths (in Area 8 and central reservations; plates 7 - 8) and were a maximum of 0.50m in depth, placed within the existing modern make up for the road, central reservations and pavements.

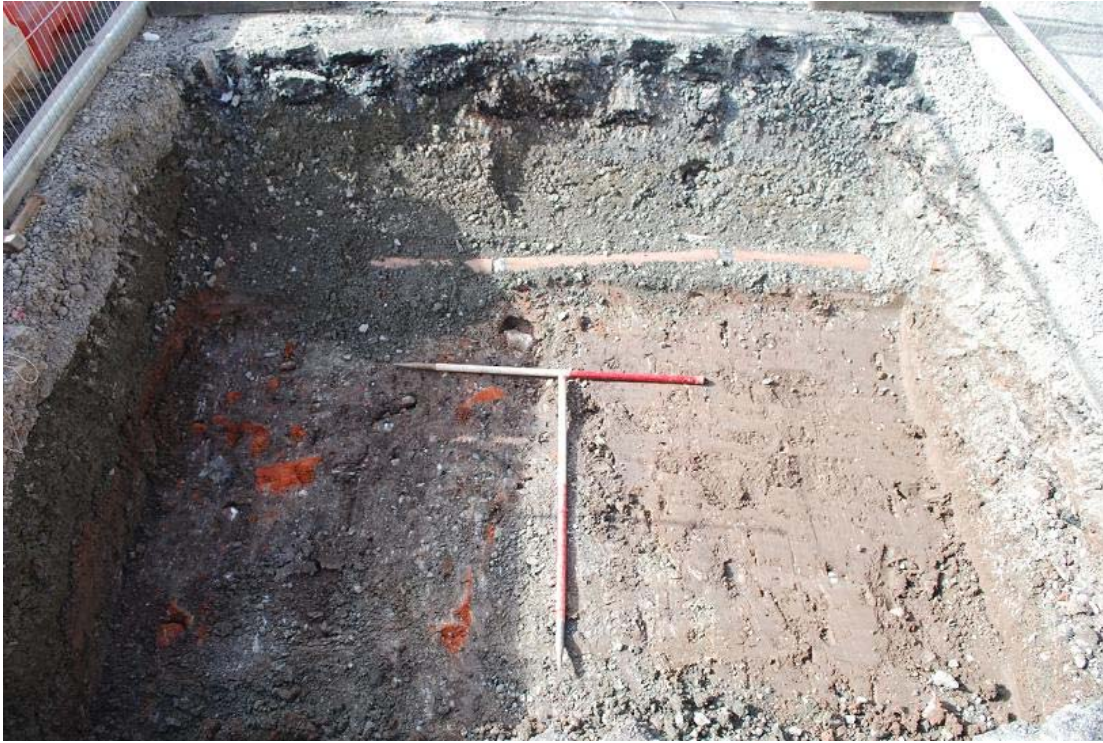
Plate 9 Example of Tree pit 1 in plan showing made ground, a service trench. View west.

A total of 12 tree pits (Plates 9 and 10, light green on Fig. 2) were excavated to a total depth of 0.80m below the existing kerb line. Made ground (402) was recorded 0.55m below the ground level to the base of the tree pits. Modern road stone and tarmac lay over the made ground, frequently truncated by modern service trench backfill.

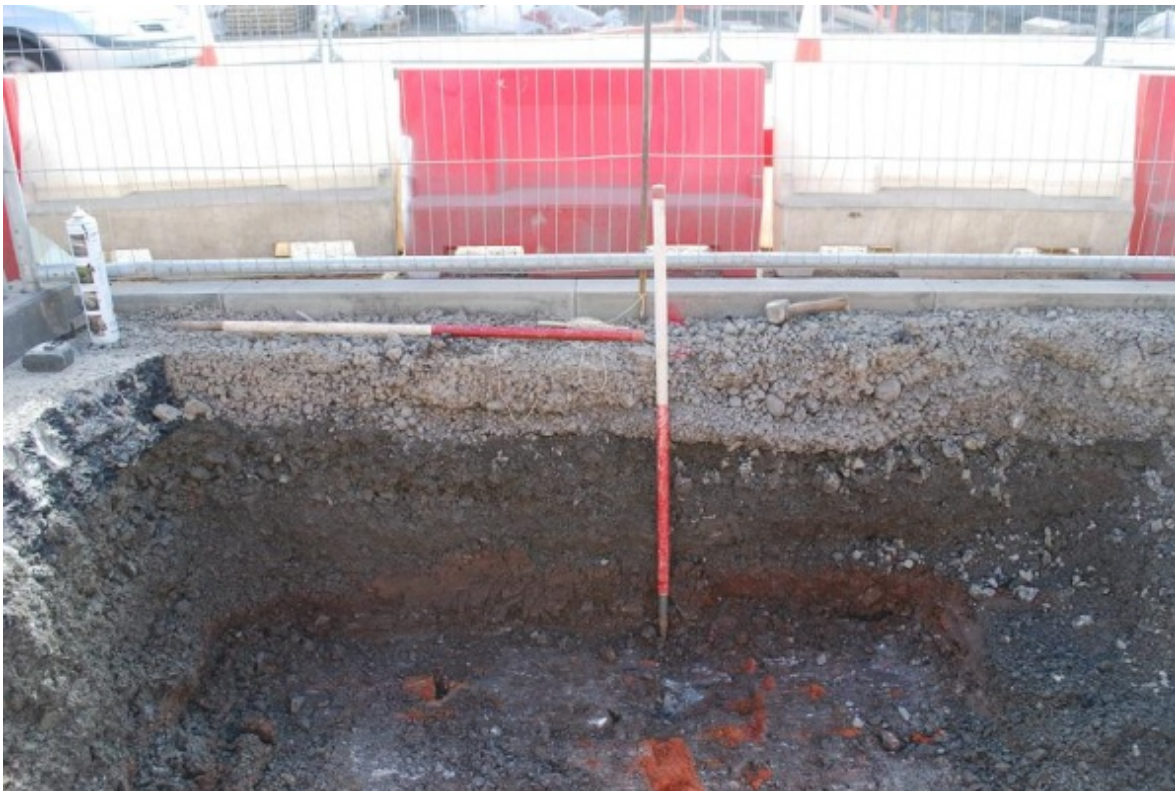
Plate 10 North-facing section of tree pit in central reservation.

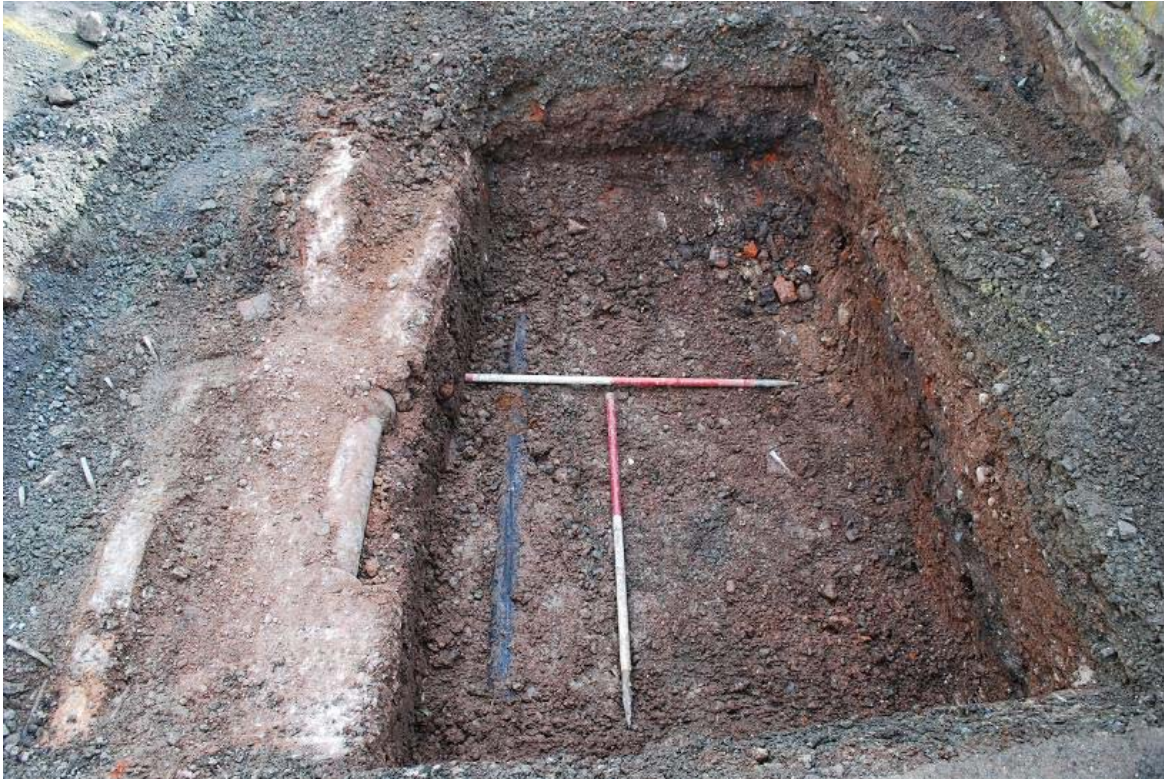
Plate 11 Plan shot of Tree pit within Newmarket Street South (Trench 7) showing modern service pipes on north side. View east.

Four tree pits (Plates 11 – 14, dark green on Fig. 2) measuring 2.70m square were excavated on the ground between Wall Street and Newmarket Street. They were located directly over modern services (703) and redeposited material for service trench backfill (704) was excavated to a total depth of 0.90m below the road level. Tree pit 16 was located on a modern landscaped bank and a deposit of modern topsoil (700) 0.3m deep was recorded here. The existing footpath surface that overlay the other tree pits had been removed previously during Area 3 works. A number of squared grey sandstone ashlar masonry blocks (plates 15-16) were found within the backfill of the service trench but these were loose and not in situ. It is likely that these had been disturbed previously when the subway was constructed and backfilled with the other waste material.

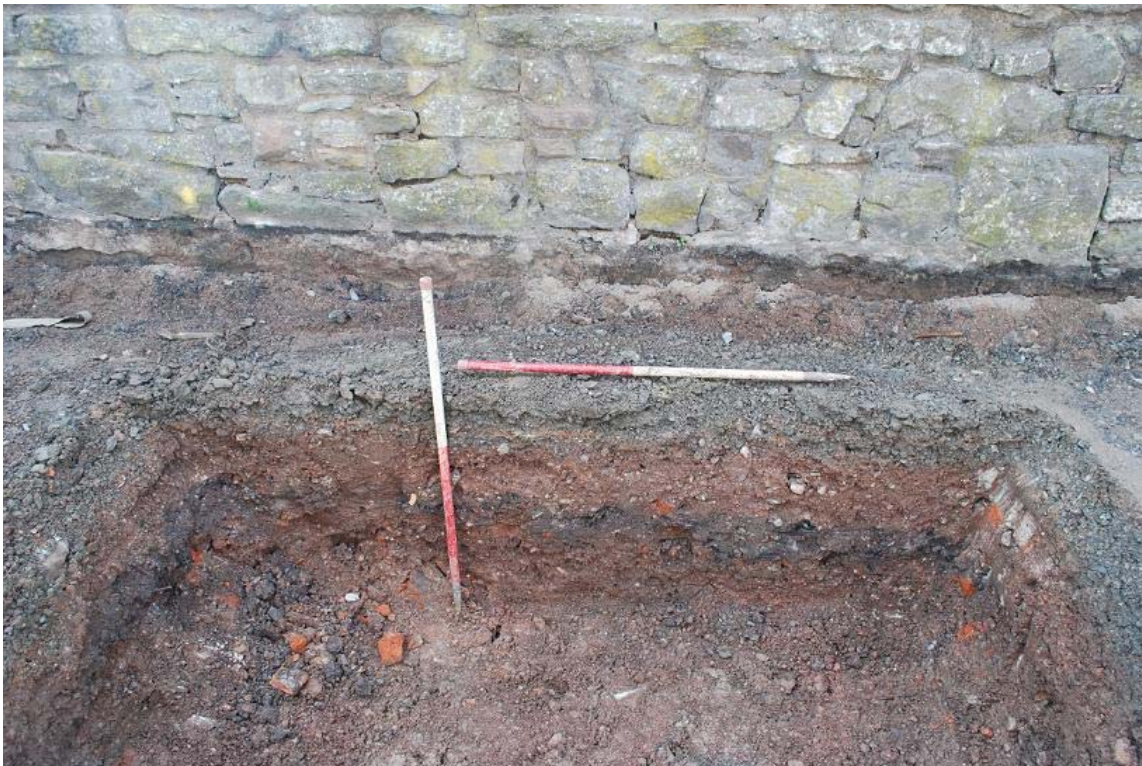
Plate 12 North facing section of Tree pit within Newmarket Street (Trench 7) showing made ground service trench backfill.

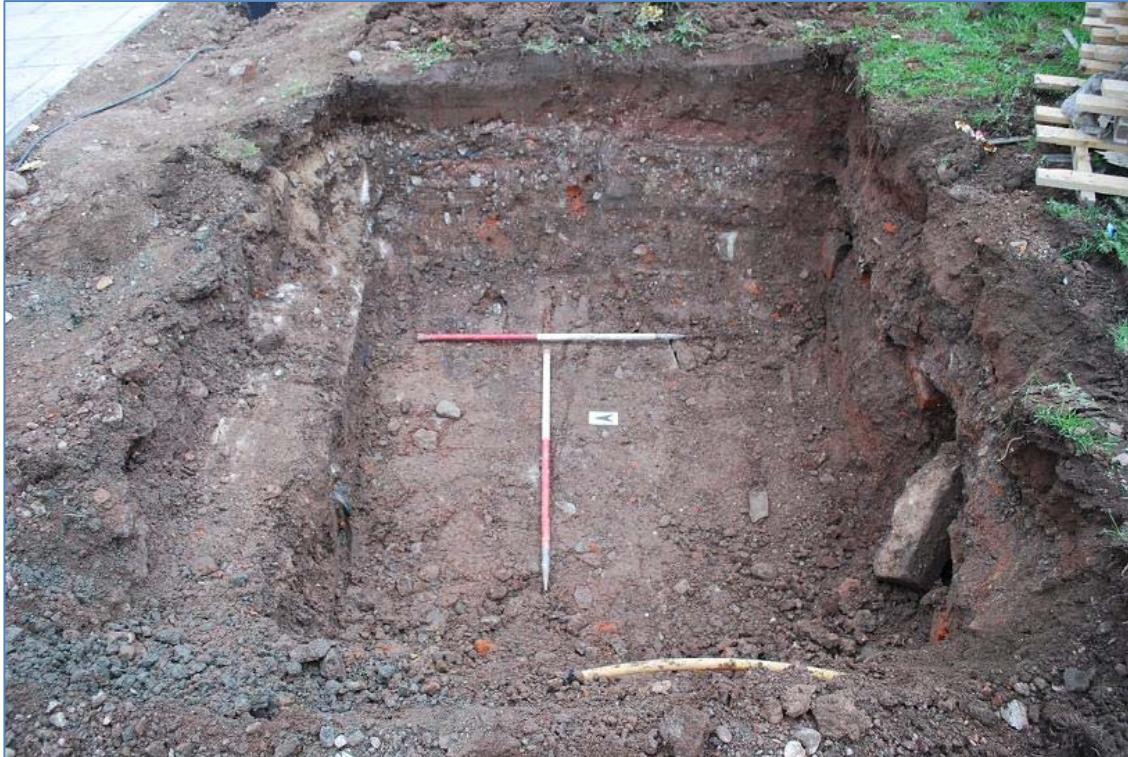
Plate 13 Eastern tree pit within Newmarket Street south. It shows a loose sandstone ashlar block in the section and modern services on the north side. View east.

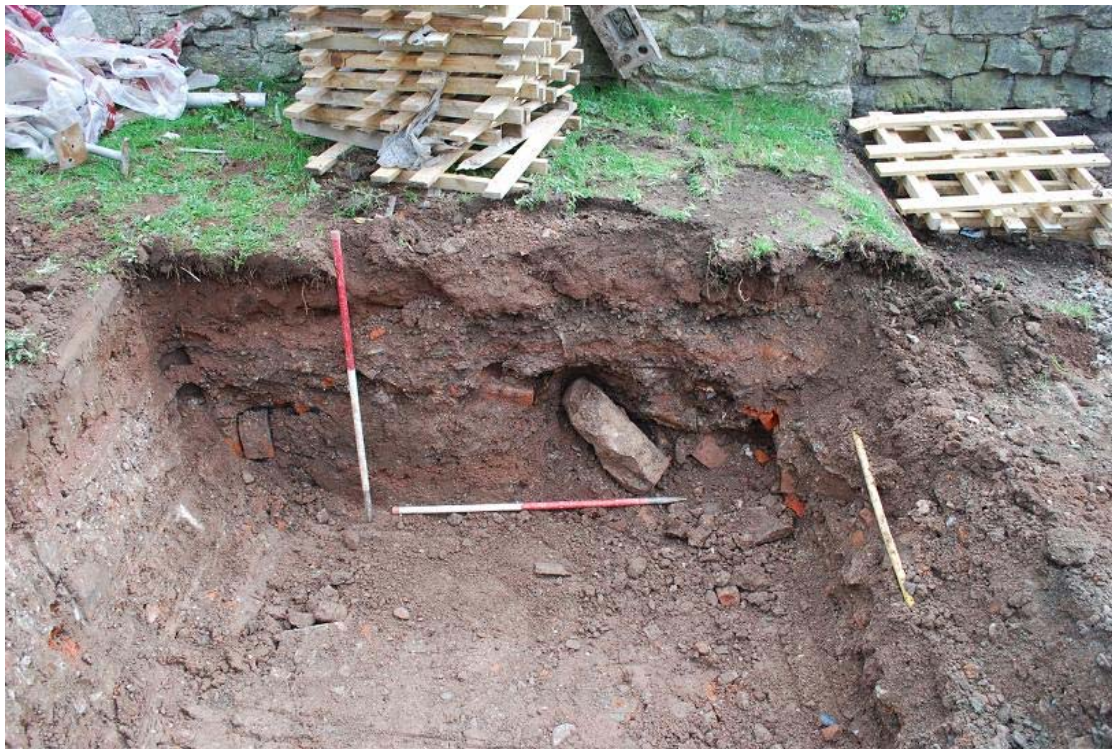
Plate 14 South facing section of eastern tree pit within Newmarket Street south.

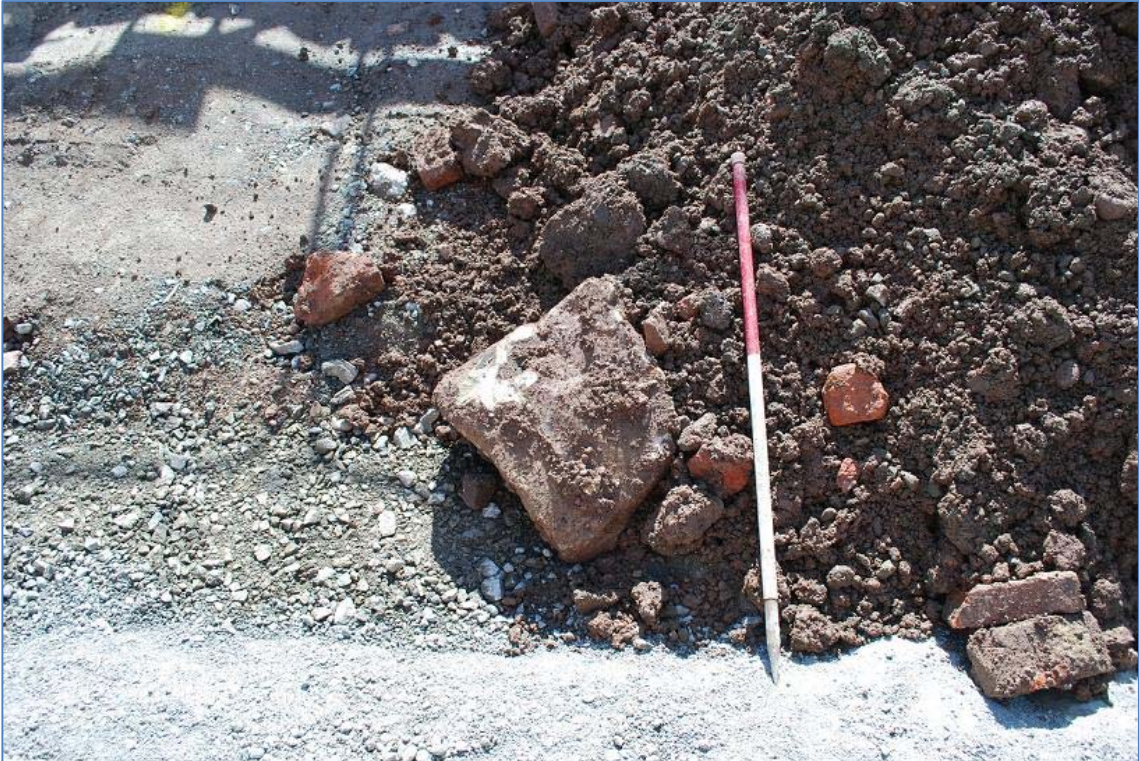
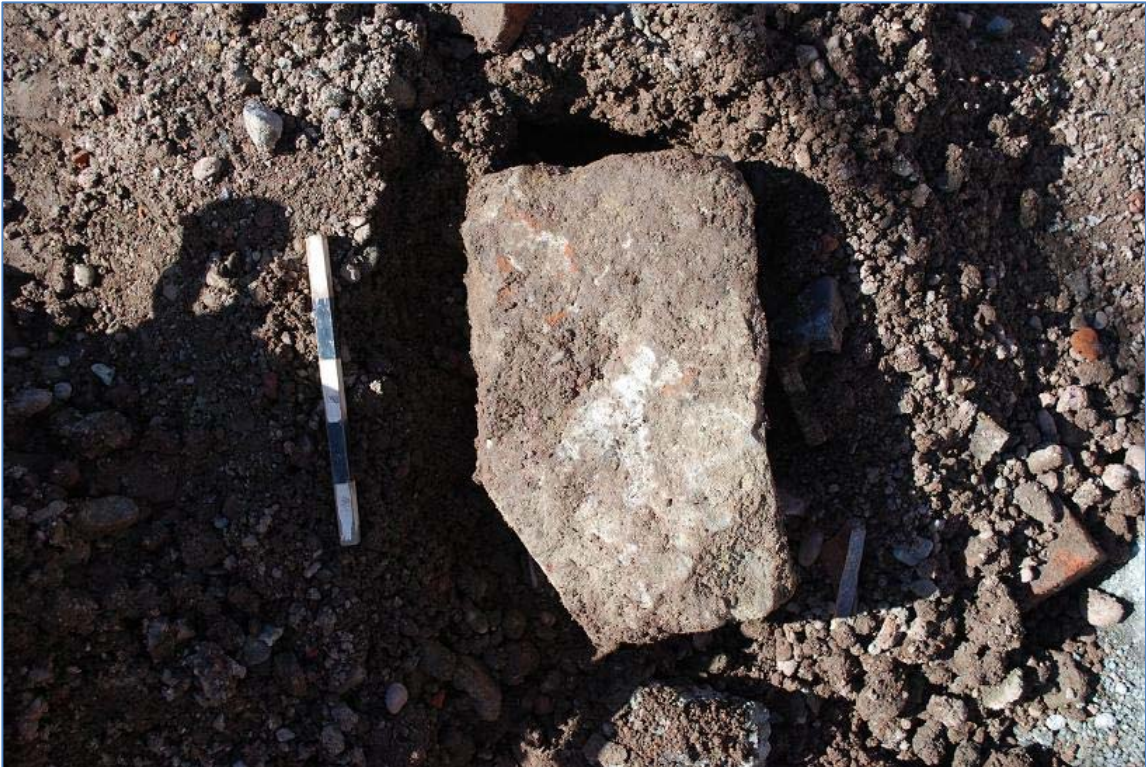
Plate 15 Example of ashlar block from Newmarket Street tree pit within modern backfill.

Plate 16 Example of ashlar block from Newmarket Street tree pit within modern backfill.

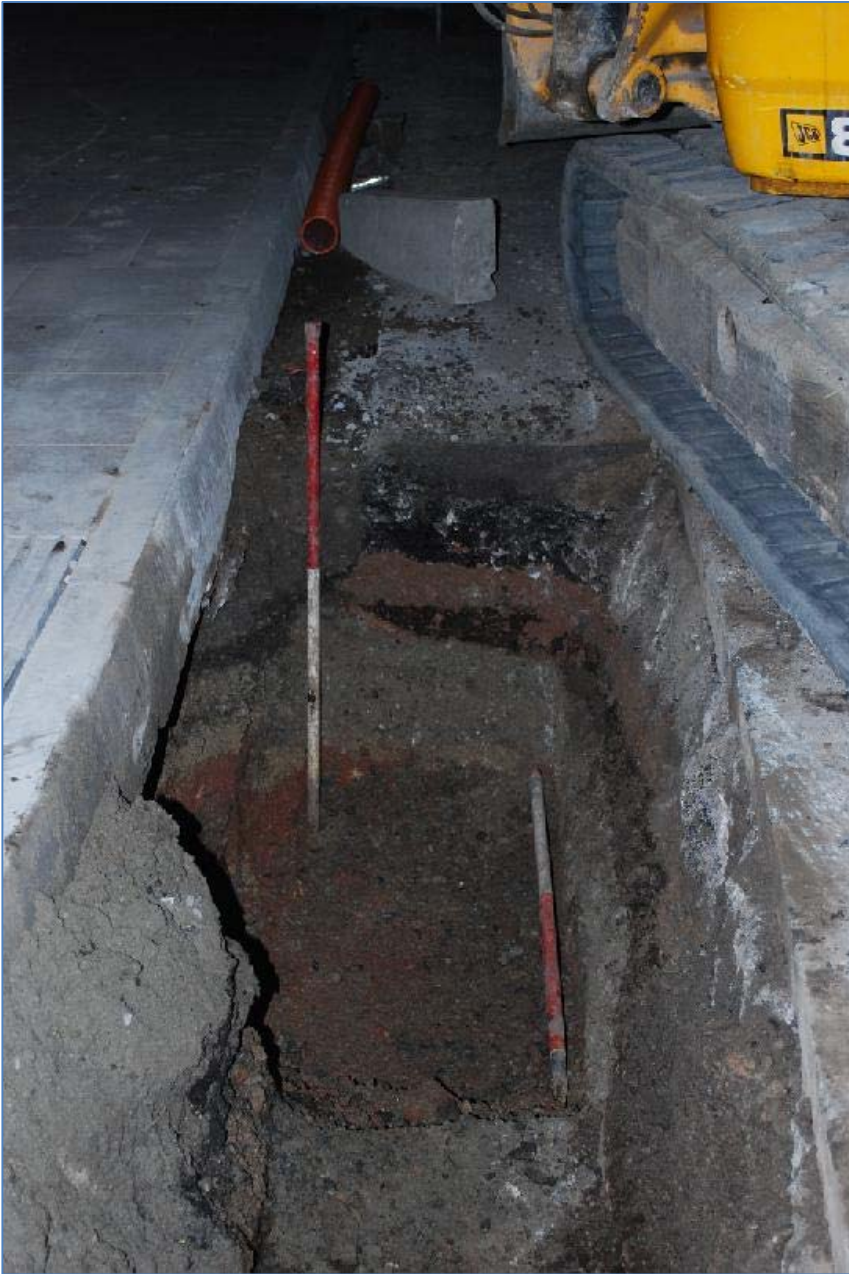
Plate 17 Gully pit adjacent to Wall Street showing layers of road make up and very compacted red gravel. View west.

Four gully pits (Marked in black on fig 3) were monitored along the south footpath in the Eastern section of the study area, along Wall Street (plate 17) and the corner between Widemarsh Street and Blueschool Street (plates 18-20). The gully pits were a maximum of 1.20m in depth and were often shallower due to the presence of live services. The gully pit on Wall Street encountered very

compact sandy gravel / marl (603) thought to be natural or redeposited natural ground at 0.80m below the ground level. Gully pits between Widemarsh Street and Blueschool Street were excavated entirely through made ground (1002) backfilled from the laying of services.

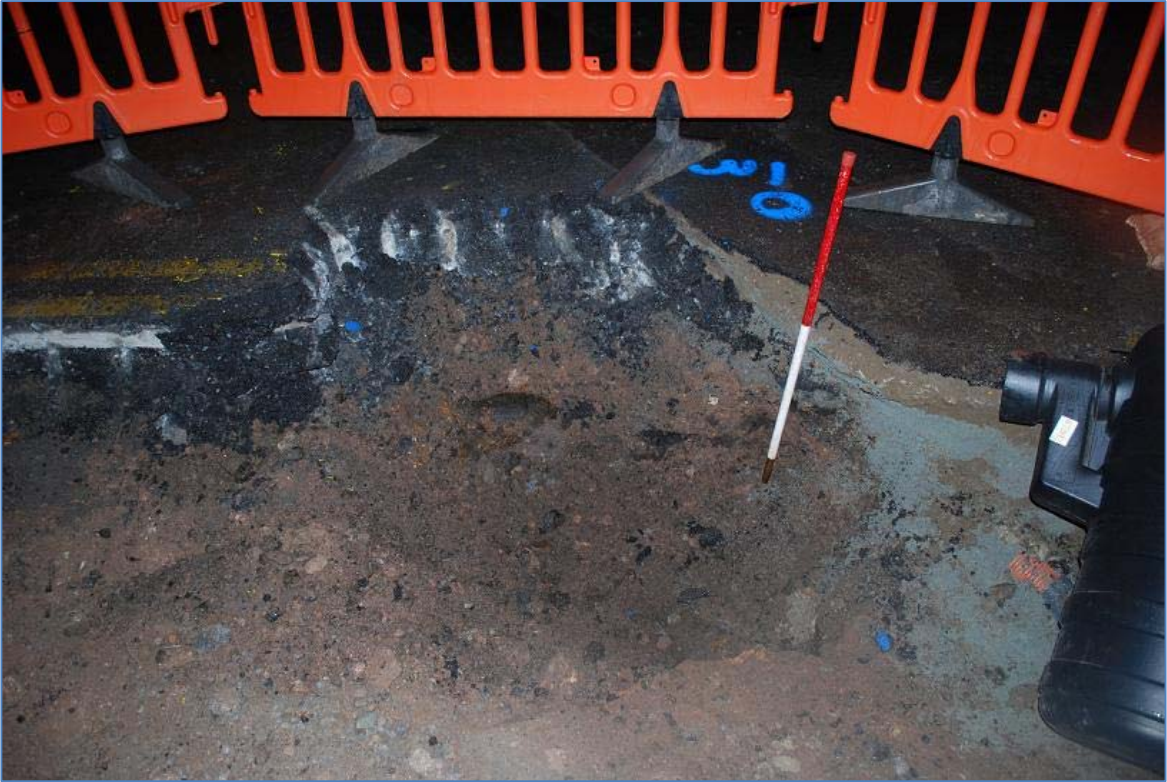
Plate 18 Widemarsh Street Gully Pit, showing modern water main and backfill of modern service trench. View West.

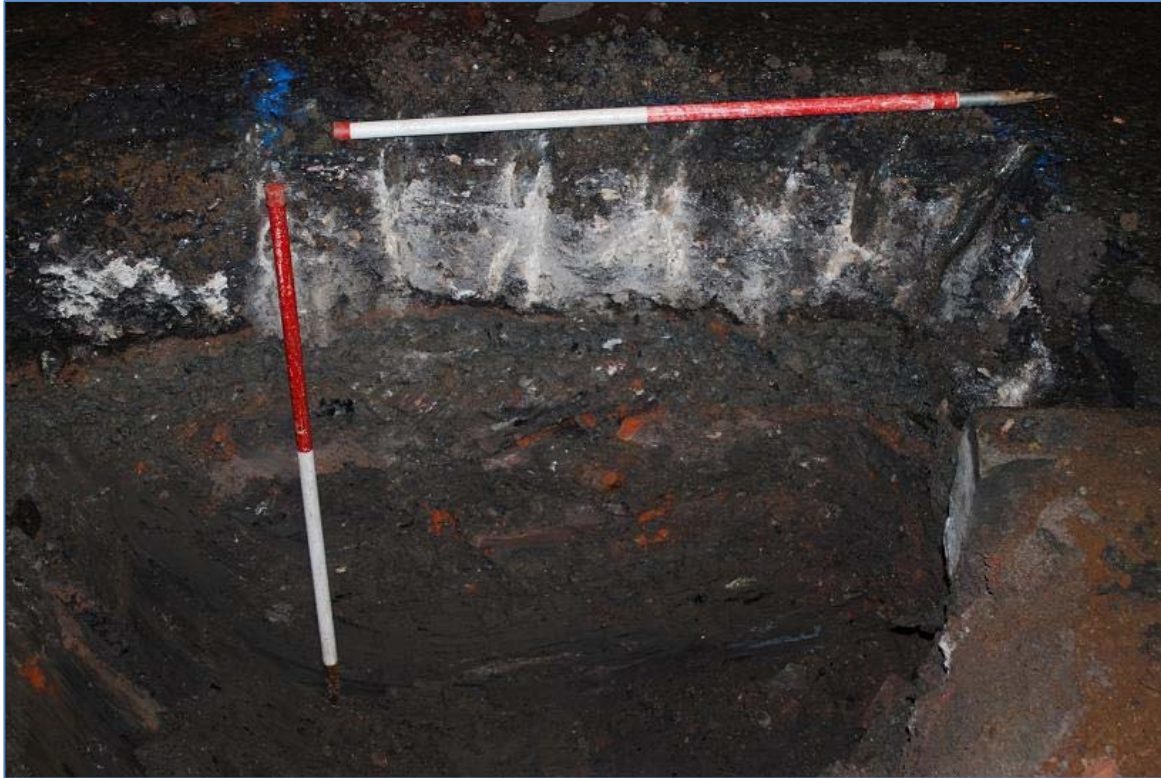
Plate 20 South facing section of Blueschool Street gully pit showing backfilled modern disturbed made ground.

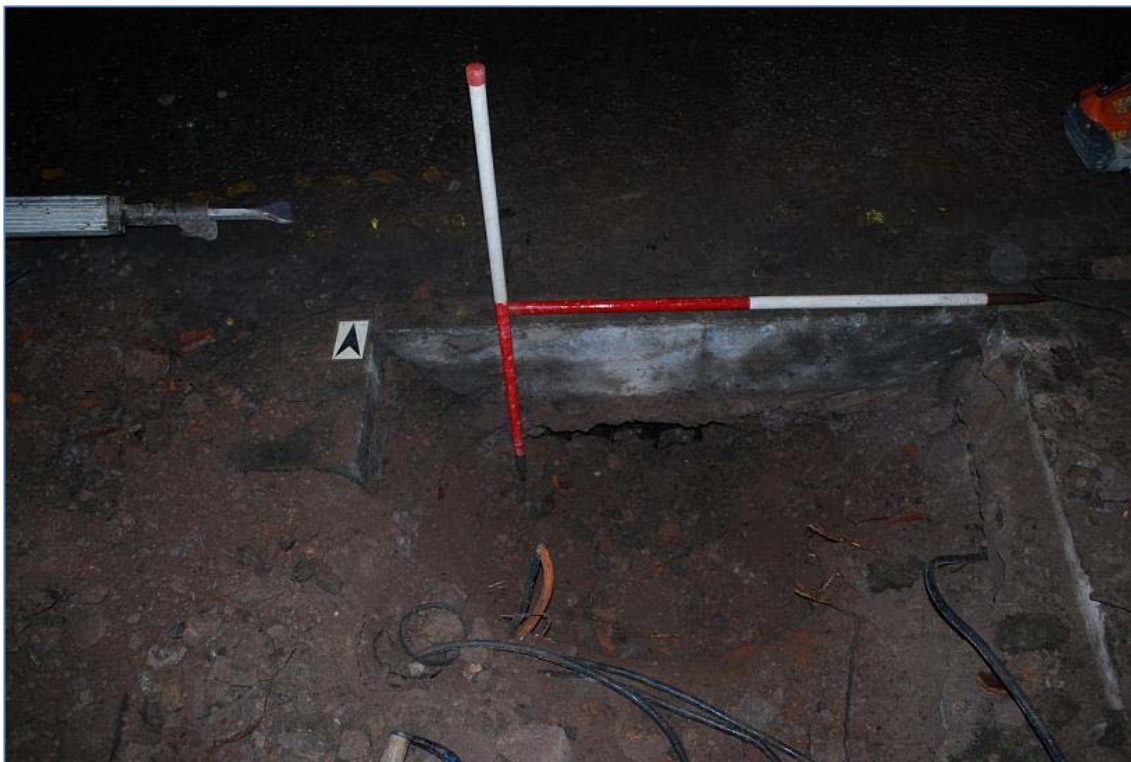
Plate 21 Trench 9 traffic light signal box and traffic light on Blueschool Street. View north.

A pit 0.45m in depth and 0.45m square was excavated over the location of Bastion 9. Only modern road surfacing and made ground (900-902) was encountered, with frequent modern services (plate 21).
