Archaeological evaluation and building recording at Sainsbury's Site, Raglan Street, Wolverhampton

Status: Raglan Street, Wolverhampton
Date: 31 January 2014
Author: Andrew Mann, Richard Bradley and Shona Robson-Glyde
Contributors: Dennis Williams
Illustrator: Carolyn Hunt
Project reference: P3813
Report reference: 2065
HER reference:

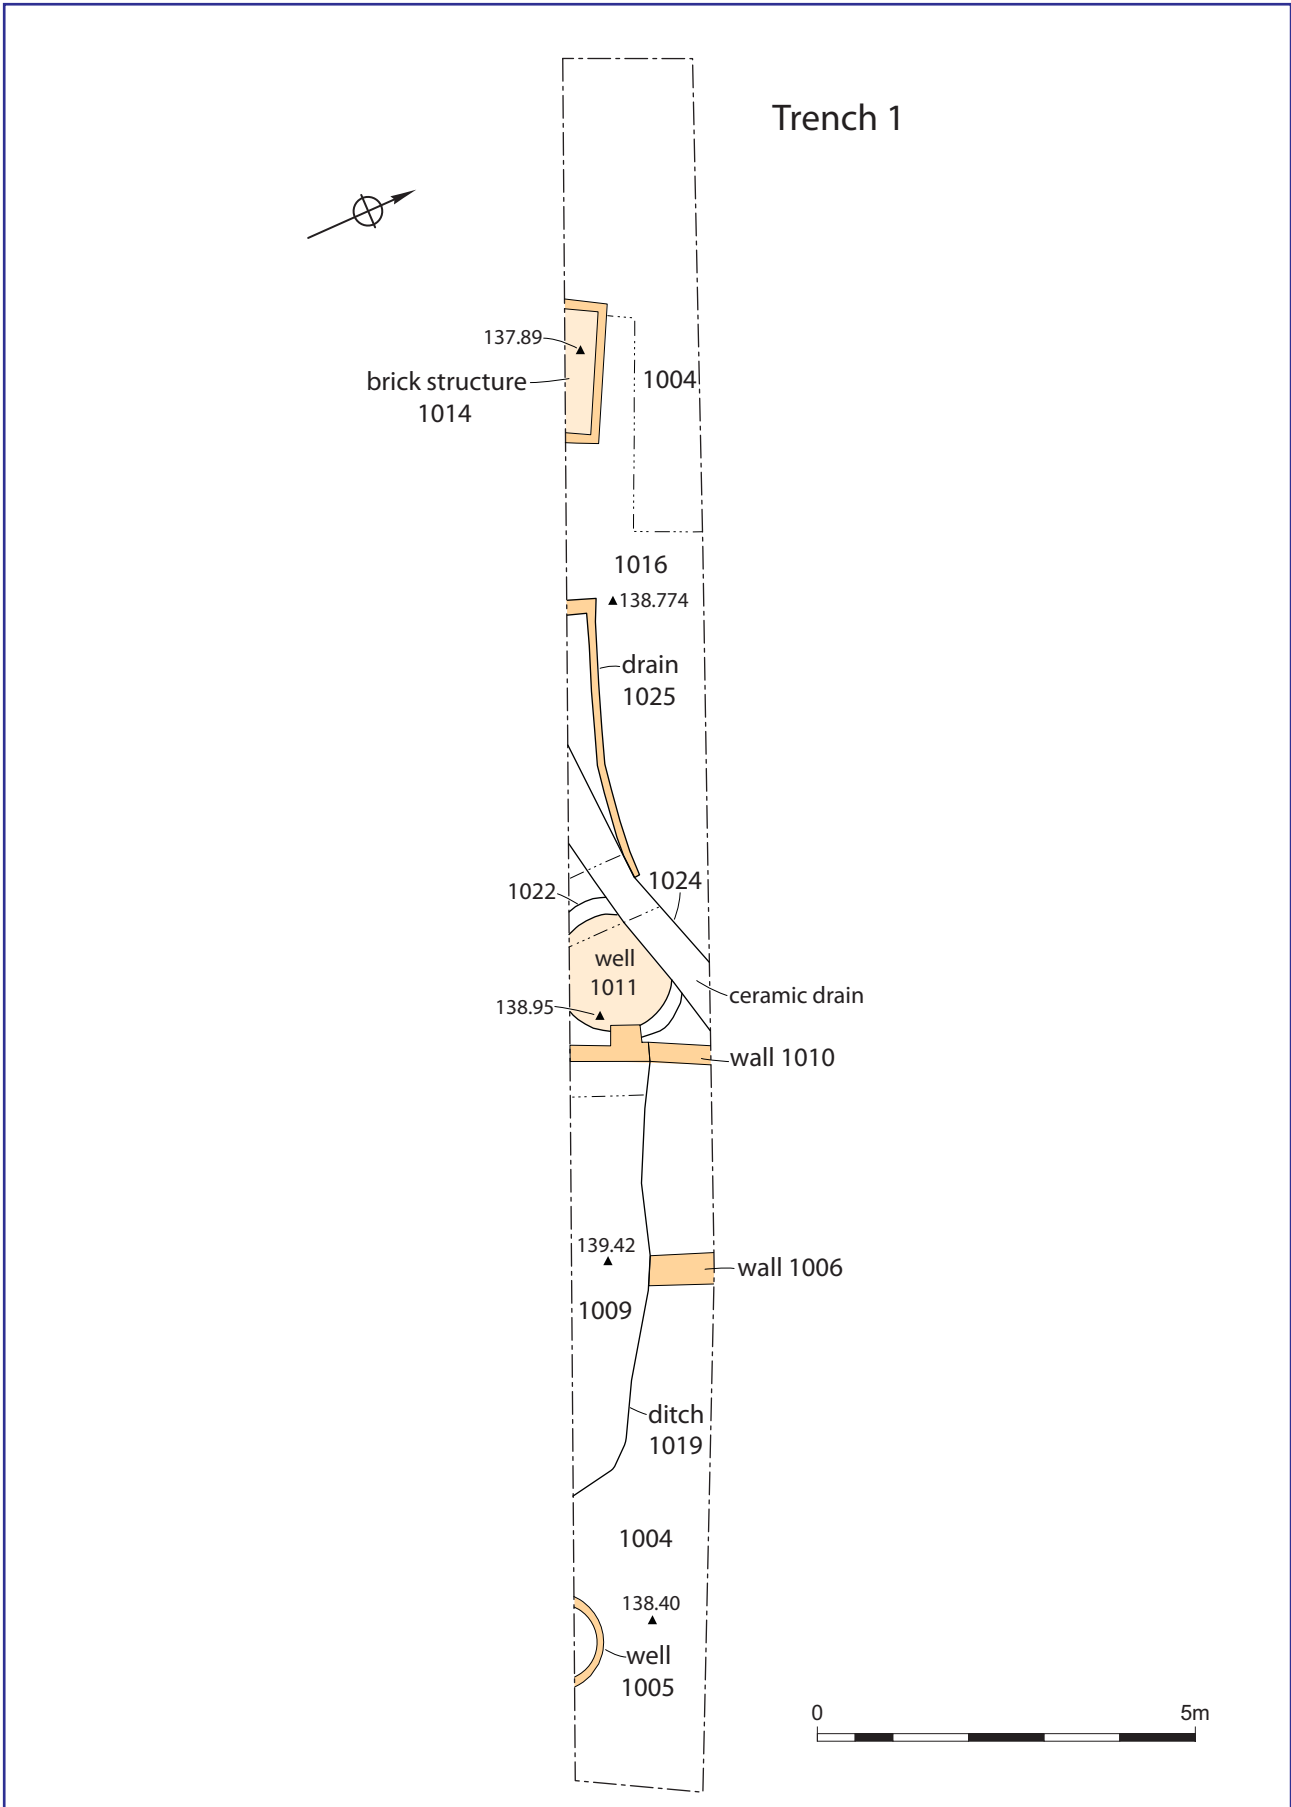
Figure 3

Trench 1 plan

The earliest identified remains are from the mid/late 19th century and are dominated by brick built foundations and structures. In Trench 1 (Fig 3) two capped wells built from red bricks in stretcher bond (1005 and 1011; Plate 1) were identified that are thought to have been within the back yards of the terraced houses along St Mark's Street, first shown on the map of 1871 (Turley Associates 2011, fig 6). Two walls (1006 and 1010) associated with a part of a damaged floor surface (1021) within Trench 1 are also likely to be part of outbuildings in this yard space (Plate 2) and brick samples taken from a number of these structures appeared to be post-1840 in date. The function of one square brick feature (1014) in the western end of Trench 1 is not clear, but the location of this would suggest it was positioned in the centre of 'Court No. 1', accessed through an alleyway off St Mark's Street (Plate 3). It was built of red bricks in English Garden Wall bond and is potentially part of a drainage culvert.

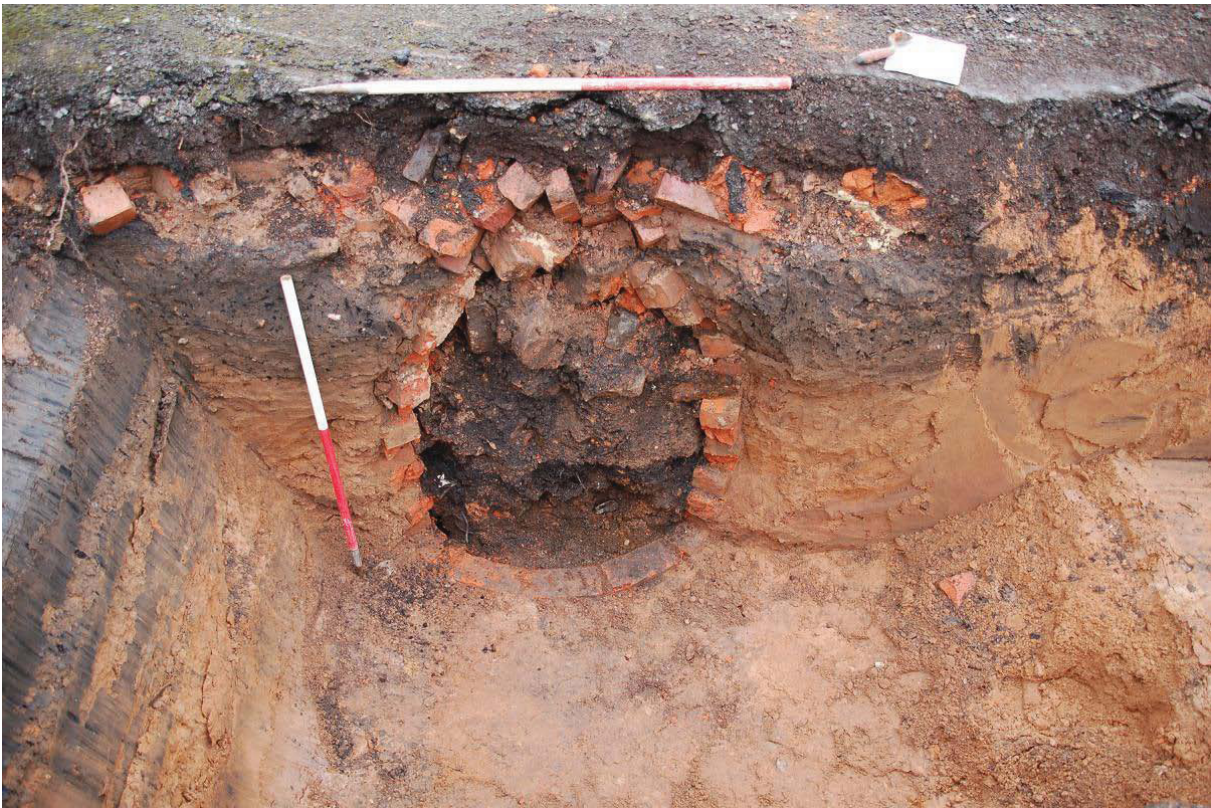
Plate 1: Trench 1, capped well 1005, facing south

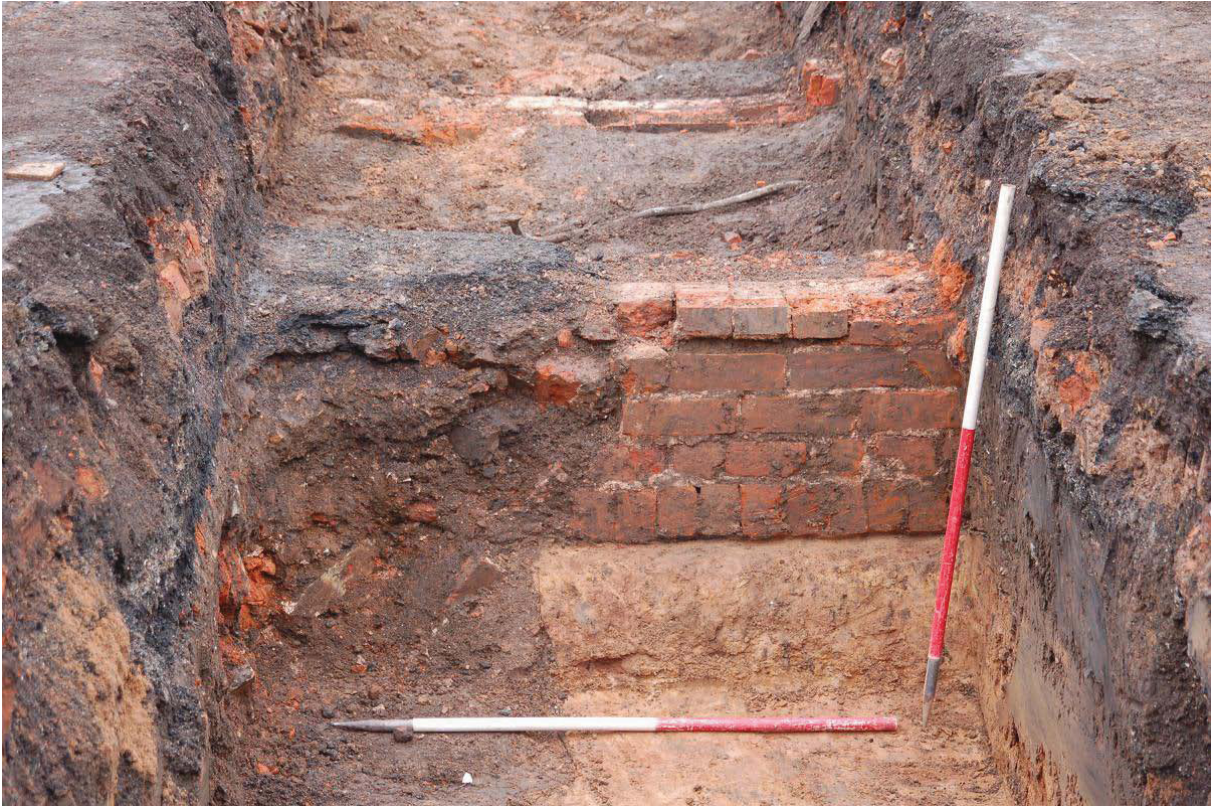
Plate 2: Trench 1, wall 1006 and pipe cut 1019, facing west

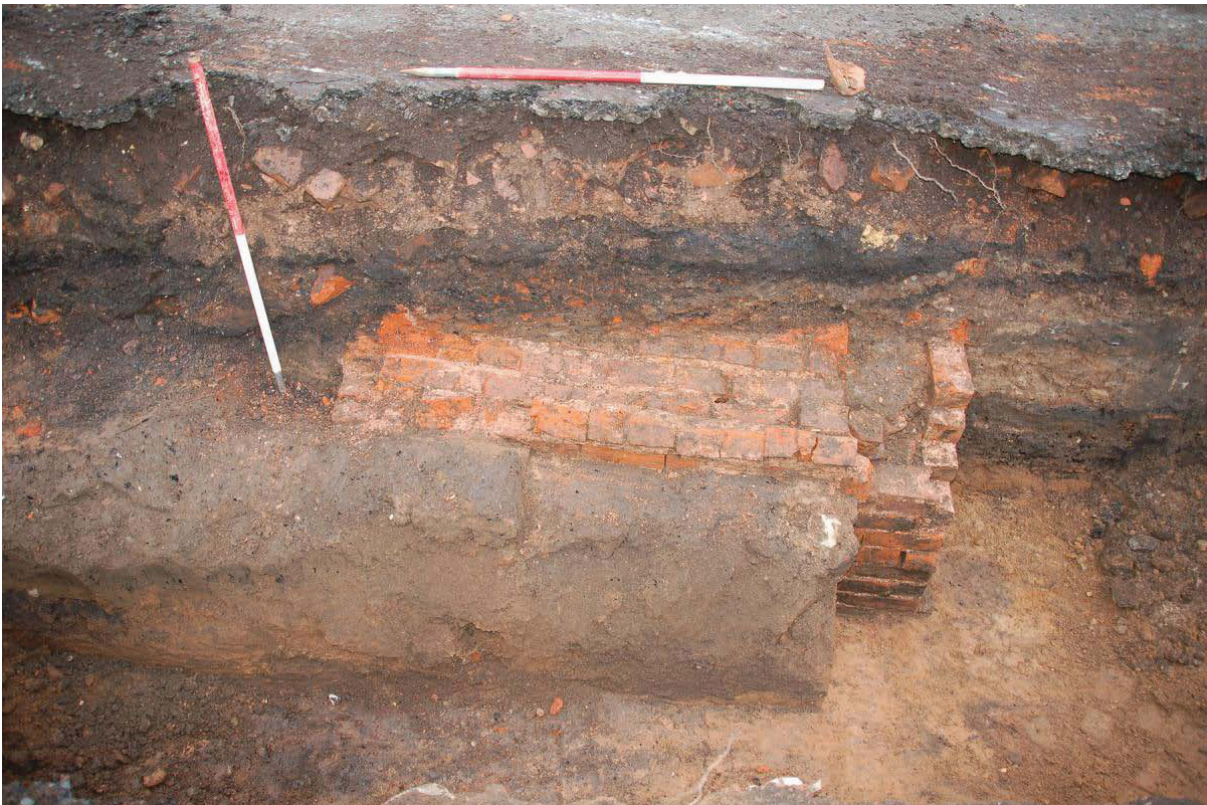
Plate 3: Trench 1, brick structure 1014, facing south

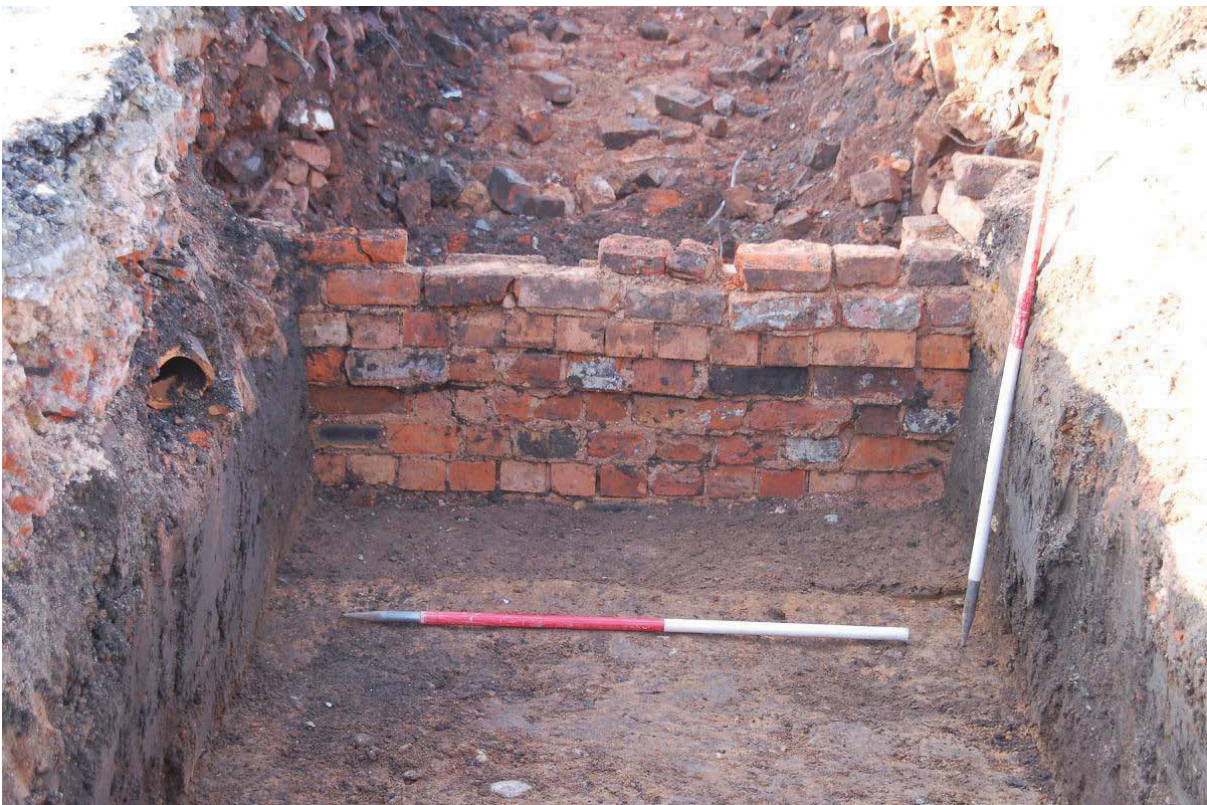
Plate 4: Trench 3, cellar wall 3011, facing west

Within Trench 3 (Fig 4) two cellars were identified (3011 and 3017) that are believed to be associated with mid-late 19th century buildings at the back of Raglan Street, in close proximity to a yard adjacent to the 'Raglan Works' (Plate 4). It is possible that these acted as storage areas or outbuildings for the works, but although they were observed to be a minimum of 2m deep, the loose rubble backfill prevented further excavation. Wall (3017) was adjacent to a further wall (3016) that may have been a boundary wall dividing up yard spaces in this area. The brickwork again suggested a post-1840 date of construction for the structures here.

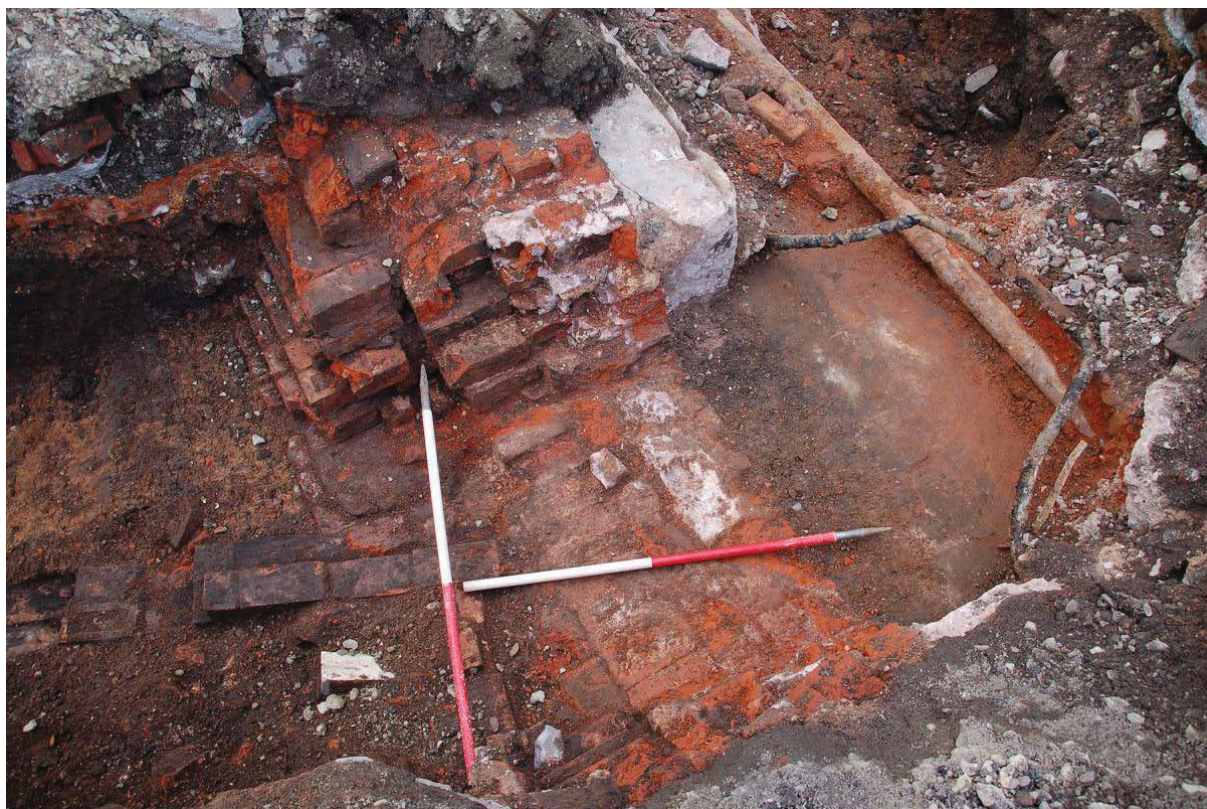
Plate 5: Trench 4, walls 4007, 4008, 4011 and 4012 facing west

site) into the area of the 'Raglan Works' (Fig 4). These had been repaired by later brick, cement and concrete walls on the same alignment that are likely to relate to the later industrial activity upon the site (Plate 5).

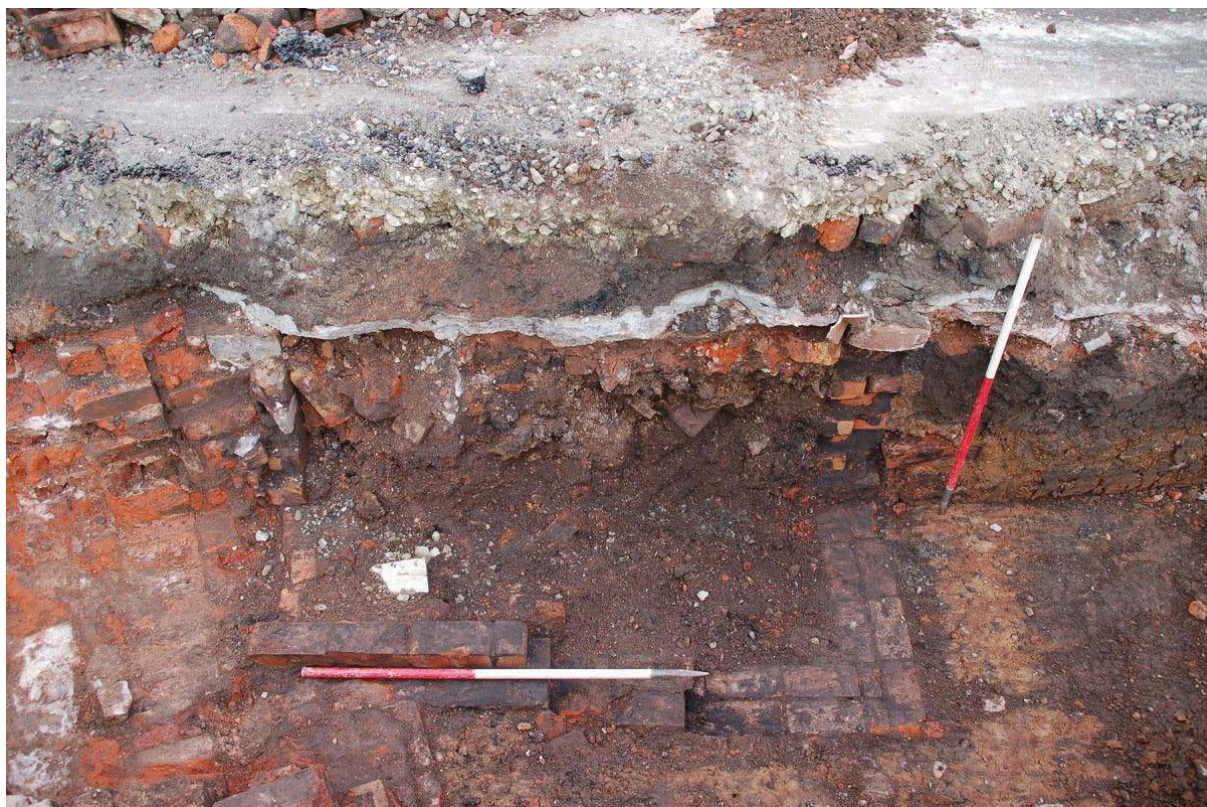
Plate 6: Trench 4, brick structure 4015 facing east

The majority of the later features on the site are drains (1012, 1024, 3005, 3008 and 5013) or services (1019 and 4016). Another square brick structure similar to that found in Trench 1, but constructed using frogged bricks (4015), was also identified within Trench 4 (Plate 6) and a square manhole type structure built from a variety of re-used bricks (5004) was found in Trench 5 (Plate 9). Evidence for potential industrial activity appeared at various positions in the trench sequences, although there was no clear indication of the origin of this material and it could also relate to domestic activities on the site. Two clinker/ash dumps (1020 and 3003) were found to post-date structures and services in Trench 1 and Trench 3, whilst another ashy layer (6012) was found to be beneath the made ground build-up for the surfaces in Trench 6.

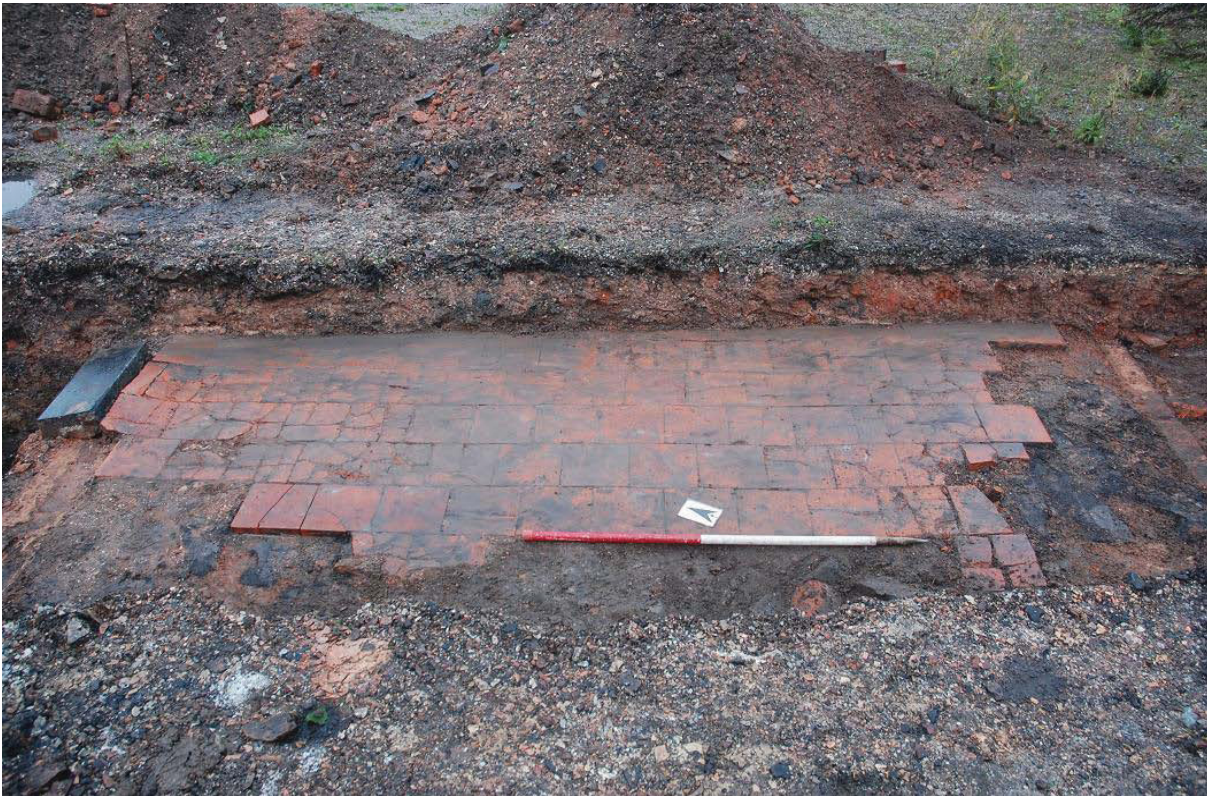
Plate 7: Trench 6, tiled floor surface 6003 facing north-east

A fragment of unglazed tile, from floor surface 6003, was of late 19th or early 20th century manufacture. Flat roof tile fragments recovered from various fills and deposits were probably 18th or early 19th century in date, whilst grey roofing slate and glazed drainage pipes, of 19th or 20th century date, were also noted.

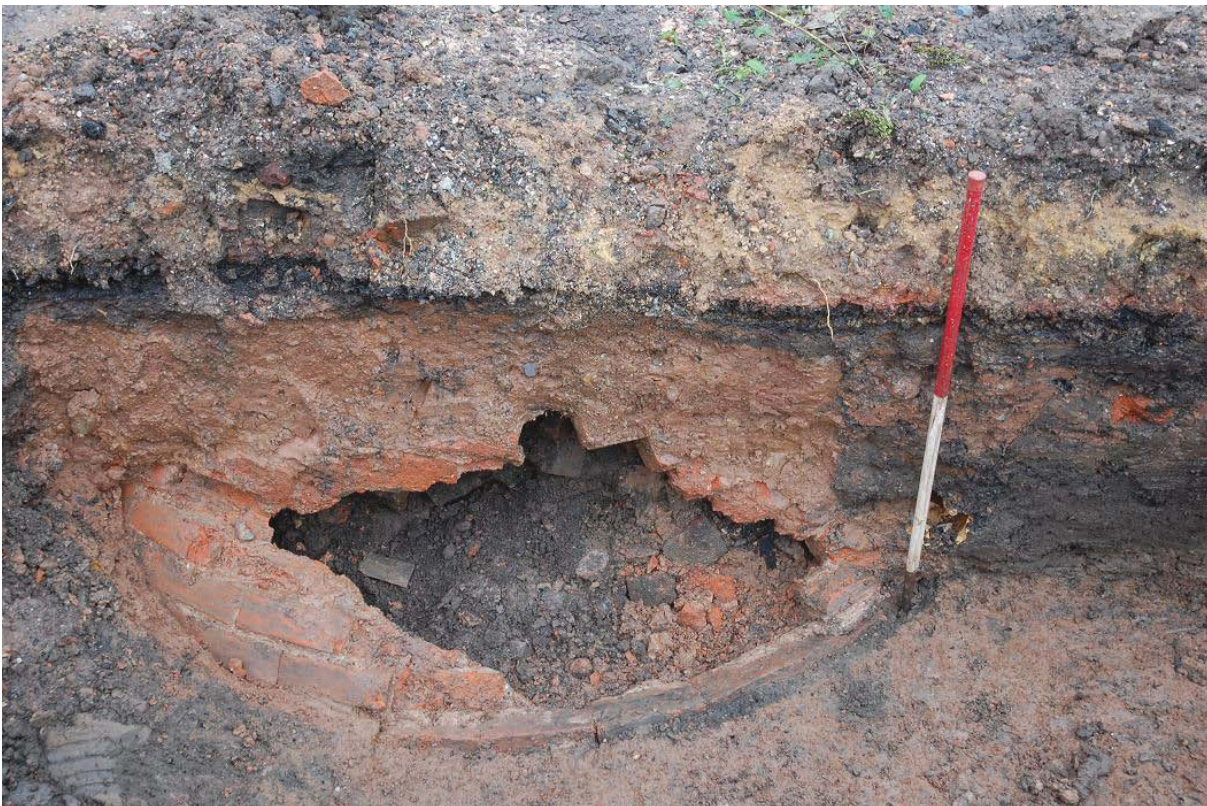
Plate 8: Trench 6, capped well feature 6009 at north-west end of the trench

In Trench 6 (Fig 5) a capped well, built of red brick similar to those in Trench 1, was found at the north-west end of the trench (6009; Plate 8). This is likely to have been in the back yard area identified as 'Court No. 2' on the historic maps, an area accessible through an alleyway leading from Raglan Street. A brick yard surface (6002) and a quarry tile floor (6003) were also encountered in Trench 6 (Plate 7) and were probably the remains of a rectangular outbuilding mapped adjacent to this courtyard, accessed across threshold (6004). A sample of the tile was dated to the late 19th or early 20th century.

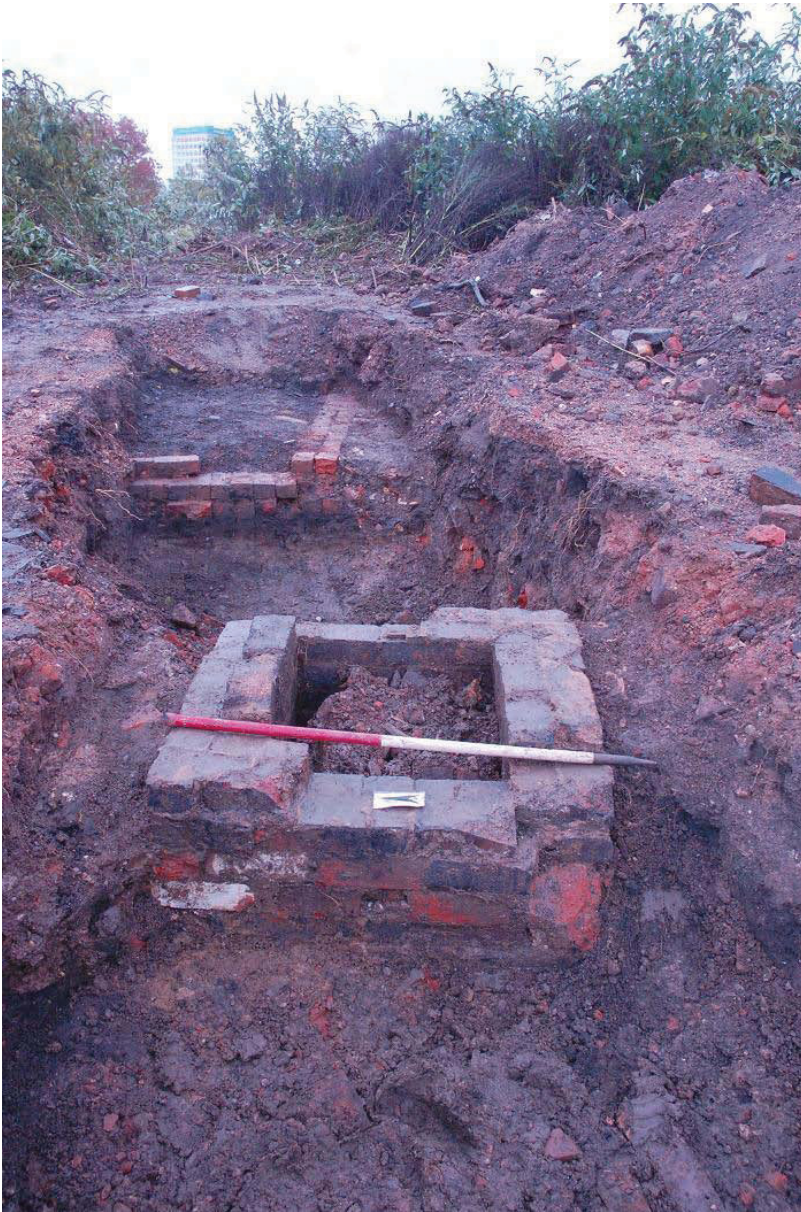
Plate 9: Trench 5, manhole feature 5004 and boundary wall 5003 facing east

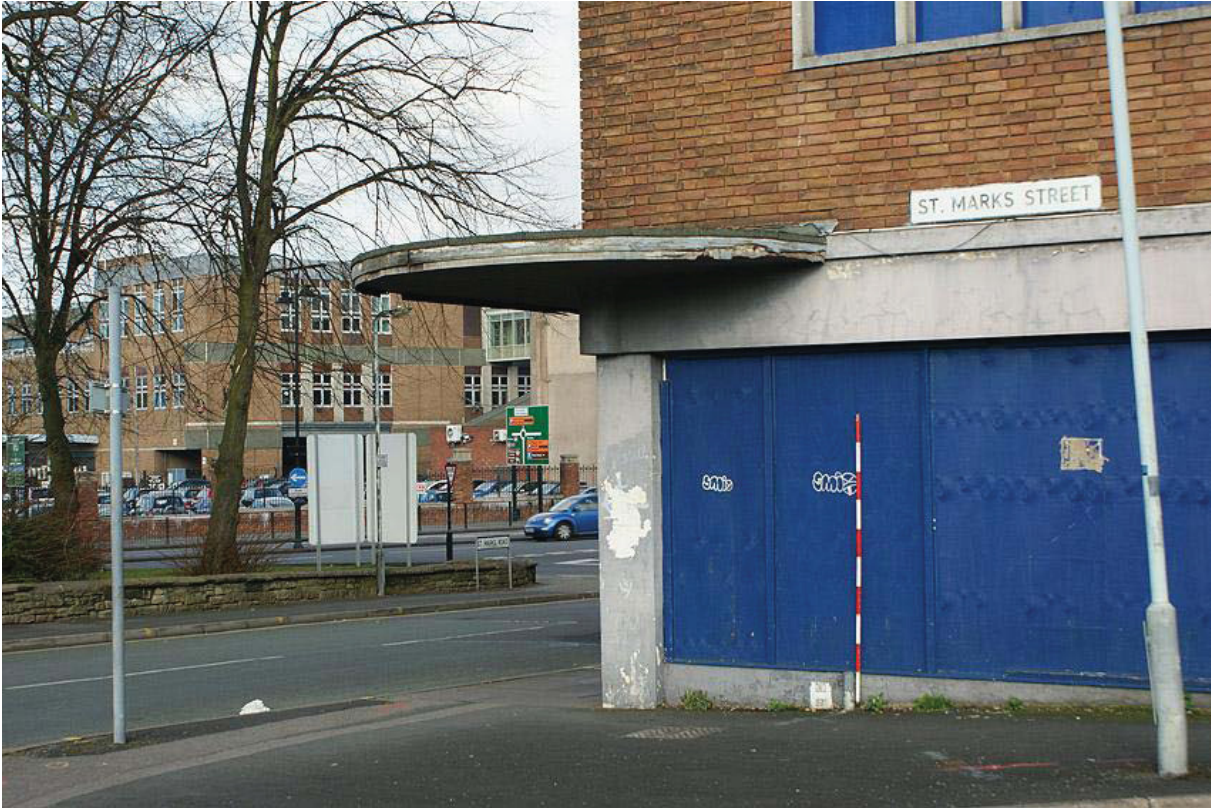
Plate 13: Rounded end of canopy from the south-west

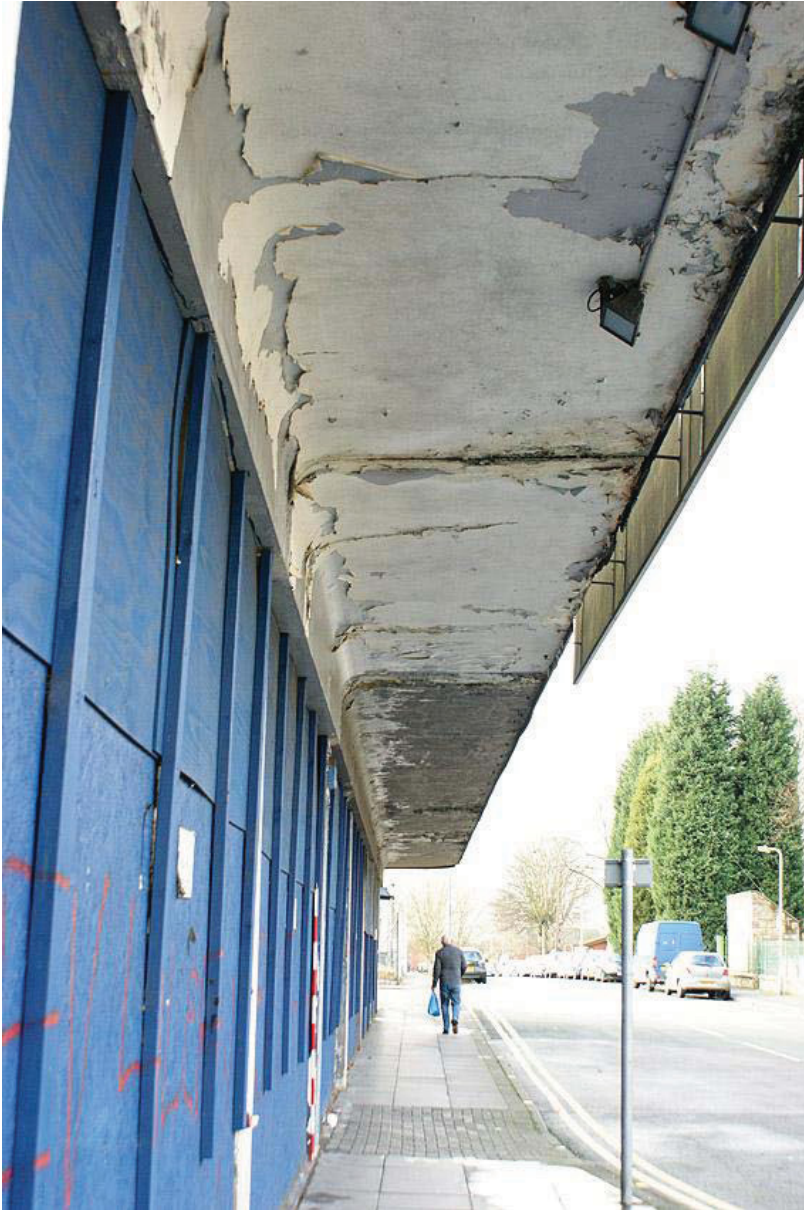
Plate 14: Coving on underside of canopy

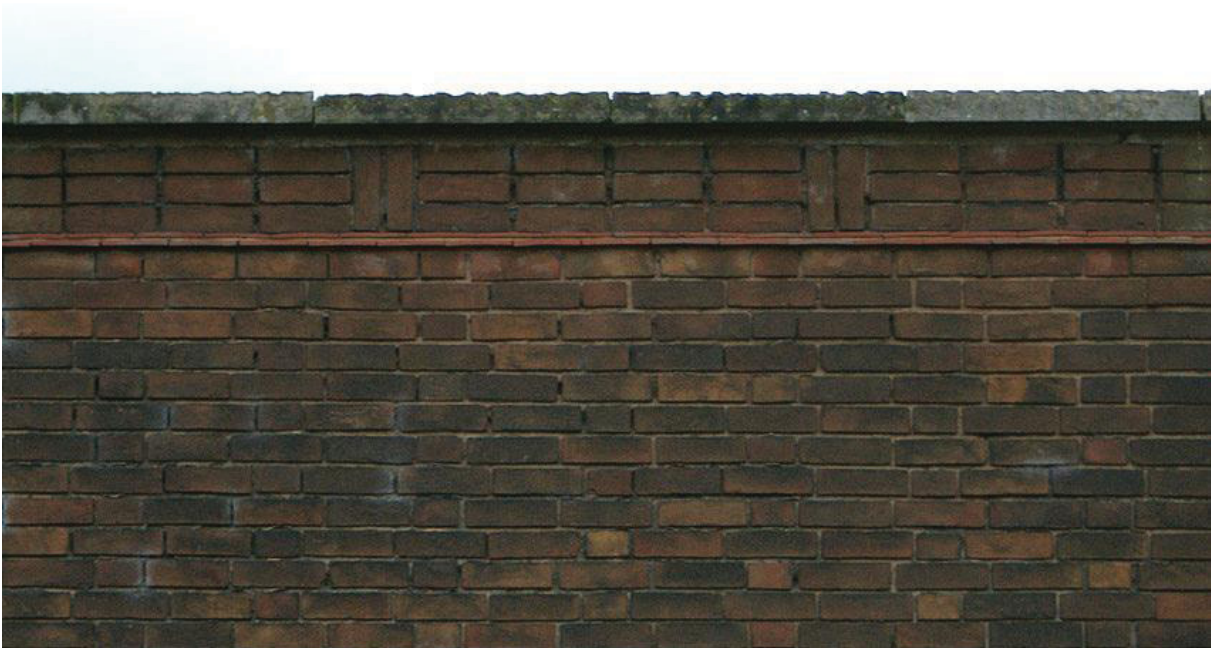
Plate 15: Decorative brickwork and concrete coping of parapet

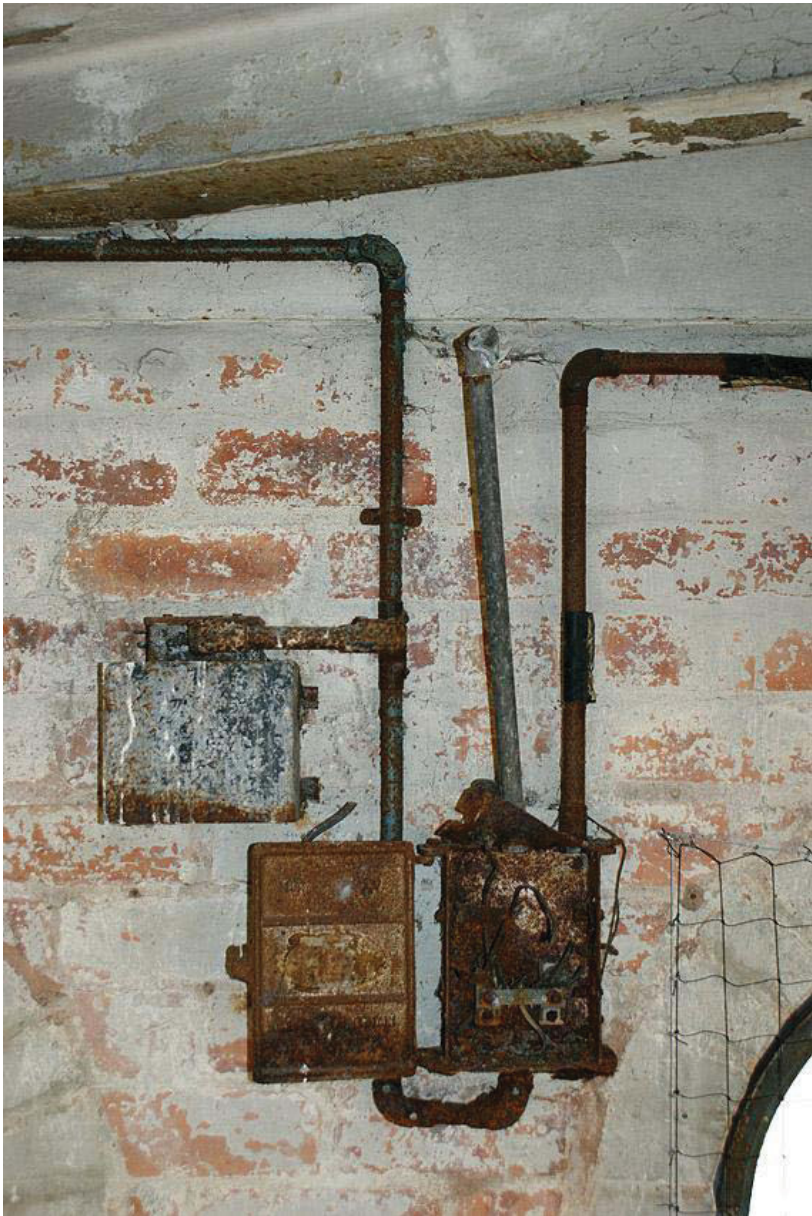
Plate 27: Original electrics within tower

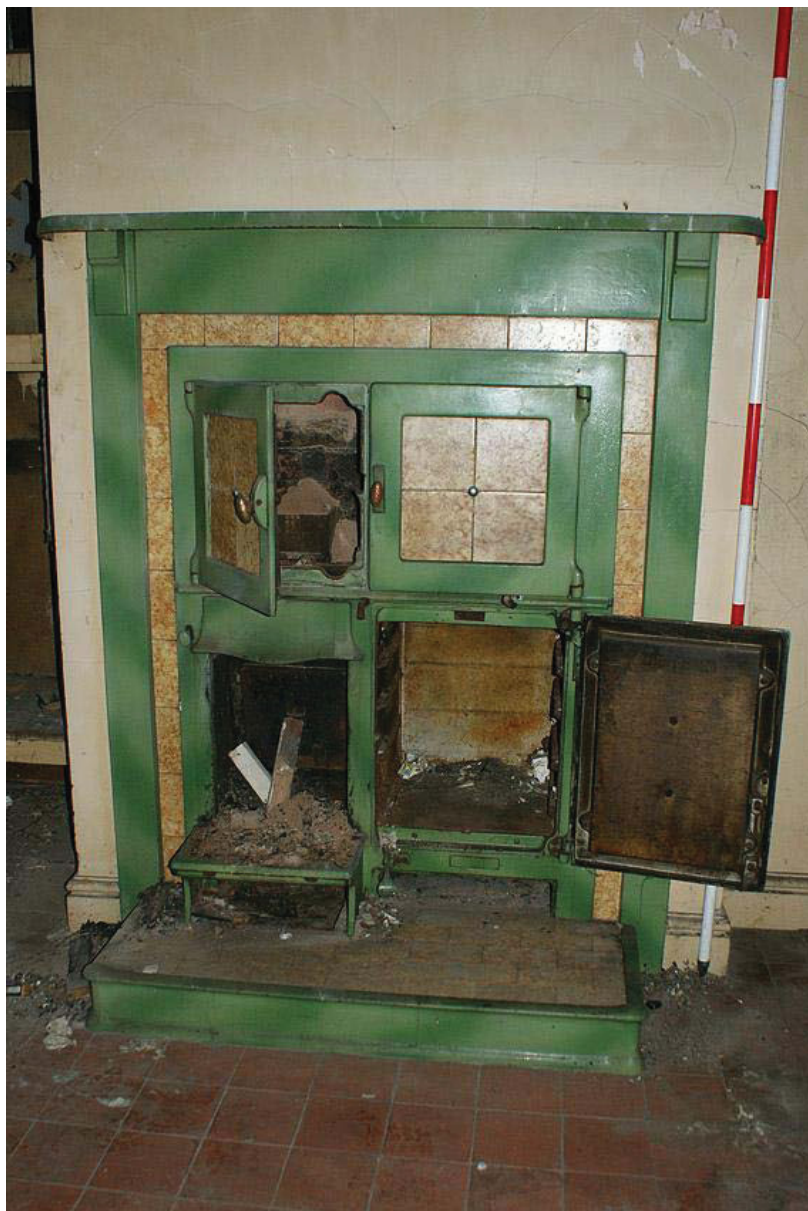
Plate 34: Triplex Grate, C Pattern, within 2nd floor flat

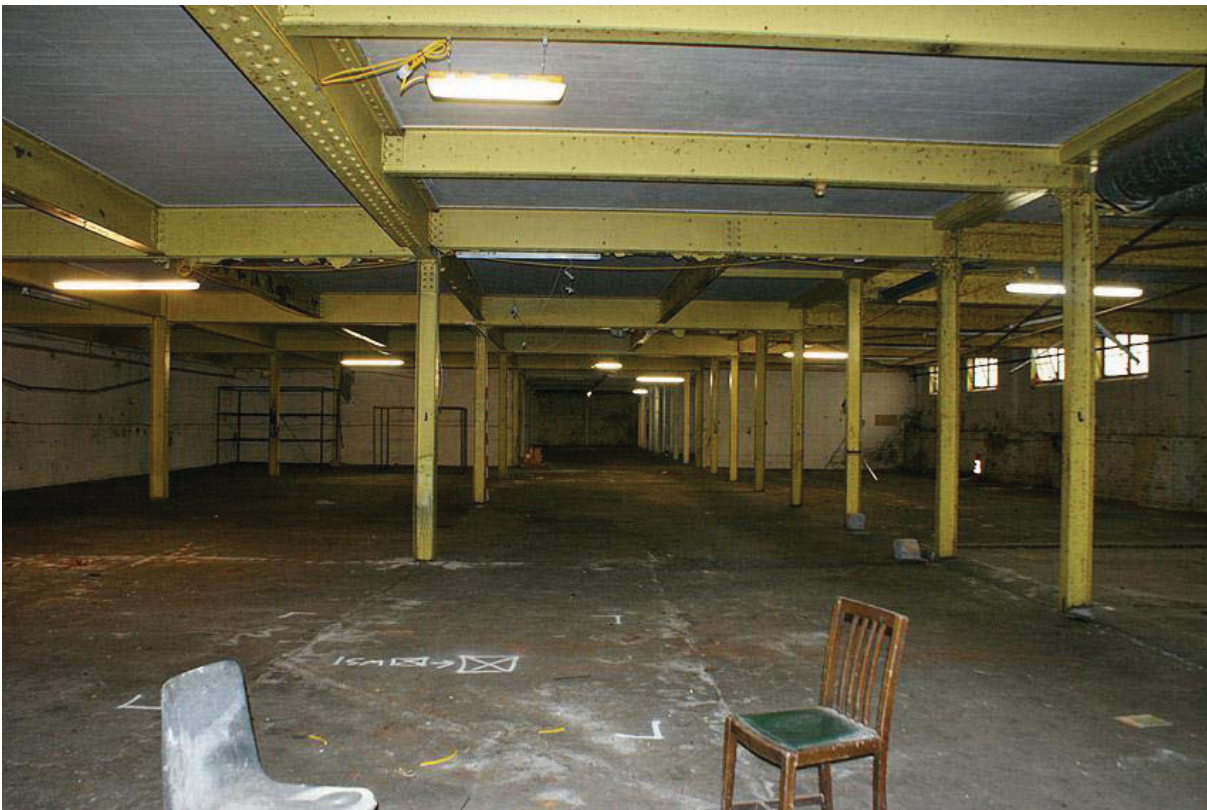
Plate 41: 1950s ground floor interior showing stanchions and RSJs

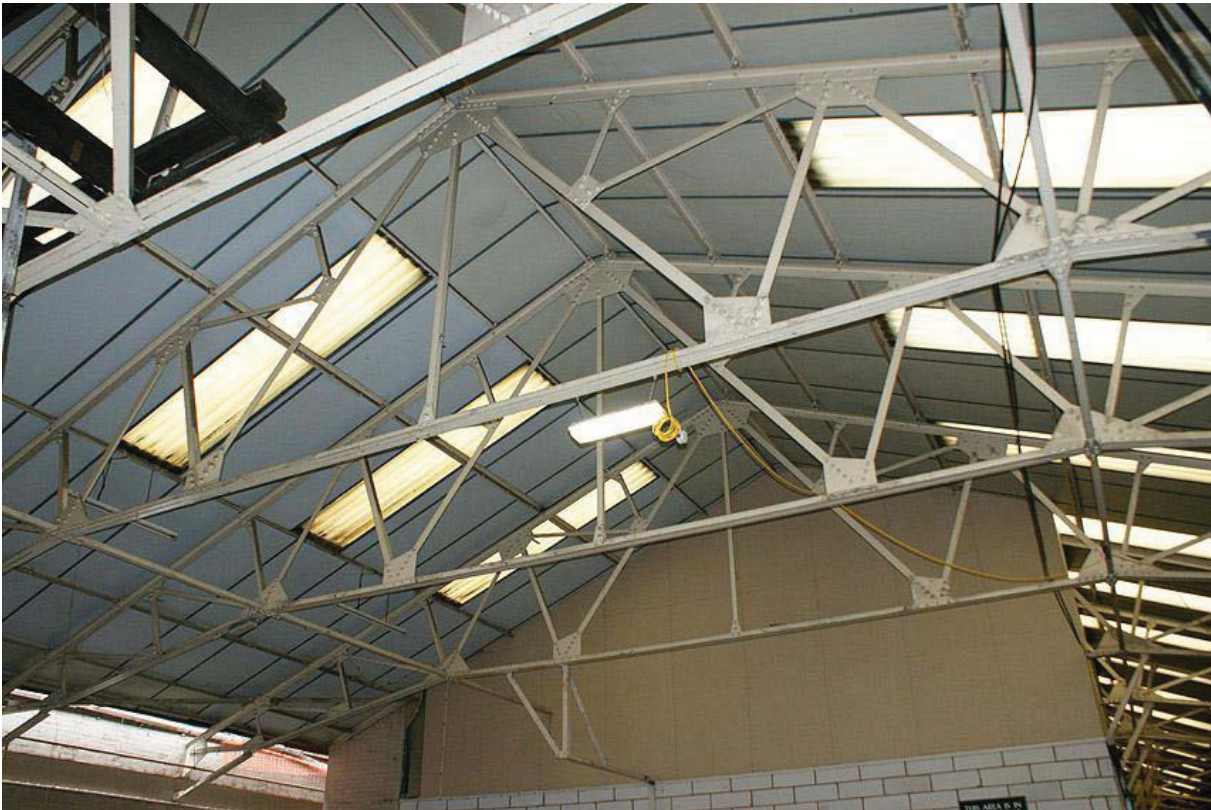
Plate 42: 1950s steel roof structures

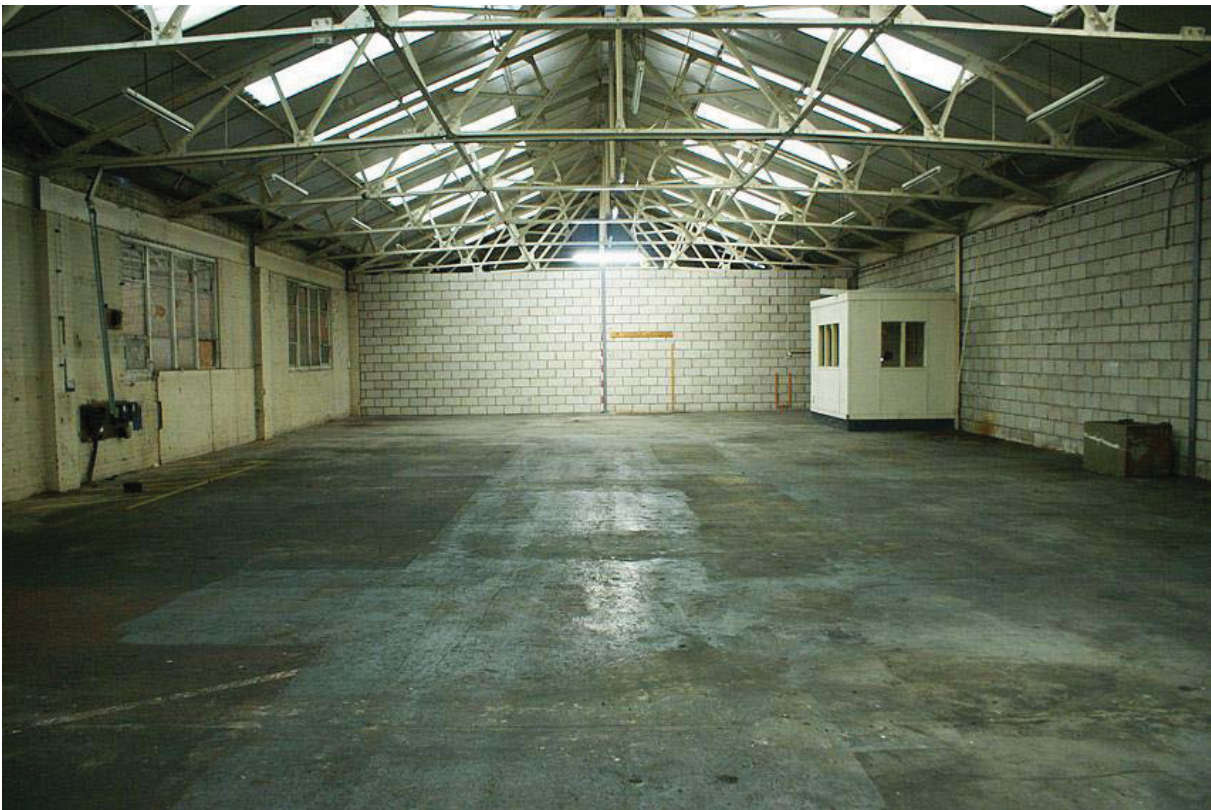
Plate 43: 1950s open space and roof trusses
