# Desk-based assessment of Barn 2 (Unit 3), Pottery Farm, Mucklow Hill, Halesowen, West Midlands

Date: 6 January 2014  
Author: Elizabeth Connolly, [econnolly1@worcestershire.gov.uk](mailto:econnolly1@worcestershire.gov.uk)  
Illustrator: Shona Robson-Glyde  
Project reference: P4245  
Report reference: 2082

## **Desk-based assessment of Barn 2 (Unit 3), Pottery Farm, Mucklow Hill, Halesowen, West-Midlands**

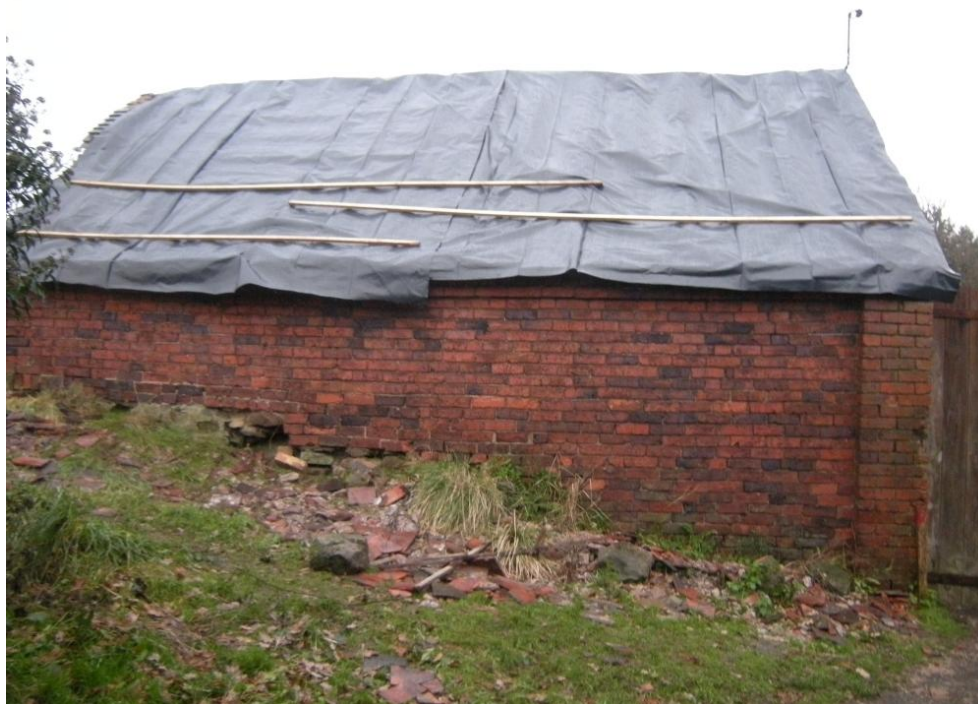
Barn 2 (Plate 1) stands on the northern edge of Pottery Farm, a former farm which lies immediately north-west of the A458 Mucklow Hill Road. Pottery Farm and the site of Bellevue Potteries occupy

*Plate 1 Barn 2 from south-west*

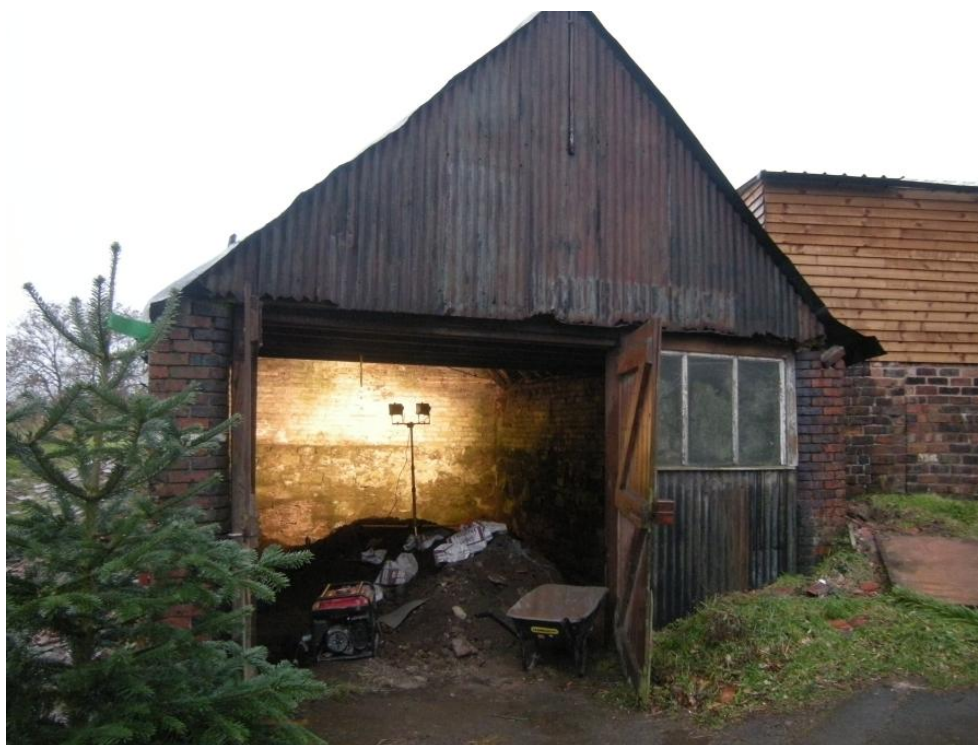
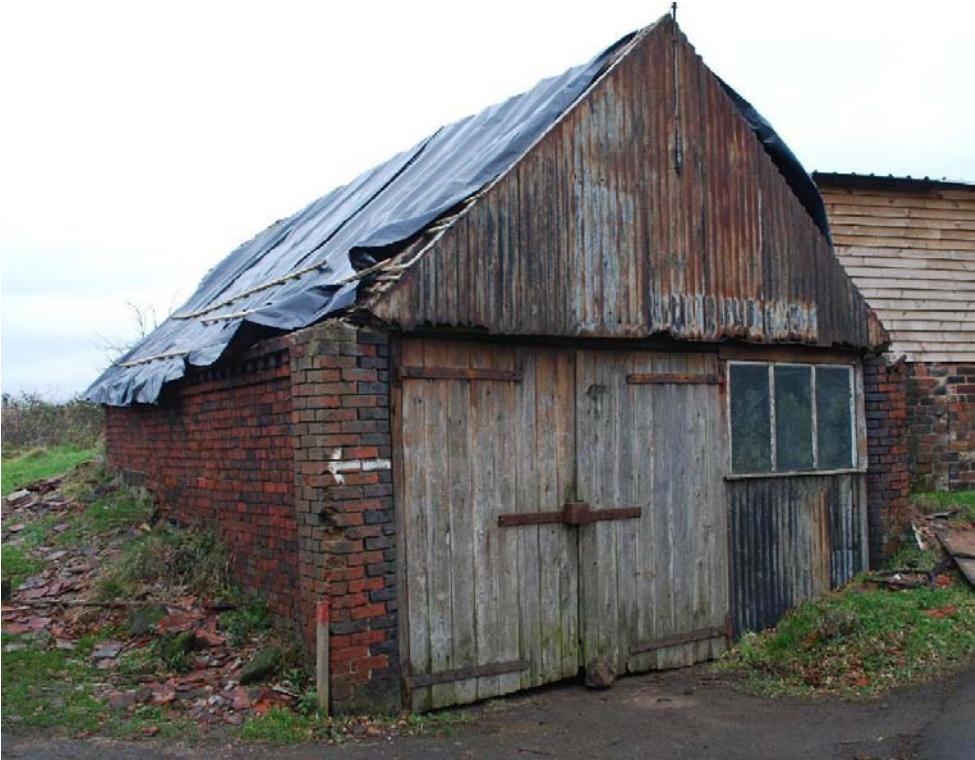
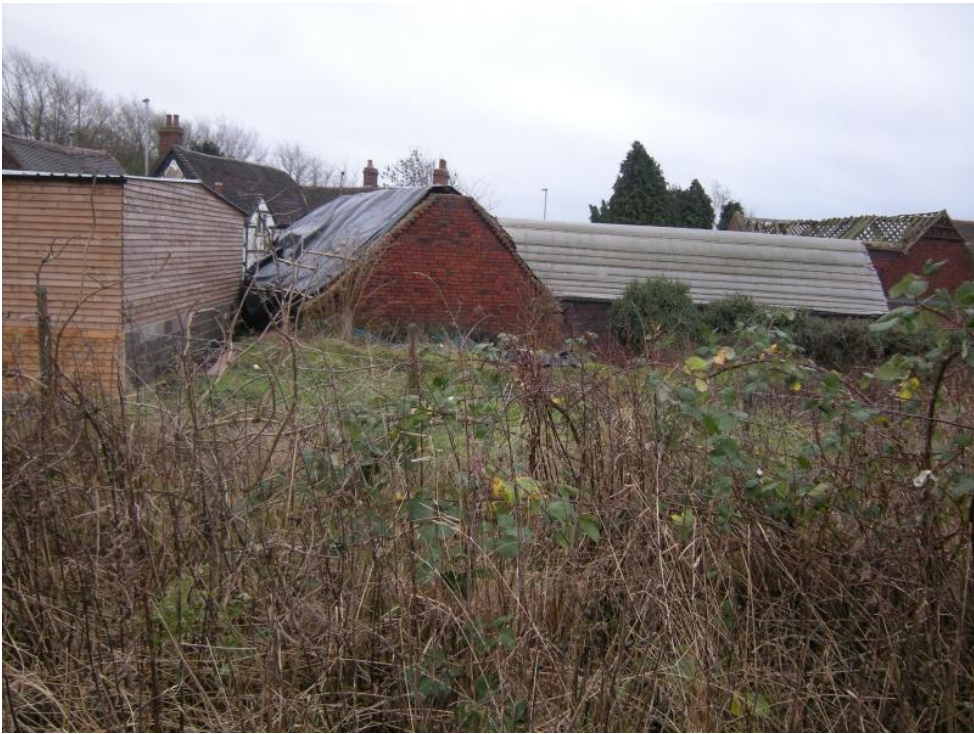
Barn 2 is a derelict structure (Plates 2-4) which lies immediately to the north of the complex of buildings which comprise Pottery Farm (Plates 5-6); c 20m from The Old House (875-MDD43) (the original farm house to the farm), less than 10m from Pottery Farm Barn (876-MDD44). It is located c 40m from Pottery Farm Holloway (7077-MDD1131). It is a rectangular building approximately 7m by 5m constructed of brick with a rough stone base. The roof is currently plastic sheeting over rafters but was previously tiled. The frontage of the barn is currently galvanised metal into which a window and double wooden doors are set.

The barn is surrounded from the south-west to the north-east by dumped material, which is banked up behind the barn and onto the site of the former pottery. Two small elder bushes are growing from directly behind the barn and some tires and plastic are dumped behind the north-west wall. A modern (post 1955) barn has been renovated recently, which abuts Barn 2 to the north-east. From the south-east to the south-west the ground around Barn 2 is laid with tarmac.

*Plate 2 Barn 2 from south-east*

*Plate 3 Barn 2 from south*

*Plate 4 Barn 2 from north-west*

In order to mitigate the impacts identified above, it is recommended that a programme of building recording be carried out prior to the renovation of Barn 2. Furthermore it is recommended that

groundworks associated with the renovation of the barn including the laying of service runs, additional foundations and underpinning works be subject to an archaeological watching brief.

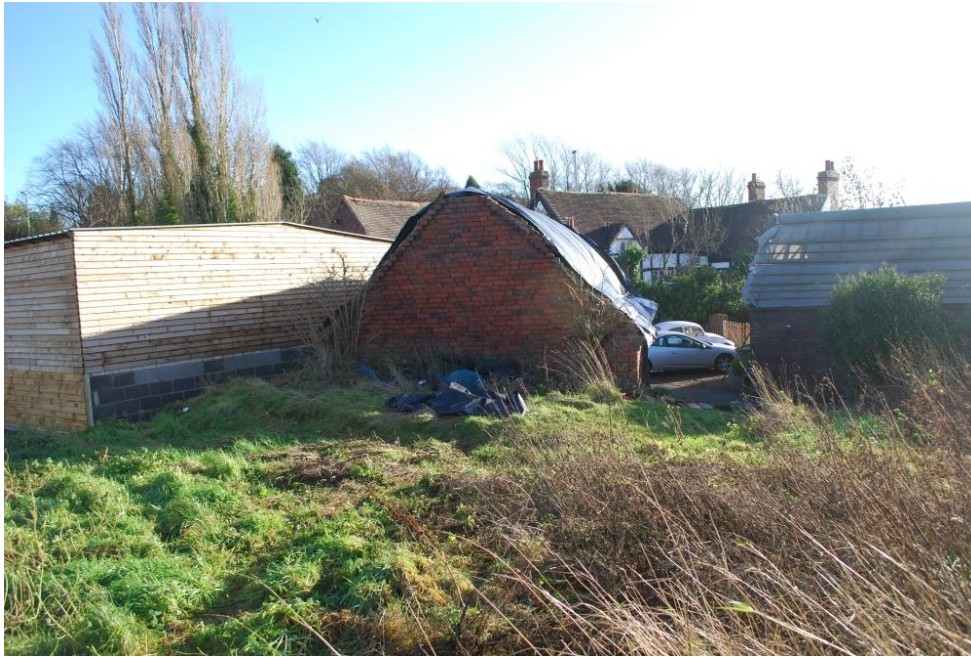
*Plate 5 Barn 2 from north-west, showing The Old House and some of Pottery Farm Barn*

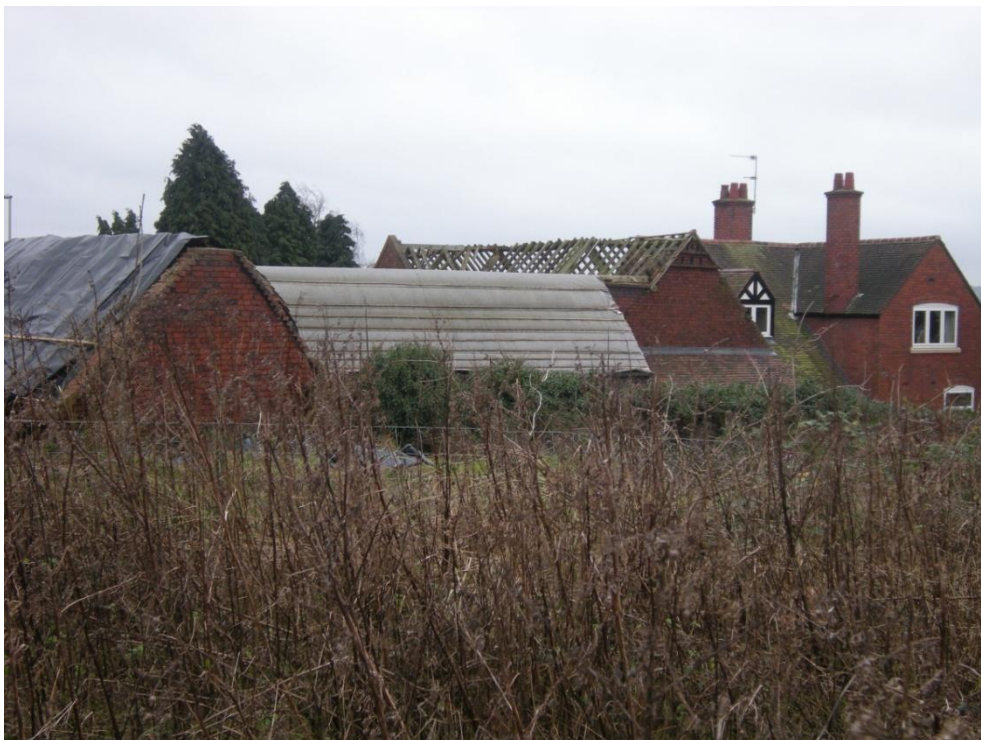
*Plate 6 Barn 2 from north-east, showing Pottery Farm Barn (Barn 1)*

There are three Grade II listed buildings within the study area, one of which is part of the larger development site; Pottery Farm Barn (876-MDD44) is Barn 1 in the proposed development (Plate 6). It is described in the HER as a 17<sup>th</sup> century barn with a hay loft of timber frame with red brick infilling. The timber frame is recorded on the HER as reputed to contain timbers of Anglo-Saxon origin although the reference for this is not stated.

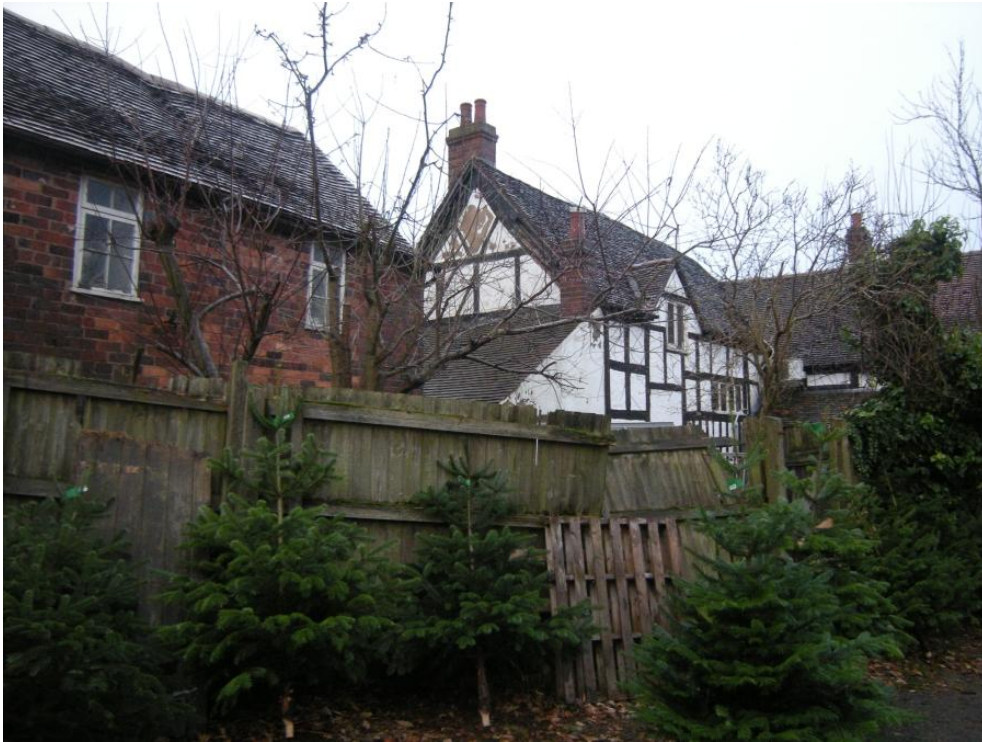
The Old House (875-MDD43) was previously known as Pottery Farm farm house (Plate 7), and is within 20 metres of Barn 2. It has a late 16<sup>th</sup> - early 17<sup>th</sup> century timber frame with later infilling of rough cast brick. It comprises one-storey and an attic, with a projecting gabled wing on the left hand side.

*Plate 7 The Old House from north-west, from Barn 2*

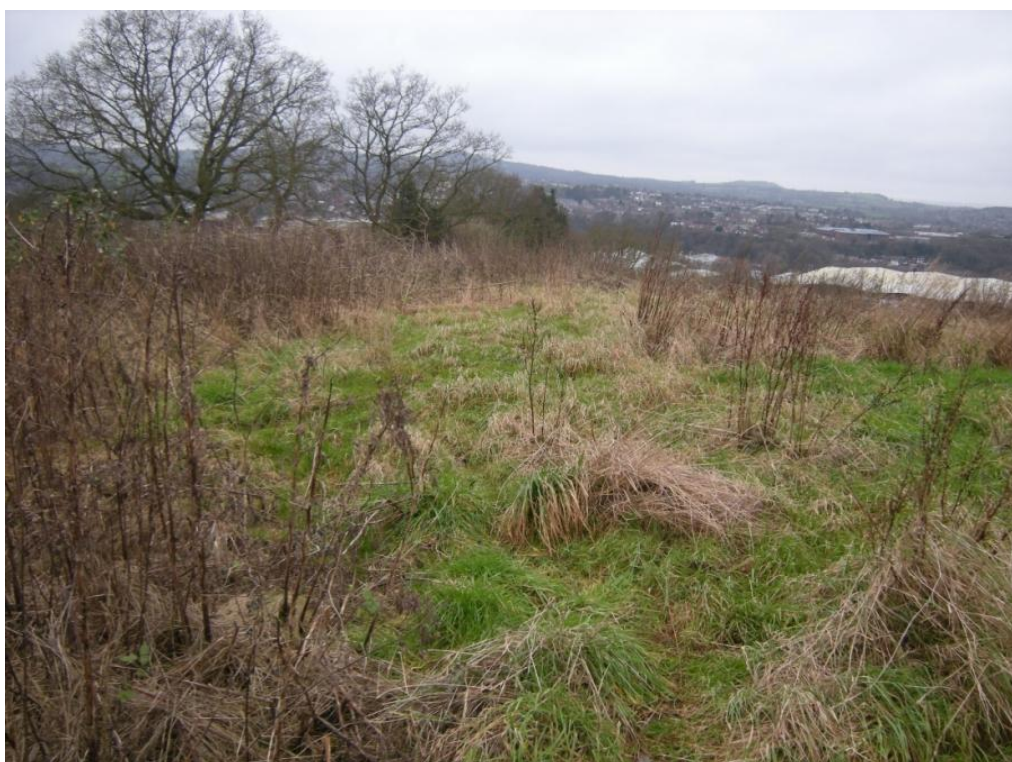
Bellevue Potteries (7876-MDD1826) are first depicted on the 1883 OS 1<sup>st</sup> Edition, occupying a plot depicted on the 1846 tithe map. The potteries are also depicted on the 1886-1890 map, but by 1919 most of the buildings are no longer shown, presumably demolished, with Barn 2 and another building, now also derelict, clearly visible on the map. There is a strong potential for the survival of buried remains associated with the pottery in the form of surfaces, foundations and artefacts. The ground in this area is markedly irregular lending weight to this supposition (Plate 10).

*Plate 10 Site of Bellevue Potteries, from east*

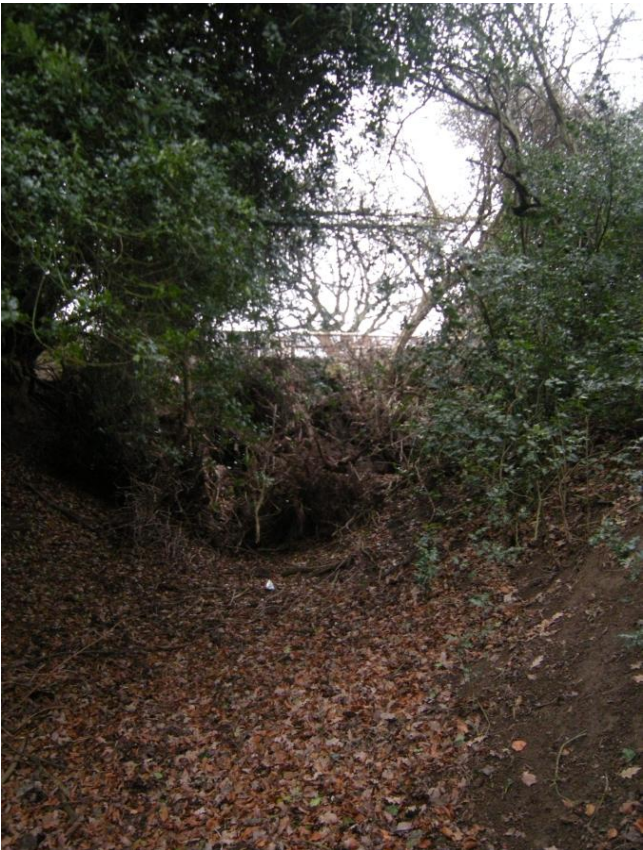
The earliest feature recorded on the HER within the study area is the Pottery Farm Holloway (Plate 11; 7077-MDD1131) which runs westwards from close to the site of the proposed development. It is clearly visible, although recently there has been a large amount of spoil dumped just west of a gateway that forms part of the boundary of Pottery Farm. The spoil is several metres in depth and includes earth, rubble and tree roots. The Holloway is visible beyond the dumped spoil, and beyond this is in good condition.

*Plate 11 Pottery Farm Holloway, from west*
