DIG BROMSGROVE COMMUNITY ARCHAEOLOGY EXCAVATION 2013

Status: Final report
Date: 25th November 2013
Author: Richard Bradley
Contributors: Rob Hedge and Dennis Williams
Illustrator: Carolyn Hunt
Project reference: **P3758**
Report reference: **2057**
HER reference: WSM 49636

Dig Bromsgrove Community Archaeology Excavation 2013, Bromsgrove, Worcestershire

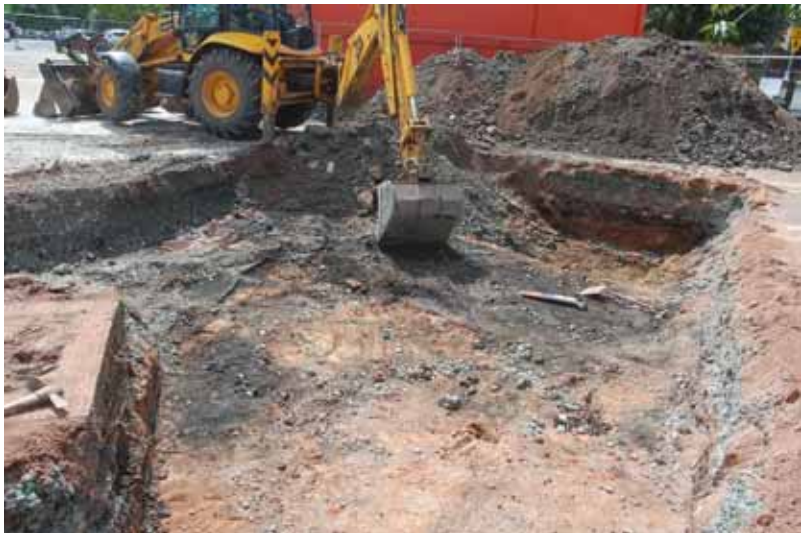
The site being opened with the JCB

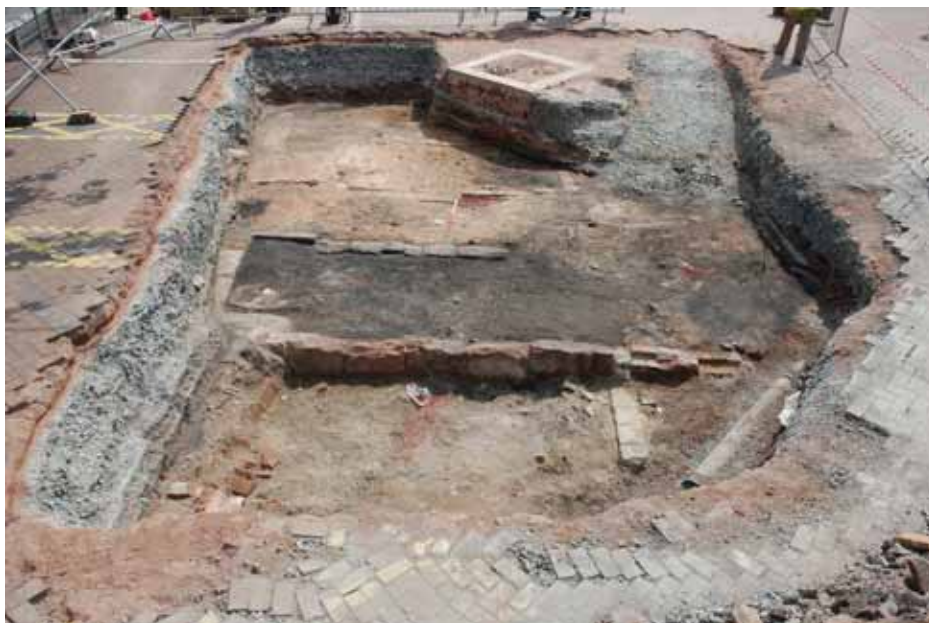
The site after initial cleaning (5 St John Street to rear of site and cellar of no 6 in foreground). North to left

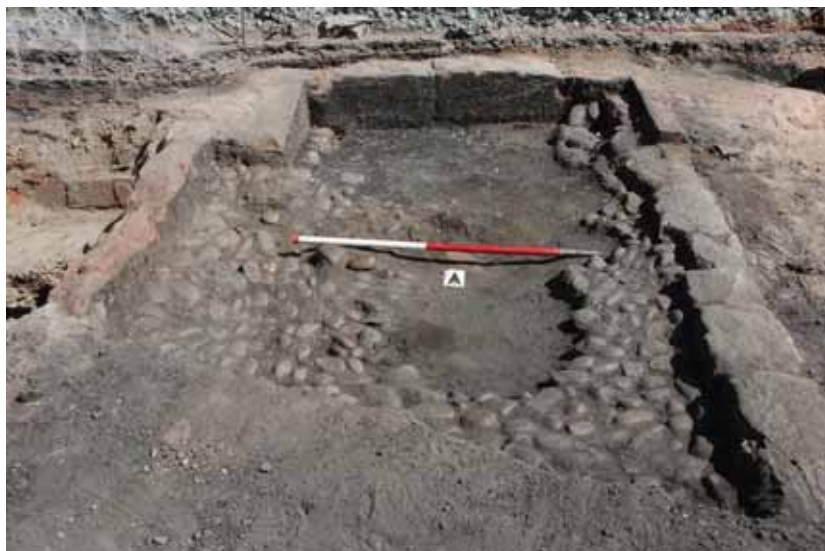
The cobbled back-yard surface

A 1.5m wide gap noted between some of the walls is likely to have been an alley passage running through the building from the St John Street frontage to the back of the house. This led to an area of worn stone cobbling that probably represents the remains of a back-yard space.

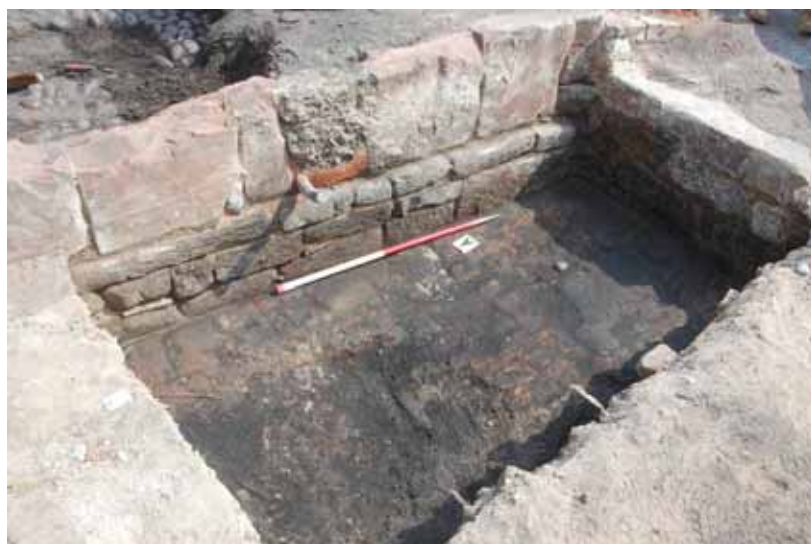
Sandstone wall foundations of the cellar of no 6

A second tenement was evidenced by further sandstone foundations in the western part of the trench that formed a cellar. As with the foundations of house no. 5, the variable block sizes and irregular surface dressing suggested at least some level of re-use in this construction. The floor of the cellar was very uneven and although constructed of sandstone, contained a number of areas of brick patching which may be indicative of a long period of substantial use.

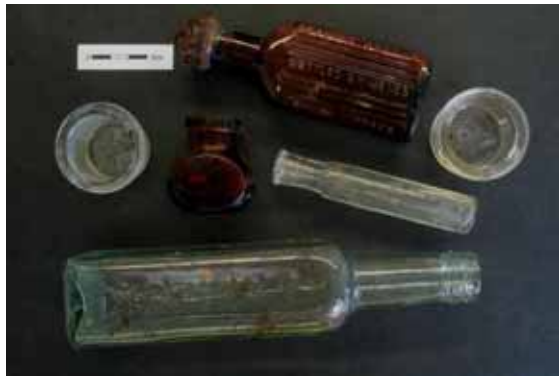
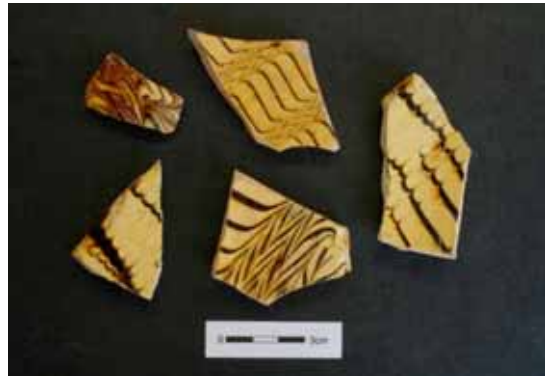
Glass bottles and post-medieval (18th century) buff ware pottery

The artefactual assemblage consisted of bone, brick, clay pipes, glass, metal, plastic, pottery, rubber, shell and tile, and included some interesting items. Overall, the assemblage displayed a range of artefacts that were representative of post-medieval occupation and use, but most of the

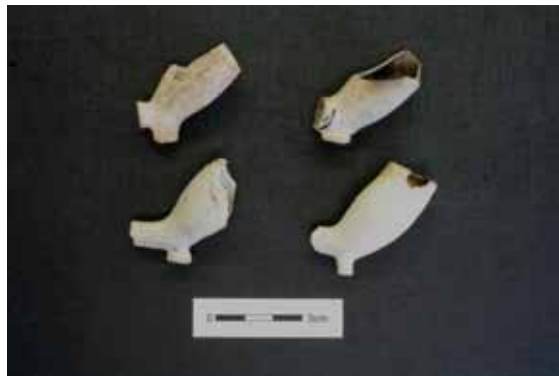
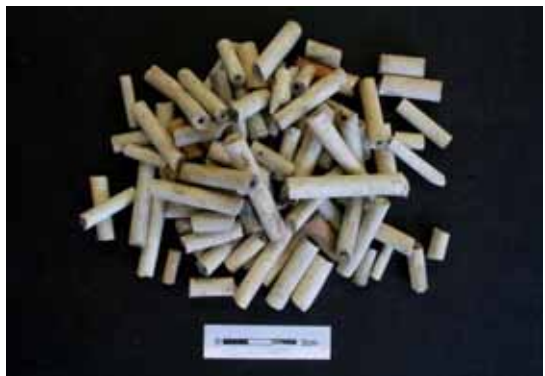
Clay pipe bowls (late 17th–18th century) and stems

Clay pipe stems and bowls were found throughout, some of the latter being datable as follows by reference to Oswald (1975): 1640–1680 (deposits 17 and 20), 1690–1710 (39).

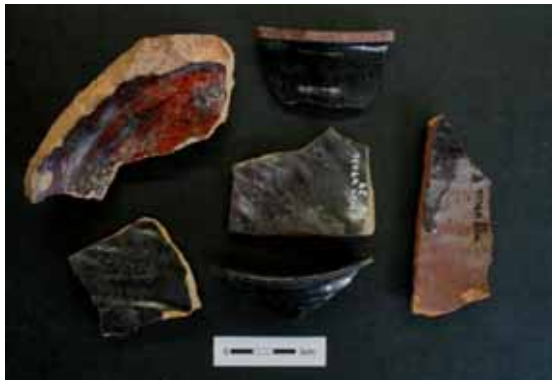
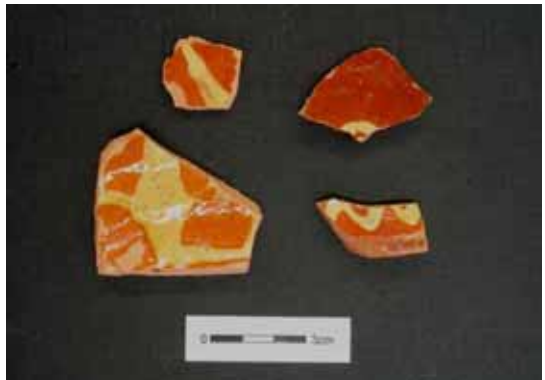
Post-medieval red ware pottery (mostly 17th century)

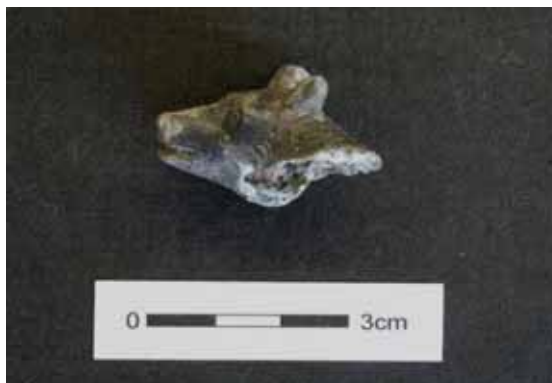
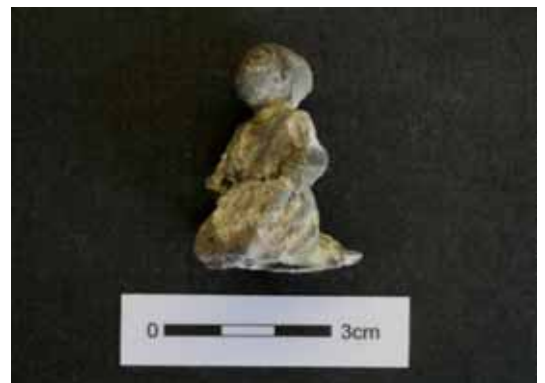
Metal figures (?toys). Left: animal head. Right: kneeling child

Large quantities of corroded iron were recovered from the demolition contexts. Where identifiable, this material was late post-medieval or modern in date - including nails and building fittings. Notable brass items included a gear from a clock, an engraved draughtsman's ruler (bearing the name 'J Henfrey') and a fire hydrant sign (deposit 19). Decorative castings of a wolf's head (context 9), and a kneeling girl (context 20), were lead alloy and possibly of post-medieval date.

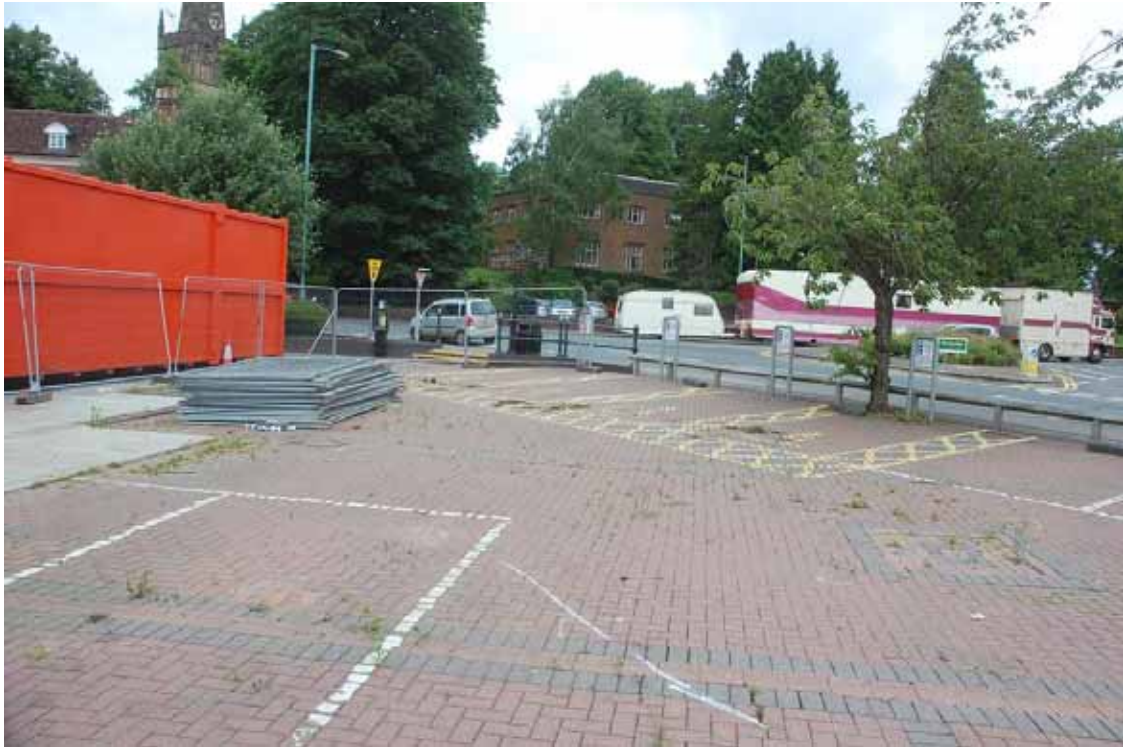
Plate 1: The car park before excavation, facing west

The excavation took place within a fenced compound now used for equipment storage by Bromsgrove District Council on the site of the demolished Market Hall (Plate 1). This is at the north-east end of the Hanover Street/St John Street public car park, located between St John's Church and the Spadesbourne Brook, just to the south-west of the main high street of the town (NGR SO 9579706). The area of the trench was defined not only by the space available to use within the existing compound, but also the presence of live services in the vicinity and the proximity of a concrete culvert channelling the Spadesbourne Brook from which a minimum stand-off zone of 1m was maintained when positioning the trench.

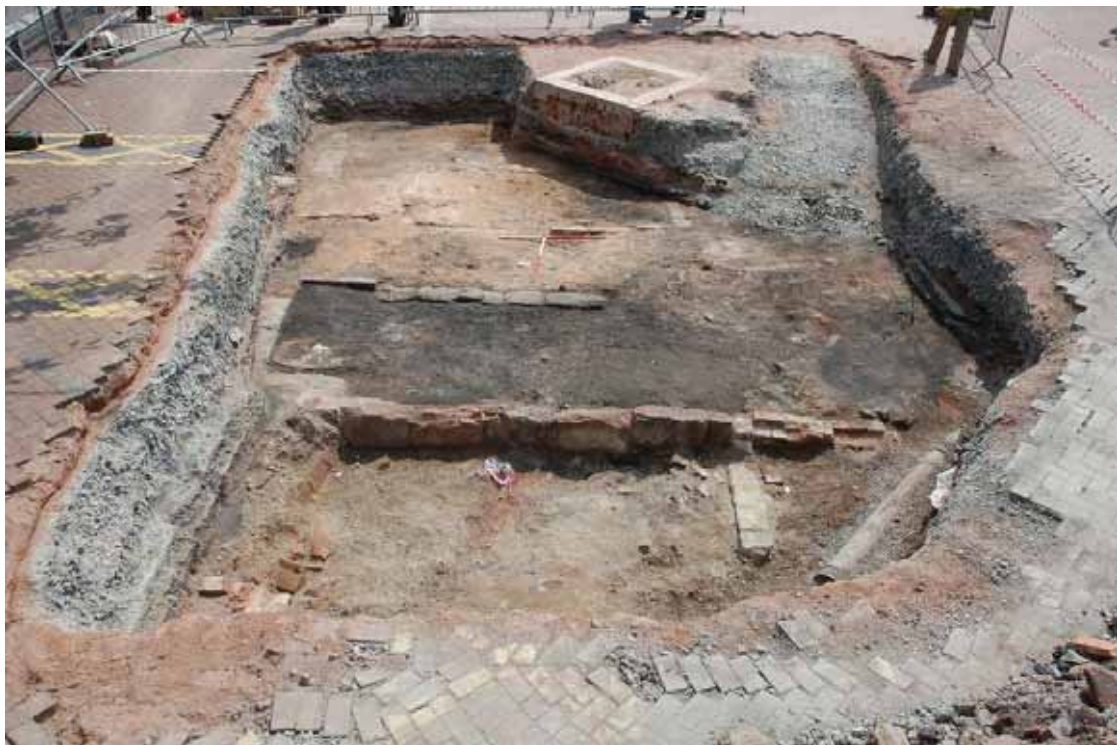
Plate 2: The trench after initial cleaning, facing east

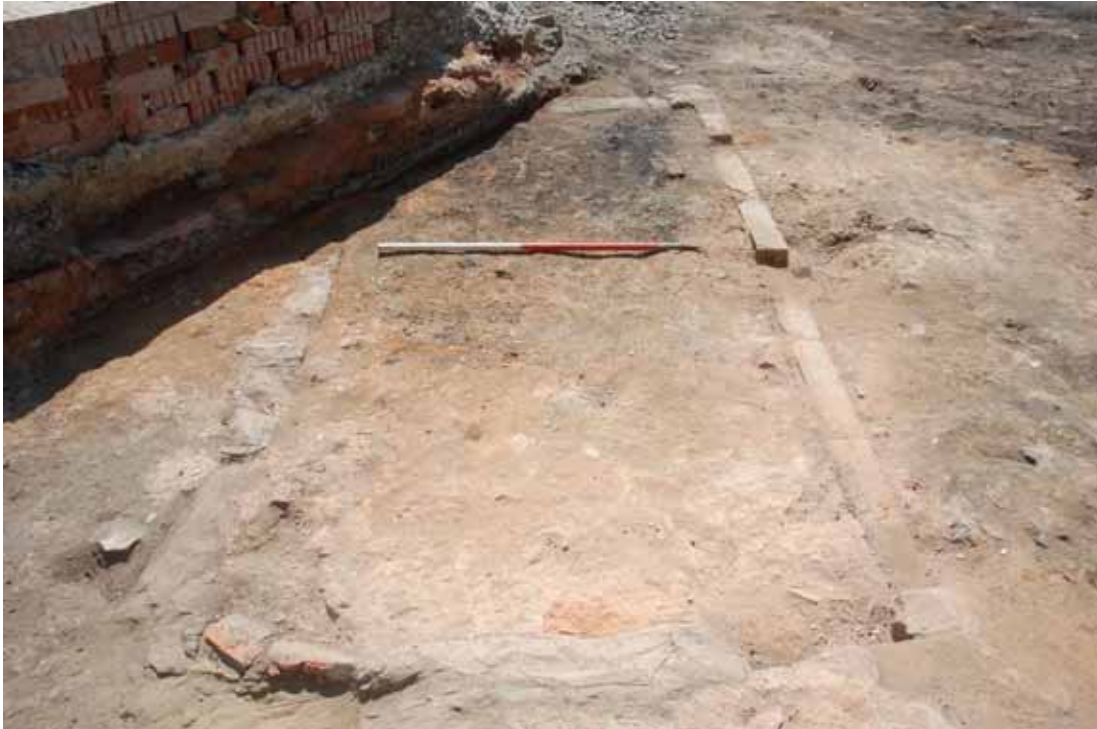
Plate 3: Small outbuilding at the back of house number 5, facing south

The remains of later brick walls and surfaces were built against (and above) these footings and included a possible small outbuilding in the eastern part of the area (Plate 3). This is clearly visible as half of a square extended area on the 1st edition ordnance survey map, positioned at the back of the building identified as house no. 5. It was defined by a regular course stretcher-bond wall (29) that abutted an earlier sandstone wall (30), as well as containing a single, very smooth and worn brick step (31). The bricks used in this structure were dated to the 18th century, which compares well with the suggested dating for the sandstone foundations. It also supports an assessment of the historic photographs of house no. 5, which show a building frontage that appears to be early 18th century in date (S. Robson-Glyde, pers. comm.). The outbuilding was 1.70m wide by 3m long and appears to have been reached across a regular square quarry tile floor (27) that was located at the back of the property and found at 84.48m AOD, a similar level as many of the building remains in the rest of the trench (Plate 4). Rubble deposit (36) had infilled the outbuilding and then a series of mortar patches used to cover up this part of site. It is possible that these compacted mortar areas represented floor layers or perhaps the levelling/bedding layers for a series of later brick or tile surfaces that had been removed on disuse. Finds from these layers were attributable to the first half of the 20th century, indicating that these were either much later additions to the building or that they had been deposited during the demolition of the properties.

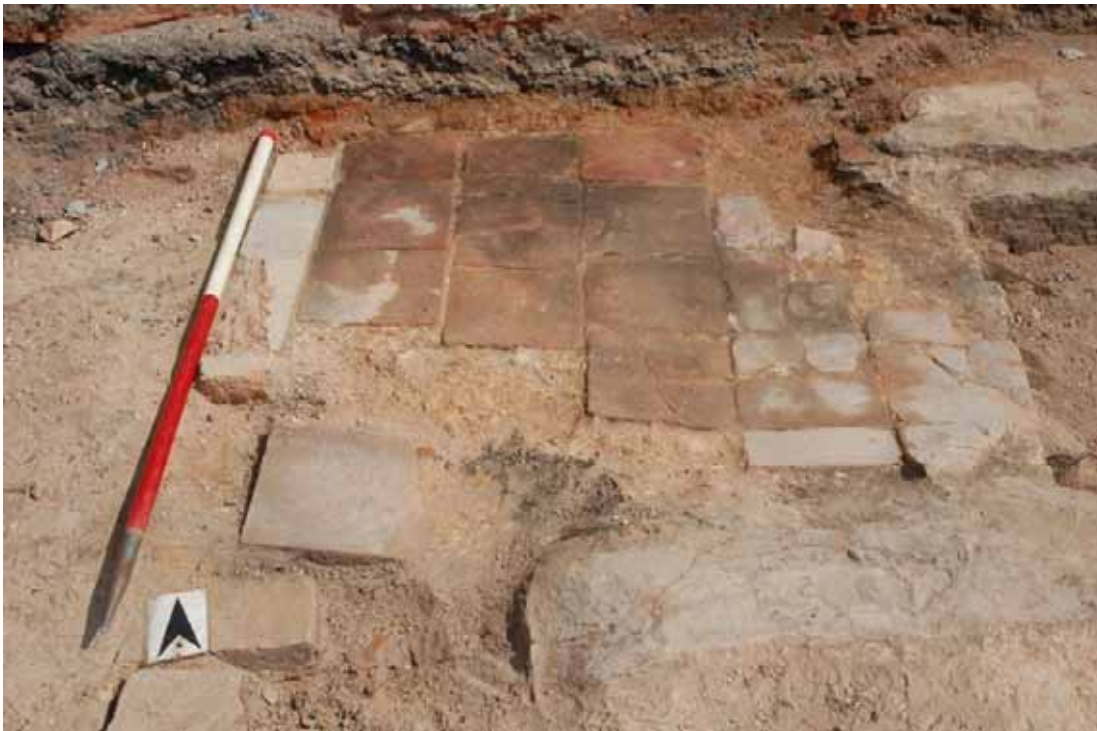
Plate 4: Quarry tile floor (27) at the back of house number 5

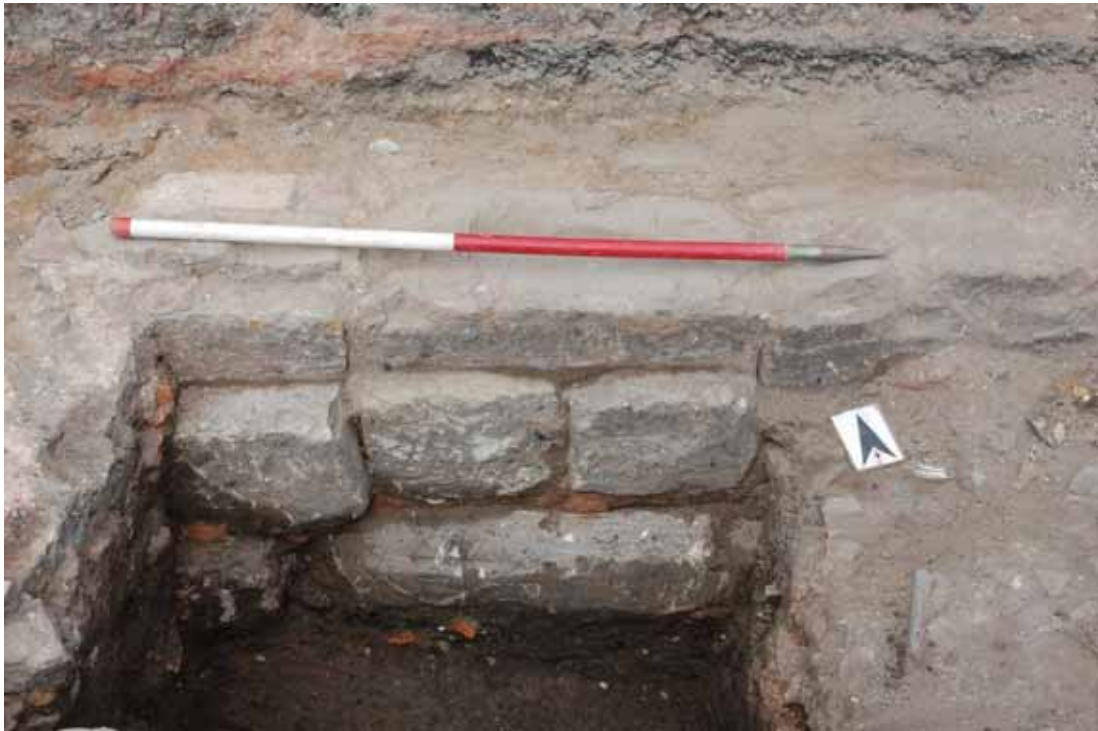
Plate 5: Sandstone foundation wall (26), forming the footings for house number 5; high quality chamfered stone visible in lowest course

Two foundation walls, (26) and (28), which directly related to layer (42), were both three courses high and constructed of irregular grey hand-worked sandstone blocks up to 770mm in length, 300mm in width and 125mm in depth (see Plate 5). Some of the stones were shaped and others were not, indicating that they are likely to have been reused from elsewhere rather than being originally designed for use in this structure, and at least one was of very high quality. A rubble-rich mixed deposit (39) 0.60m in depth, containing a ceramic drain pipe but otherwise undisturbed by later activity, abutted the walls and contained pottery of up to mid 18th century origin. With the pottery of 17th century date found in layer (42) beneath the walls, this suggests that the sandstone foundations were put in around the late 17th to early 18th century.

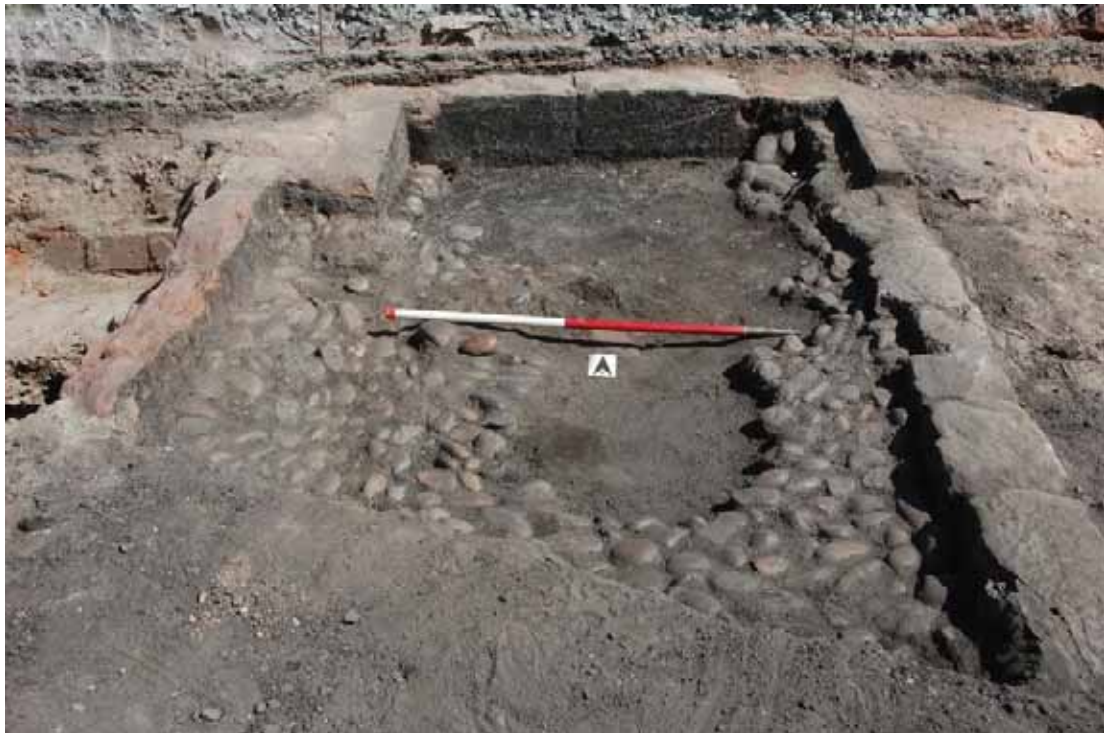
Plate 6: Exposed area of cobbled yard surface (25) facing north

the other side of the square extended area at the back of the building visible on the mapping. A 1.5m wide gap between walls (38) and (29) is likely to have been an alley passage running through the building from the St John Street frontage to the back of the house. This is noticeable as a void on the photograph showing demolition of the properties during the 1950s. Walls (37) and (38) defined an area of worn stone cobbling (25) that appears to be the remains of a cobbled space in this back-yard area (Plate 6). The cobbles abutted the wall of the adjacent property to the west, house no. 6.

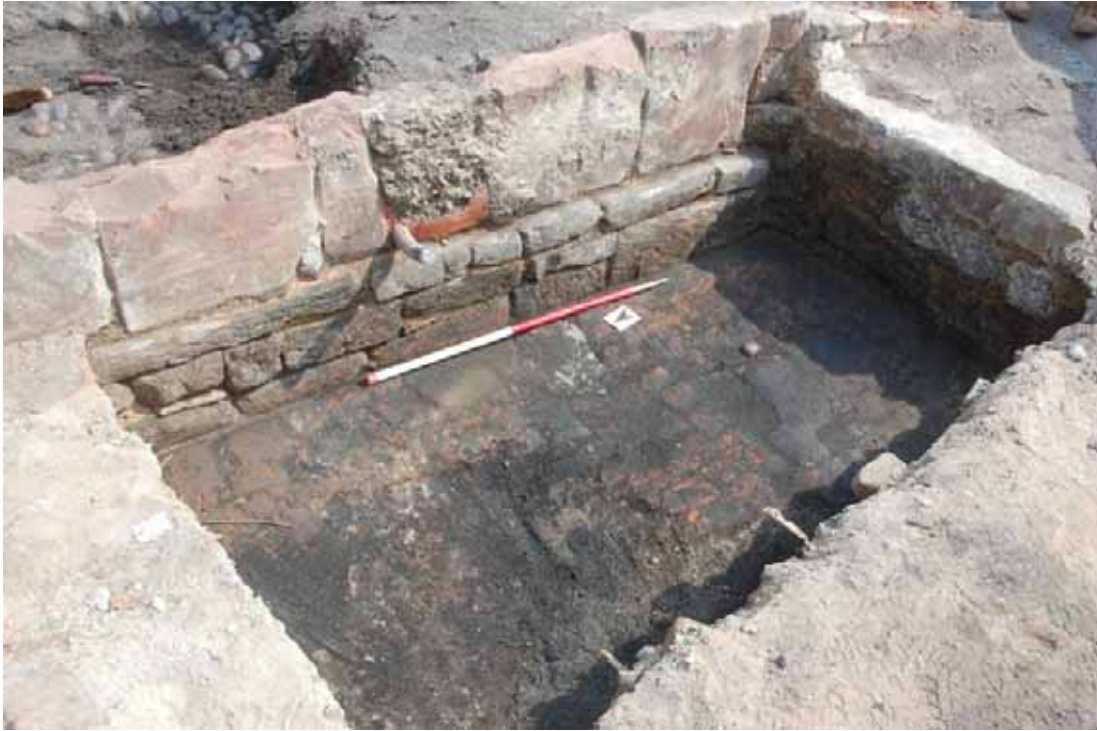
Plate 7: Sandstone foundations and floor of the cellar at the back of house number 6

Additional sandstone foundations - (32) and (33) - were revealed at the west end of the trench and these formed what appeared to be a cellar space 3.29m in length and at least 1.5m wide (Plate 7). As with the foundations of house no. 5, the variable block sizes and irregular surface dressing suggested at least some level of re-use in this construction. They had probably come from a substantial building as again, a number of the stones were of a considerable size, being up to 550mm in length, 180mm in width and 550mm in depth. The floor of this cellar, (35), was very uneven and although constructed of sandstone, contained a number of areas of brick patching which may be indicative of a long period of substantial use. It was also stained black by a dark deposit, potentially representing residue from the storage of coal and was reached 1.75m below the car park surface at a level of 83.84m AOD. The north-west corner of the site contained a partially visible sandstone and brick structure (40) with a repair (41) that appears to be a part of the steps that had once led down into this cellar space. A later brick addition (34) to the south of the cellar was also recorded and this probably demonstrates a dividing wall or perhaps an expansion of the building to create more working space. A brick sample from this wall was dated as 17th century and this supports the evidence on historic photographs, which shows house no. 6 to have a later 17th century frontage (S. Robson-Glyde, pers. comm.). The position of the cellar as revealed in this trench ties in with the mapped evidence from the 1st edition ordnance survey onwards, which shows a long extended building at the rear of house no. 6.
