BOREHOLE SURVEY AND
ASSESSMENT OF
ENVIRONMENTAL REMAINS AT
WARWICKSHIRE COUNTY
CRICKET GROUND,
EDGBASTON ROAD,
BIRMINGHAM
Nicholas Daffern and Nick Watson (ARCA)

13 November 2012

Project 3868
Report 1955

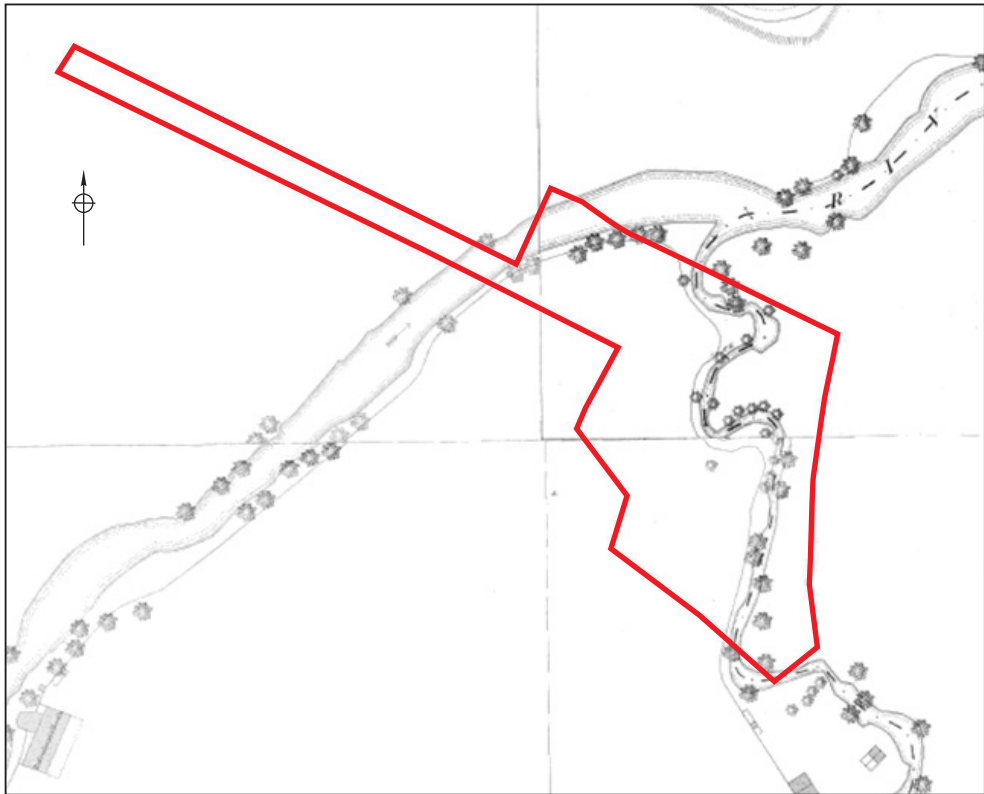
Figure 2

Area of investigation

An archaeological borehole survey was undertaken at Warwickshire County Cricket Ground, Edgbaston Road, Birmingham (NGR SP 0677 8434) (Figures 1 and 2). The borehole survey and subsequent environmental assessment were undertaken on behalf of Mansell Construction Services Ltd in response to proposed development including intrusive ground works with the potential to disturb palaeoenvironmental remains of unknown date.

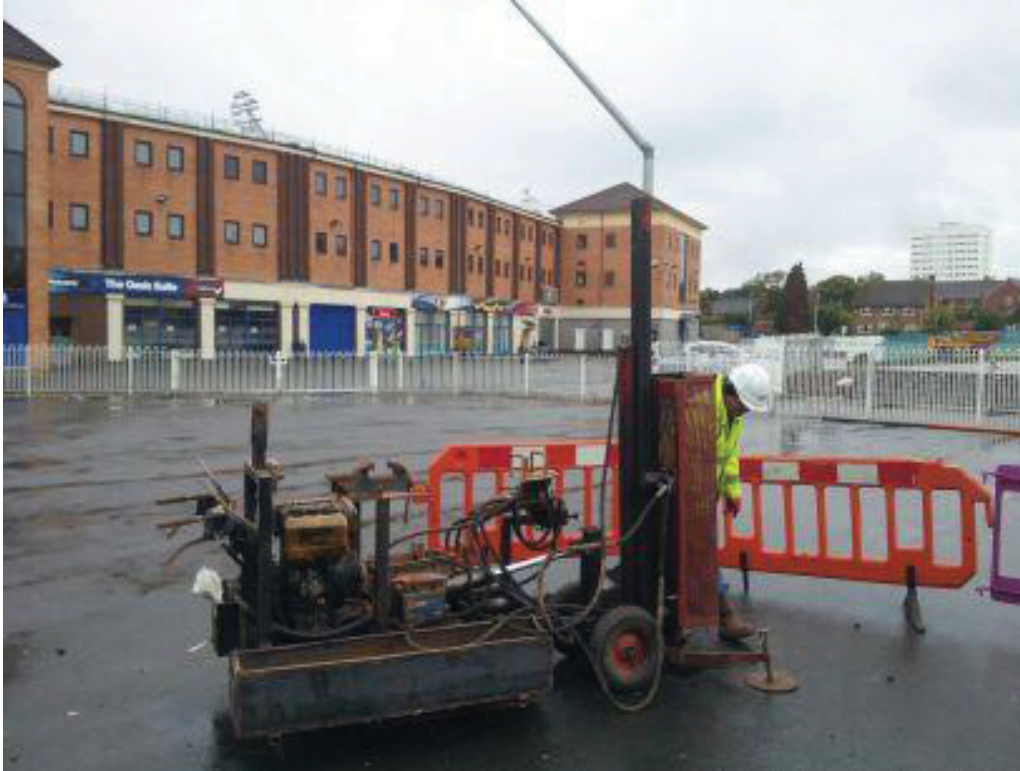
Plate 1 Sinking Borehole 3, looking south-west

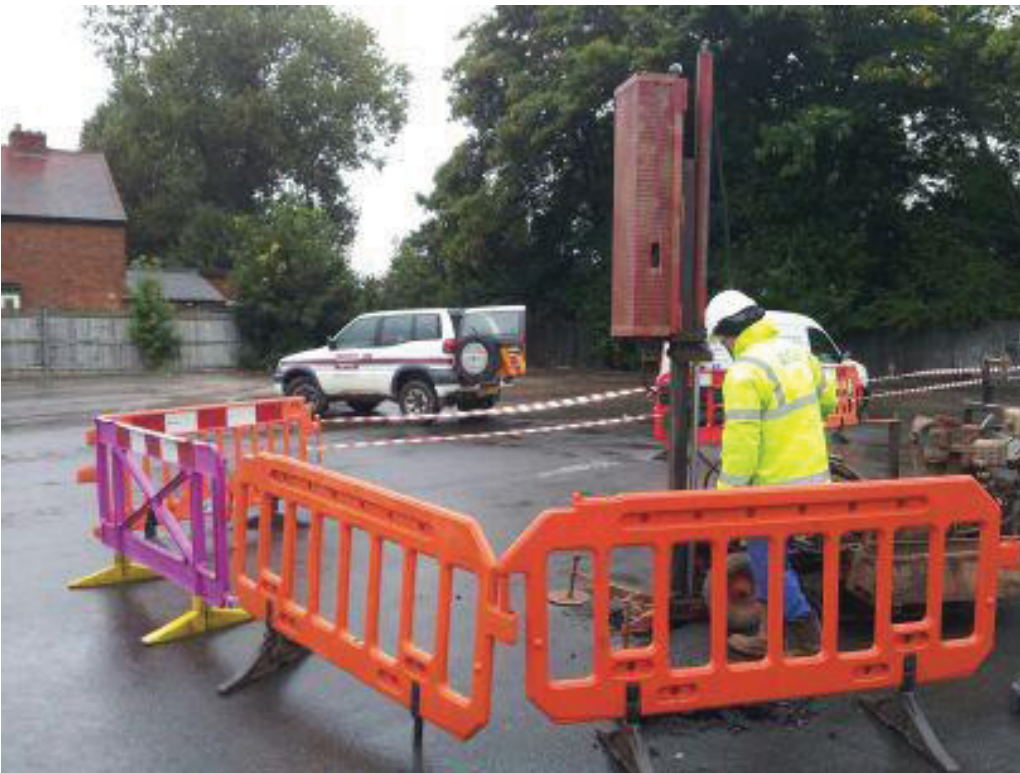
Plate 2 Sinking Borehole 3, looking north-east

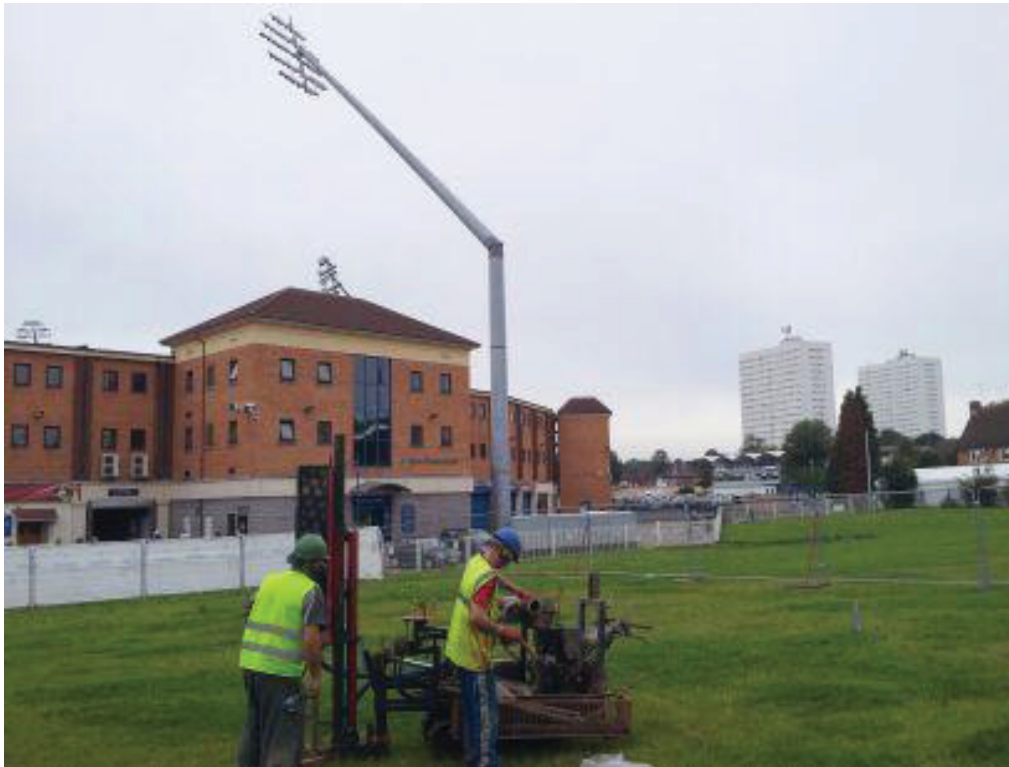
Plate 3 Sinking Borehole 7, looking south-west

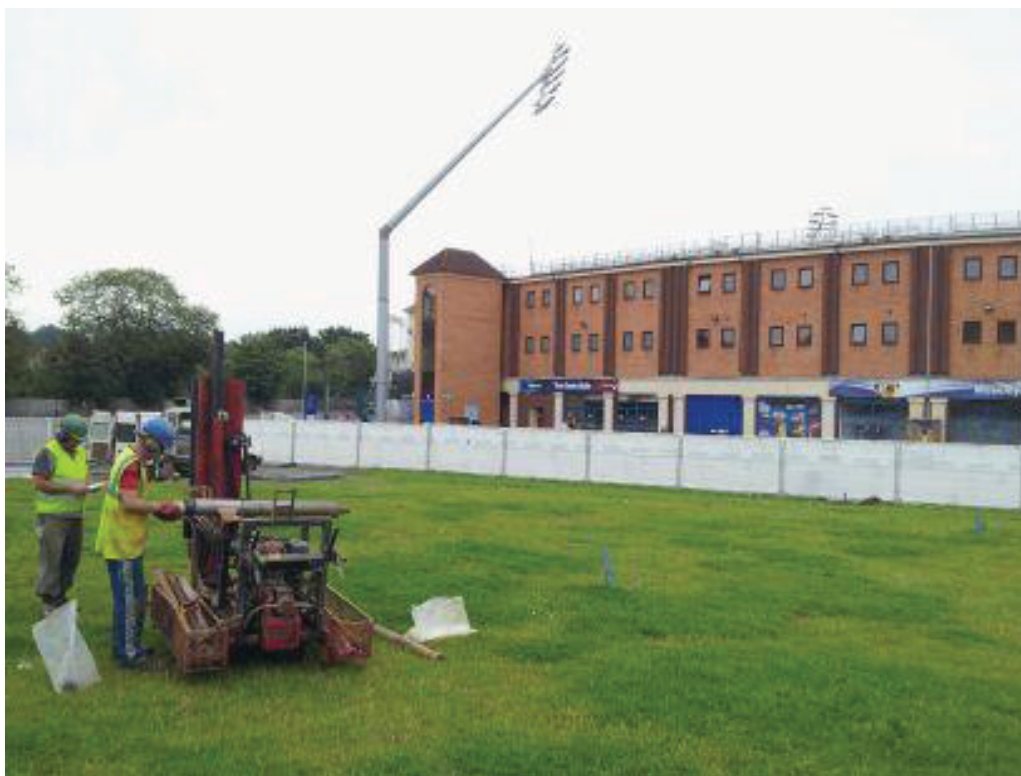
Plate 4 Sinking Borehole 7, looking south-east
