ARCHAEOLOGICAL INVESTIGATIONS  
AT  
SUNRISE BUSINESS PARK,  
WOLLASTON,  
STOURBRIDGE

Status:  
Date: 19 December 2013  
Author: Andrew Walsh and Tim Cornah  
Contributors: Dennis Williams  
Illustrator: Carolyn Hunt  
Project reference: P4124  
Report reference: 2080

## **Archaeological investigations at Sunrise Business Park, Wollaston, Stourbridge**

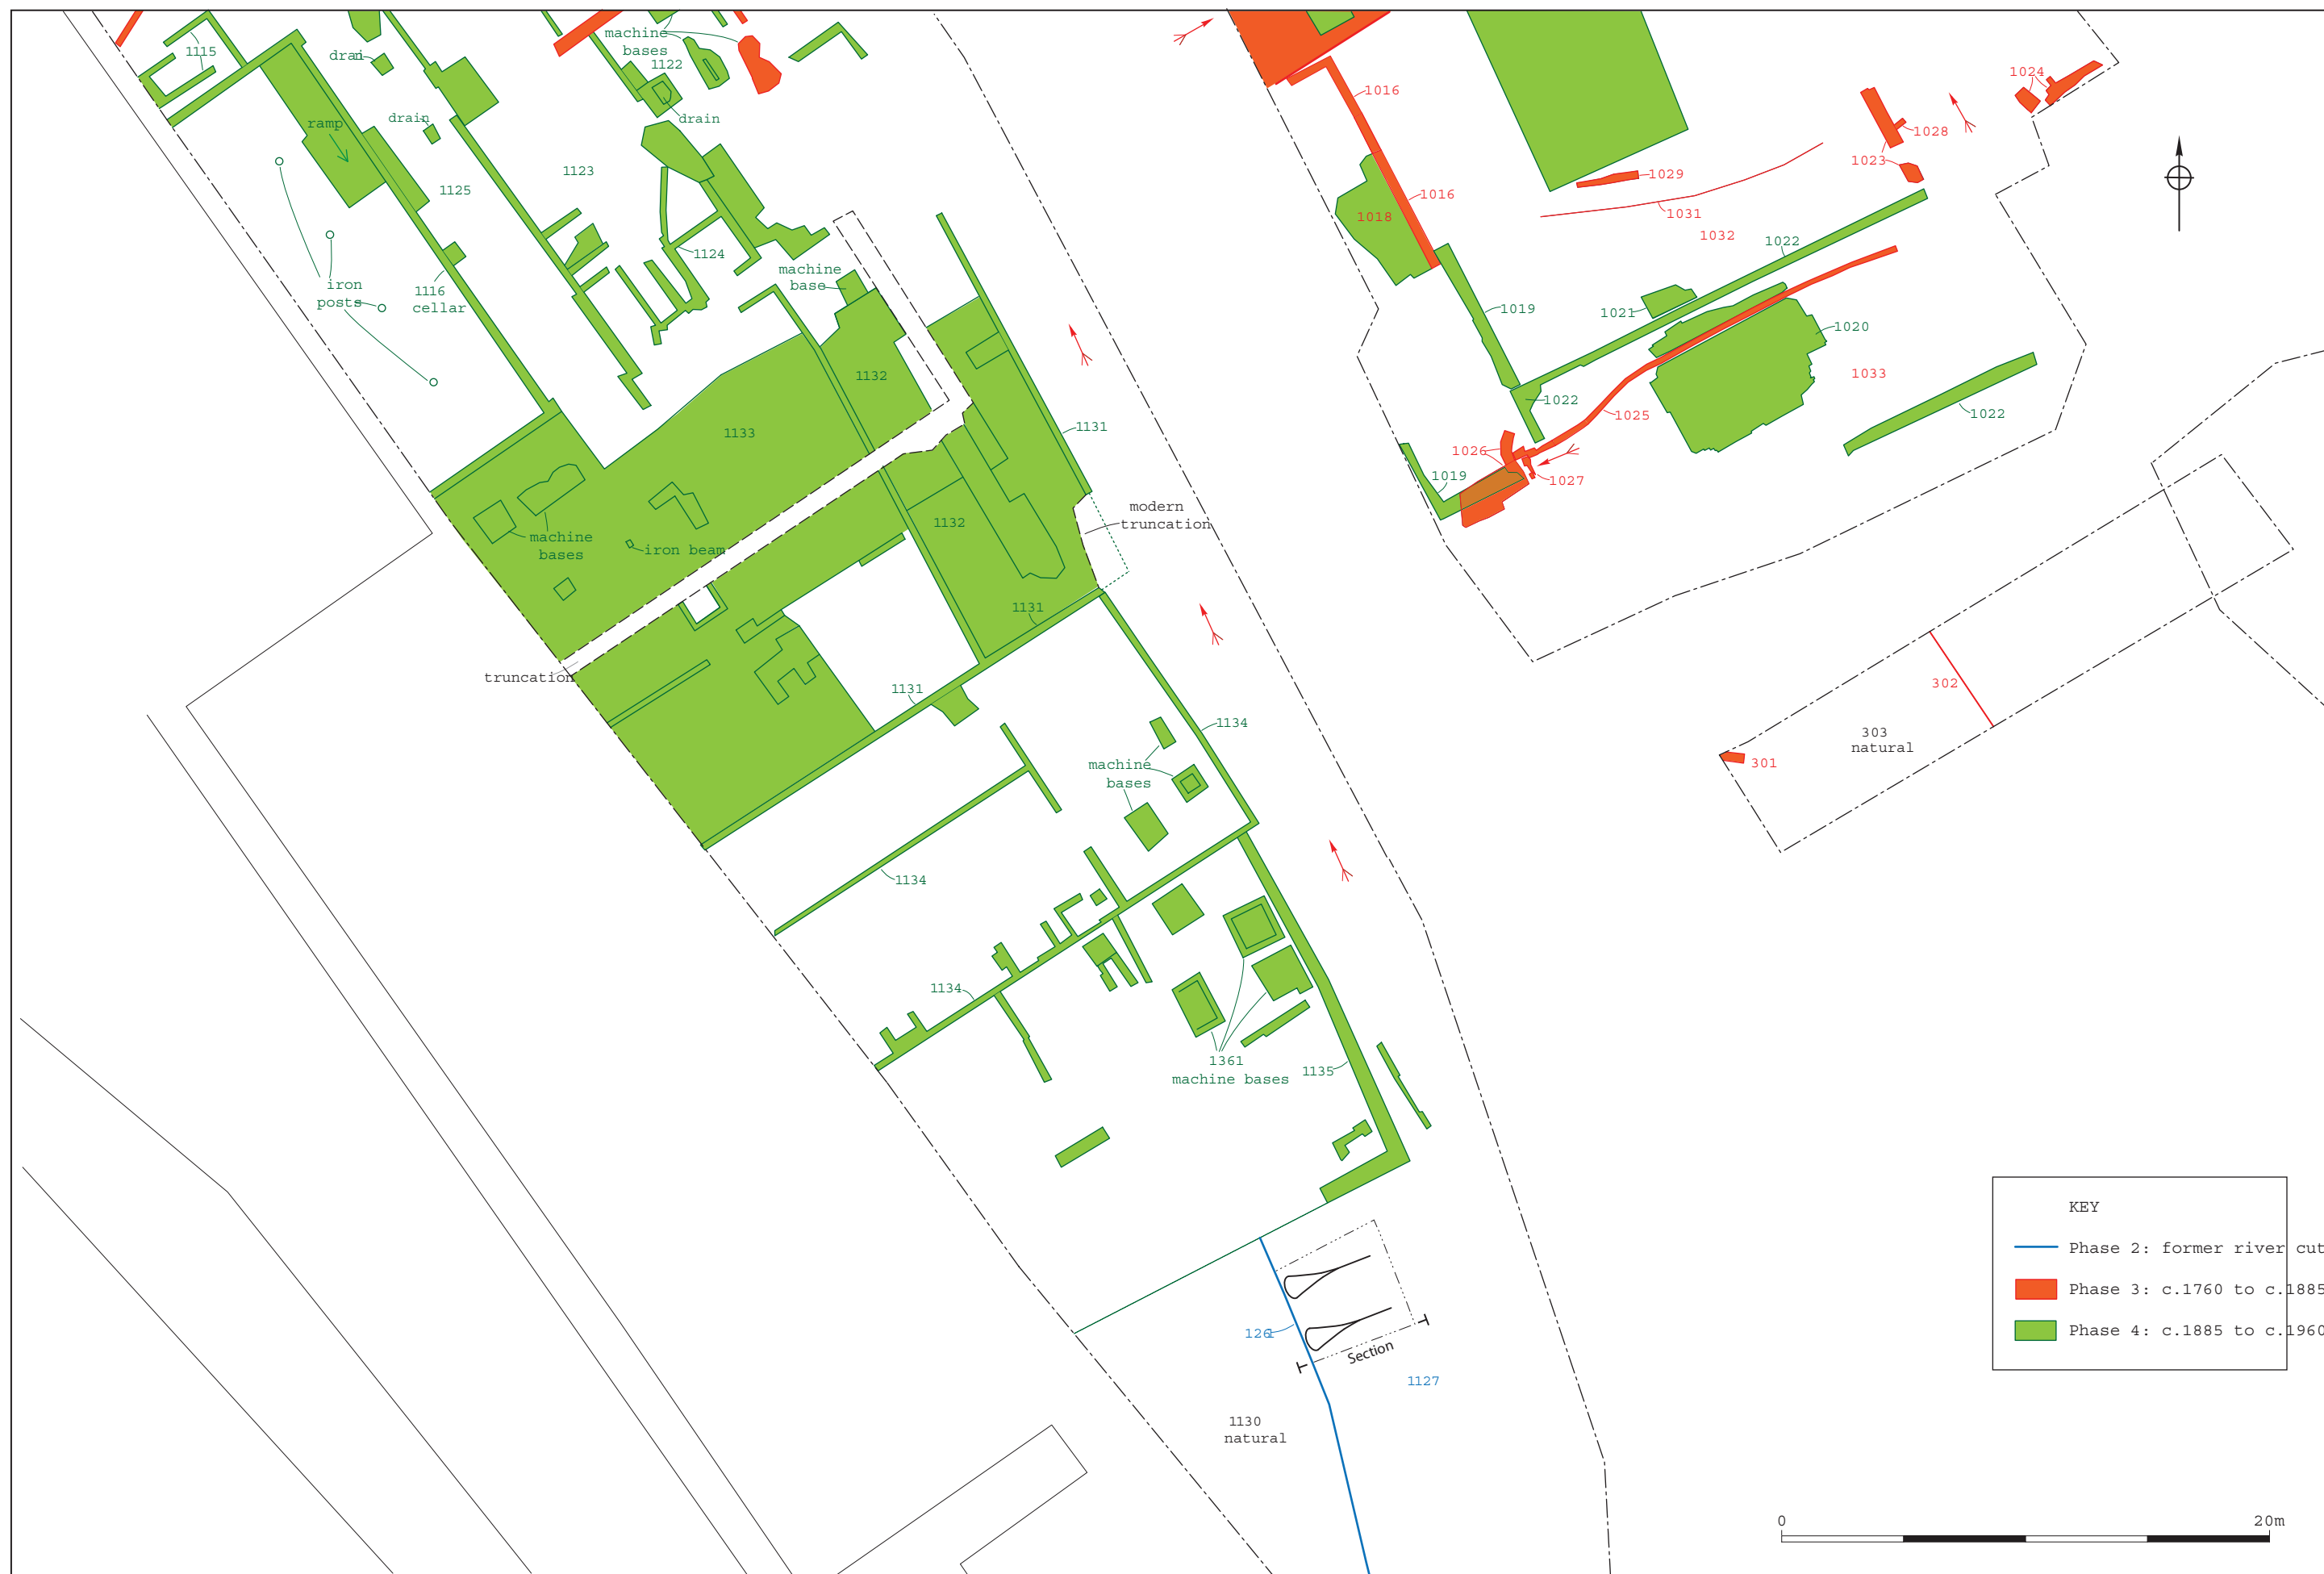
Figure 3b

Phase plan: southern ar

The observed areas and features recorded are shown in Figures 3a-c and 4a-b. The features are discussed by phase and from north to south. The phased features are illustrated in Figures 4a-b. They are overlain on the 1<sup>st</sup> edition 25" to 1 mile OS map (1885) in Figure 5 and the 1955-6 edition in Figure 6. Unless stated otherwise, the walls were constructed of ceramic bricks.

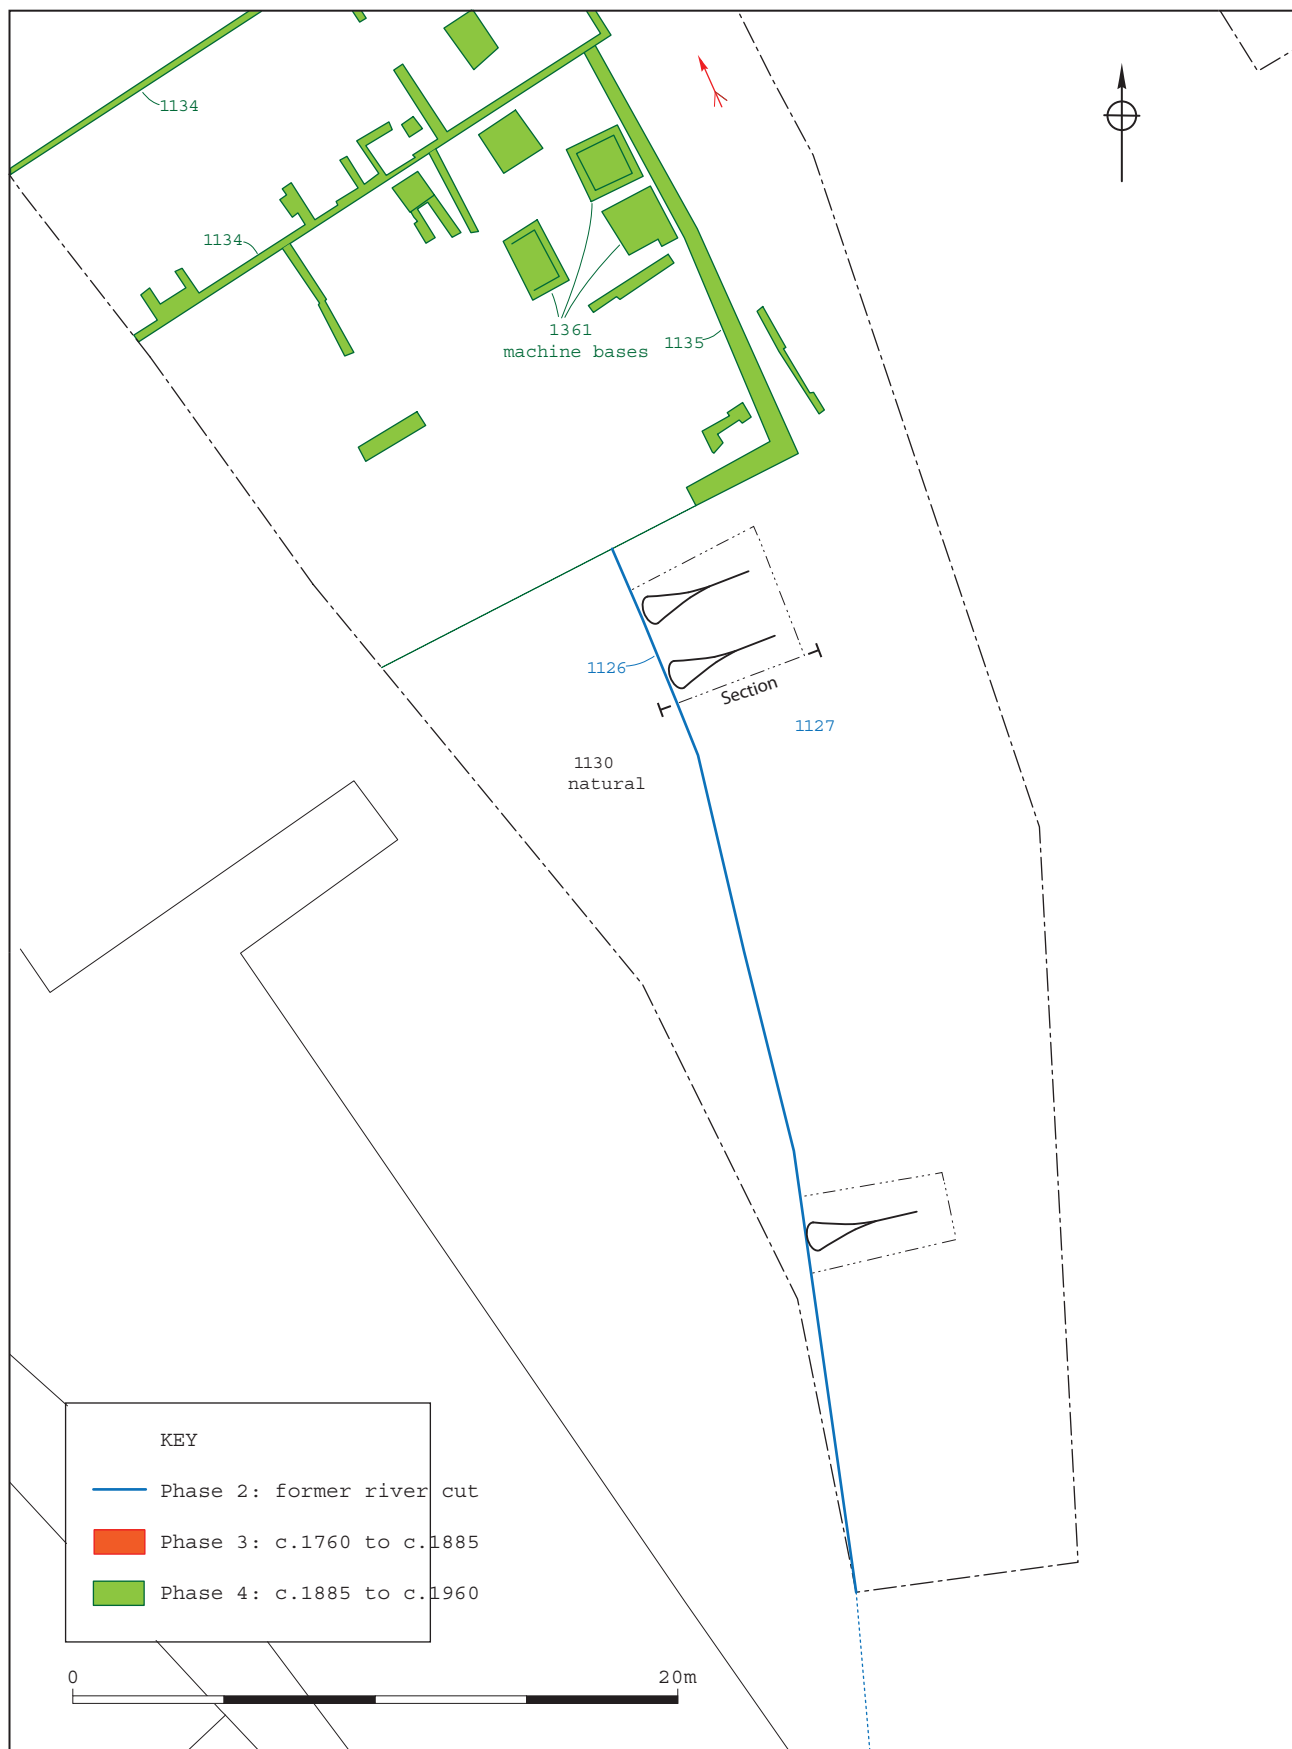
Figure 3c

Phase plan: tip of southern area

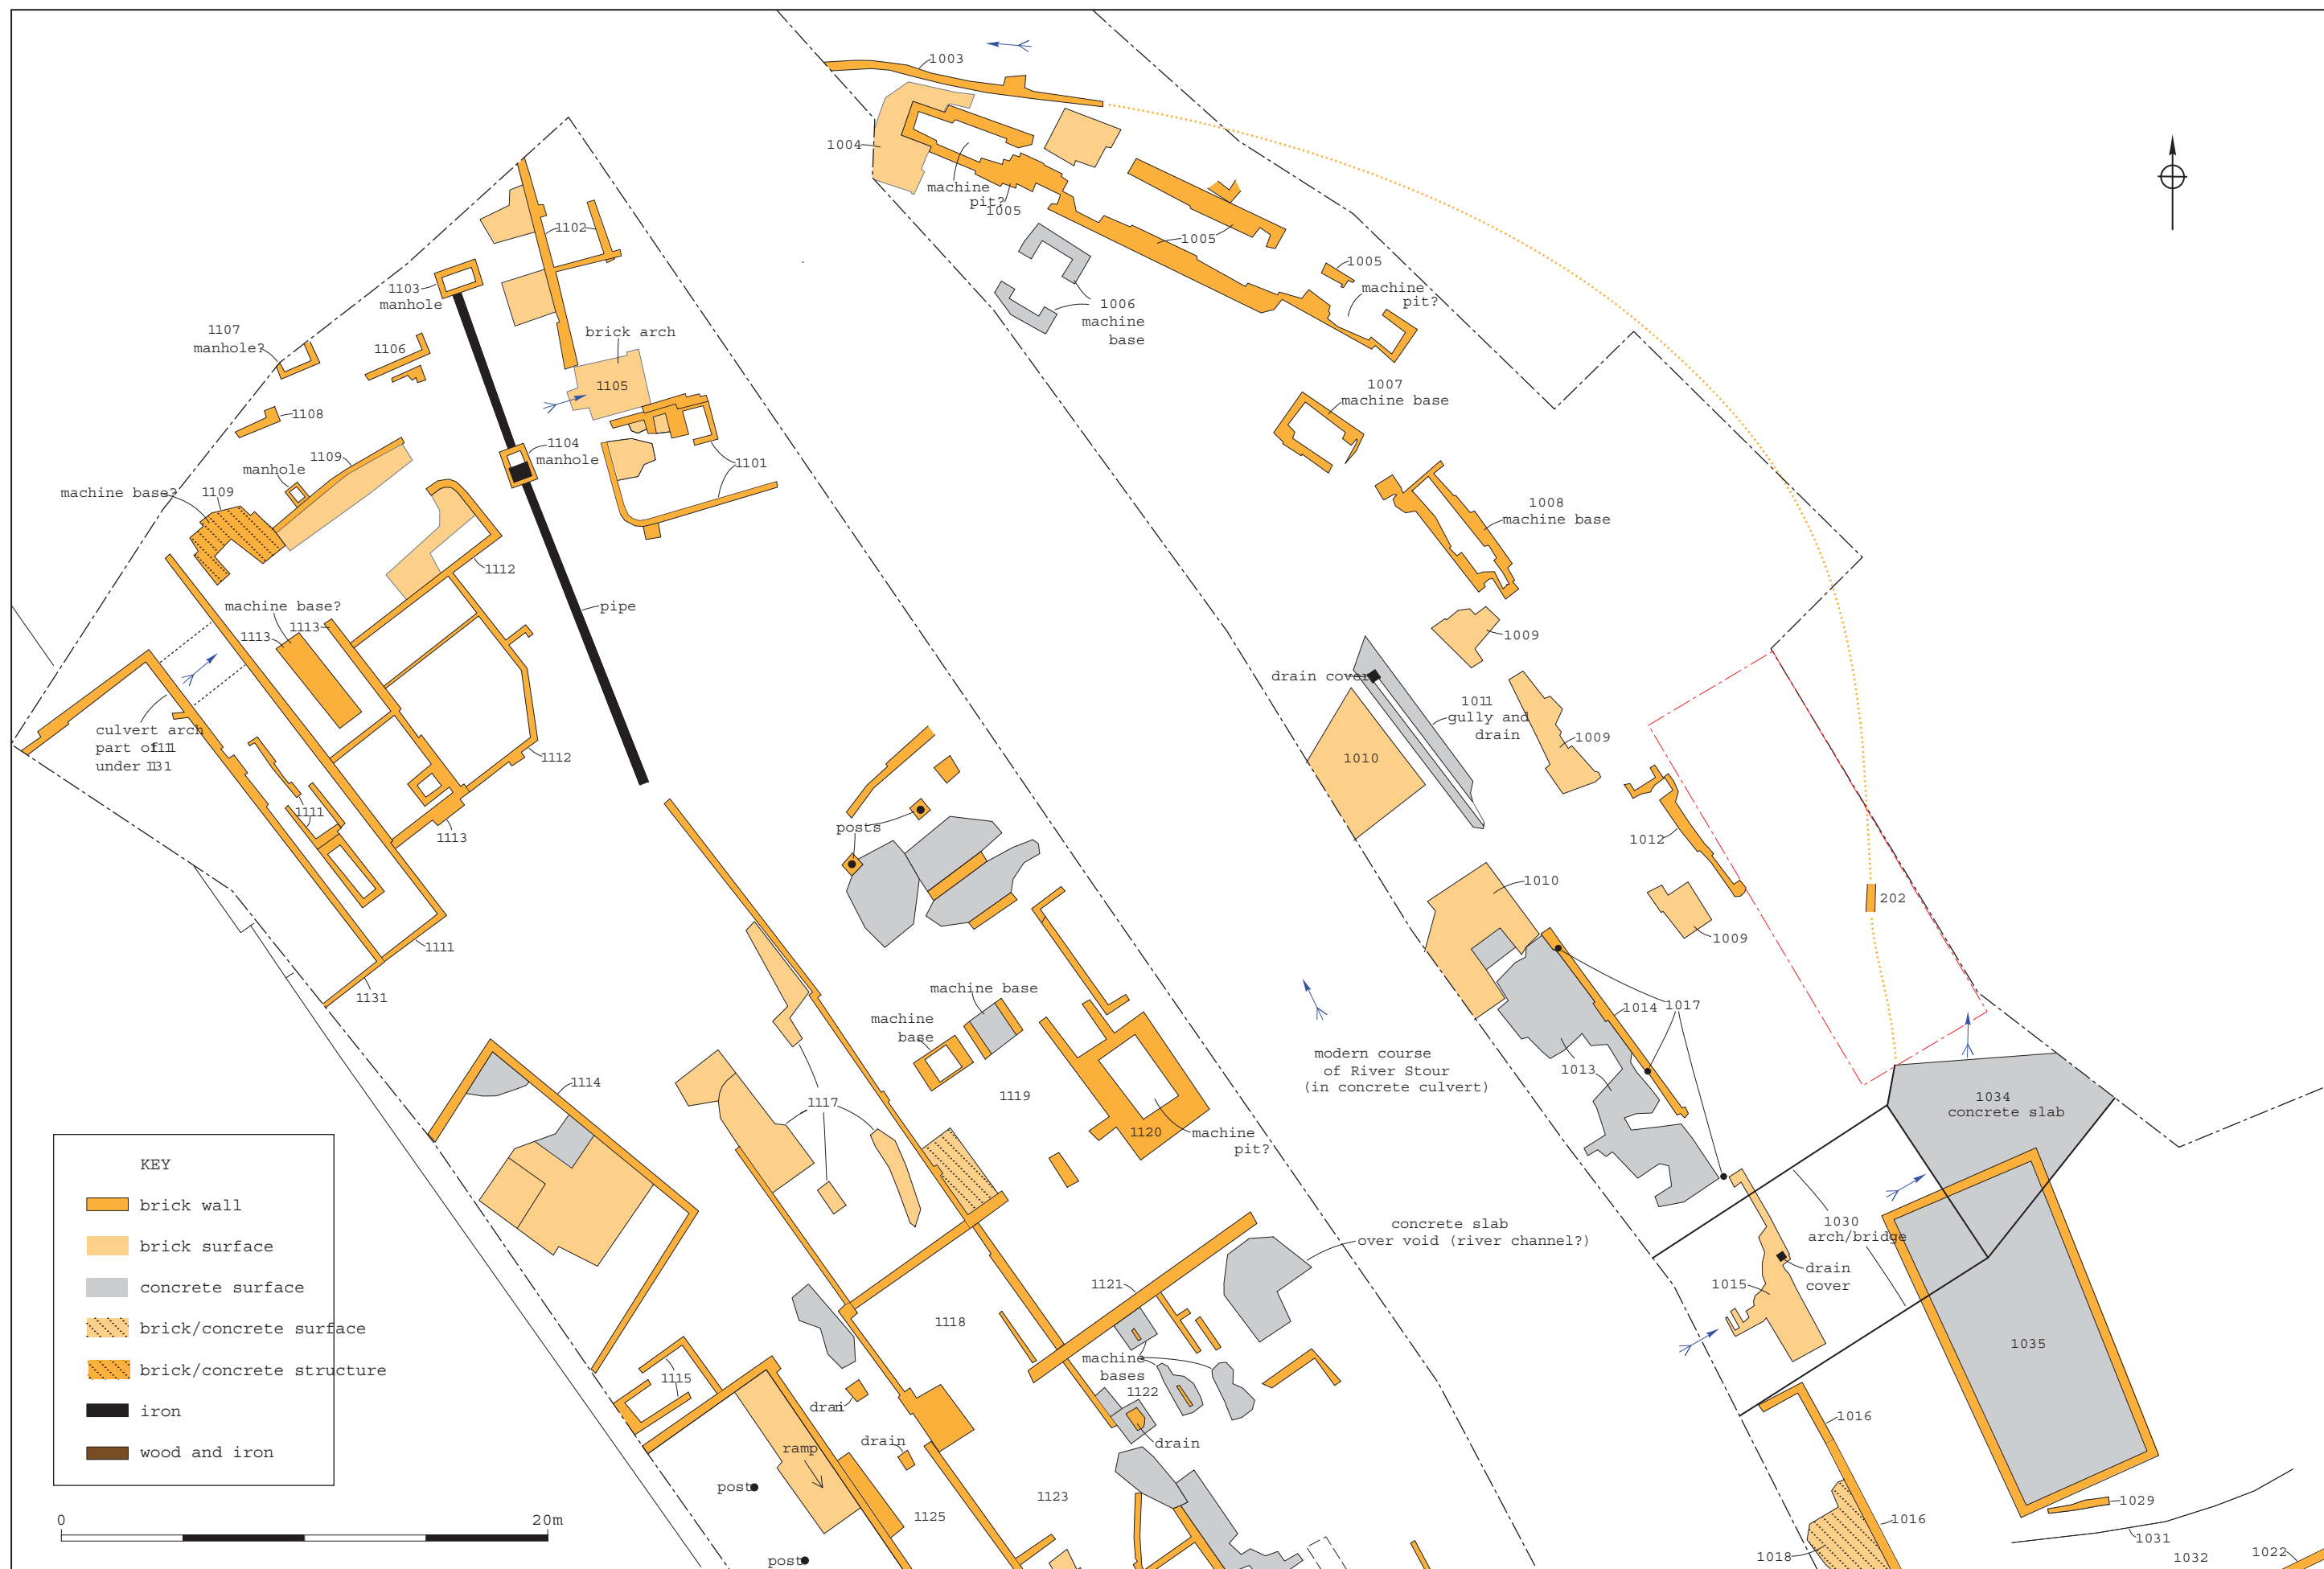
Figure 4a

Features: northern ar

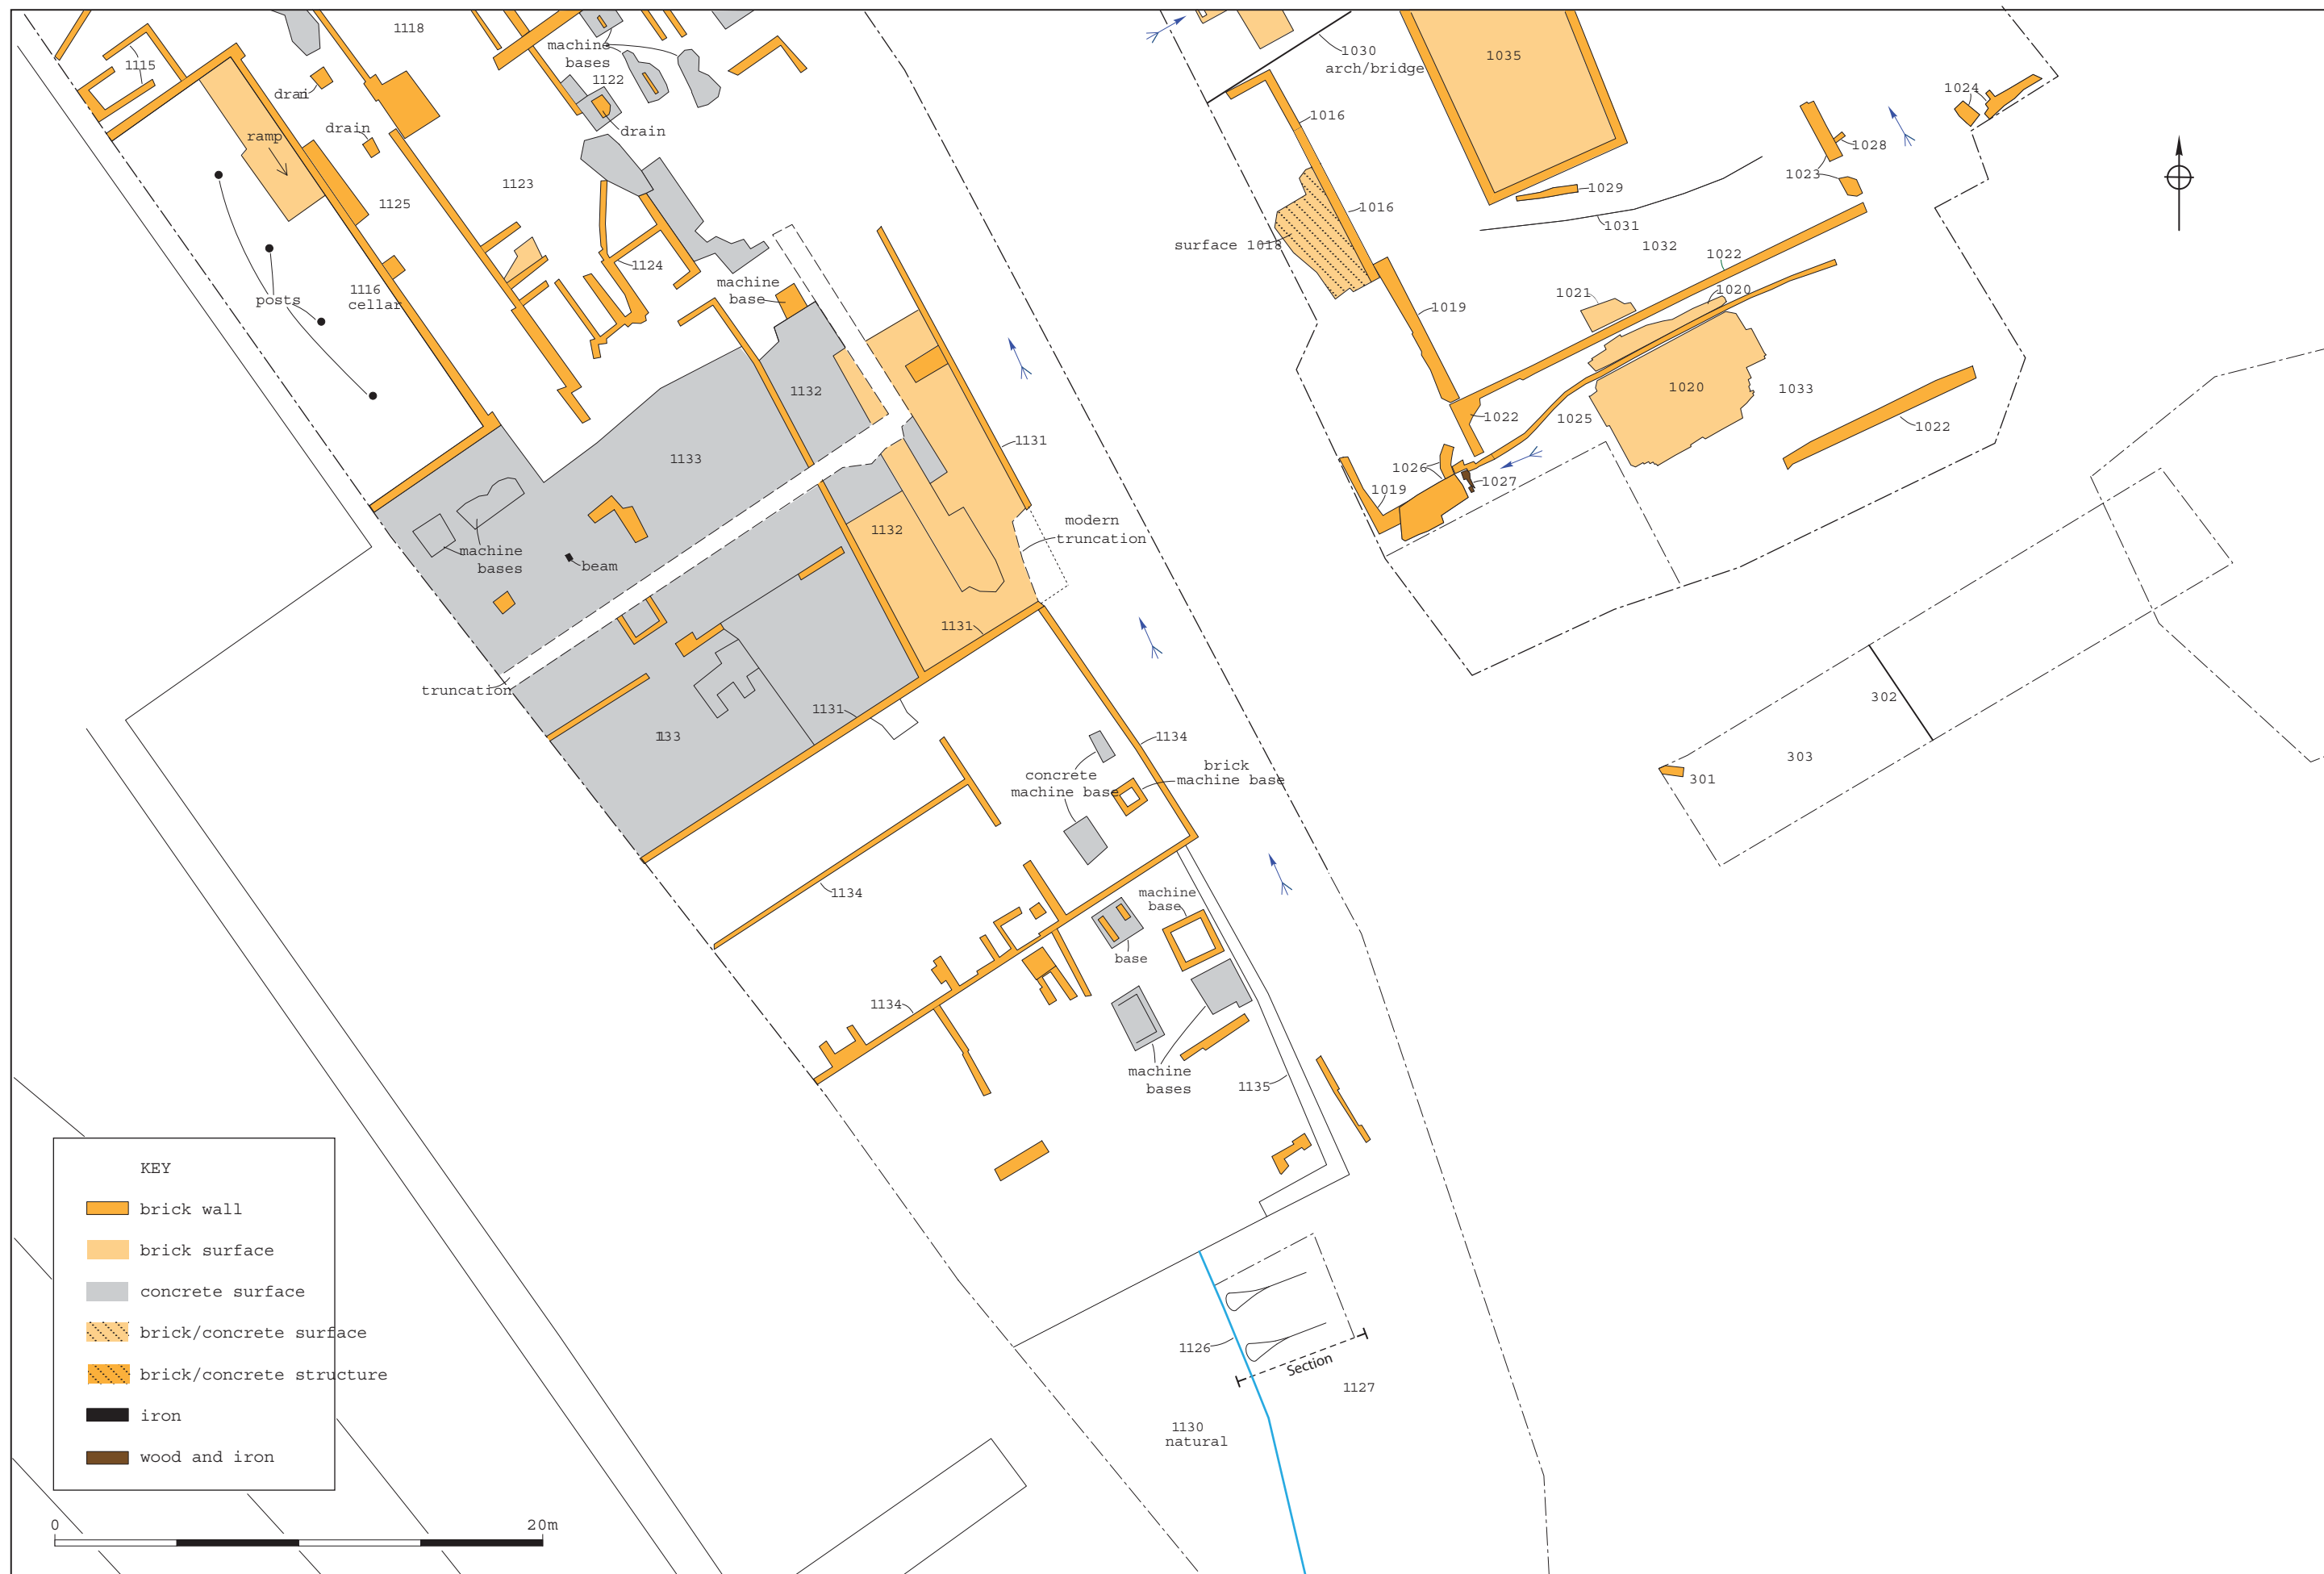
Figure 4b

Features: southern area

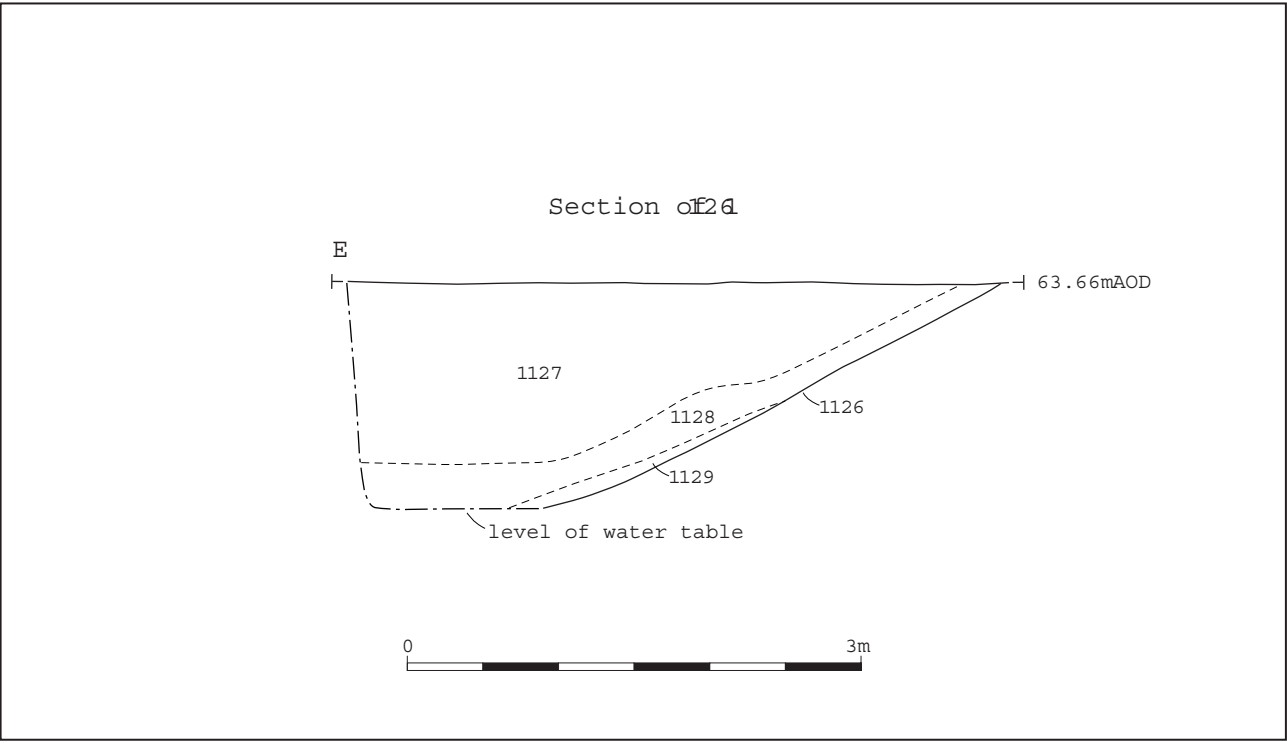
Figure 7

Section of 1126

At the southern edge of Trench 11, feature (1126) was observed cutting natural (1130). It was exposed for approximately 25m in length, aligned roughly north to south, though it was seen turning slightly towards the south-west. To the north the feature was truncated by buildings (1135) and (1136). It was machine and hand excavated to a depth of 1.2m, until the water table was encountered (Plate 5; Figure 7). This feature was probably the top of the west bank of the River Stour, although it was truncated to the east by the concrete culvert built in the 1960s to enclose the realigned river, and the full width of the channel could not be established.

No dating evidence was recovered from the fills, although the lower fills (1128 and 1129) appeared to be dark, ash rich deposits suggesting they probably date from the industrialisation of the area in the late 18<sup>th</sup> century onwards (Plate 5). It is likely that the upper fill (1127) dates to the 20<sup>th</sup> century, and may be contemporary with the construction of structure (1135) to the north (Phase 3), or the redevelopment of the site in the mid 20<sup>th</sup> century (Phase 4).

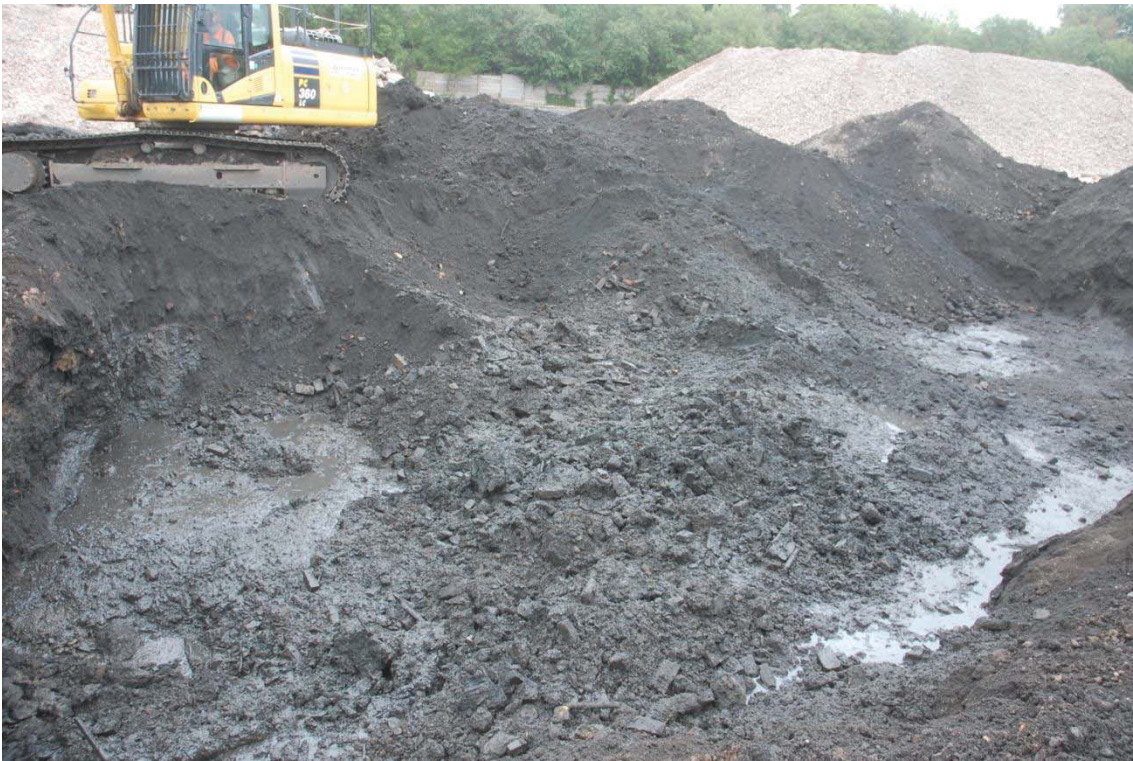
*Plate 1: The nature of the groundworks during the watching brief (WB Area 1)*

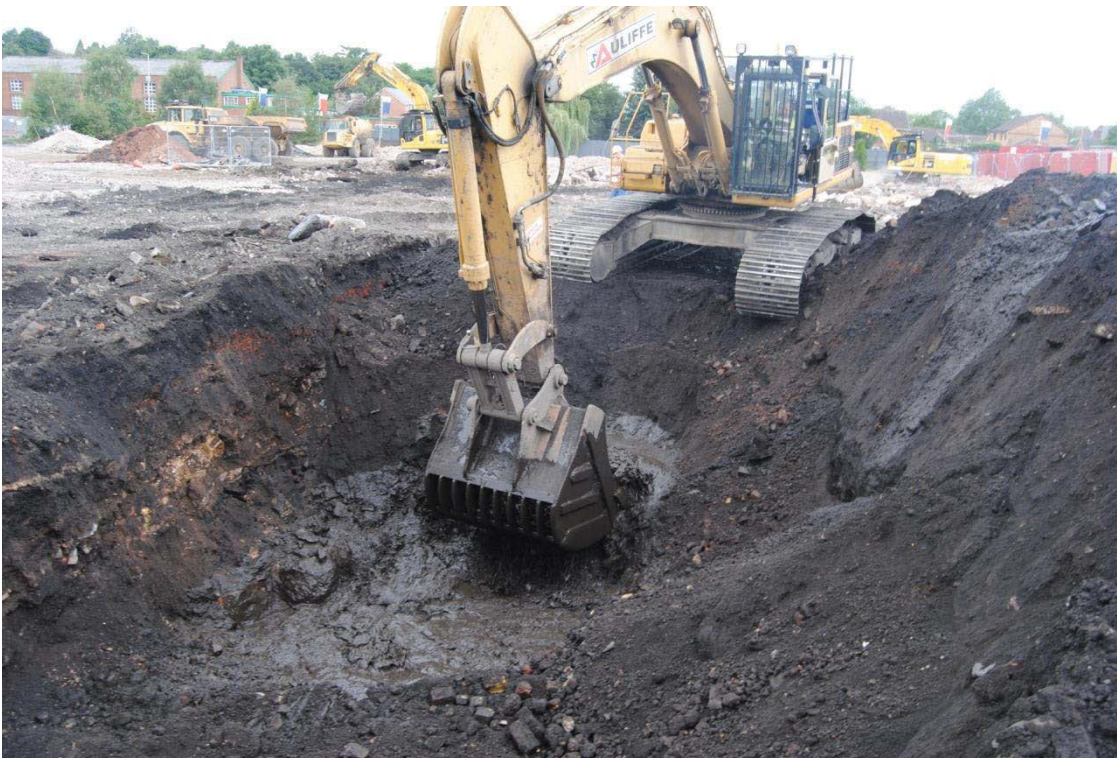
*Plate 2: Although structural remains, such as the brick wall to the left of the bucket, were observed it was not possible to safely record the features (WB Area 2)*

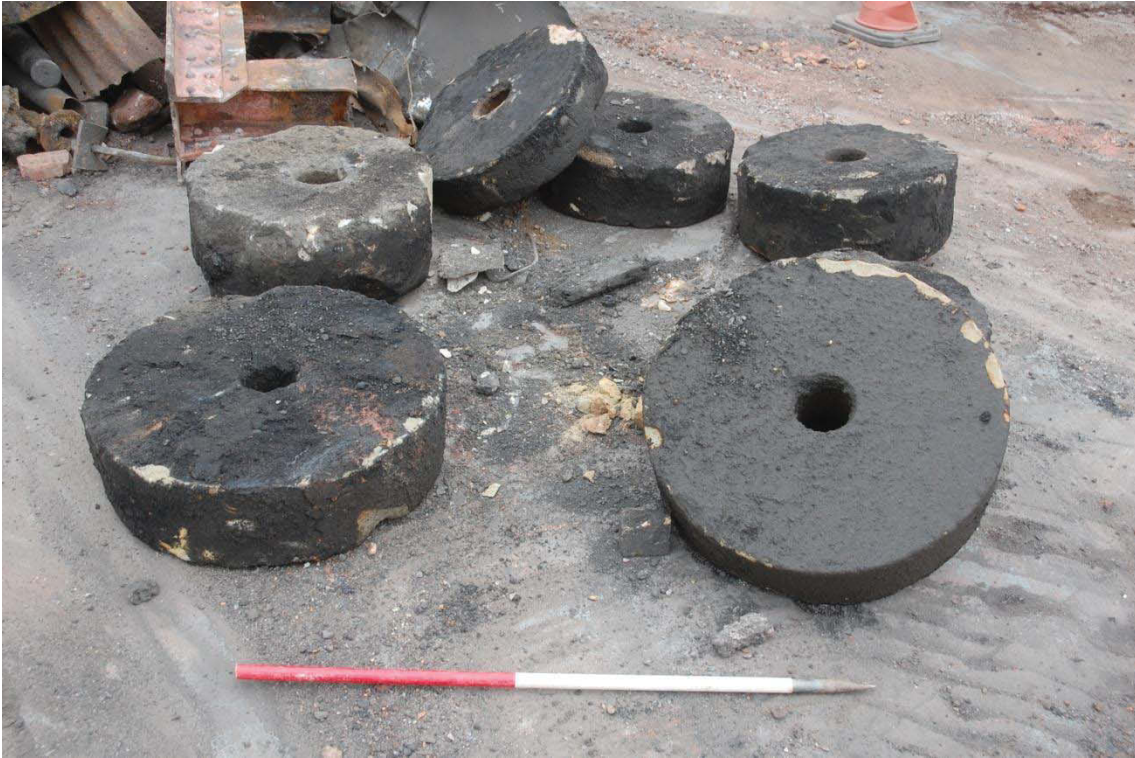
*Plate 3: Mill stones recovered during the watching brief*

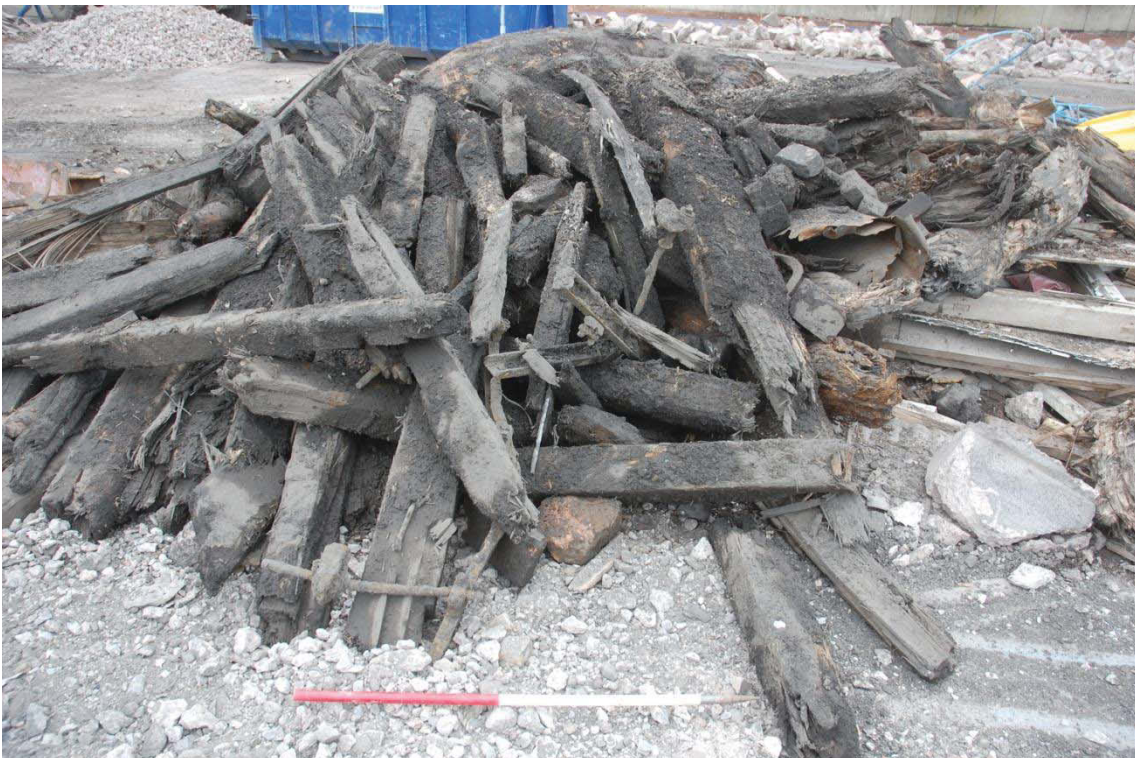
*Plate 4: Some of the wooden remains observed during the watching brief*

A Written Scheme of Investigation was prepared by EDP, and a detailed specification was also produced by WA (WA 2013). Initially the site remediation ground works were monitored under watching brief conditions. This involved the breaking out and removal of concrete, followed by the excavation grubbing out of all concrete and brick remains (Figure 2). Four areas (Figure 2; WB Areas 1-4) were monitored under these conditions but the depth and nature of the excavations, often at over 3m in depth (Plate 1), meant that recording often had to be undertaken from a distance, at the edge of the excavation area or after structures were removed (Plate 2). For example, brick walls, mill stones (Plate 3) and wooden remains (Plate 4) were all frequently observed in the machine bucket.

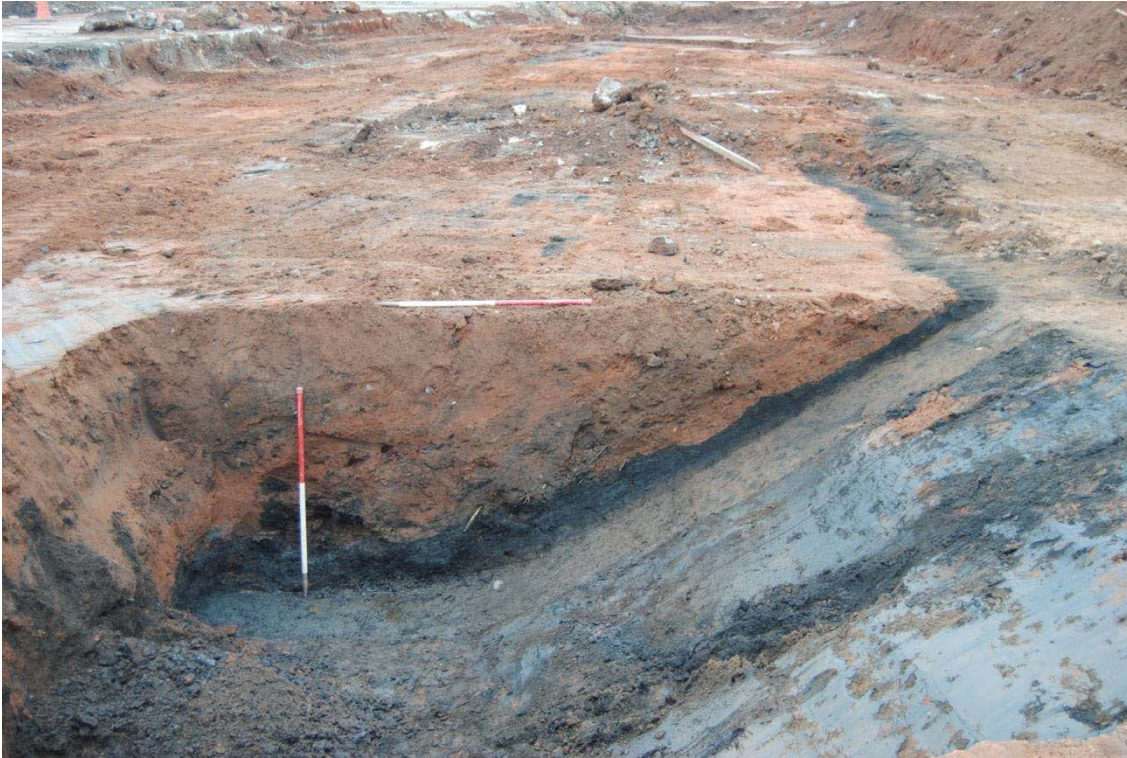
*Plate 5: Feature 1126 was the former course of the River Stour, and was truncated by the modern alignment in a concrete culvert (visible top left); view south*

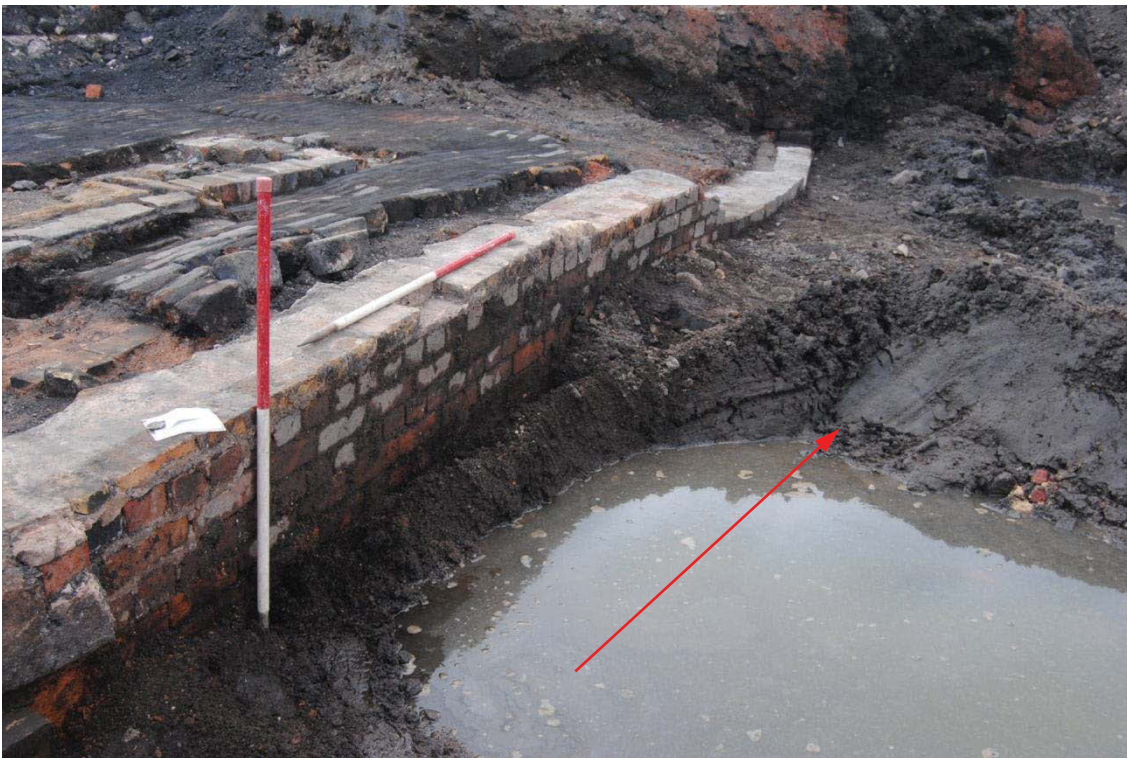
*Plate 6: Wall (1003) formed a retaining wall for the channel running to the east of the mill. The arrows indicate the direction of flow; view west*

At the northern end of Trench 10, a brick wall (1003) was observed running roughly south-east to north-west (Plate 6). It formed the retaining wall of the west side of an infilled channel, recorded on the historic mapping as by-passing the eastern side of mill complex. It was also observed in WB Trench 2 as wall (202), and further south it was visible joining brick culvert (1030).

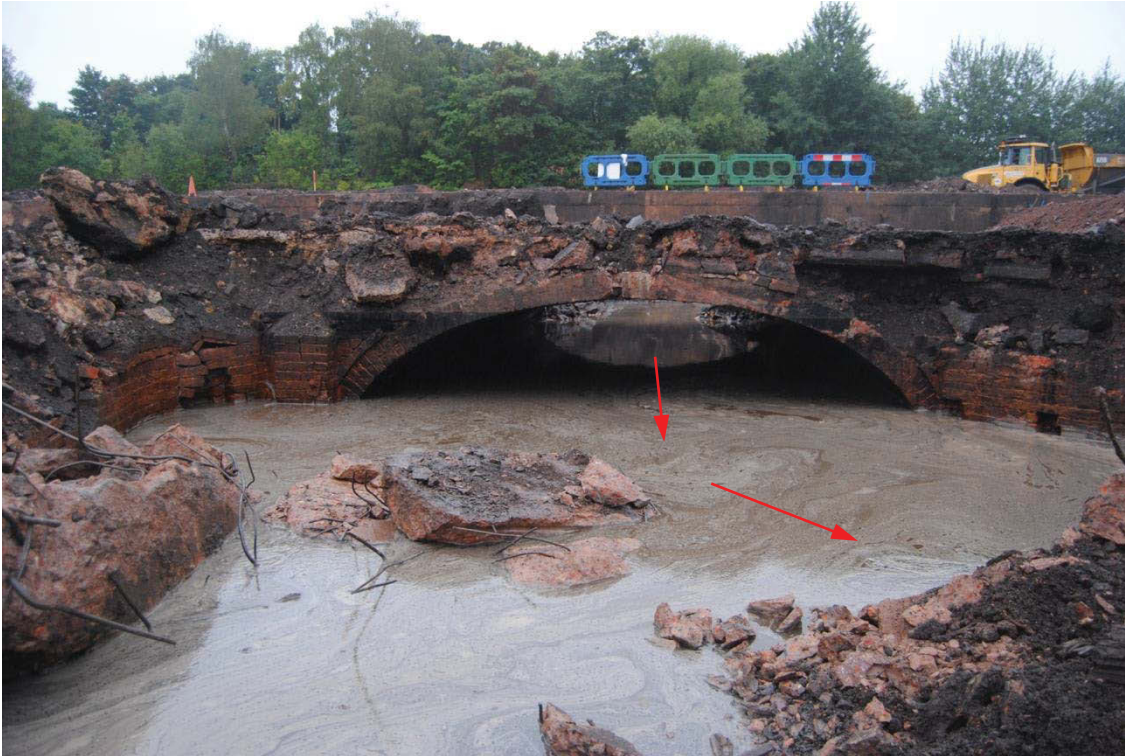
*Plate 7: Brick culvert (1030), with retaining wall (202/1003) visible to the right. In the foreground the broken out remains of a later concrete slab extension to the culvert (1034) are visible; view south-west*

Culvert (1030) was located below the deposits exposed during the strip and map operation. The culvert was orientated south-west to north-east and measured 7.5m in width and 11.5m in length although it was truncated by the realigned river to the west. To the east were a brick arch and two curtain walls, which turned in a northerly direction forming the course of the channel described above. The height of the culvert could not be established due to the presence of water (Plate 7).

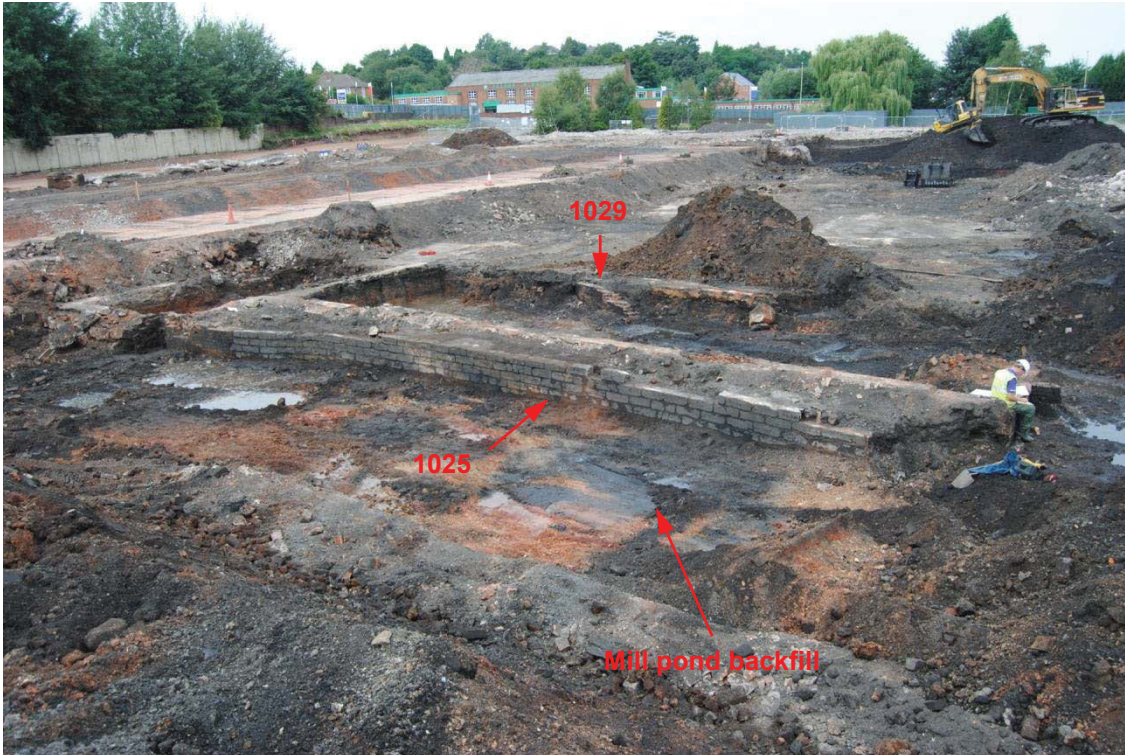
*Plate 8: Walls (1025) and (1029) were probably retaining walls on either side of the track between the mill and the canal; the mixed backfill (1033) of the southern mill pond (302) is also visible; view north-west*

To the south-east of this building were a group of features which related to the track, and the southern mill pond. Although no road surface was observed during the works, the alignment of wall (1025) suggests that it formed a retaining wall between the track and the mill pond (302) to the south. This wall, which was constructed of iron slag bricks, was exposed for 14.60m length and presumably also acted as a dam for the mill pond (Plate 8). To the north a short section of a corresponding brick wall (1029) was also observed. Although the wall was truncated a clear cut (1031) between a disturbed yellowish sandy clay (1032), which would have laid under the track, and rubble infill of the channel to the north, continued on the same alignment towards the north-east.
